# BOK KAI TEMPLE

## Historic Structure Impact Report

Prepared for  
HDR, Inc.

Prepared by  
Garavaglia Architecture, Inc  
30 January 2013

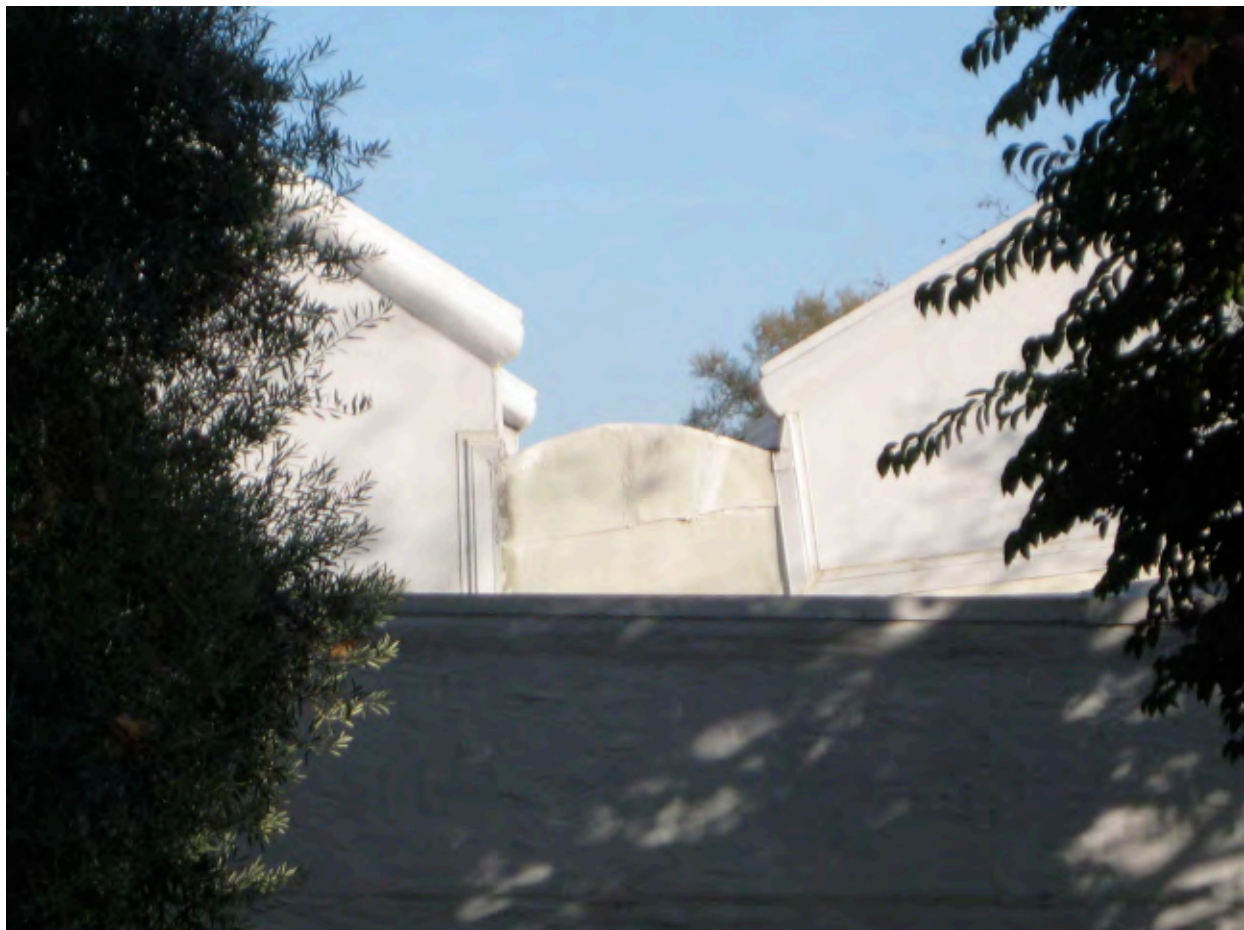
While cracking of the gable ends over the central building section has been addressed, there is horizontal cracking of the stucco on the barrel-vault roof connecting the two halves of the central building section (Figure 5). It is unclear if this is an active crack or a historical condition that is stable but covered by a failing surface coating.

**Figure 5. Horizontal crack in barrel vault.** Even though the roof was repaired and strengthened in 2006, horizontal cracking in the small barrel vaulted section is ongoing. (Photo by Garavaglia Architecture, Inc., 2011.)

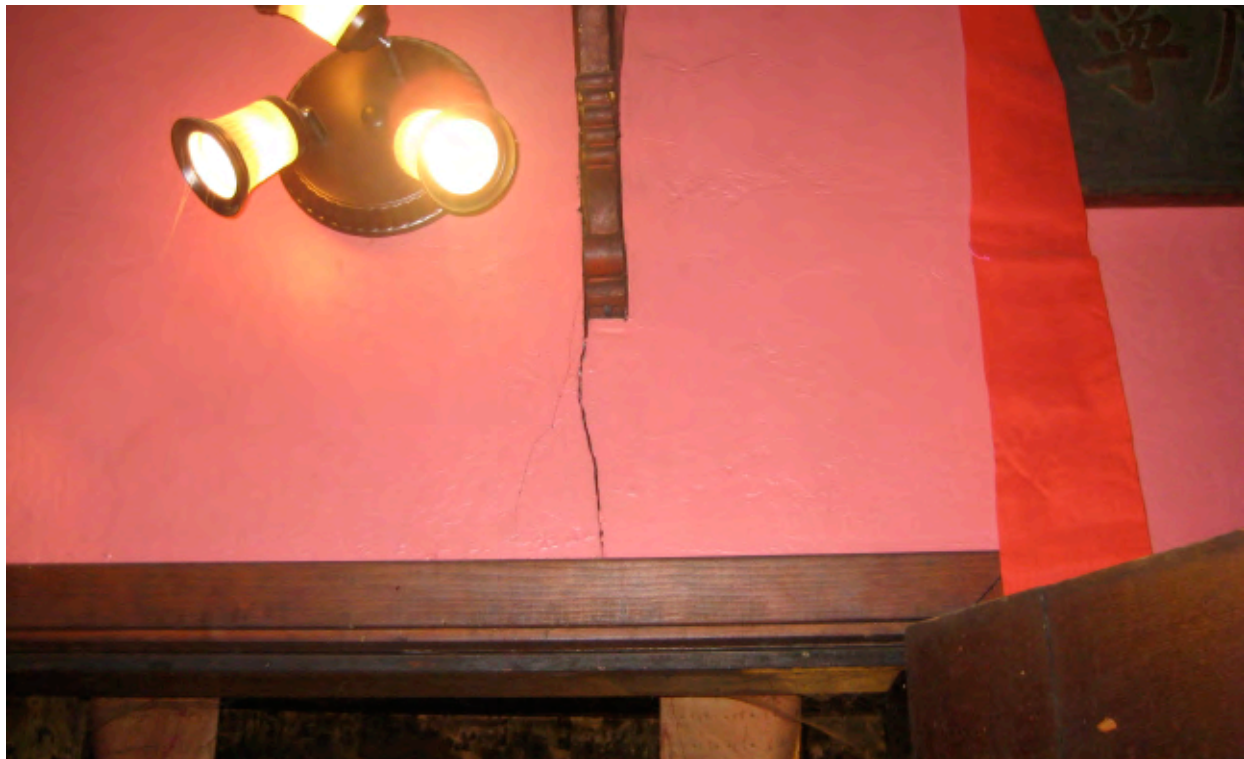
Conditions in the central section, where the main temple is located, are obscured by recently installed textured panelboard. A crack was visible above the east door, below the Threshold Screen bracket (Figure 6). The ceiling in this space is quite dark from years of burning candles and incense. The floors are newly installed stone tiles. The same tiles are used on the new altar table. They replaced a wood altar table and wood floor surface to improve fire resistance within the worship space. In general the surfaces appeared to be new and free from defects. However, a number of objects are suspended from the ceiling or attached to the wall in this section of the building. The security of these connections is questionable.

**Figure 6. Crack in the new wall paneling.** This crack is above the door to the Fortune Readers's Room. The condition of the underlying brick wall could not be surveyed. (Photo by Garavaglia Architecture, Inc., 2011.)

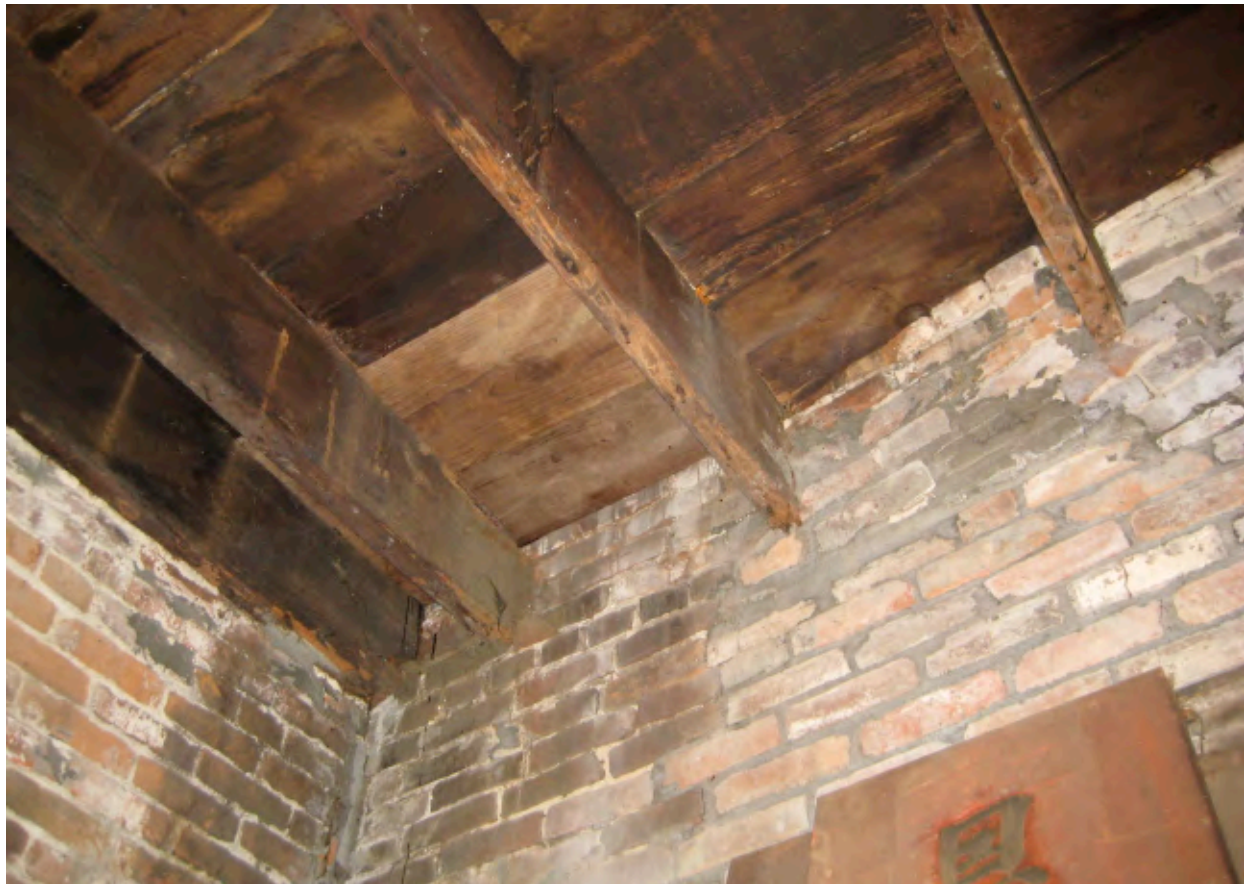
**Figure 7. Moisture staining in the Gambler's Room.** This area is near a roof drain that was improperly functioning. The area has since been repaired, but the damage is evident. (Photo by Garavaglia Architecture, Inc., 2011.)
