MARYSVILLE HISTORIC COMMERCIAL DISTRICT

Historic Structure Impact Report

Prepared for
HDR, Inc.

Prepared by
Garavaglia Architecture, Inc
30 January 2013

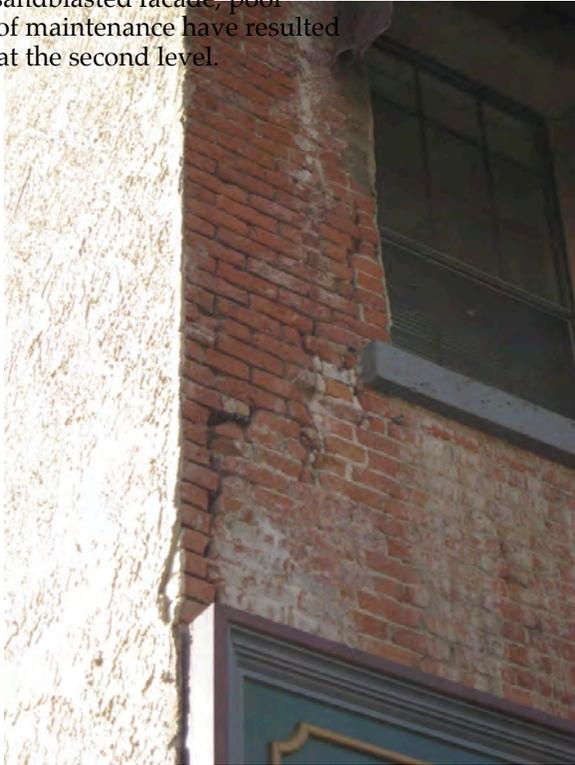
Figure 3. Crack at the northeast corner of 320 Street. The sandblasted facade, poor mortar, and lack of maintenance have resulted in loose material at the second level.

Deteriorating mortar

The buildings within the historic district date to the 19th century and early 20th century. As such, the mortar had a low Portland cement content (potentially no Portland cement) and a high lime content. This results in a softer mortar that typically used today in modern construction. Like all materials, mortar requires periodic replacement to maintain the integrity of the wall. Many of the buildings along First Street have original, or very early mortar, that is deteriorating because of age, impact damage from sandblasting, and water exposure from improper roof drainage. The worst locations have mortar that can be raked from joints by hand, leaving bricks ill-secured and vulnerable to small surface impacts, including low-level vibrations.

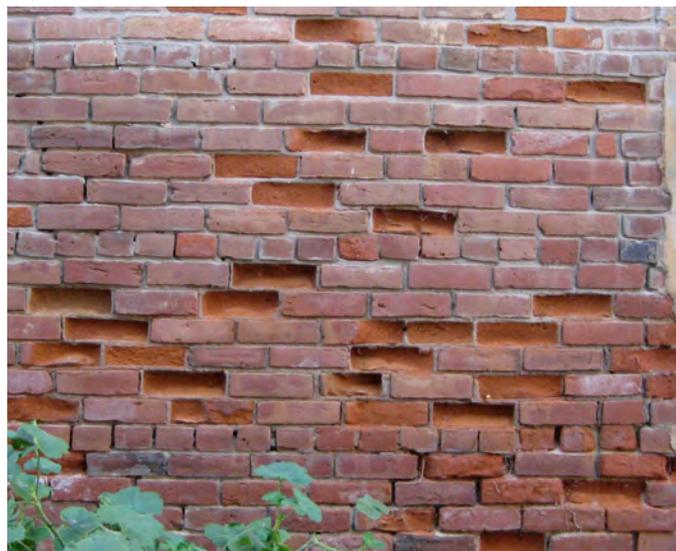
Improper repairs

Where historic materials have deteriorated, modern materials have been used for repairs. Historic brick and mortar is much softer than modern counterparts. As water travels up the wall, it carries dissolved salts and other impurities with it. It moves to the brick face through the easiest means possible and evaporates. Generally this results in a surface layer of salts and other materials that have come out of solution. In a traditional system, this evaporation happens through the softest part of the wall, the mortar. Mortar is easily repaired and in high-lime mortars, somewhat self-repairing. Where modern materials have been introduced, water is forced into the historic wall sections. This forces an increased amount of salts to crystallize at the face of the historic brick.

Figure 4. Spalled brick, typical. The quality of brick varies throughout the district. Poor brick and improper repairs have led to widespread failure of many units.

Crystallization is an expansive process that ends up causing spalling of the fired brick face. The soft inner volume then washes away with repeated moisture exposure leaving voids in the wall, framed by the modern, harder, less permeable mortar.

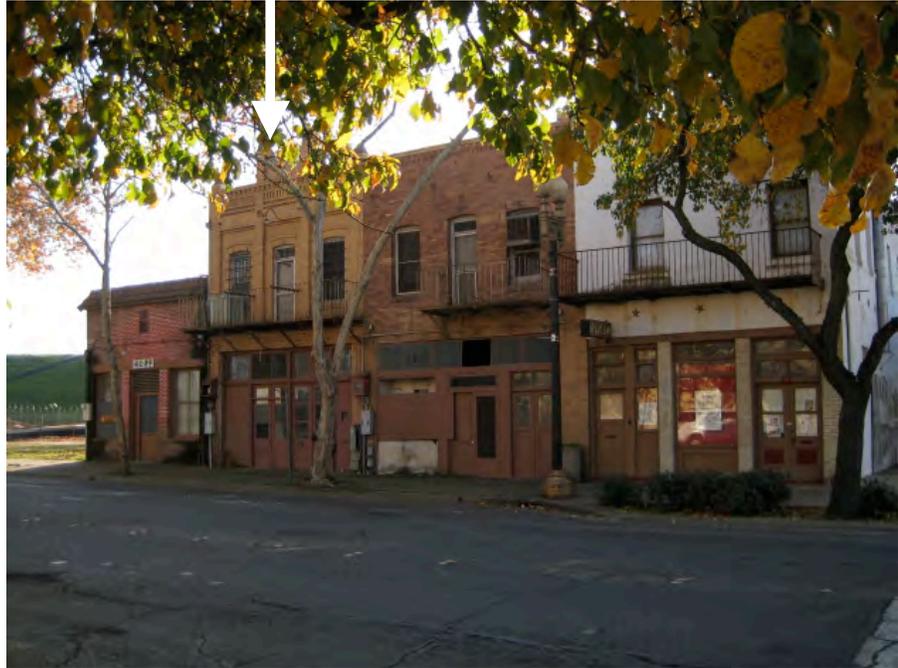
- Walls
 - Exposed brick (front)
 - Stuccoed brick (east and south)
- Floors
 - Wood framed
- Roof
 - n/a
- Foundation
 - n/a
- Seismic or other strengthening
 - No seismic retrofit work apparent.
- Other
 - Tall parapet is not braced
 - Appears to share a party wall with 230 First Street

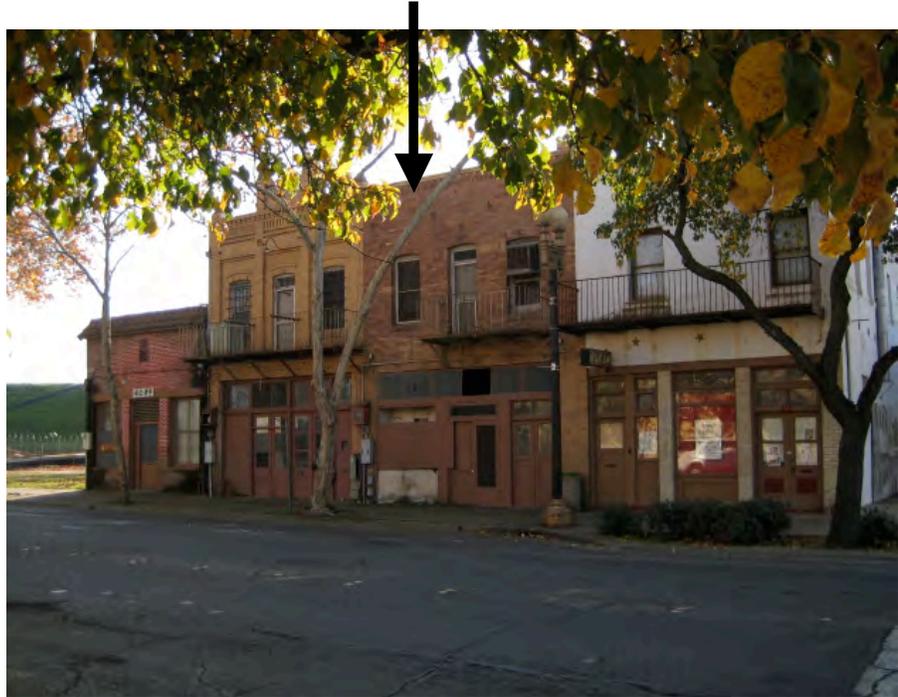
- Walls
 - Exposed brick
- Floors
 - Wood framed
- Roof
 - n/a
- Foundation
 - n/a
- Seismic or other strengthening
 - No seismic retrofit work apparent.
- Other
 - Parapet is not braced

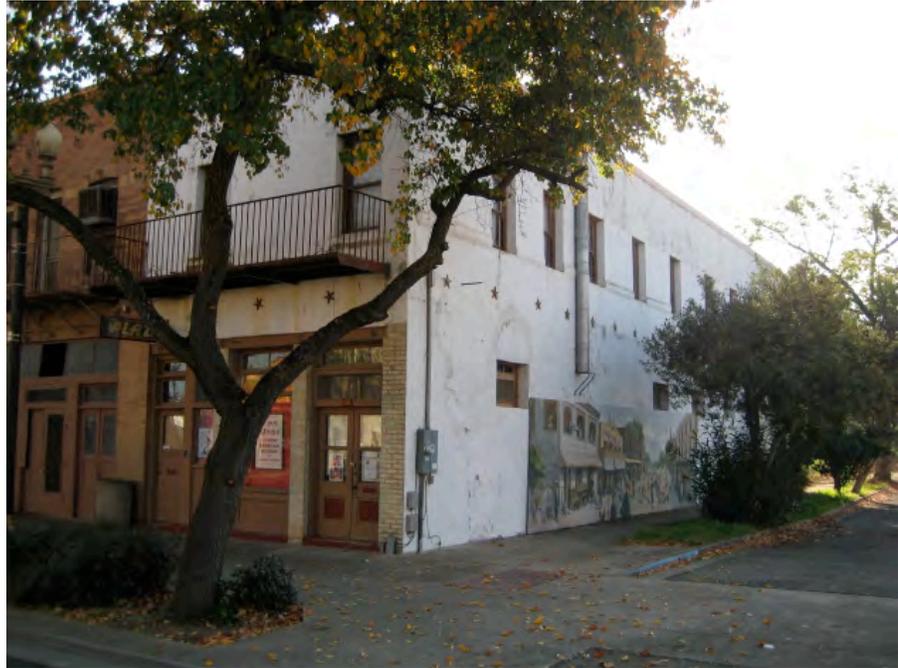
- Walls
 - Stuccoed brick with murals
 - Wood and exposed brick storefront
- Floors
 - Wood framed
- Roof
 - n/a
- Foundation
 - n/a
- Seismic or other strengthening
 - Minimal bolting (note stars in the above image) at the second floor level noted
- Other
 - 1st floor museum, 2nd fl apartment and meeting room
 - settlement noted on 2nd floor at NW corner

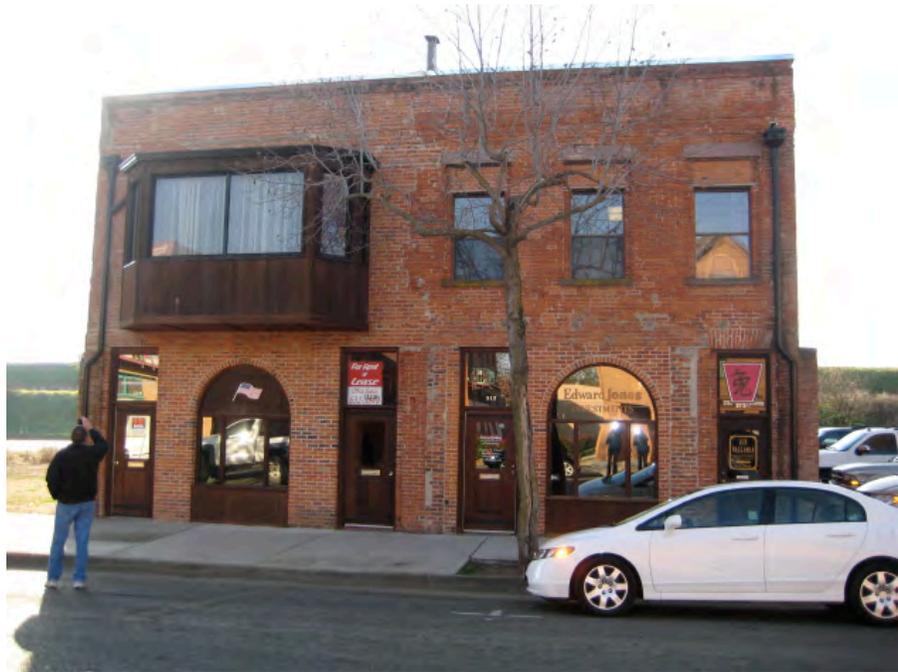
- Walls
 - Exposed brick walls (front and west)
 - Sanded stucco finish on brick walls (east)
- Floors
 - Wood framed (suspected)
- Roof
 - n/a
- Foundation
 - n/a
- Seismic or other strengthening
 - No seismic retrofit work apparent.
- Other
 - Parapet bracing is unknown.
 - Interior brick sealed
 - Thru-wall crack on west wall

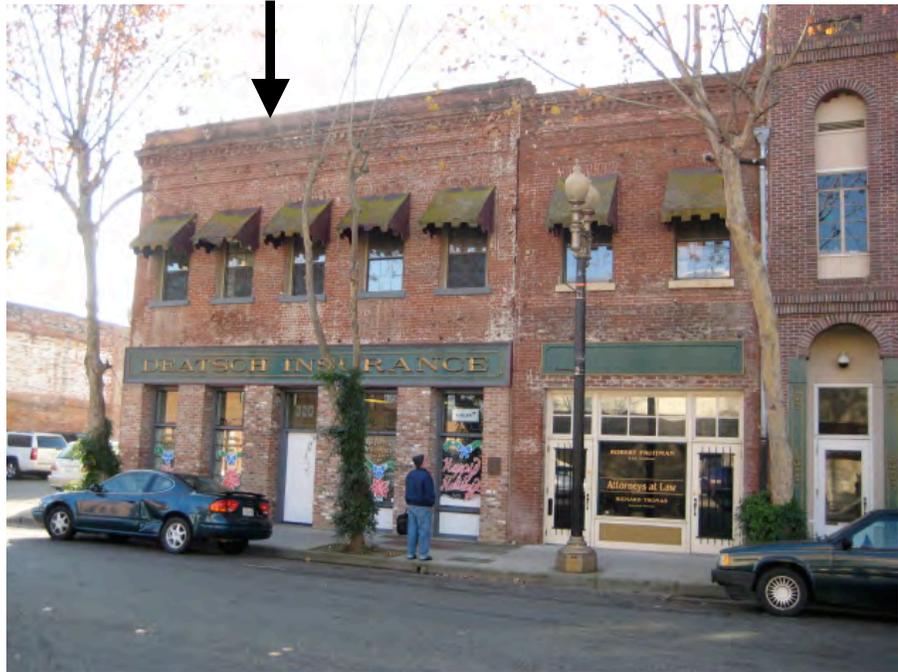
- Walls
 - Exposed brick walls (front)
 - Rough stucco finish on brick walls (side)
- Floors
 - Wood framed (suspected)
- Roof
 - n/a
- Foundation
 - n/a
- Seismic or other strengthening
 - Minimal bolting at the second floor level noted
 - Does not meet current codes
- Other
 - No parapet bracing
 - Seismic retrofit in 1980s
 - Back section is 8-10" below grade
 - Openings in party wall infilled – former exterior wall
 - Floor slopes toward rear
 - Roof drains may not be functioning
