# 2012 ANNUAL EROSION RECONNAISSANCE ENGINEERING REPORT

Sacramento River Bank Protection Project  
Sacramento River and Tributaries

**February 2013**

**SACRAMENTO DISTRICT**

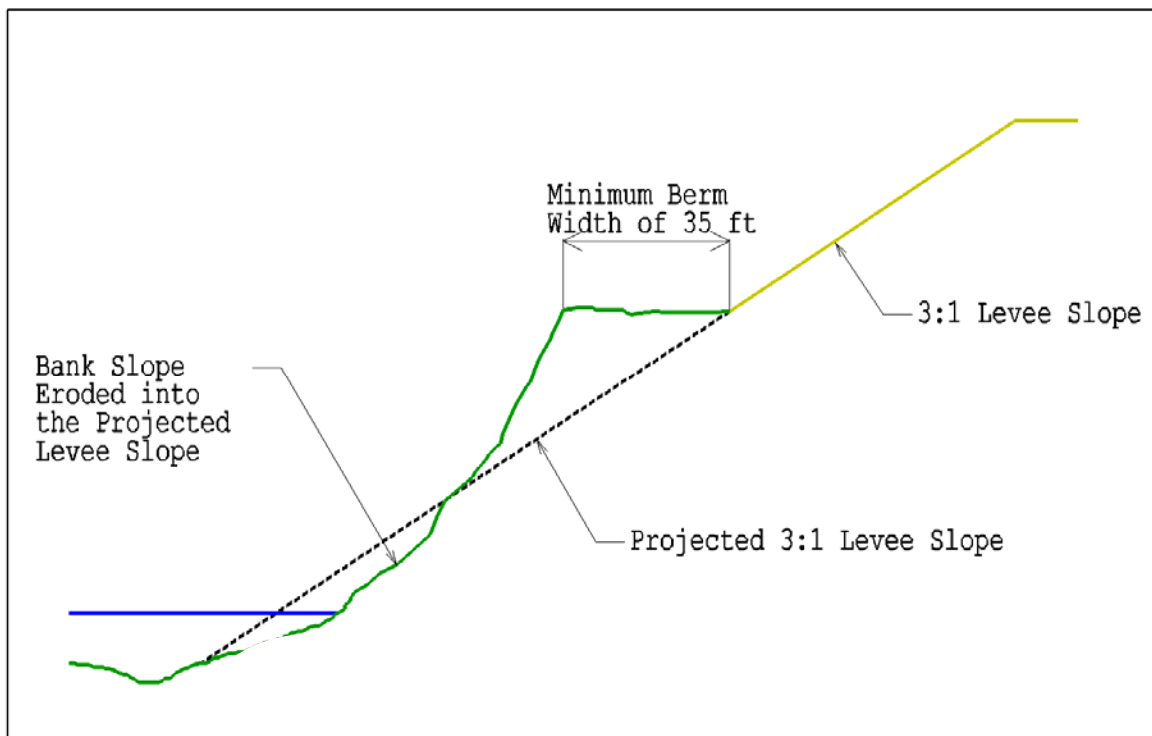
The criteria for when an erosion site should be added to the inventory is if the erosion is into the projection of the 3H:1V levee slope, as shown in **Figure 3**. If a berm is present on an eroding bank, the site is added if the berm is typically less than 35 ft (this distance may vary given the levee height). There are areas in the SRFCS where the bank is visibly eroding, but if the erosion is away from the projection of the levee slope, then it does not meet the criteria for an erosion site. Within the criteria, we have six (6) terms for the status of the sites as described below:

**Figure 3. Schematic of Erosion Site Criteria**

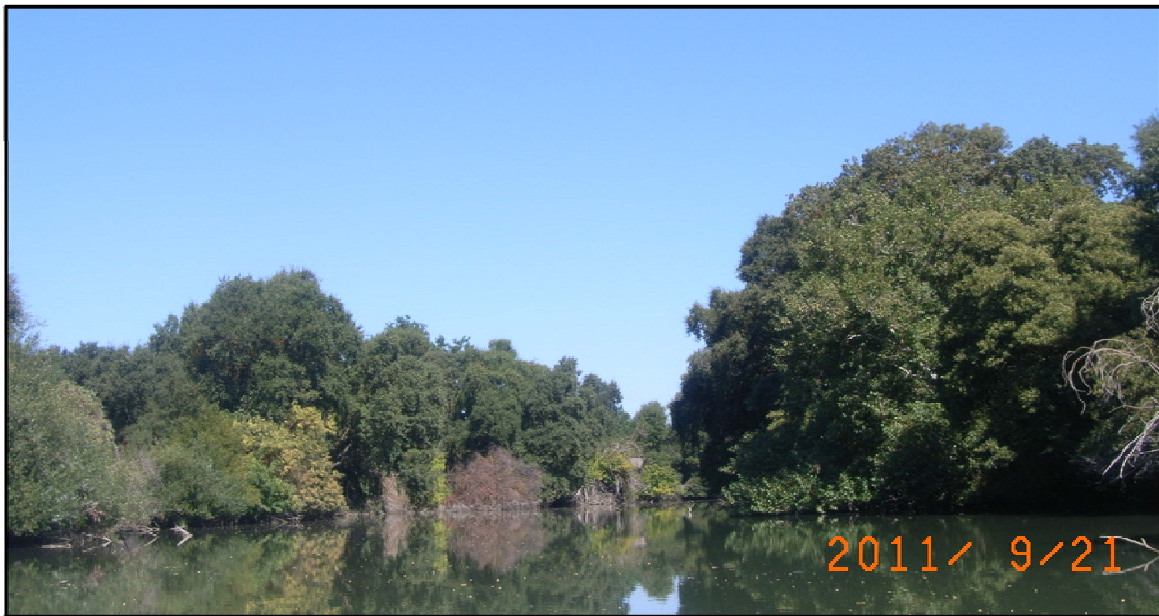
Elk Slough – Elk Slough was cut off from the Sacramento River on the upstream end by the Sacramento River levee and therefore has no inflow, it is purely a backwater channel with some tidal influence. The channel is shallow, and the banks are full of vegetation and heavily used by humans. The levee slopes are over-steepened and built out of non-cohesive dredge material. The entire levee reach is in poor condition, with slumping, holes, and slope stability problems. **Figure 12** shows a typical view of Elk Slough. With the levees being in such poor shape the entire leveed reach (right bank and left bank) is classified as an erosion site. This reach would benefit from a reach wide repair.

**Figure 12. Typical View of Elk Slough.**

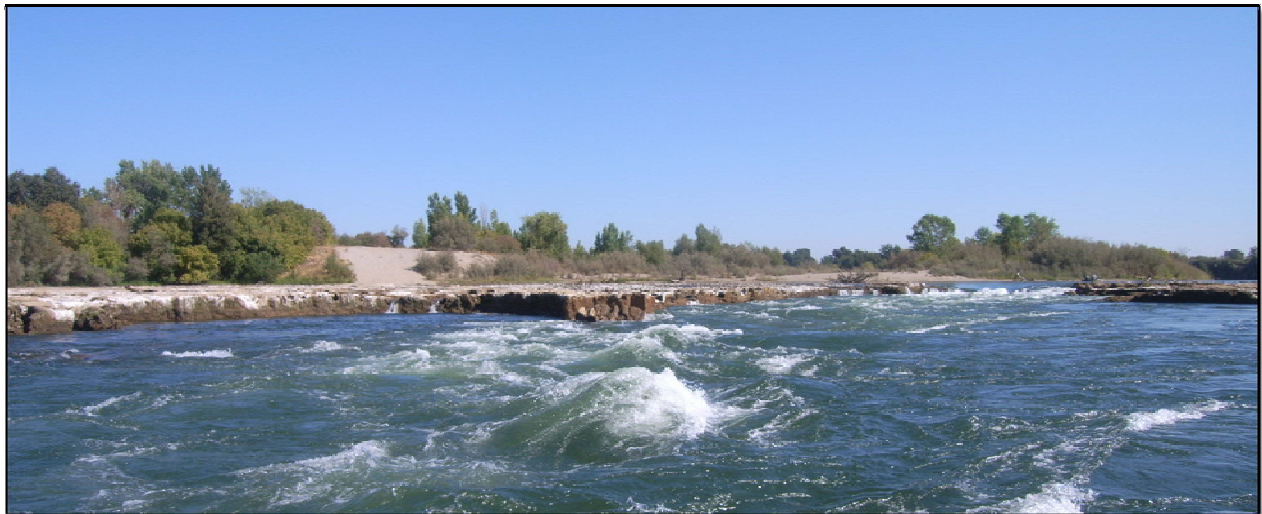
Middle Reach of the Feather River, South of Yuba River (RM 28 to RM 7) – The middle reach of the Feather River is wide and shallow and has a large amount of sand bedload coming from the Yuba River. There is a large clay plug at RM 24.8 that had been slowly moving through the system. This feature acted as a grade control feature in the river and as of early February 2012, this clay plug has been breached. The impacts of this breach are not yet known, but there will most likely be further erosion to the system and potentially new erosion sites in the future. **Figures 15** shows the clay plug in its current state. The levees are setback in this reach and a new setback levee was recently constructed on the left bank from RM 25 to RM 18. The primary causes of erosion in this reach are fluvial and mass failure of eroded banks. There is currently one erosion site in this reach of the Feather River.

**Figure 15. View of Clay Plug on the Feather River at RM 24.8 in late 2012.**

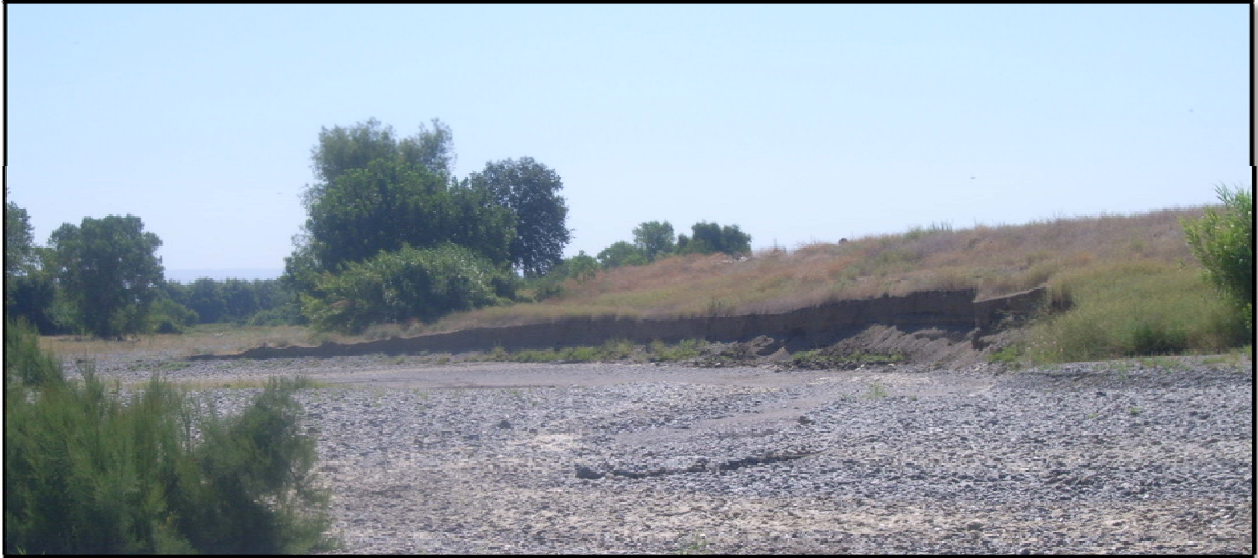
Elder Creek – Elder Creek is located in the upper Sacramento Valley, it flows from the east side of the Coastal Mountain range and ends at the Sacramento River near RM 230. Only portions of the creek, near the lower end, are leveed to protect the towns of Gerber and Tehama. Elder Creek is an incised channel with short levees. The channel meanders through a gravel bed and has multiple point bars. The primary mechanisms of erosion are fluvial and whole bank failure. **Figure 20** shows a typical view of Elder Creek channel and eroding bank. There are currently two (2) erosion sites on this creek.

**Figure 20. Typical View of the Channel and Eroding Bank of Elder Creek.**

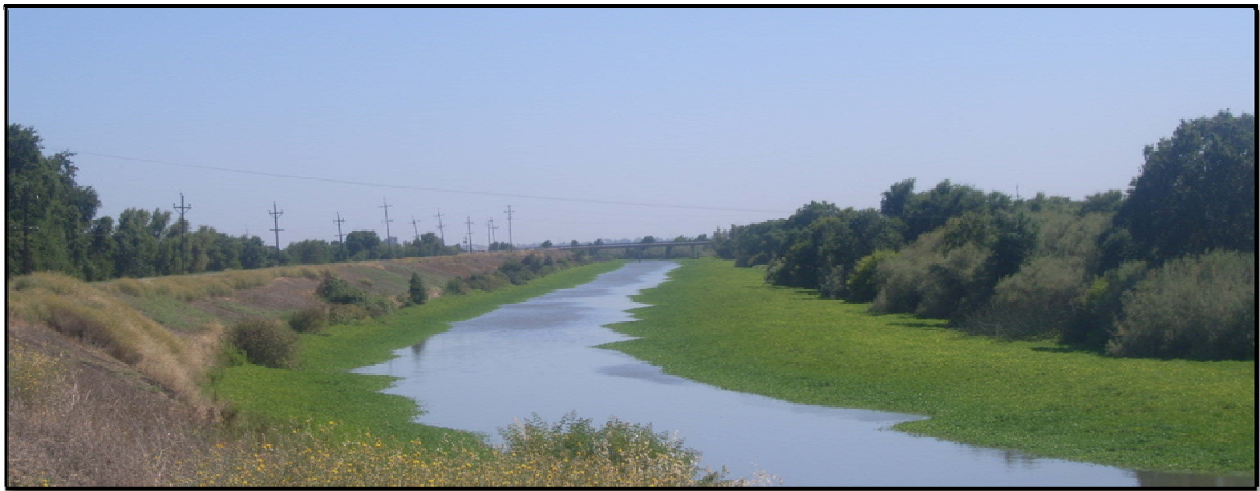
Knights Landing Ridge Cut – The Knights Landing Ridge Cut runs from the Colusa Basin Drainage Canal to the Yolo Bypass. The levees are in poor condition with steep slopes and slumping of the toe throughout most of the system. There are cracks along the middle of the left levee crest that may indicate potential

mass movement and further slumping. **Figure 23** shows a typical view of the Knights Landing Ridge Cut. There are seven (7) erosion sites in this reach.

**Figure 23. Typical View of the Knights Landing Ridge Cut.**
