Isabella Dam Consensus Report External Peer Review of DSAC-1 Projects

November 1, 2007

Isabella Dam Consensus Report External Peer Review of DSAC-1 Projects November 1, 2007

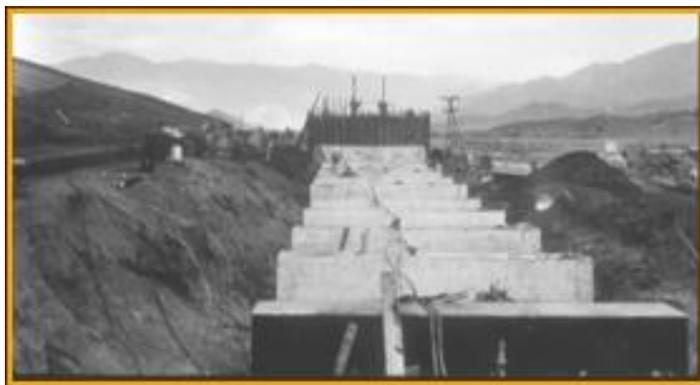
Because capacity to generate power had to be maintained, the Borel conduit (at the auxiliary dam) consisting of two barrels was constructed as shown in the adjacent picture looking downstream. The inside dimensions of both barrels are 5 feet and 8 inches by 10 feet. The conduit was founded in the alluvium deposit with the top of the seepage collars slightly below original ground.

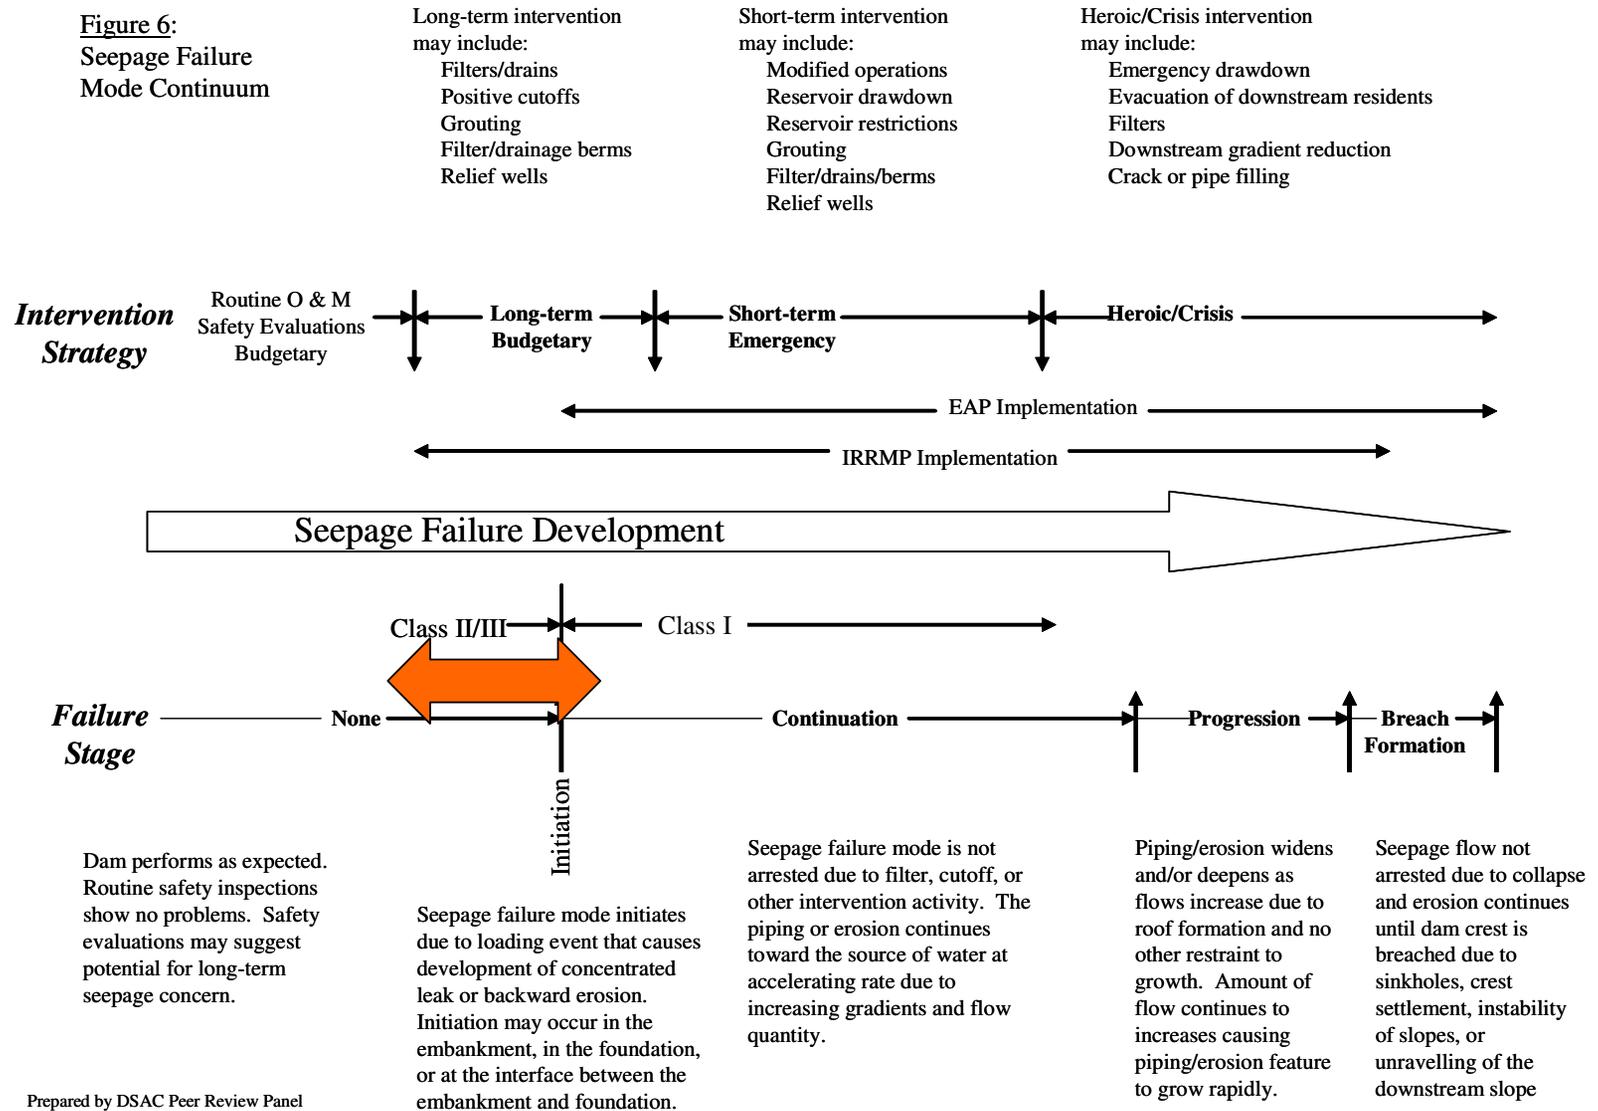
Figure 6:
 Seepage Failure
 Mode Continuum

The Panel considers that a breach formation/failure is not imminent. Seepage has occurred for a period of 53 years without any observed deleterious effects. However, the Panel notes that the pool is rarely full for sustained periods of time. Under these conditions, it is unknown if there are areas, other than at the conduit, where seepage and a potential for piping exist.

The Panel's assessment of the Auxiliary dam's condition is shown on the seepage and piping failure mode continuum diagram in Appendix B. This diagram suggests that a seepage related failure mode has initiated. The extent of the arrow on the continuum is reflective of the confidence interval of the Panel's assessment.
