1.0 BACKGROUND

Each year, personnel from the U.S. Army Corps of Engineers (Corps), Sacramento District, and their local sponsor, the California Department of Water Resources (DWR), conduct a field reconnaissance review of the Sacramento River Flood Control System. Since 1998, Ayres Associates has assisted the Corps and their local sponsors with this annual review and inventory of erosion sites. **Figure 1** shows the overall extent of waterways in this field review.

3.0 RECONNAISSANCE COVERAGE AND PROCEDURES

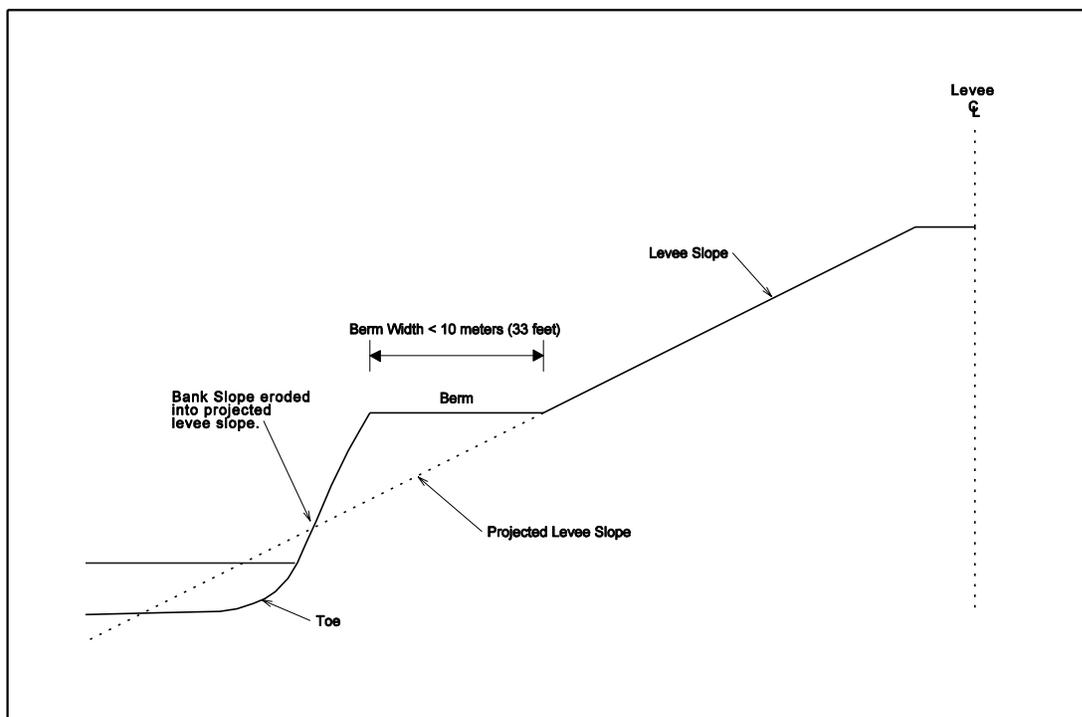
Figure 2. Schematic of Inventory Erosion Site Criteria

Figure 2 shows a schematic illustrating these two criteria.

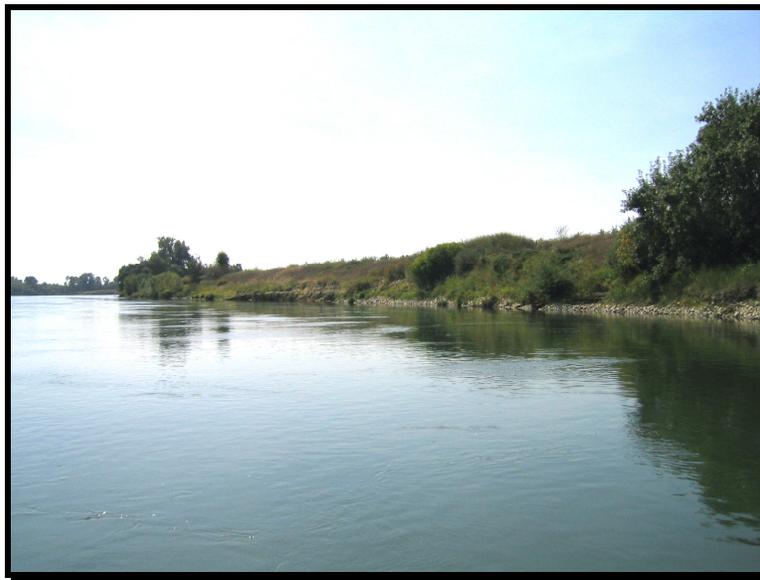
Photograph 1. Bank Erosion into the Levee Toe at RM 182R

Photograph 1 shows the inventory erosion site at RM 182R on the day of the 2003 review. The river is immediately adjacent to the levee and is cutting into the riverside slope of the levee toe. Erosion is slow at this location but continues to worsen each year.

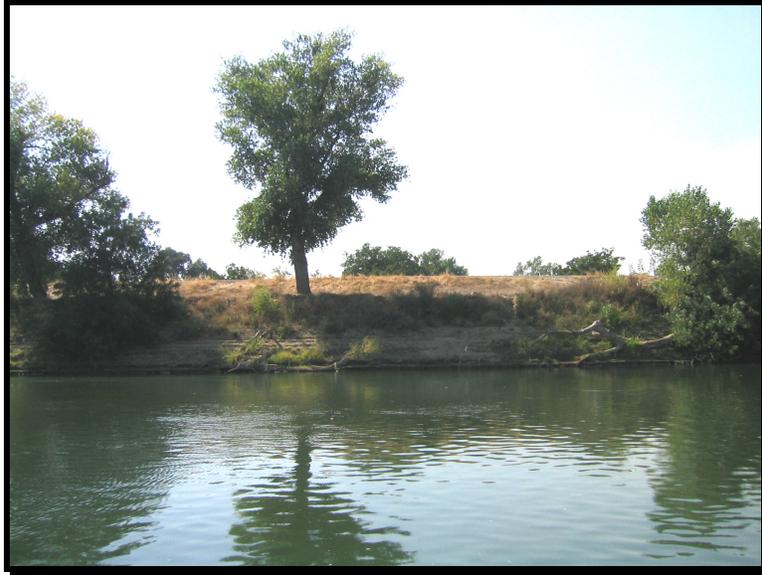
Photograph 2. Bank Erosion at RM 164R at Princeton

Photograph 2 shows one of the Contract 42F sites that plans and specifications have been prepared for but no construction activity is planned at this time. This erosion site is adjacent to the small town of Princeton. The riverbank soils appear to be somewhat erosion resistant and have slowed the encroachment rate into the levee cross section.

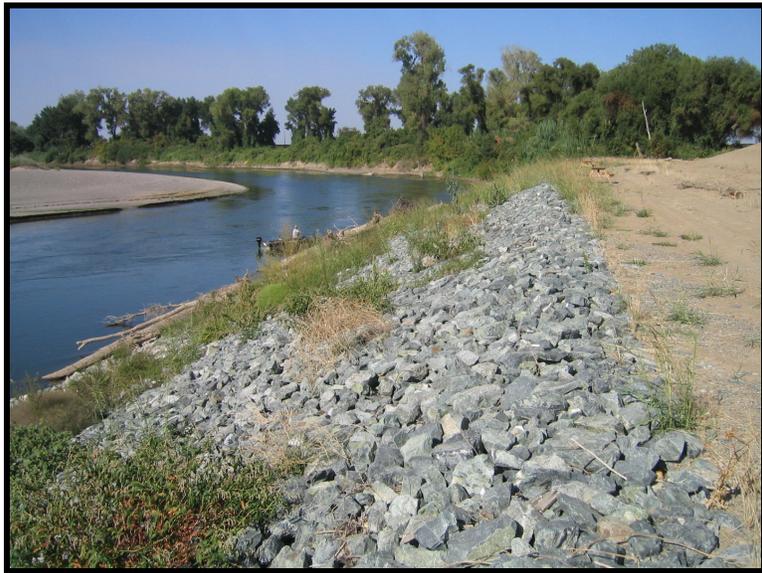
Photograph 3. Completed Bank Repair at RM 149L

Photograph 3 is of the completed repair at RM 149L. This site has been removed from the inventory.

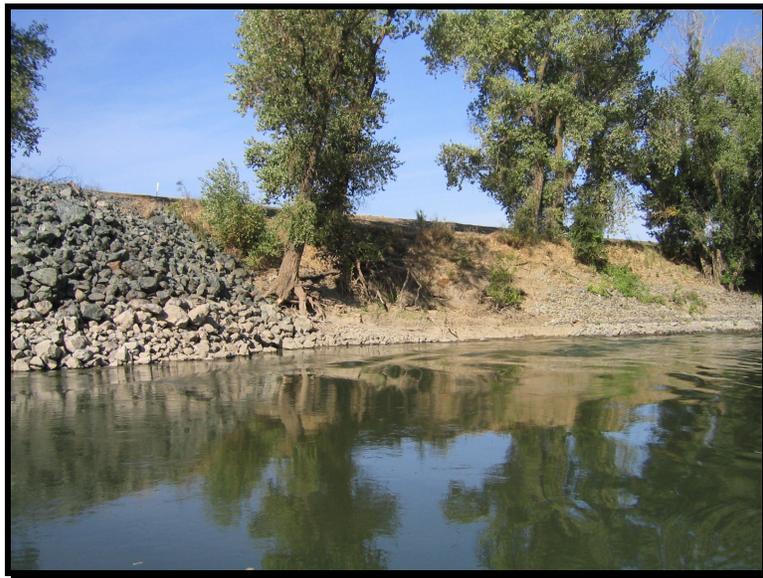
Photograph 4. Bank Erosion at RM 141.4R.

Photograph 4 shows a critical site at RM 141.4R as it looks on the 2003 inventory trip. The downstream portion of the original site was repaired between the 1998 and 1999 inventory inspections but the upstream area continues to worsen. It is very possible that the large tree within the erosion site will overturn during the next high flow taking an additional volume of soil with it. This site needs to be monitored closely during any high flow event.

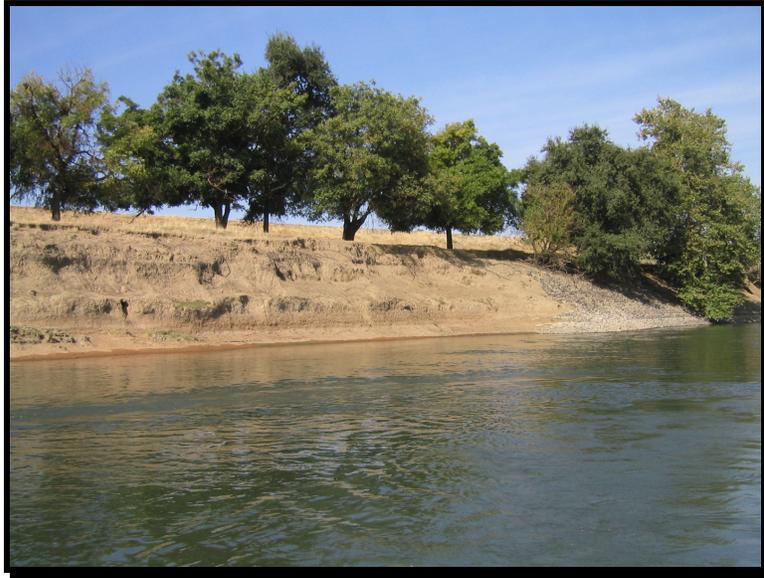
Photograph 5. Bank Erosion at RM 136.9R.

Photograph 5 shows a site that has a very steep bank where the cohesive soils in the bank appear to be slowing the erosion process. This site is located at RM 136.9R. The bank is very steep and appears unstable from a geotechnical standpoint. We have estimated the berm width at approximately 35 feet which should provide some safety factor before the bank slope encroaches into the levee crown. This site appears particularly bad because all of the vegetation has been removed by grazing with goats, which makes the site further susceptible to surface erosion.

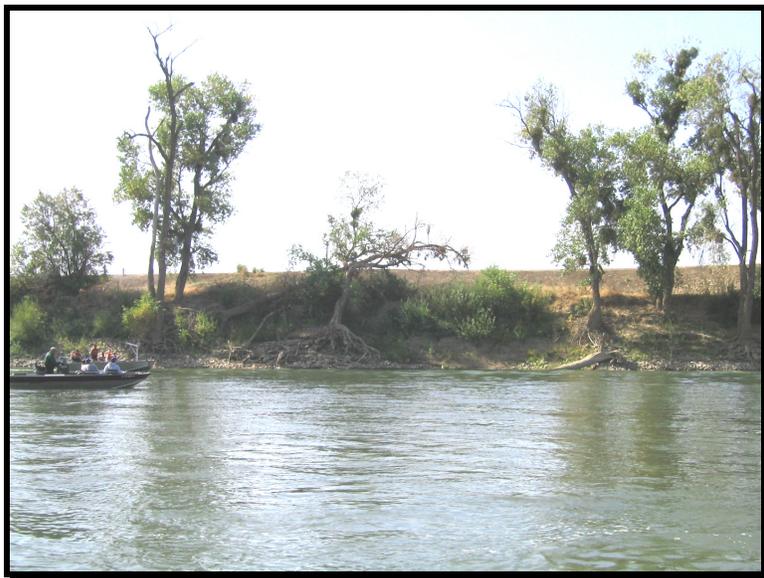
Photograph 6. Contract 42F Erosion Site at RM 130.8R.

Photograph 6 is a critical erosion site at RM 130.8R and is part of Contract 42F. This was one of the identified high priority sites following the 1997 high runoff event.

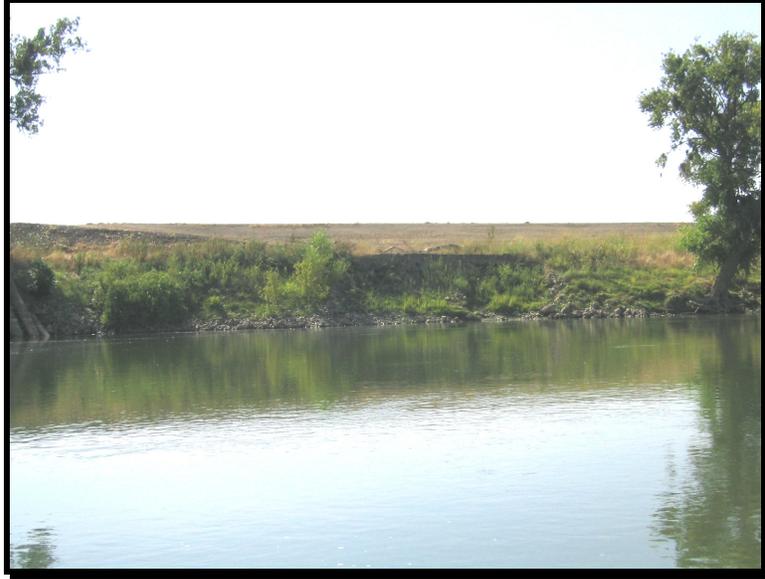
Photograph 7. Critical Erosion Site at RM 125.8L.

Photograph 7 shows damage at RM 125.8L and is a critical site. Emergency repairs were performed under PL84-99 sometime in the 1999-2000 runoff season.

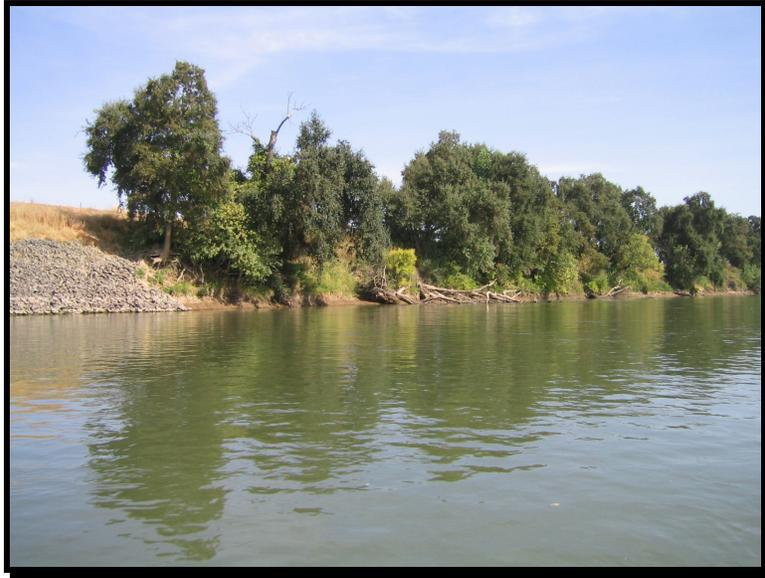
Photograph 8. Potentially Critical Inventory Erosion Site at RM 78L.

The site in **Photograph 8** is characterized as potentially critical in the inventory because the erosion appears to be slow moving and the levee top width is wide (Garden Highway is on the levee crown). However as part of another study of this area (Ayes Associates, 2002), recent bathymetric surveys of the site shows 7 feet of degradation at the toe of the slope since 1997. So while the erosion on the slope above the water line appears slow, the degradation at the toe may greatly increase the risk of a larger mass failure of the entire waterside slope.

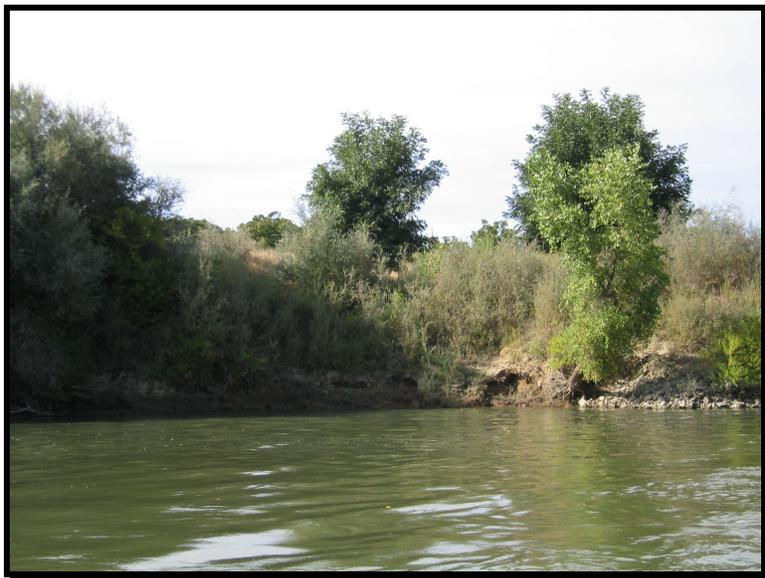
Photograph 9. Potentially Critical Inventory Erosion Site at RM 73R.

Photograph 9 is representative of the right bank of the river in this reach. Soil types in the riverbank are a mix of fine-grained silts and clays. The overall erosion rates are low but continue to encroach toward or into the projection of the levee cross section. At this particular site it appears that a tree may have overturned and caused the initial erosion scar.

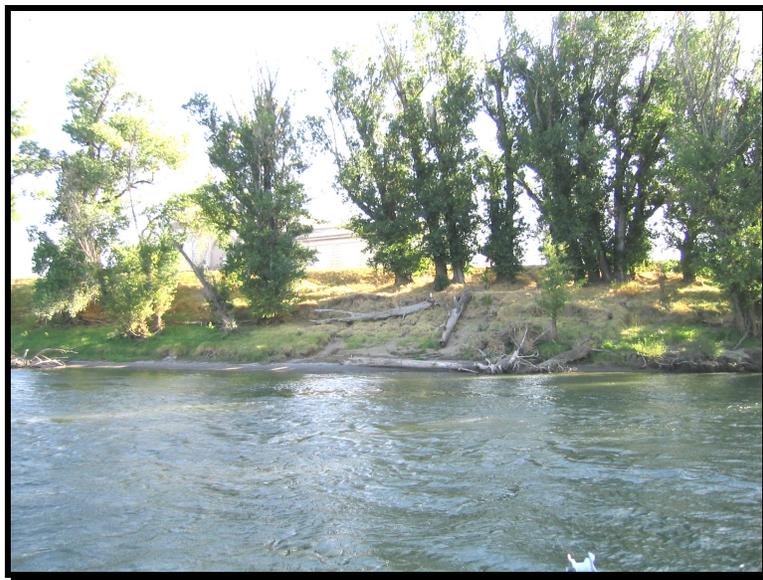
Photograph 10. Inventory Erosion Site at RM 60L.

Photograph 10 shows an erosion site on the left bank immediately downstream of the confluence with the Lower American River. Notes from past reconnaissance trip (2000) state that this may be caused by turbulence from the old City water intake tower. Subsequent two-dimensional hydraulic modeling performed for the Corps showed that the tower has little influence on the velocities at the riverbank (Ayres Associates, 2001).

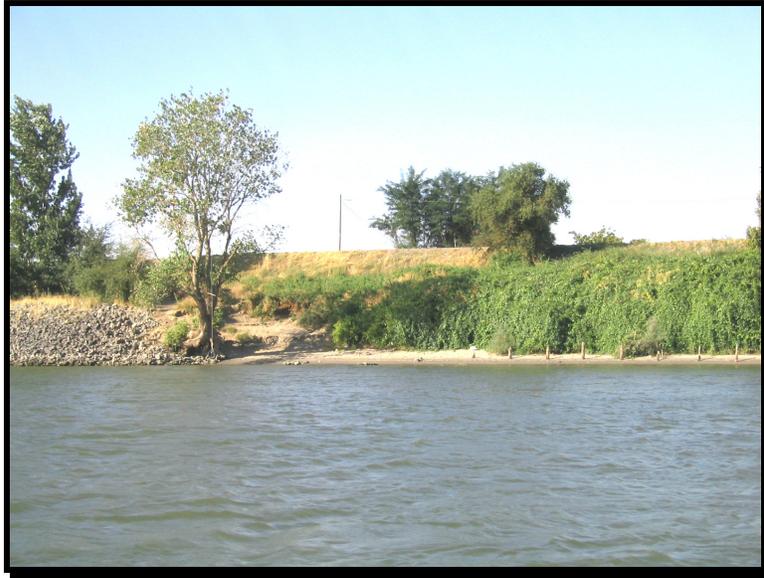
Photograph 11. Inventory Erosion Site At RM 56.5R.

Photograph 11 shows erosion of the mid-bank portion of the levee. Levee soils at this location are typically fine silty sandy materials.

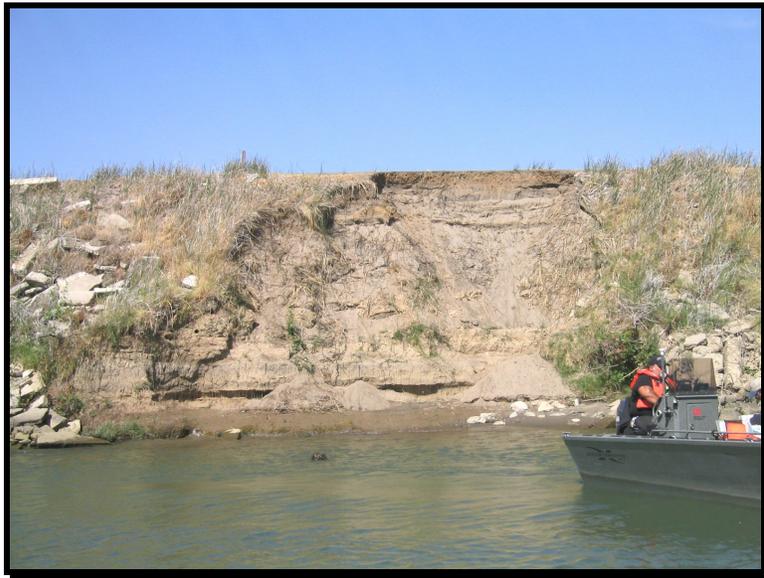
Photograph 12. New Inventory Erosion Site at RM 34.5R

Photograph 12 shows new erosion at an old erosion site that was at one time dropped from the inventory because it was small enough to be considered a maintenance site. Last years flows produced this new erosion pocket and this is now recommended as a high priority for repair.

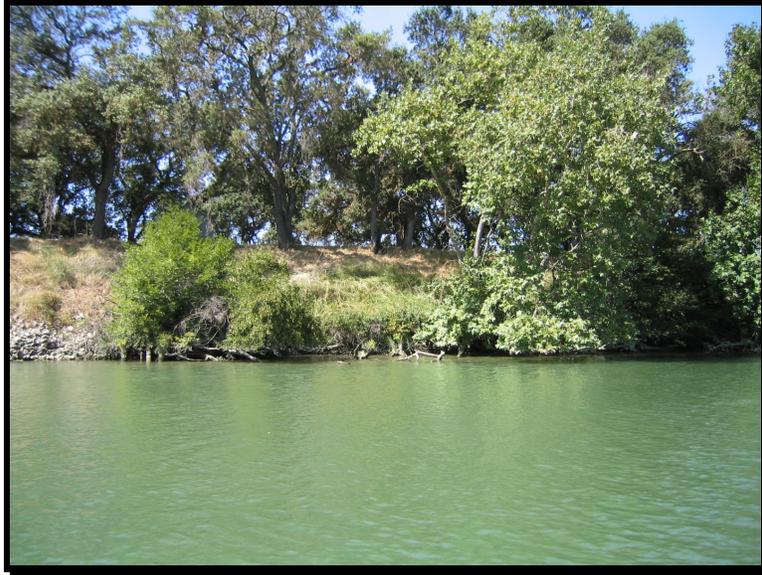
Photograph 13. Inventory Erosion Site on Steamboat Slough, RM 23.9R

Photograph 13 shows a typical erosion site in this part of the system.

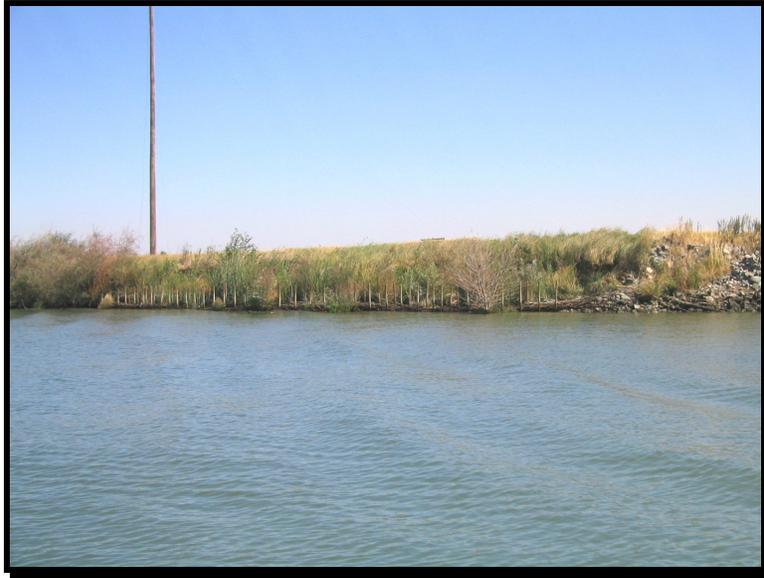
Photograph 14. Inventoried Erosion Site on Georgiana Slough, RM 2.3L.

The site depicted in **Photograph 14** shows significant erosion into the toe of the levee slope and a subsequent repair using a biotechnical approach. These repairs have been initiated by R.D. 563 and have been placed within the last two years. The repair consists primarily of a matrix of staked brush or branches (trade name “brush box”) with selected live plantings behind this windrow. The purpose is to break the wave action, preventing further erosion of the slope and to trap sediments near the slope to rebuild the eroded bank. The roots from the live vegetation help to reinforce the eroded area and hold the sediments in place.

Even though these sites have been repaired, we have left them in the inventory. The repairs have gone a long way in preventing further erosion but do not address the loss of structural stability due to erosion into the levee slope. The possibility for additional slumping failures on the levee slope still exists. There is also some question as to the availability of sediments from the river to deposit and re-establish the levee banks.

7. The biotechnical repairs on Georgiana Slough are helping to prevent further damage at these sites, however due to a low sediment load from the river, the long term stability of these repairs is uncertain at this time.

6. Further study and analysis of the biotechnical repairs on Georgiana Slough should be completed to verify their long-term effectiveness and possible use for other sites within the system.

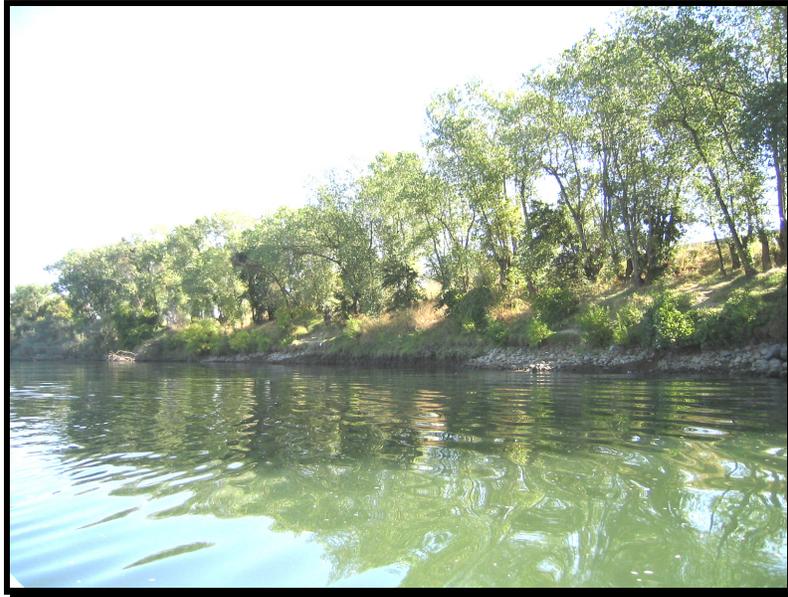
Photograph 15. Inventory Erosion Site, Feather River at RM 7L.

Photograph 15 is typical of the inventoried erosion sites in the lower reach of the Feather River and consists of toe erosion in and around old cobble revetment sites.

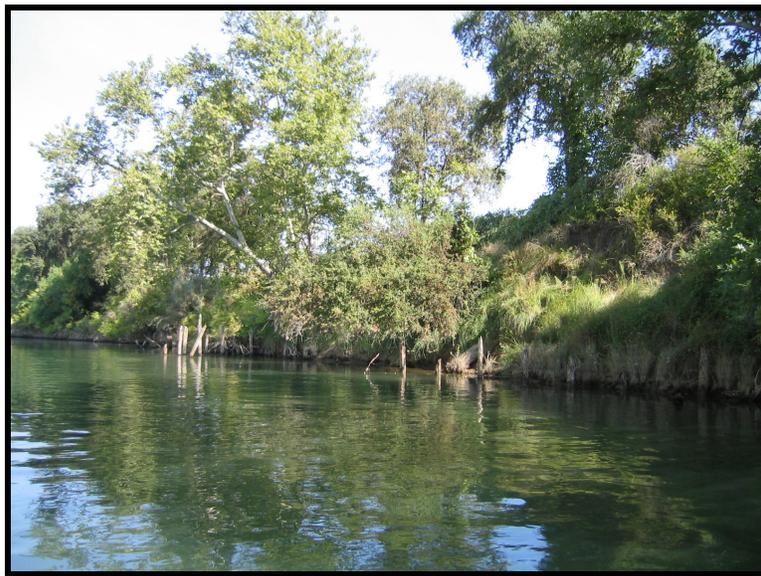
Photograph 16. Looking Upstream at RM 19.7L

Photograph 16 shows a new site at RM 19.7L. This site has a large mass failure that extends up most of the exposed river bank and appears to encroach into the projection of the levee slope.

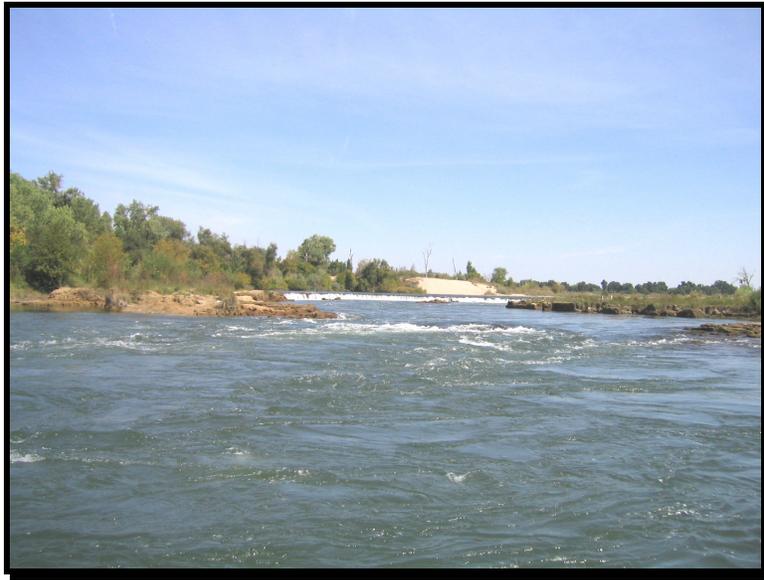
Photograph 17. Looking Upstream at a Headcut on Feather River at RM 25.6

Photograph 17 shows the headcut that is moving through the old hydraulic mining slickens layer at RM 25.6. This headcut is actively moving upstream and should be monitored to see if there is an effect on the upstream levees as this channel degradation continues upstream.

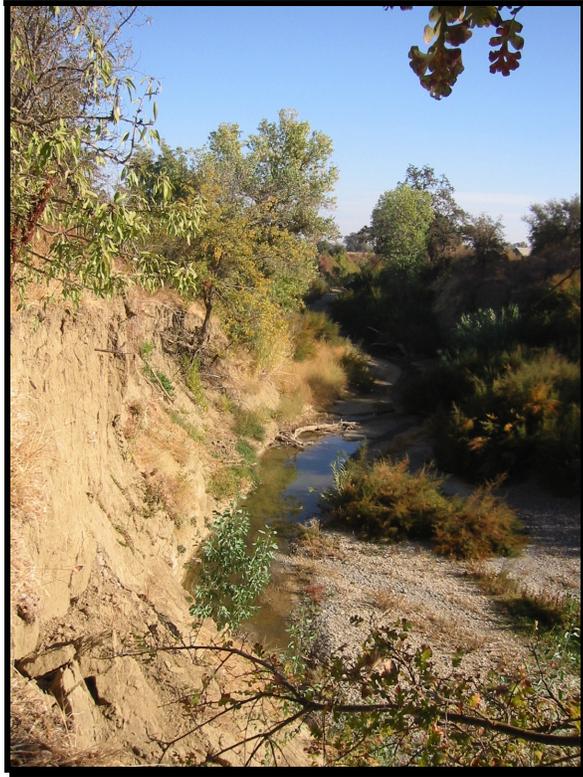
Photograph 18. 2002 Inventory Erosion Site on Cache Creek, LM 0.8 L

Photograph 18 shows the actively eroding bank of a typical critical site on Cache Creek. This bank failure is encroaching on the berm and decreasing the distance to the levee toe.

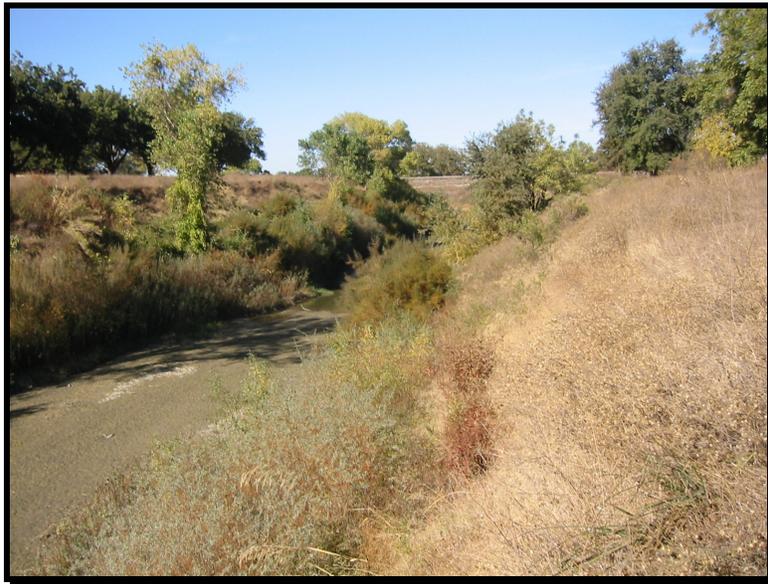
Photograph 19. 2002 Inventory Erosion Site on Cache Creek, LM 3.4 L

Photograph 19 shows a typical non-critical site in this part of the system. The banks are steep (> 2:1 slope) and eroding but still have some vegetation growing in the upper bank.
