**LAKE TAHOE BASIN FRAMEWORK STUDY  
WASTEWATER COLLECTION SYSTEM  
OVERFLOW/RELEASE REDUCTION EVALUATION**

**LAKE TAHOE, CALIFORNIA AND NEVADA**

**FINAL**

**April 2003**

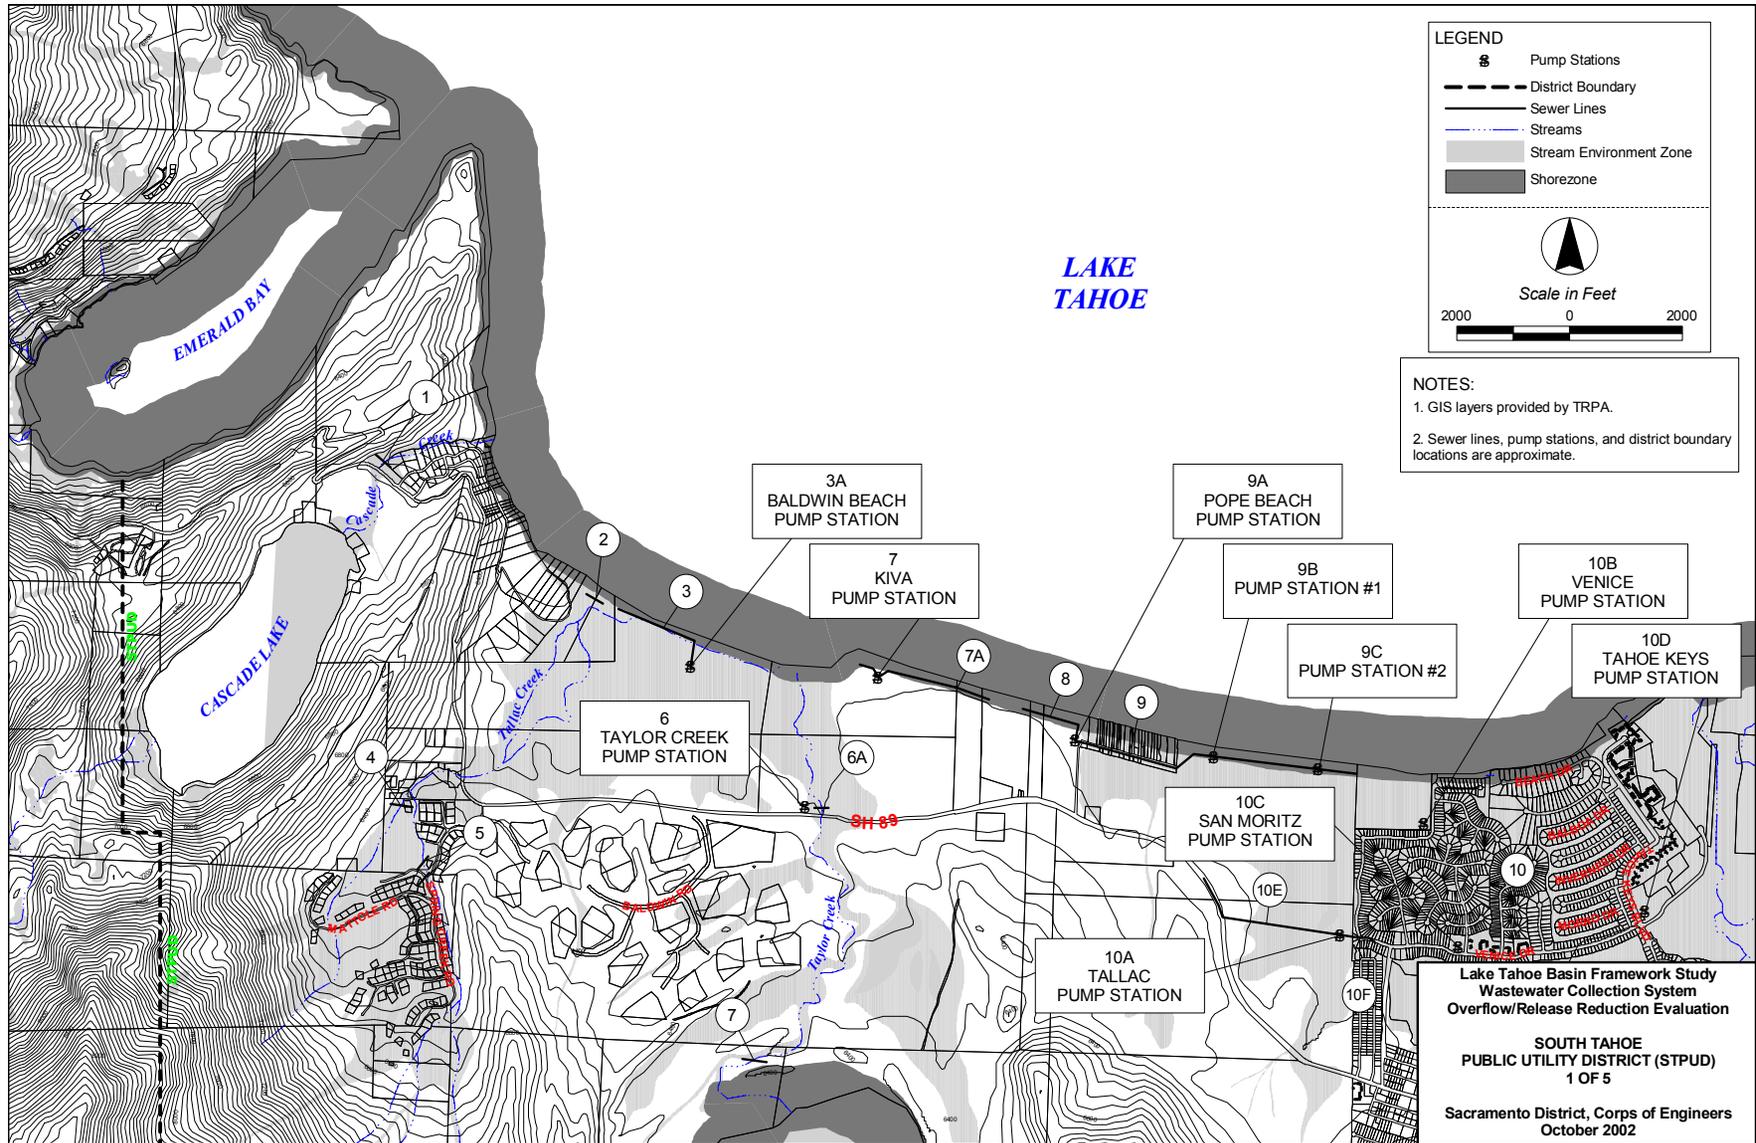
Figure 12-2

on Figure 12-1. Figures 12-2, 12-3, 12-4, 12-5, and 12-6 identify the location of potential problems with the sewer facility. Table 12-2 identifies the type and description of the facility, the category, the criteria, the risk factor, and then briefly describes the problem. A priority level is then assigned to the identified problem. Table 12-3 identifies the problem, lists several alternative measures, and then describes a potential action plan. First costs are given for the selected measure and the priority level for each problem is listed. These measures and unit costs are discussed in more detail in Chapter 6.
