4.6.7 Edgewood Creek

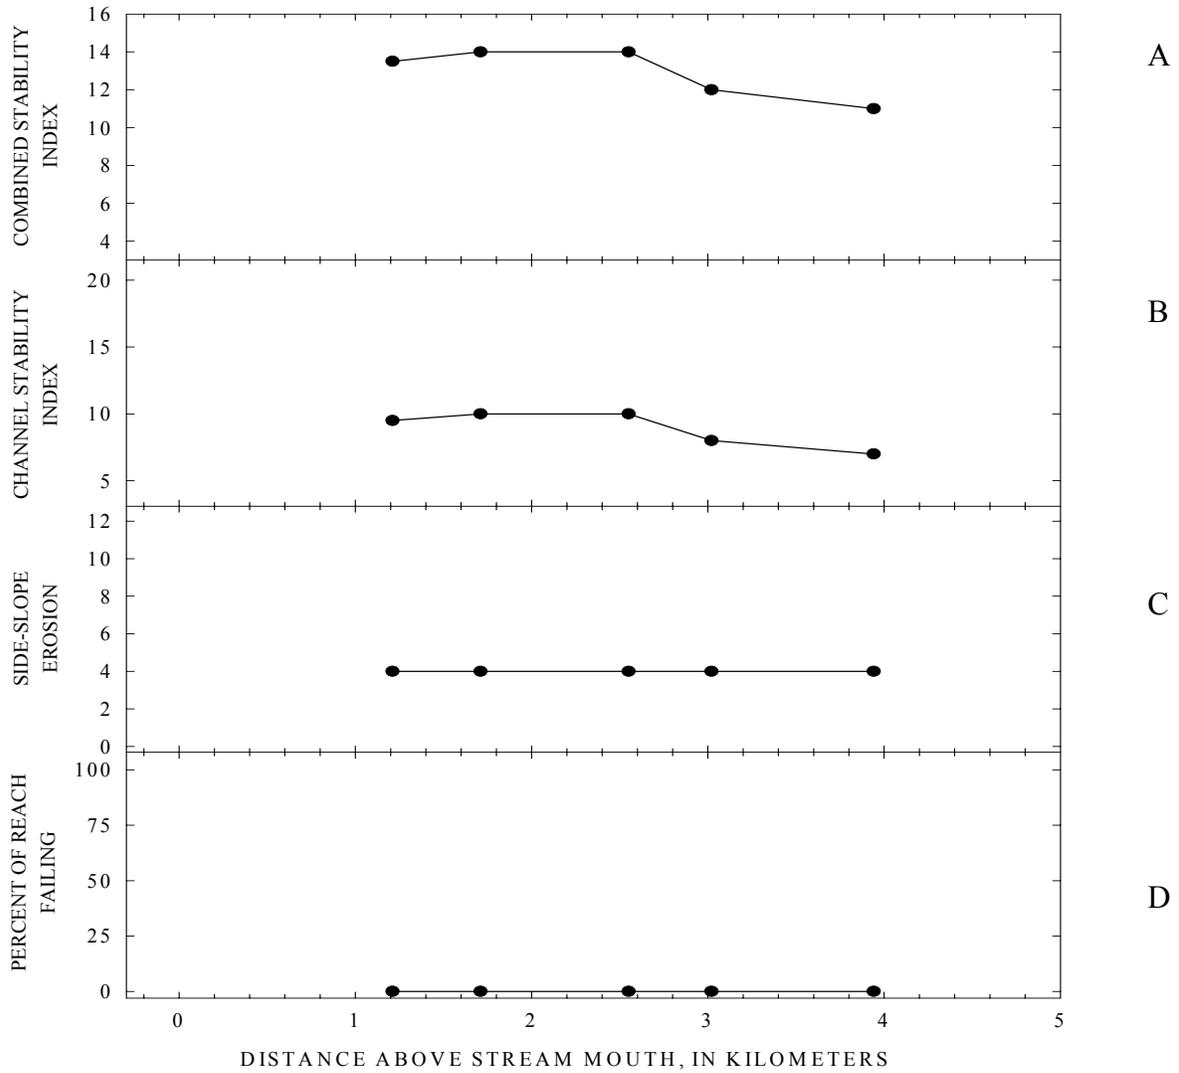
Figure 4-48. Results of RGAs conducted along Logan House Creek showing the longitudinal distribution of the combined, channel and side-slope erosion indexes, and the percent of reaches undergoing streambank failures.

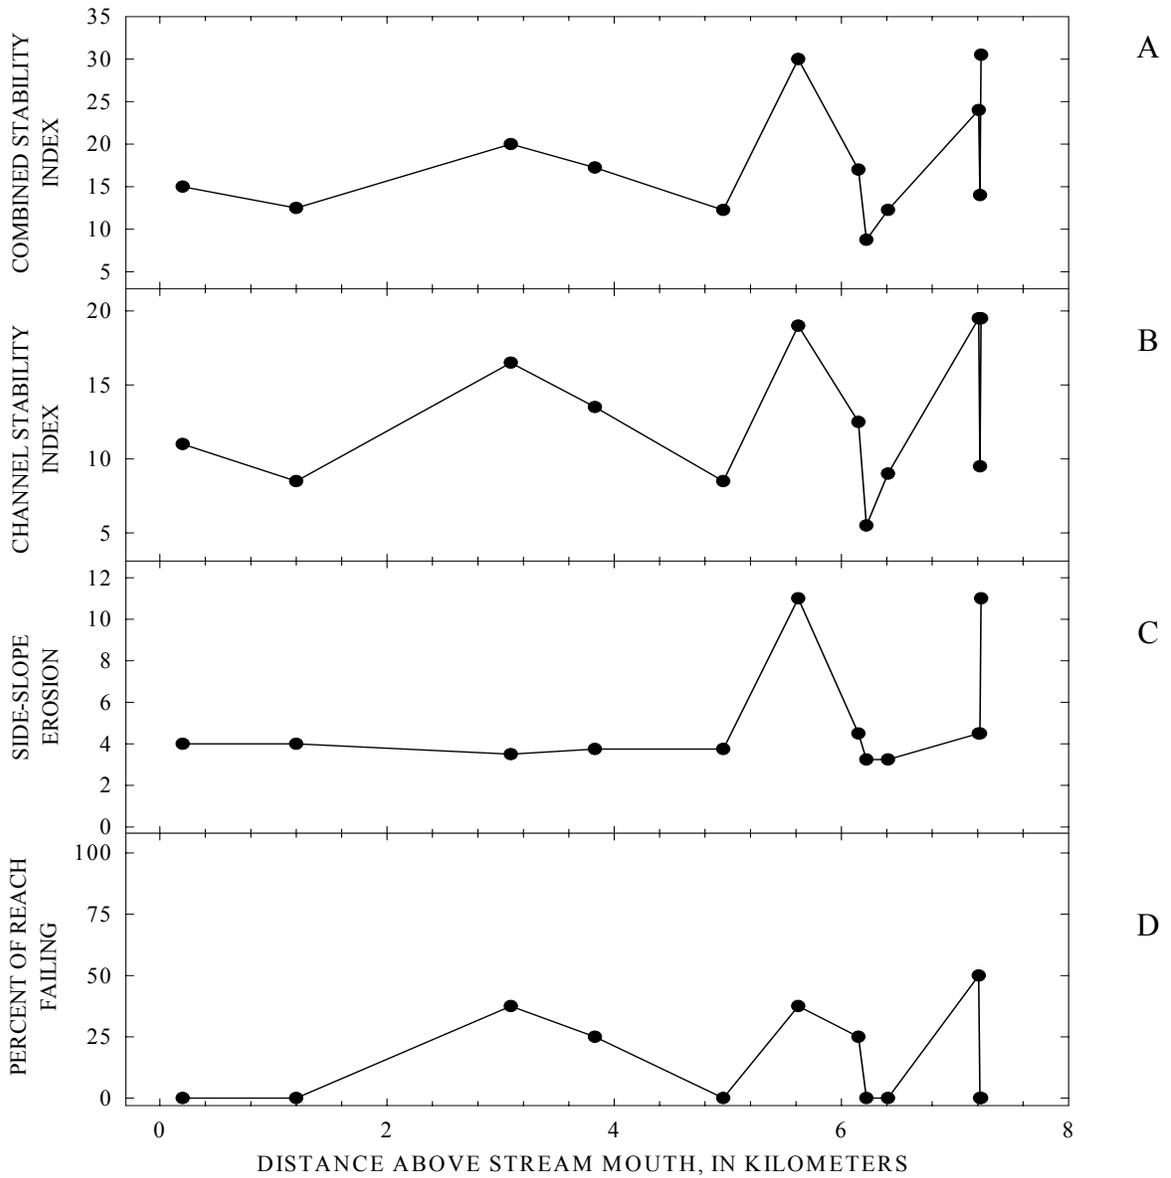
Edgewood Creek, based on limited data, overall appears to have a low quantity of fine material readily available for erosion through fluvial action. The channel is stable along its lowest 5 km (Figure 4-49 A) and, although the channel becomes less stable near the headwaters, the fact that the channel is physically small limits the amount of sediment that can be liberated during a high flow event (Figures 4-49 A-D). Overall fine-sediment availability from both the alluvial plain and highland is deemed low.

Figure 4-49. Results of RGAs conducted along Edgewood Creek showing the longitudinal distribution of the combined, channel and side-slope erosion indexes, and the percent of reaches undergoing streambank failures.
