## 4.0 CHANNEL EROSION AND BASIN GEOMORPHOLOGY

### 4.2 Direct Comparison of Measured Cross Sections

#### 4.3.1 Evaluation of Continuous Stream Lengths (Stream Walks)

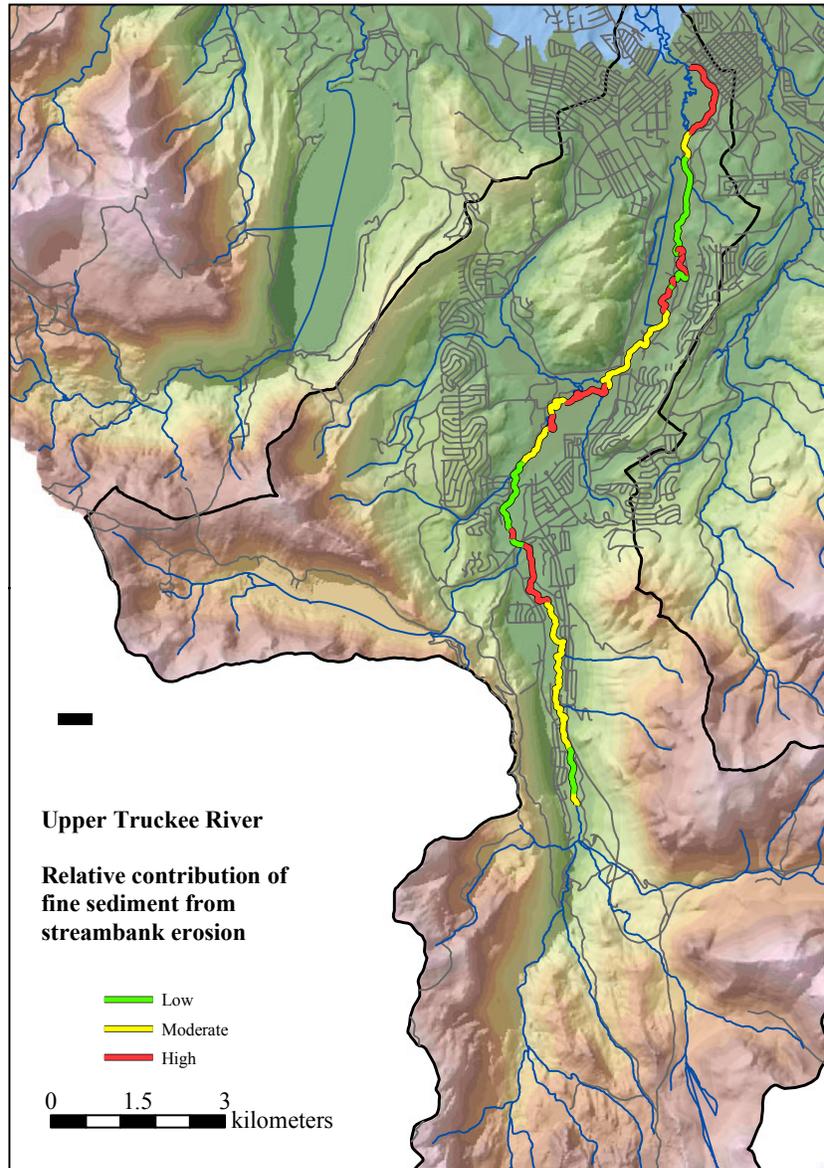
40	758975	4300020	1.5 m high eroding L bank	low
41	759073	4299718	1.5 m high undercut/slumped L bank	low
42	759072	4299677	5 m high escarpment	moderate
43	759078	4299581	2 m high slumped bank	moderate
USGS Stream Gage: 10336580

**Figure 4-14. Map of the relative contribution of fine sediment from streambank erosion for the Upper Truckee River main stem.**

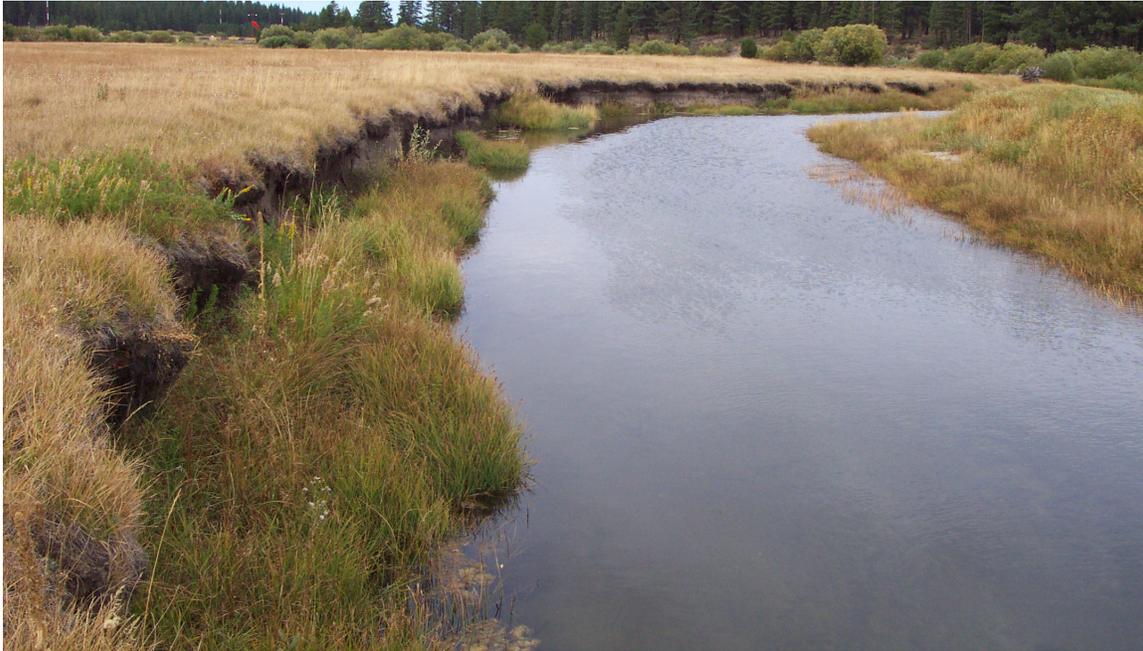
the upstream part of the reach, the frequency of sloughing cut-banks drops off, indicative of the potential role of woody plants in strengthening streambanks. The overall bank erosion potential of the reach is considered to be major (Hotspots 18-22, Table 4-7).

**Figure 4-15. A typical reach rated “high” for fine-sediment contribution due to high silt containing banks and extensive failure length. The upper-meadow reach of the Upper Truckee River.**

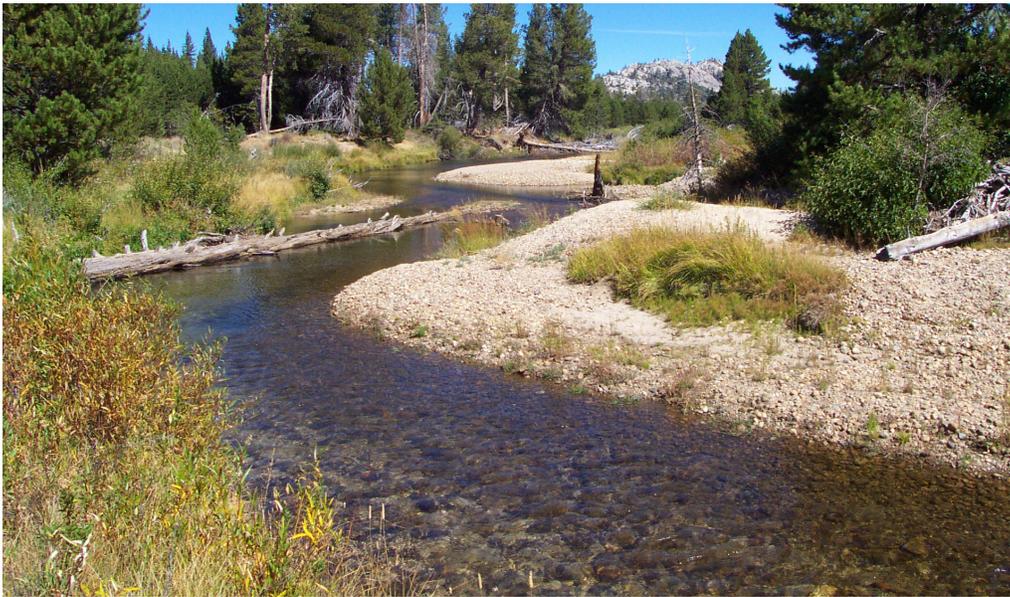
and bank materials are well sorted with sand and gravel predominant in this reach. Near the upper end of the reach bank materials transition to silt and fine sand which appear to be beaver pond deposits. Channel widening is causing undercutting and bank failure of these fine grained banks, however the bank heights, at about 1 m, and the shortness of the reach indicates this area is probably not a great supplier of fine grained material. Overall the fine-sediment availability in this reach is considered to be low due to the coarseness of available material and aggradational nature of the reach.

**Figure 4-16. Gravel-bedded aggrading reach composed of well-sorted gravel is rated “low” due to low bank heights, and coarse bed and bank material. Middle of the meandering pool-riffle reach above the golf course.**

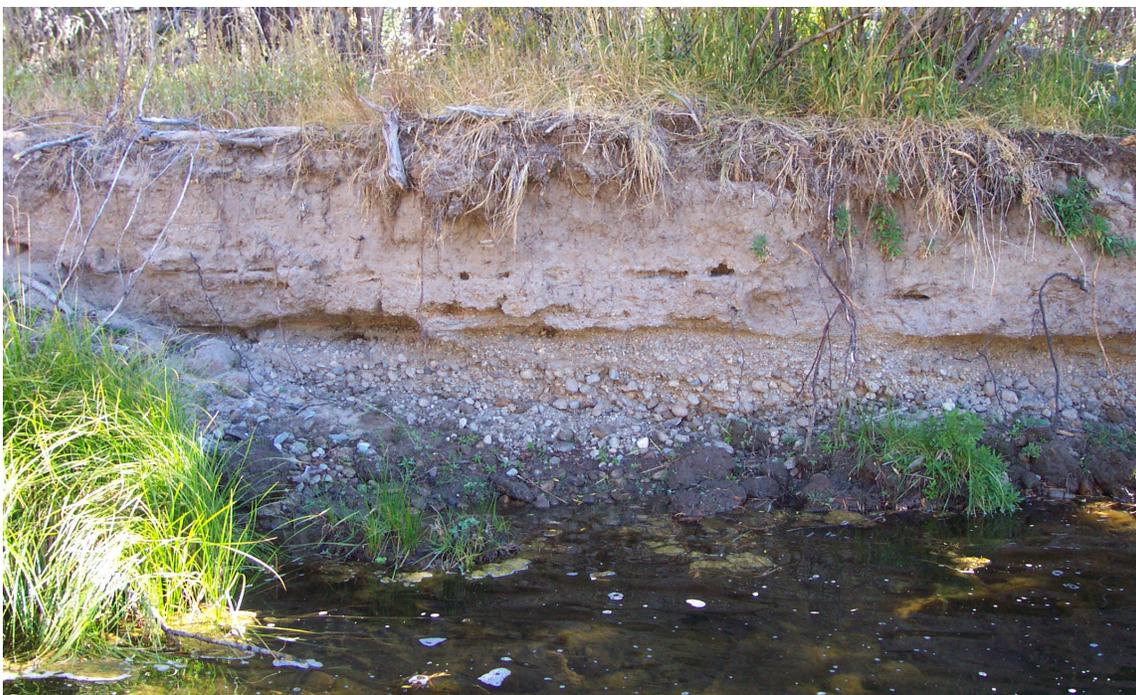
**Figure 4-17. Typical bank rated “moderate” in fine-sediment contribution due to large portion of coarse material in the bank.**

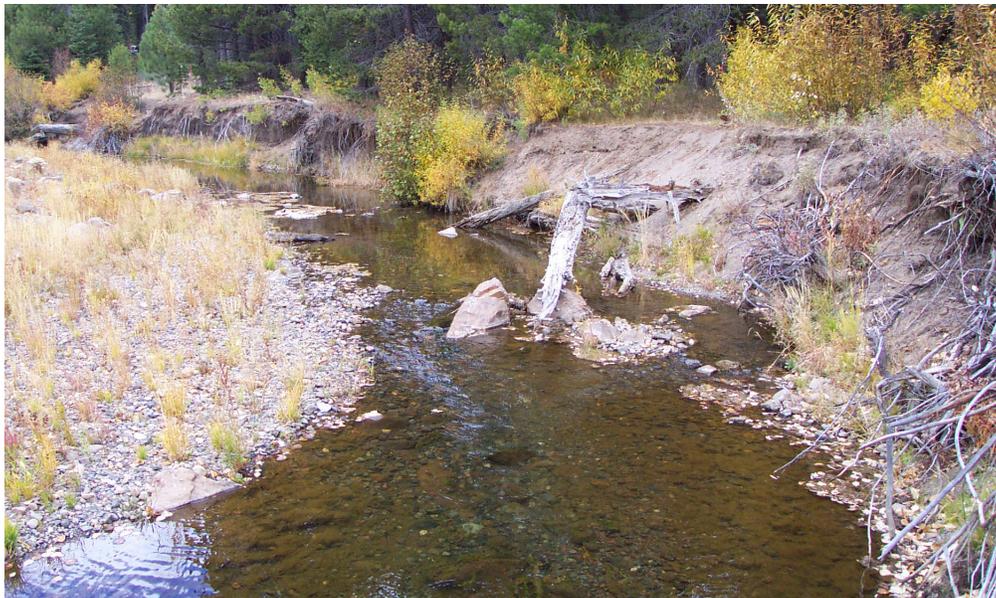
Within the 0.5 km nearest the lake sea walls have been constructed along the stream, thereby helping to reduce sediment delivery from bank failures. The remaining 3.5 km of the initial reach (Hotspots 1-5, Table 4-8) is primarily a gravel- bedded sinuous channel. There are one to three m-high banks primarily silt and sand at the RGA sites. Measured quantities of silt/clay content for each site are given in Appendix B, with an average bank composition of 6%. The vegetation ranges from pine forests to grass meadows, however the outside bends are sufficiently high to prevent roots from protecting the full height of the banks (Figure 4-21).

**Figure 4-21. Typical failing outside bend along the lower 4 km of Blackwood Creek. This site is rated “high” in fine-sediment availability due to the bank height and length of reach failing. Similar sites, with lower banks, are rated “moderate.”**

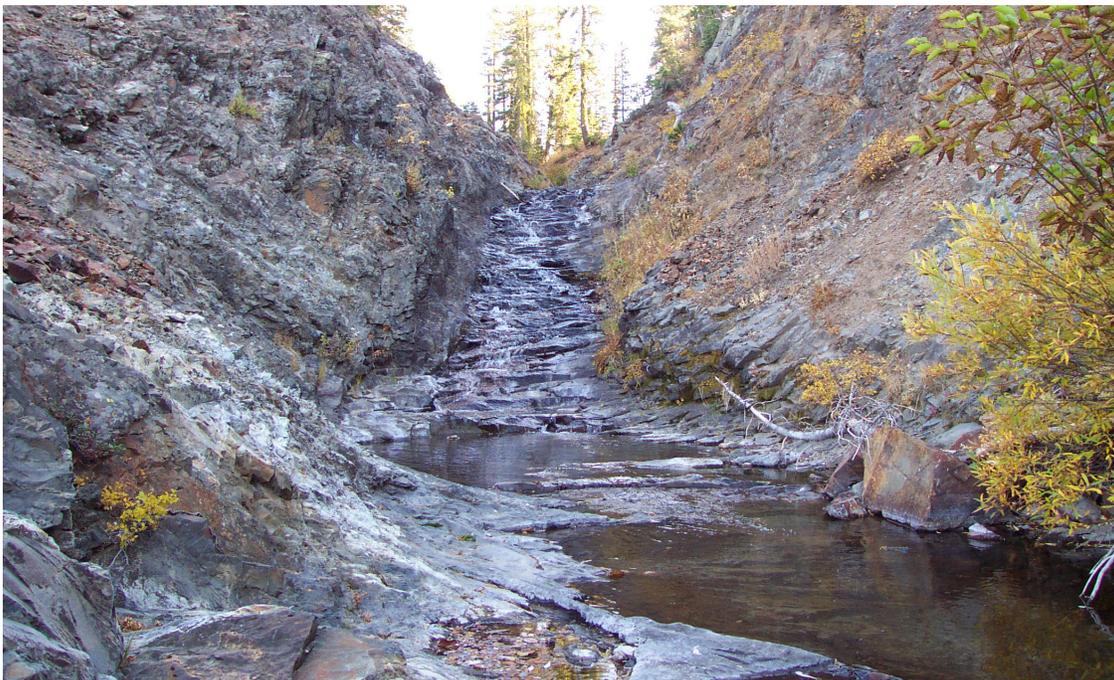
**Figure 4-22. Bedrock channel with a “low” fine sediment rating typical of the canyon reach of Blackwood Creek.**

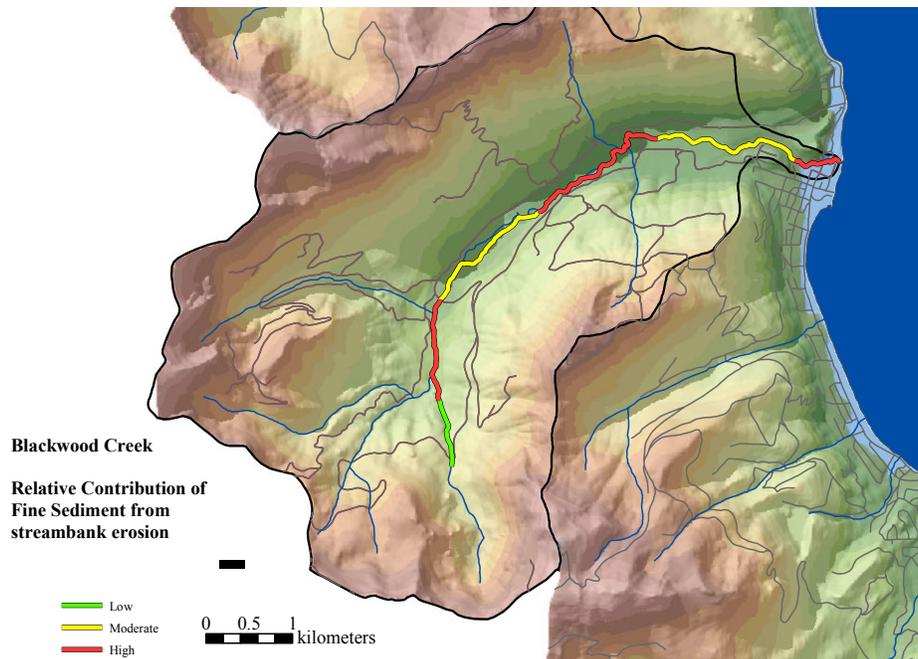
**Figure 4-23. Map of the relative contribution of fine sediment from streambank erosion for Blackwood Creek.**

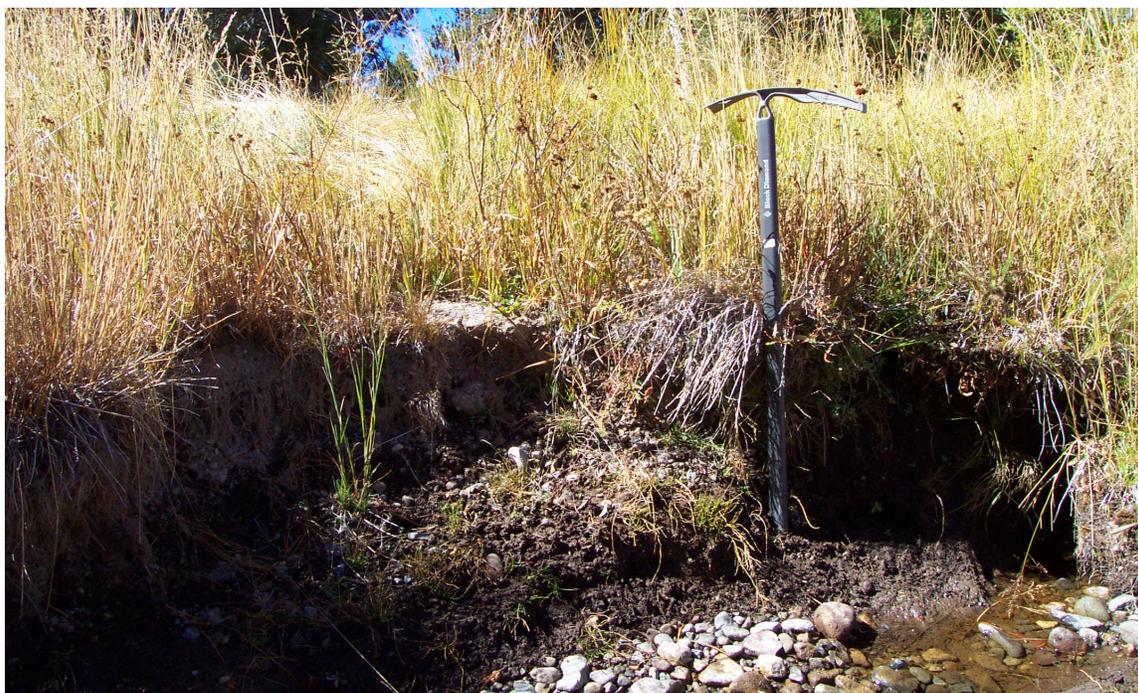
**Figure 4-27. Failing bank of fine beaver-pond deposits is rated “low” in fine sediment availability due to low bank height and dense roots fully penetrating bank. The ice axe is 0.75 m tall. Till plain/beaver meadow reach of Ward Creek.**

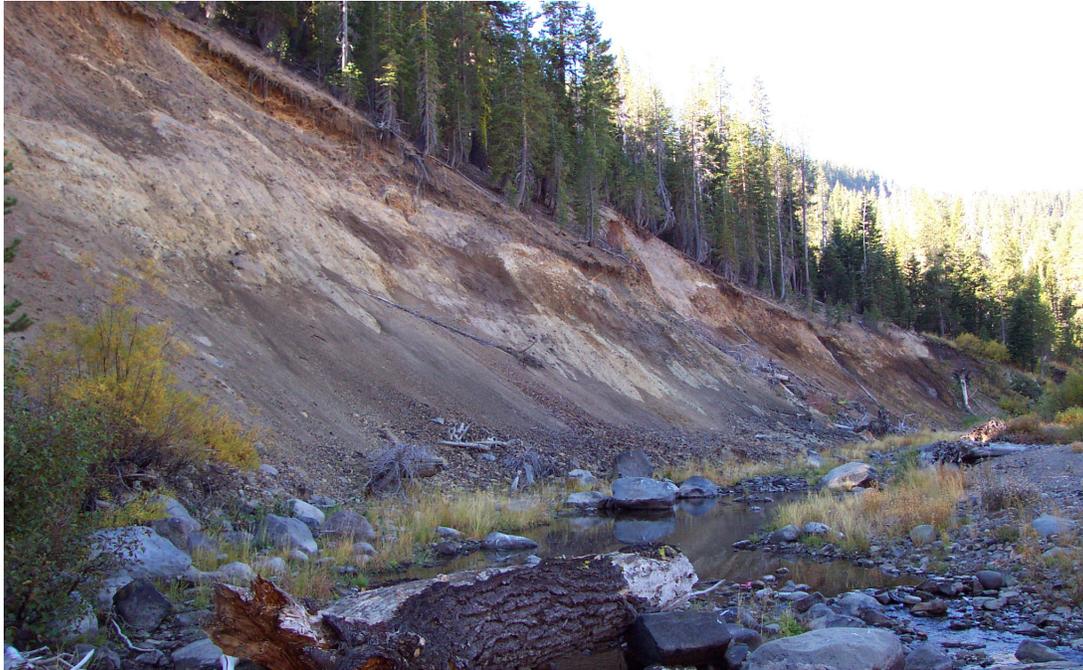
**Figure 4-28. Example of “high” erosion area along Ward Creek where stream has created a 12 m-high escarpment by meandering into the glacial till valley wall.**

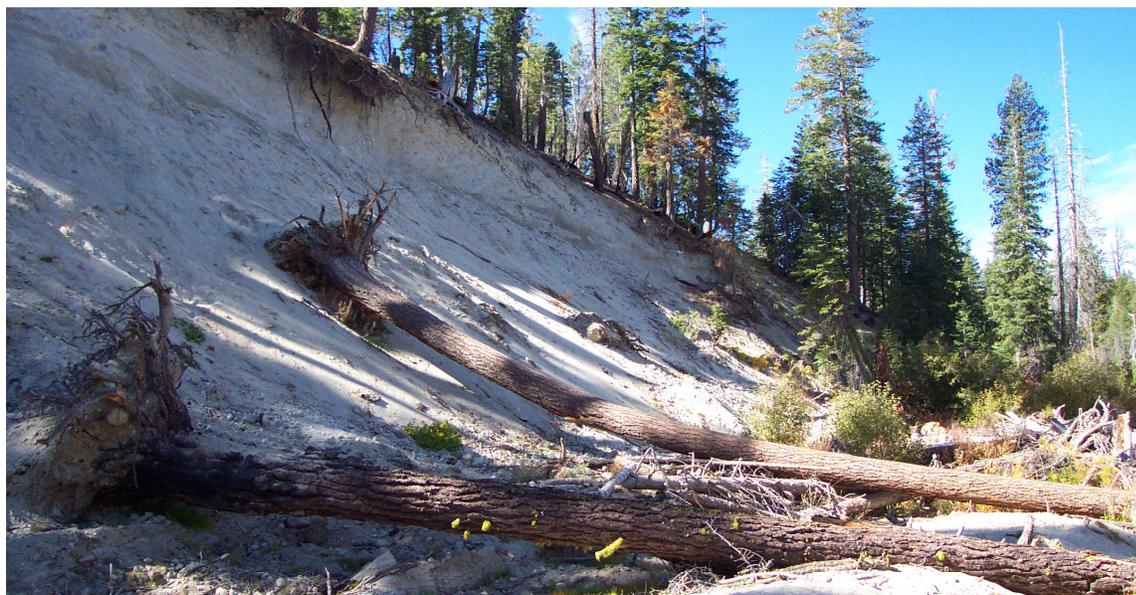
**Figure 4-33. Escarpment where stream has cut into high till terrace is rated as “high” in fine-sediment availability. Incised till reach, General Creek.**

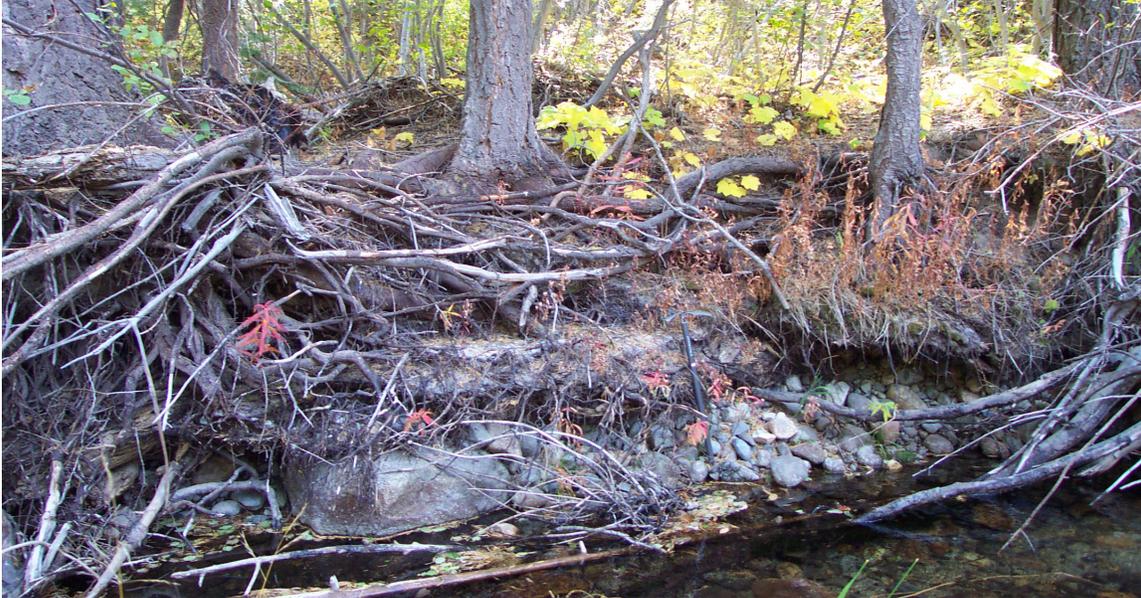
**Figure 4-34. Typical bank rated “low” in fine-sediment availability. Bank is composed of cobble and boulder sized clasts with well established woody vegetation holding banks in place. General Creek.**

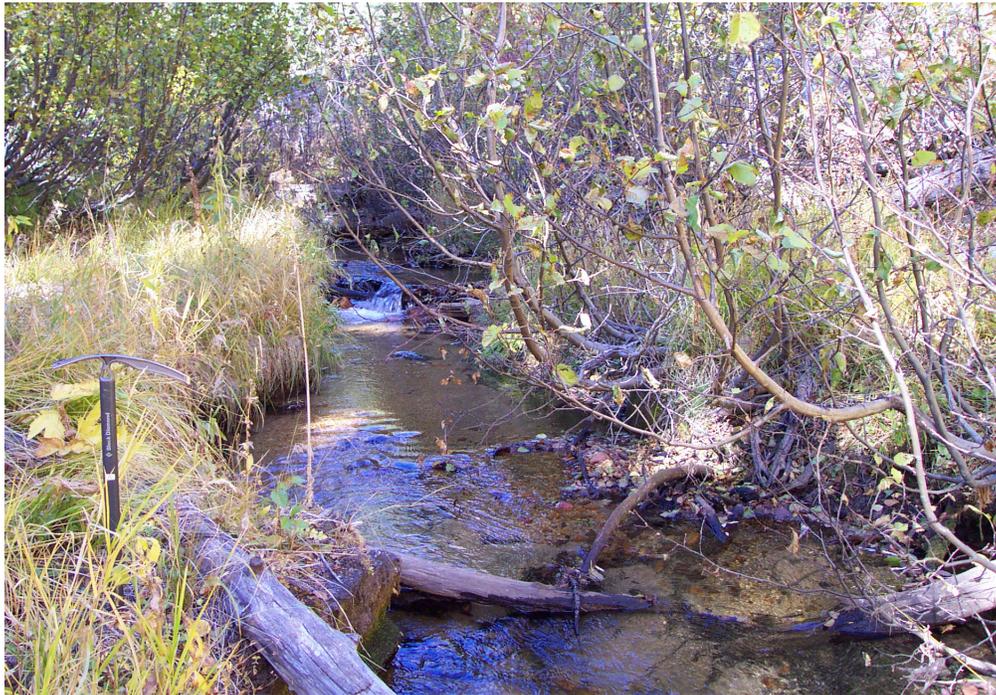
**Figure 4-39. Typical channel along the upper reaches of Incline Creek. Dense alders and grass protect the low banks from eroding.**

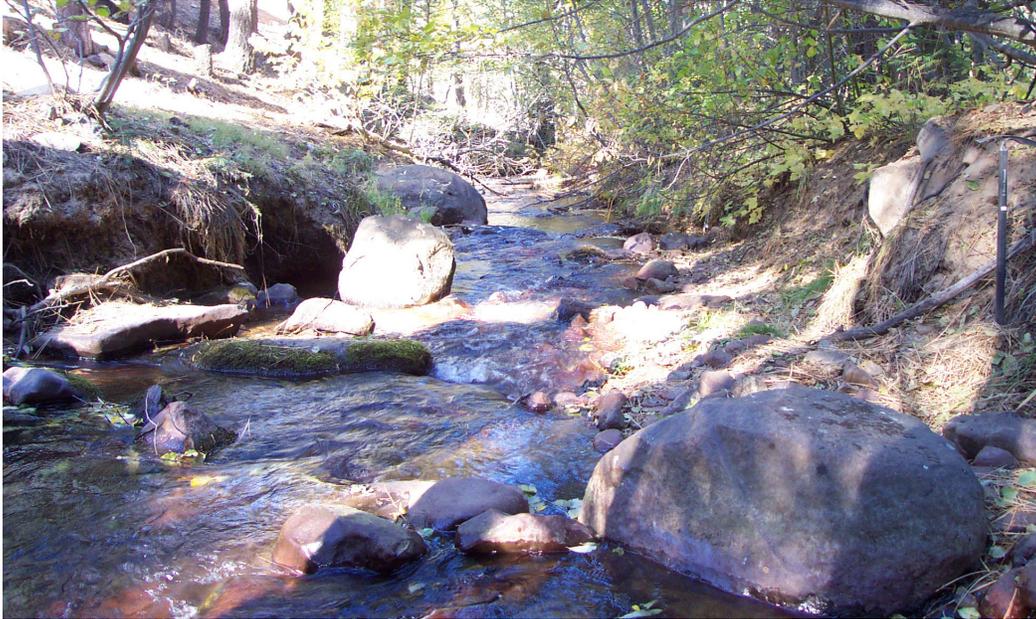
**Figure 4-40. Lack of vegetation increases potential for erosion on the left bank along the urbanized reach of Incline Creek.**

The lower urbanized reach has a greater number of streambank exposures and there are two apparent reasons. Firstly, the channel becomes progressively larger downstream until the banks are higher in places than the depth of plant roots. Secondly, removal or alterations to vegetation in the riparian zone have created short reaches where the banks have been left with inadequate root support. However these areas are infrequent making the overall fine sediment availability rating of the channel low.

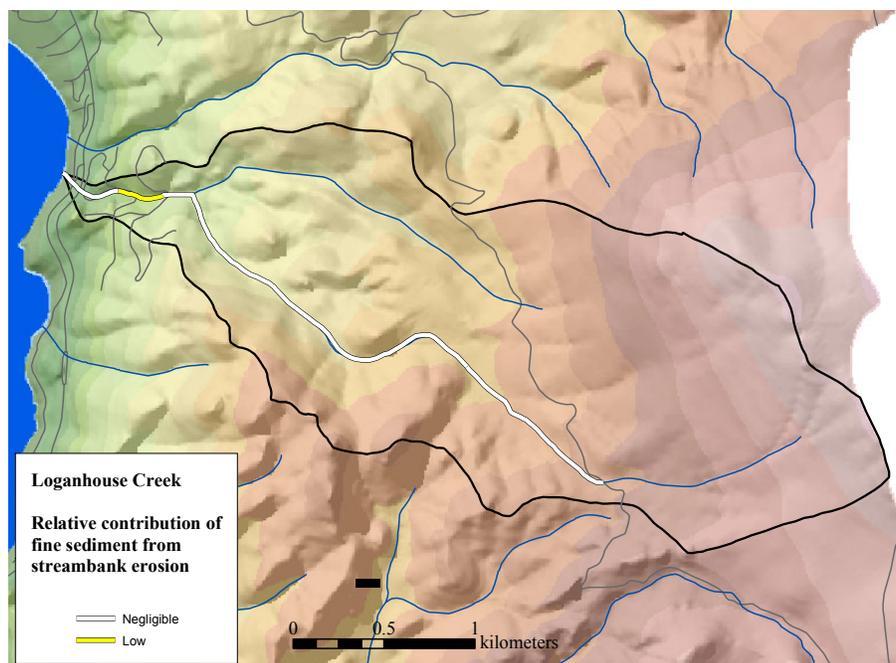
Over the lowest 0.7 km above the mouth, Logan House Creek flows through a residential neighborhood. Bank-erosion potential is negligible. Only two minor erosion points have been noted. One is a 1 m-high bank of fine material lacking root support. The other is a yard where all vegetation and duff has been removed all the way to the water's edge (Hotspots 1 and 2, Table 4-12).

**Figure 4-45. Map of the relative contribution of fine sediment from streambank erosion for Logan House Creek.**
