**BANK PROTECTION WORKING GROUP
DRAFT EROSION ASSESSMENT
SACRAMENTO RIVER EAST BANK EROSION ASSESSMENT
AMERICAN RIVER (RM 60.1) TO FREEPORT (RM 45.2)**

DRAFT REPORT

9 August 2019

NHC Ref. No. 5004539

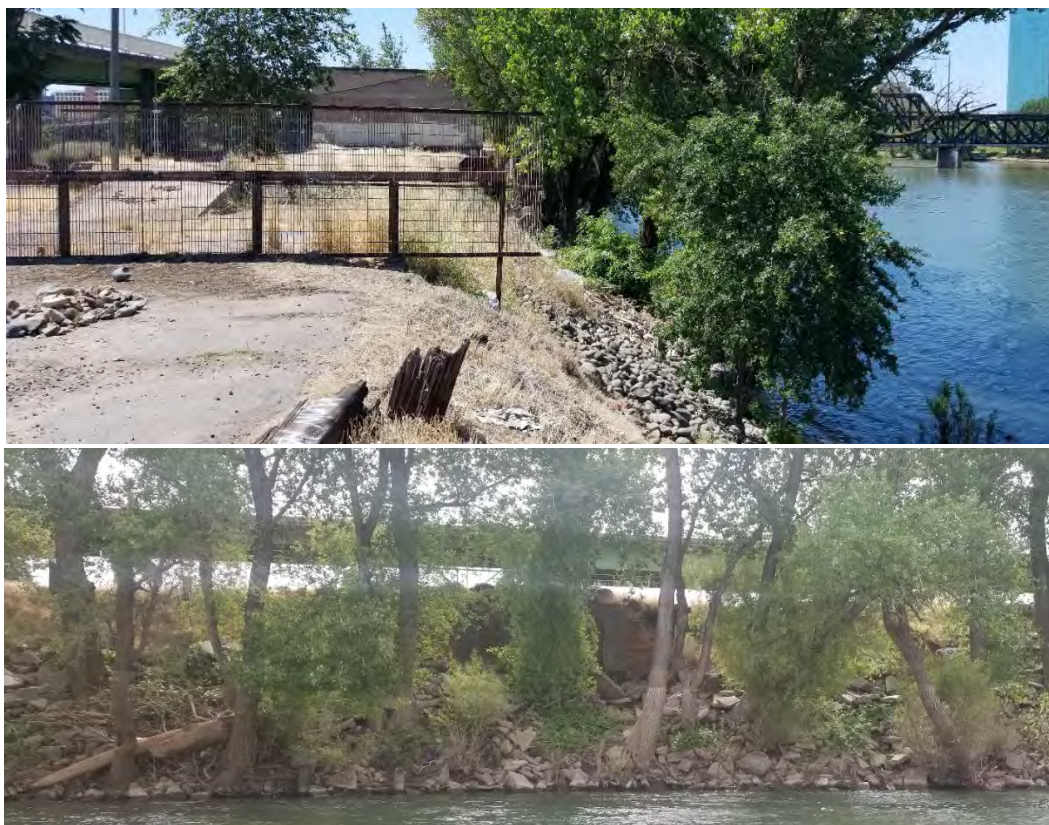
Figure 2-2a and 2-2b - RM 59.55 Land and Waterside Views of Bank Located Near the I St Gage and the I St Bridge with an Abandoned Building, Power Poles, Older Rip Rap, Cobble and Rubble Line a Slumping Bank.

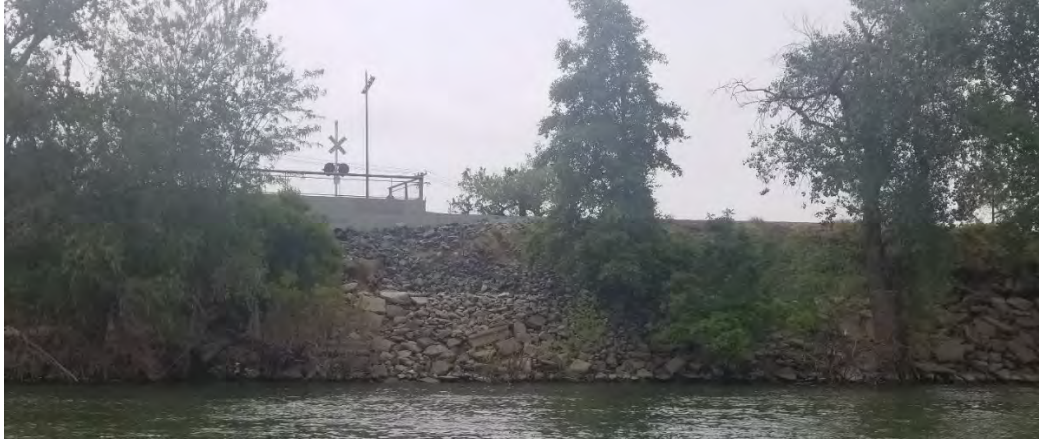
Figure 2-3 - RM 58.65 is at the downstream end of the Old Sacramento River floodwall where a variety of rip rap, cobble and broken concrete has been placed over the erosion and slumping that has occurred.

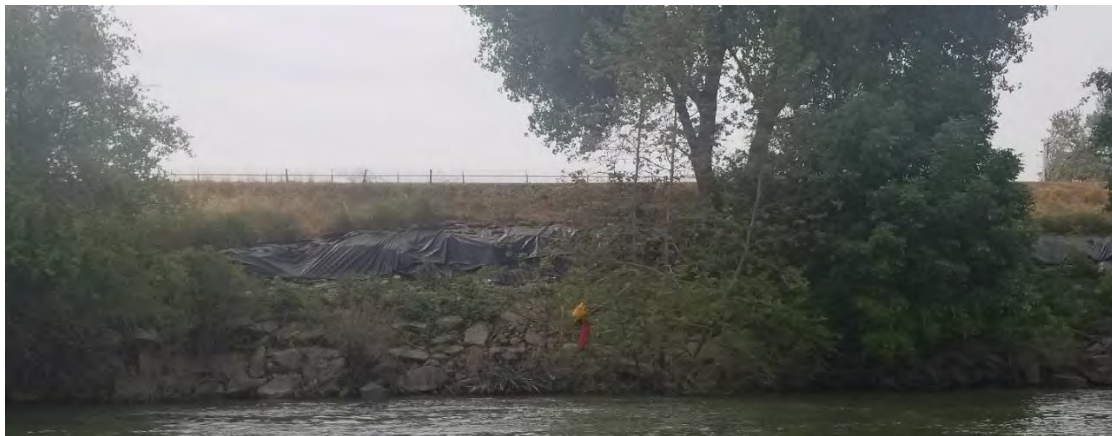
Figure 2-4 - RM 58.45 is located at the Pioneer Reservoir. Recent erosion behind existing rock and concrete rubble has prompted emergency repairs with black plastic sheeting.

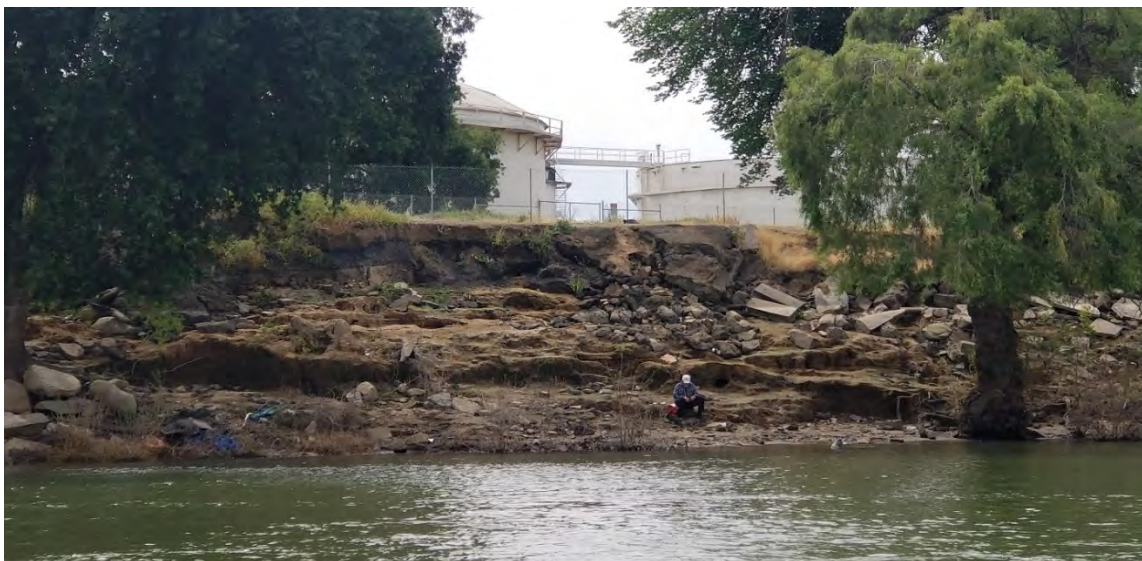
Figure 2-5 - RM 58.2 North of Miller Park and Marina where concrete and asphalt waste rubble has been placed ongoing erosion is evidenced by the crumbling asphalt road and slumping bank slope.

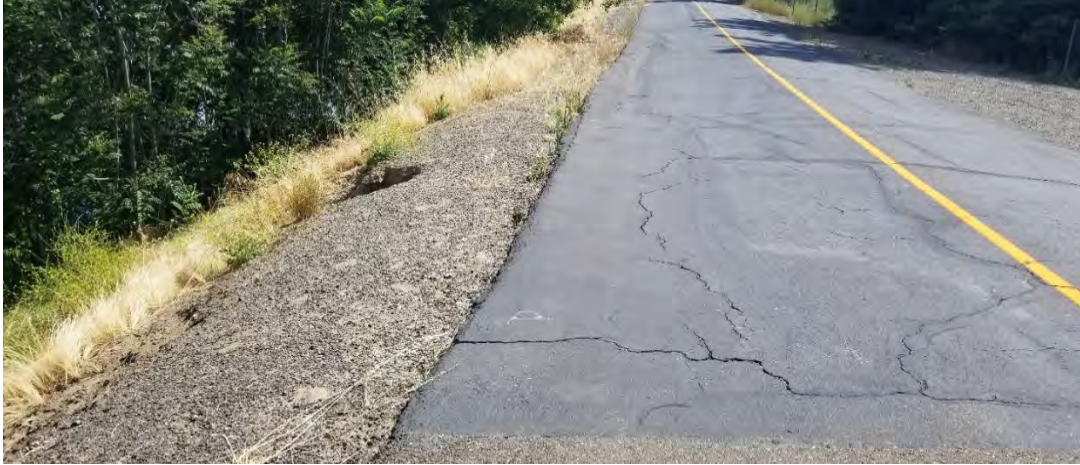
Figure 2-7 - RM 55.55 looking upstream at levee top near the Westin Hotel parking lot showing tension cracks, possibly indicative of landslide headcut and evidence of past repairs to the bike path on the waterside levee slope. This location has no berm and the waterside levee face extends into the left bank of the river.

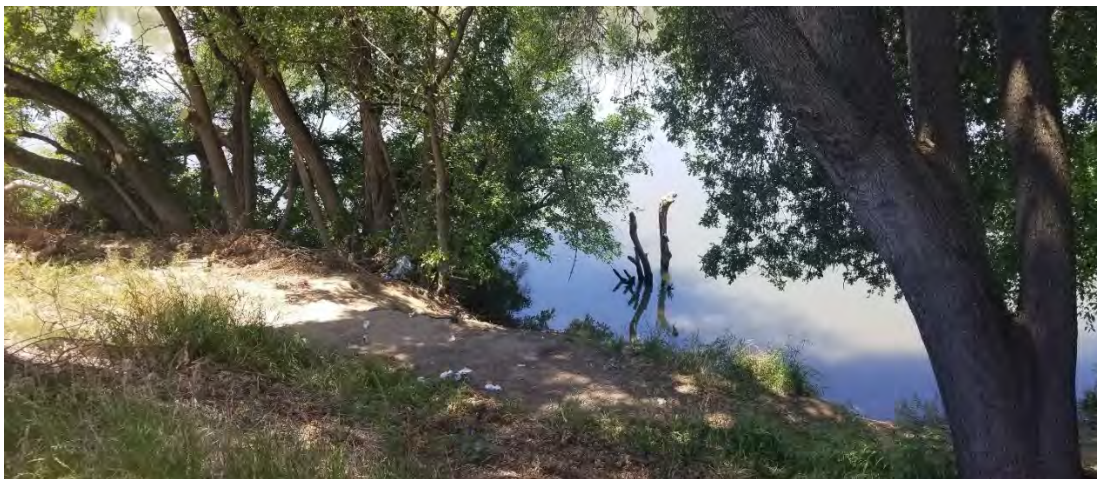
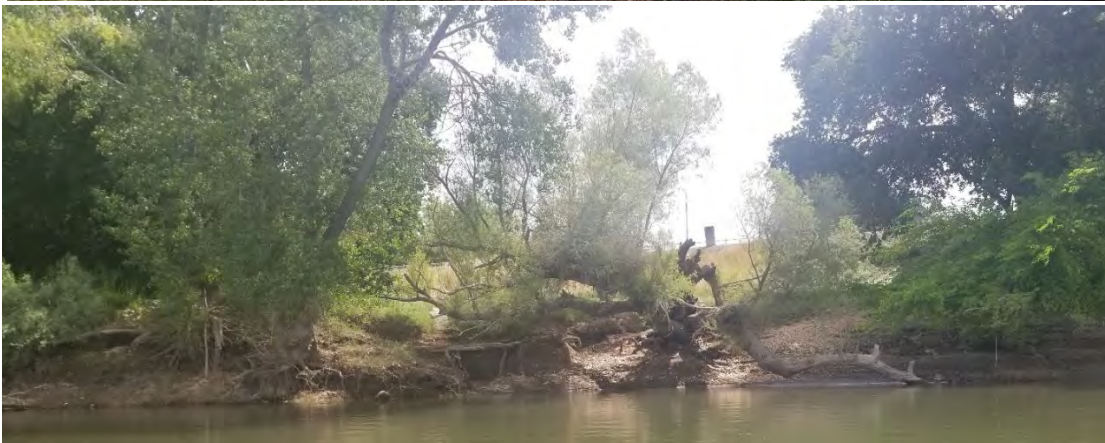
Figure 2-8a and 2-8b – Land and waterside views of RM 53.8 at Oak Hall Bend has evidence of ongoing erosion and a narrow berm at the outside edge of the apex of a bend near Little Pocket.

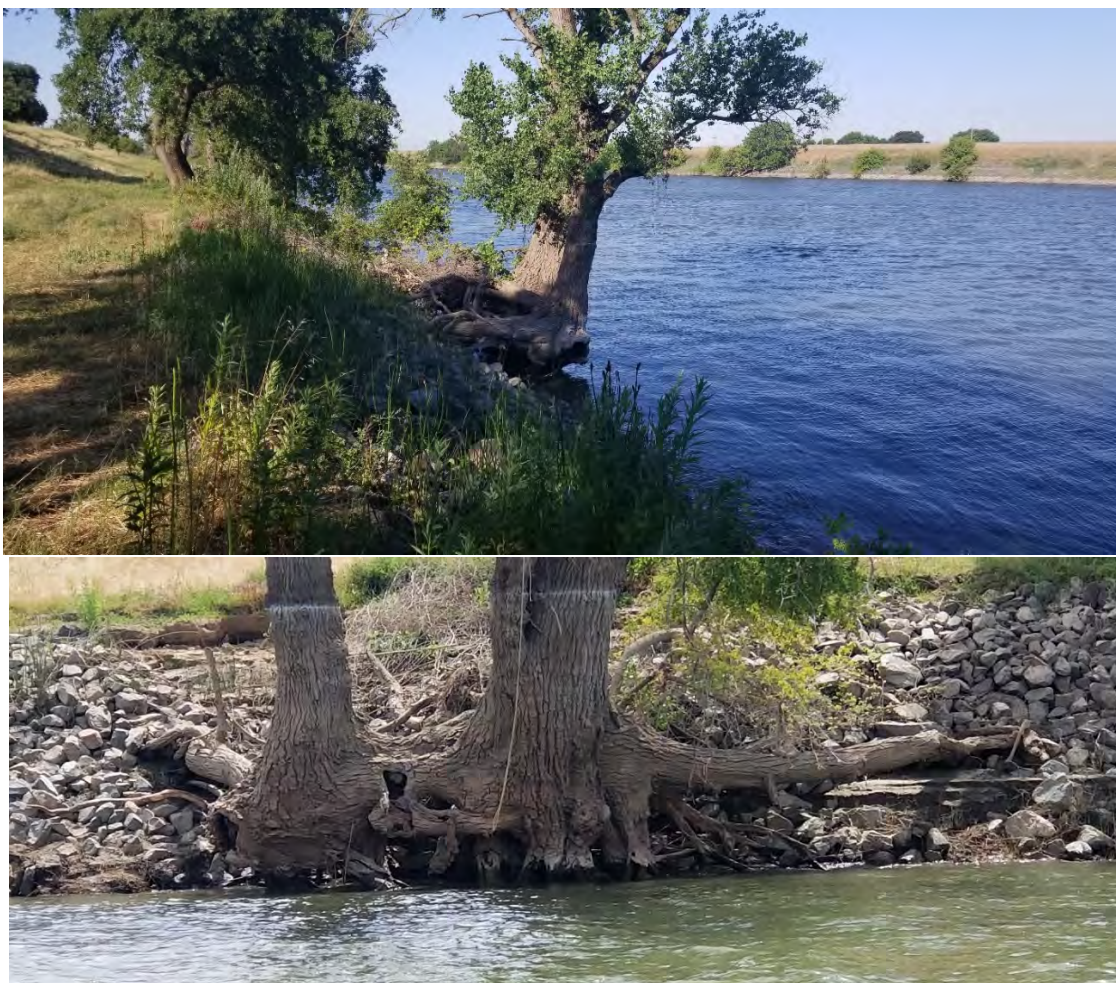
Figure 2-9a and 2-9b – Land and waterside views at RM 51.9 at the north-west corner of the Pocket area has shows extreme erosion around tree roots, a narrow berm and spot repair rip rap.

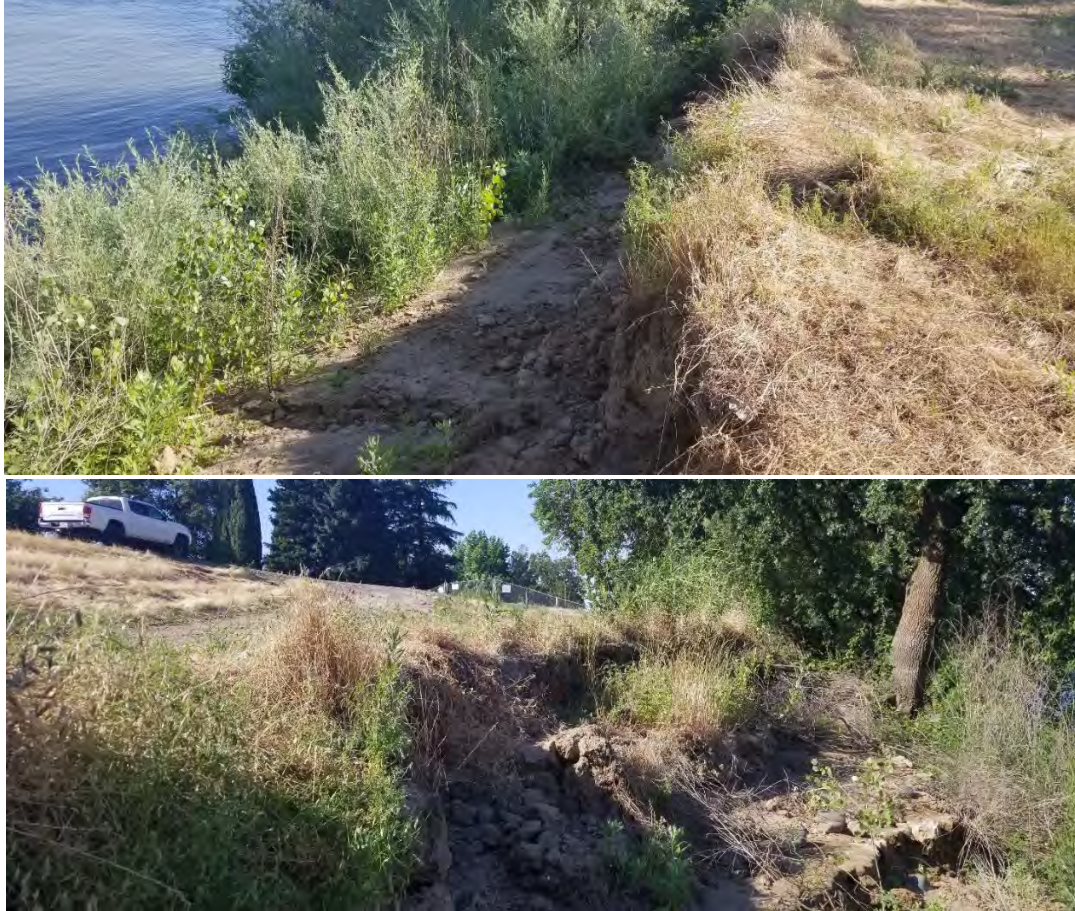
Figure 2-10a and 2-10b - RM 51.75 has a bare silty-clay outcrop. Upstream (top) and downstream (bottom) views of erosion location where clay rich outcrops are visible in blocky steps and in vertical banks. Upper photo shows extensive natural seedling recruitment of willow and cottonwood on gently sloping eroding bank.

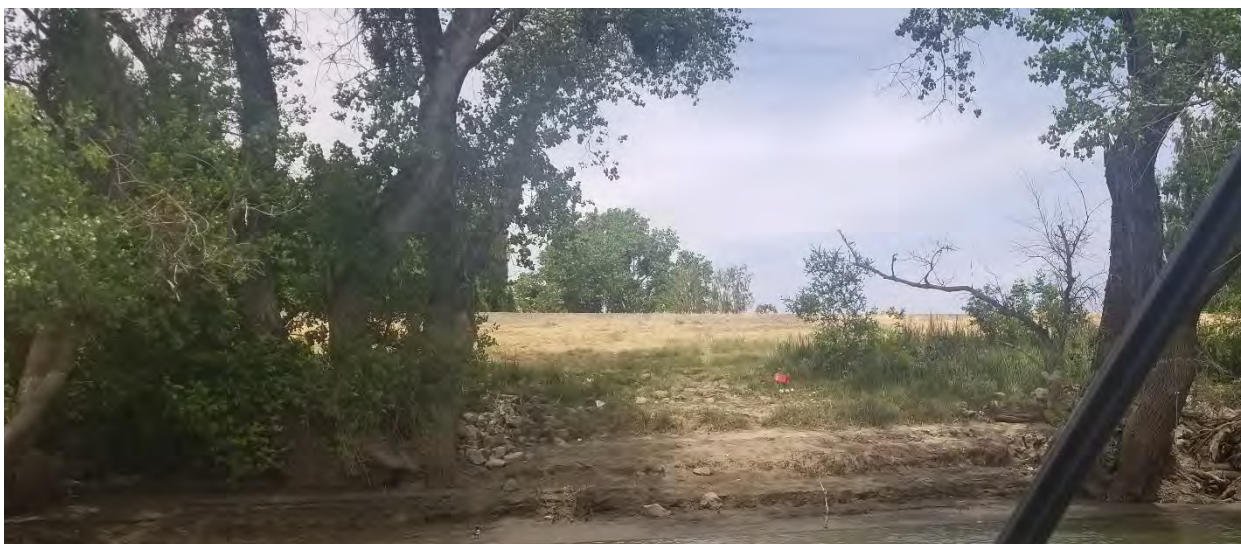
Figure 2-12- RM 48.3 is a large barren gap caused by loss of a large tree in the recent past and old concrete rubble.

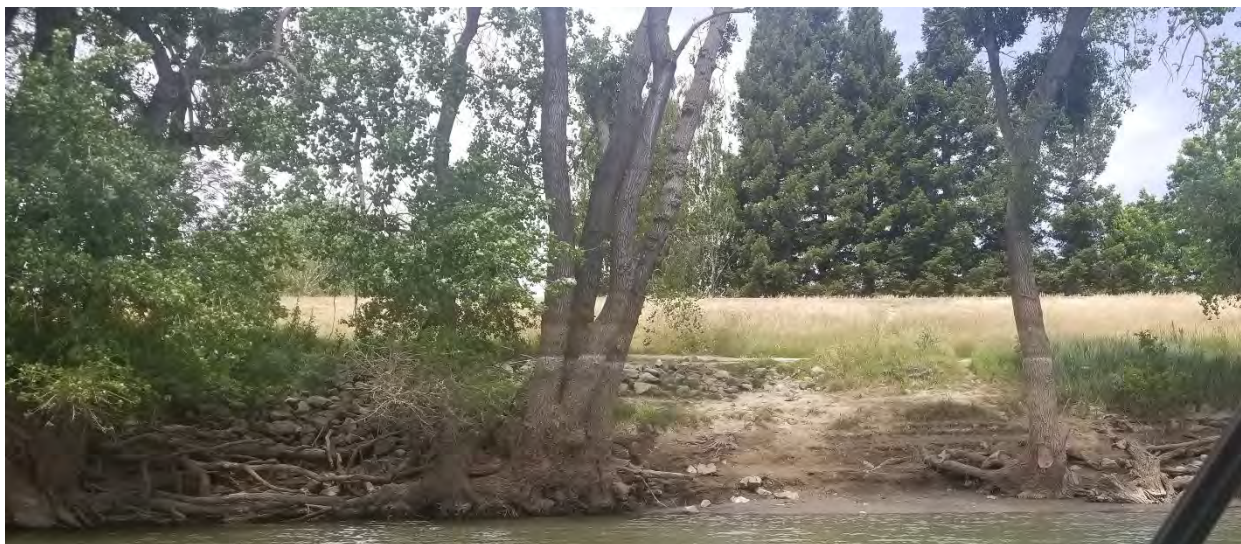
Figure 2-13 - RM 48.2 showing gaps in vegetation no bank protection and large tree roots being undermined.

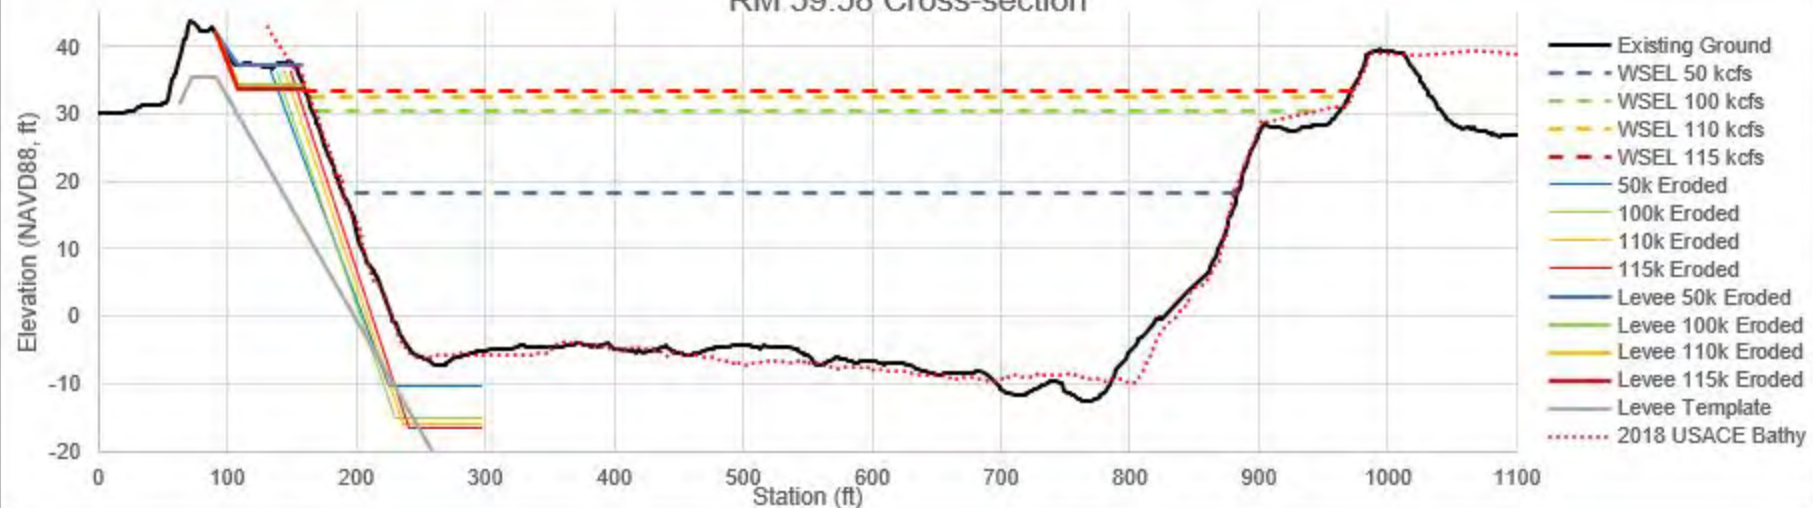
RM 59.58 Cross-section

The bank is steep and over 40 feet high and rates high for erodibility due to silty sand materials and high for slope failure susceptibility. Vegetation cover protection is rated inadequate due to its sparseness and the ongoing undermining of large tree roots systems. The projected scour depths at all flows encroach into the levee prism with lateral erosion extents up to 8 feet. Shear stress ranges from 0.08 lbs/ft² for 50 kcfs to 0.17 lbs/ft² for 115kcfs which is significantly higher than the 0.045 lbs/ft² for the silty sand bank materials. As a result, segment 2 is rated high for overall erosion potential.

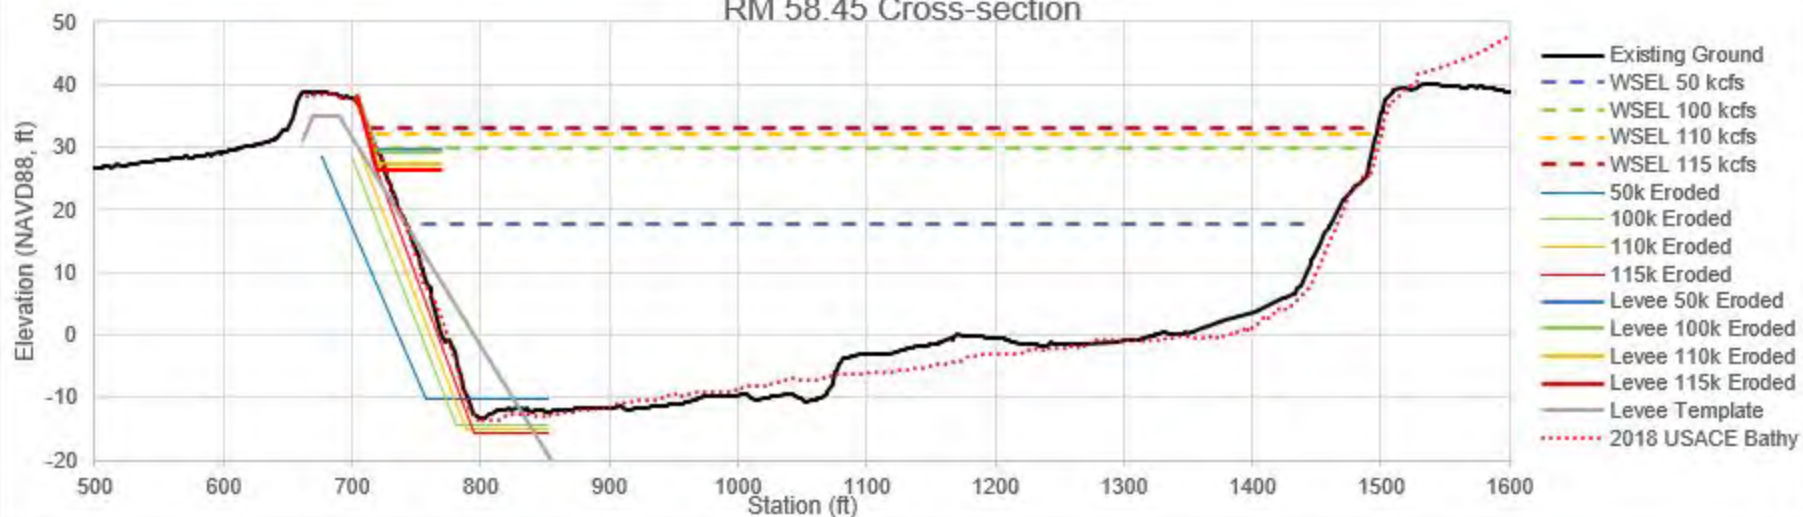
RM 58.45 Cross-section

minimum). The risk to levee decreases as the levee moves hundreds of feet away from the bank downstream of Highway 50, through Broadway and into Miller Park.

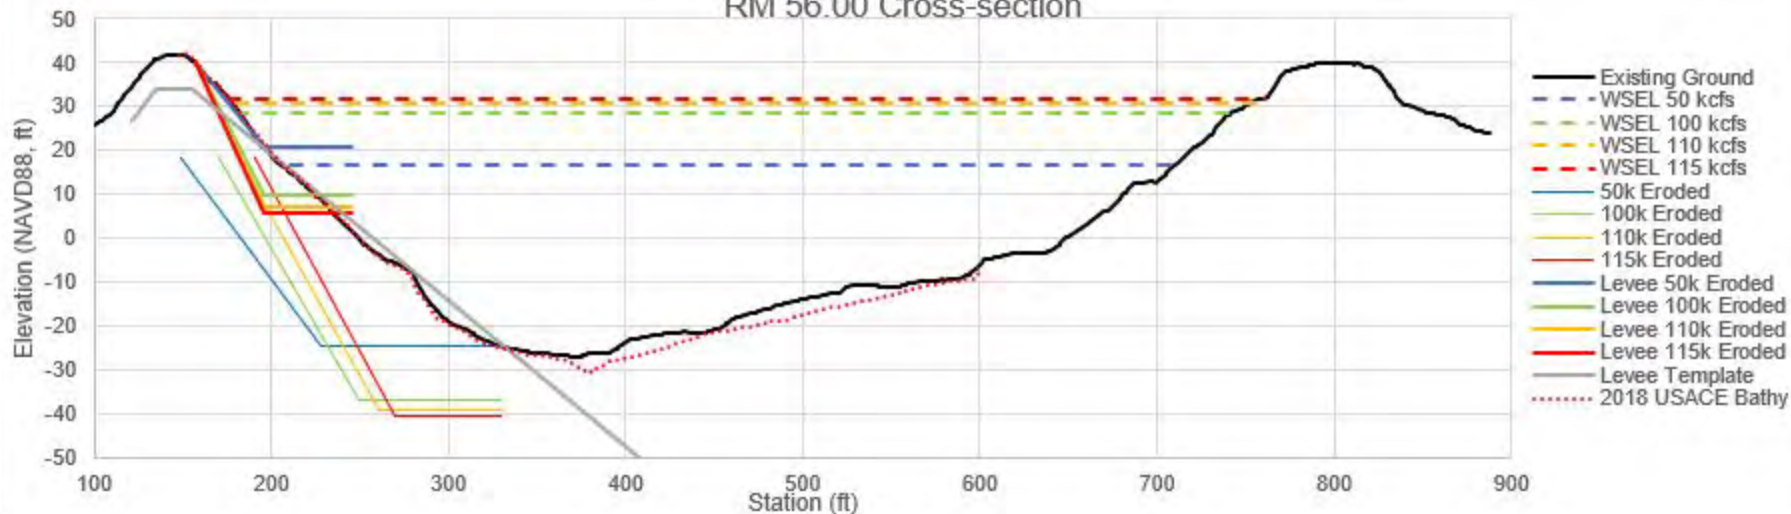
The bank is steep and 65 feet high from thalweg and toe of bank (elevation -25.0 feet) to top of levee (elevation 40 feet). The current bank line encroaches into the levee prism before consideration of estimated scour and lateral erosion. There is no berm and the bank slope coincides with the levee slope.

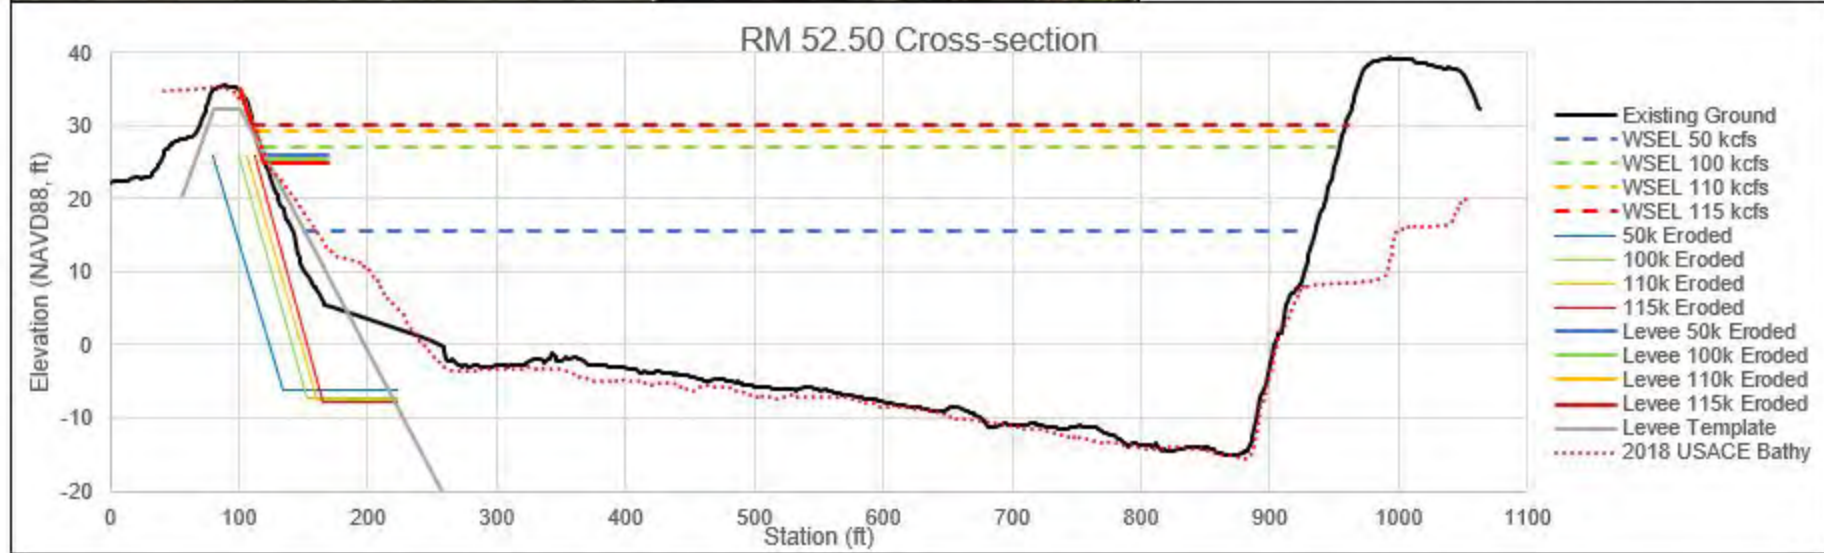
The overall bank erosion potential is rated low for the revetment section (1,200 feet) but the unprotected 800 feet is rated high due to inadequate cover. This yields an overall high erosion potential for the segment all flows. The bank scour and lateral erosion extents encroach into the levee at all flows.

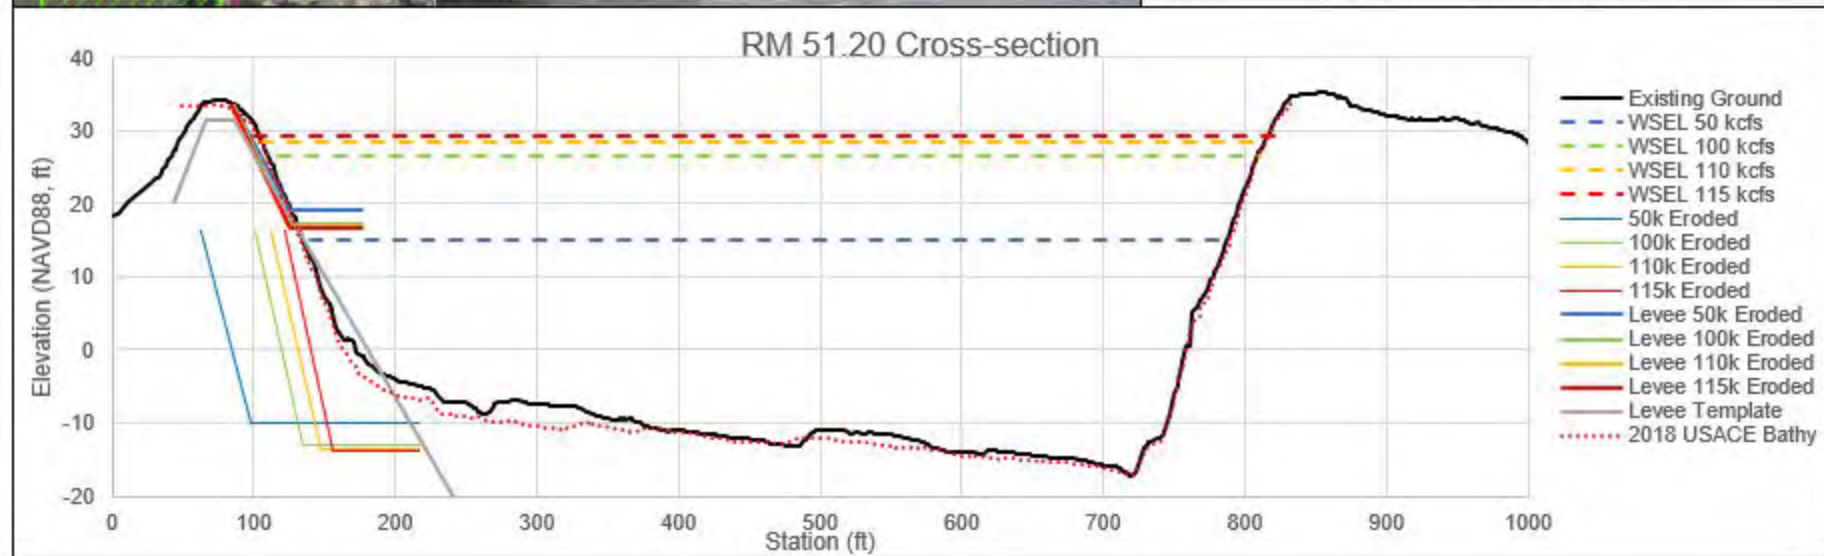
encroached with the levee prism and it appears that there has been roughly 10+ feet of progressive erosion of the bank toe between 2008 and 2018 bathymetry surveys.

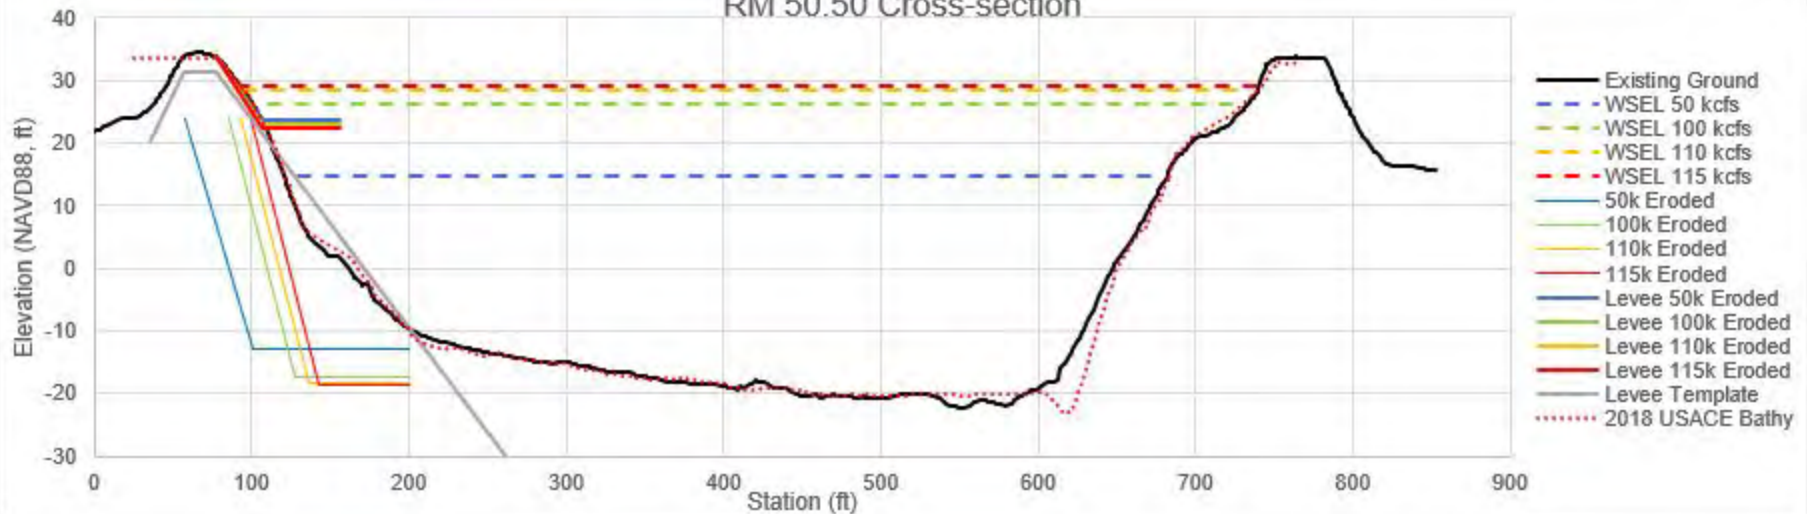
levee prism. Scrub vegetation along the shoreline is fairly contiguous. The 2006 era rip rap appears to have been placed in an excess volume so as to launch when the lower bank eroded. None of this rip rap is found along the lower bank shoreline, although there are patches of older repairs in cobble, rubble and rip rap.
