2015 ANNUAL EROSION INVENTORY ENGINEERING REPORT

SACRAMENTO RIVER BANK PROTECTION PROJECT SACRAMENTO RIVER AND TRIBUTARIES

**U.S. Army Corps
of Engineers**
Sacramento District

JULY 2015

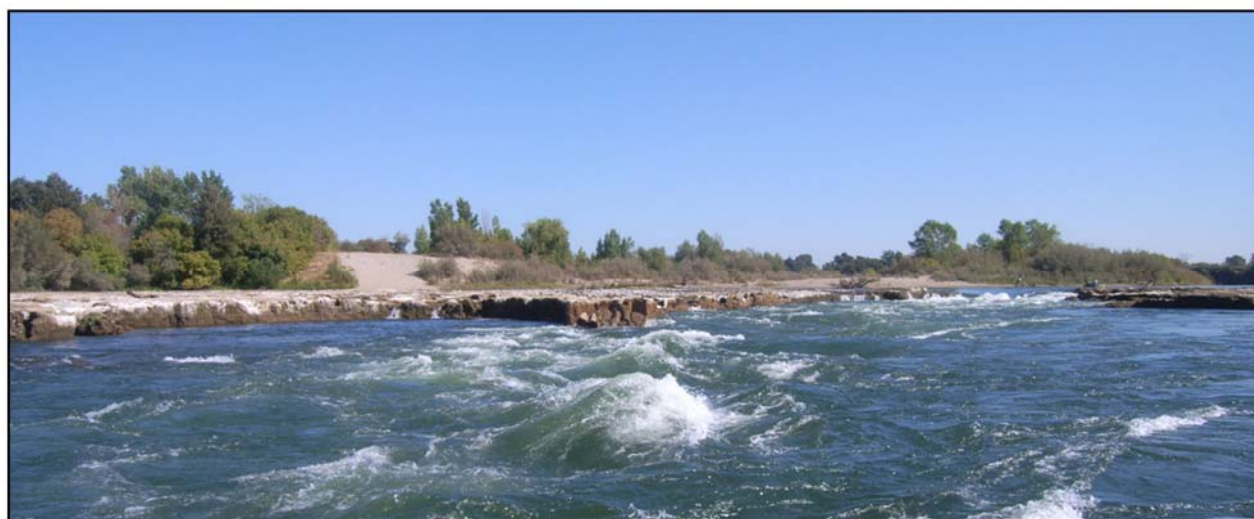
Middle Reach of the Feather River, South of Yuba River (RM 28 to RM 7) – The middle reach of the Feather River is wide and shallow and has a large amount of sand bedload coming from the Yuba River. At RM 24.8, Shanghai falls, there is a large clay plug that has slowly been moving through the system. This feature acted as a grade control feature in the river and as of early February 2012, this clay plug has been breached. The full impacts of this breach are not yet known, but there will most likely be further erosion to the system. **Figures 15** shows the clay plug in its current state. The levees are setback in this reach and a new setback levee was recently constructed on the left bank from RM 25 to RM 18. The primary causes of erosion in this reach are fluvial and mass failure of eroded banks. There are currently three (3) erosion site in this reach of the Feather River, and two (2) were new in 2013.

Figure 15. View of Clay Plug on the Feather River at RM 24.8 in late 2012.

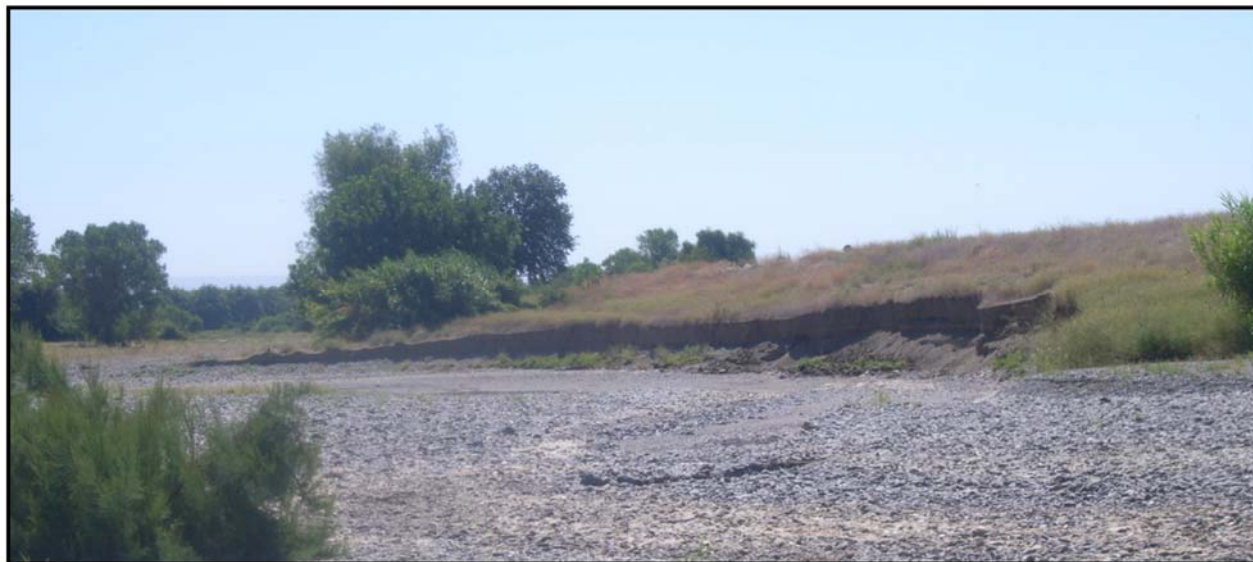
Elder Creek – Elder Creek is located in the upper Sacramento Valley, it flows from the east side of the Coastal Mountain range and ends at the Sacramento River near RM 230. Only portions of the creek, near the lower end, are leveed to protect the towns of Gerber and Tehama. Elder Creek is an incised channel with short levees. The channel meanders through a gravel bed and has multiple point bars. The primary mechanisms of erosion are fluvial and whole bank failure. **Figure 21** shows a typical view of Elder Creek channel and eroding bank. There are currently two (2) erosion sites on this creek.

Figure 21. Typical View of the Channel and Eroding Bank of Elder Creek.
