2017 ANNUAL EROSION RECONNAISSANCE FIELD REPORT

Sacramento River Bank Protection Project

SACRAMENTO RIVER AND TRIBUTARIES

September 2018

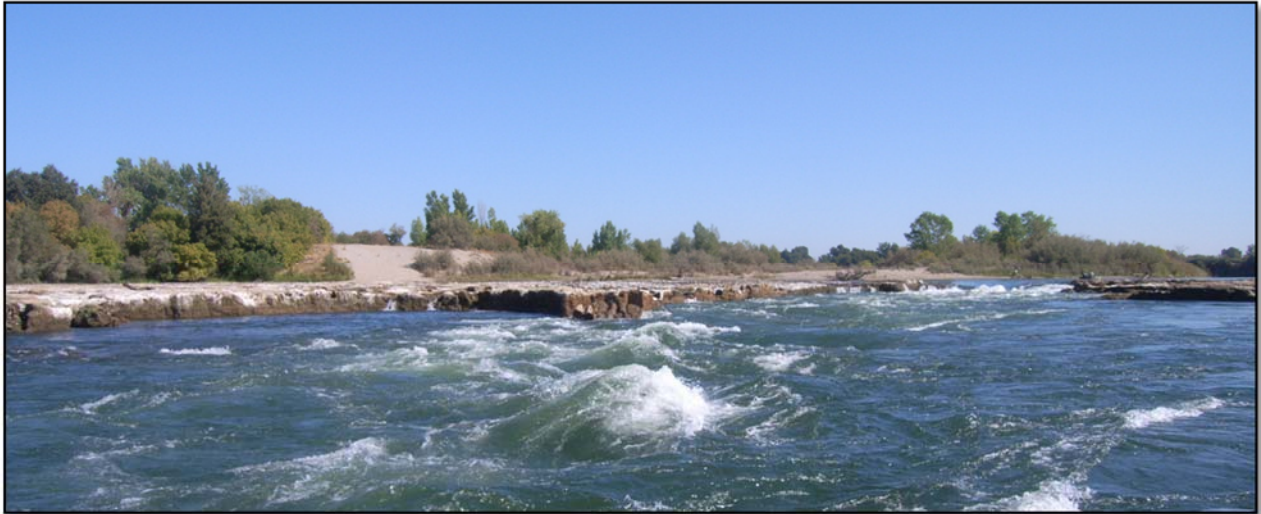
Figure 15. View of Clay Plug on the Feather River at RM 24.8 in late 2012.

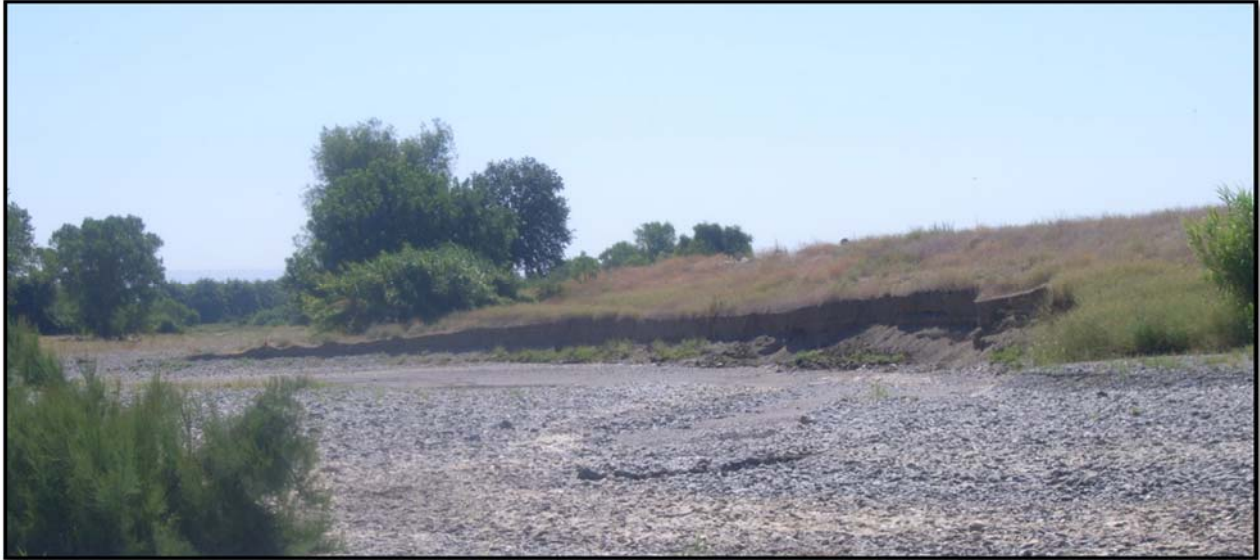
Figure 21. Typical View of the Channel and Eroding Bank of Elder Creek.

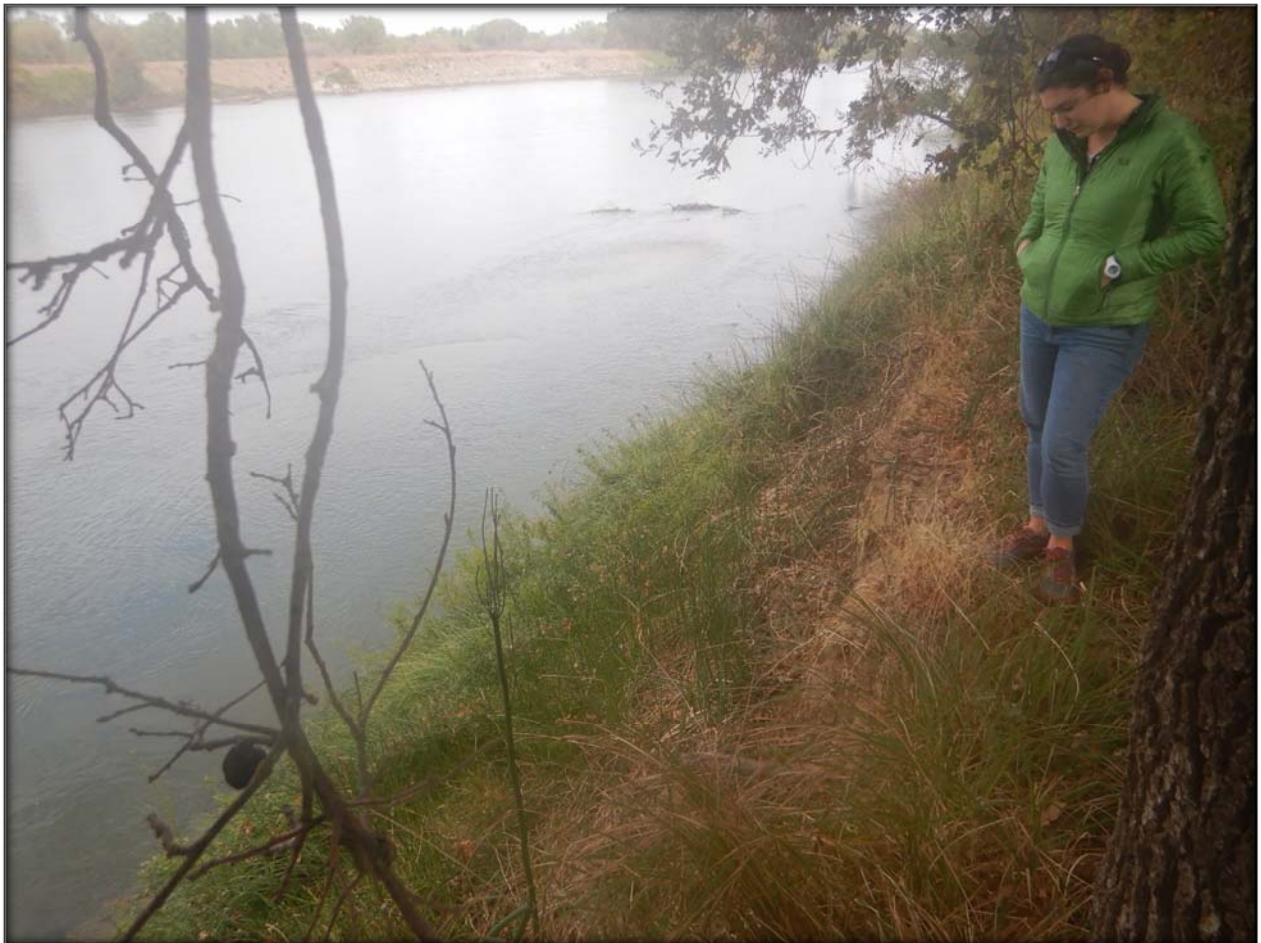
Figure 8. Erosion Site along the Feather River at RM 6.0, Left Bank.

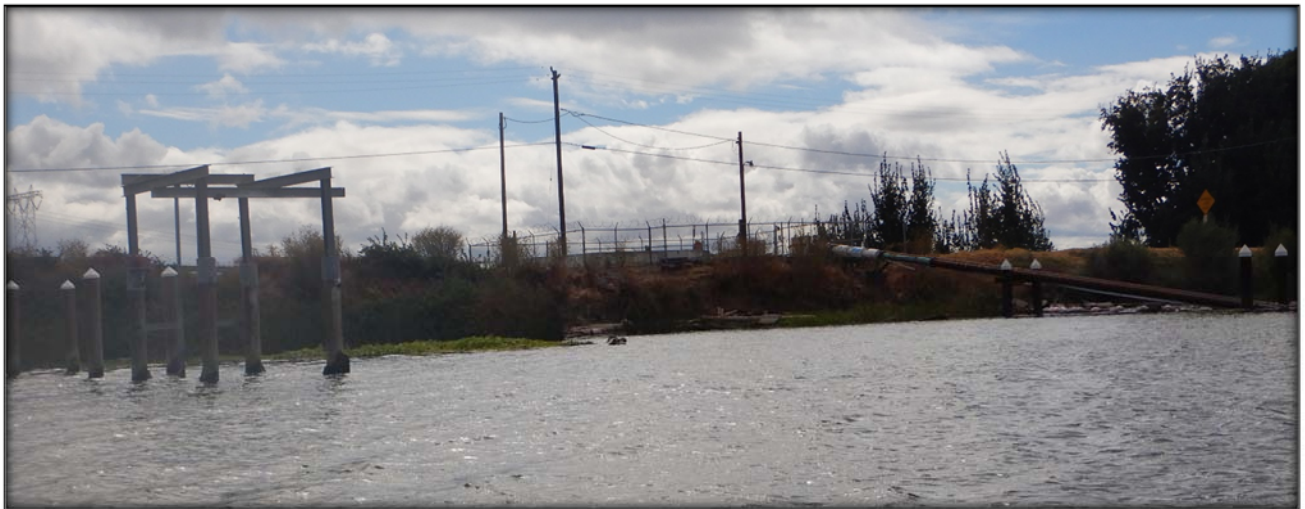
Figure 19. Encroachments and Slumping along the left bank of the Sacramento River at RM 7.3.

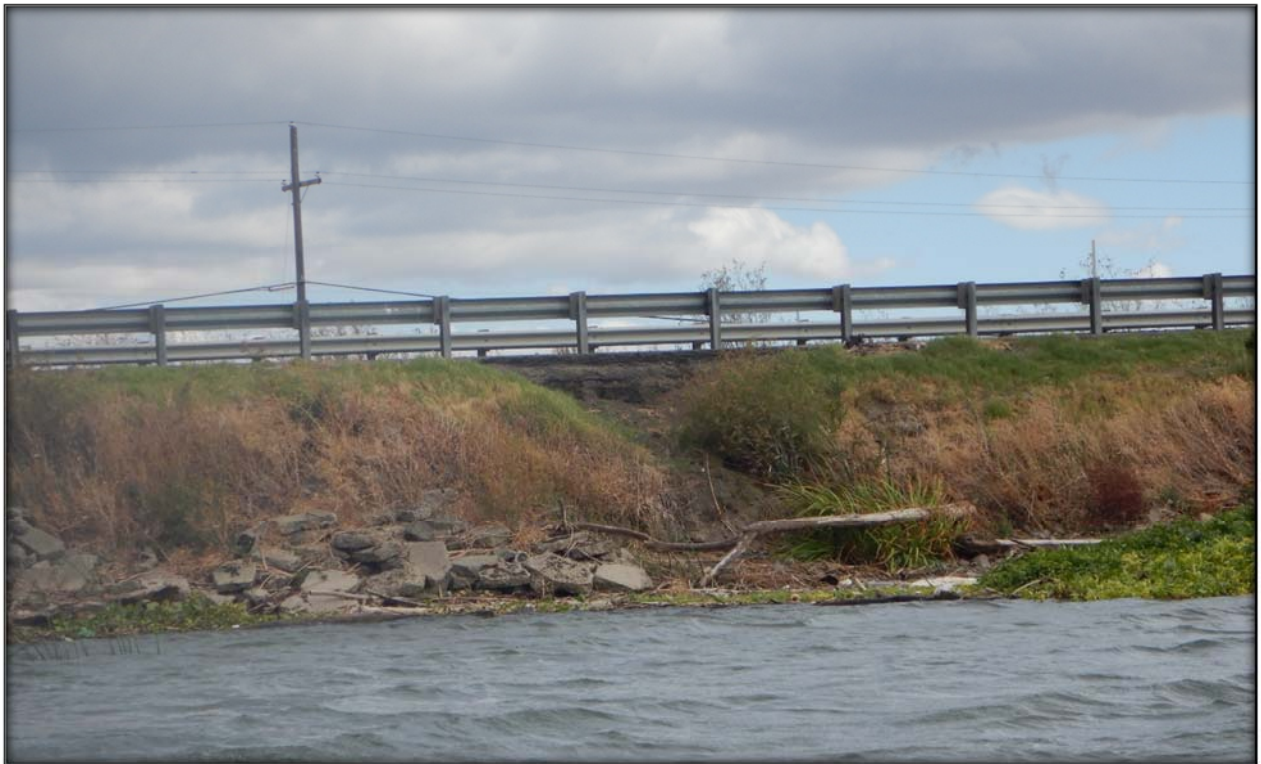
Figure 20. Erosion from Surface Runoff along the left bank of the Sacramento River at RM 7.9.

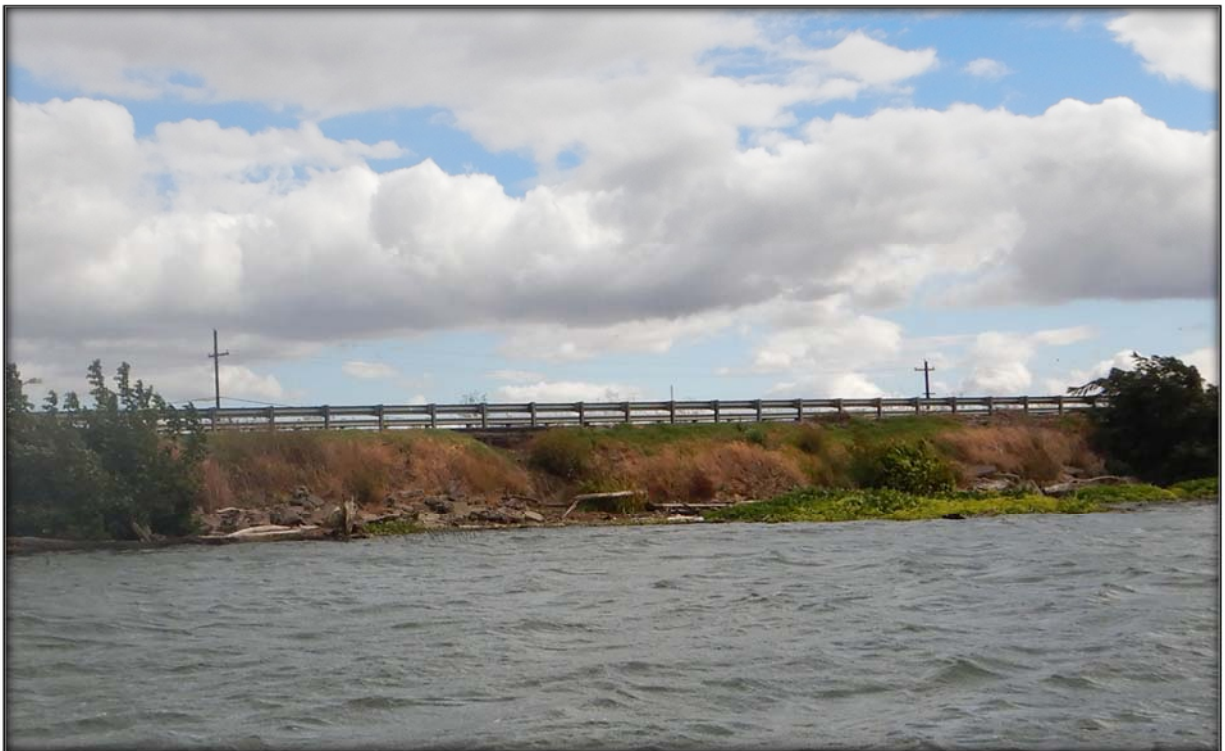
Figure 23. Erosion from surface runoff along the left bank of the Sacramento River at RM 8.0.

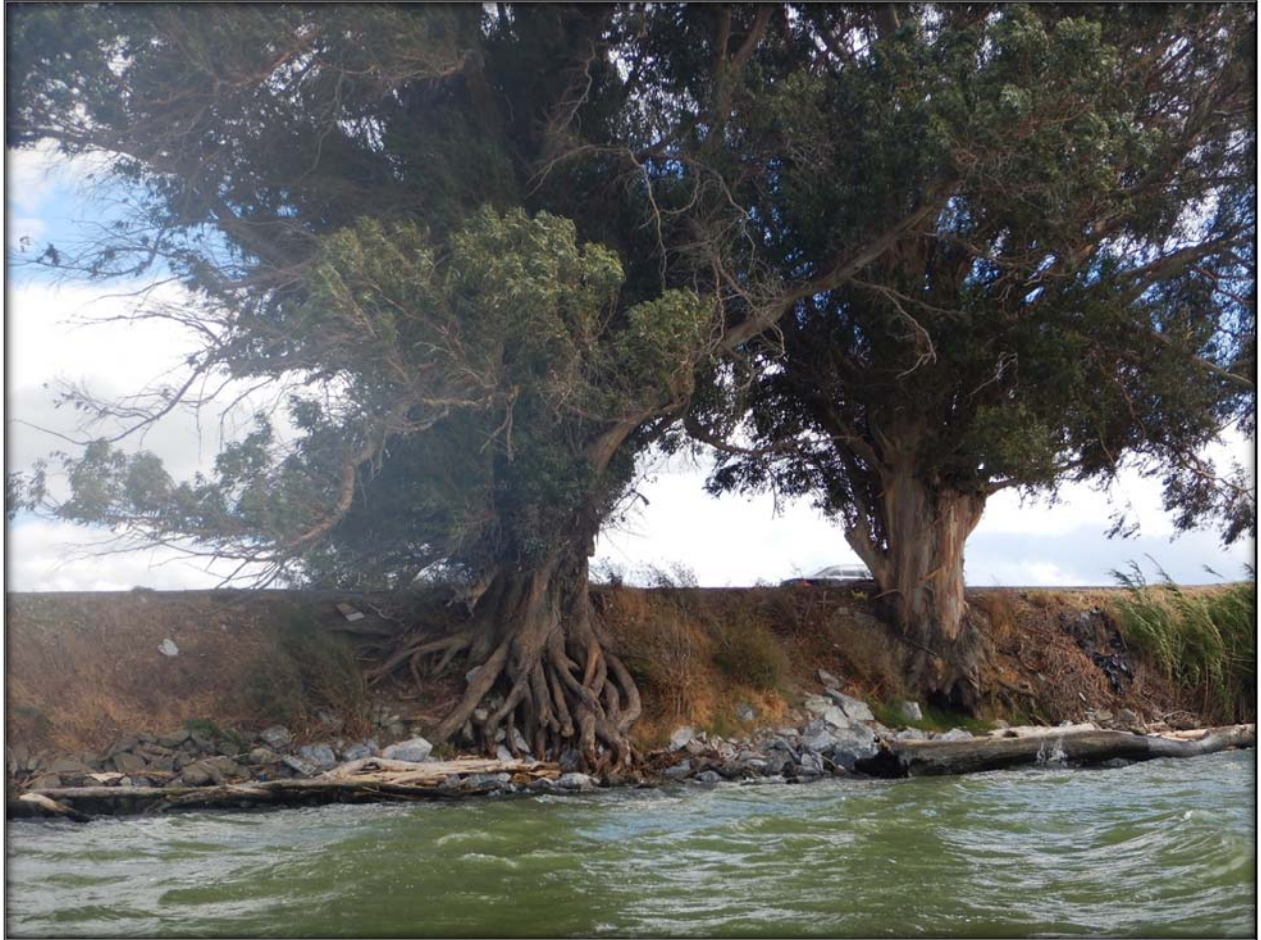
Figure 25. Eroded bank and large trees with exposed roots along the left levee slope of the Sacramento River at RM 11.2.

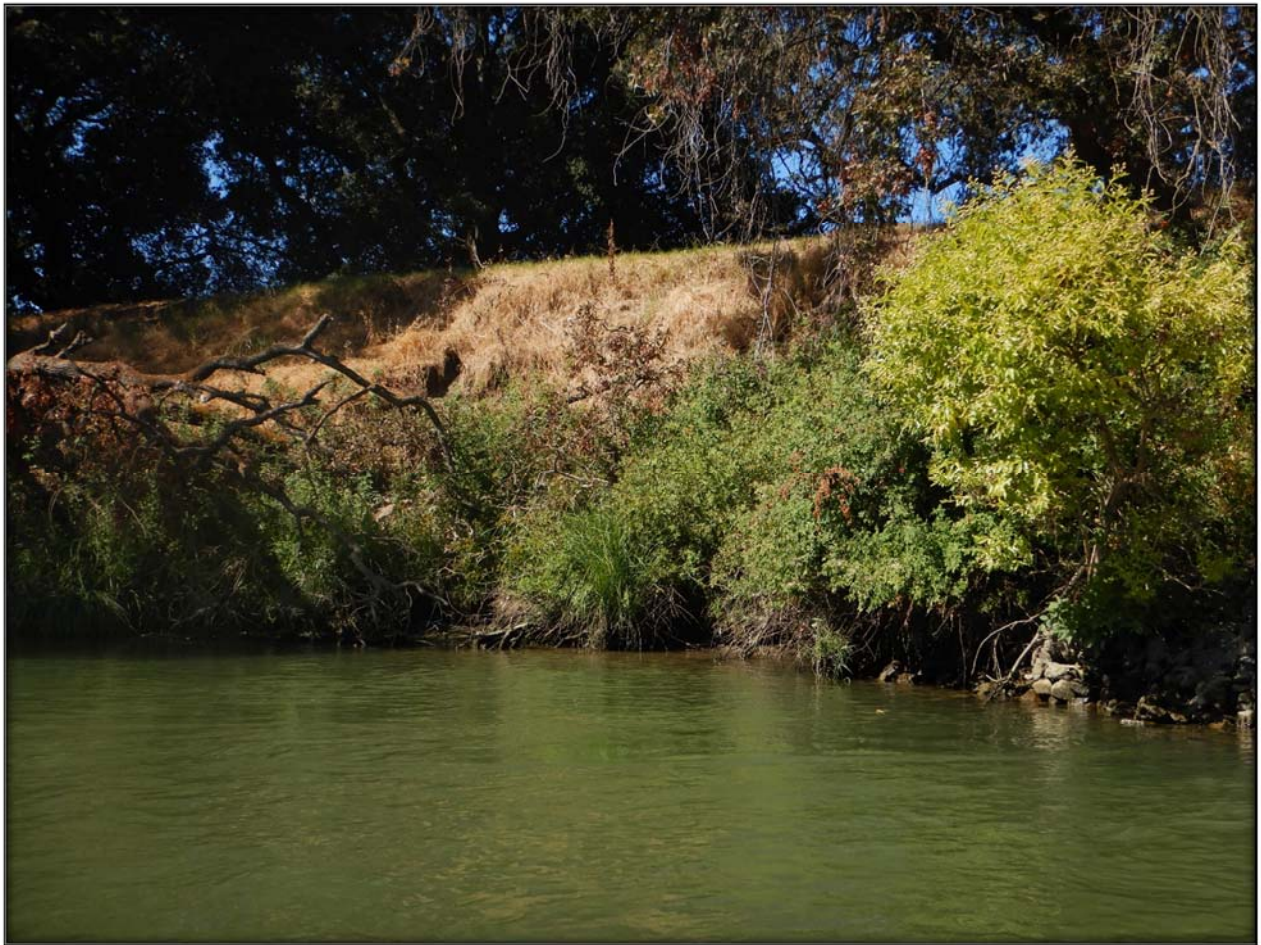
Figure 39. Eroding bank along the right bank of Steamboat Slough at RM 25.8.
