## Sacramento River Bank Protection Project - Critical Sites Memorandum

May 14, 2018

This Memorandum for Record is a summary of the Critical Bank Erosion Sites identified during the Sacramento River Bank Protection Project (SRBPP) 2017 Erosion Inventory field work. The erosion inventory field work is conducted every year to keep track of erosion threatening the levees of the Sacramento Flood Control Project (SRFCP). This memorandum does not discuss all of the erosion sites identified, only those that were deemed critical. A critical erosion site is defined as a site where there is a potential for a levee breach or serious levee issues (an issue which at the minimum would require flood fighting) during the next large storm event. This memorandum is to illustrate the details of the critical sites and the immediate need to repair.

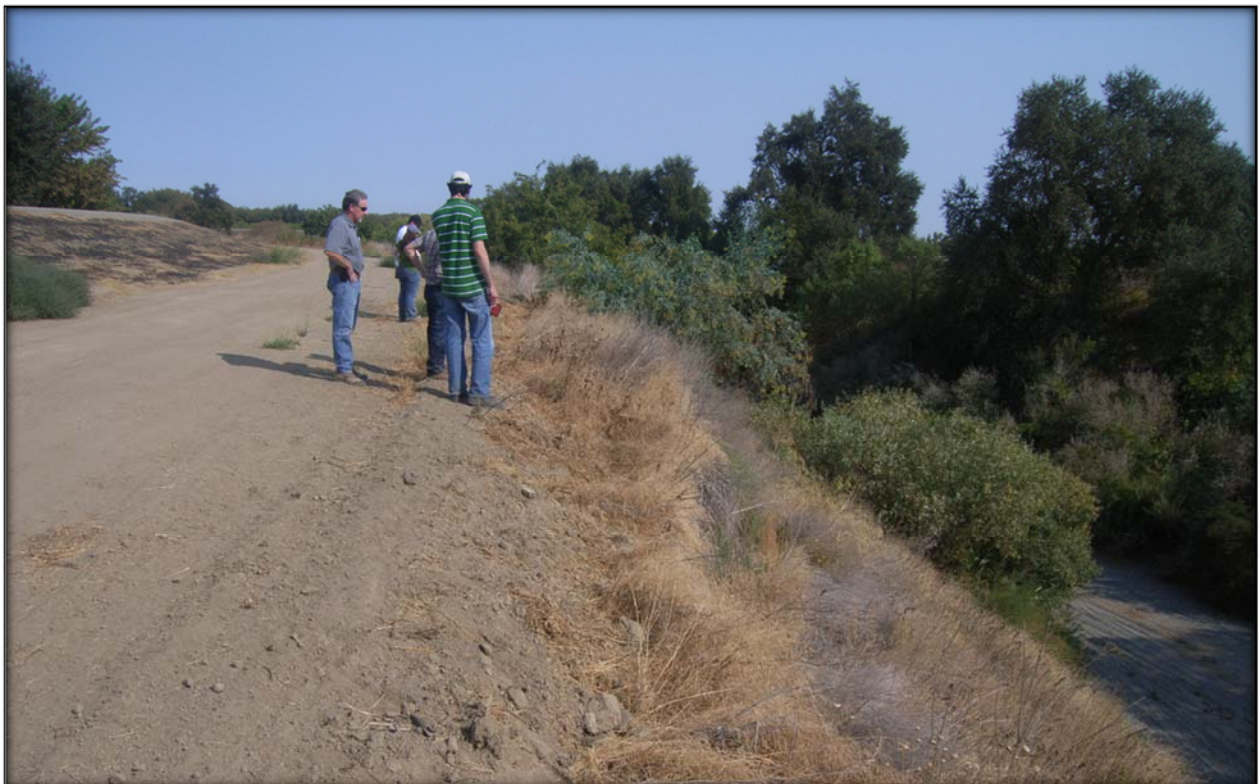
The main cause of erosion along CHC 2.4L is fluvial action of the river; a combination of high velocities, over-steepened slopes, and poor soils have led to significant erosion. Additional issues at this site are vertical banks, animal holes, cracks, and slumping<sup>1</sup>. Fresh erosion was observed in 2013 and 2017. Seepage is a known issue along this levee reach.

**Figure 3. Looking Downstream along Cache Creek LM 2.4L**

Due to how narrow the channel width is and how deep the channel is, a setback levee is the only type of repair that is likely acceptable at this site. However, adjacent to this levee (on the landside) is a house (with multiple smaller structures) which will require real estate acquisition for any repair work, DWR is currently working to find a long term solution. Photos depicting this site are shown in **Figures 3 and 4**.

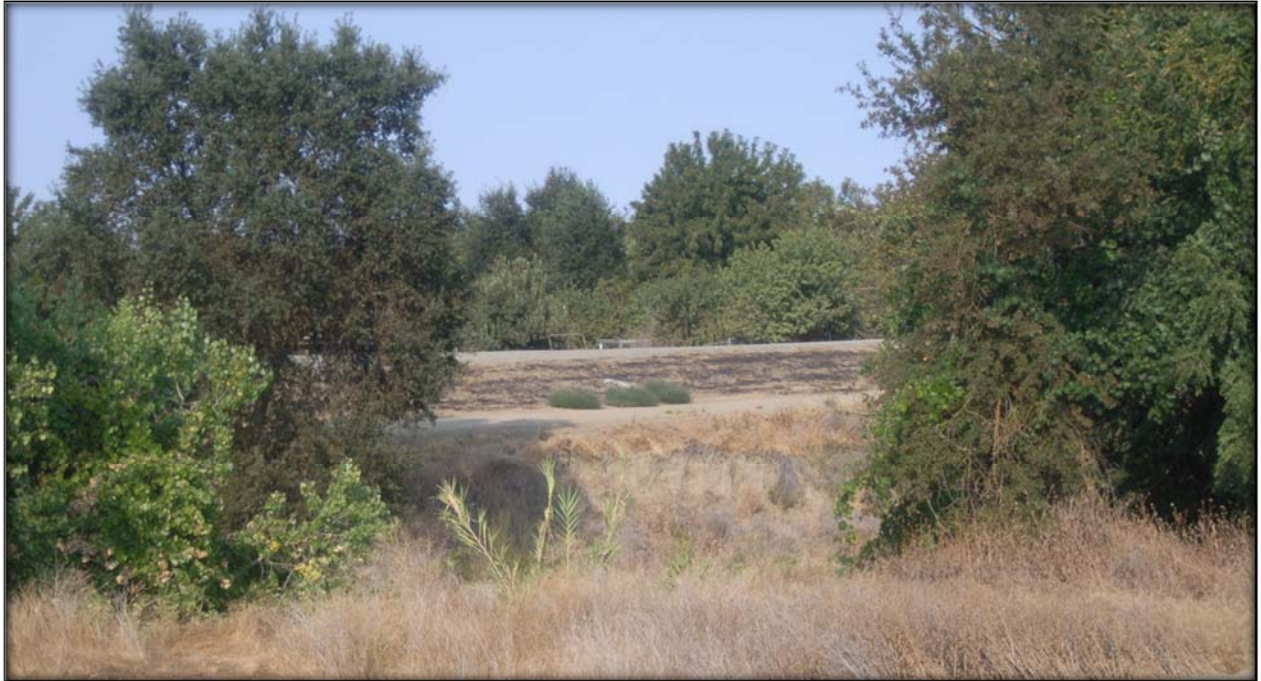
**Figure 4. View of Cache Creek LM 2.4L from Opposite Bank**

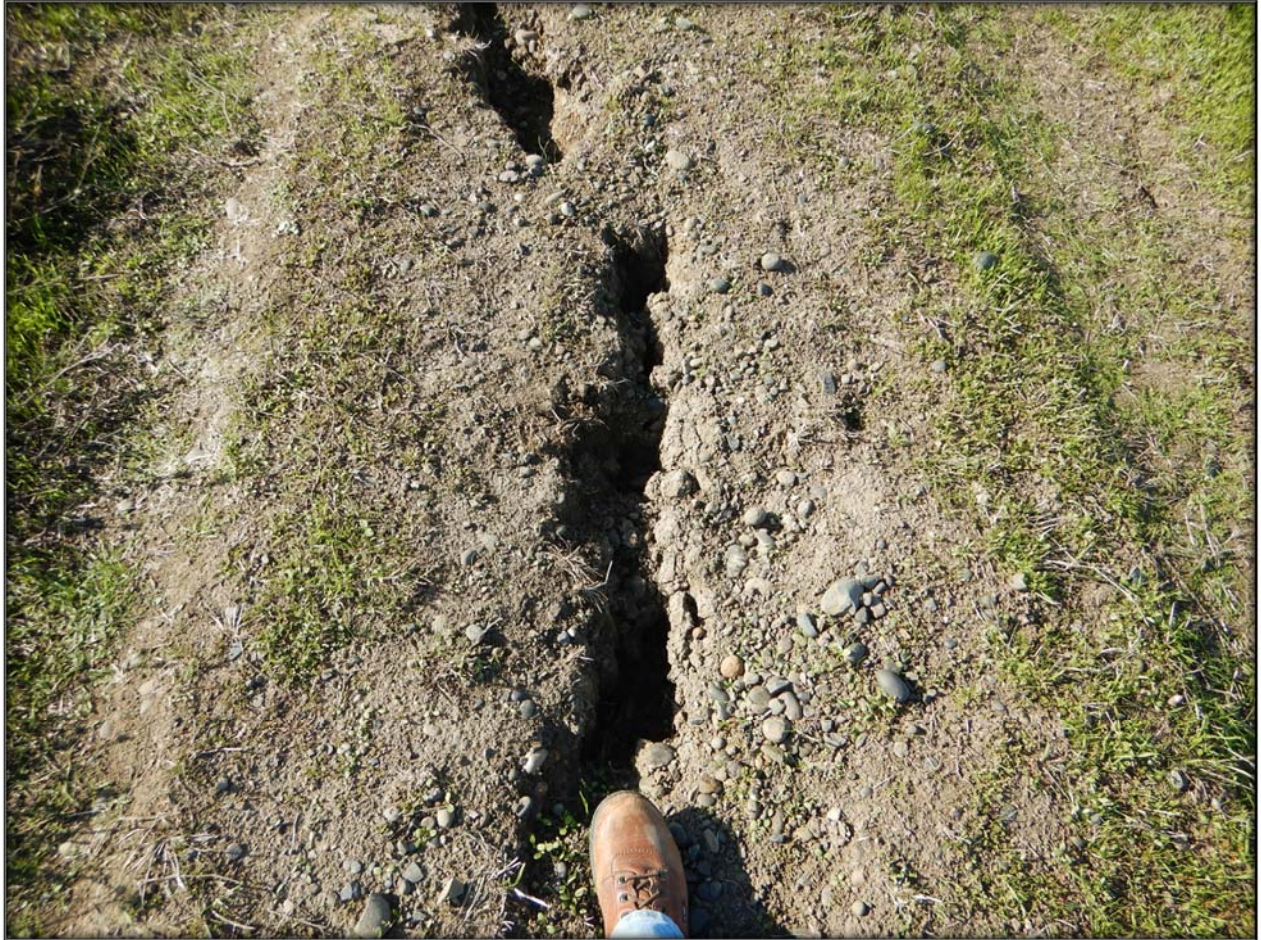
The main cause of concern along CHI 1.8L is slump cracking; the entire levee is at risk of eminent slump failure from deep cracks that run almost the length of the levee on both the waterside and landside. While the site does not currently have active erosion, the potential for slump is very high and eminent, which will result in an erosion issue. This site will need an erosion repair if immediate action is not taken to repair the slump cracks. An additional issue at this site are large trees on the levee slope. Seepage is a known issue along this levee reach.

**Figure 5. Slump Crack showing width of the crack (with boot for scale) at Cache Slough, RM 1.8L.**

Due to the poor soils and deep cracks, this levee would not benefit from the traditional SRBPP rock repair. It would require either a reconstruction of the levee or a policy decision to decommission the levee. Photos depicting this site are shown in **Figures 5 and 6**.

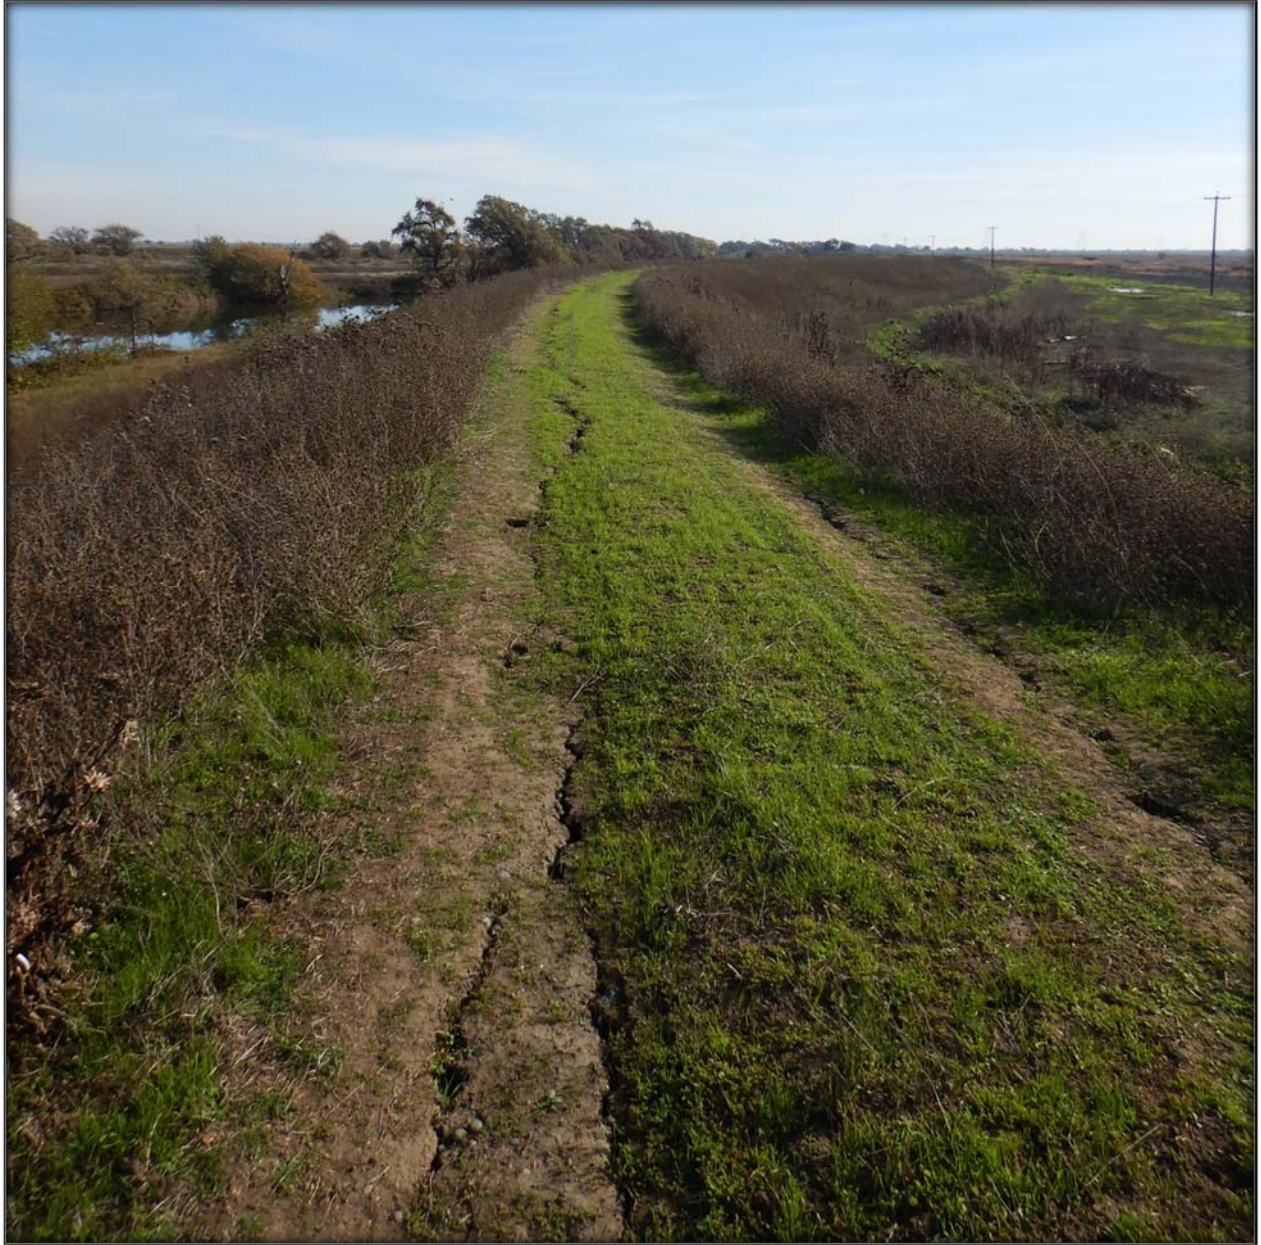
**Figure 6. Slump Cracks observed on both the landside and waterside of Peters Pocket at Cache Slough, RM 1.8L.**

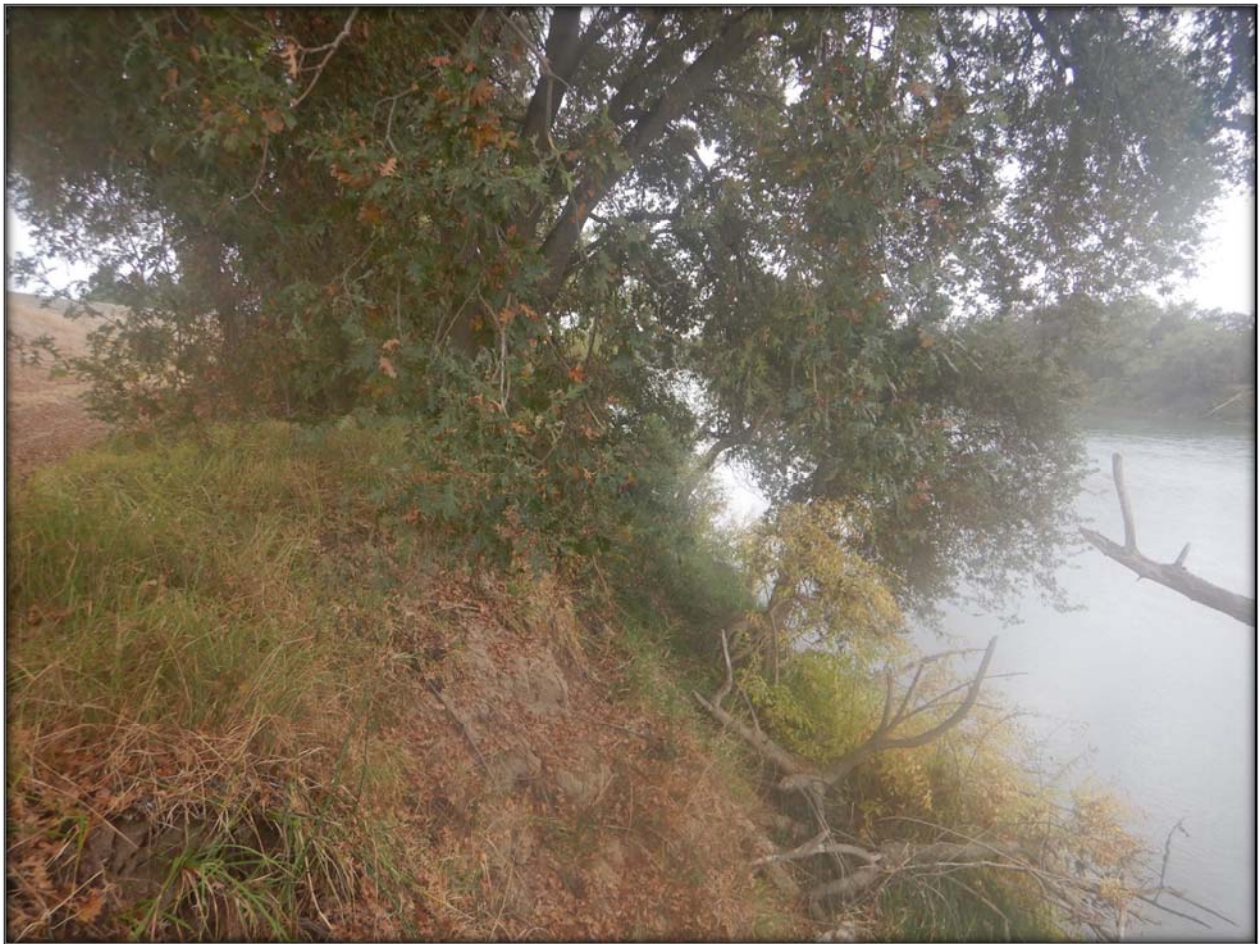
The main cause of erosion along FHR 5.0L is from the fluvial action of the river and whole bank failure<sup>2</sup>; a combination of over-steepened slopes along with non-cohesive soils have led to significant erosion. Additional issues at this site are vertical banks, trees with exposed roots that are leaning over, animal holes, and slumping. Significant new erosion was observed following the 2017 flood season and the site has a history of tree pop-outs<sup>3</sup>. Seepage is a known issue along this levee reach. Although further analysis is needed, it is likely that a vegetation variance or removal of vegetation encroachments may be required at this site. Photo depicting this site is shown in **Figure 7**.

**Figure 7. Erosion Site at Feather River, RM 5.0 Left Bank.**

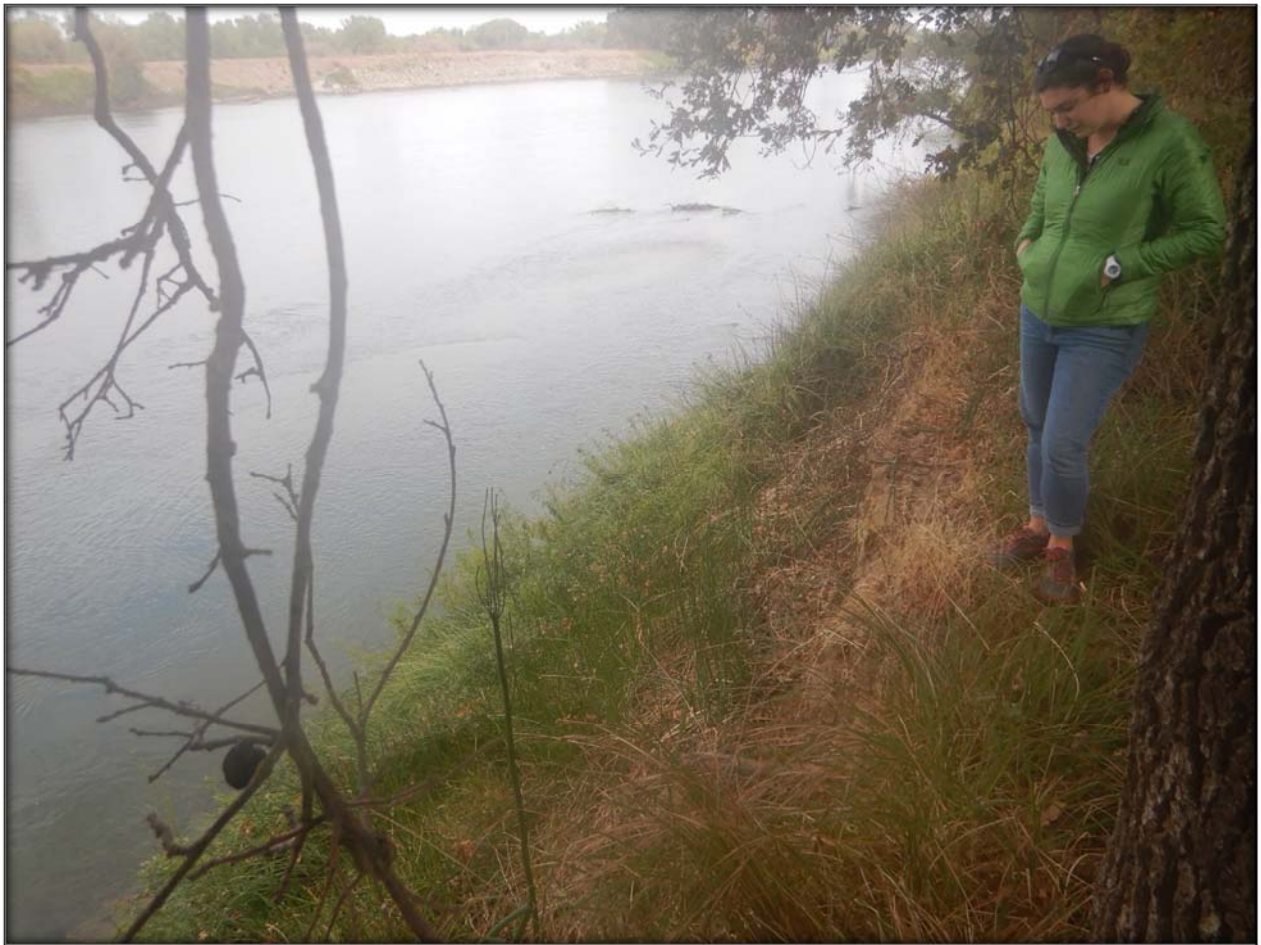
The main cause of erosion along FHR 6.0L is from the fluvial action of the river and whole bank failure; a combination of over-steepened slopes along with non-cohesive soils have led to significant erosion. The entire bank slope is slumping. Additional issues at this site are bank slopes at less than 1:1, trees with exposed roots that are leaning over, animal holes, and slumping. Significant new erosion was observed from the 2017 flood season. Seepage is a known issue along this levee reach. Although further analysis is needed, it is likely that a vegetation variance or removal of vegetation encroachments may be required at this site. Photo depicting this site is shown in **Figure 8**.

**Figure 8. Erosion Site along the Feather River at RM 6.0, Left Bank.**

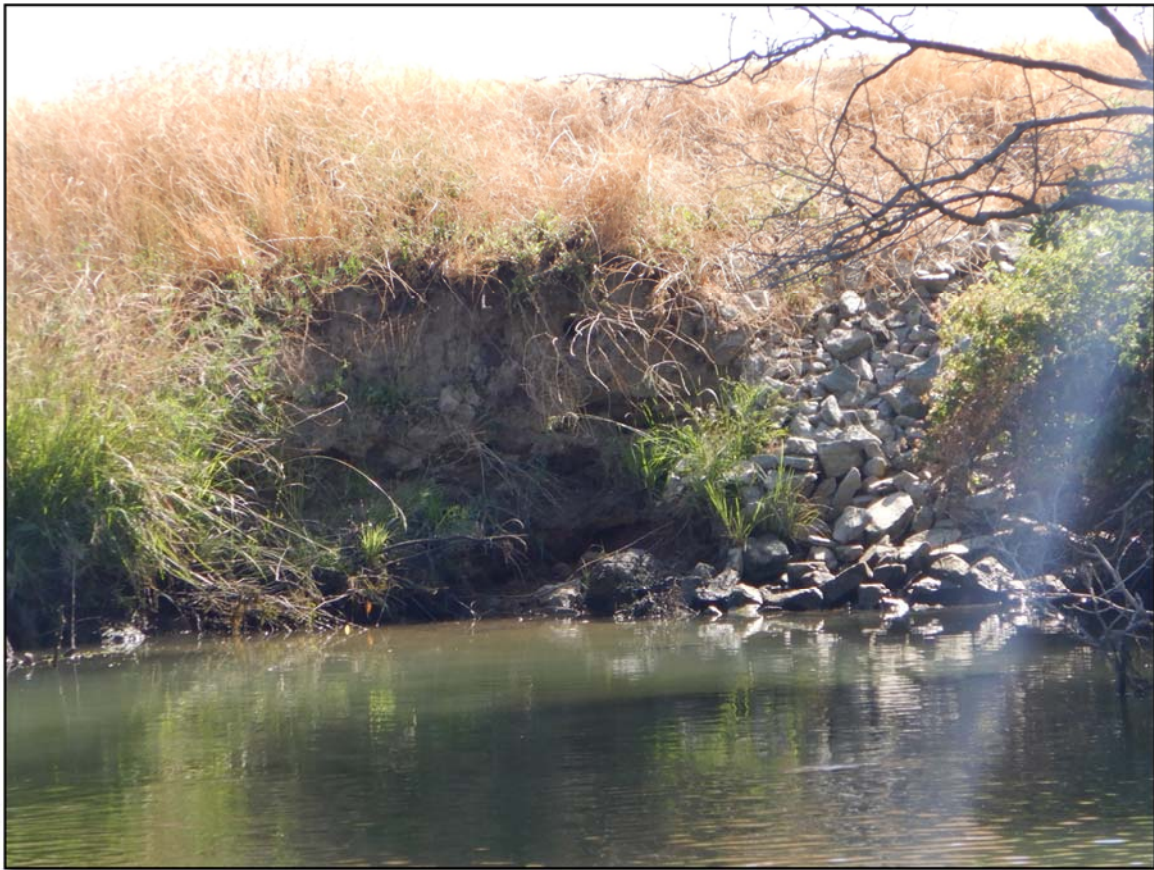
The main cause of erosion along GEO 6.3L is from whole bank failure and wave wash; a combination of wind waves, boat wakes, and being in the tidal zone along with poor soils have led to failure of the entire bank slope. Additional issues at this site are tall vertical sections, animal holes, slumping, and large trees with exposed roots. Fresh erosion was observed following the 2017 flood season. The vertical sections typically extend from the mid-slope to the toe, however in some sections there is a vertical face from the levee hinge to the toe. Seepage is a known issue along this levee reach. Although further analysis is needed, it is likely that a vegetation variance or removal of vegetation encroachments may be required at this site. There are encroachments throughout this site, including a bridge, pipes and a telephone crossing. A Photo depicting this site is shown in **Figure 9**.

**Figure 9. Erosion Pocket along the Georgiana Slough RM 4.5, Left Bank.**

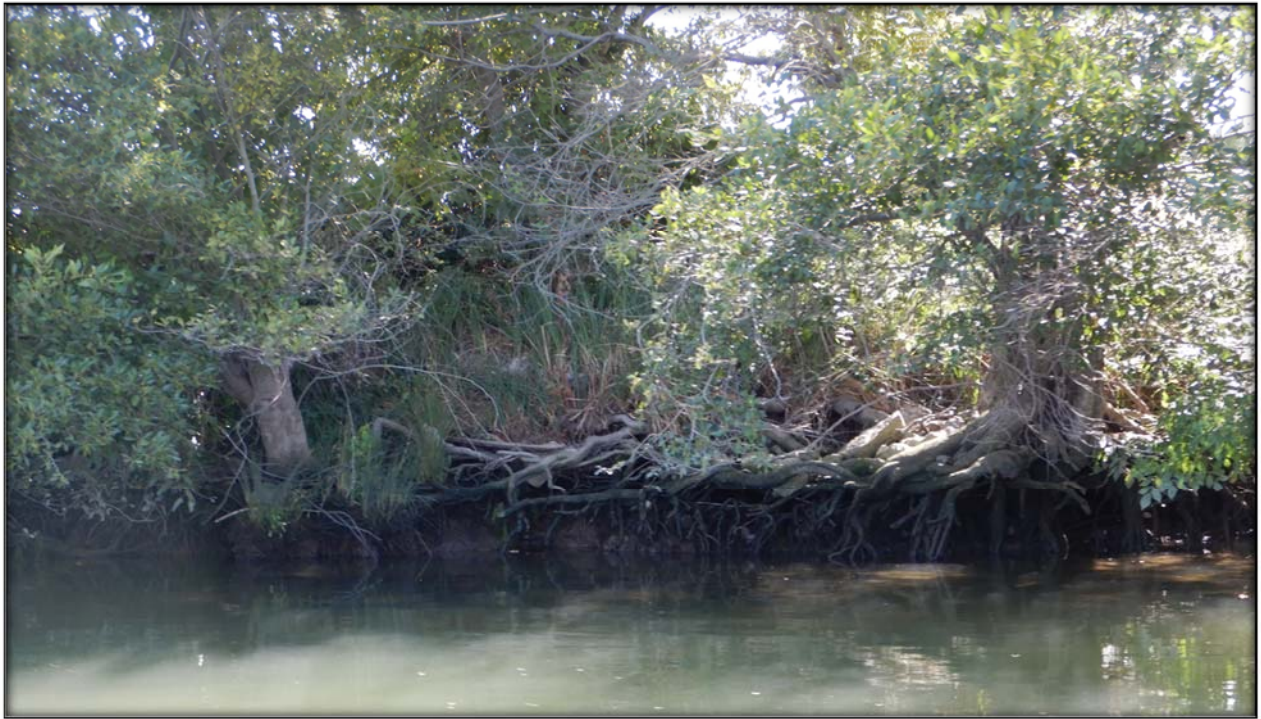
The main cause of erosion along GEO 6.3L is from wave wash and erosion pockets<sup>4</sup>; a combination of wind waves, boat wakes, and being in the tidal zone along with poor soils have led to significant toe erosion and pockets of failed bank slope. Additional issues at this site are tall vertical sections, animal holes, and slumping. Fresh erosion was observed following the 2017 flood season, along with evidence of beaver activity. The vertical sections typically extend from the mid-slope to the toe, however in some sections there is a vertical face from the levee hinge to the toe. Seepage is a known issue along this levee reach. Although the locals have been placing rock in many of the erosion pockets, the site continues to deteriorate. Although further analysis is needed, it is likely that a vegetation variance or removal of vegetation encroachments may be required at this site. There are encroachments throughout this site, including pipes and a PG&E crossing. Photos depicting this site are shown in **Figures 10 and 11.**

**Figure 10. Toe Erosion along the Georgiana Slough RM 6.3, Left Bank.**

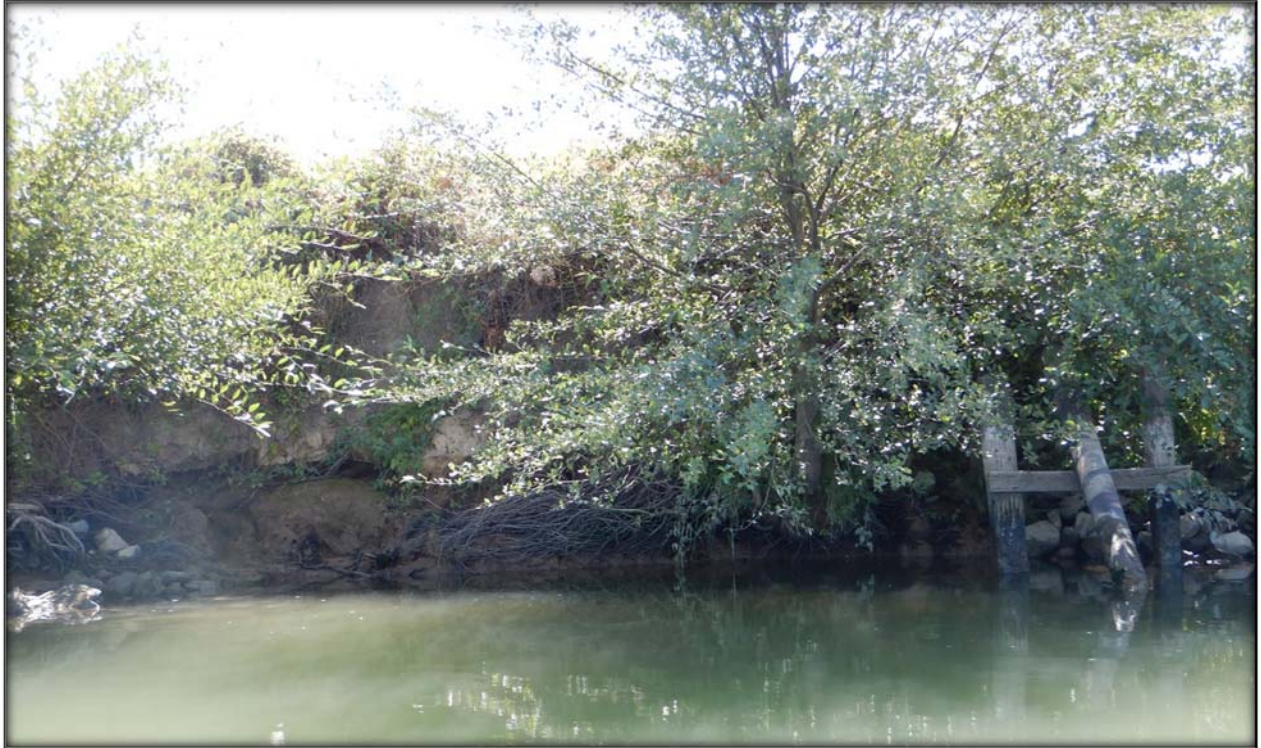
**Figure 11. Erosion Pocket showing whole bank failure along the Georgiana Slough RM 6.3, Left Bank.**

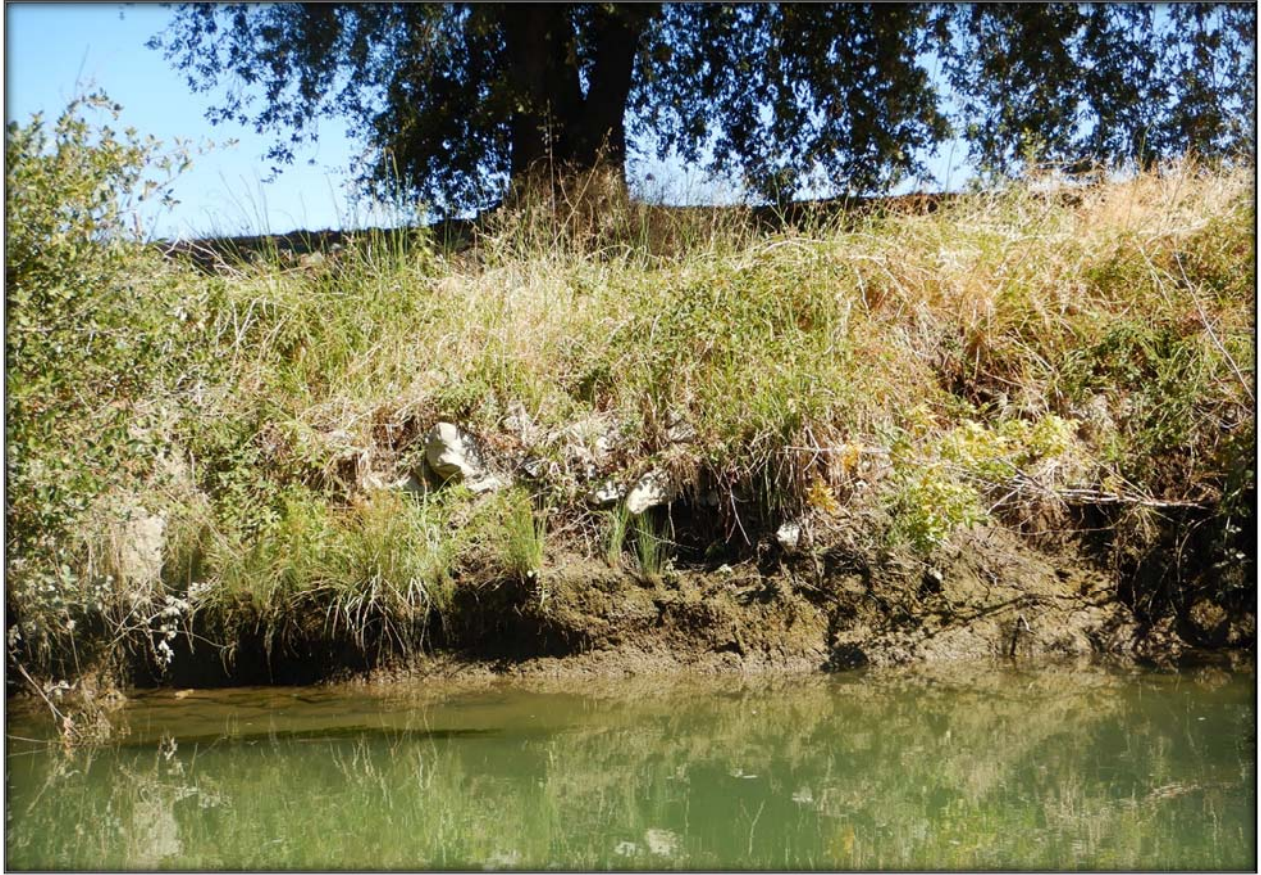
The main causes of erosion along GEO 11.4 are wave wash and toe scour; a combination of wind waves, boat wakes, and being in the tidal zone along have led to significant toe erosion and failed bank revetment. Additional issues at this site include short sections of vertical bank, animal holes, tree pop-outs, and slumping. This site increased in length by more than 3,000 ft since the last inspection (2015) due to new erosion from the 2017 flood season. The bank has some sub-vertical sections, areas of failed revetment, and eminent tree pop-outs are expected. Seepage is a known issue along this levee reach. Although further analysis is needed, it is likely that a vegetation variance or removal of vegetation encroachments may be required at this site. There are encroachments along this site, including a pump. A photo depicting this site are shown in **Figures 12 and 13**.

**Figure 12. Typical toe erosion along the left bank of Georgiana Slough at river mile 9.3**

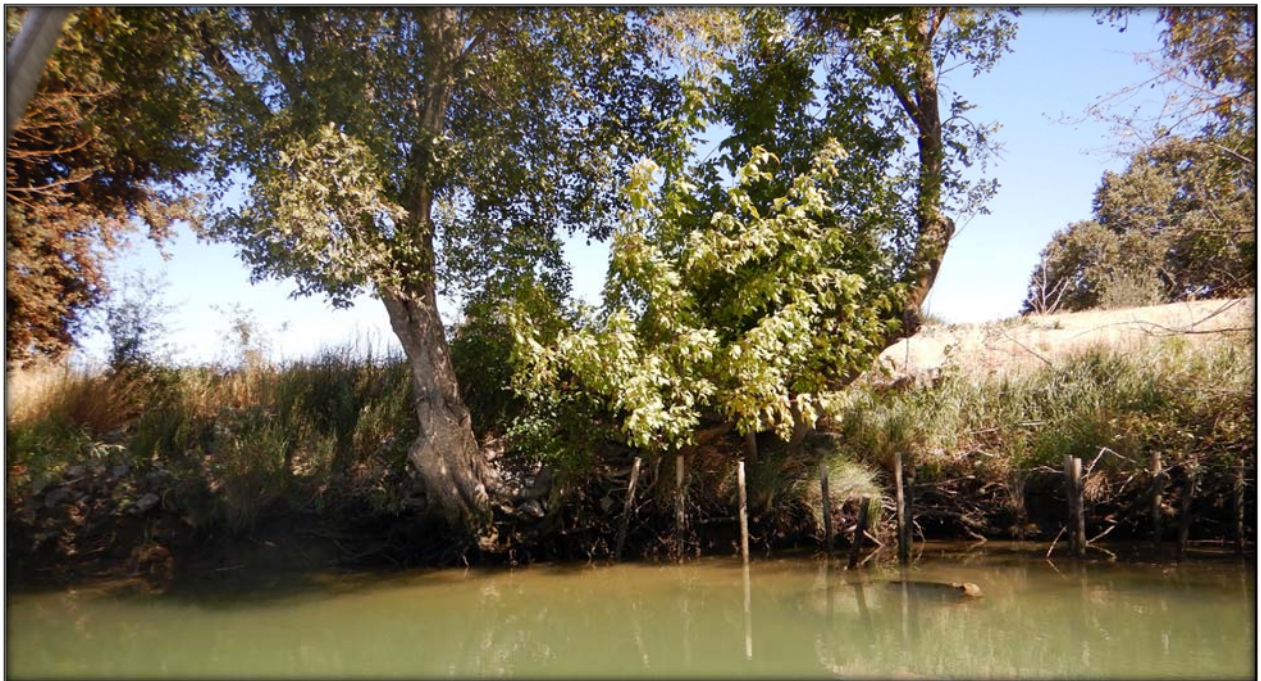
**Figure 13. Photo depicting failing revetment and eminent tree pop-out at Georgiana Slough, RM 9.3L.**

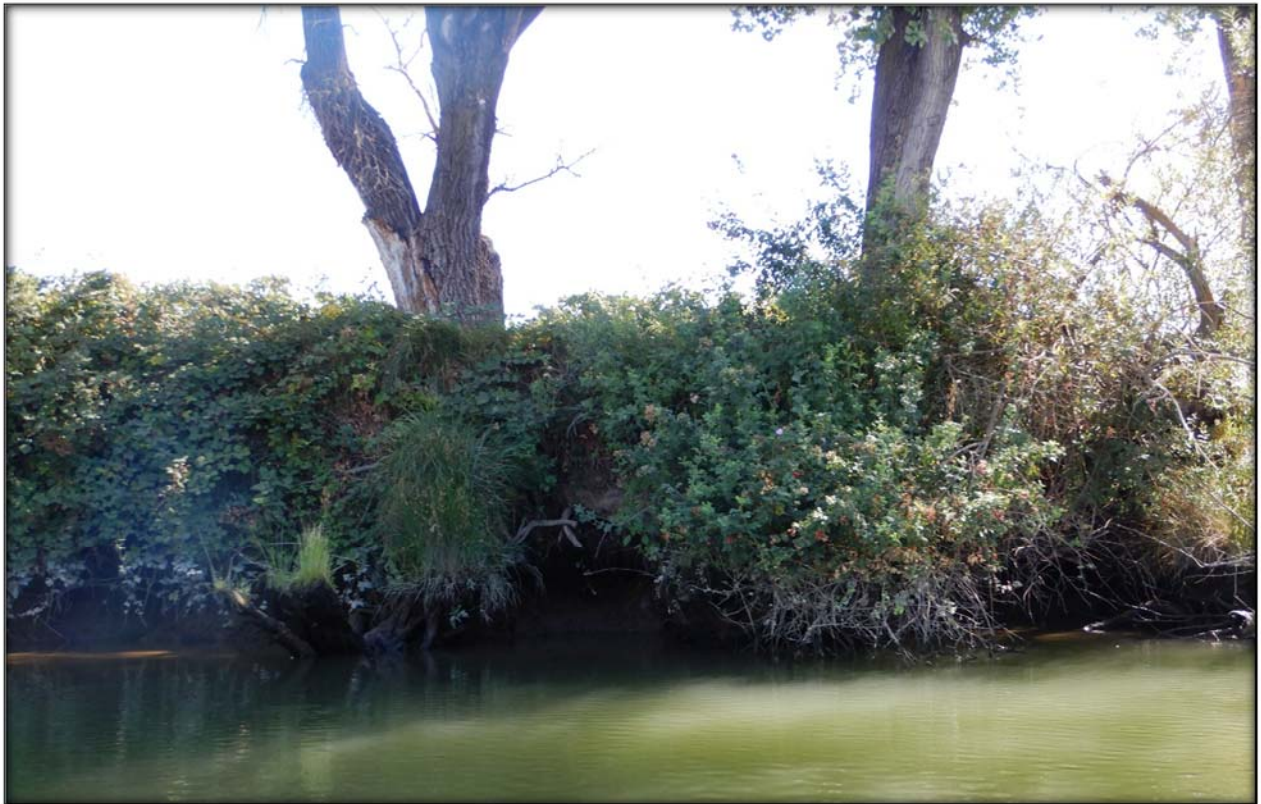
The main cause of erosion along GEO 11.4 is toe scour and whole bank failure; a combination of wind waves, boat wakes, and being in the tidal zone along with poor soils have led to significant toe erosion and failed bank slope. Additional issues at this site are vertical bank slopes, animal holes, trees with exposed roots, and slumping. The new erosion at this site occurred from the 2017 flood season. The bank has a sub-vertical face from the levee hinge to the toe. Seepage is a known issue along this levee reach. Although further analysis is needed, it is likely that a vegetation variance or removal of vegetation encroachments may be required at this site. A photo depicting this site is shown in **Figure 14**.

**Figure 14. Erosion along the left bank of Georgiana Slough at RM 11.4.**

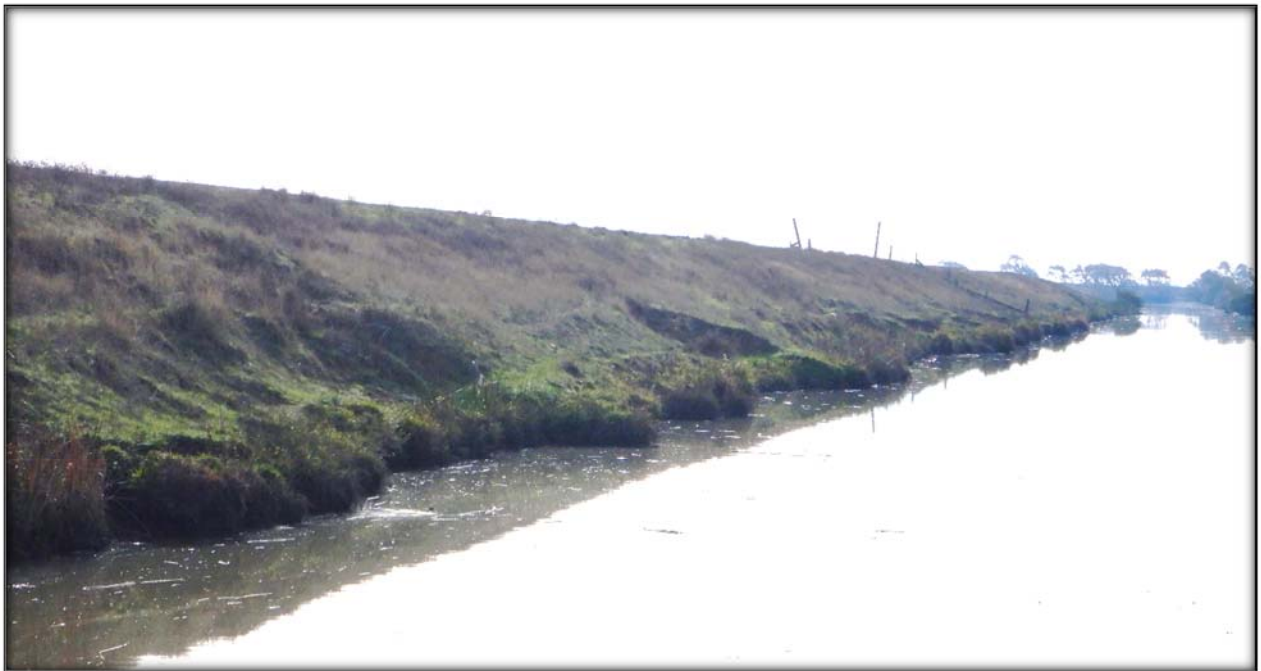
The main cause of erosion along LDS 0.7R is wave wash and erosion pockets; a combination of wind waves, and being in the tidal zone along have led to significant pockets of eroded bank. Additional issues at this site are over steepened slopes, excessive loading from cattle, short vertical sections of bank, eddy<sup>5</sup> currents, and shallow cracks. Seepage is a known issue along this levee reach. Some concrete rubble in poor condition is located in sections along this site. A vegetation variance or vegetation removal does not appear to be required at this site. Photos depicting this site are shown in **Figures 15 and 16.**

**Figure 15. Erosion Pockets along the Left Bank of Haas Slough at LM 9.7.**

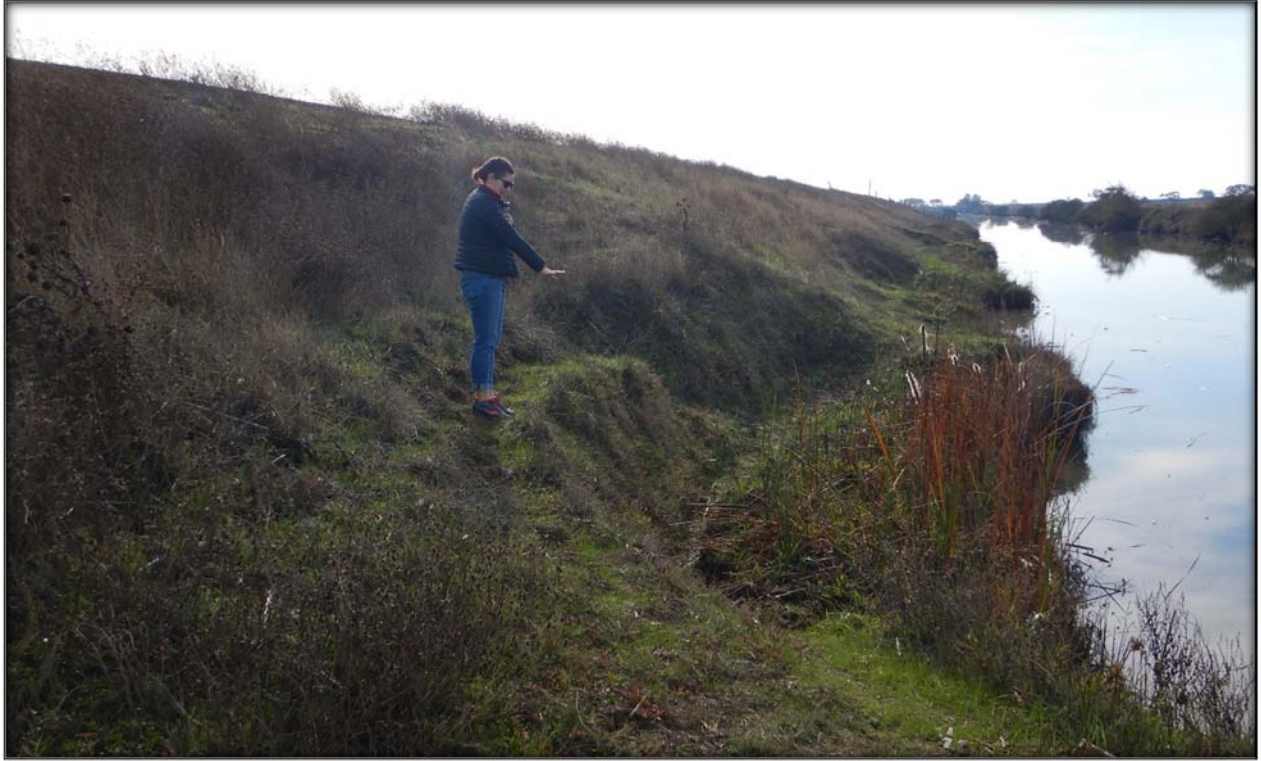
**Figure 16. Slumps at Haas Slough LM 9.7 L.**

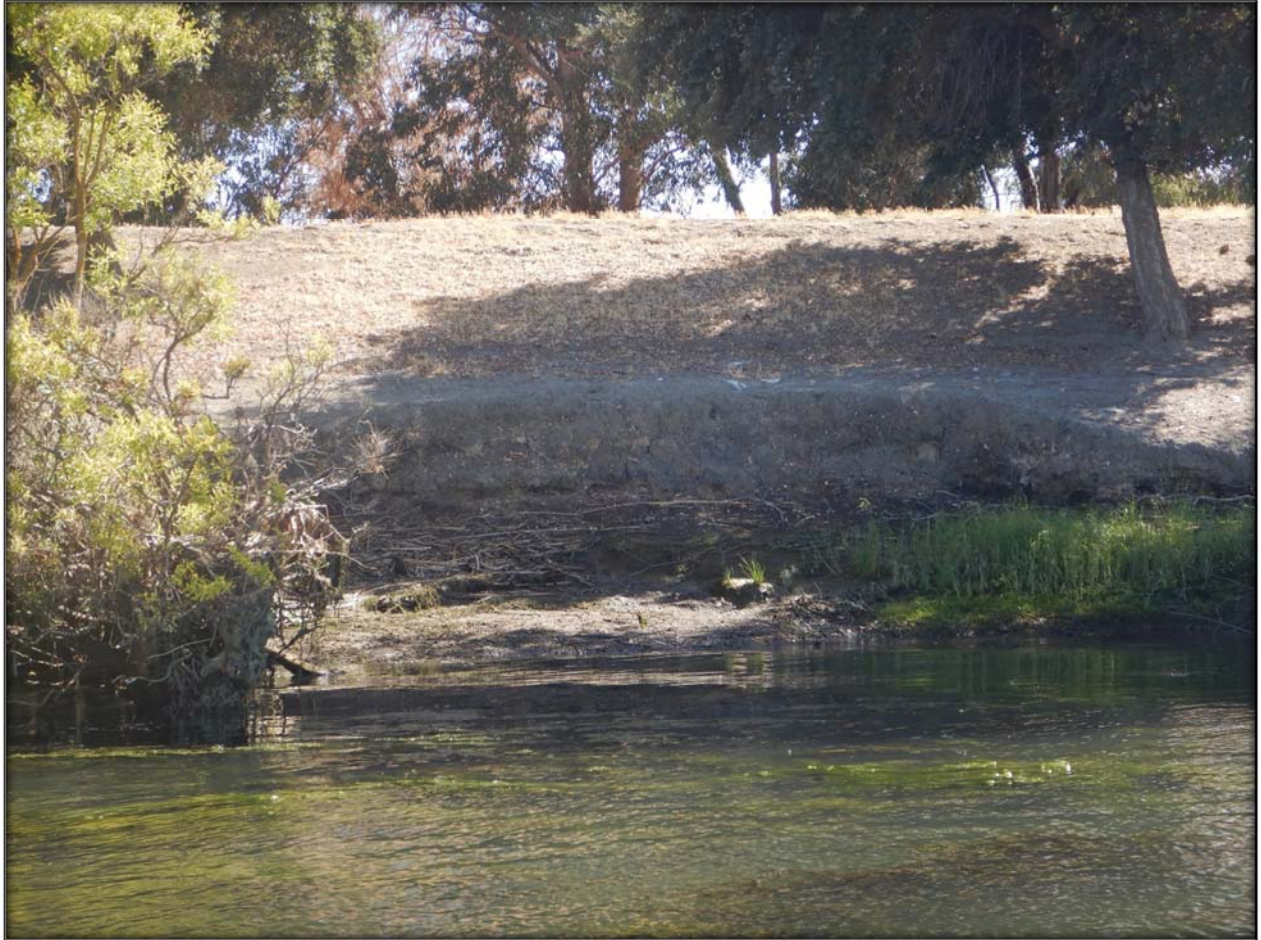
The main cause of erosion along LDS 0.7R is wave wash and erosion pockets; a combination of wind waves, and being in the tidal zone along have led to significant pockets of eroded bank. Although further analysis is needed, it is likely that a vegetation variance or removal of vegetation encroachments may be required at this site. A photo depicting this site is shown in **Figure 17**.

**Figure 17. Erosion Pocket along the right bank of Lindsey Slough at river mile 0.7.**

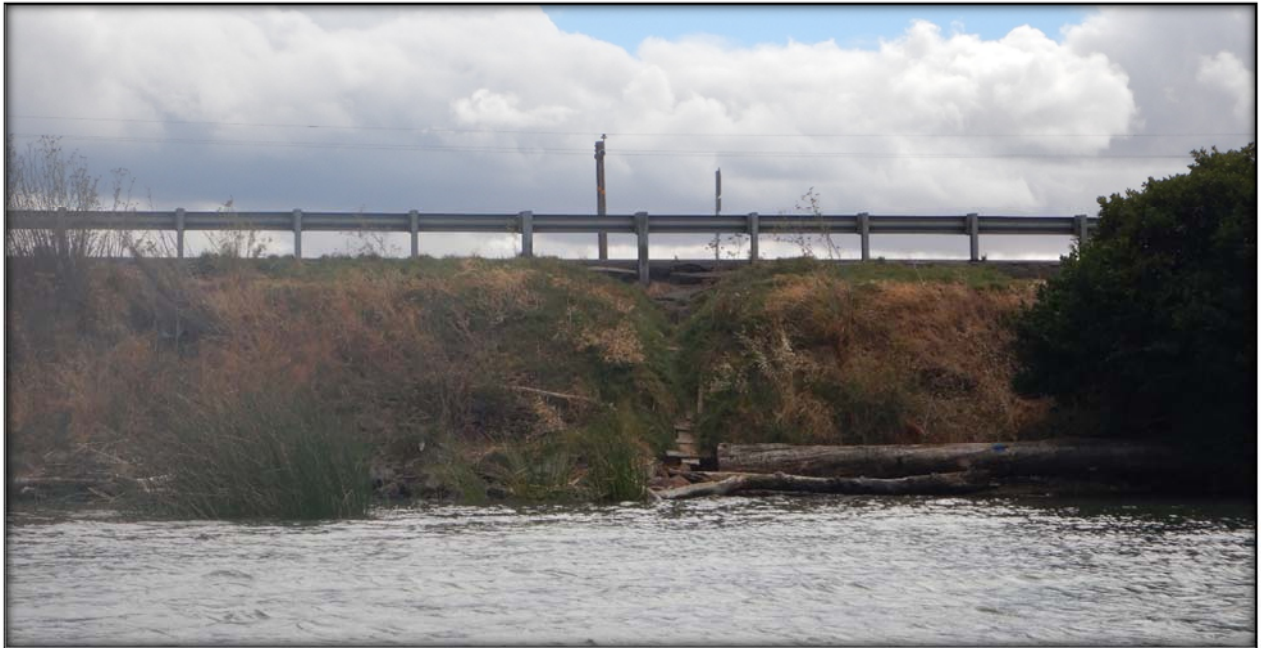
The main cause of erosion along SAC 7.3L is surface runoff and whole bank failure; a combination of surface runoff, bank slumping of poor soils along with wind waves, and being in the tidal zone have led to significant slumping, the formation of a gully<sup>6</sup>, and failed bank slope. Additional issues at this site are short vertical<sup>7</sup> sections of eroding bank, animal holes, shallow cracks, eddy formations, and slumping. Seepage is a known issue along this levee reach. Some concrete rubble in poor condition is located in sections along this site. There are encroachments at this site, including pipes fish release system, pilings,

**Figure 18. Surface Runoff Issue on the left bank of the Sacramento River at RM 7.3.**

conduit, netting, and power poles. Although further analysis is needed, it is likely that a vegetation variance or removal of vegetation encroachments may be required at this site. Photos depicting this site are shown in **Figures 18 and 19**.

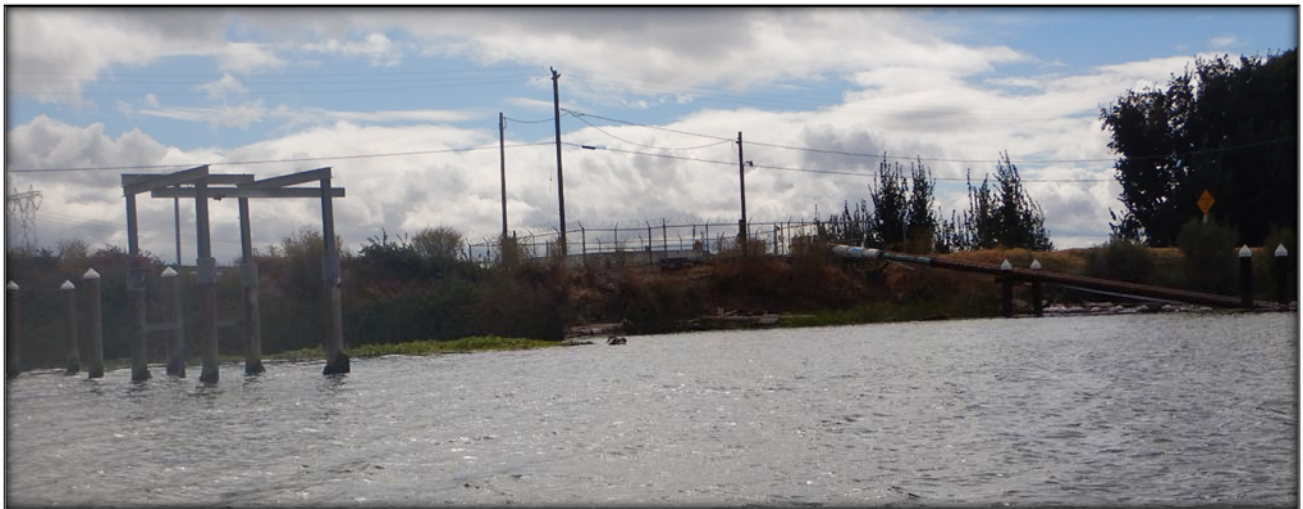
**Figure 19. Encroachments and Slumping along the left bank of the Sacramento River at RM 7.3.**

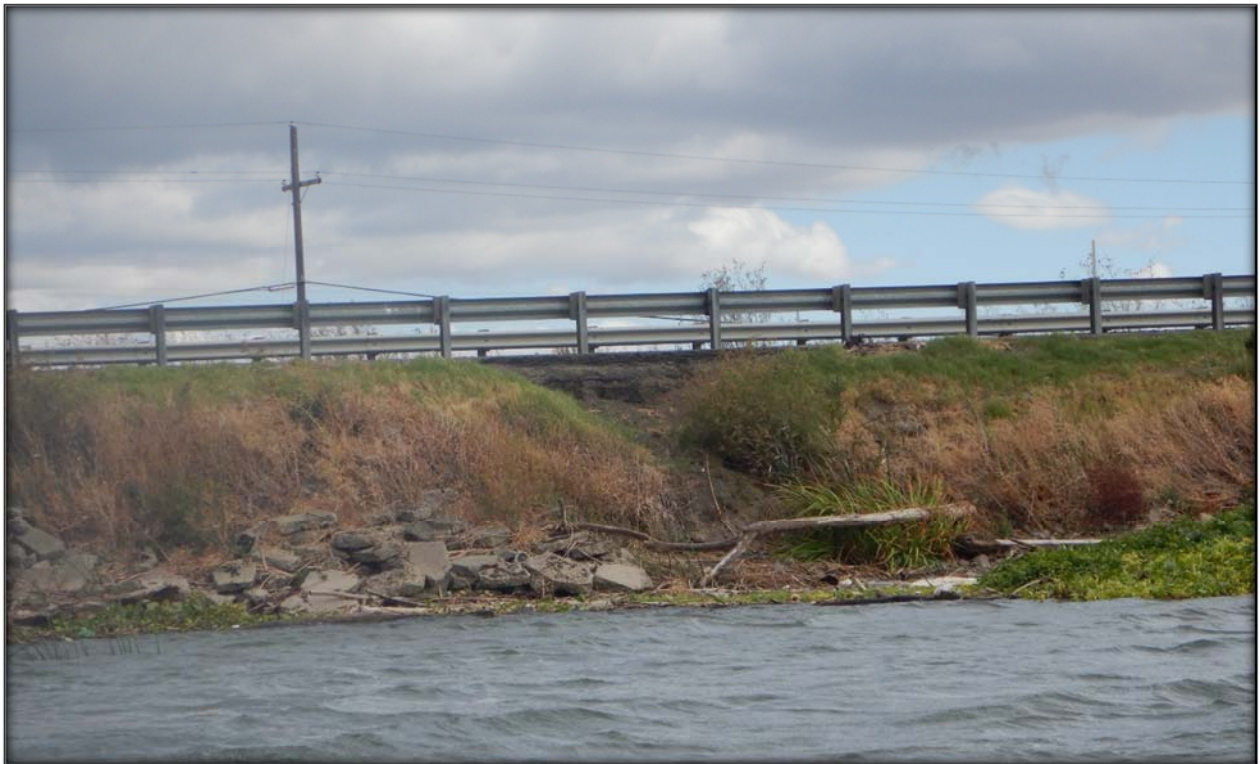
The main cause of erosion along SAC 7.9L is wave wash and whole bank failure; a combination of wind waves, boat wakes, and being in the tidal zone along with poor soils have led to significant toe erosion and pockets of failed bank slope. Some surface runoff from the Highway is also causing erosion along the bank and road base is now exposed. This site was extended by 800 ft due to new erosion from the 2017 flood event. Trees with exposed roots along the levee slope are a significant issue, one tree popped out during or following the 2017 flood season, and more trees are likely to go in the future. Additional issues at this site are tall vertical sections of eroding bank, deep cracks, animal holes, and slumping. Seepage is a known issue along this levee reach. Some concrete rubble in poor condition is located in sections along this site. A vegetation variance or removal of vegetation encroachments may be required at this site. Photos depicting this site are shown in **Figures 20 and 21**.

**Figure 20. Erosion from Surface Runoff along the left bank of the Sacramento River at RM 7.9.**

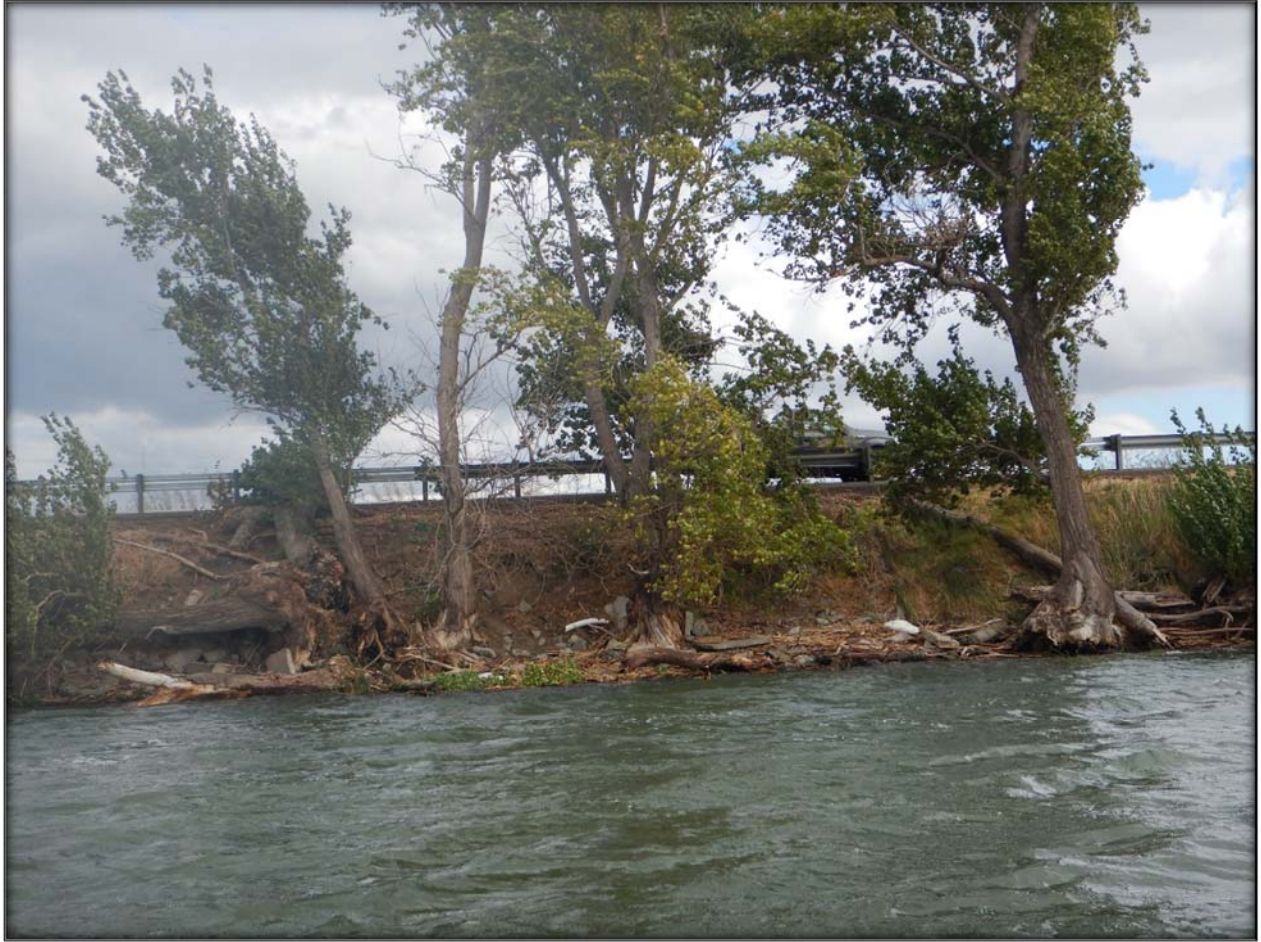
**Figure 21 – Eroded levee slope and trees with exposed roots along the left bank of the Sacramento River at RM 7.9.**
