## Sacramento River Bank Protection Project - Critical Sites Memorandum

May 14, 2018

This Memorandum for Record is a summary of the Critical Bank Erosion Sites identified during the Sacramento River Bank Protection Project (SRBPP) 2017 Erosion Inventory field work. The erosion inventory field work is conducted every year to keep track of erosion threatening the levees of the Sacramento Flood Control Project (SRFCP). This memorandum does not discuss all of the erosion sites identified, only those that were deemed critical. A critical erosion site is defined as a site where there is a potential for a levee breach or serious levee issues (an issue which at the minimum would require flood fighting) during the next large storm event. This memorandum is to illustrate the details of the critical sites and the immediate need to repair.

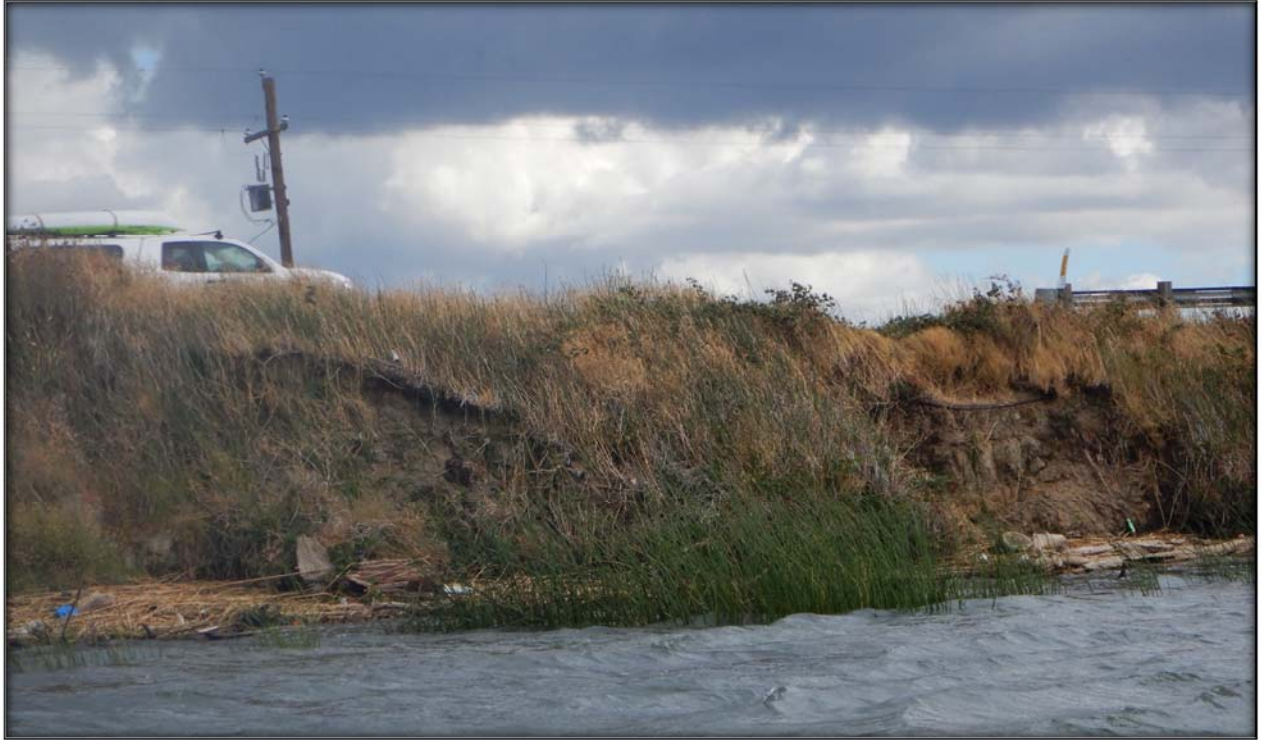
The main cause of erosion along SAC 8.0L is wave wash and whole bank failure; a combination of wind waves, boat wakes, and being in the tidal zone along with poor soils have led to significant toe erosion and pockets of failed bank slope. Some surface runoff from the Highway is also causing erosion along the bank. This site was extended by 400 ft due to new erosion from the 2017 flood event. Additional issues at this site are tall vertical sections of eroding bank, shallow cracks, eddy formations, and slumping. Seepage is a known issue along this levee reach. Some concrete rubble in poor condition is located in sections along this site. Although further analysis is needed, it is likely that a vegetation variance or removal of vegetation encroachments may be required at this site. Photos depicting this site are shown in **Figures 22 and 23**.

**Figure 22. Bank erosion along the left levee slop of the Sacramento River at RM 8.0.**

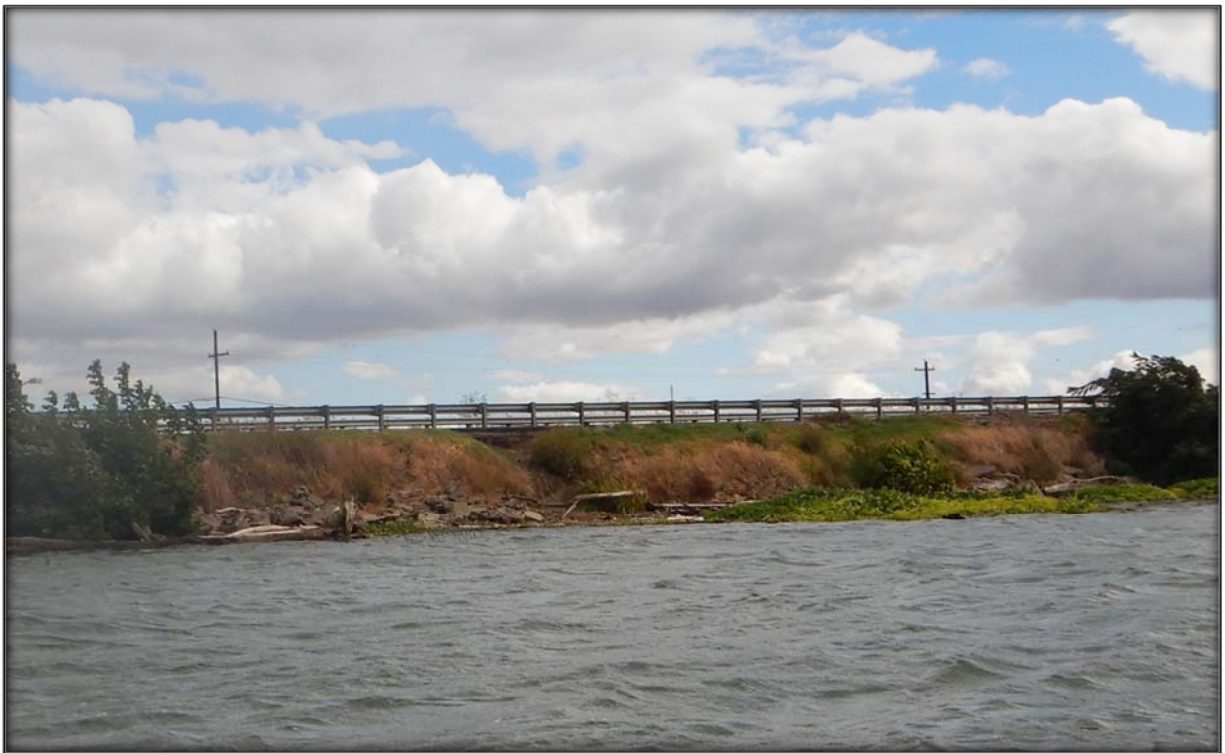
**Figure 23. Erosion from surface runoff along the left bank of the Sacramento River at RM 8.0.**

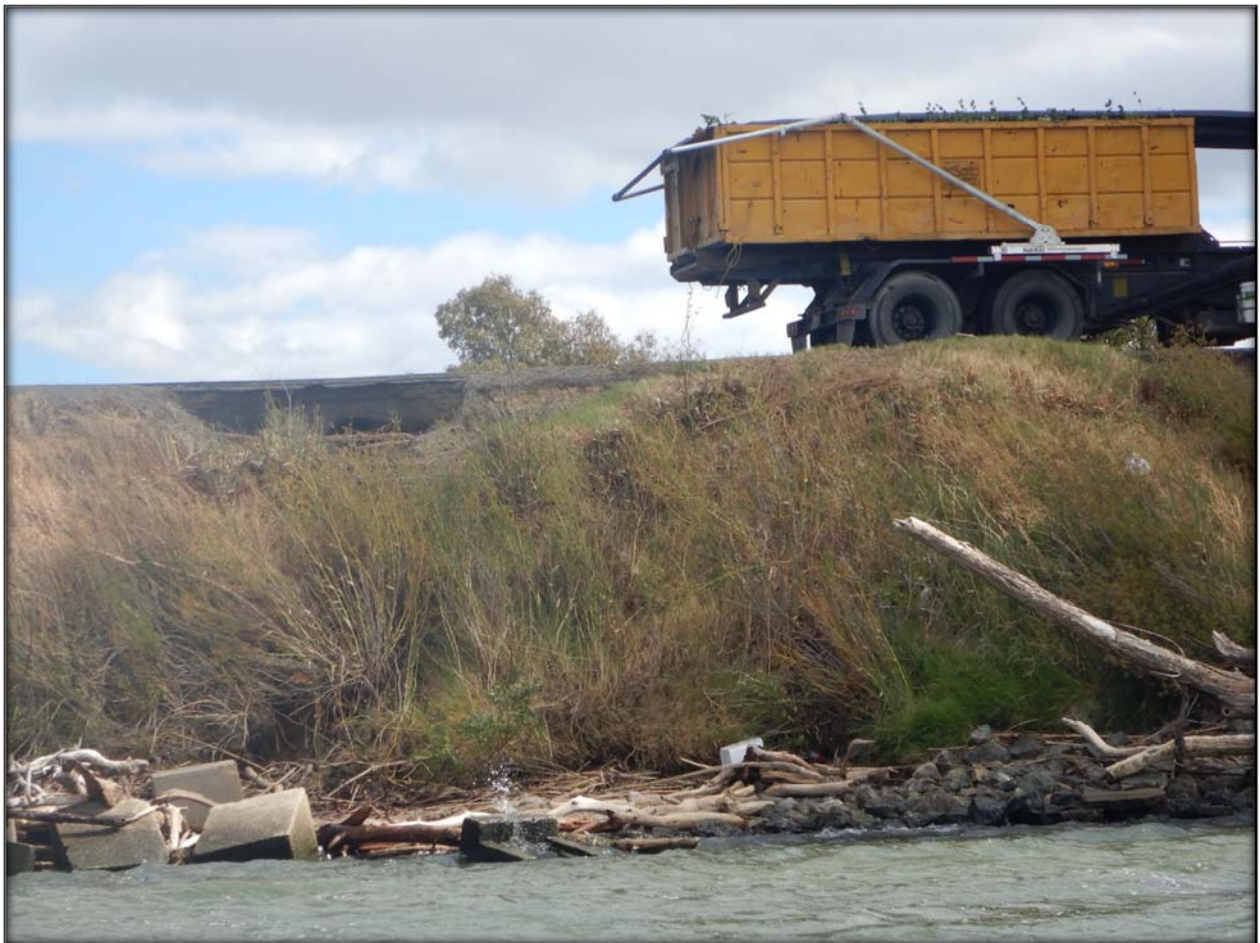
The main cause of erosion along SAC 11.2L is wave wash and whole bank failure; a combination of wind waves, boat wakes, and being in the tidal zone along with poor soils have led to significant toe erosion and pockets of failed bank slope. The eroded levee slope has scoured out a section under the Highway 160 road base material. This site was extended by 700 ft due to new erosion from the 2017 flood event. Additional issues at this site are large trees with exposed roots, tall vertical sections of eroding bank, animal holes, deep cracks, eddy formations, and slumping. Seepage is a known issue along this levee reach. Some quarry stone in fair condition is located in sections along this site. There are encroachments at this site, including a pipe through the levee. A vegetation variance or removal of vegetation encroachments may be required at this site. Photos depicting this site are shown in **Figures 24 and 25**.

**Figure 24 – Section of levee that has eroded under the highway along the left bank of the Sacramento River at RM 11.2.**

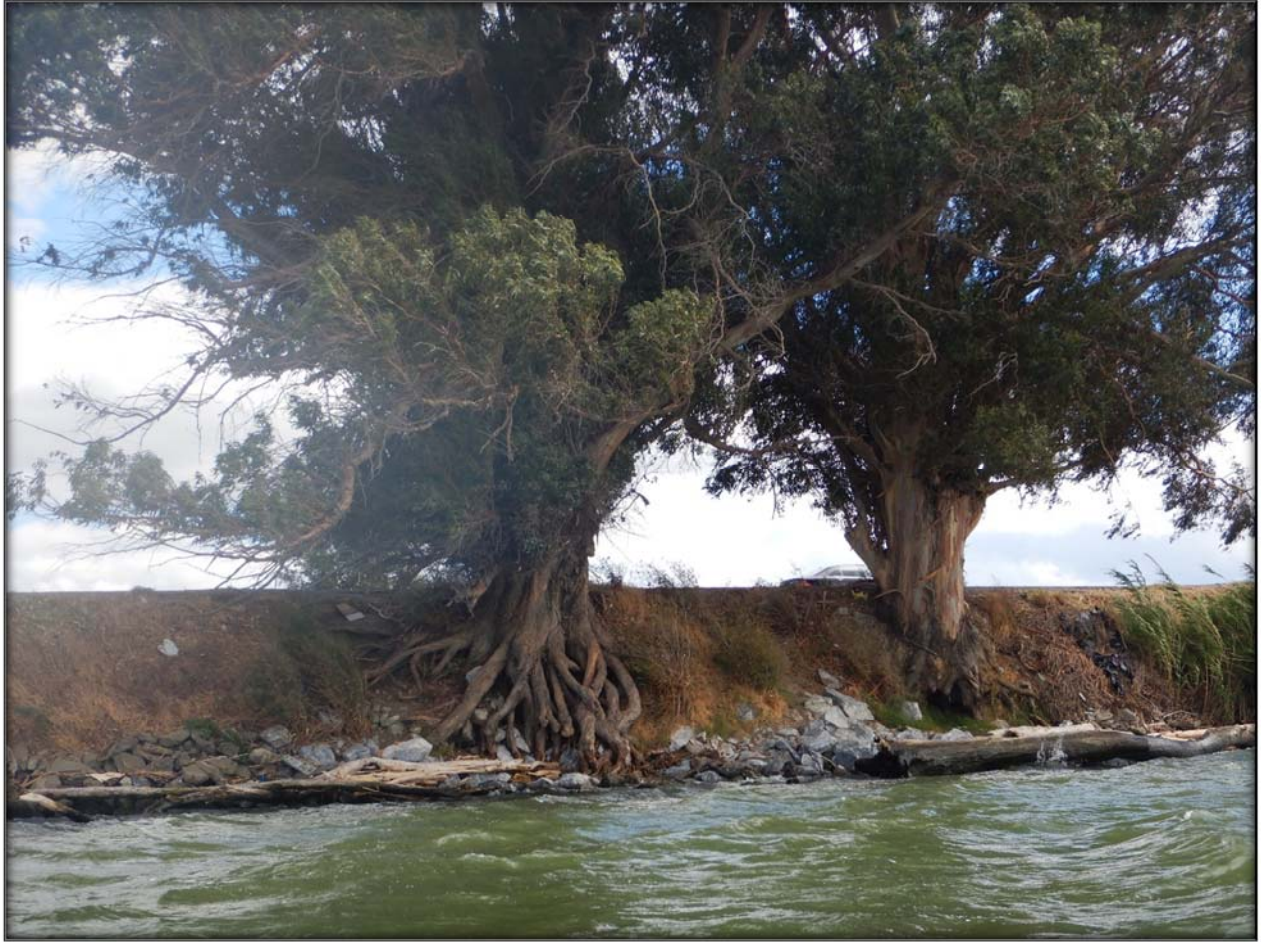
**Figure 25. Eroded bank and large trees with exposed roots along the left levee slope of the Sacramento River at RM 11.2.**

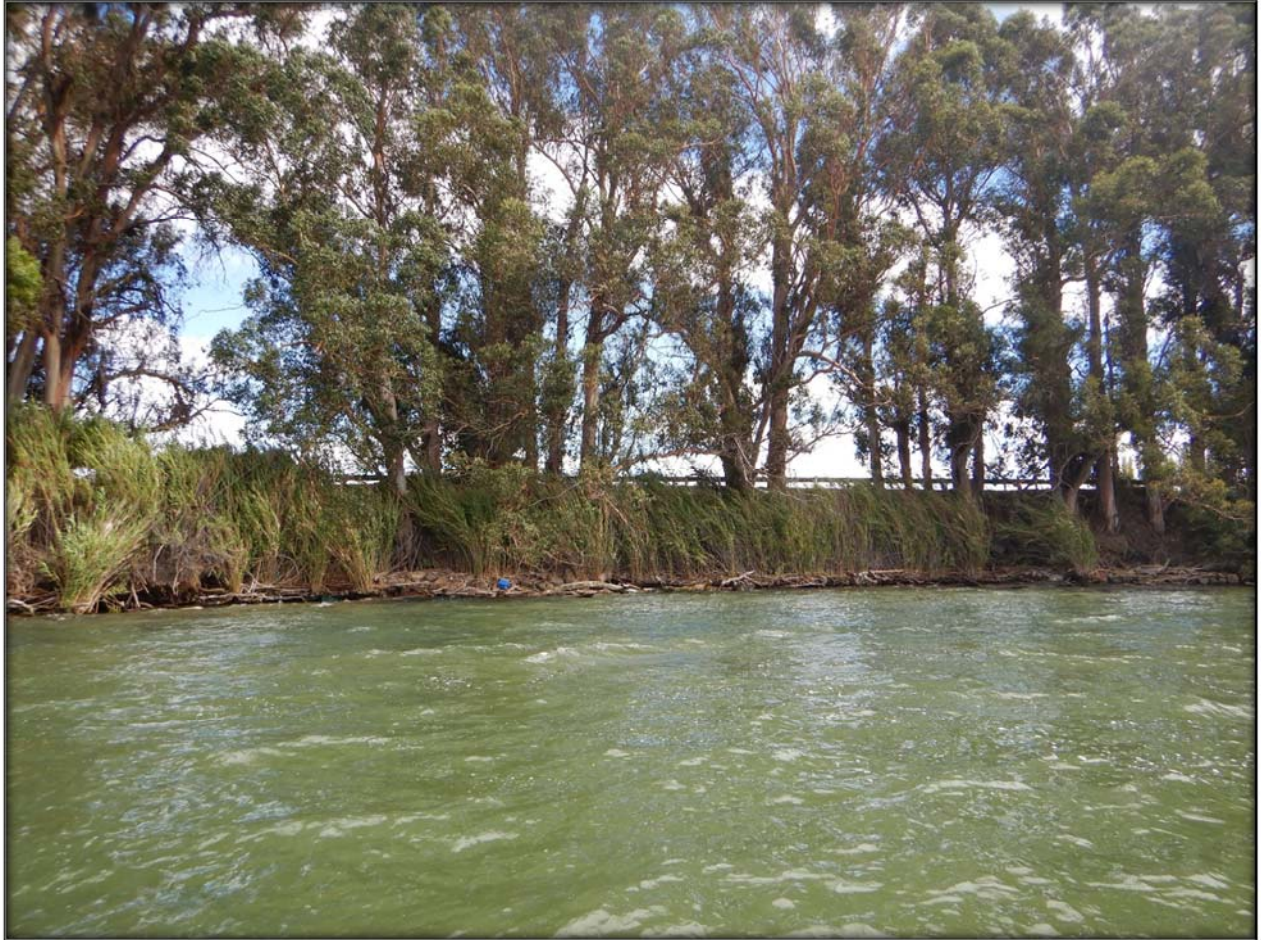
The main cause of erosion along SAC 12.1L is whole bank failure; a combination of wind waves, cargo boat wakes, and being in the tidal zone along with poor soils have led to significant erosion and failure of the entire bank slope. Additional issues at this site are large trees with exposed roots, tall vertical sections of eroding bank, animal holes, shallow cracks, eddy formations, and slumping. Seepage is a known issue along this levee reach. Some concrete rubble in poor condition is located in sections along this site. There are encroachments at this site, including a pipe through the levee, gas line, ramp, dock, boat launch, and utility poles. A vegetation variance or removal of vegetation encroachments may be required at this site. A photo depicting this site is shown in **Figures 26**.

**Figure 26. Eroded bank with large trees in the slope along the left bank of the Sacramento River at RM 12.1.**

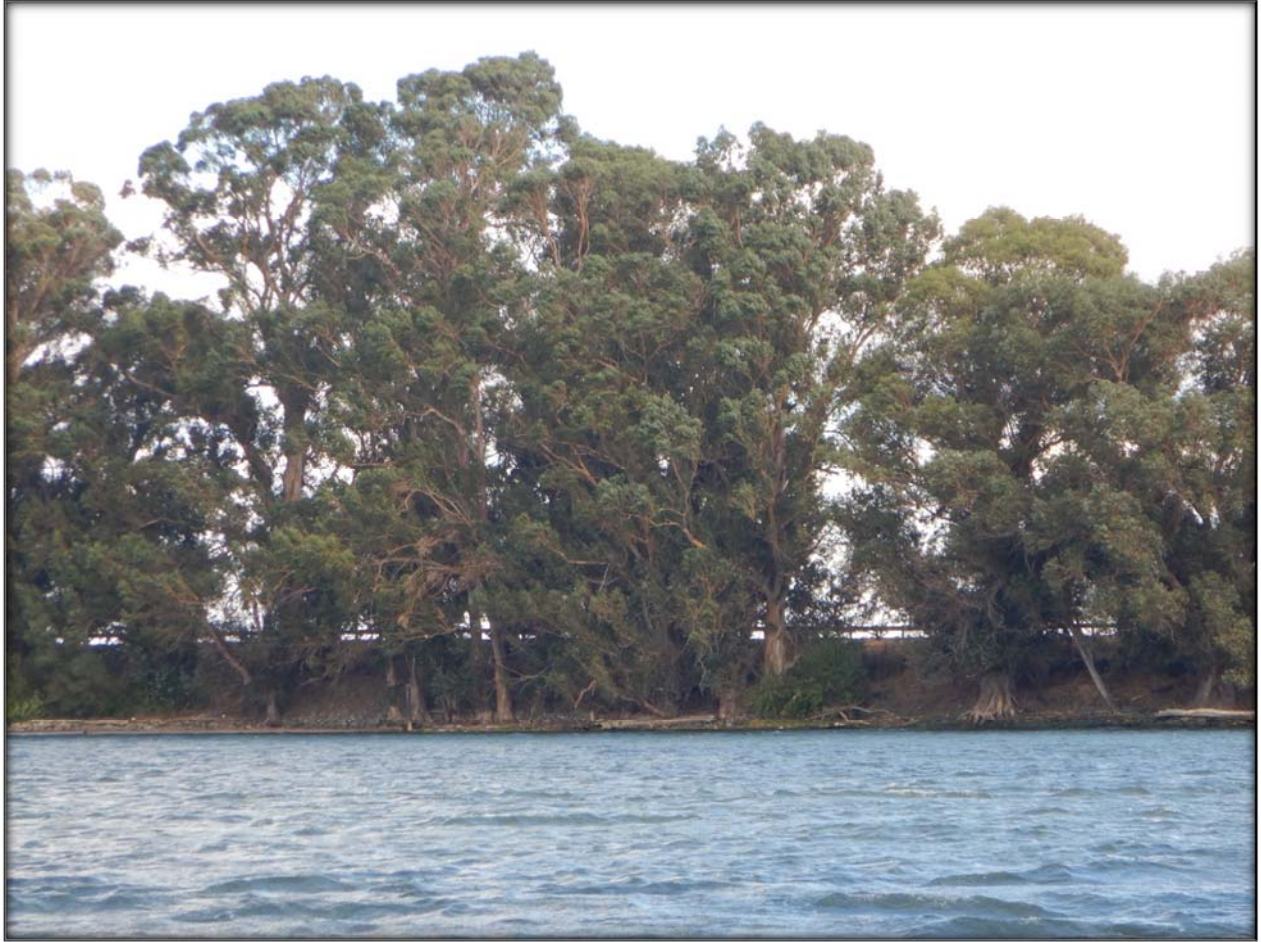
The main cause of erosion along SAC 13.6L is whole bank failure; a combination of wind waves, cargo boat wakes, and being in the tidal zone along with poor soils have led to significant erosion and failure of the entire bank slope. There is a nearly vertical face of eroding slope from the levee hinge to the water line. Trees with exposed roots along the levee slope are a significant issue, with tree pop-outs expected in the coming years. Additional issues at this site are animal holes, shallow cracks, and eddy formations. There are encroachments at this site, including a marina at the upstream end. A vegetation variance or removal of vegetation encroachments may be required at this site. A photo depicting this site is shown in **Figures 27**.

**Figure 27. Whole bank failure and large trees with exposed roots along the left bank of the Sacramento River at RM 13.6.**

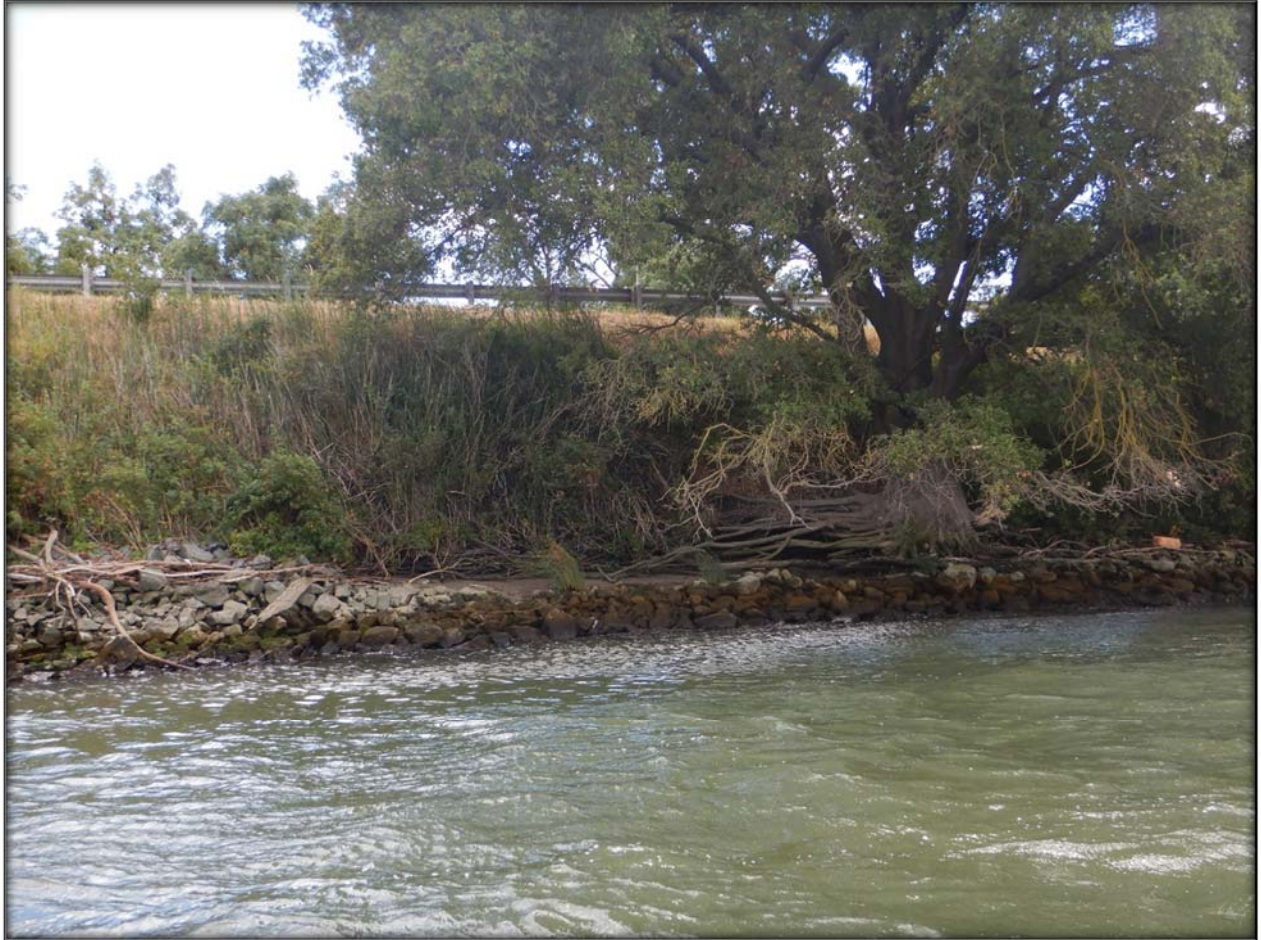
The main cause of erosion along SAC 7.3L is wave wash and fluvial action of the river; a combination of wind waves, boat wakes, and being in the tidal zone along with poor soils have led to significant bank erosion. The eroded levee slope has scoured behind a large tree, leaving a vertical face on the levee and exposed roots of the tree, with a potential tree pop-out eminent. Additional issues at this site are eddy formations, and slumping. Quarry stone in fair condition is located along the toe of this site and minimally helping with wave wash. A vegetation variance or removal of vegetation encroachments may be required at this site. A photo depicting this site is shown in **Figure 28**.

**Figure 28. Eroded bank slope along the left bank of the Sacramento River at RM 18.1.**

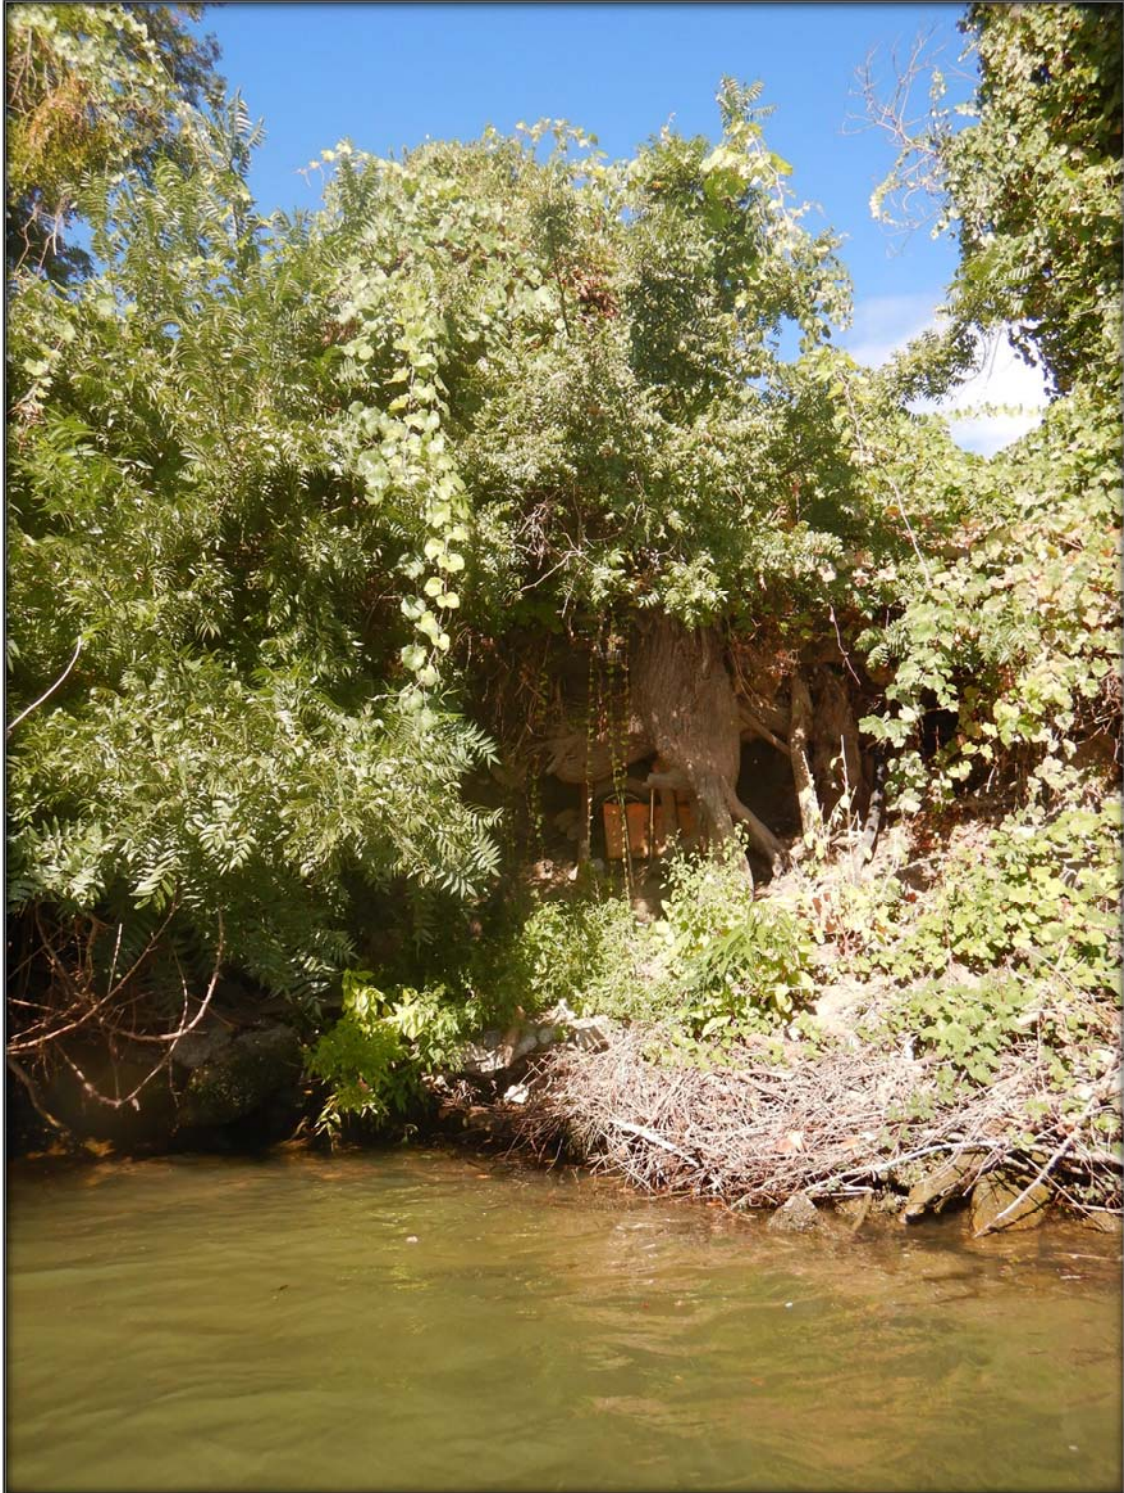
The main cause of erosion along SAC 33.9R is toe scour and wave wash; a combination of boat wakes and wind waves, along with poor soils have led to significant toe erosion. Significant scour has undermined a tree on the levee slope, there is nothing structurally underneath the majority of the root structure (with the exception of a chair and ice chest) and a tree pop-out seems eminent. The 2017 flood season has resulted in new erosion along this site. Additional issues at this site are short vertical sections of eroded bank, eddy formations, and slumping. Some concrete rubble in poor condition is located in sections along this site. A vegetation variance or removal of vegetation encroachments may be required at this site. A photo depicting this site is shown in **Figure 29**.

**Figure 29. Scour underneath tree roots along the right bank of the Sacramento River at RM 33.9.**

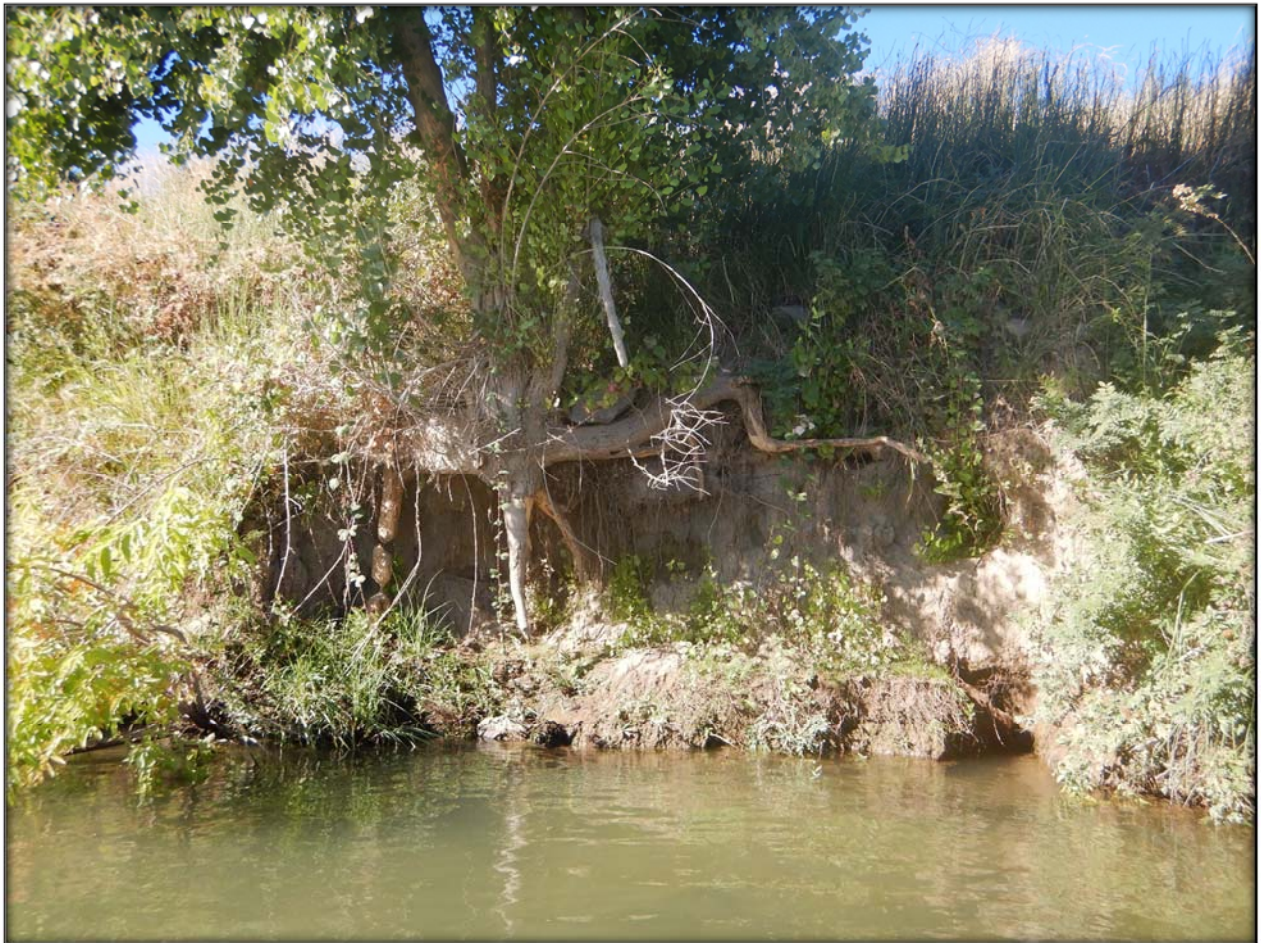
The main cause of erosion along SAC 38.5R is the fluvial action of the river and whole bank failure; a combination of high velocities, over-steepened slopes, and poor soils have led to significant erosion. Significant scour has undermined a tree on the levee slope, there is nothing structurally underneath the majority of the root structure and a tree pop-out seems eminent. Additional issues at this site are short vertical sections of eroded bank, animal holes, shallow cracks, boat wakes, eddy formations, and slumping. Some quarry stone in fair condition is located in sections along this site. Although further analysis is needed, it is likely that a vegetation variance or removal of vegetation encroachments may be required at this site. A photo depicting this site is shown in **Figure 30**.

**Figure 30. Scoured section of levee that has undermined a tree along the right bank of the Sacramento River at RM 38.5.**

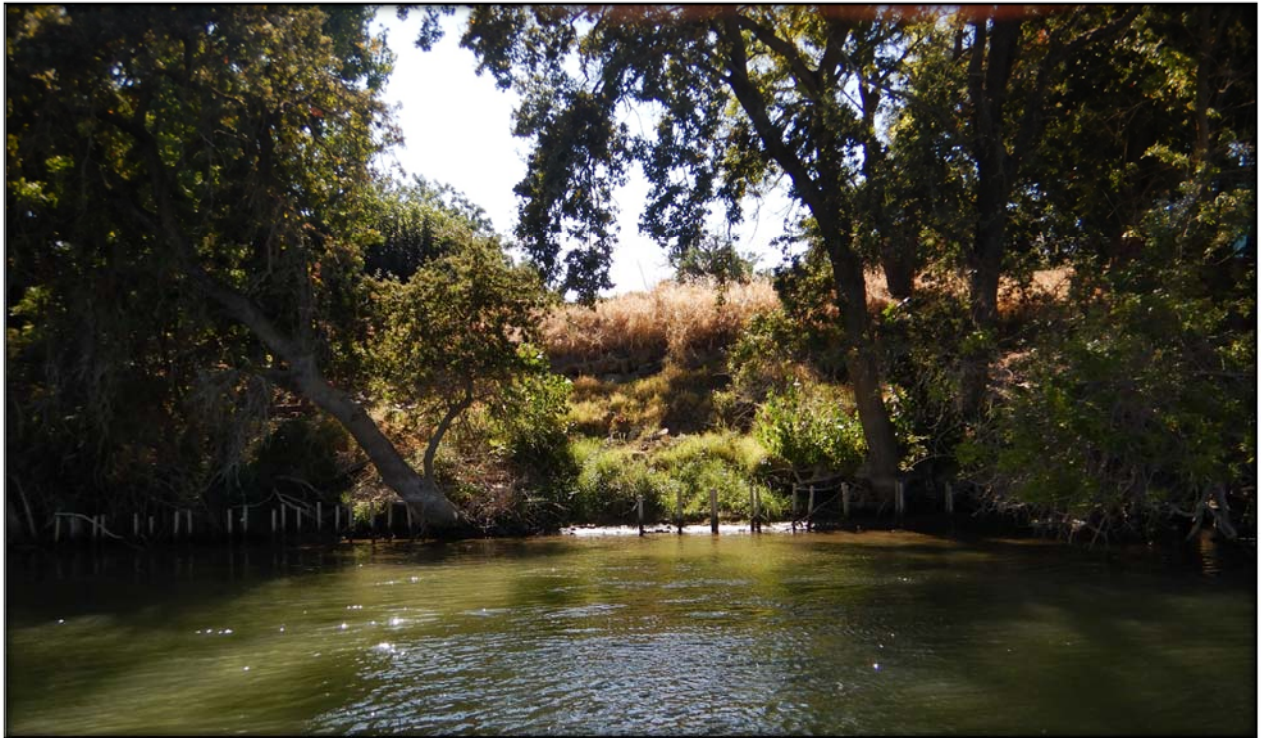
The main cause of erosion along SAC 38.5R is toe scour and whole bank failure; a combination of high velocities, over-steepened slopes, and boat wakes have led to significant erosion of the toe. Additional issues at this site are tall vertical sections of eroded bank, large trees with exposed roots that are leaning over, animal holes, eddy formations, and slumping. When the site was first added, there was some failed cobbles, and only a minimal amount of revetment remains today. Brush boxes were attempted at this site to slow the effects of wave wash, but they were not maintained so they did not help reduce toe scour. The 2017 flood season resulted in fresh erosion throughout the site. The erosion under the tree roots is especially concerning as the lack of structure underneath the large trees will likely cause tree pop-outs and leave a large hole in the bank. There are encroachments at this site, including a gas pipeline and power poles. A vegetation variance or removal of vegetation encroachments may be required at this site. A photo depicting this site is shown in **Figure 31**.

**Figure 31. Toe scour and erosion of the levee slope along the right bank of the Sacramento River at RM 41.9. Empty brush boxes and leaning trees are also seen.**

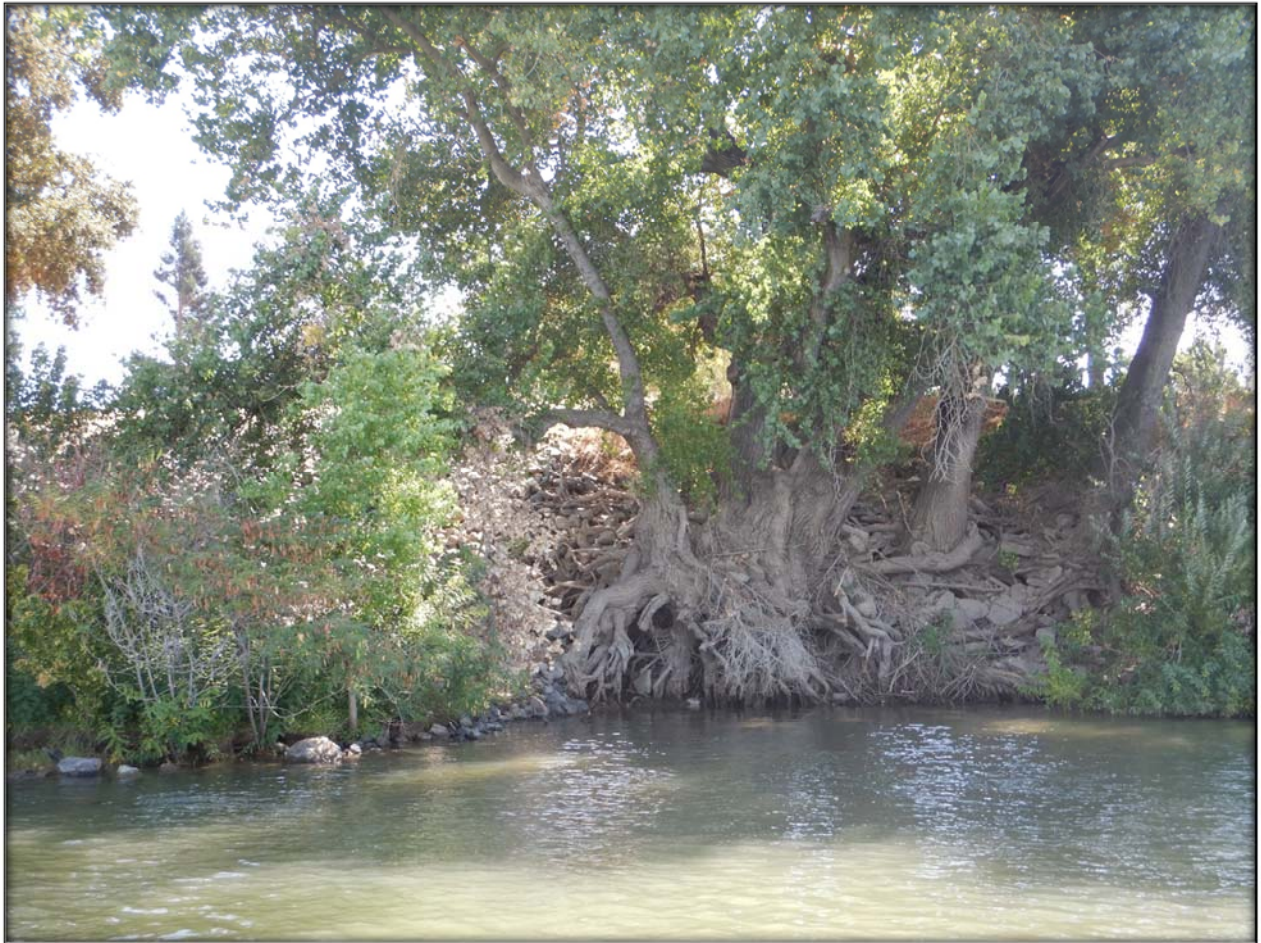
The main cause of erosion along SAC 52.4R is tree pop-outs and toe scour; a combination of high velocities and over-steepened slopes have resulted in a tree popping out of the levee slope, leaving a large hole and this has led to erosion of the toe. A second tree with scoured roots is expected to pop-out soon, taking a large chunk of the levee with it. Additional issues at this site are short vertical sections of eroded bank, animal holes, boat wakes, eddy formations, and slumping. There is some concrete rubble in fair condition along the slope. A vegetation variance or removal of vegetation encroachments may be required at this site. A photo depicting this site is shown in **Figure 32**.

**Figure 32. Scoured out tree roots along the left bank of the Sacramento River at RM 52.4.**

This site is in the WRDA 2016 repair area and they are planning to repair the banks in this vicinity. Once the WRDA 2016 repairs are complete, we expect to remove the site from the erosion inventory.

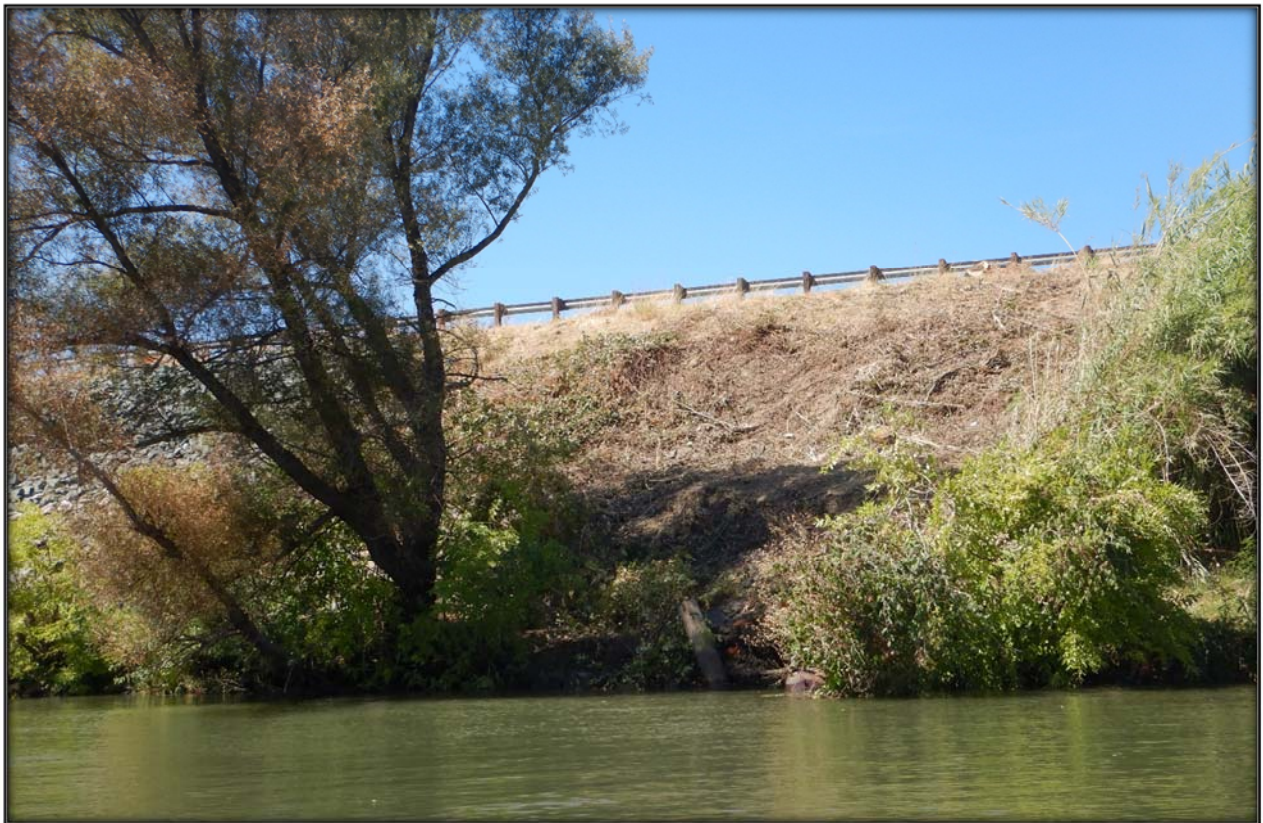
The main cause of erosion along SAC 38.5R is the fluvial action of the river and whole bank failure; a combination of high velocities, over-steepened slopes, boat wakes, and poor soils have led to significant erosion of the toe. Additional issues at this site are tall vertical sections of eroded bank, large trees with exposed roots that are leaning over, animal holes, eddy formations, and slumping. The 2017 flood season resulted in fresh erosion throughout the site. There are encroachments at this site, including a boat dock, pipes, power poles, and dolphins. Seepage is a known issue along this levee reach. There is quarry stone in good condition along the slope, however the revetment is not enough to help all the issues at this site. A vegetation variance or removal of vegetation encroachments may be required at this site. A photo depicting this site is shown in **Figure 33**.

**Figure 33. Eroded and over-steepened slope of the right bank of the Sacramento River at RM 55.7.**

Although this site is critical, with significant levee failure issues, and adjacent to a large metropolitan area, no fix is recommended for this site under the SRBPP. There is currently a setback levee being constructed in the vicinity that will address this site and once it is completed, we expect to remove the site from the inventory.

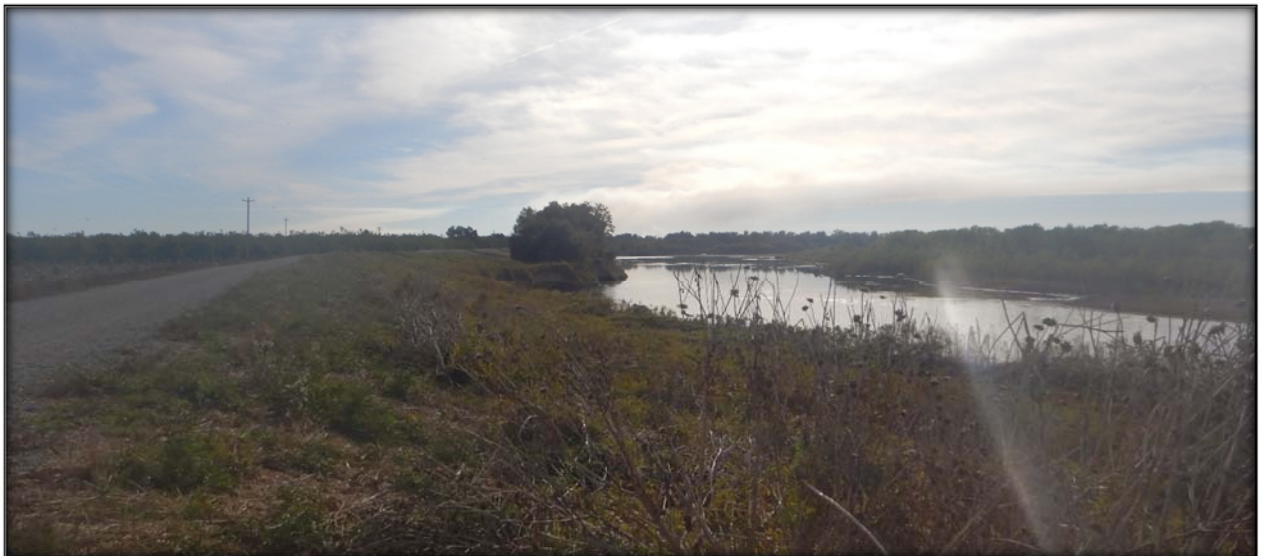
The main cause of erosion along SAC 172.0L is the fluvial action of the river and whole bank failure related to growth of a meander bend. Bank retreat at this site has been quick, with the channel migrating over 500 ft east in the last 20 years, and greater than 100 ft of bank erosion towards the levee (at the most critical point) since its inclusion in the erosion inventory. Although this site still has some berm between the natural bank and the levee toe, the erosion is entering the levee prism. The rate of erosion is of concern and a large storm event has the potential to cause significantly more bank erosion, possibly breaching the levee toe.

Additional issues at this site are vertical banks, animal holes, and slumping. Although further analysis is needed, it is likely that a vegetation variance or removal of vegetation encroachments may be required at this site. A photo depicting this site is shown in **Figure 34**.

**Figure 34. Bank Erosion into the levee prism along the left bank of the Sacramento River at RM 172.0.**

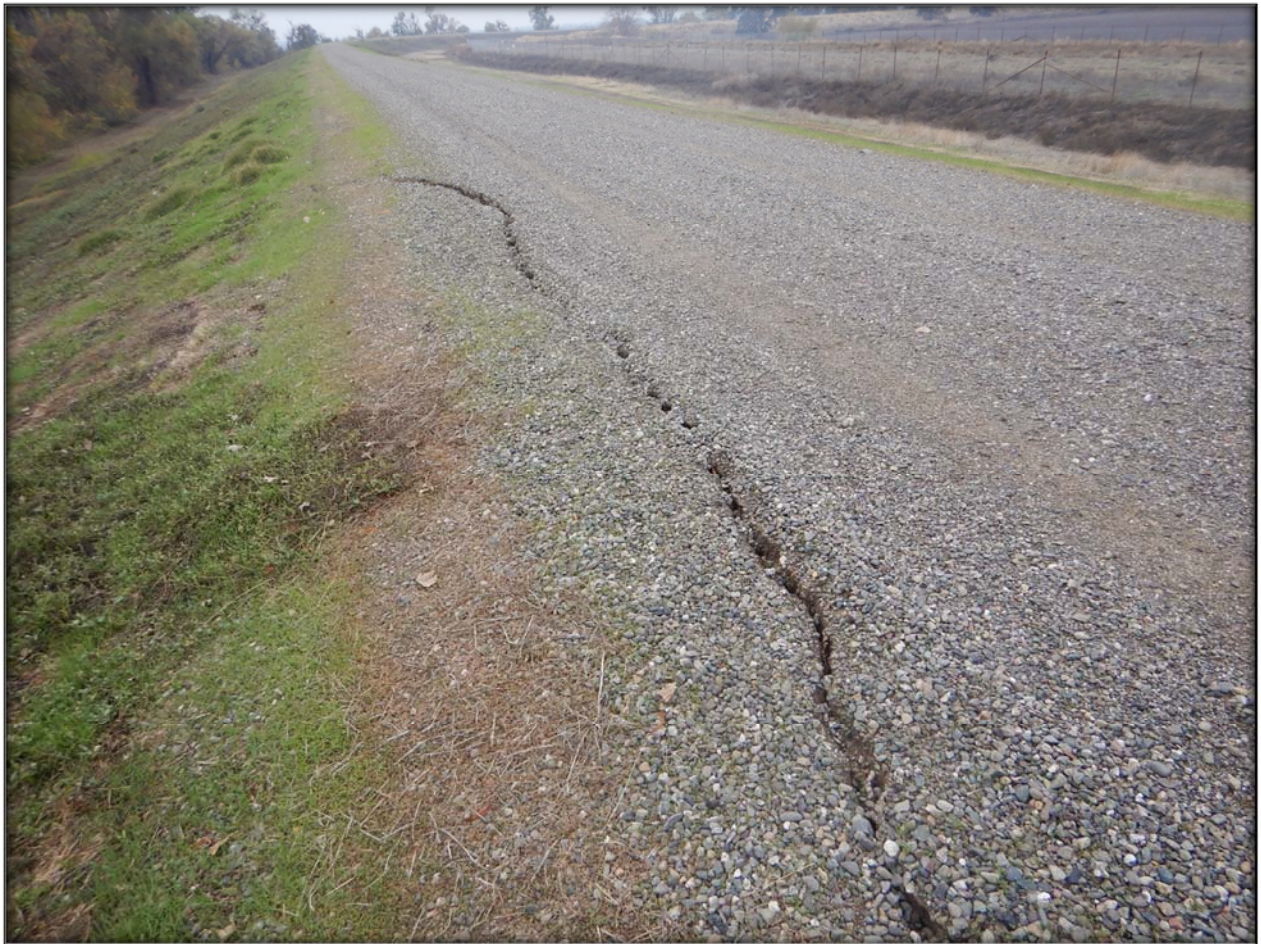
The main cause of concern along SAP 1.4R is a slump crack; a slump failure is forming, with deep cracks along the levee crest that may results in a large slump failure during the next heavy rain event. A photo depicting this site is shown in **Figure 35**.

**Figure 35. Slump Crack along the right bank of the Sacramento Bypass at LM 1.4.**

Although this site is critical, and a failure could impact the levee bypass system, no fix is recommended for this site under the SRBPP. This site is in the WRDA 2016 repair area and they are planning to setback the Elkhorn levee on the west side which would likely eliminate this site. Once the WRDA 2016 repairs are complete, this site should be removed from the inventory.

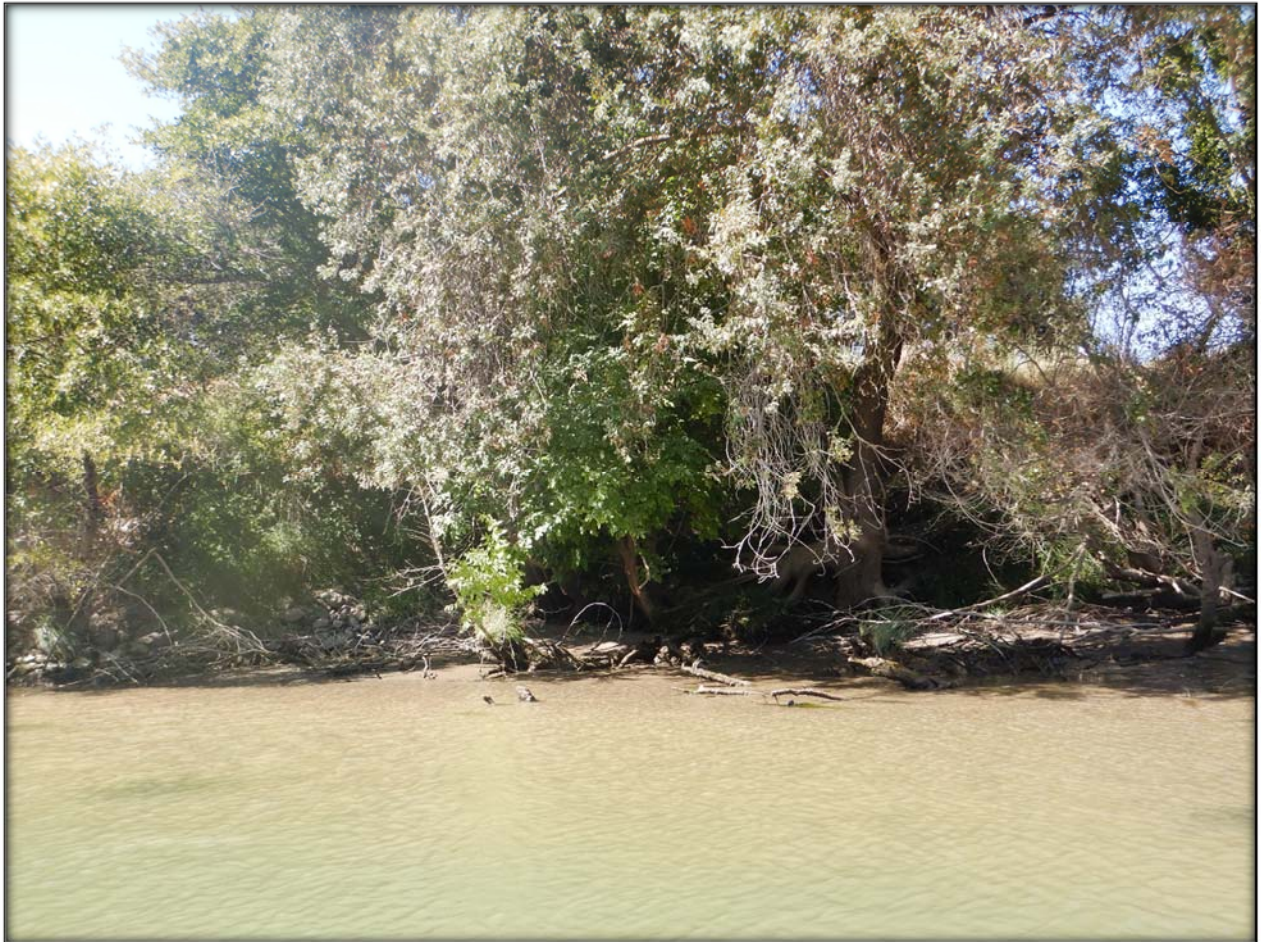
The main cause of erosion along STM 24.7R is wave wash and fluvial action of the river and whole bank failure; a combination of wind waves, boat wakes, and being in the tidal zone along with poor soils have led to significant bank erosion. There are near vertical banks at the downstream end and new erosion was observed throughout the site. Additional issues at this site are large trees on the slope, eddy formations, and slumping. Seepage is a known issue along this levee reach. Quarry stone in poor condition is scattered throughout this site, but not helping with bank stability. A vegetation variance or removal of vegetation encroachments may be required at this site. A photo depicting this site is shown in **Figure 36**.

**Figure 36. Erosion along the right bank of Steamboat Slough at RM 24.7.**

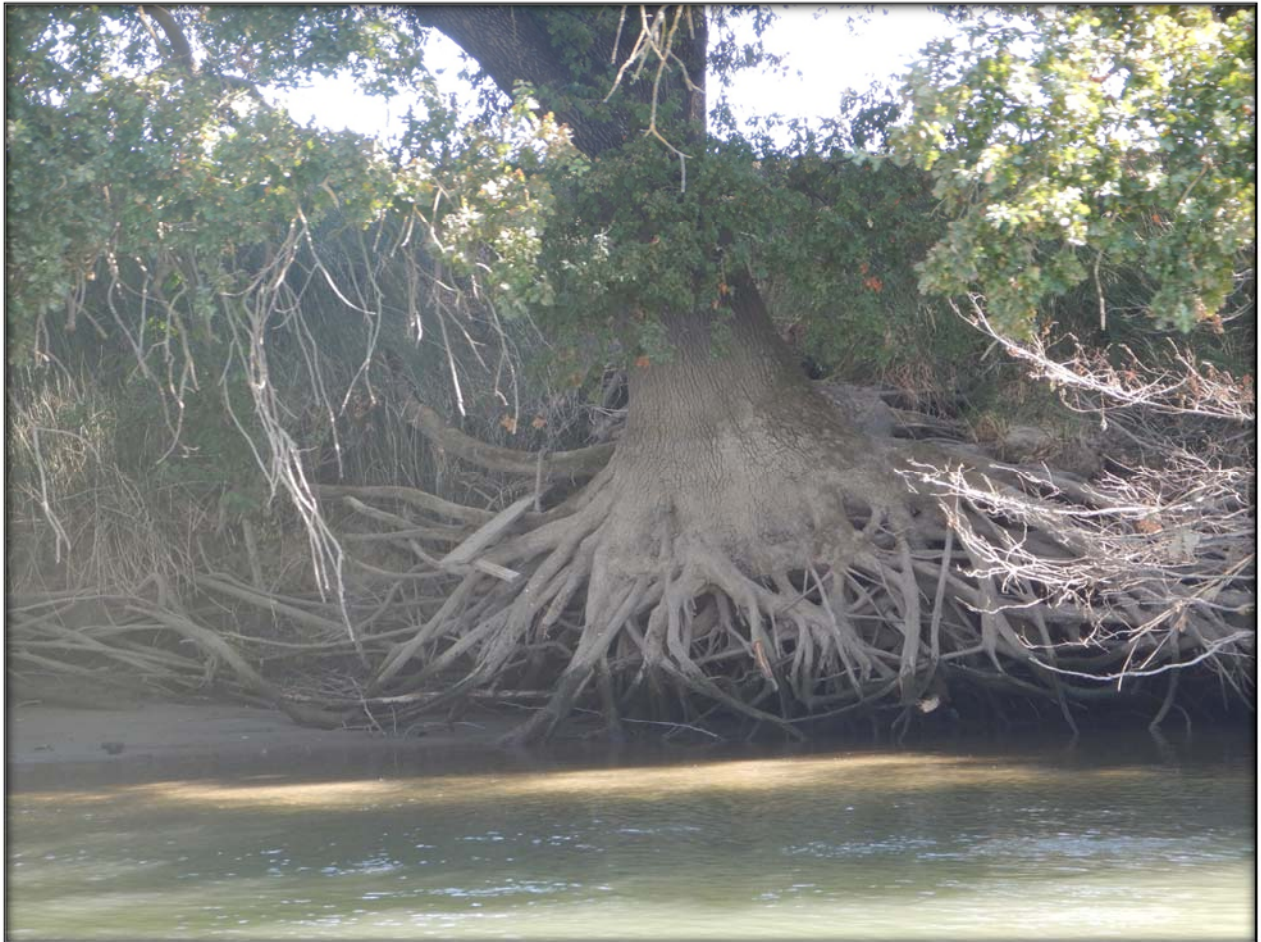
The main causes of erosion along STM 25.0L are eddy scour, fluvial action of the river, and whole bank failure; in addition to a large eddy at this site, a combination of wind waves, boat wakes, and being in the tidal zone along with poor soils have led to significant bank erosion. Significant new erosion was observed throughout the site from the 2017 flood season, and at the upstream end the banks are near vertical to the top of the levee. Additional issues at this site are tree with exposed roots, tall vertical sections of eroding bank, animal holes, and slumping. Seepage is a known issue along this levee reach. A vegetation variance or removal of vegetation encroachments may be required at this site. Photos depicting this site are shown in **Figures 37 and 38**.

**Figure 37. Typical exposed roots along the eroded left bank of Steamboat Slough at RM 25.0.**
