## Sacramento River Bank Protection Project - Critical Sites Memorandum

May 14, 2018

This Memorandum for Record is a summary of the Critical Bank Erosion Sites identified during the Sacramento River Bank Protection Project (SRBPP) 2017 Erosion Inventory field work. The erosion inventory field work is conducted every year to keep track of erosion threatening the levees of the Sacramento Flood Control Project (SRFCP). This memorandum does not discuss all of the erosion sites identified, only those that were deemed critical. A critical erosion site is defined as a site where there is a potential for a levee breach or serious levee issues (an issue which at the minimum would require flood fighting) during the next large storm event. This memorandum is to illustrate the details of the critical sites and the immediate need to repair.

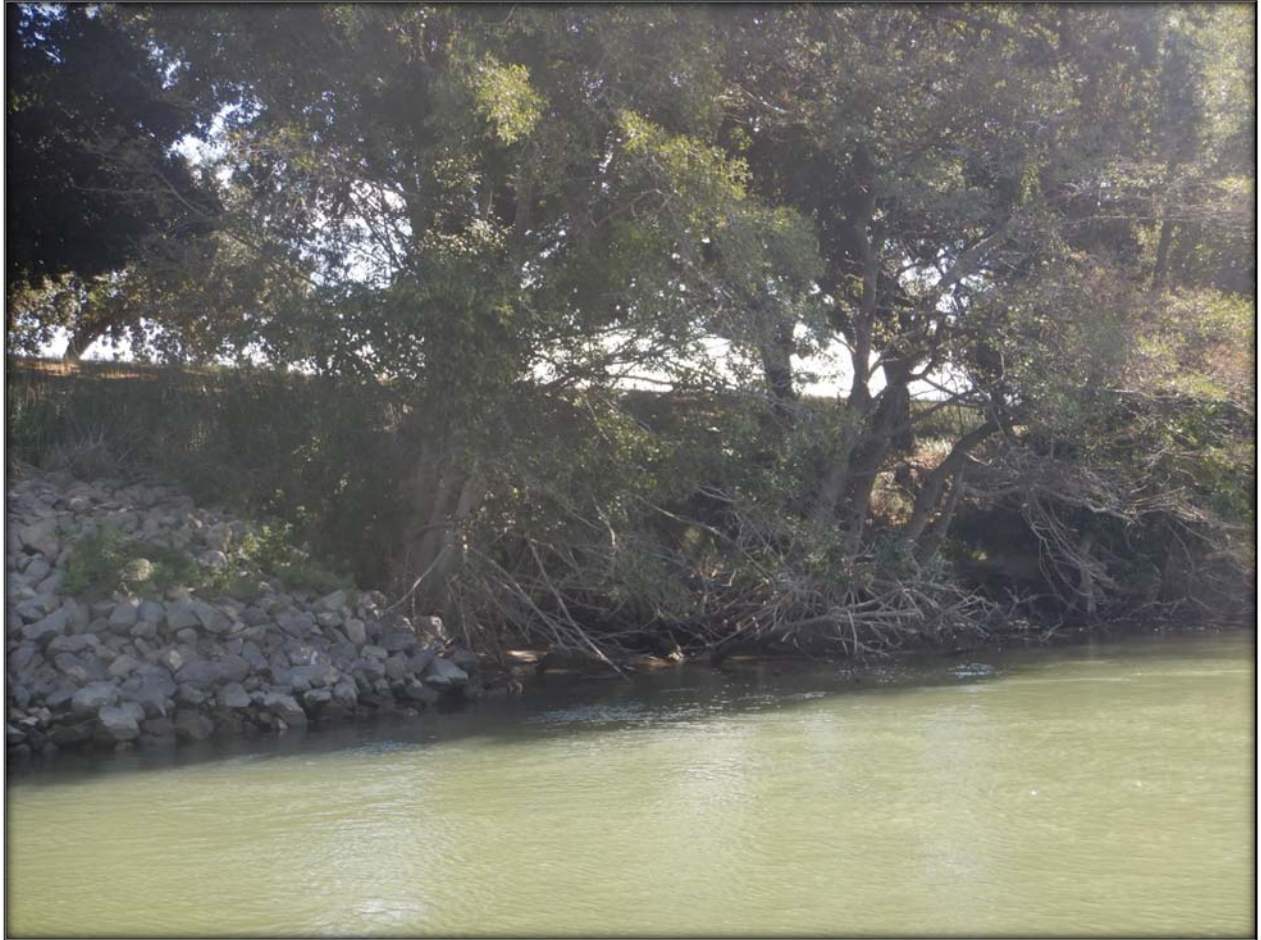
**Figure 38. Eroded bank from eddy formation off adjacent rock protection along the left bank of Steamboat Slough at RM 25.0.**

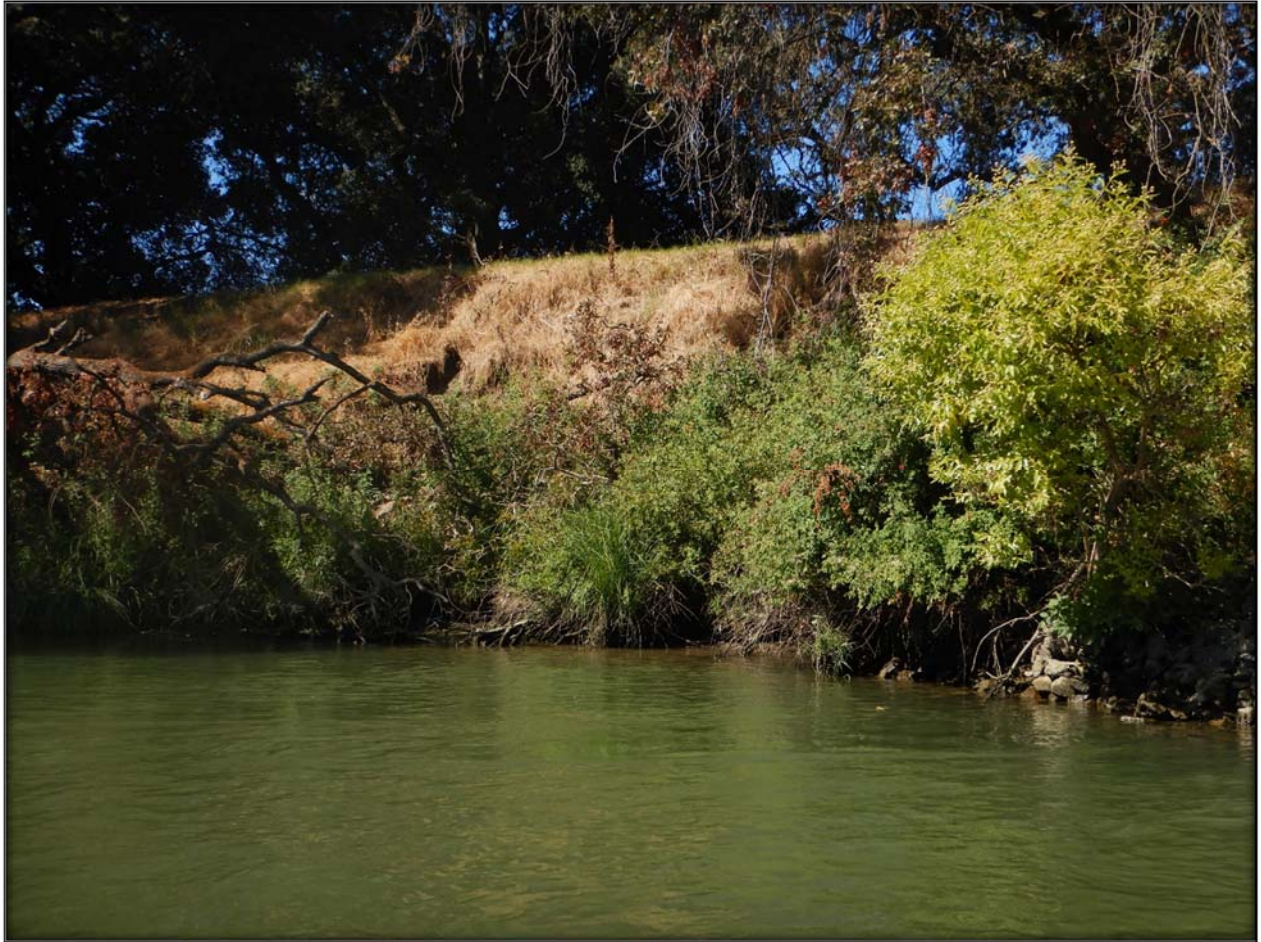
The main cause of erosion along STM 25.8R is wave wash and fluvial action of the river and whole bank failure; a combination of wind waves, boat wakes, and being in the tidal zone along with poor soils have led to significant bank erosion. There was significant new erosion was observed throughout the site from the 2017 flood season. Additional issues at this site are tree pop-outs, tall vertical sections of eroding bank, animal holes, eddy formations, and slumping. Seepage is a known issue along this levee reach. Quarry stone in fair condition is scattered in sections at this site, but not helping with bank stability. A vegetation variance or removal of vegetation encroachments may be required at this site. A photo depicting this site is shown in **Figure 39**.

**Figure 39. Eroding bank along the right bank of Steamboat Slough at RM 25.8.**

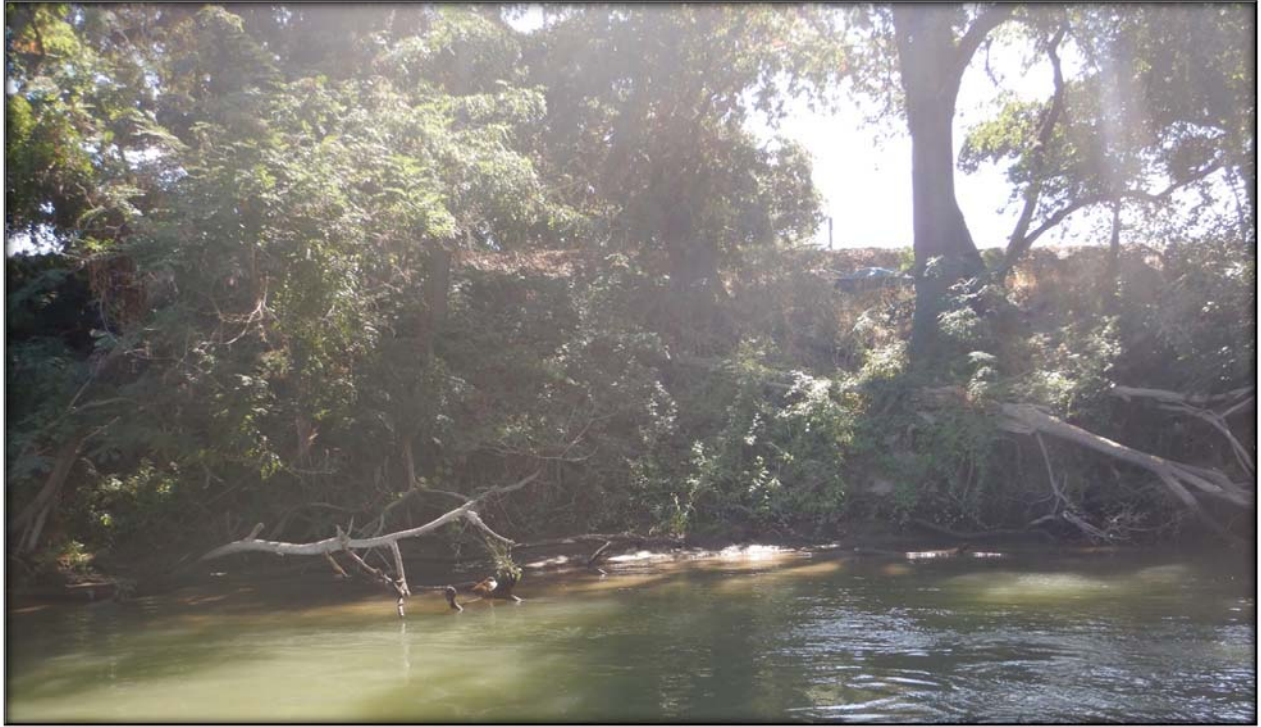
The main cause of erosion along STM 26.0L is wave wash; a combination of wind waves, boat wakes, and being in the tidal zone along with poor soils have led to significant bank erosion. There was significant new erosion from the 2017 flood season, and mass failure of the berm slope on the upstream end. Additional issues at this site are tree with exposed roots, tall vertical sections of eroding bank, animal holes, eddy formations, and slumping. Seepage is a known issue along this levee reach. A vegetation variance or removal of vegetation encroachments may be required at this site. A Photo depicting this site is shown in **Figure 40**.

**Figure 40. Erosion along the left bank of Steamboat Slough at RM 26.0.**

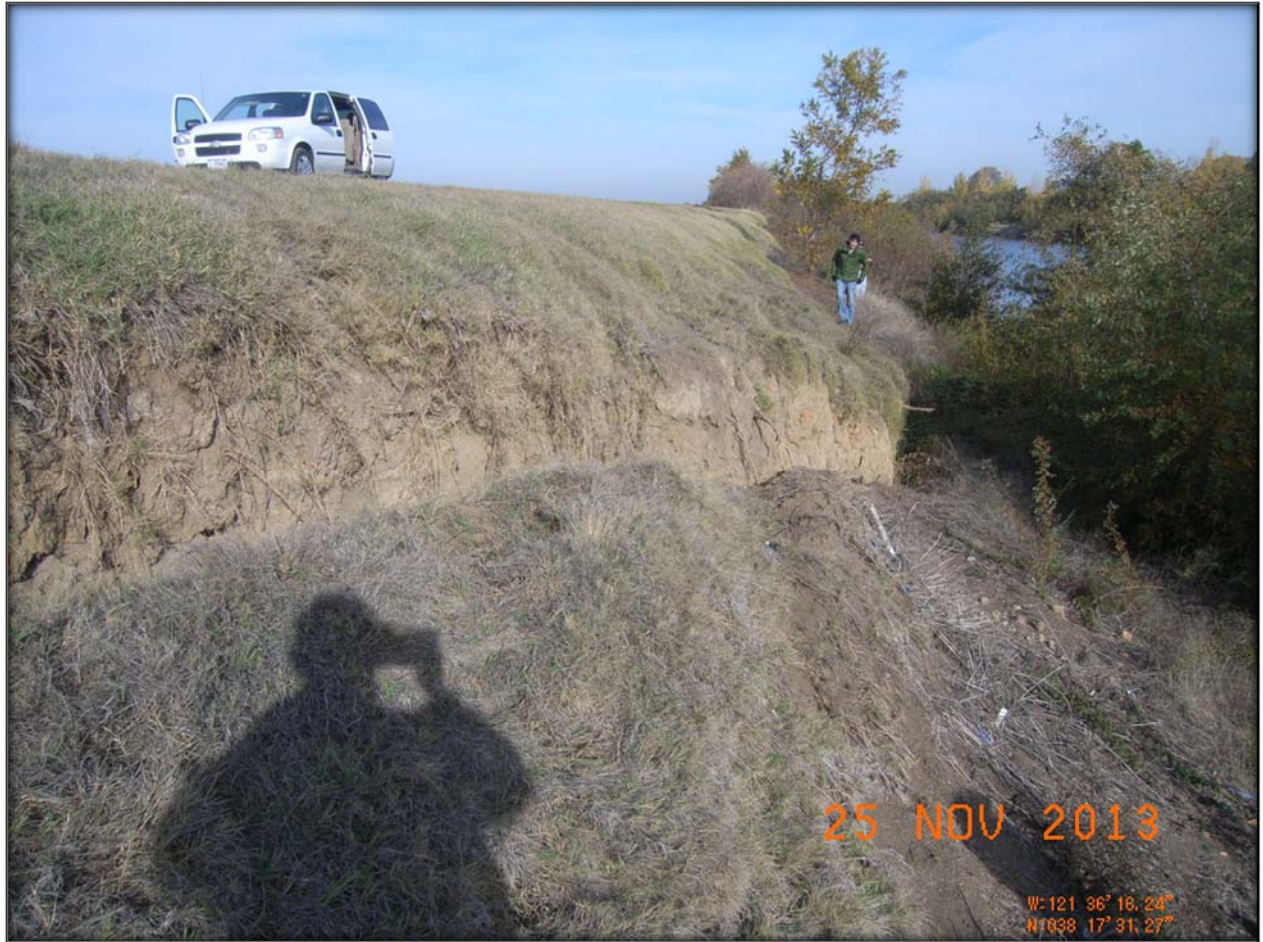
The main cause of erosion along STR 24.7R is toe scour and whole bank failure; a combination of high velocities, over-steepened slopes, and boat wakes have led to significant erosion of the toe. In 2013, a severe slump of the upper levee slope occurred at this site. The 2017 flood season resulted in fresh erosion at the toe and new vertical sections throughout the site. Additional issues at this site are large trees with exposed roots that are leaning over, animal holes, shallow cracks, eddy formations, and slumping. There is quarry stone in fair condition in places along this site, and the locals have placed more in the worst areas, but the bank continues to erode. Seepage is a known issue along this levee reach. A vegetation variance or removal of vegetation encroachments may be required at this site. Photos depicting this site are shown in **Figures 41 and 42**.

**Figure 41. Large slump on the upper levee slope that occurred in 2013 along the right bank of Sutter Slough at RM 24.7.**

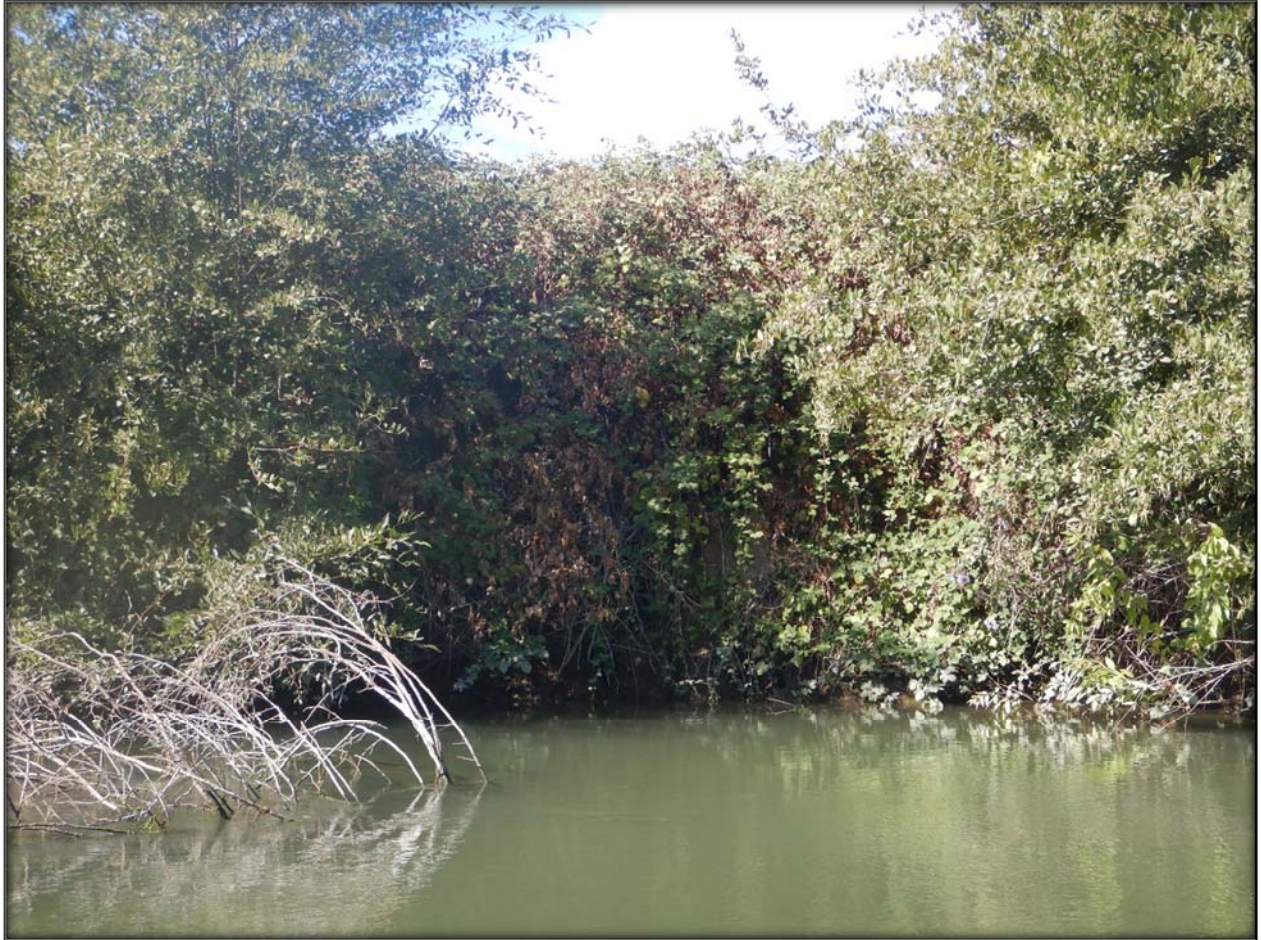
**Figure 42. Vertical Bank (covered with vines) of the right bank of Sutter Slough at RM 24.7.**
