#### 4.5.4 Sub-Reach Channel Activity Results

#### 4.6 **Ground Reconnaissance: Results of RGAs and Stream Walks**

##### 4.6.1 **Upper Truckee River**

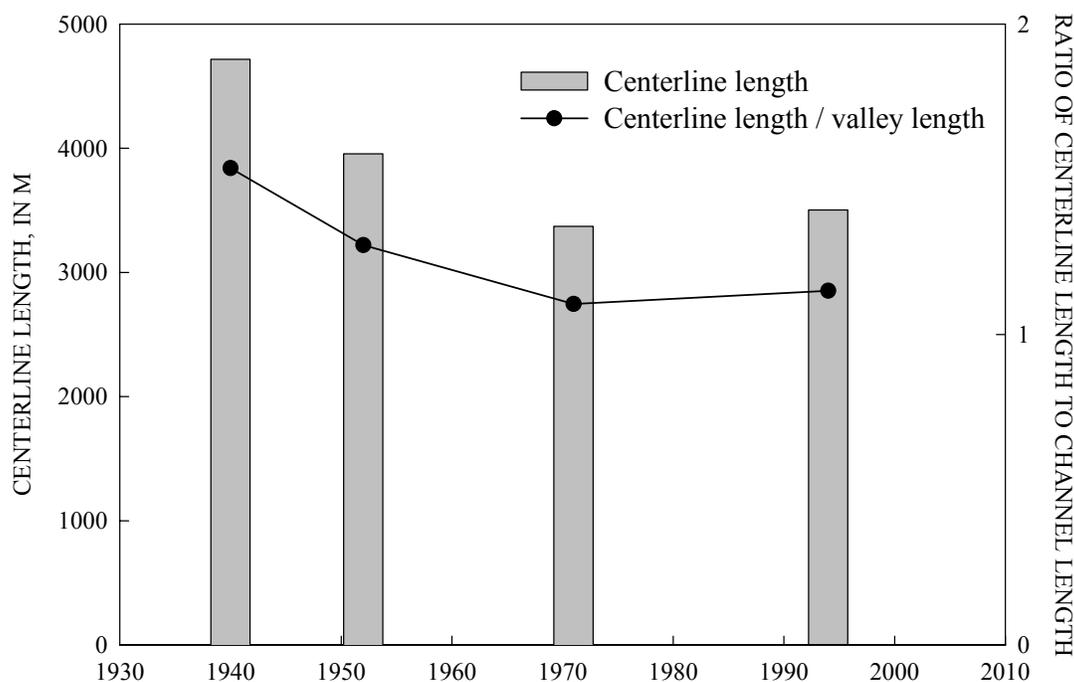
**Figure 4-10. Upper Truckee River channel length results, 1941 – 1994.**

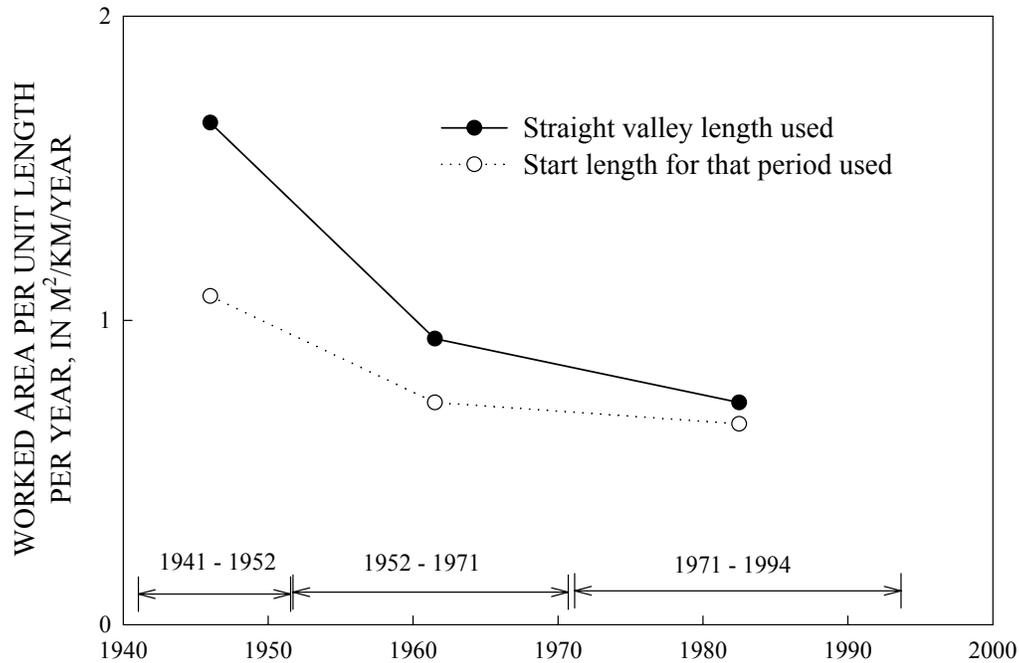
The active area of this section of the Upper Truckee River has decreased since the years 1940 to 1952, to present (Table 4-5; Figure 4-11). This can be attributed in part to the construction of cutoffs by local landowners and channel incision related to these and other cutoffs constructed near the airport. Although this reach of the Upper Truckee River had a more stable planform between 1971 and 1994 than it did previously, it is currently still quite active. If we assume that this reach is representative of adjacent alluvial reaches, particularly those downstream from the golf course, these data also support the contention that fine-grained suspended-sediment loads emanating from streambanks of the Upper Truckee are high, but decreasing with time. A regression of annual, fine-grained concentrations with time for the index station on the Upper Truckee River (10336610) was found significant at the 0.03 level over the past 22 years.

**Figure 4-11. Upper Truckee River channel-activity results, 1941 – 1994.**

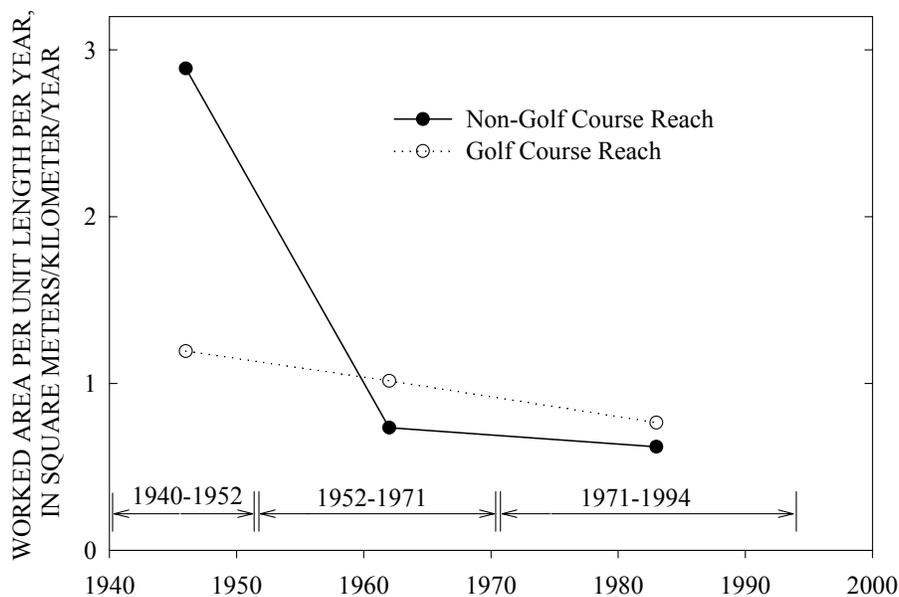
**Figure 4-12. Channel activity for golf course and upstream sub-reaches, using valley length.**

The first period of the reach upstream of the golf course possessed the largest active area value. The active area of the golf course reach is also comparatively high during this period. Between 1952 and 1971, and 1971 and 1994, the reach upstream of the golf course showed slightly lower activity values than the reach in the golf course. This may be attributable to the construction of a sheet-pile grade control structure in the upstream reach which serves to arrest further channel incision. Still, activity rates for both reaches show a decline over the 53-year

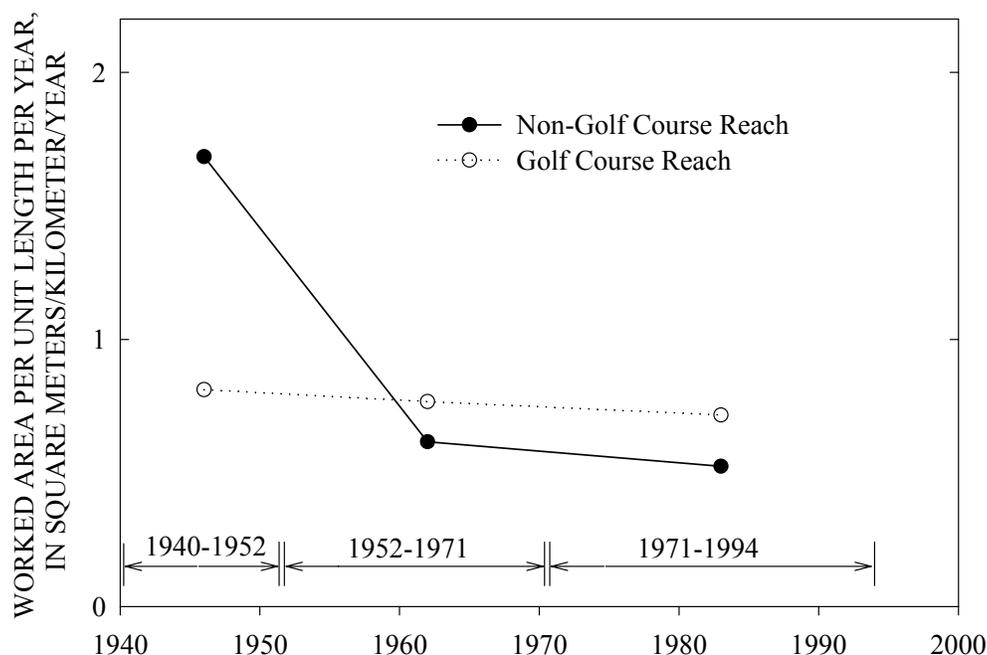
Comparison between reaches adjacent to and upstream of the golf course show decreasing channel activity with time. Figure 4-13 contains graphs summarizing results of analysis of the golf course reach and remaining upstream reach and Table 4-6 tabulates this information.

**Figure 4-13. Channel activity for golf course and upstream sub-reaches, using centerline start length.**

time period, further supporting the view that sediment loads from the Upper Truckee River are decreasing.
