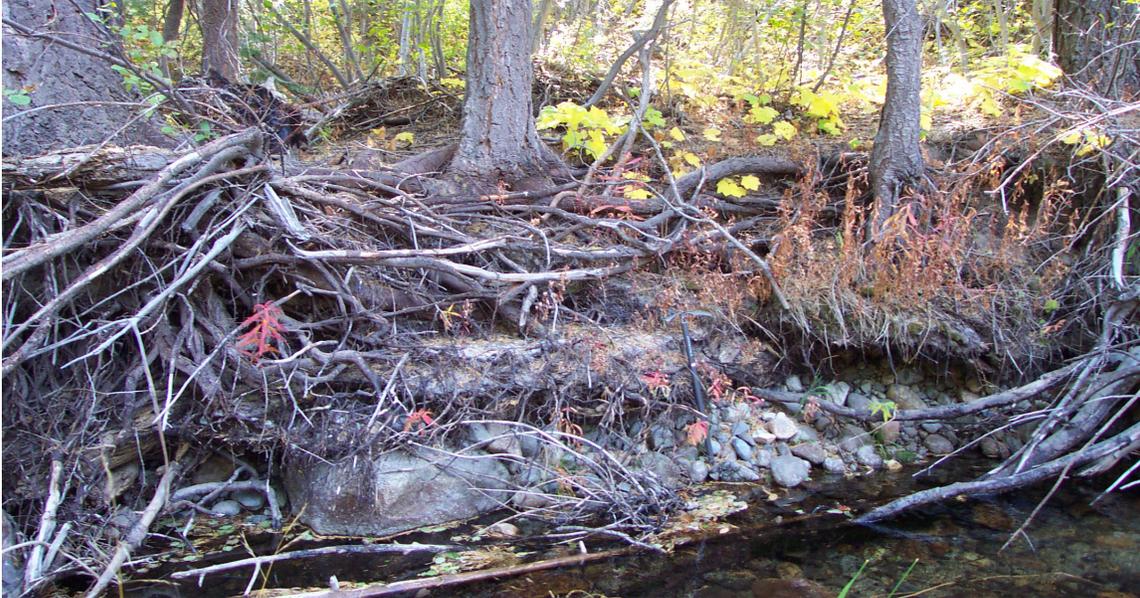
**Figure 4-34. Typical bank rated “low” in fine-sediment availability. Bank is composed of cobble and boulder sized clasts with well established woody vegetation holding banks in place. General Creek.**
