Full Prospectus

**Colusa Basin Mitigation Bank,  
Colusa County, California**

**October 9, 2012**

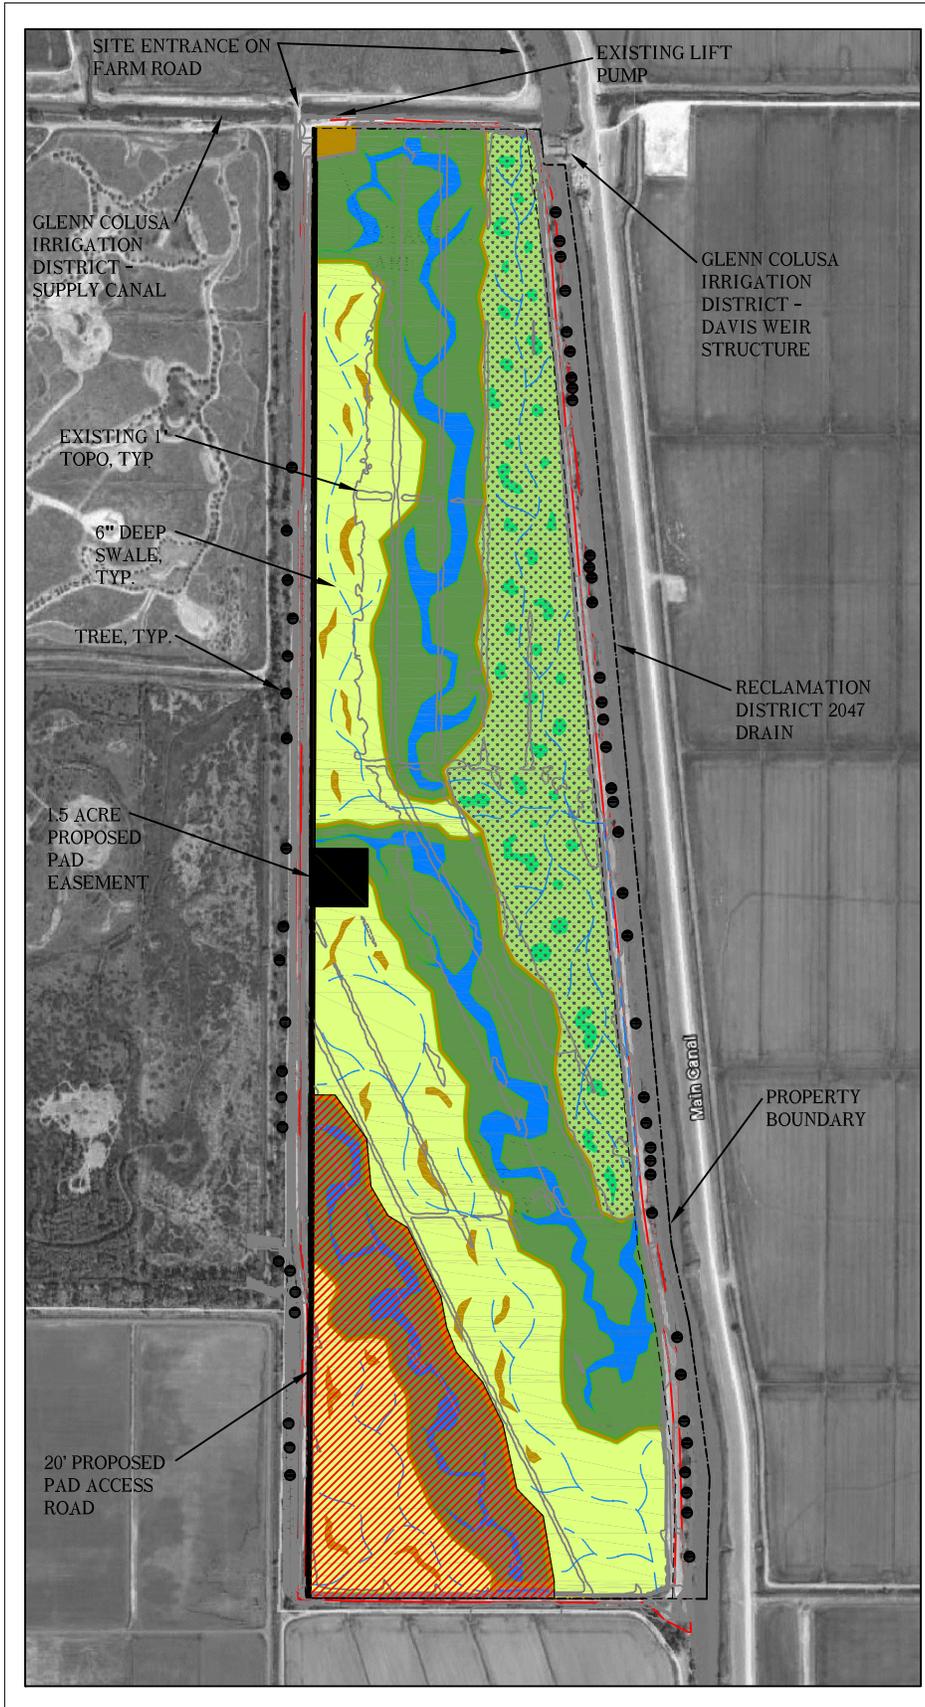
**FIGURE 13** SITE PLAN

HABITAT RESTORATION LEGEND	
Item	Description
	Perennial Marsh
	Semi-Permanent Marsh
	Open Water Within Perennial Marsh
	Seasonal Wetlands - (404 Wetlands)
	Uplands
	1' Deep Pothole Within Seasonal Wetland

The goal of the habitat development activities is to restore a complex of wetlands and uplands in place of the existing rice field (Figure 13). In addition to creating natural and managed wetlands, this plan provides all of the necessary habitat requirements for GGS including: (1) adequate water during the GGS's active season (early-spring through mid-fall) to provide food and cover; (2) emergent, herbaceous wetland vegetation, such as cattails and bulrushes, for escape cover and foraging habitat during the active season; (3) grassy banks and openings in waterside vegetation for basking sites to thermo-regulate; and (4) higher elevation uplands for cover and refuge from flood waters during the GGS's dormant season in the winter.

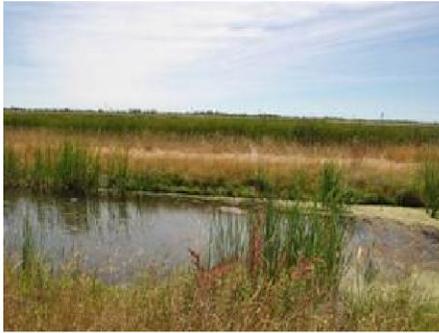
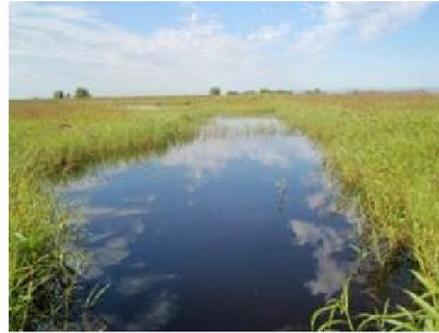
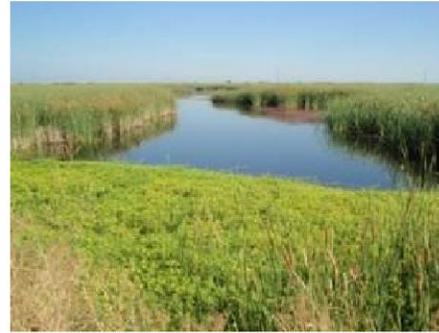
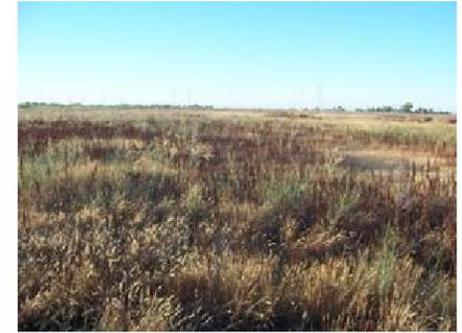
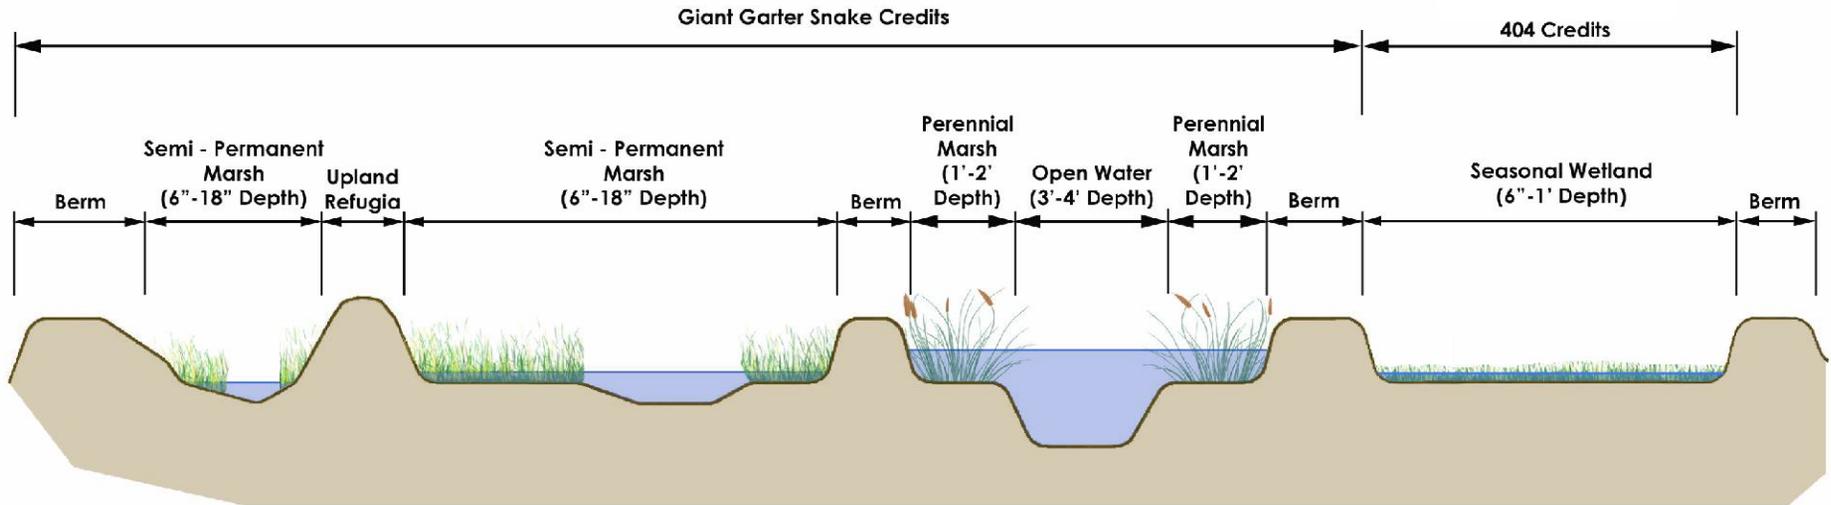
Figure 14  
Typical Habitat Cross-section

Berms and Refugia

Semi-Permanent Marsh

Perennial Marsh and Open Water

Seasonal Wetland

Habitat types developed at the Bank include open water, perennial marsh, semi-permanent marsh, uplands, and seasonal wetlands (Figure 14). To create the proposed habitat features, portions of the existing rice field will be de-leveled to create the habitat complex. Channels in the managed-marsh will be cut and the fill will be used to create berms and mounds. Berms are planned to be no greater than 3-feet above existing field elevations. Upland refugia mounds will be up to 6 feet high and are all located outside of the designated floodway. Existing and new water control structures will be used to adjust the water level in the managed marsh GGS habitat. A total of 118 acres of GGS habitat will be developed in a matrix consisting of approximately 17 acres of open water, 40

acres of perennial marsh, 51 acres of semi-permanent marsh, and 10 acres of uplands.

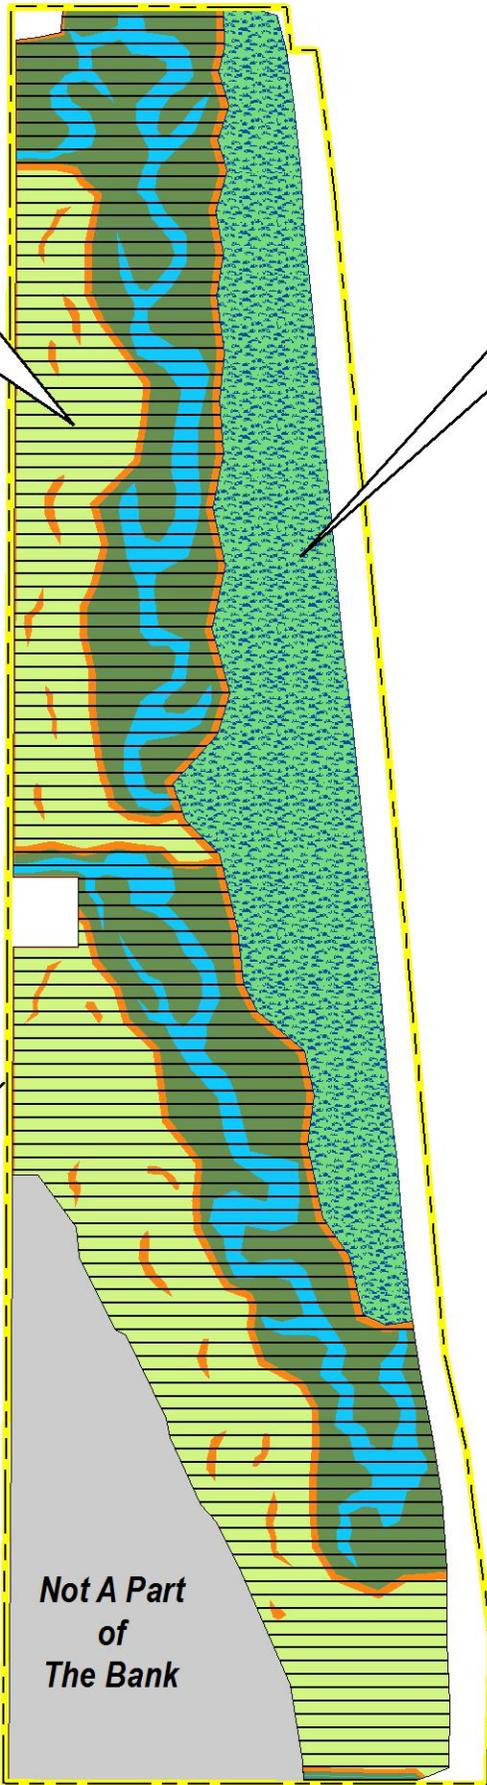
### Figure 15 Credit Evaluation

- Seasonal Wetlands, Precipitation Only
- 42 Acres = 42 Credits

WES is proposing to restore a matrix of seasonal wetlands, aquatic habitats, and uplands on a 160-acre portion of the Property adjacent to the 33.5-acre Maxwell PUD Mitigation Site. The Bank is being proposed as a combination Conservation and Mitigation Bank and will utilize the Bank Enabling Instrument (“BEI”) templates developed for California by the signatory agencies. Two separate credit types will be developed; 1) *Waters of The U.S. Creation Credits* would offset impacts regulated by the Federal Clean Water Act and 2) *Covered Species Creation Credits (giant garter snake and its habitat)* to offset impacts regulated only by the Federal and State ESA (see **Table 2**). Hydrology for the Waters of the US credit area is derived from precipitation and occasional floodwater, while hydrology for the GGS habitat credit areas is derived primarily from applied water supplemented by precipitation and occasional floodwater. **Figure 15** depicts the habitat types and credits on a map of the Bank Property.
