Markham Ravine Mitigation Bank Full Prospectus

March 2016

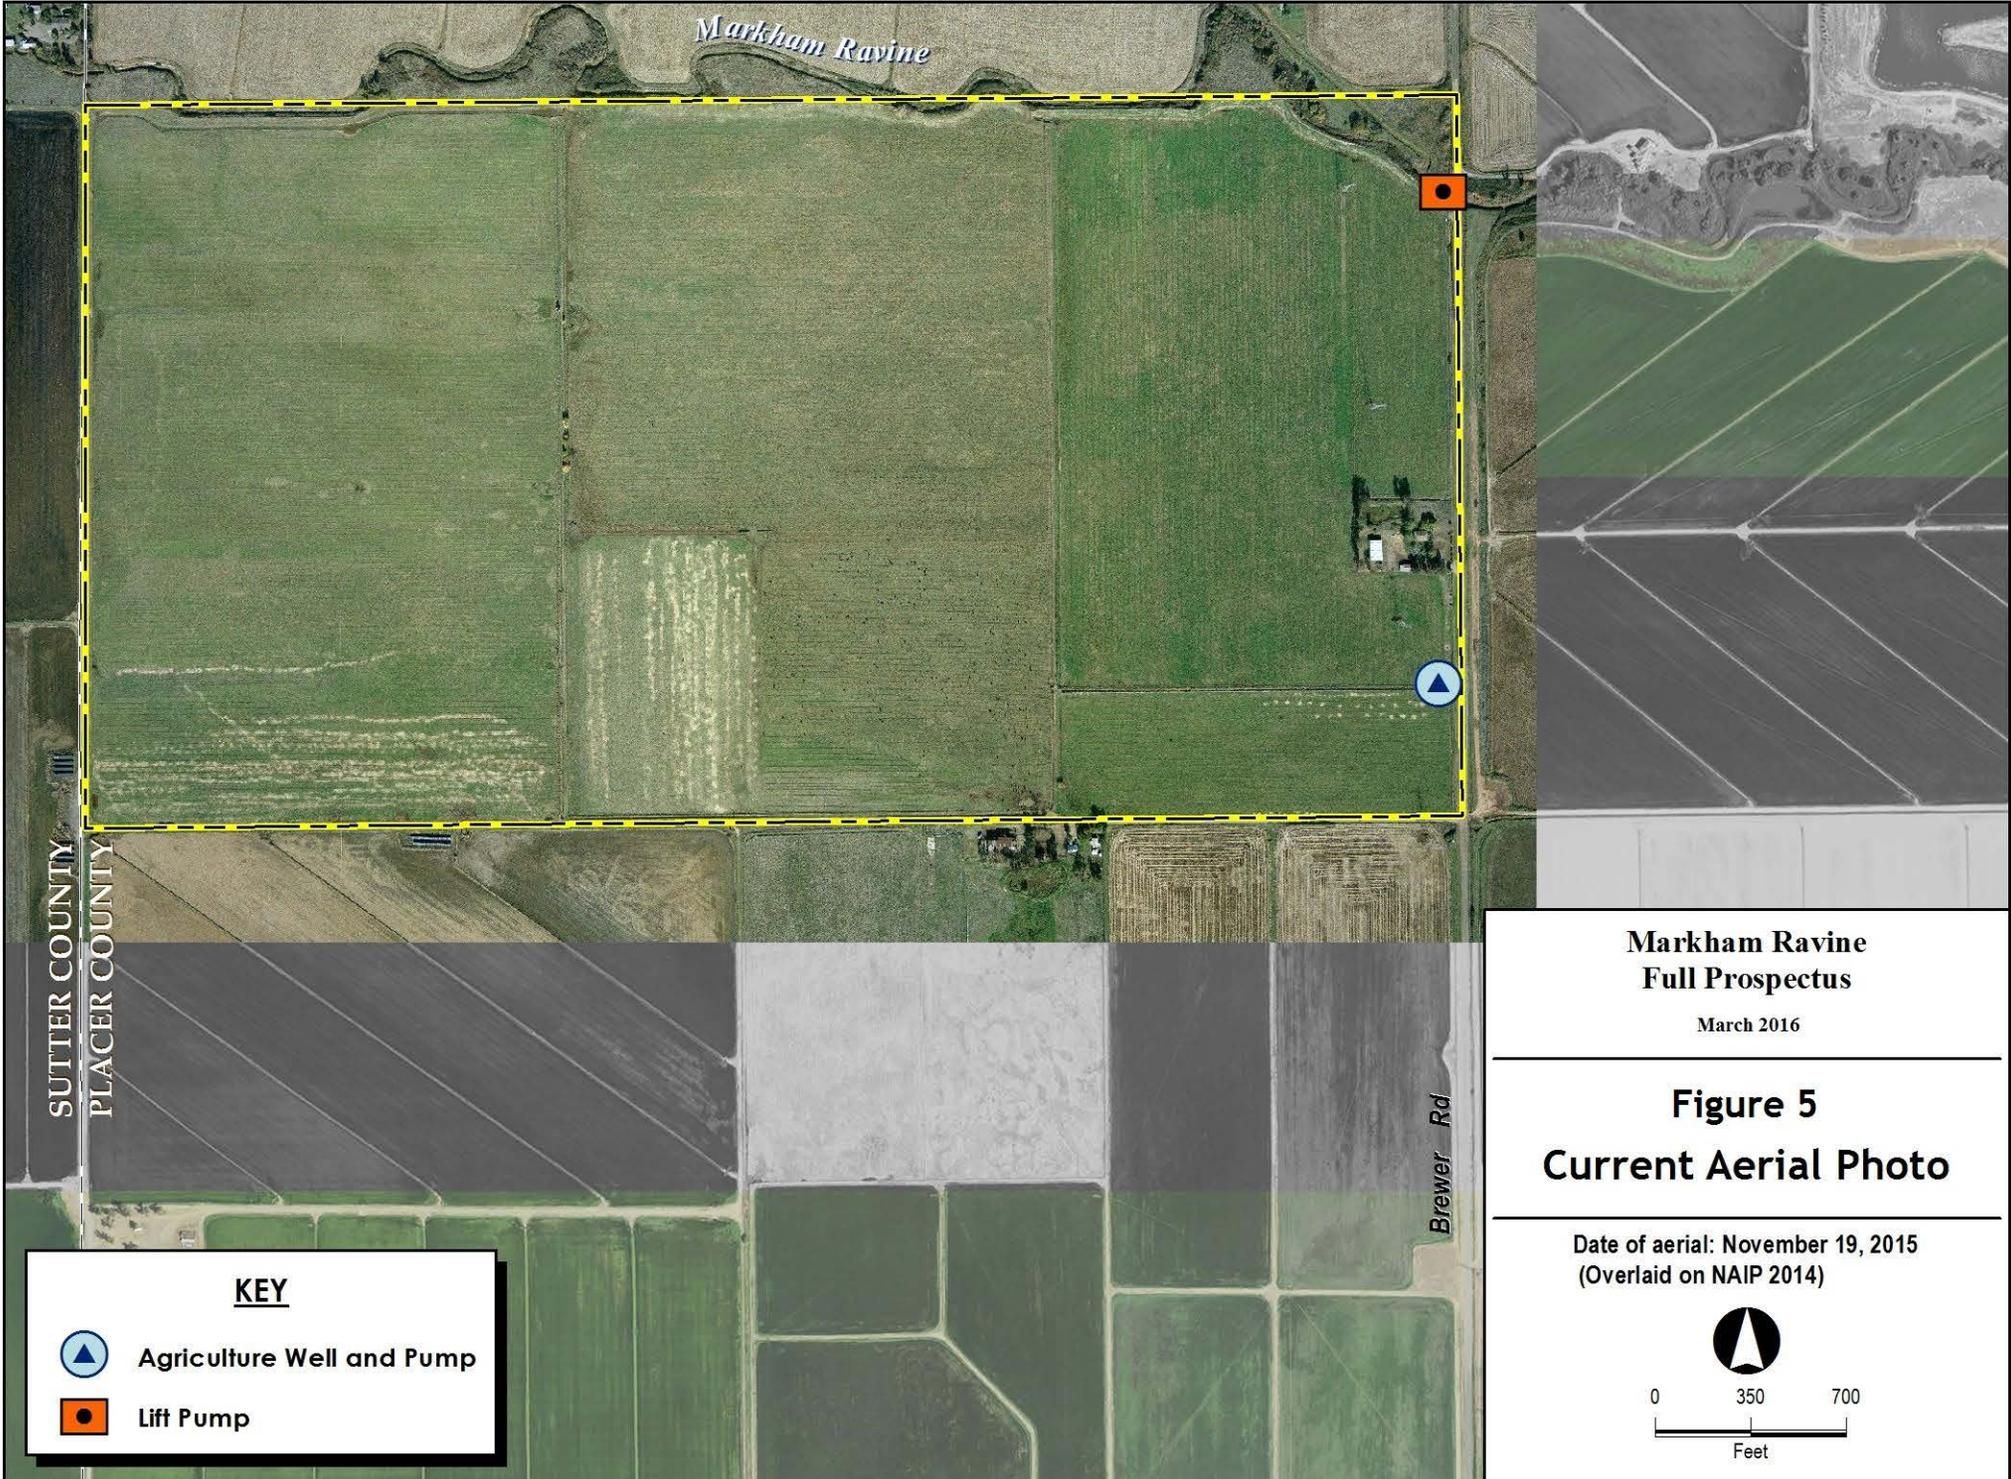
**Figure 5
Current Aerial Photo**

Date of aerial: November 19, 2015
(Overlaid on NAIP 2014)

seasonally irrigated pastureland is moderately valuable as foraging habitat for the SWHA (**Figure 5**). Cattle infrastructure, including troughs for watering, a windmill and well, fencing and gates occur on the Property. Open irrigation canals separate the sites ten irrigated fields. Photographs of the site can be found in **Exhibit B**.

The Ravine is now perennial and utilized by the Nevada Irrigation District (“NID”) and operated by South Sutter Irrigation District (“SSID”) for delivery of irrigation water to adjacent farms. The Property Owner has the ability to purchase water through NID to irrigate the Property. The perennial Ravine located on the Property is surrounded by informal farm berms that protect the site from flooding. The berms are primarily vegetated with native and non-native tree and herbaceous riparian vegetation as discussed in **Section 3.1.4.1**. The northeast corner of the Bank features a lift pump, which is currently used to supply purchased NID irrigation water from the Ravine into an underground, concrete, gravity fed pipeline running along Brewer Road which exits to the west into an irrigation ditch (**Exhibit B**, Photo 12). This pipeline provides the primary water source for the irrigated fields located on the Bank. An agricultural well located near the southeast corner of the Property supplies water to the remainder of the Property, and is accessed by a high volume, diesel powered lift pump (**Exhibit B**, Photo 5). A drinking water panel meeting the standards of the Safe Drinking Water Act is being performed on the wells ground water and is presented in the BEI. Two overflow irrigation ditches run down the center of the Property and drain toward the Ravine. A decommissioned well is located at the midpoint of the westerly ditch.
