Appendix G  
**Public Health and Environmental Hazards**  
**Technical Appendix**

## Area-Wide Assessment Summary Report

# **Sacramento River Southport Early Implementation Project West Sacramento, California 92101**

**Technical Memorandum  
Phase II Environmental Site  
Assessment  
Subsurface Soil and Groundwater  
Investigation**

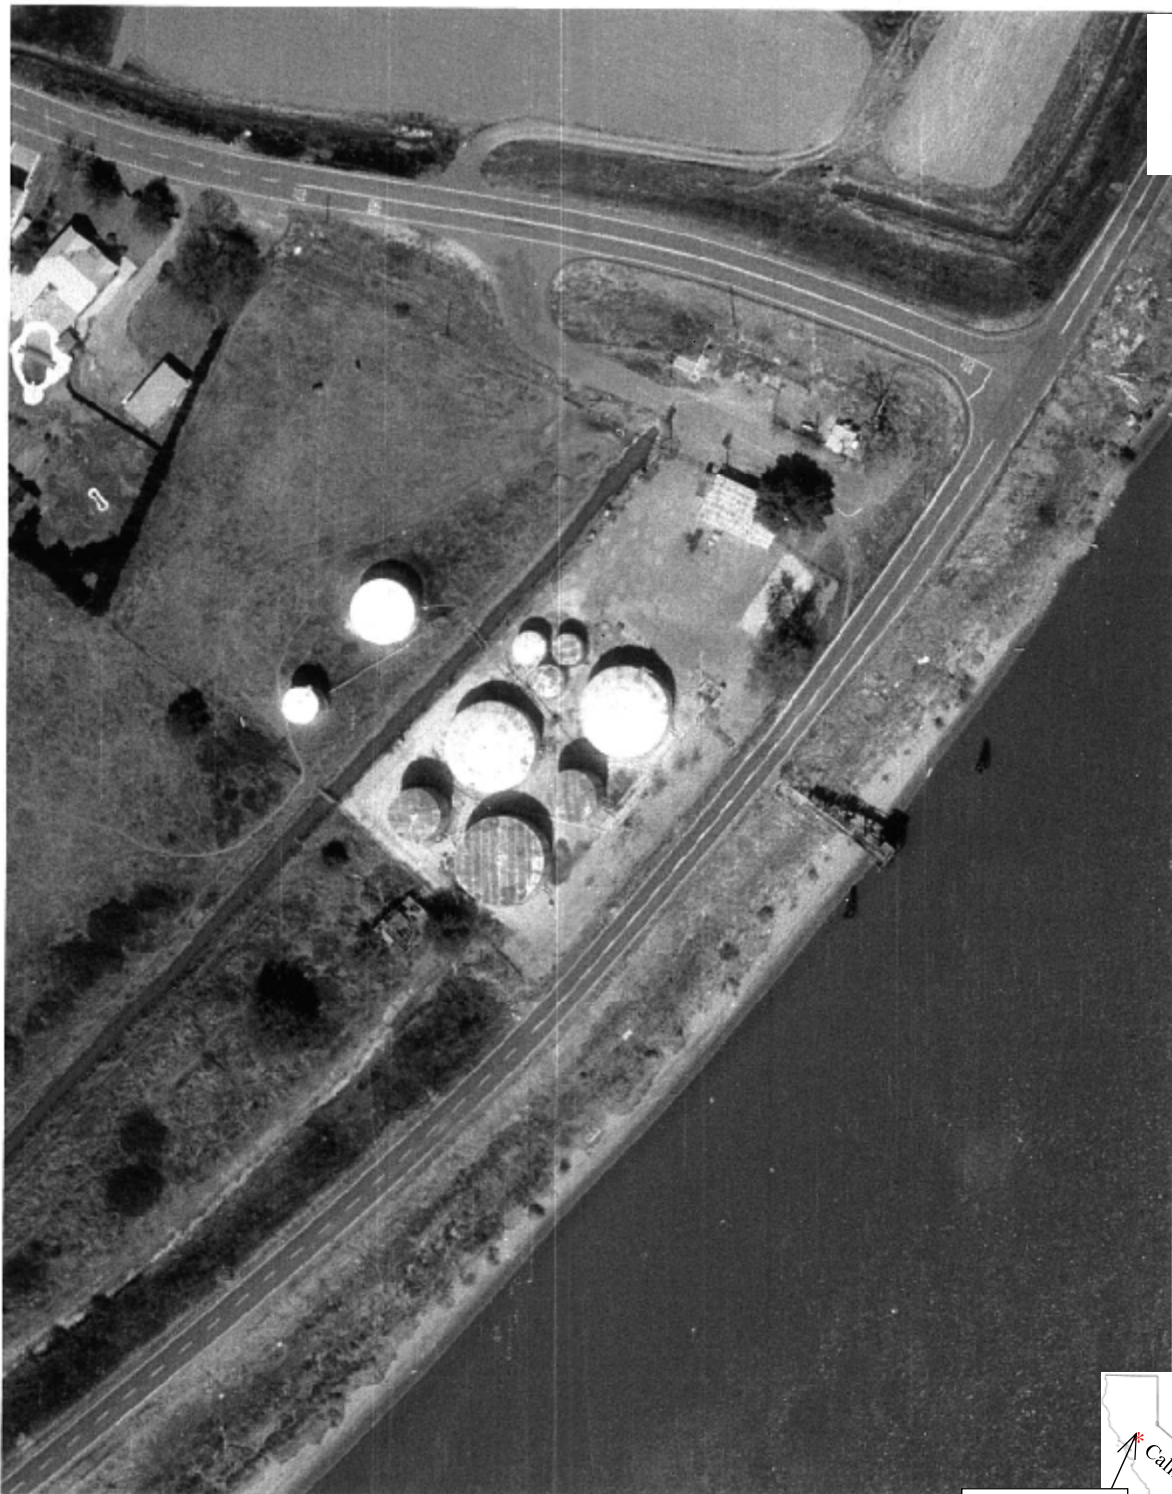
Figure 2

The Site location map is shown on Figure 1. A 1976 aerial photograph shows the ASTs, associated piping, and Site structures (Figure 2).

## 1976 Aerial Photo

A more extensive historic documentation review was then completed and it was determined that Time Oil Co. (dba TOC Holdings) installed ASTs on-Site and utilized the ASTs for petroleum products storage from at least 1952 through 1975. Time Oil Co. built an associated pier and pipeline during 1952 and/or 1953. The pier and pipeline were installed to allow transport of petroleum products from barges, traveling on the Sacramento River, to the associated ASTs. It has been reported that trucks would haul the petroleum products from the ASTs to local fuel stations or other customers. According to the historic documentation, TOC Holdings discontinued operations on the Site sometime between 1972 and 1974. According to historic aerial photos, the ASTs were removed sometime between 1978 and 1980.

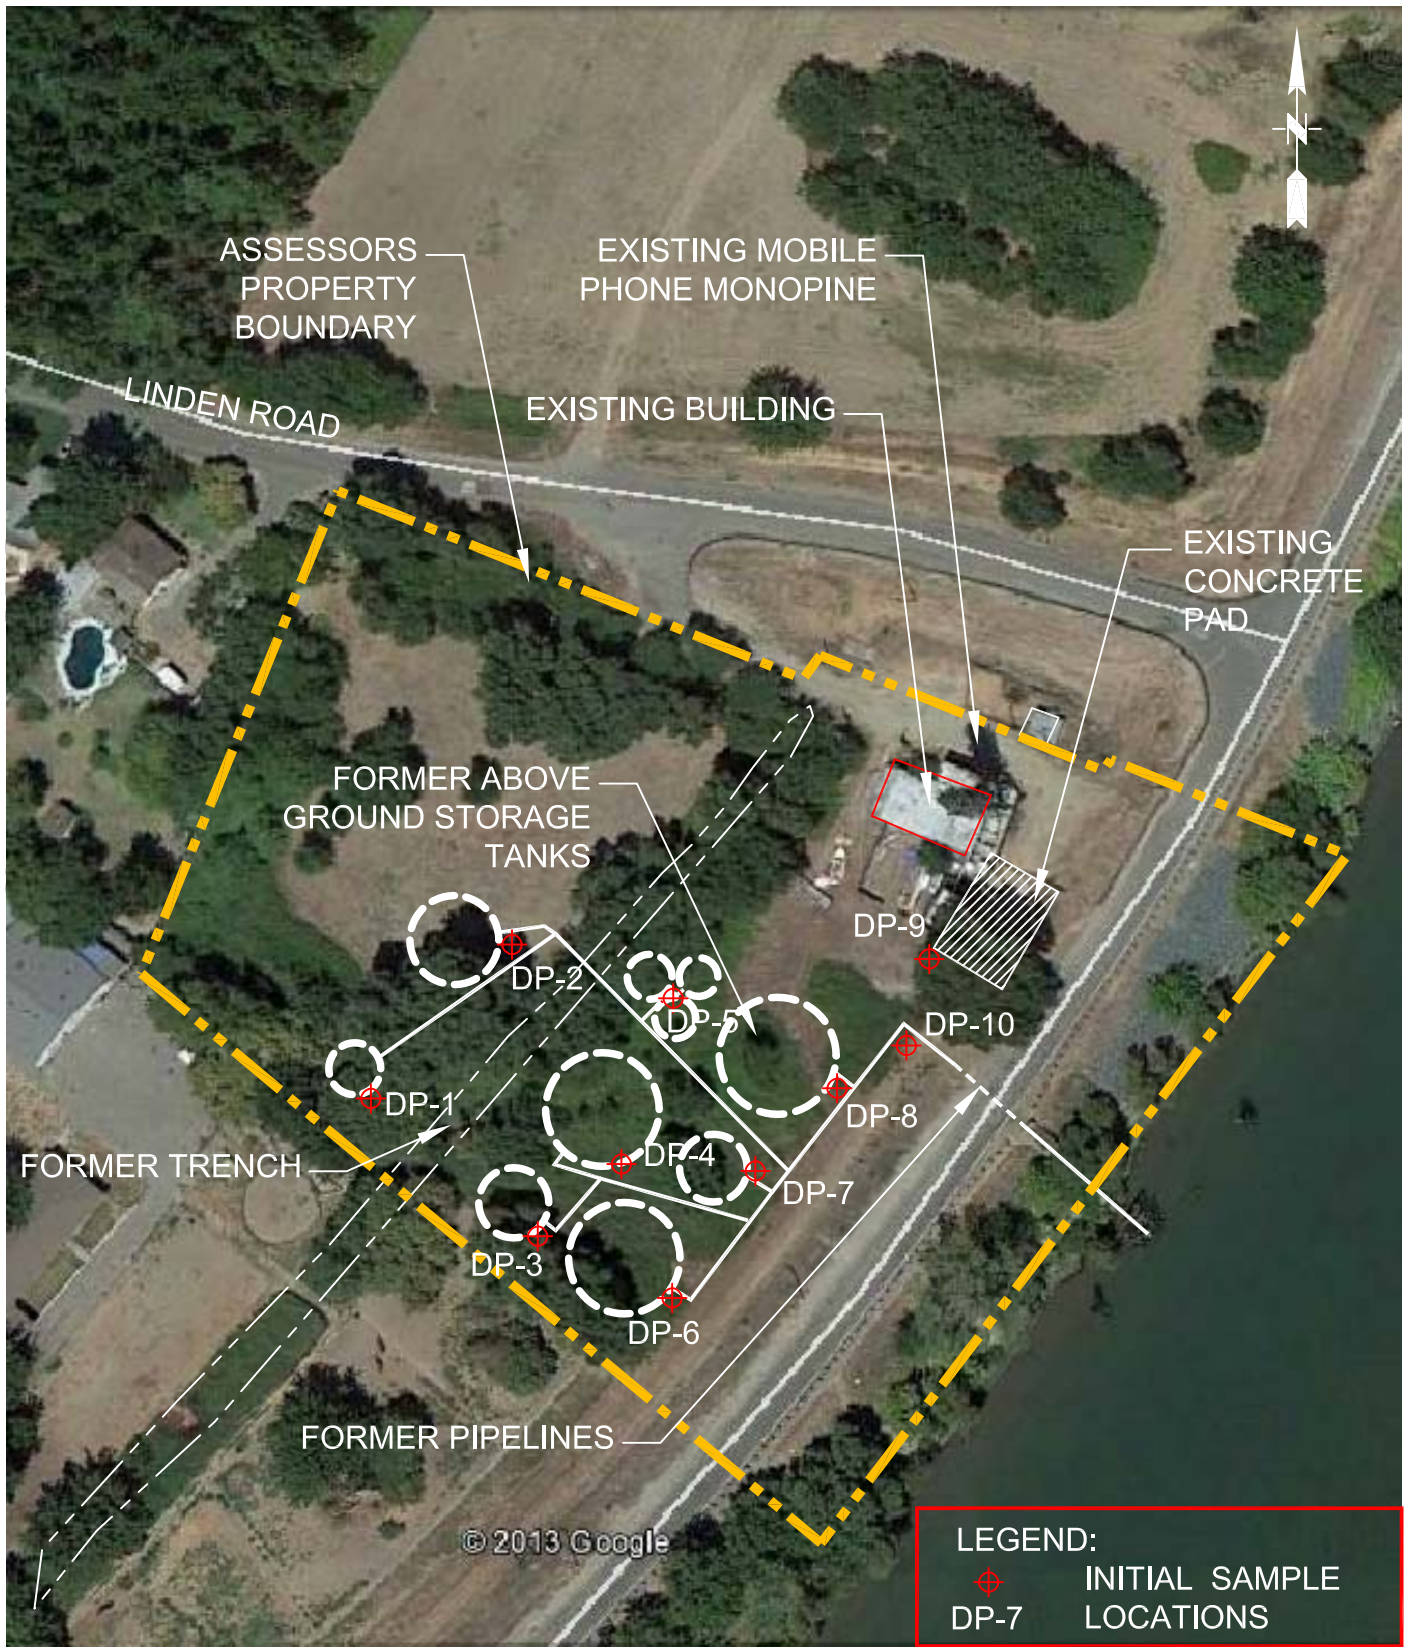
FIGURE NO.: 3

The ten direct push borings were located as shown on Figure 3, and designated DP-1 through DP-10. The borings collected continuous soil cores and the soils were screened for PID detections, and visual and odor impacts. Where impacts were noted, samples were retained for laboratory analysis. At least two soil samples were collected from each boring regardless of whether there was a field indication of potential impacts. It was intended that at least one sample from each boring would be collected just above groundwater, and one would be collected from the top of the saturated zone.

Stage 1 soil analysis results are given in Table 1. Blank cells indicate there was no detection for that parameter. Borings DP-1 through DP-5, and DP-8 and DP-9, did not have any TPH compounds detected. Soil impacts were observed in the samples from DP-6, DP-7, and DP-10, with the highest total TPH detected in DP-10. The detection locations are along the eastern edge of the property next to the levee berm.

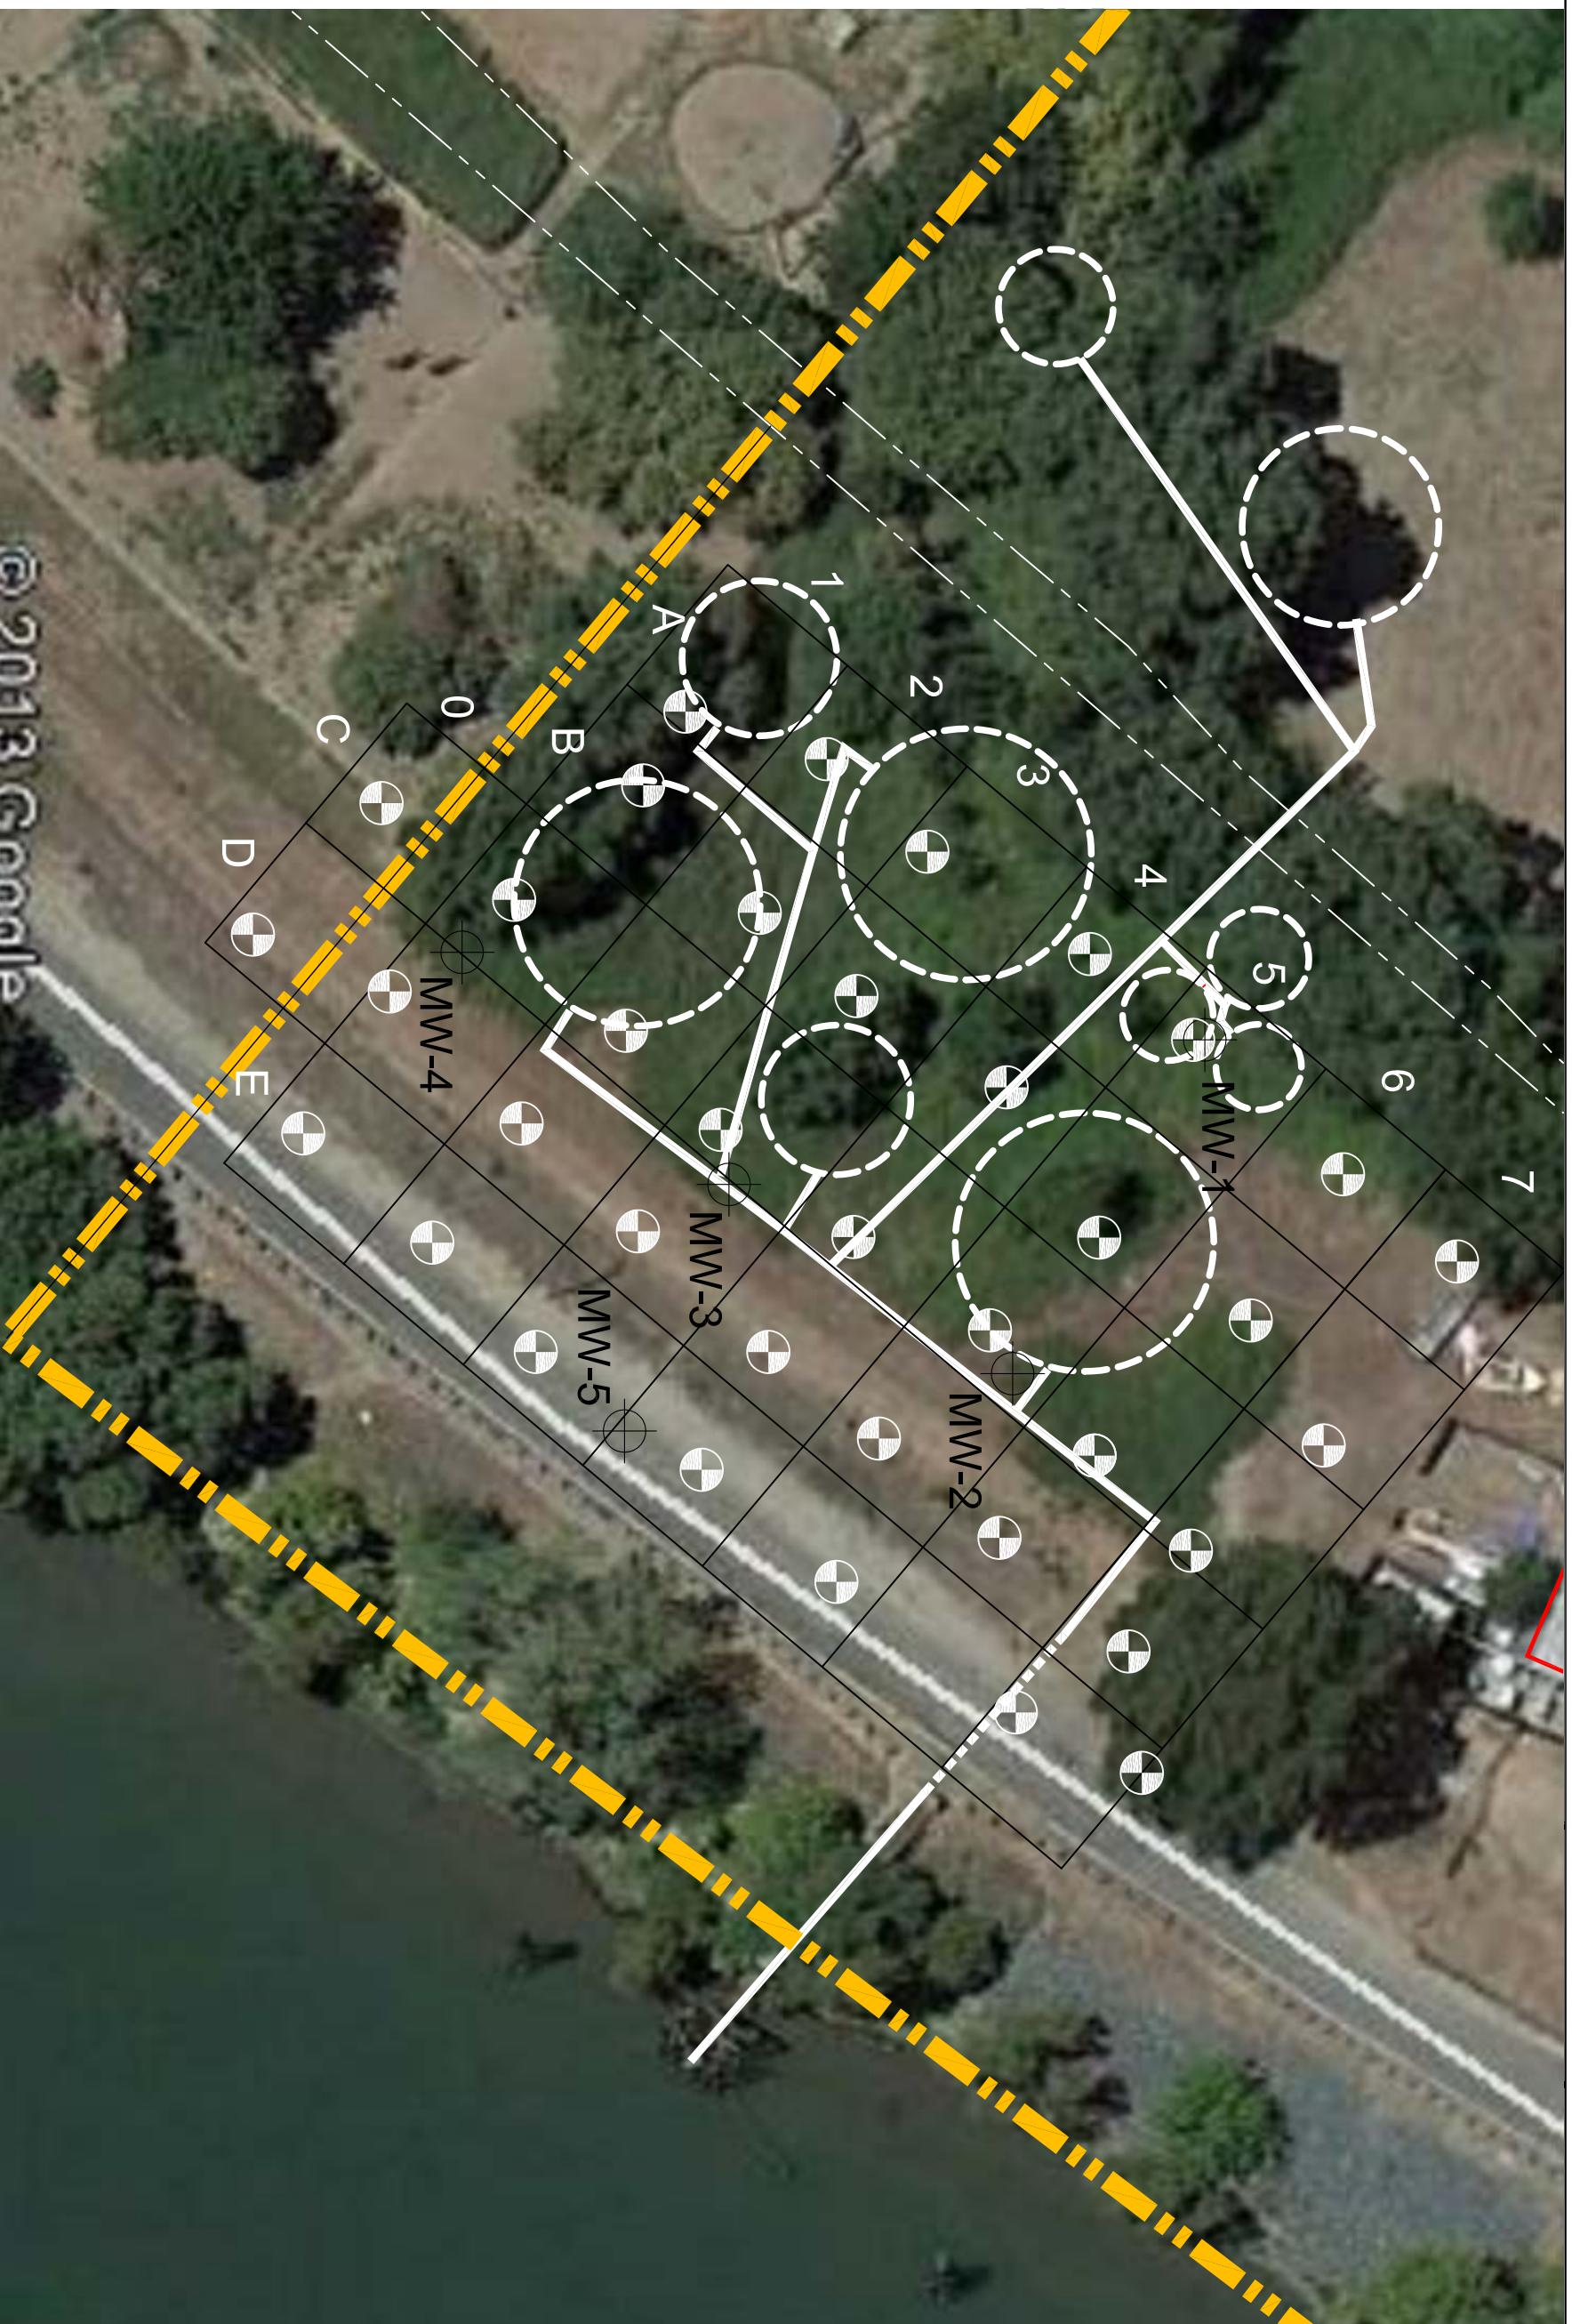
In addition to the 37 soil borings, five groundwater monitoring wells were drilled, constructed, developed, and sampled. These are shown on Figure 4 as MW-1 through MW-5. The wells were screened with 15 feet of well screen placed with approximately 10 feet of screen below the water table, and five feet above the water table. This was to allow for water table fluctuations and provide a means to observe whether light non-aqueous phase liquids (LNAPL – also known as floating free product) exists floating on groundwater.

Stage 2 groundwater results are given in Table 4. No VOCs were detected in well MW-1, MW-2 or MW-5. The highest VOC concentrations were in MW-4 in the southeastern corner of the property. The absence of VOCs detected in the monitoring well installed through the levee (MW-5), and the highest concentrations being observed in MW-4, indicates that groundwater flow, and transportation of contaminants in groundwater, may be primarily moving south parallel to the levee, as opposed to flowing under the levee directly toward the river.
