CHAPTER 2

EXISTING AND LIKELY FUTURE WITHOUT- PROJECT CONDITIONS

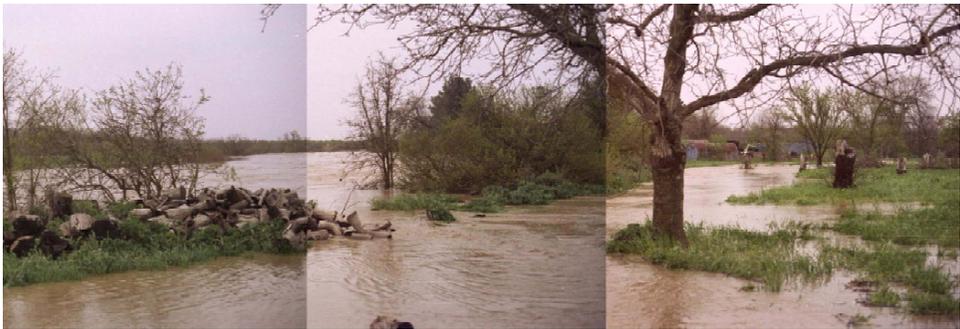
Overbank spill upstream of existing project, just west of I-5 – 1995.

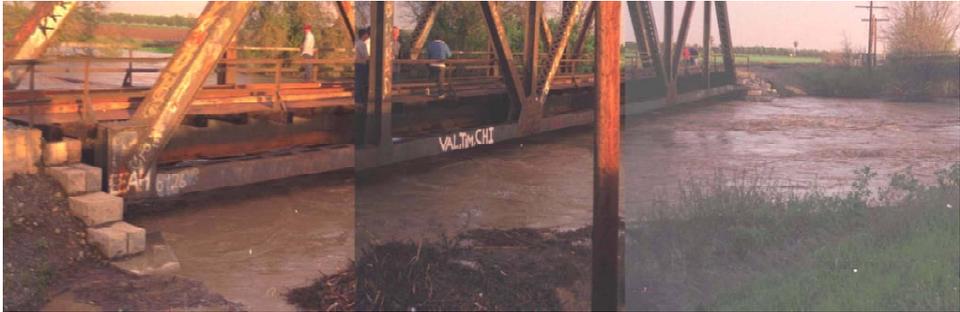
Upstream of railroad bridge near town of Yolo – 1995.

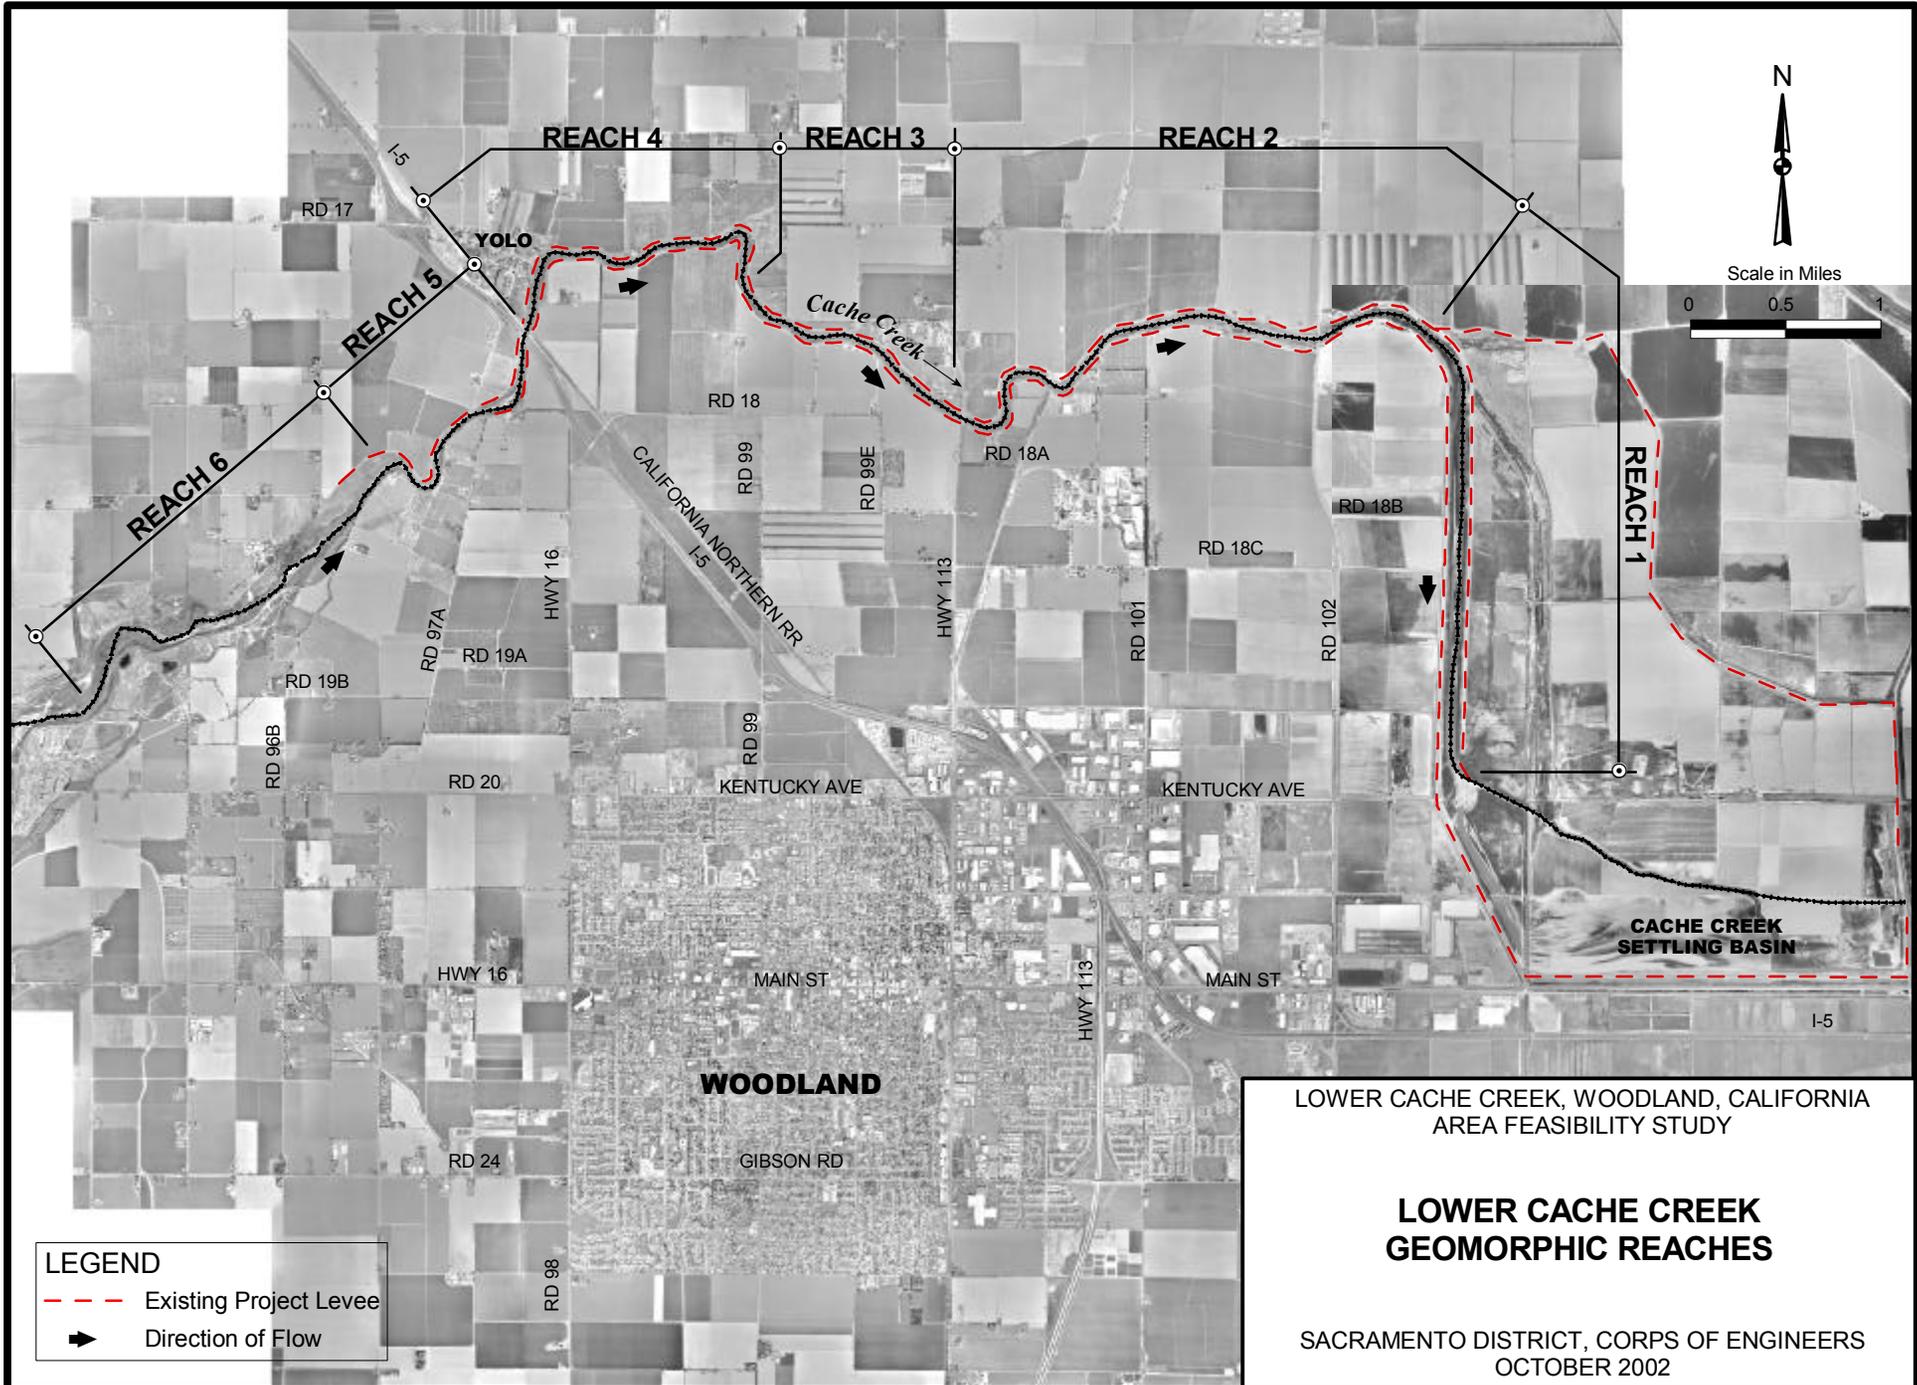
FIGURE 2-1

Lower Cache Creek exhibits several geomorphically distinct reaches along its length (Figure 2-1). The most significant reach change is 1.7 miles upstream from I-5. Upstream from this location, Cache Creek was historically mined for aggregate, whereas areas downstream were not. As a result, channel morphology is vastly different between these two sections of the project area. These and other geomorphic changes can be used to subdivide the creek into the six project-distinct reaches, described below.

Reach 1 is 12,000 feet in length. Cache Creek flows south in an artificially constructed channel that directs Cache Creek flows into the settling basin. The artificial channel exhibits a regular, trapezoidal cross section with little or no change in flow capacity along its length. Dense vegetation cover throughout this reach greatly restricted the observation of in-channel features during the field inspection. As a result, in-channel features were assessed primarily from year 2000 aerial photographs, which showed no apparent bank erosion sites in Reach 1.

Reach 2 is 15,500 feet in length and located between SH 113 and Reach 1. From aerial photographs, bank vegetation in Reach 2 varied from forest cover with dense understory to open areas of tall grass extending to the water's edge. Channel banks in Reach 2 appeared stable, and no areas of significant bank erosion were observed. However, some small, isolated areas of streambank erosion were identified in the reach. In addition, vertical scarps of exposed bank sediments approximately 3 feet high were also observed near the top of bank in the upstream part of the reach. These breaks in bank

Reach 3 is 6,500 feet long and forms a transitional reach between the wider Reach 2 downstream and the narrower Reach 4 upstream. The downstream 1,500 feet of Reach 3 exhibits a fairly consistent line of trees along the south bank, probably planted there several decades ago. These trees occupy the lower part of the streambank near the water's edge, indicating that little or no bank erosion has occurred here over the last several decades. Other areas of Reach 3, particularly along the north bank, are largely devoid of tree cover and instead exhibit grass- and shrub-covered bank slopes.

Reach 5 is 9,000 feet in length and characterized by large meander bends that exhibit severe bank erosion along high (30 feet and greater) vertical banks over hundreds of lineal feet. This morphology results in the most severe and extensive bank erosion in

Reach 6 is 11,000 feet long and located in a historically gravel-mined section of the project reach. This reach is very broad in comparison with the rest of the project area and is characterized by large gravel bars, areas with little vegetation that were mined as recently as the mid-1990's, and undisturbed areas of dense vegetation. Vegetation is gradually returning to denuded portions of the creek following the cessation of instream gravel mining operations in 1996.

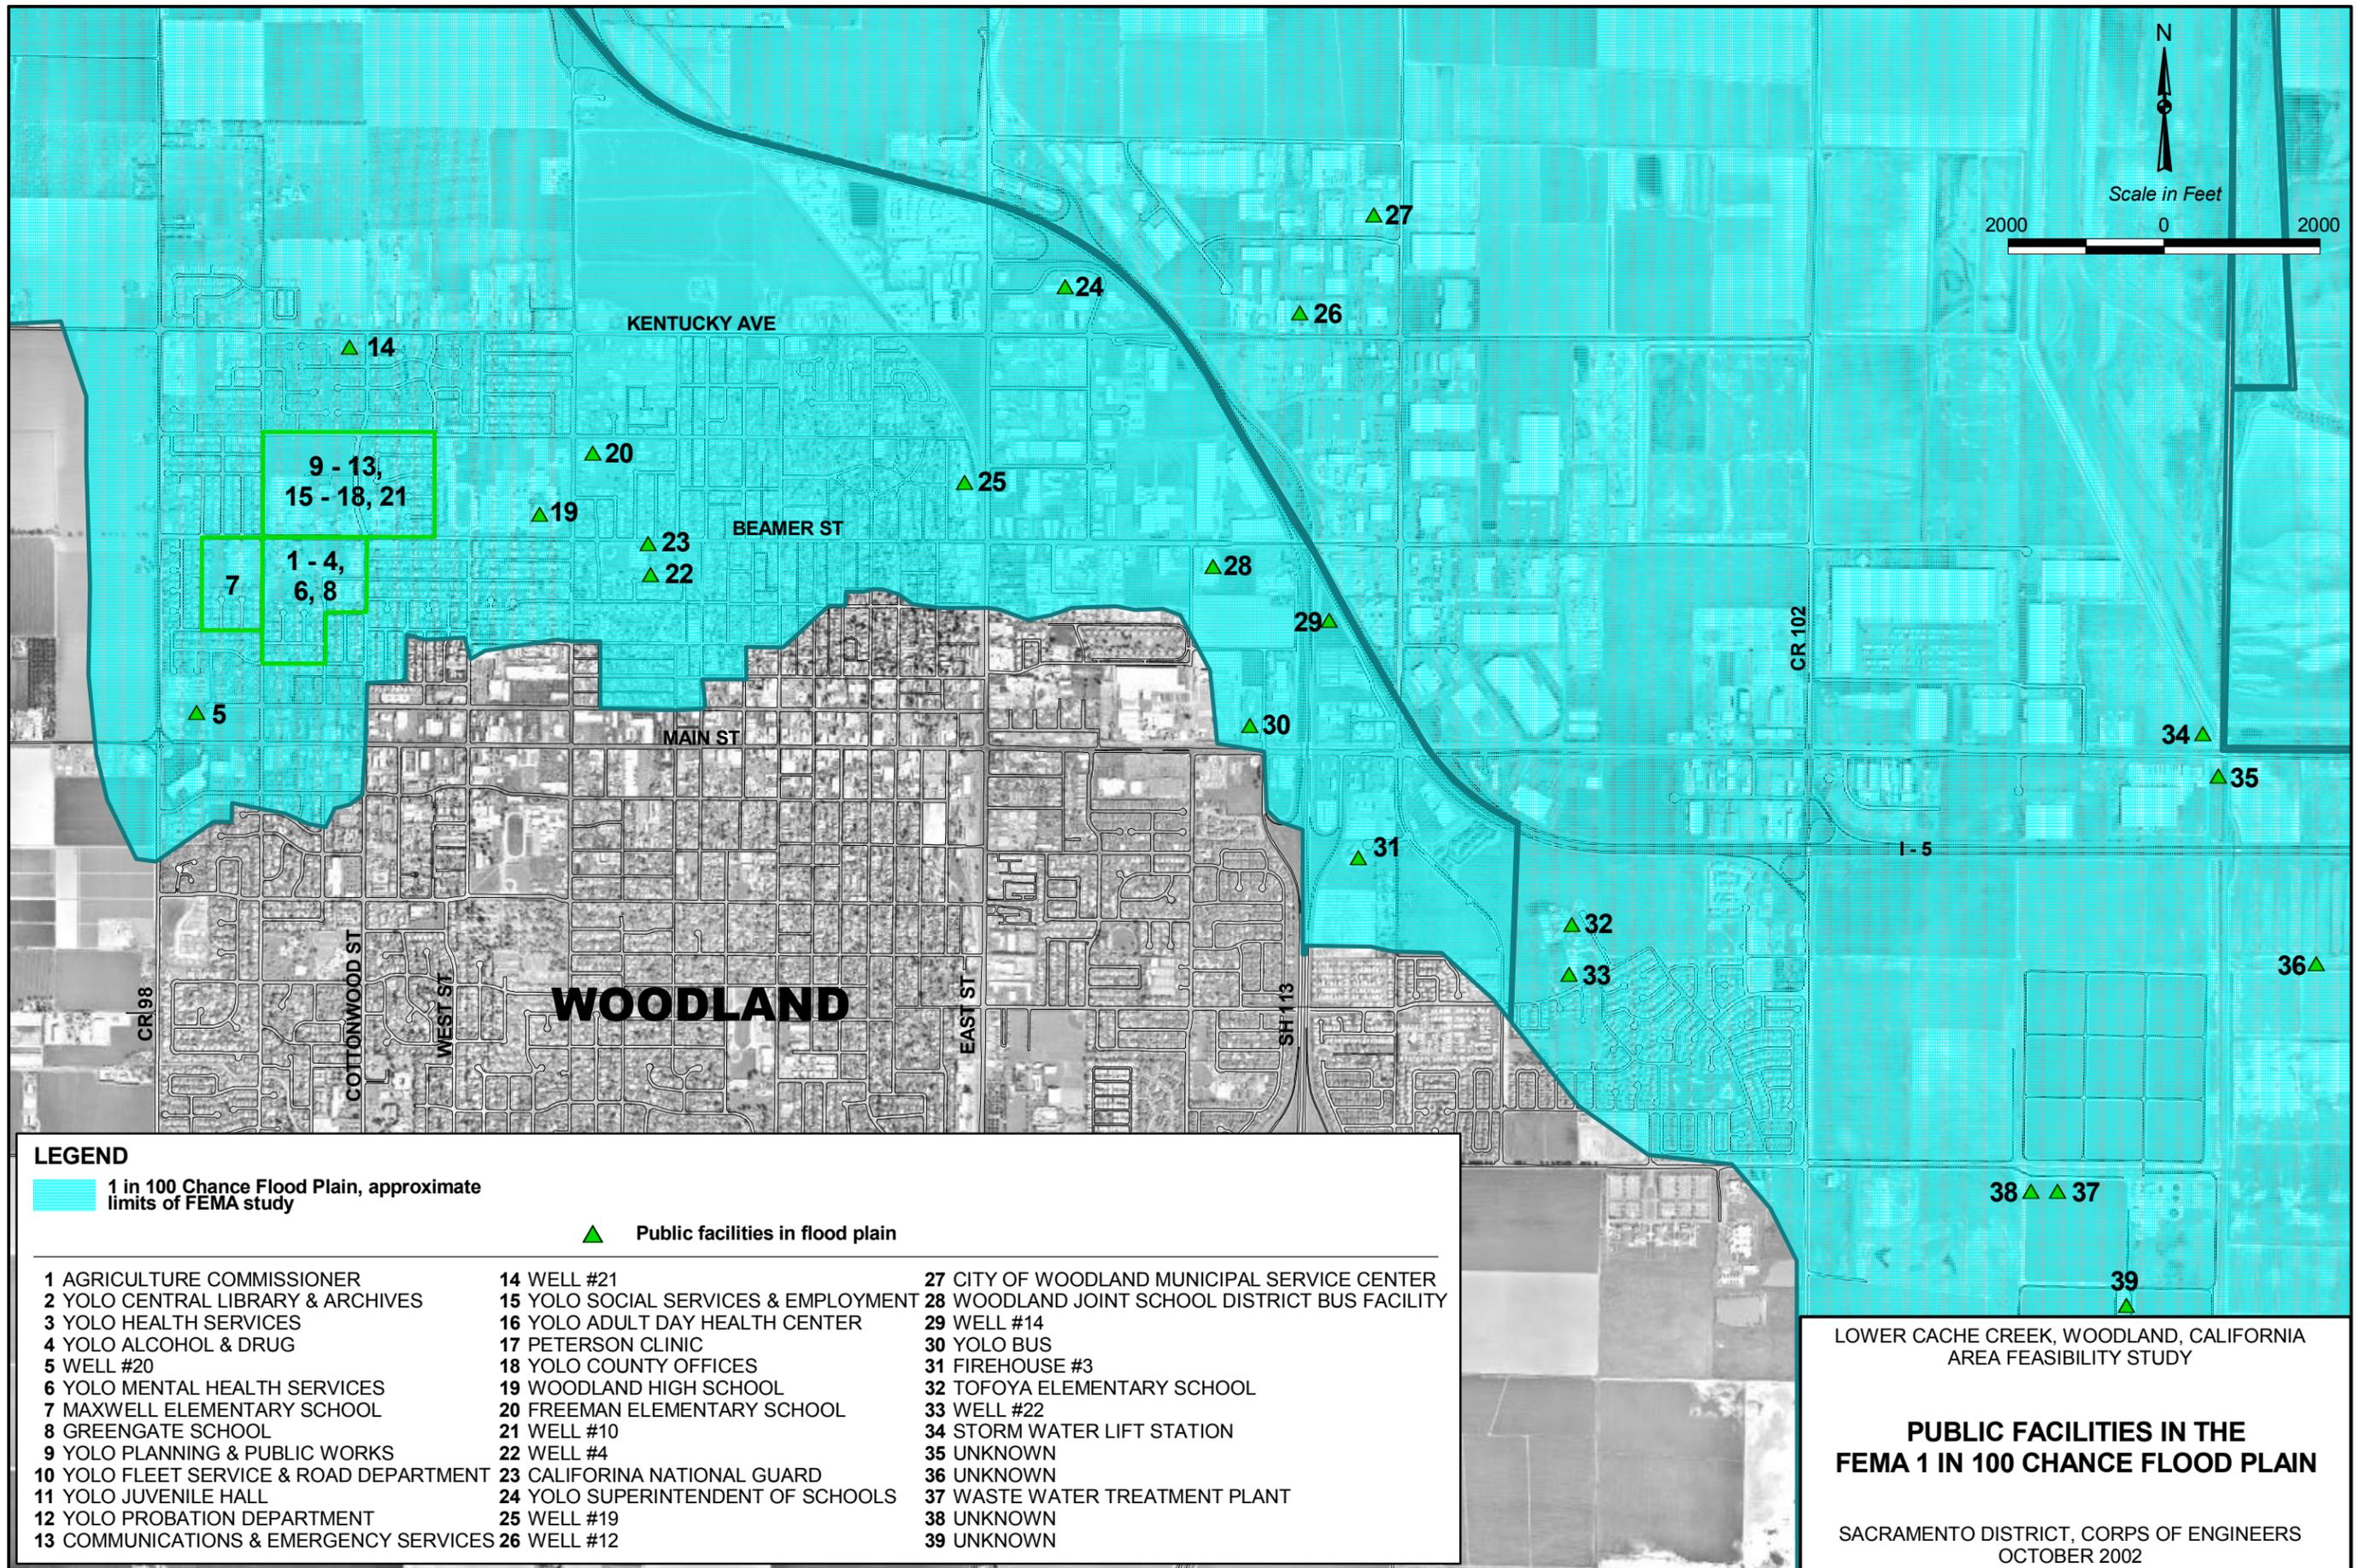
1 in 100 Chance Flood Plain, approximate limits of FEMA study

The City of Woodland is the largest incorporated community within the study area; the population in 2002 was 50,614. The zoning for the city is shown on Plate 2. Originating as an agriculture support community, Woodland remains surrounded by agricultural lands. Most industrial development occurs in the north and eastern parts of the city, which are within the FEMA flood plain. Residential areas lie primarily to the west of downtown; current developments are to the south. The residential areas in the north and east part of Woodland are in the FEMA flood plain.

The northern residential areas are in the FEMA flood plain (about 3,200 single-family homes and 300 multiple-family homes). An additional 500 structures (industry,
