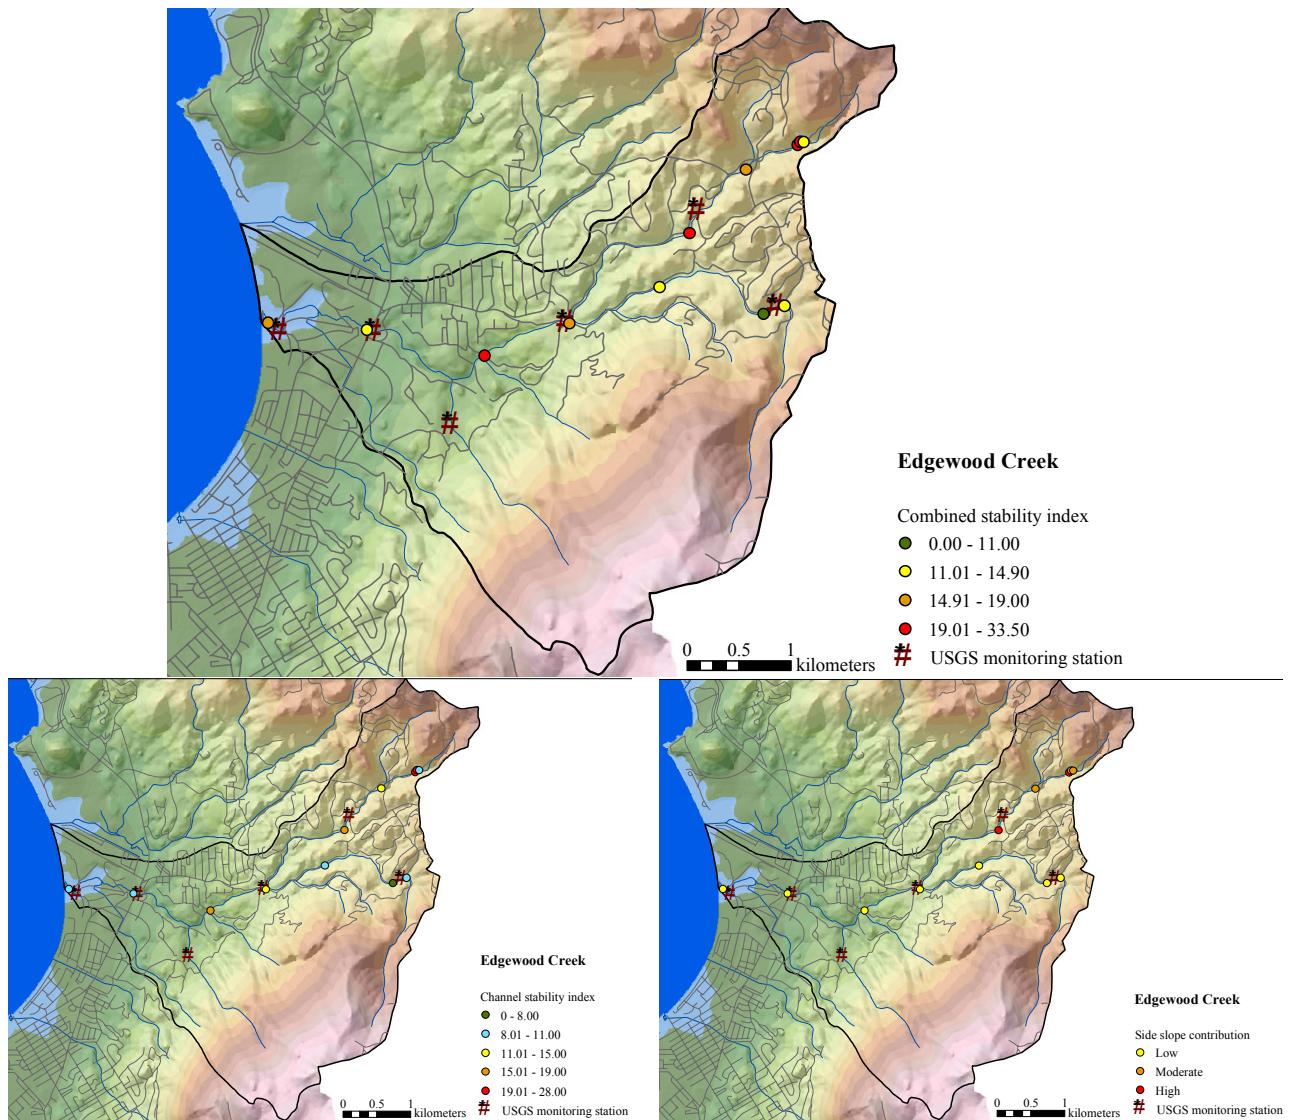
**Figure 4-50. Results of rapid geomorphic assessments of Edgewood Creek showing the relative contributions of channel- and side-slope indexes to the combined stability index and critical erosion areas.**
