Dugway Proving Ground Restoration Advisory Board Meeting

November 14, 2007
Dugway Proving Ground
Dugway, Utah

PROJECT UPDATES

Keller Davis - Shaw Environmental, Inc.
Inc.

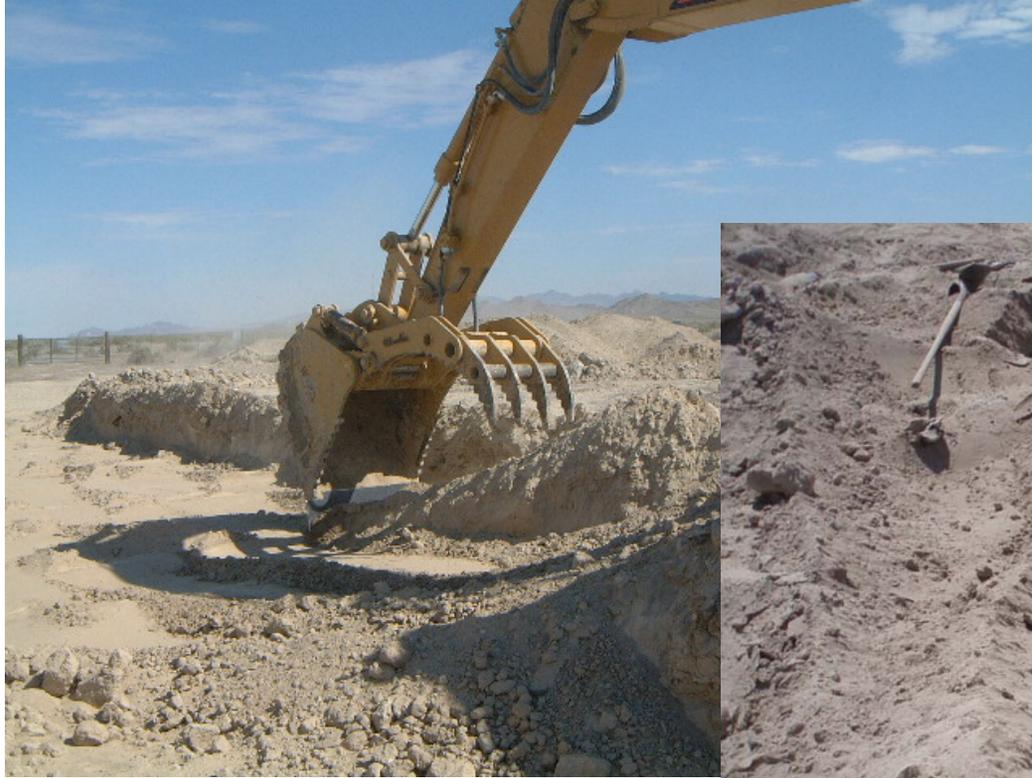
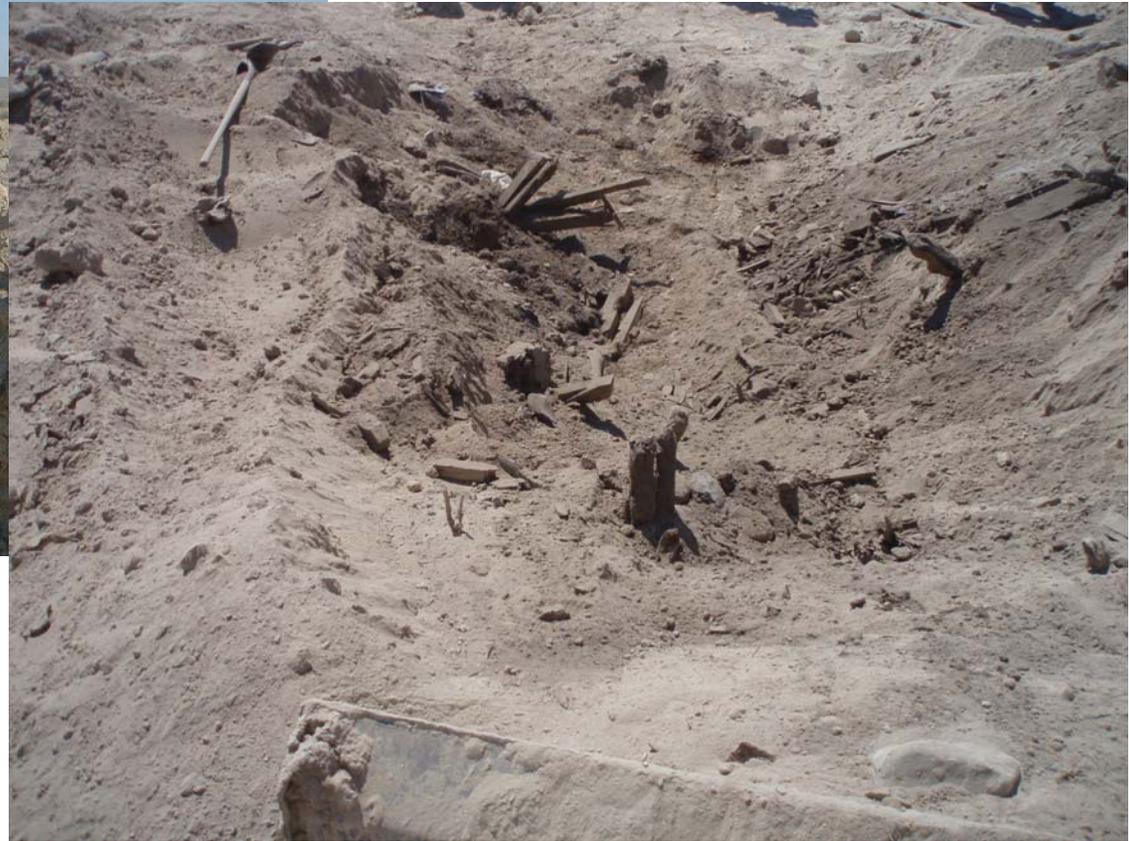
DPG-212 Removal

- Sympathetic Detonation test on underground bunker
- 330 simulant-filled M61 rockets
- Simulant used was ethylene glycol (anti-freeze)
- Following the test, live rounds were destroyed and the bunker and debris were collapsed in and buried

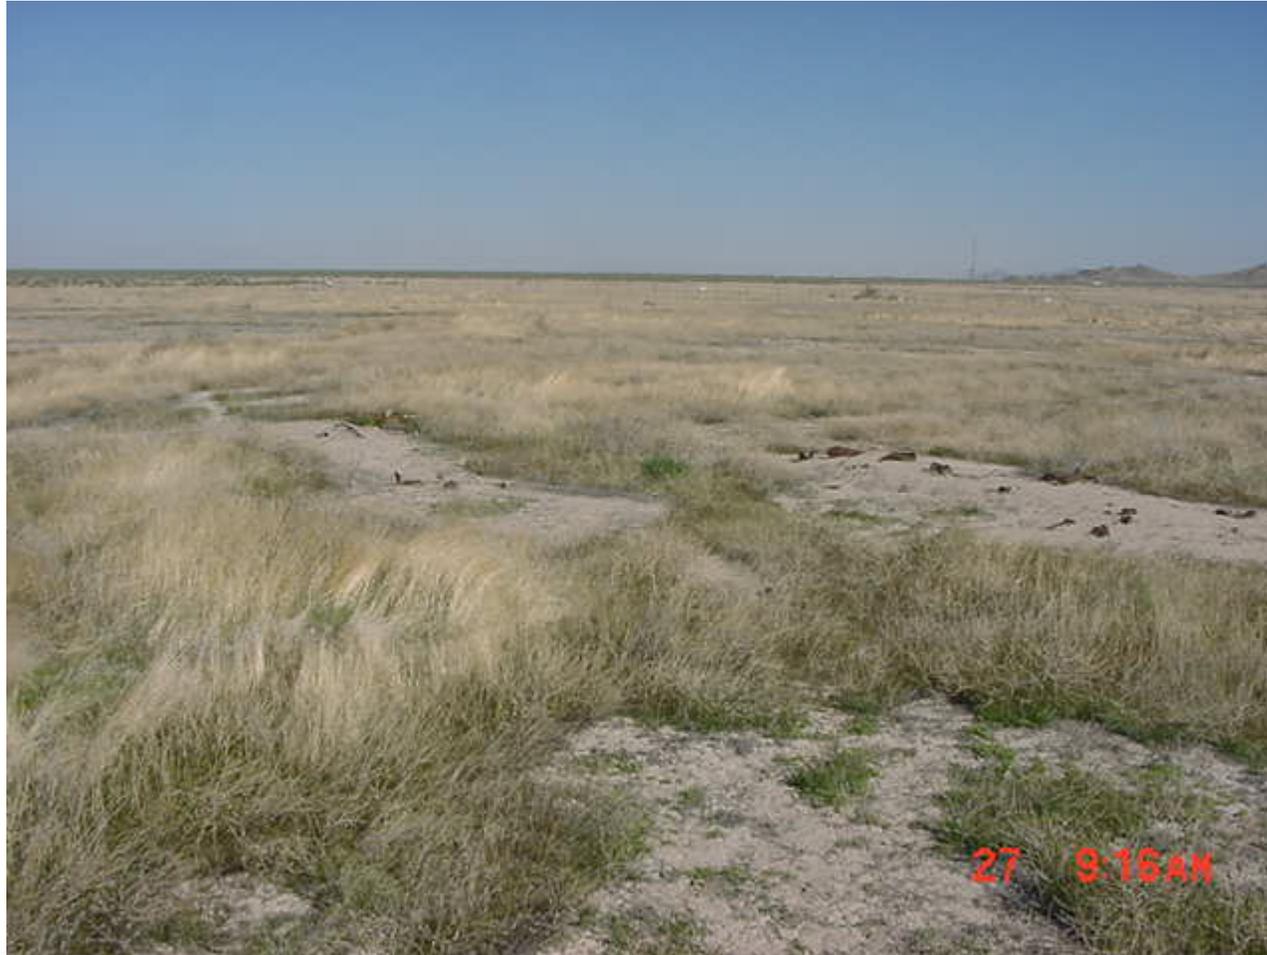
DPG-199 Surface Clearance

(MPPEH on surface)

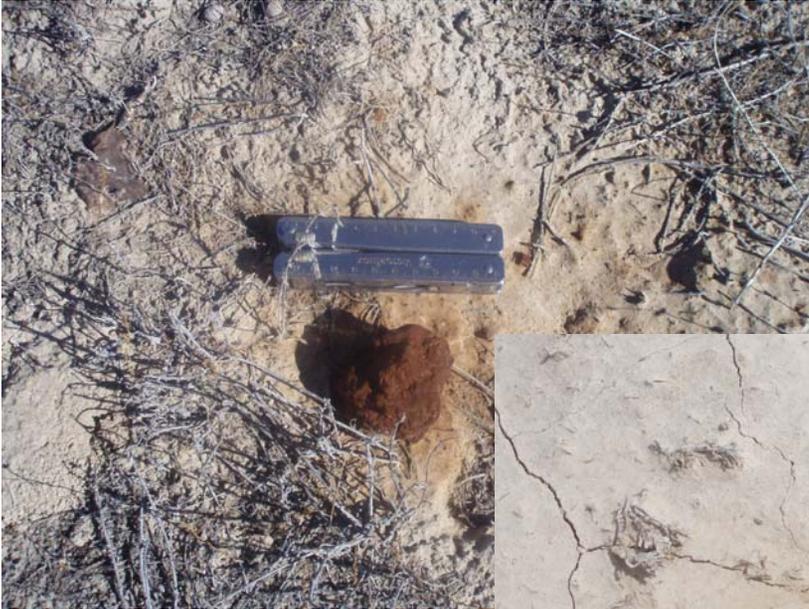
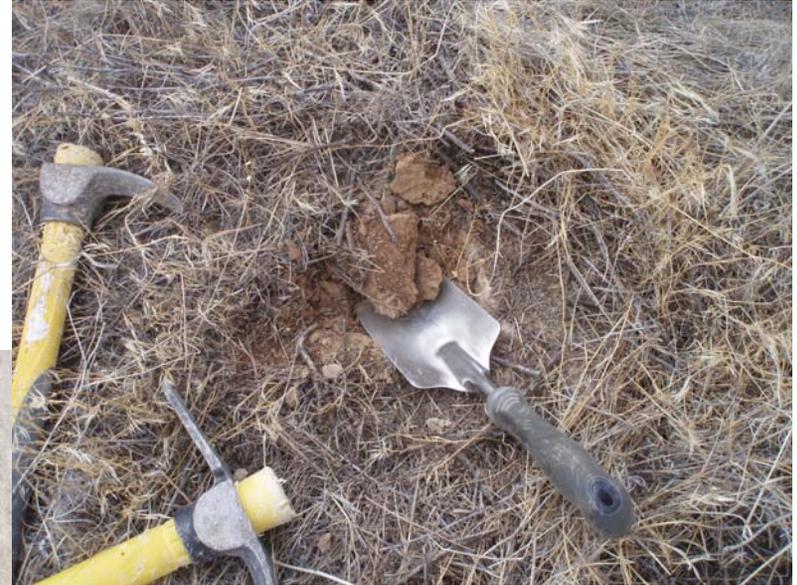
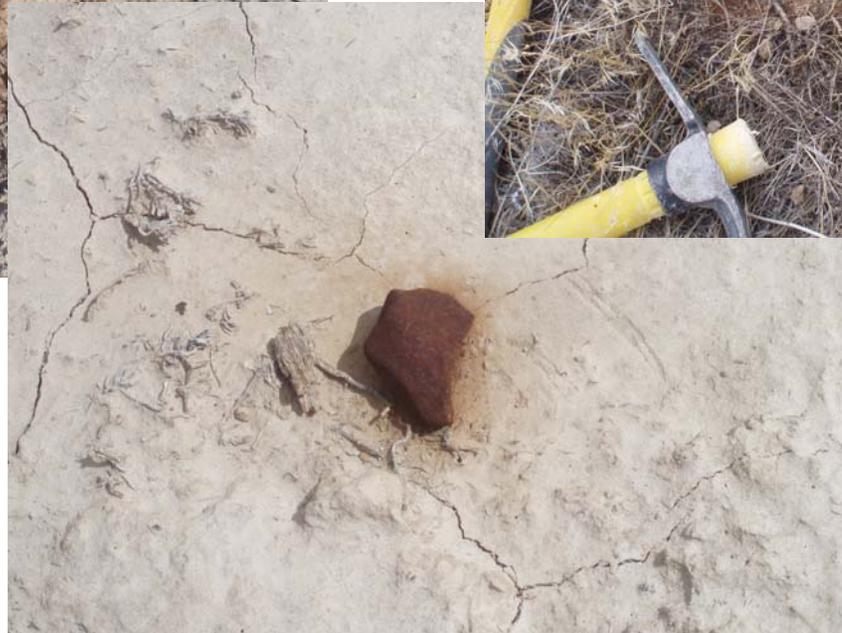
DPG-199 Surface Clearance

(MC on surface)

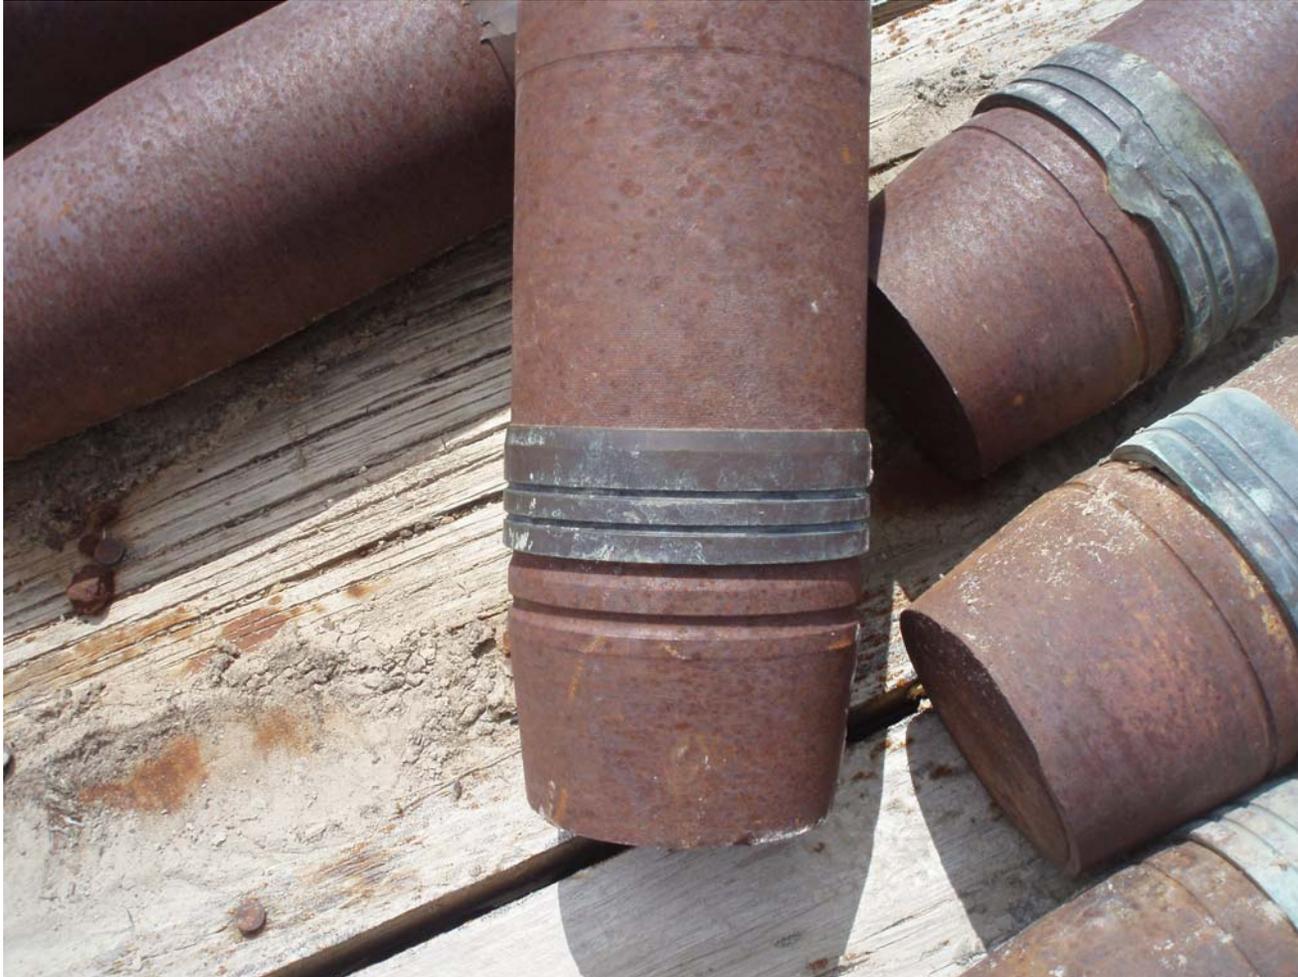
DPG-199 Surface Clearance

(MEC on surface)

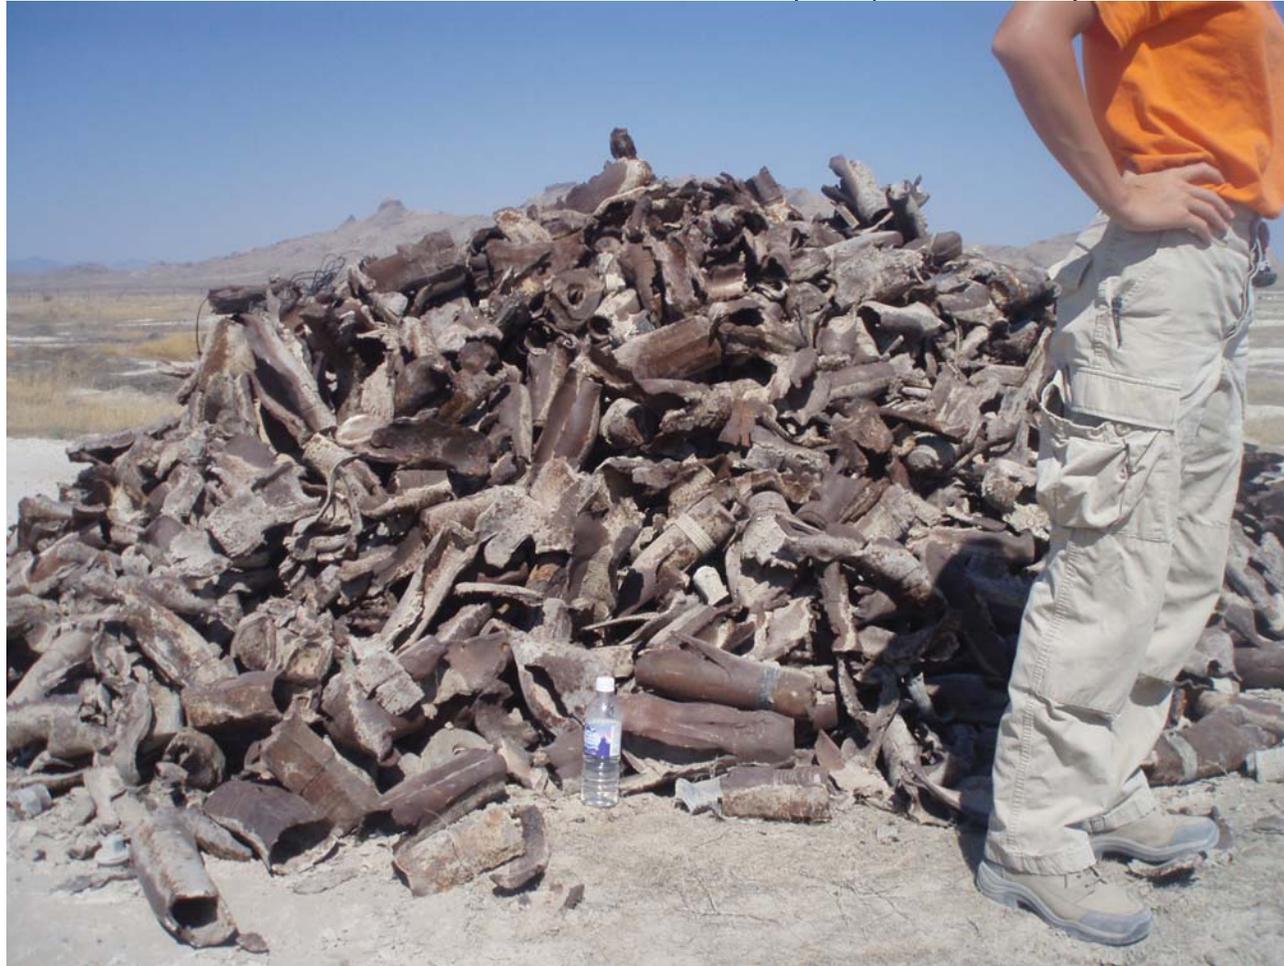
DPG-199 Surface Clearance

Recovered MD Pile (60,000 lbs)

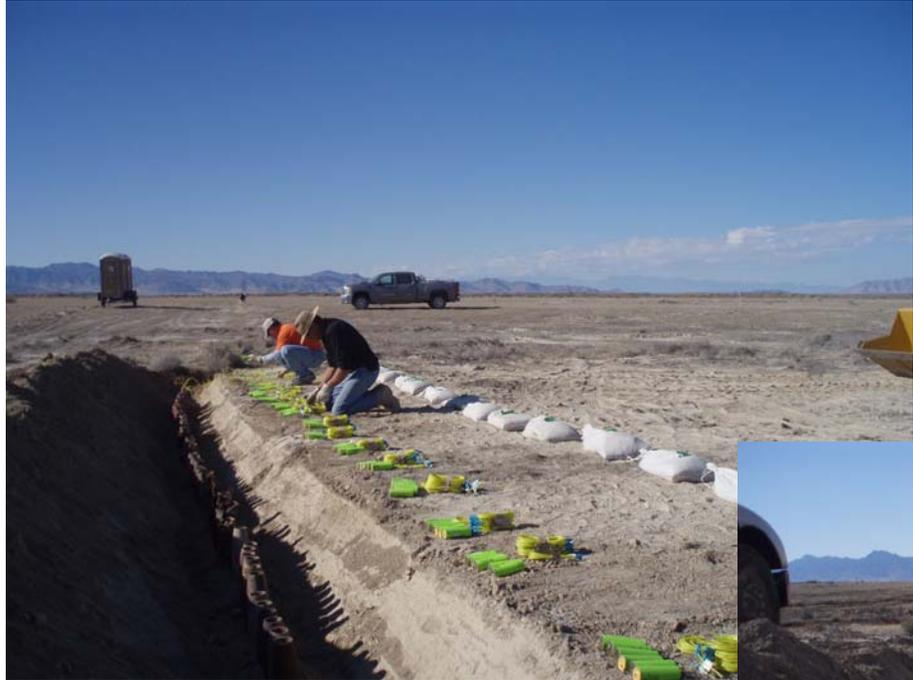
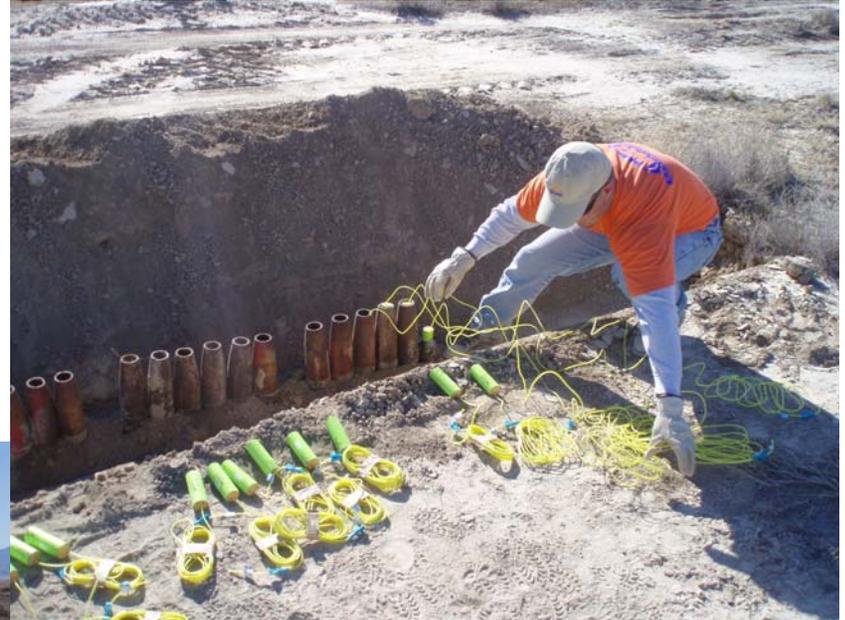
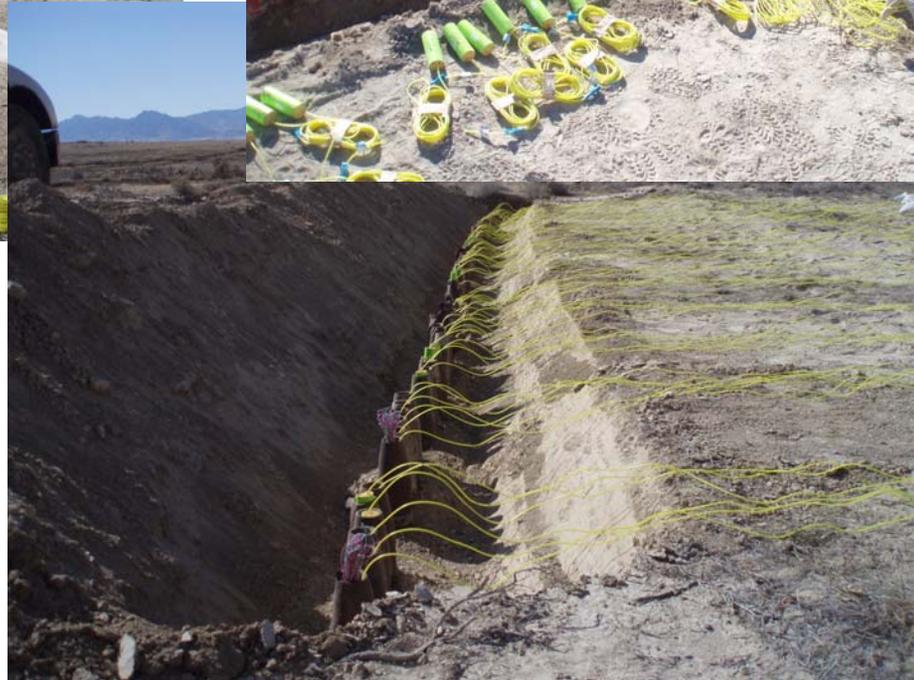
DPG-199 Surface Clearance

MEC Detonations

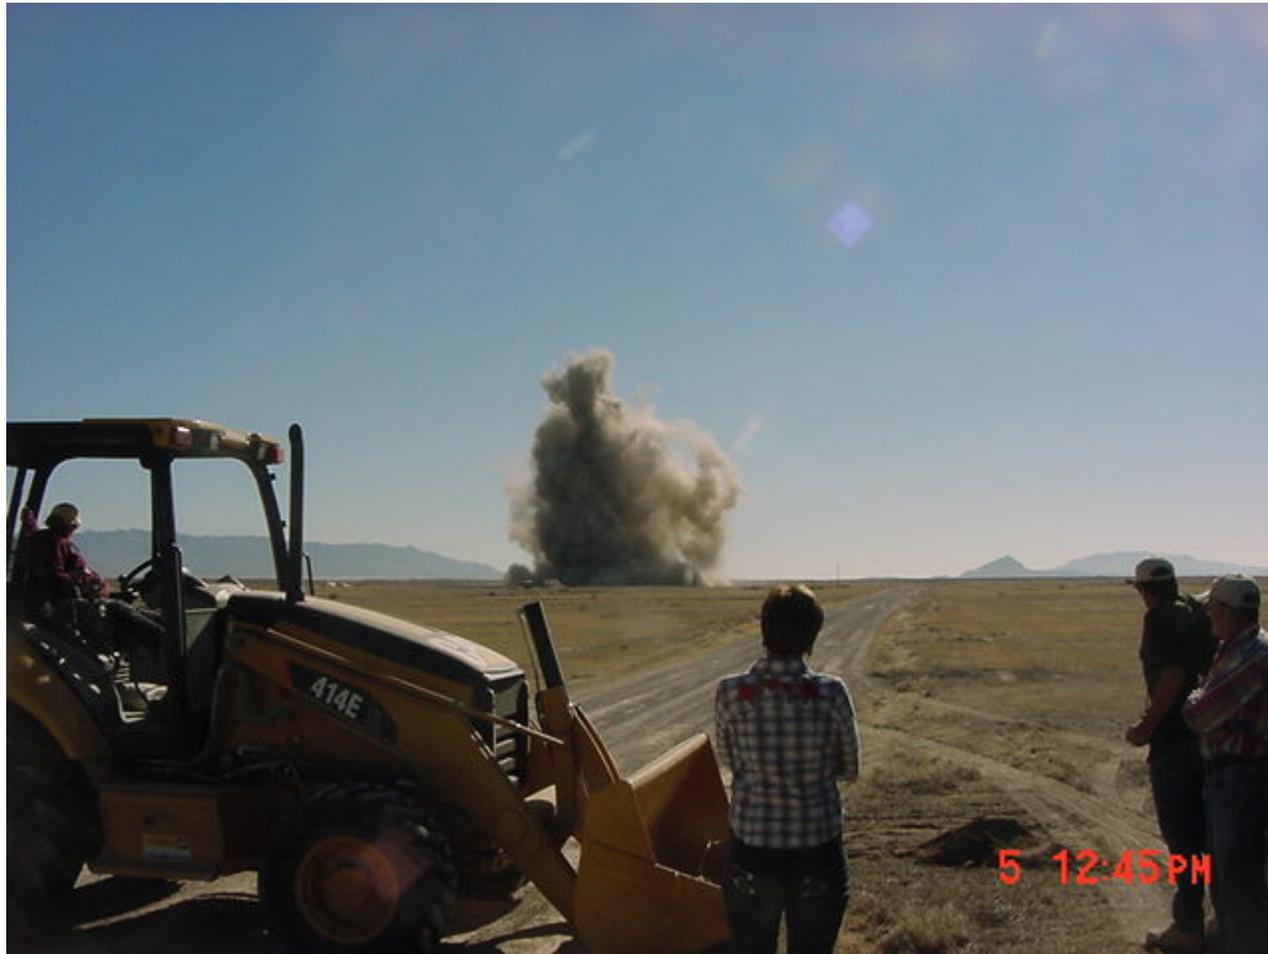
DPG-199 Surface Clearance

(MEC Detonations)

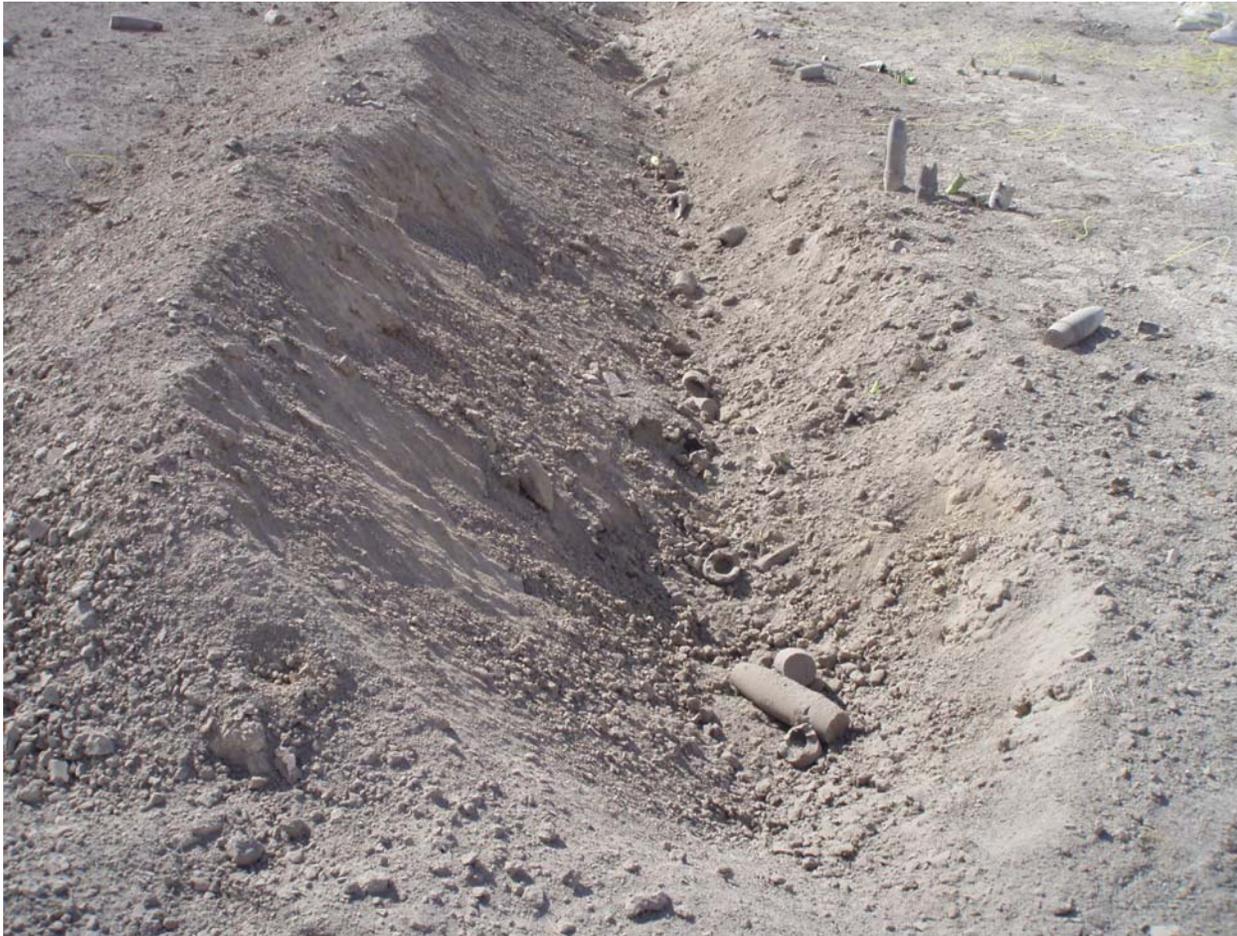
DPG-199 Surface Clearance

(MEC Detonations)

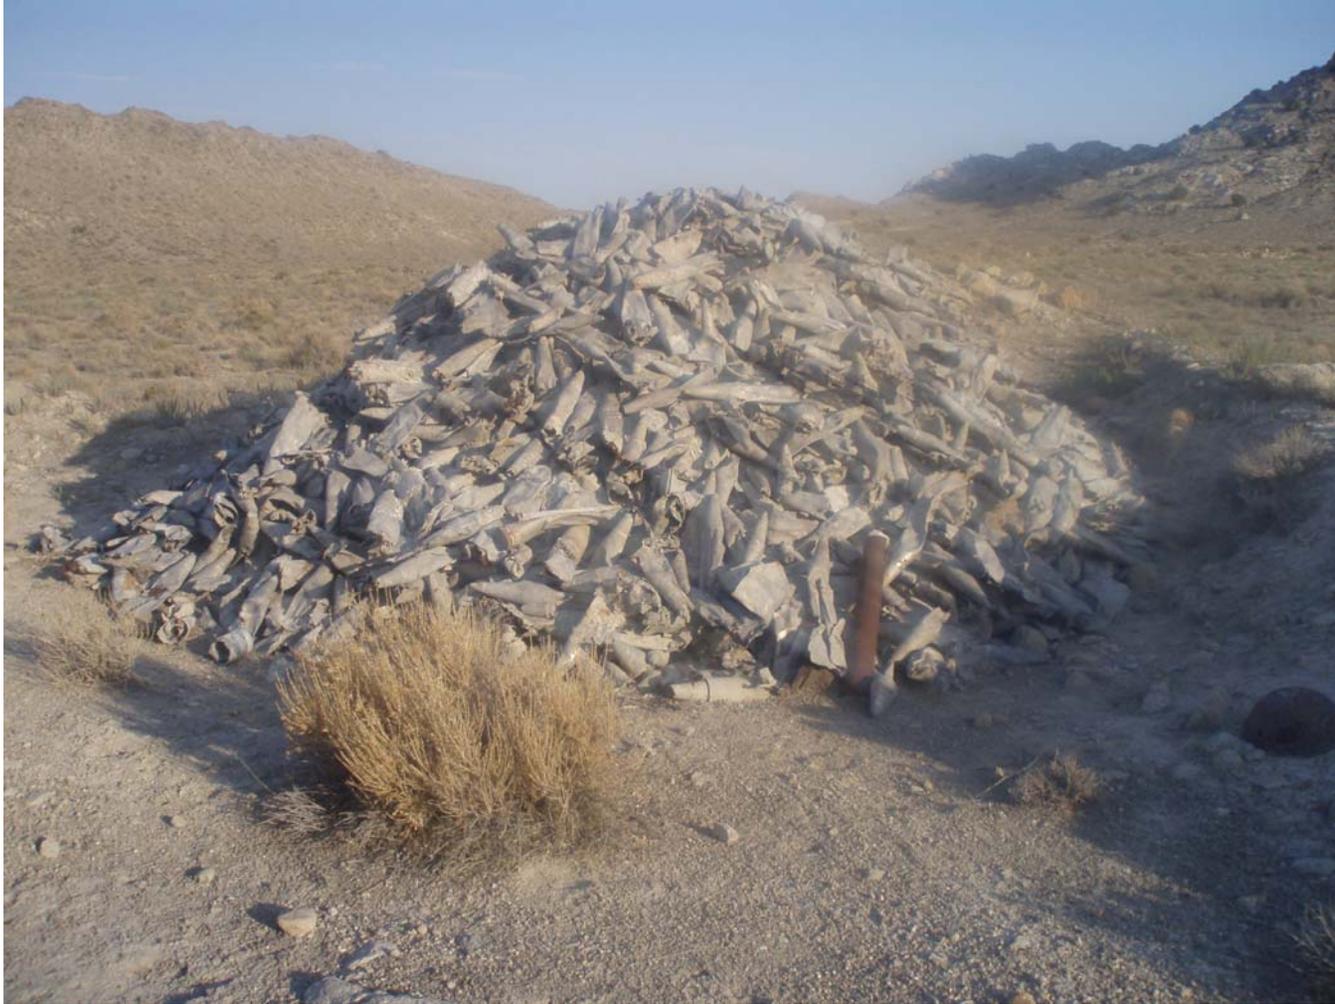
DPG-009 M55 Rocket Debris

- 36,000 M55 Rockets destroyed (burned) during test at West Granite Holding Area (DPG-192)
- All debris inspected and submerged in caustic bath at DPG-007 prior to disposal (DPG-007)
- Estimated 396 rockets and residual explosives were never disposed and remain at DPG-009

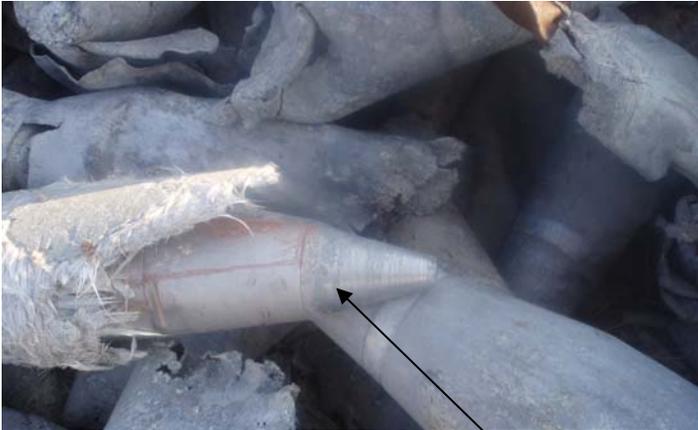
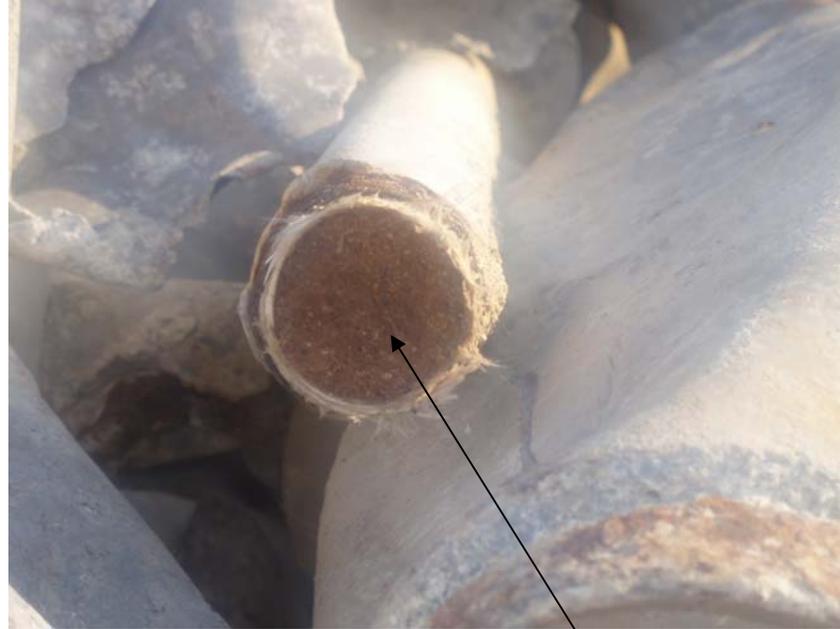
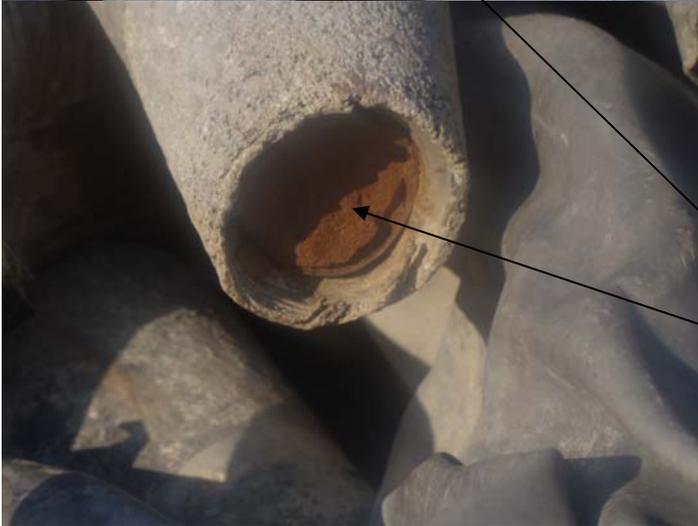
DPG-009 M55 Rocket Debris

Fuze
(RDX)

Burster Tube

60% RDX
40% TNT
