# **American River Common Features 2016 Flood Risk Management Project, Sacramento, California**

## **Supplemental Environmental Impact Statement/ Subsequent Environmental Impact Report XIV**

### **Appendix G: Engineering**

January 2025

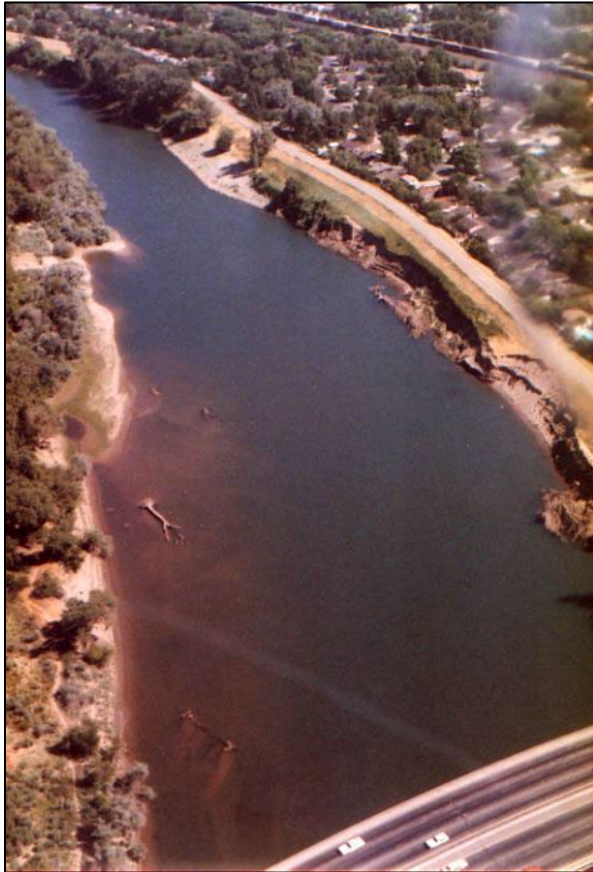
**Figure 2-1. Left bank levee and riverbank erosion from 1986 flood event (134,000 cfs) upstream of Capital City Freeway**

The 1986 flood event is significant in that it required a peak release from Folsom Dam of 134,000 cfs in order to avoid a dam failure. The peak flow was passed without a levee failure, but two locations were in the process of failing as flows were receding. Figure 2-1 shows one of these erosion sites located just upstream of the Capital City Freeway. Had the discharge sustained longer, the levee would have likely failed from erosion.

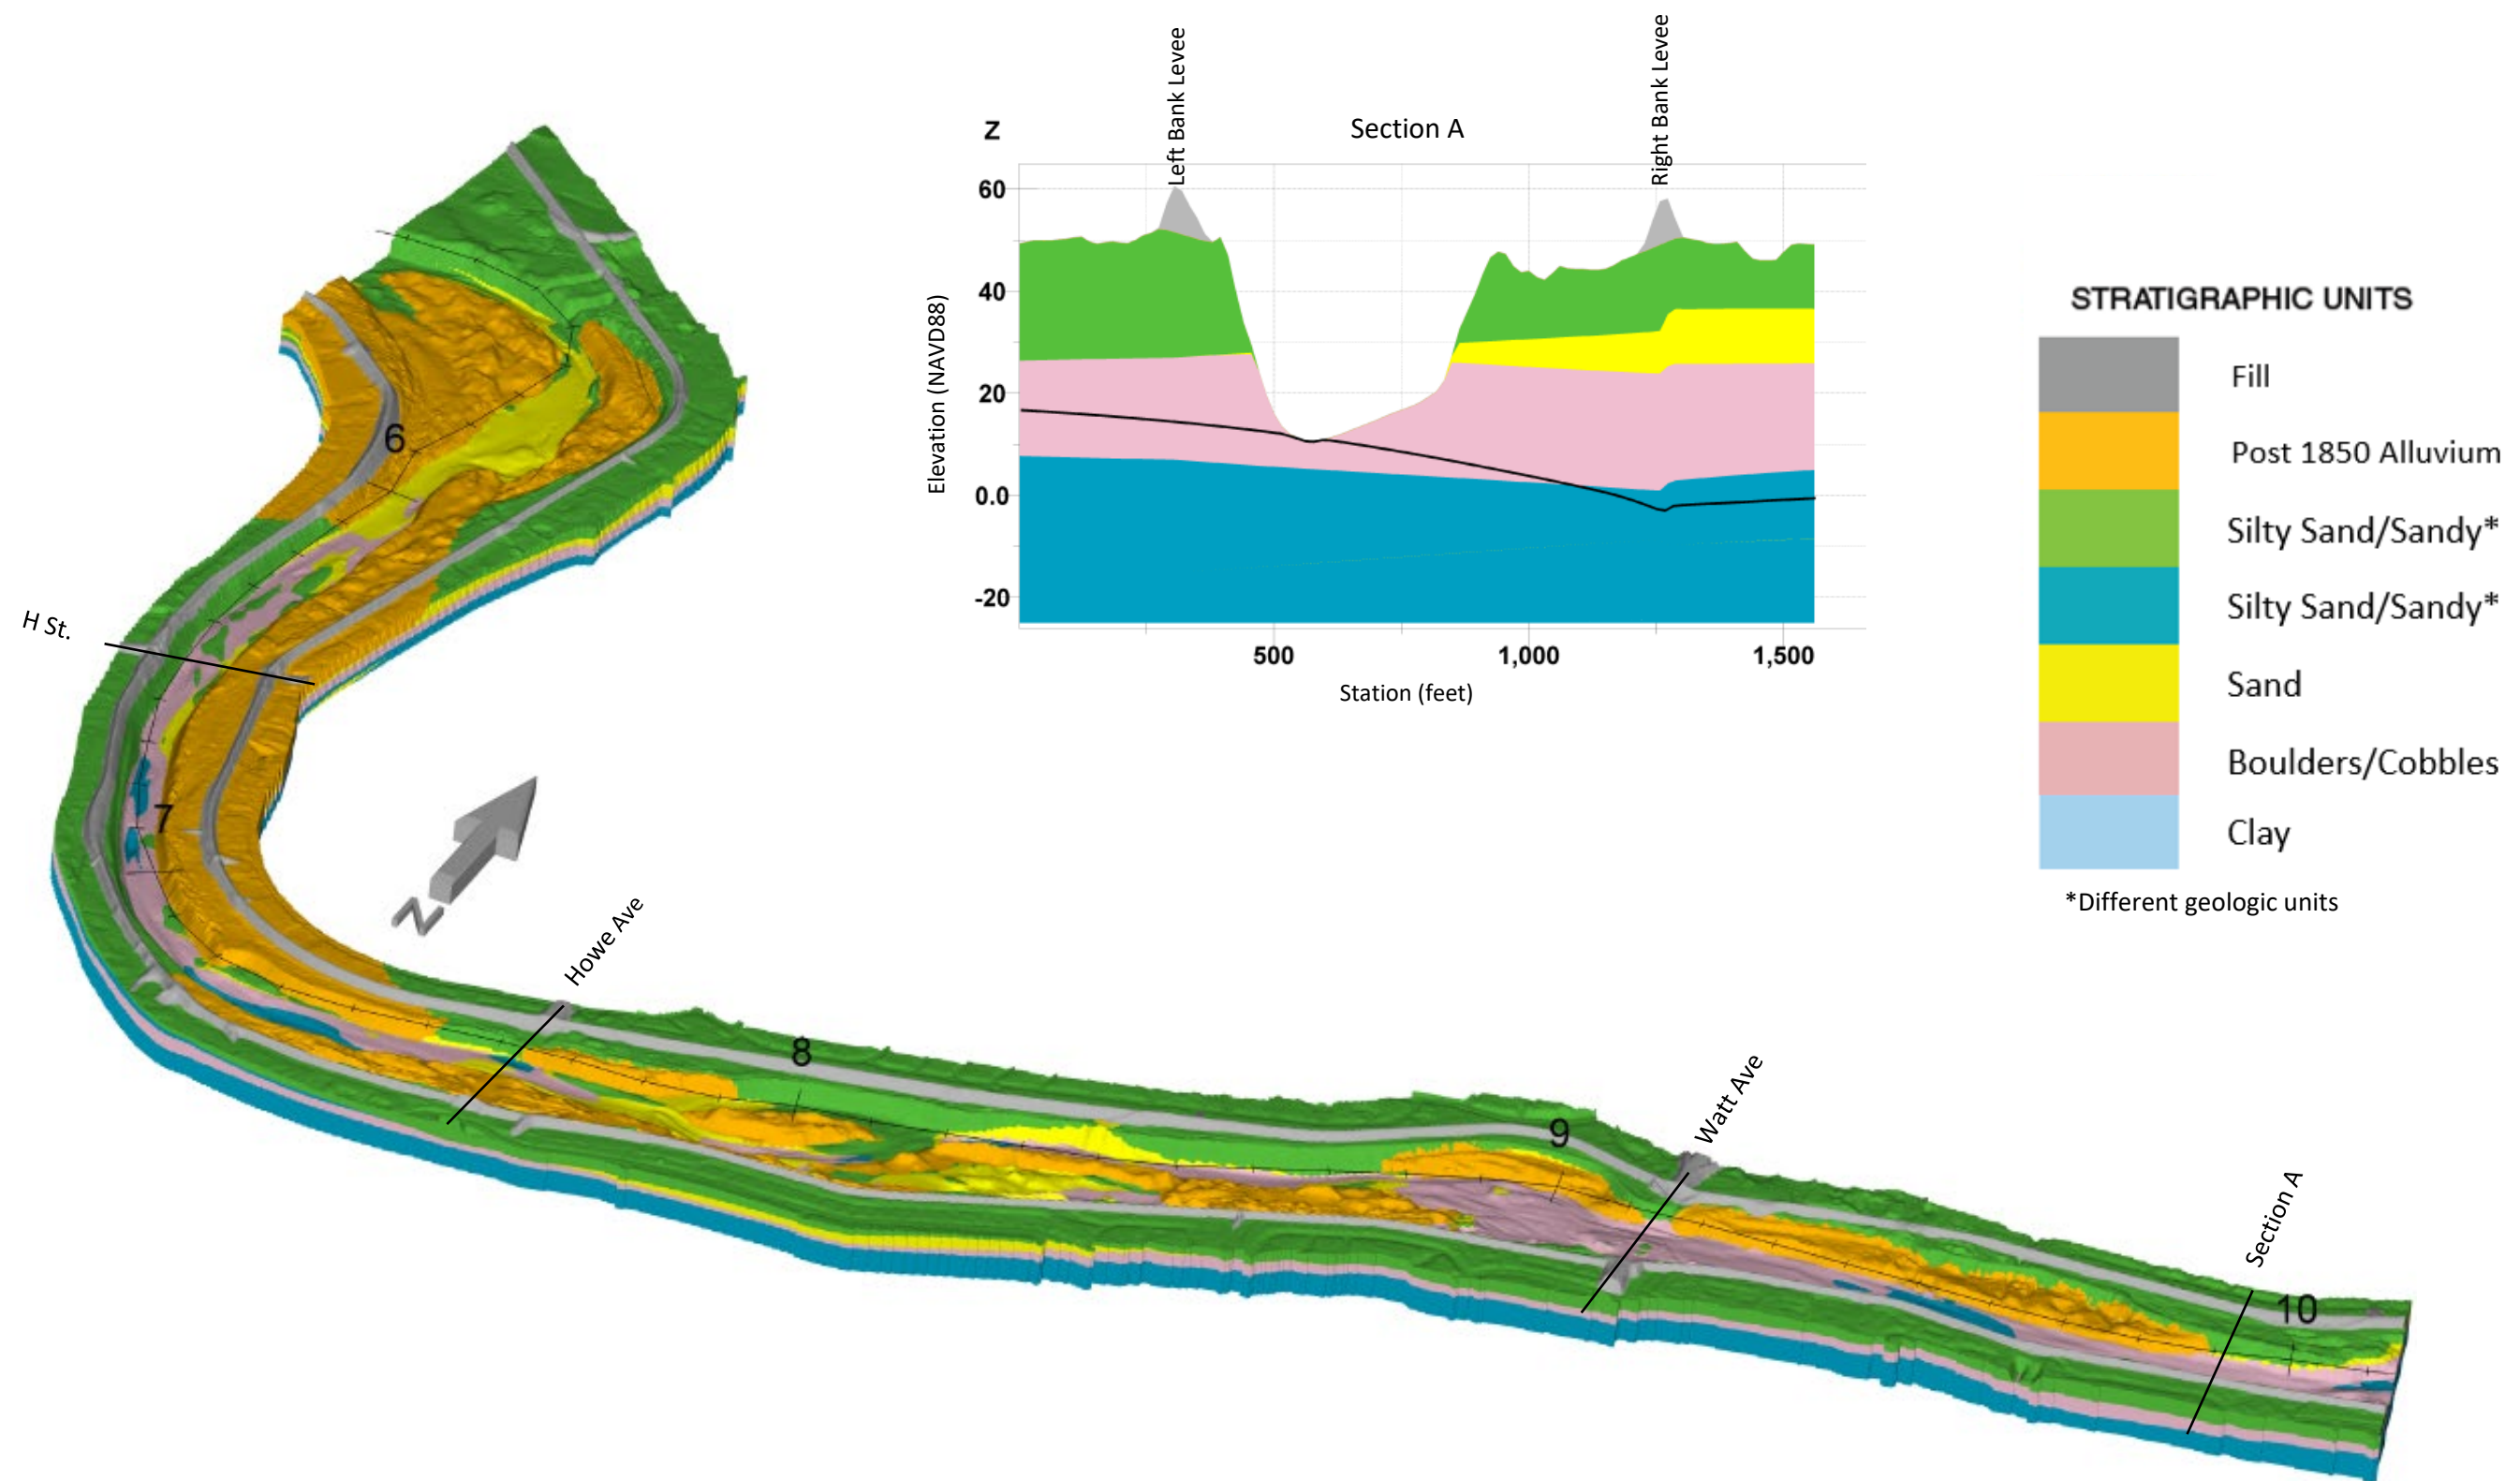
Figure 2-7. Output from URS-GEI (2013) 3D stratigraphic model of LAR extending from Paradise Beach downstream of RM6 and terminating upstream of Watt Avenue at RM 10.1

The current project geologic model was created using Leapfrog three-dimensional modeling software. The current model utilized the URS-GEI (2013) three-dimensional stratigraphic model of LAR that was developed as part of the 2016 GRR as a base point. The three-dimensional stratigraphic model was developed using geotechnical boring logs, laboratory testing of soil samples, direct current soil resistivity data collected by the USGS (2008) and geologic field mapping data. The objective of the stratigraphic model was to provide the three-dimensional visualization and coordinates of different geologic layers that were then used to inform design and risk assessments related to the potential for erosion on the site. The model focused on identifying locations of highly erodible post-1850 alluvium (e.g., loose deposits of silty sand material generated from historic hydraulic mining in the watershed) as well as the erosion resistant material (ERM), also referred to as the Pleistocene Fair Oaks Formation at LAR C3B. The current geologic model included additional geologic data from LAR borings completed by USACE after the GRR and by DWR as part of the Urban Levee Evaluation program in 2019 in addition to the original stratigraphic modeling from the GRR. Figure 2-7 shows an example of the stratigraphic model.

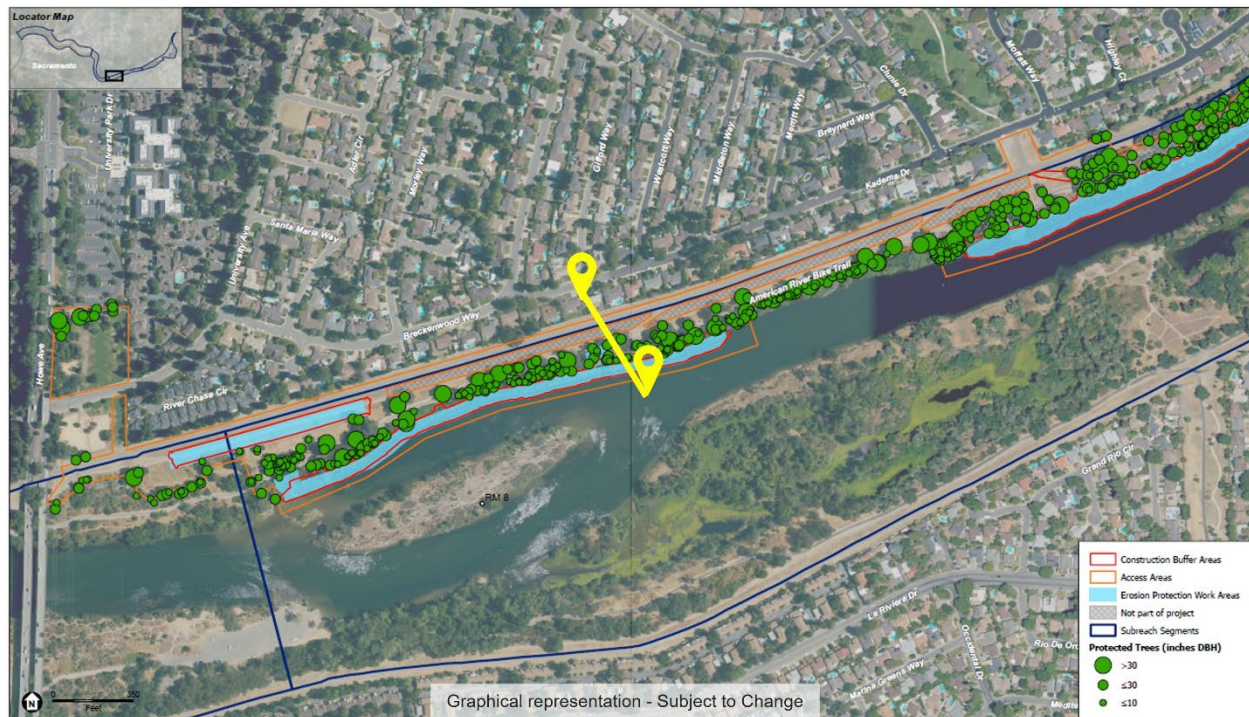
**Figure 2-12. Layout of Segment 3-9 erosion protection features and cross section location**

Figure 2-12 to Figure 2-15 provide example renderings of bank protection designs on the riverbank within Site 3-1, showing the launchable toe with planting bench and soil filled riverbank reverent feature, and maturation of the revegetation effort. It also depicts protected vegetation and recreational amenities above the proposed bank protection feature. This rendering does not show the proposed 925-ft section of work along the levee embankment closer to Howe Avenue discussed earlier in this Section. In the plan view graphic for each segment, the existing trees that are to be preserved in place are depicted as green circles.

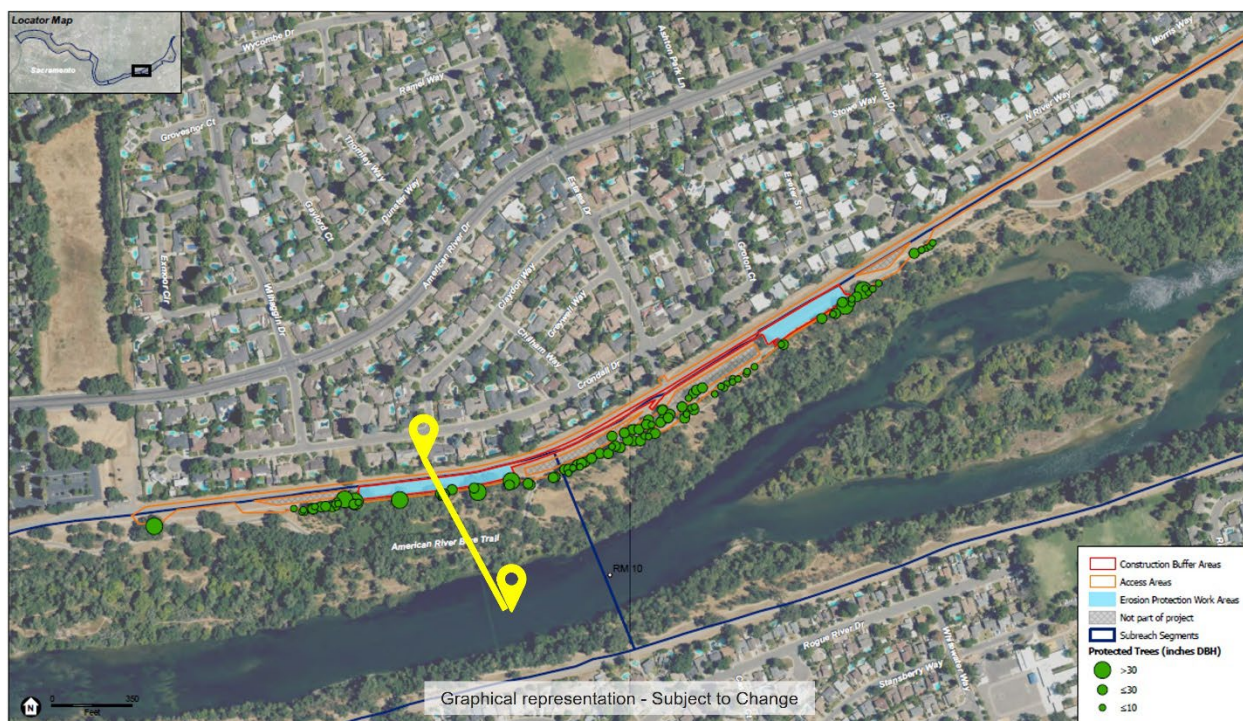
Figure 2-28. Layout of Site 4-2 erosion protection feature and cross section location

The proposed design installs soil-filled revetment on the levee embankment and will cover the soil-filled rock with one foot of topsoil to be reseeded with native grasses. The revetment is sized to resist erosion during the design event. Covering the revetment with topsoil and reseeding the topsoil will screen the project from public view and provide a naturalistic view to the project. The levee embankment is currently vegetated with grasses and will be replanted with native grasses. Design for the sections upstream and downstream of the existing revetment feature also include a volume of buried launchable trench at the levee toe to address scour potential. The layout of the buried launchable trench was designed to minimize impacts to the recreational trail in proximity as well as minimize impacts to existing vegetation. Figure 2-28 and Figure 2-29 provide an example rendering of erosion protection design within Site 4-2. The plan view also depicts vegetation to be protected as green circles.

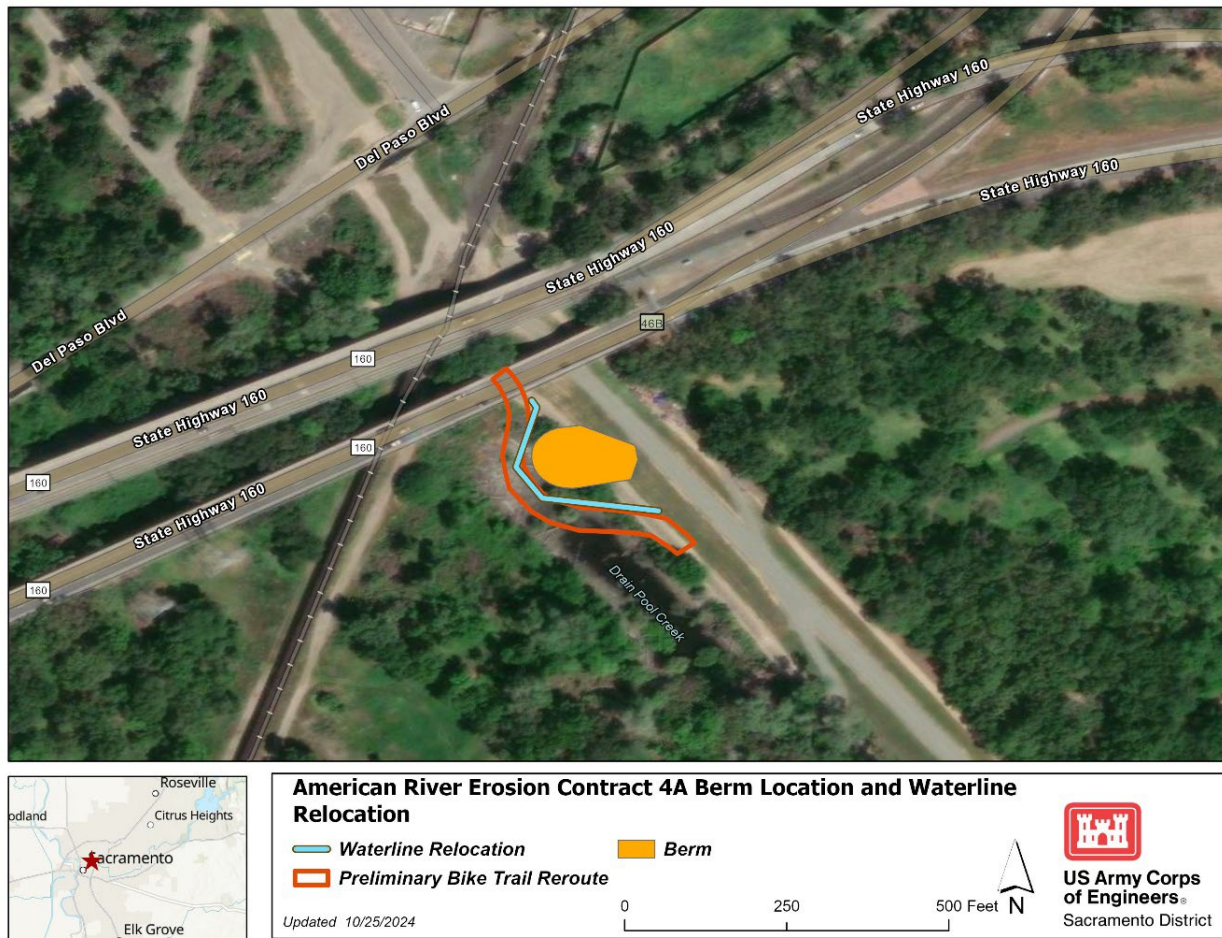
**Figure 2-30. LAR C4A project overview map**

The features of the proposed design for LAR C4A include construction of a deflector berm, relocation of a portion of the existing Jedediah Smith Memorial Bike Trail, and relocation of part of a 12-inch waterline. These features are shown on the overview map (Figure 2-30).

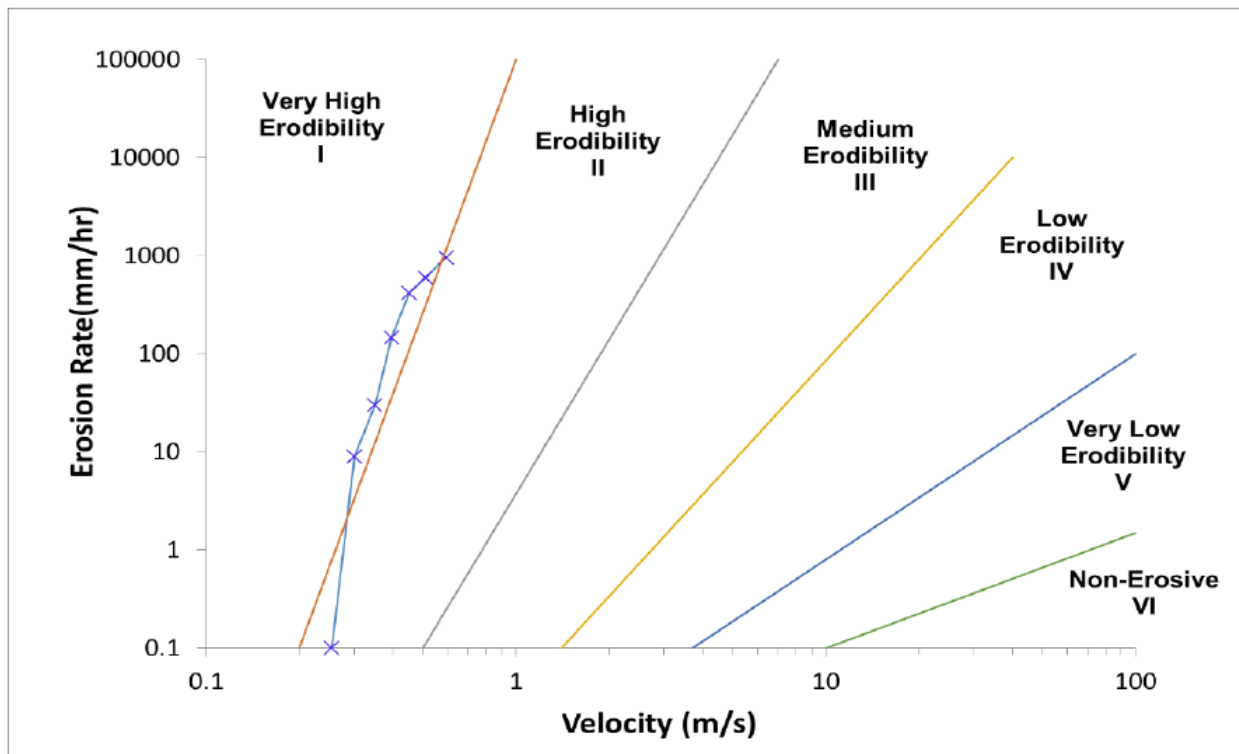
Figure 2-33. Example soil test results

The soils immediately below the levee are mostly clays and silts that are susceptible to scour and erosion from the high velocities and turbulence. Erosion testing of soil samples indicate that soils in

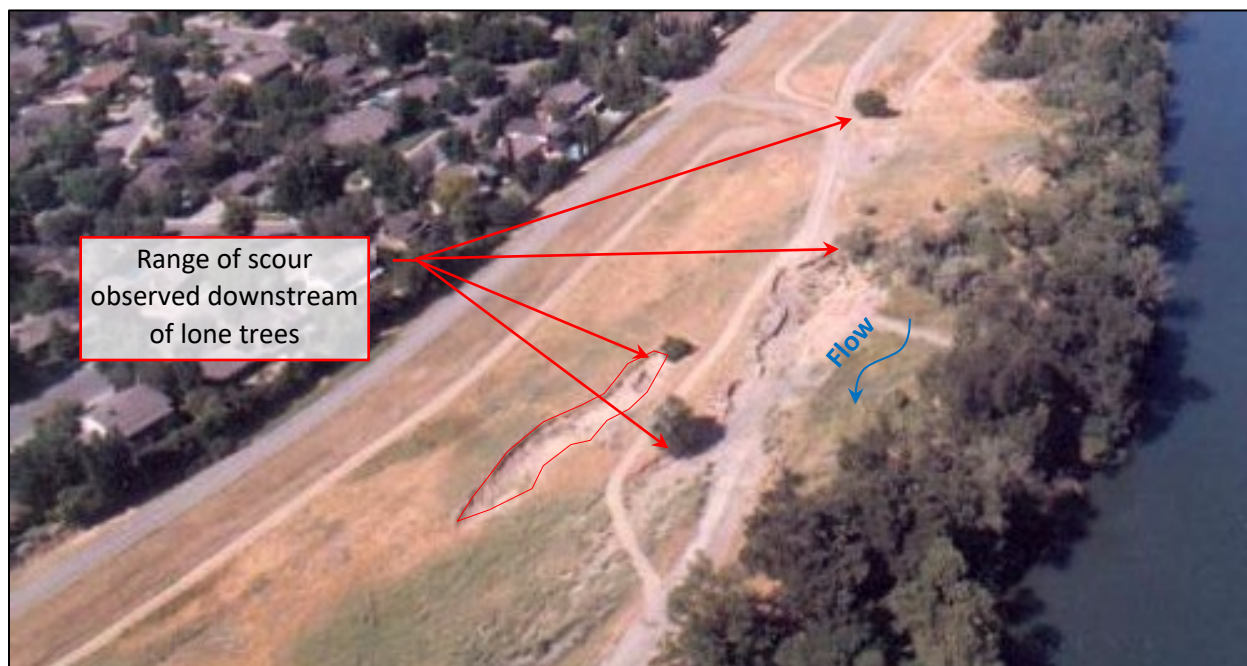
**Figure 2-35. 1986 Lower American River flood event aftermath - localized lone tree scour**

localized scour similar to bridge piers (U.S. Army Corps of Engineers, 2016). Figure 2-35 shows an example of this tree scour that occurred in the 1986 flood event while Figure 2-36 shows an example of lone tree scour, which occurred on the Big Sioux River, a Missouri River tributary, in 2024. Observed lone tree scour hole depth and extent varies widely. And more detailed analysis is needed to isolate the impact of lone tree scour effect as outline in 2.5.4.1.1. The scour excavates a depression around a given tree that, for trees located near or on the levee embankment, can extend into the levee embankment and narrow the levee inducing levee failure. The magnitude of scour is directly related to the diameter of the tree, the depth of flow, the erodibility of the soil, and the flow velocity. Trees of concern are large diameter trees (greater than 18-inch diameter at breast height (DBH)) located on or immediately adjacent to the levee at locations where the levee is not overbuilt, and at locations with relatively deep flow depths and higher velocities. With Contract 3B's Sites 3-1 and 4-1 designs optimized to address erosion of the riverbank, not lone tree scour, and the lone tree scour risk being identified late in the C3B design process, the lone tree scour risk potential is being addressed as a separate contract to allow for a more selective approach to address this unique risk driver.

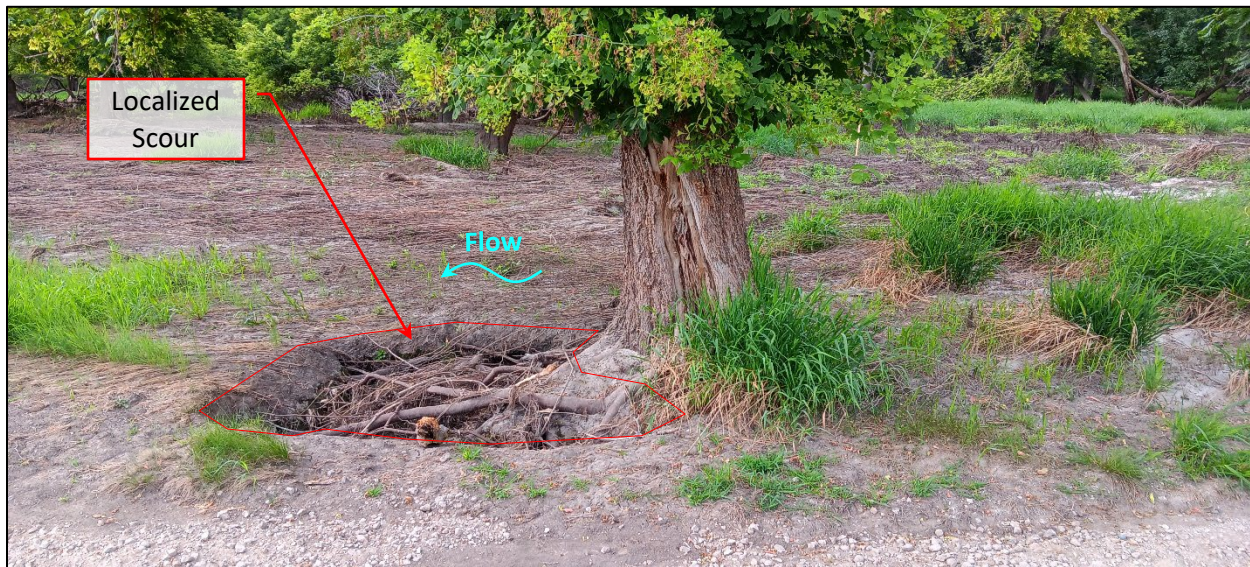
**Figure 2-36. 2024 Big Sioux River flood aftermath. Example - localized lone tree scour**

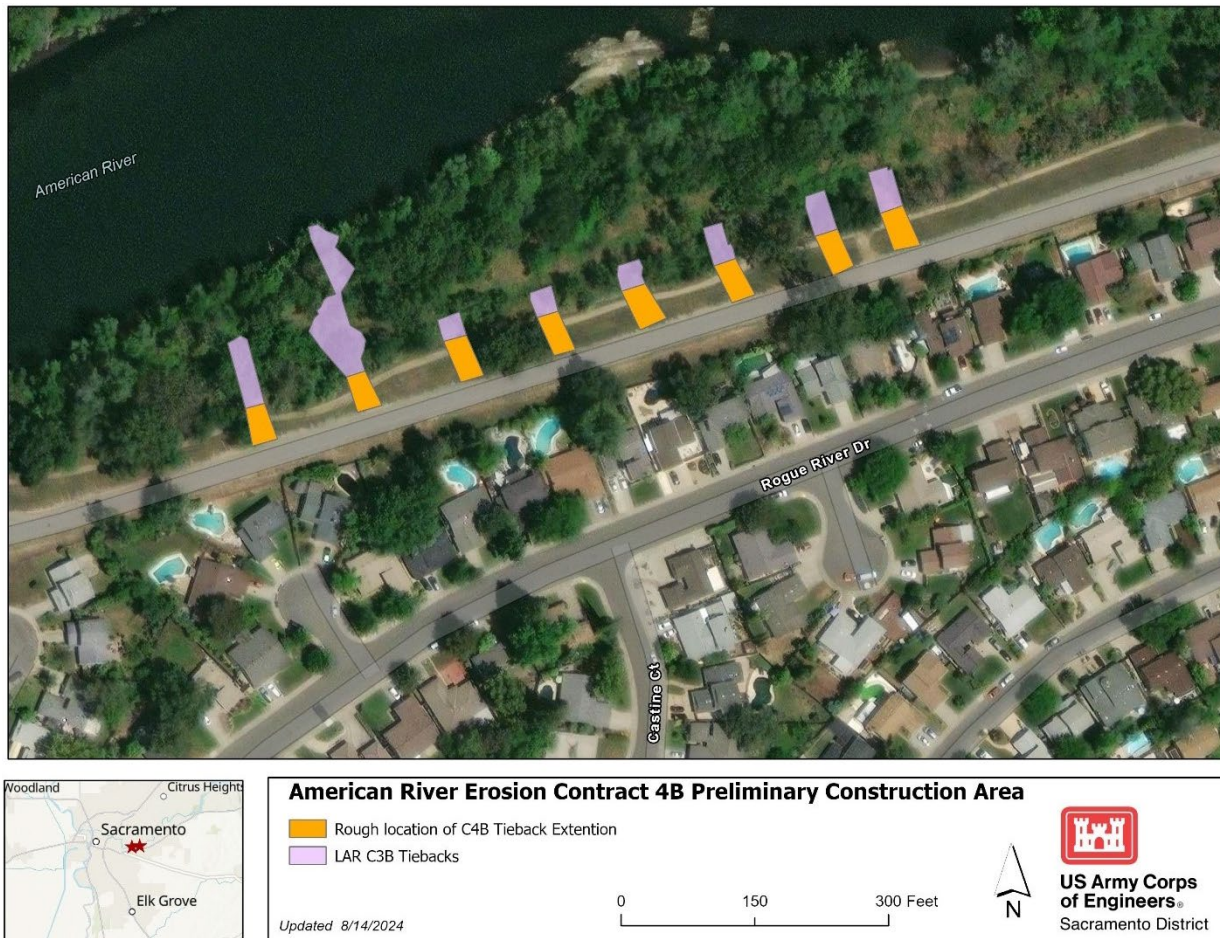
**Figure 2-41. Estimated maximum footprint of tieback extensions**

The Contract 3B tiebacks are fully buried and constructed using soil filled rock. For Contract 4B, the eight tiebacks depicted in Figure 2-39 above will be extended further landward and be constructed in the same manner as Contract 3B. The exact length of each tieback extension is still being determined but the tiebacks will extend into the VFZ and into the levee embankment. A typical cross section of the tiebacks is shown in Figure 2-40 below. A rough estimation of the extended tieback footprints is shown in Figure 2-41 below.

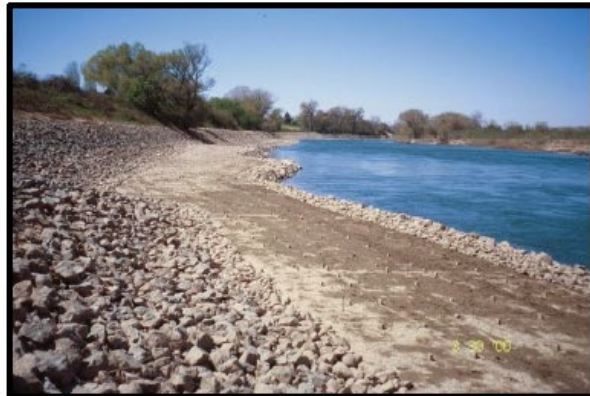
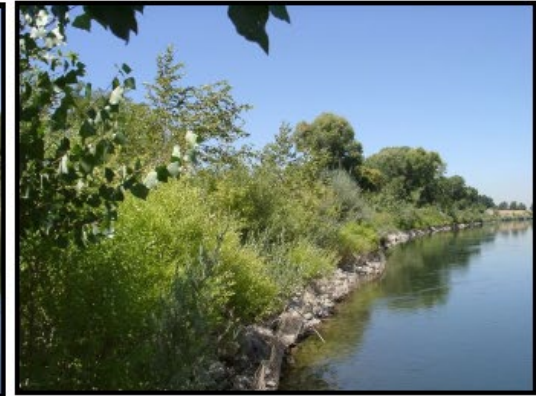
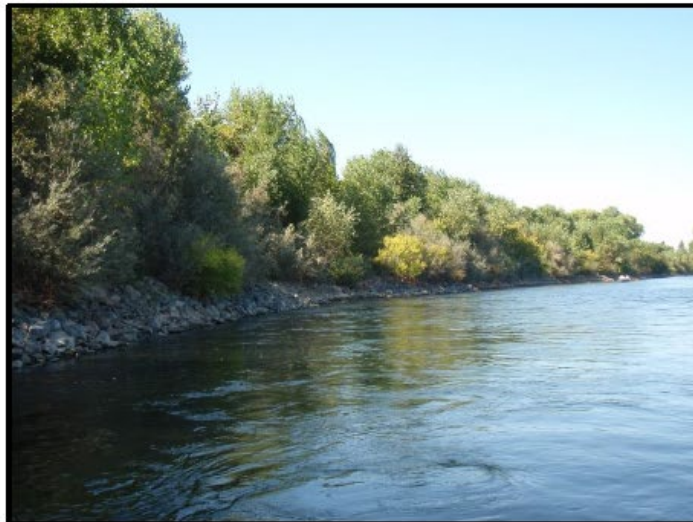
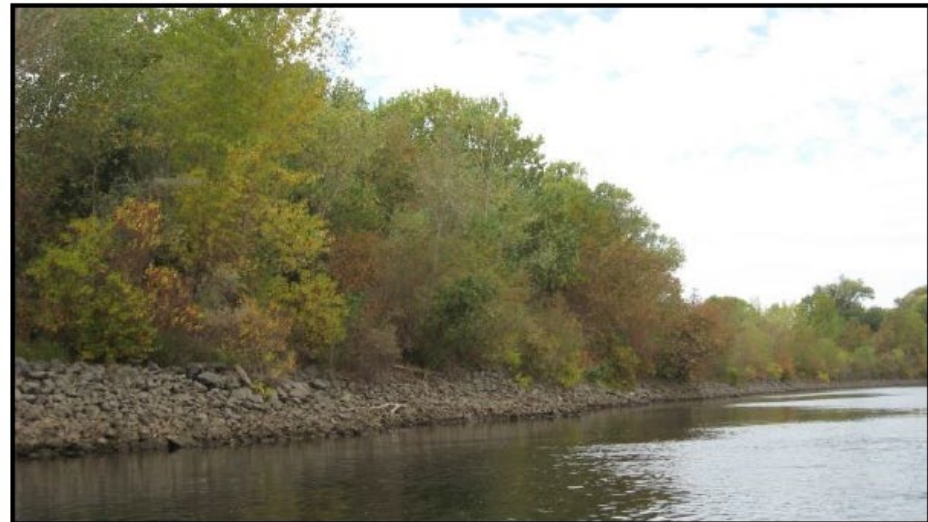
**Figure 2-42. Establishment of vegetation at RM 4.4L bank protection site after planting in 2000**

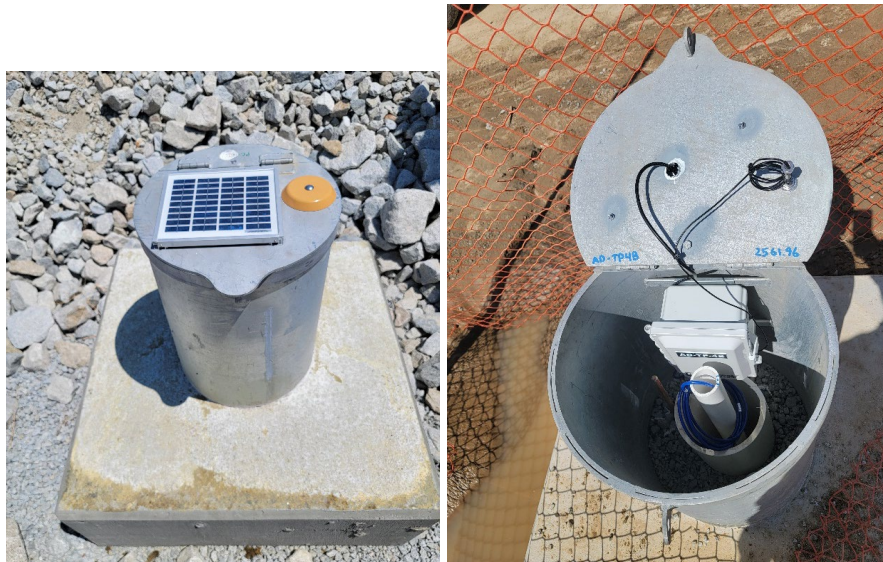
**Figure 4-3. Typical Open-Standpipe Piezometer**

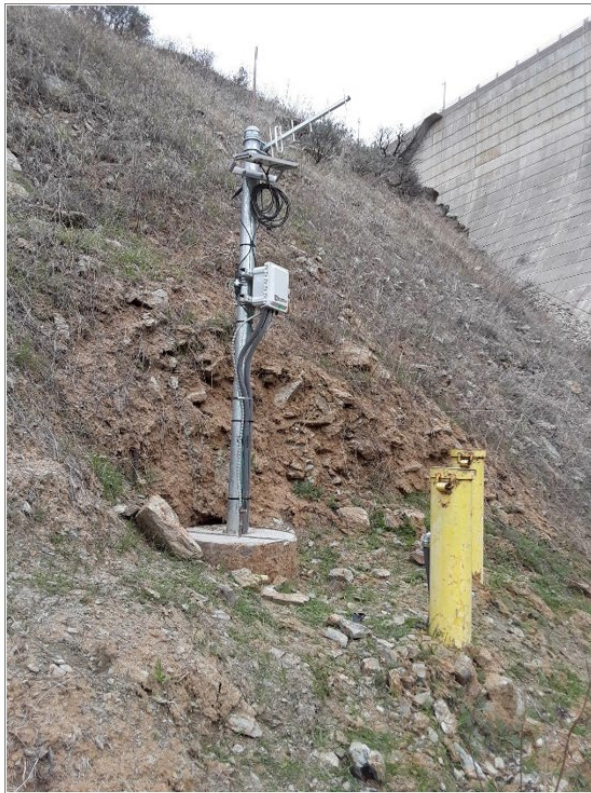
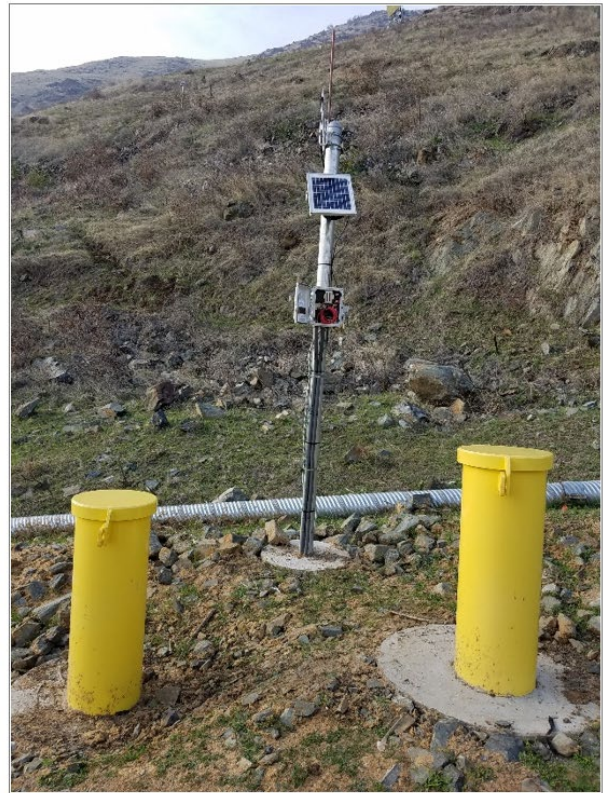
**Figure 4-4. Dual Standpipe Piezometers**
