# **Success Lake Water Control Manual Deviation Final Environmental Assessment**

**May 2017**

**FINDING OF NO SIGNIFICANT IMPACT**  
Water Control Manual Deviation at Lake Success

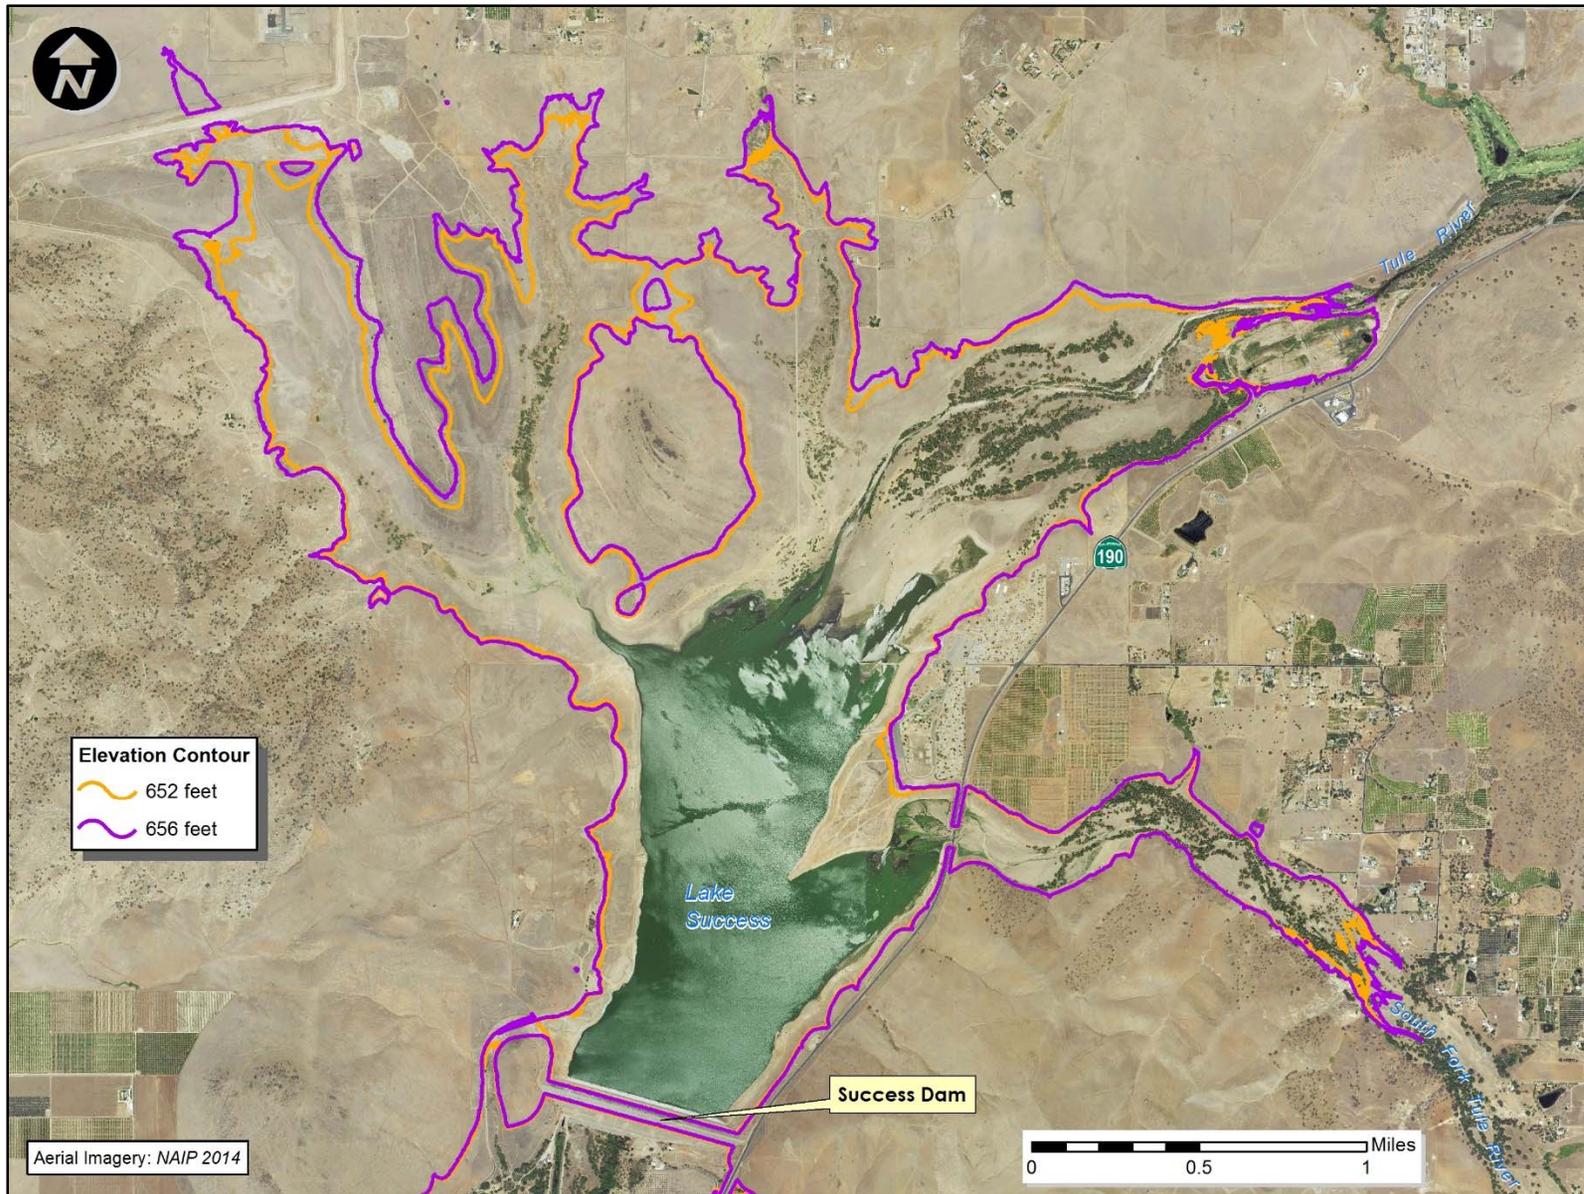
**Figure 2. Success Lake Increased Pool Footprint Area.**

The sandbag wall would allow water to be stored up to 4 feet above the spillway crest with 2 feet of freeboard. These elevations are consistent with the implementation of this measure in past high water years. As a result, the inundation area associated with this measure has been previously inundated, most recently in 1998.

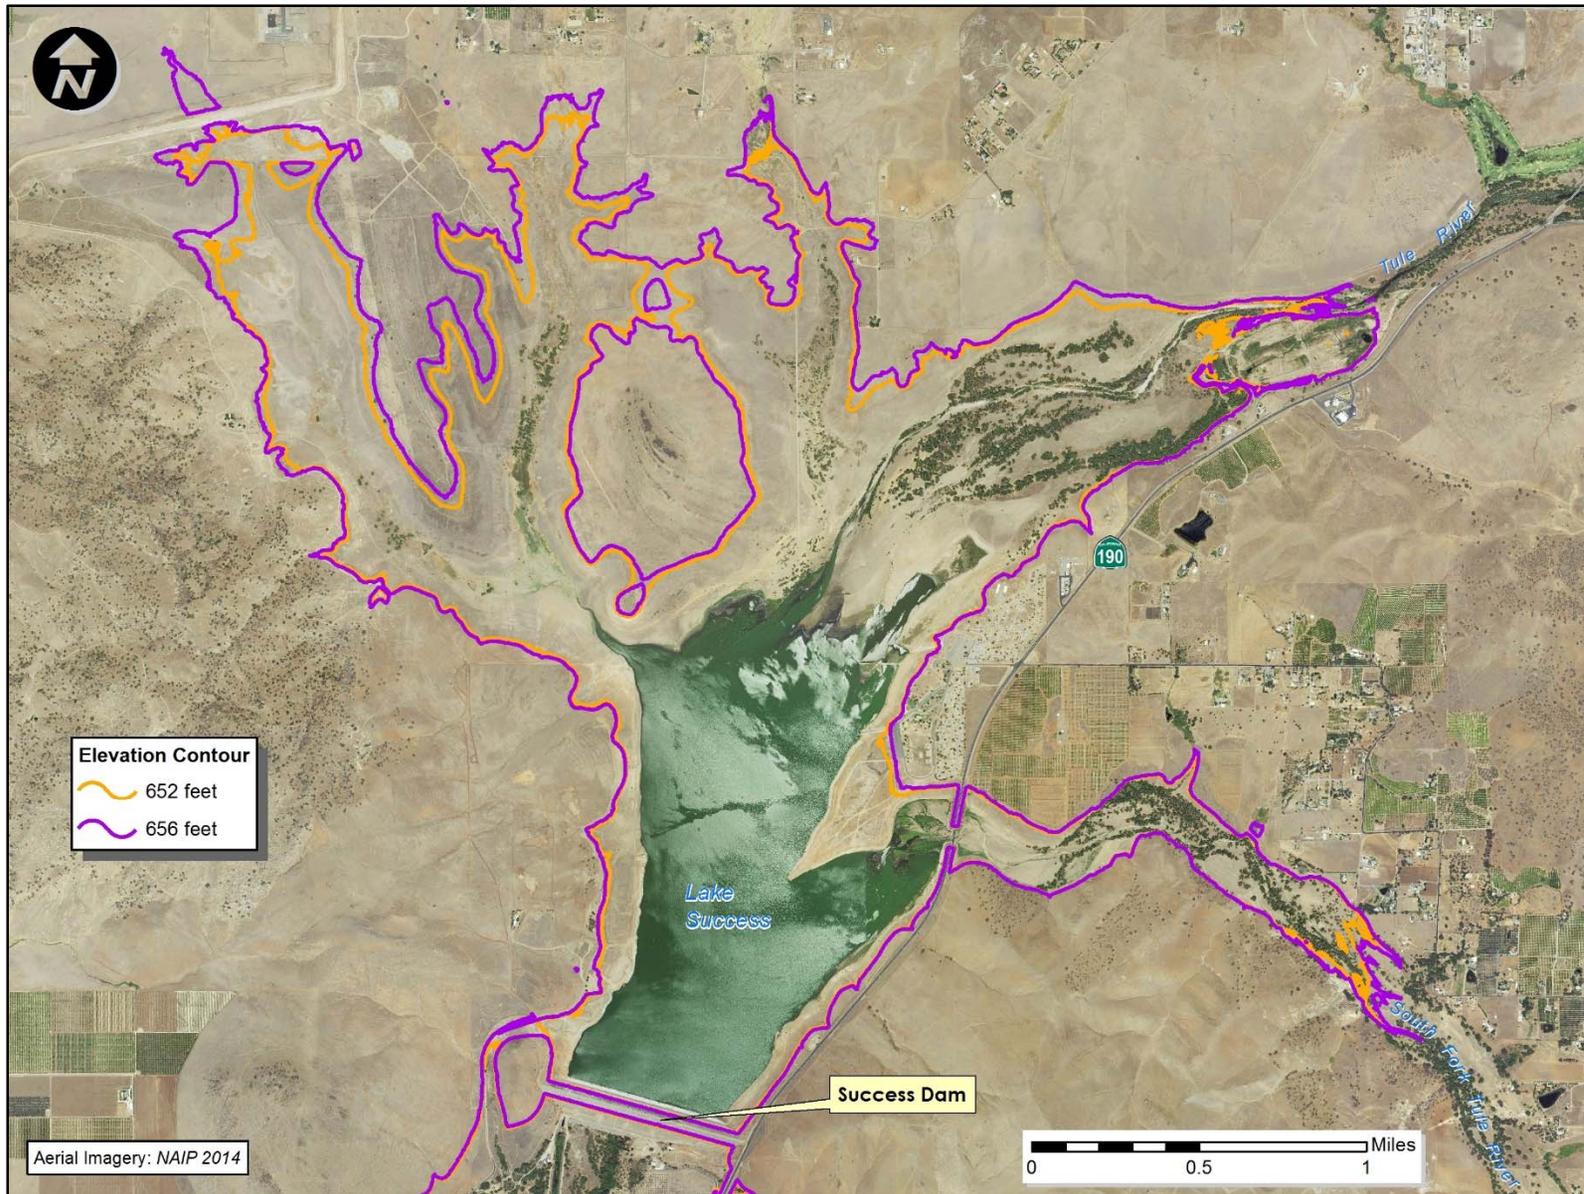
Figure 3. Lake Success Increased Pool Footprint – Action Area.

The proposed planned water control manual deviation would provide an additional 10,000 acre-feet of flood control space at Success Dam for the current snowmelt season. This would be accomplished through the construction of a temporary six foot barricade of the spillway. The barricade would be constructed of sandbags and would allow water to be stored up to four feet above the spillway crest. Reservoir releases would be managed to allow for the reduction of damaging flows to the Tulare Lakebed area. The deviation would last approximately 90 days beginning in May 2017. The footprint of the increased reservoir storage space is shown on Figure 3 below. Closer maps of the Tule River and South Fork Tule River areas of the increased pool are shown on Figures 4 and 5 below.
