KNOW YOUR RISK

LEVEE INSPECTION RESULTS GUIDE FLOOD RISK PRIORITIES

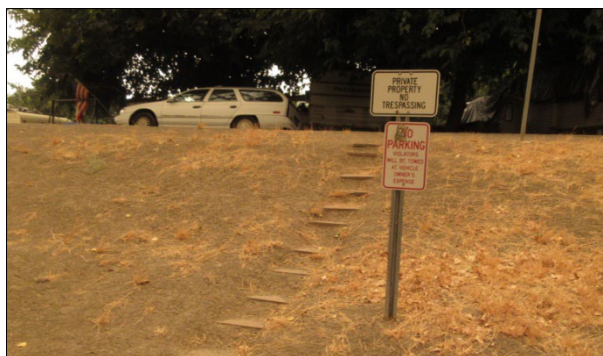
Unpermitted Encroachments on the Levee:
Unpermitted encroachments, such as the brick steps shown above, have not been evaluated to determine the potential impact to the levee.

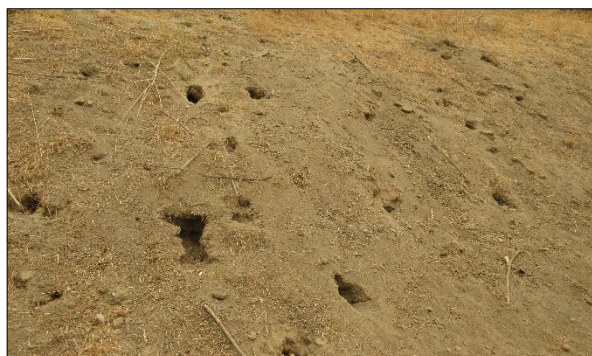
Animal Burrows:
Animals burrowing into the levee slope may allow a preferred path for floodwater. An effective animal control program can help reduce the risk associated with burrows.

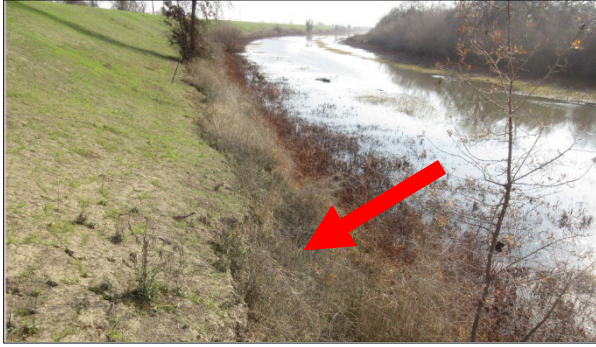
Erosion of Levee Slopes:

The waterside earthen levee slope has eroded because of river flows. Repair of the slope and placement of slope protection, such as riprap (rock), may protect the slope from future erosion.

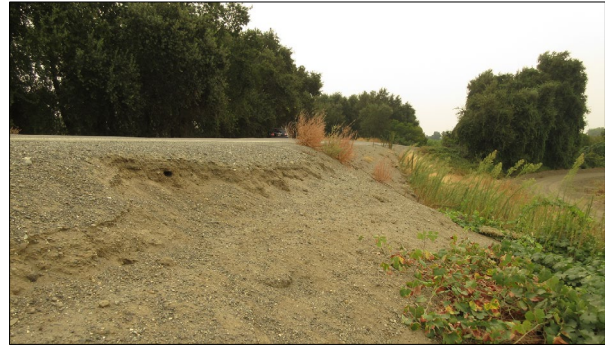
Unprotected Slopes:

The earthen levee slope has experienced surface erosion due to lack of grass cover. Grass roots hold the surface soil together preventing water from eroding the surface, as shown above.
