# KNOW YOUR RISK

## LEVEE INSPECTION RESULTS GUIDE FLOOD RISK PRIORITIES

The 120-mile-long Sacramento River West Bank levee system was inspected in December 2019 by the U.S. Army Corps of Engineers (USACE). The eastern portion extends along the west bank of the Sacramento River from Ord Bend in Glenn County to Knights Landing in Yolo County. The western portion extends along the left bank of Colusa Drain from Colusa to Knight's Landing. The city of Colusa is the most populated area behind the levee with the majority of the leveed area primarily agricultural.

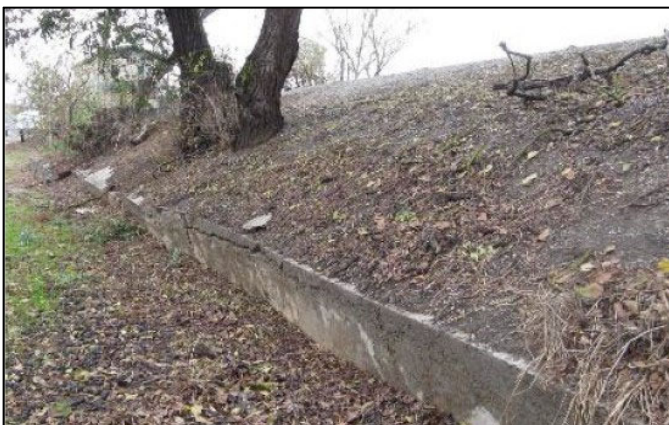
*Encroachments Near the Levee:*

Unpermitted encroachments, such as the retaining wall shown above, have not been evaluated to determine the potential to negatively impact the levee.

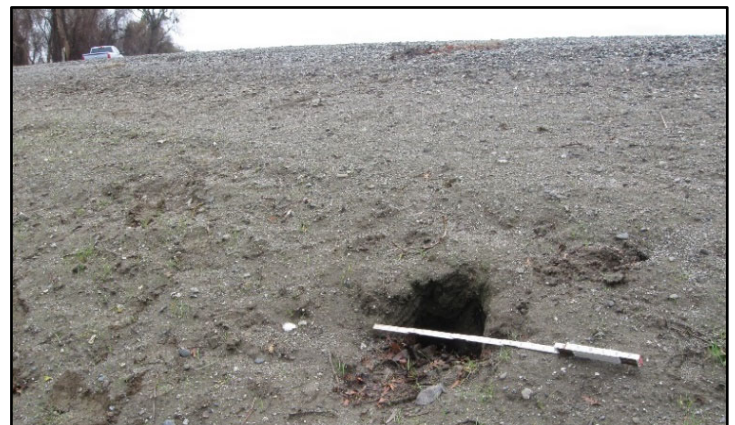
*Animal Burrows:*

Animals burrowing into the levee slope can negatively affect the integrity of the levee. An effective animal control program can help reduce the risk associated with burrows.

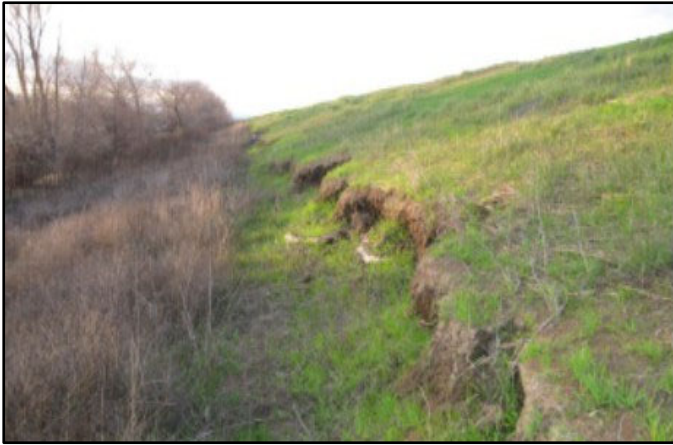
*Erosion of Levee Slopes:*

The earthen levee slope has eroded as a result of river flows. Bank protection, such as riprap, may be placed to protect the slope from additional erosion.

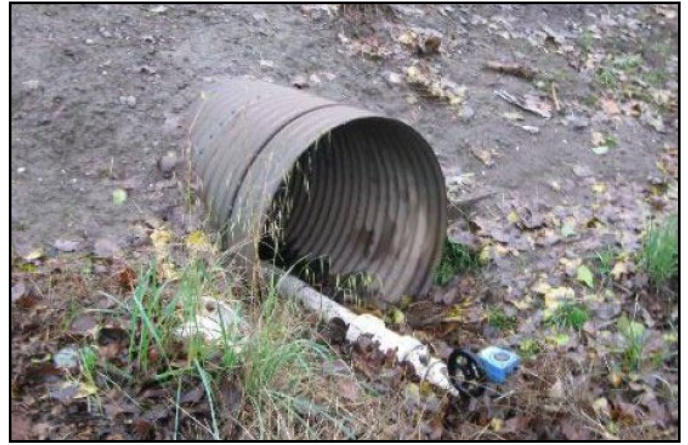
*Pipes Through the Levee:*

Every pipe that extends through the levee needs a riverside closure, such as a valve. This is to prevent possible flow of water from the riverside of the levee to the landside. Open pipes like this without closure can lead to potential flooding.
