Final Preliminary Assessment and Site Inspection Work Plan

Parks Air Force Base
Formerly Used Defense Site
Alameda County, Dublin, California

FUDS Property No. J09CA0083
FUDS Project No. J09CA0083-01 and J09CA0083-02

**Environmental Design Section
Sacramento District**

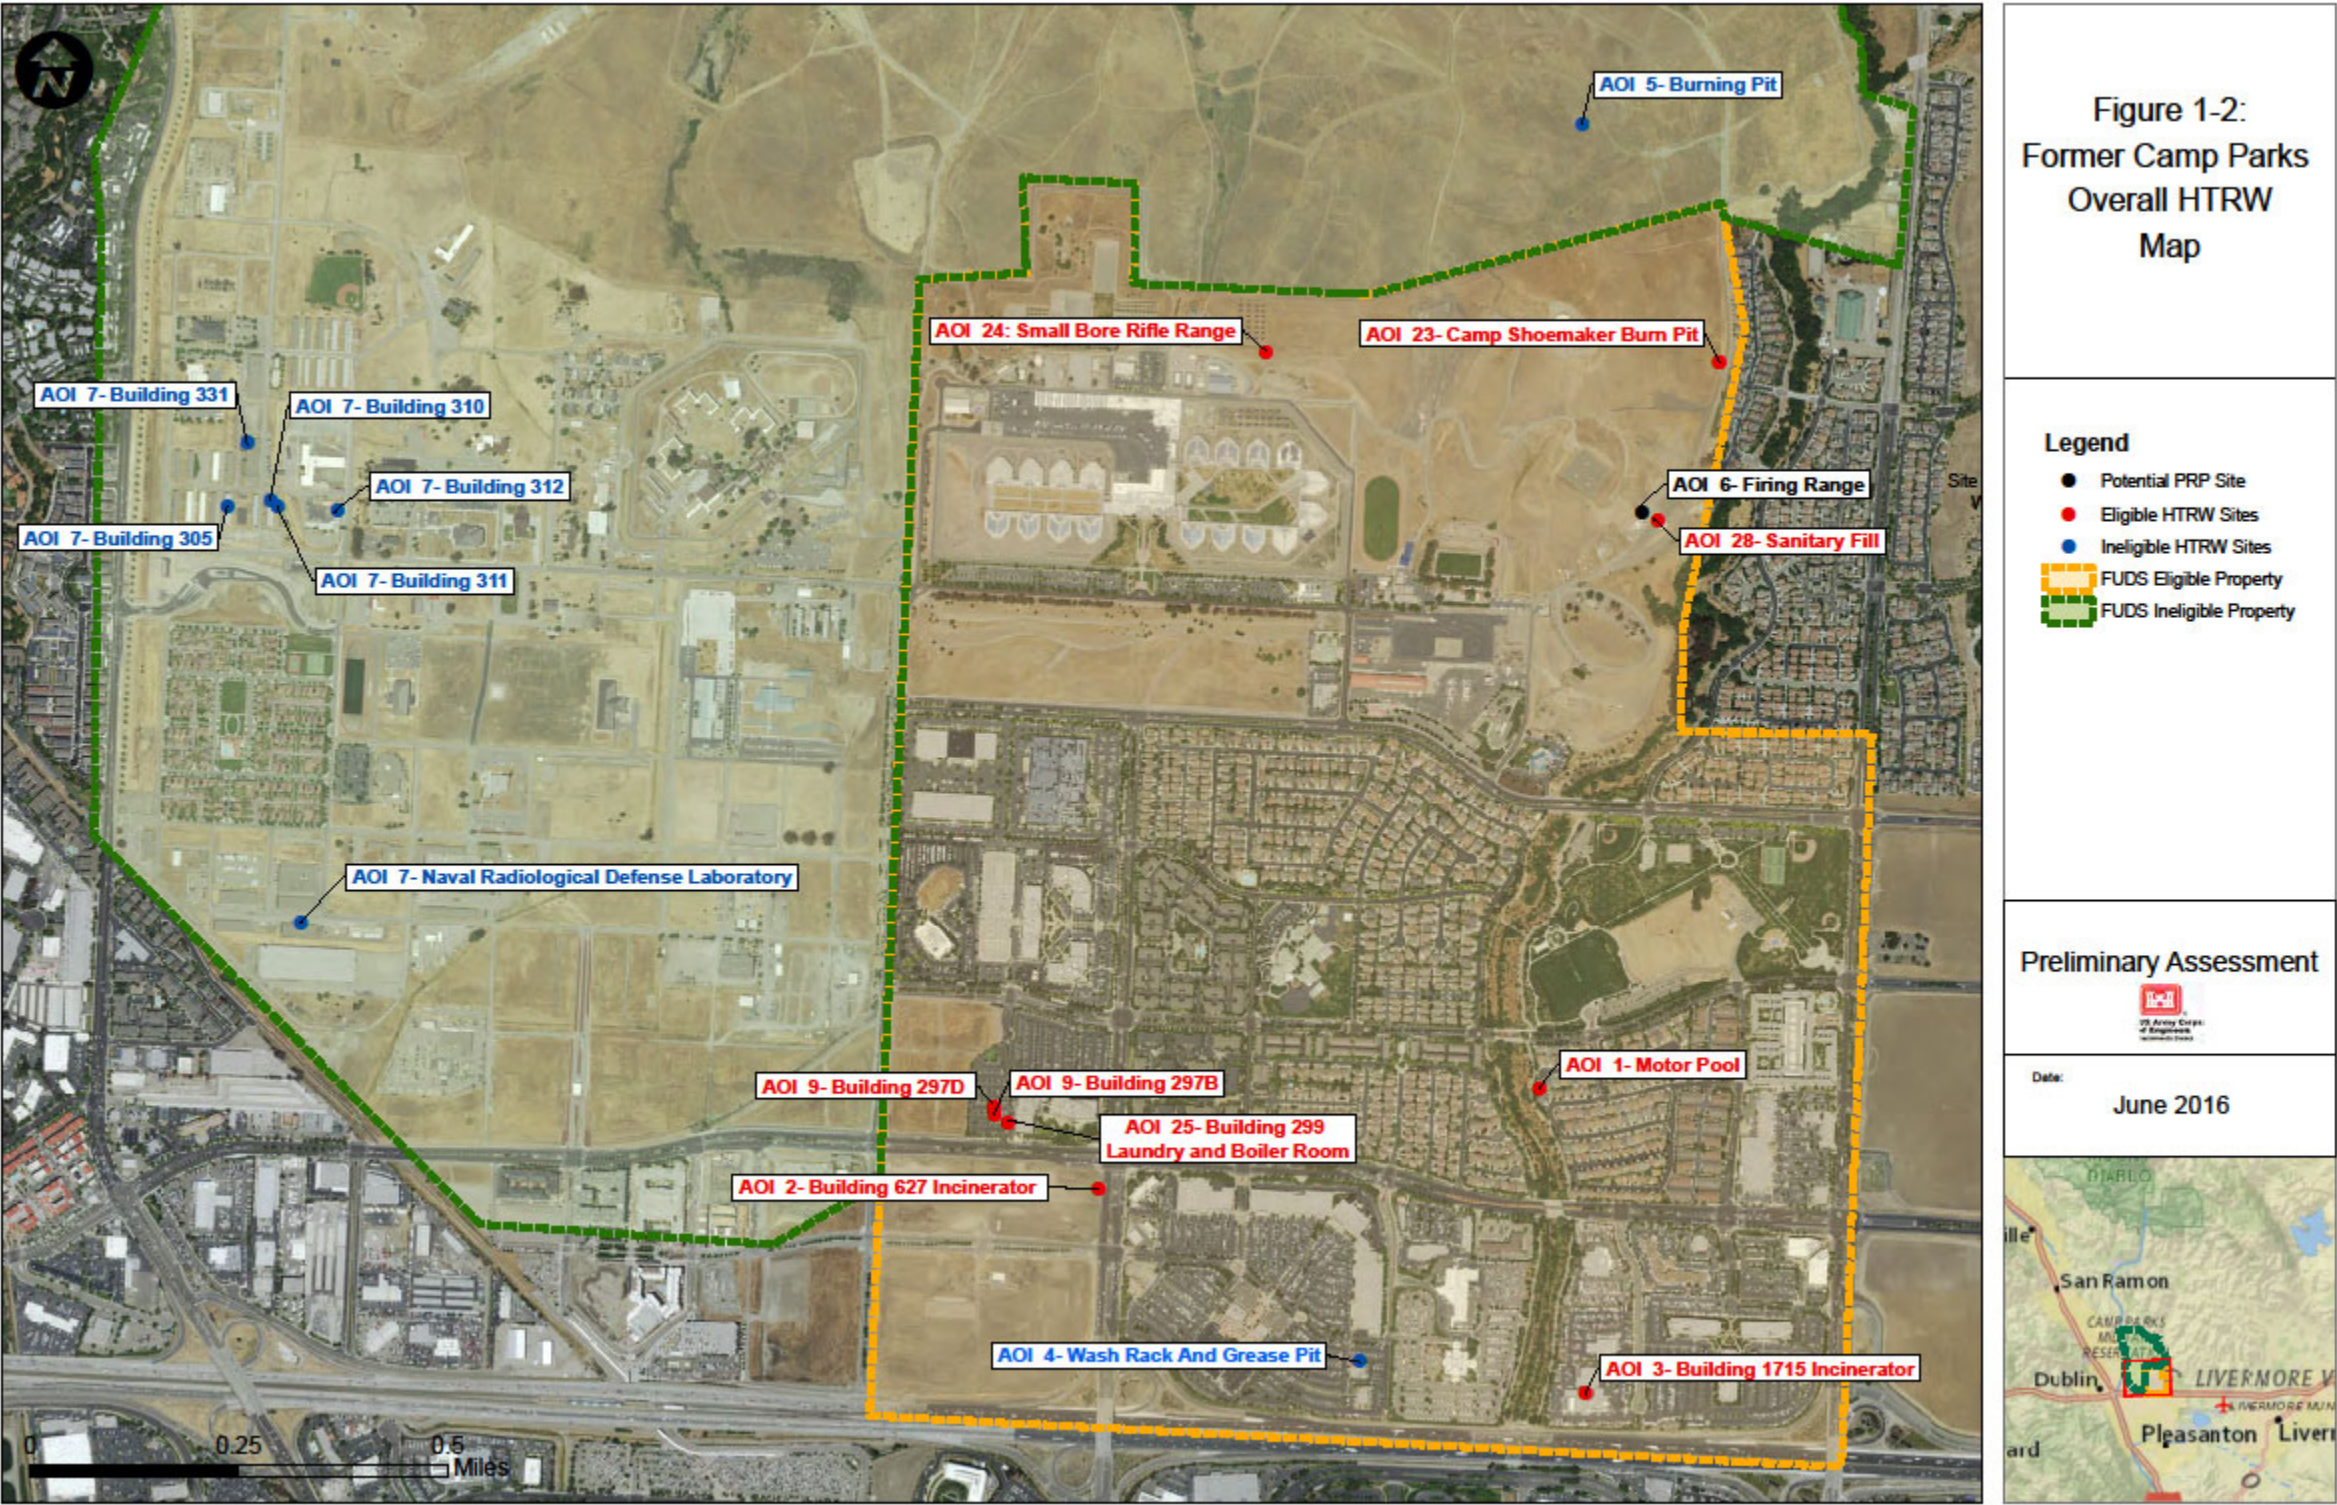
Figure 1-2 Former Camp Parks Overall HTRW Map

AOI #	AOI Name
1	Bldg. 1788 Motor Pool
2	Bldg. 627 Incinerator
3	Bldg. 1715 Garbage Incinerator
4	Bldg. 1501 Wash Rack and Grease Pit
5	Burn Area
6	Hickman Road Firing Range
7	Naval Radiological Defense Laboratory
9	Bldgs. 297B and 297D Paint Shop and Store Room
23	Camp Shoemaker Burn Pit
24	Naval Small Bore Rifle Range
25	Bldg. 299 Laundry and Boiler Room
28	Hickman Road Sanitary Fill Area

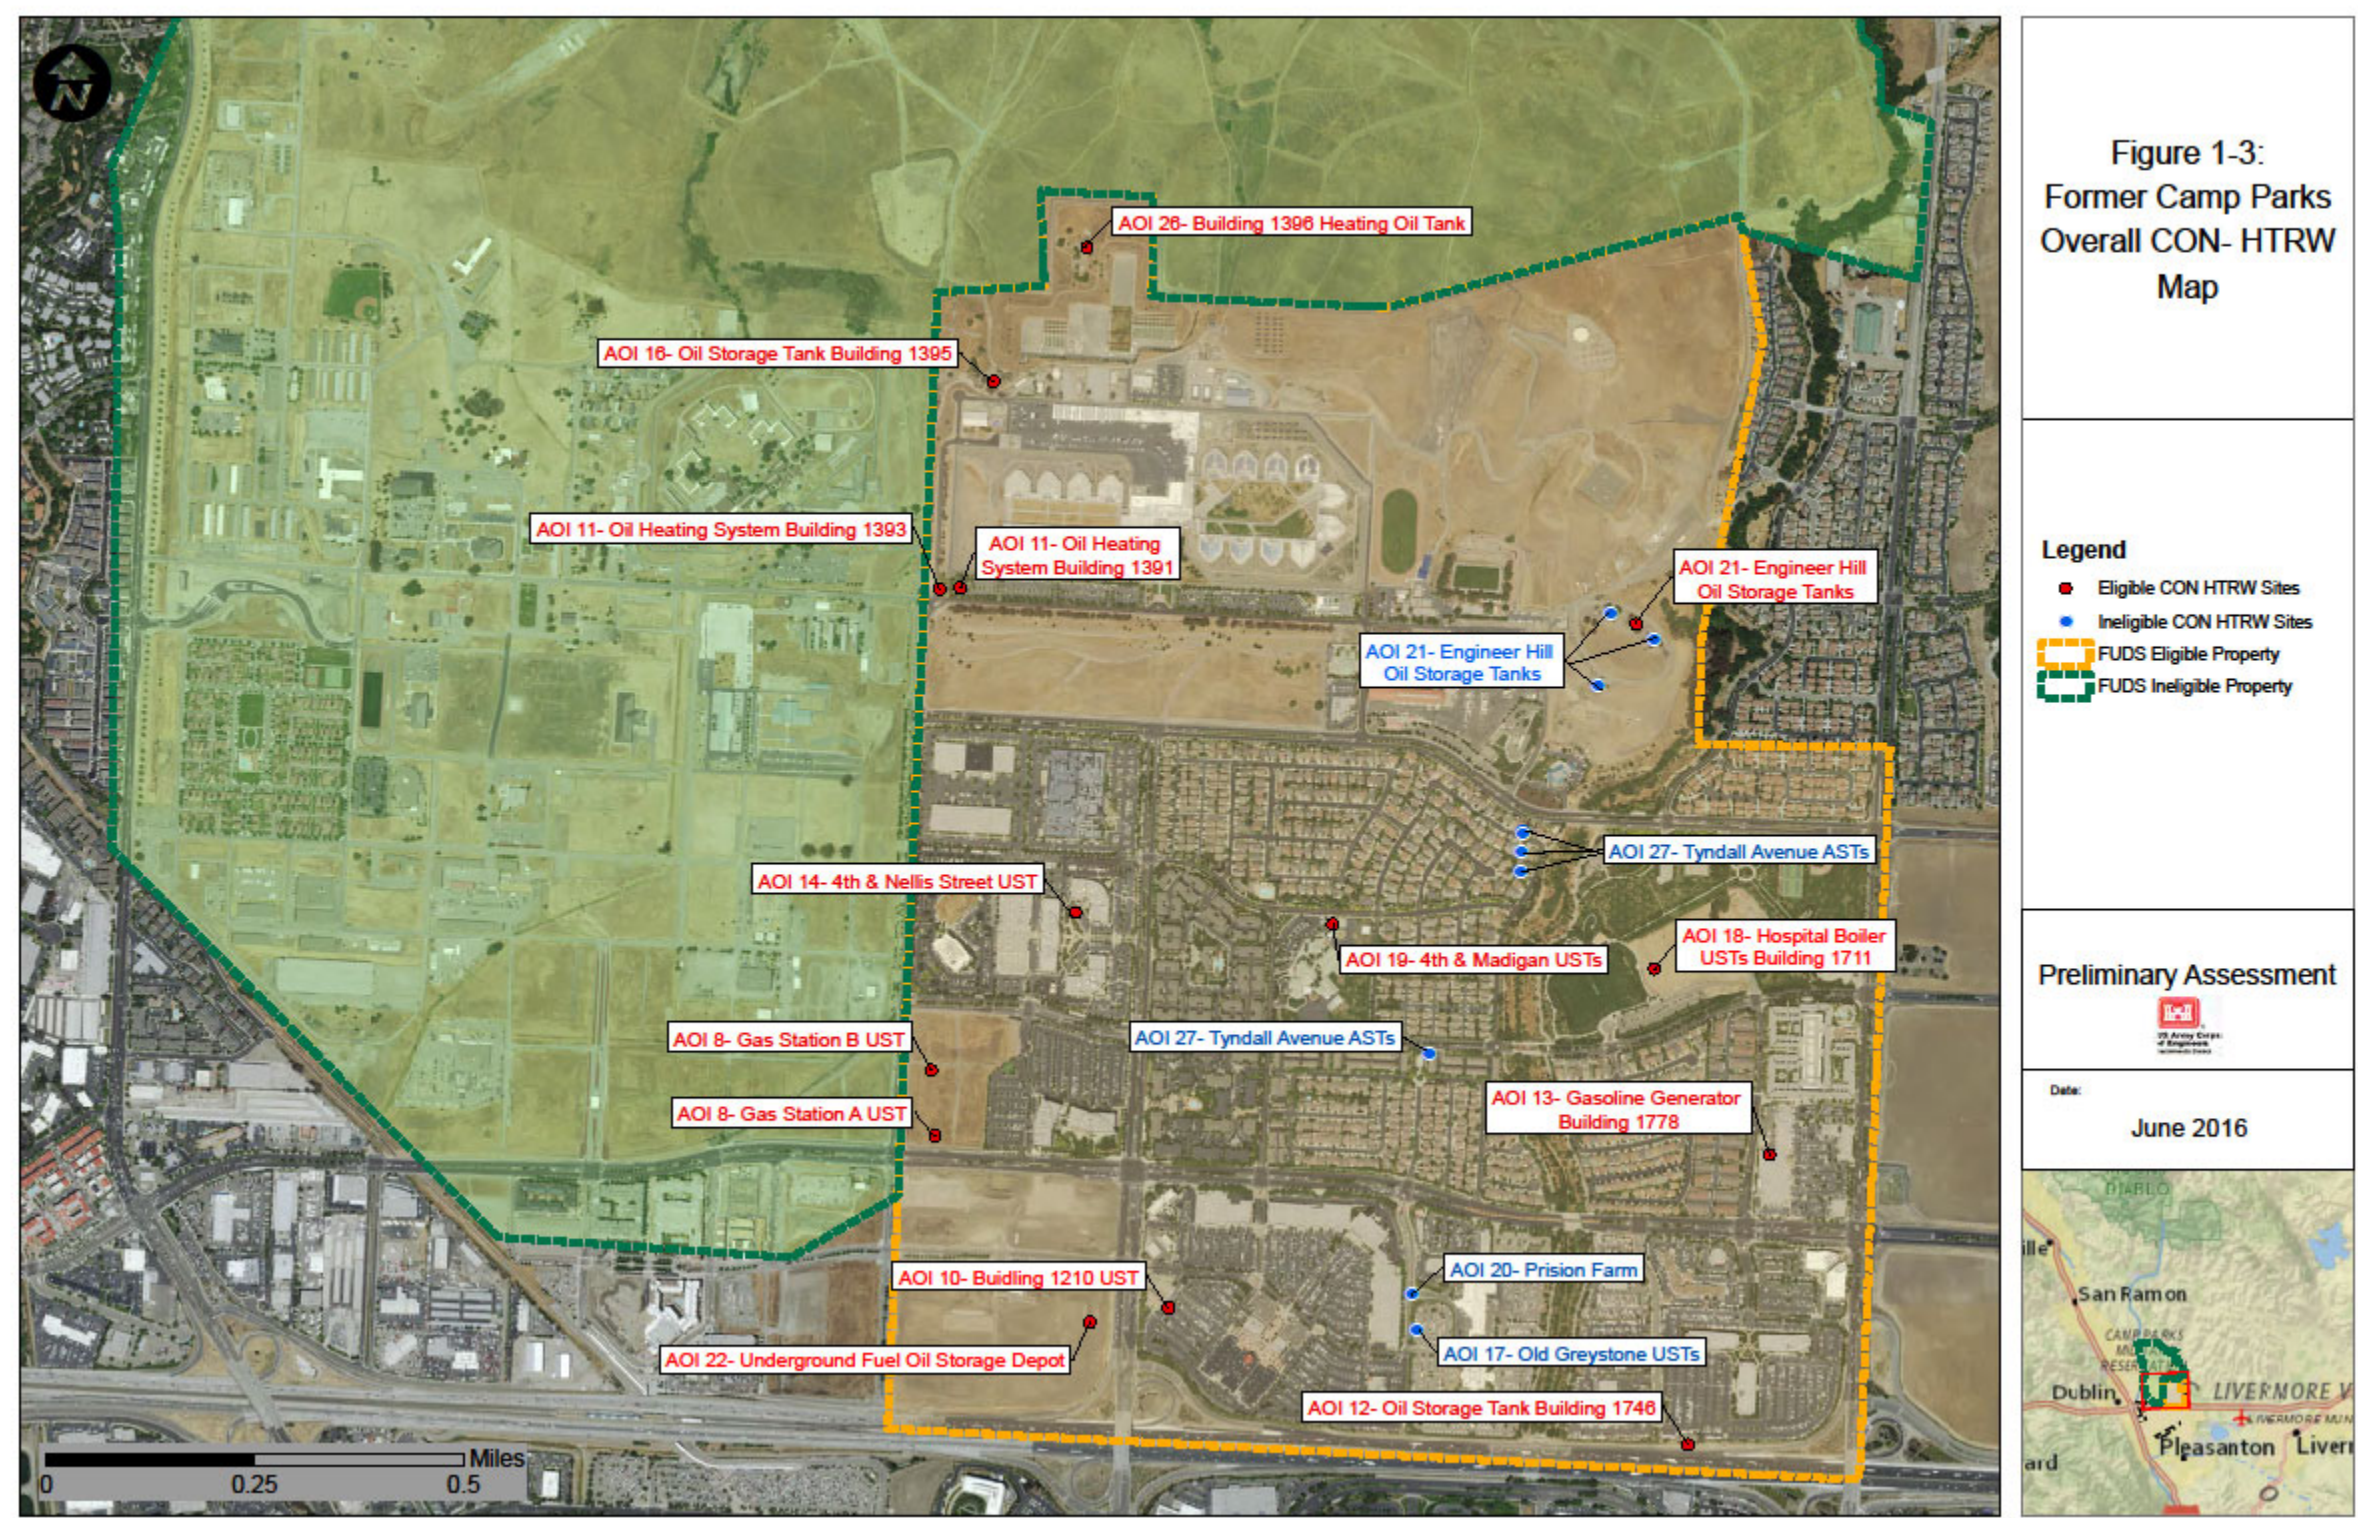
Figure 1-3 Former Camp Parks Overall CON/HTRW Map

AOI #	<u>AOI Name</u>
8	Bldgs. 468A and 468B Gas Stations
10	Bldg1210 UST
11	Bldgs. 1391 and 1393 Oil Storage Tanks
12	Bldg. 1746 Oil Storage Tank
13	Bldg. 1778 Gasoline Generator
14	4th street & Offutt Ave/4th street & Nellis USTs
15	Various Transformers
16	Bldg. 1395 Oil Storage Tank
17	Old Greystone USTs
18	Hospital Boiler USTs
19	4th and Madigan USTs
20	Former Prison Farm Tanks
21	Engineer Hill Oil Storage Tanks
22	Former Underground Fuel Oil Storage Depot
26	Bldg. 1396 UST
27	Tyndall Avenue ASTs

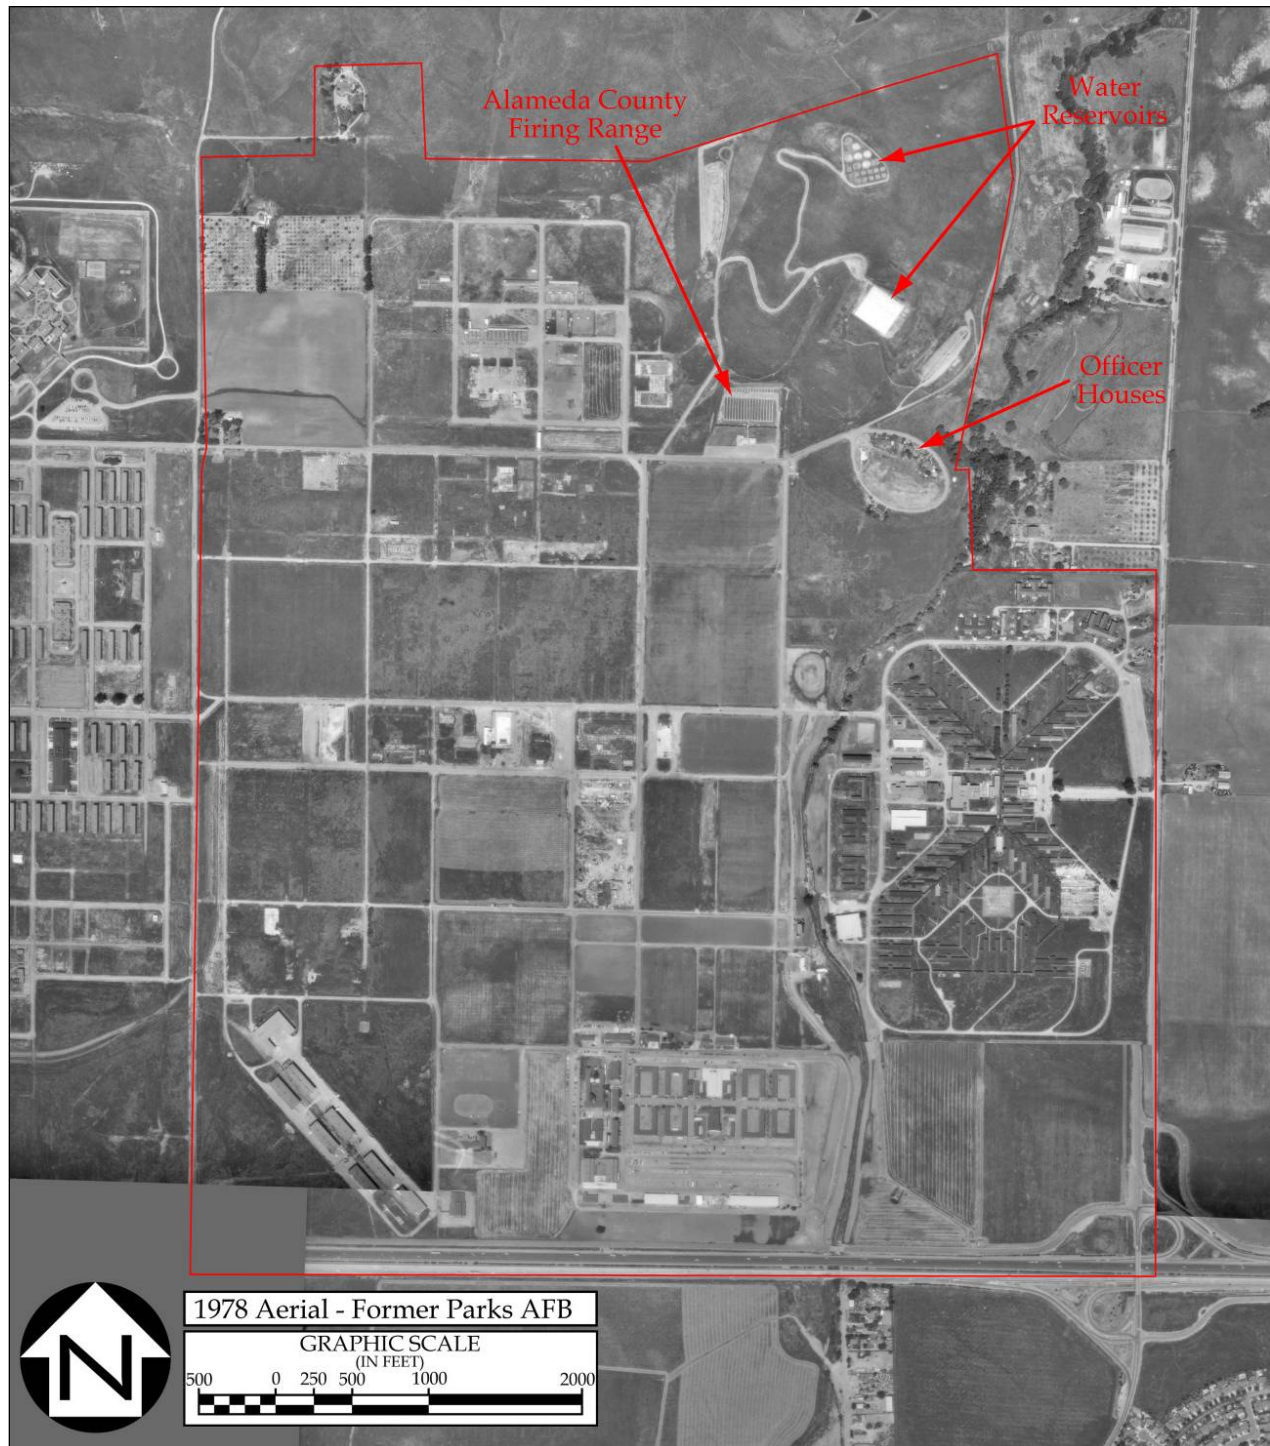
Figure 3-15 Historical Aerial Photograph of Former Camp Shoemaker Dated 1978

The historical aerial photograph dated 1978 (Figure 3-15) shows that many of the buildings at the Site have been demolished. Most of the structures at the U.S. Naval Hospital Shoemaker remain, and the Officer Houses and water reservoirs in the northeast portion of former Camp Shoemaker are intact. The Alameda County firing range is apparent near the northern boundary of the Site. An Alameda County Sheriff's Department ordnance disposal area has been constructed in the northern portion of the Site.

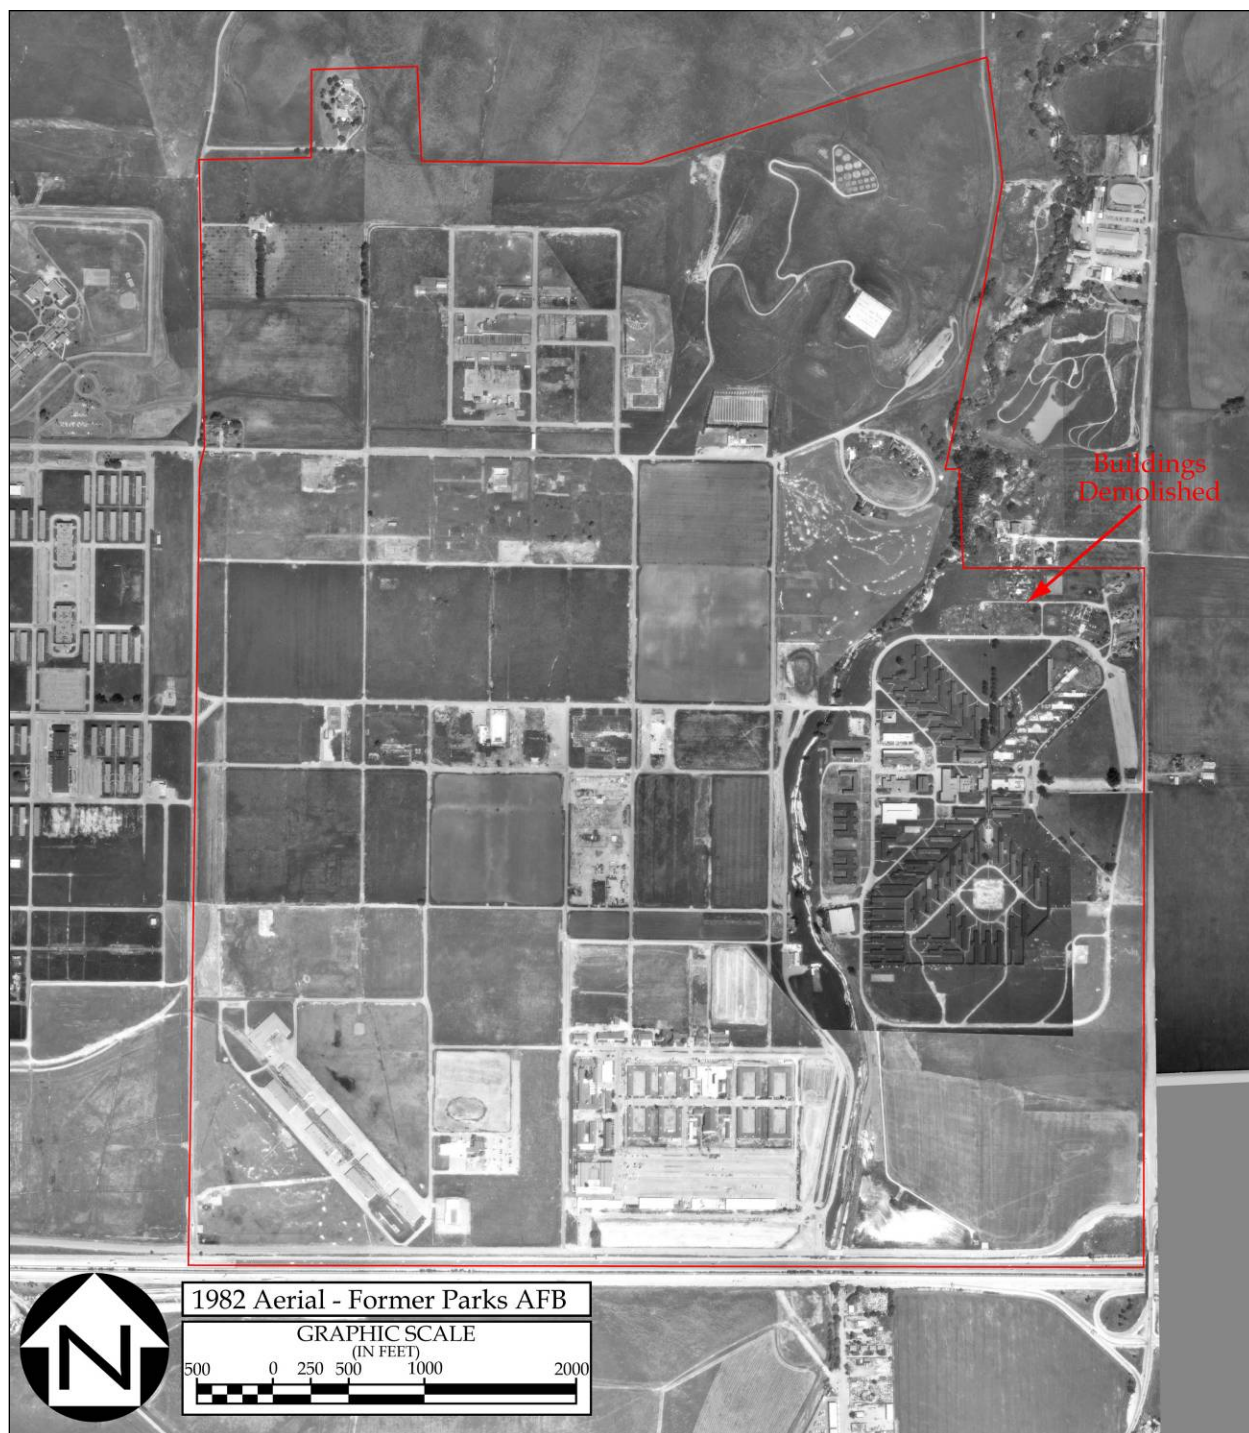
Figure 3-16 Historical Aerial Photograph of Former Camp Shoemaker Dated 1982

The historical aerial photograph dated 1982 (Figure 3-16) shows a few buildings in the northern portion of the former U.S. Naval Hospital have been removed.

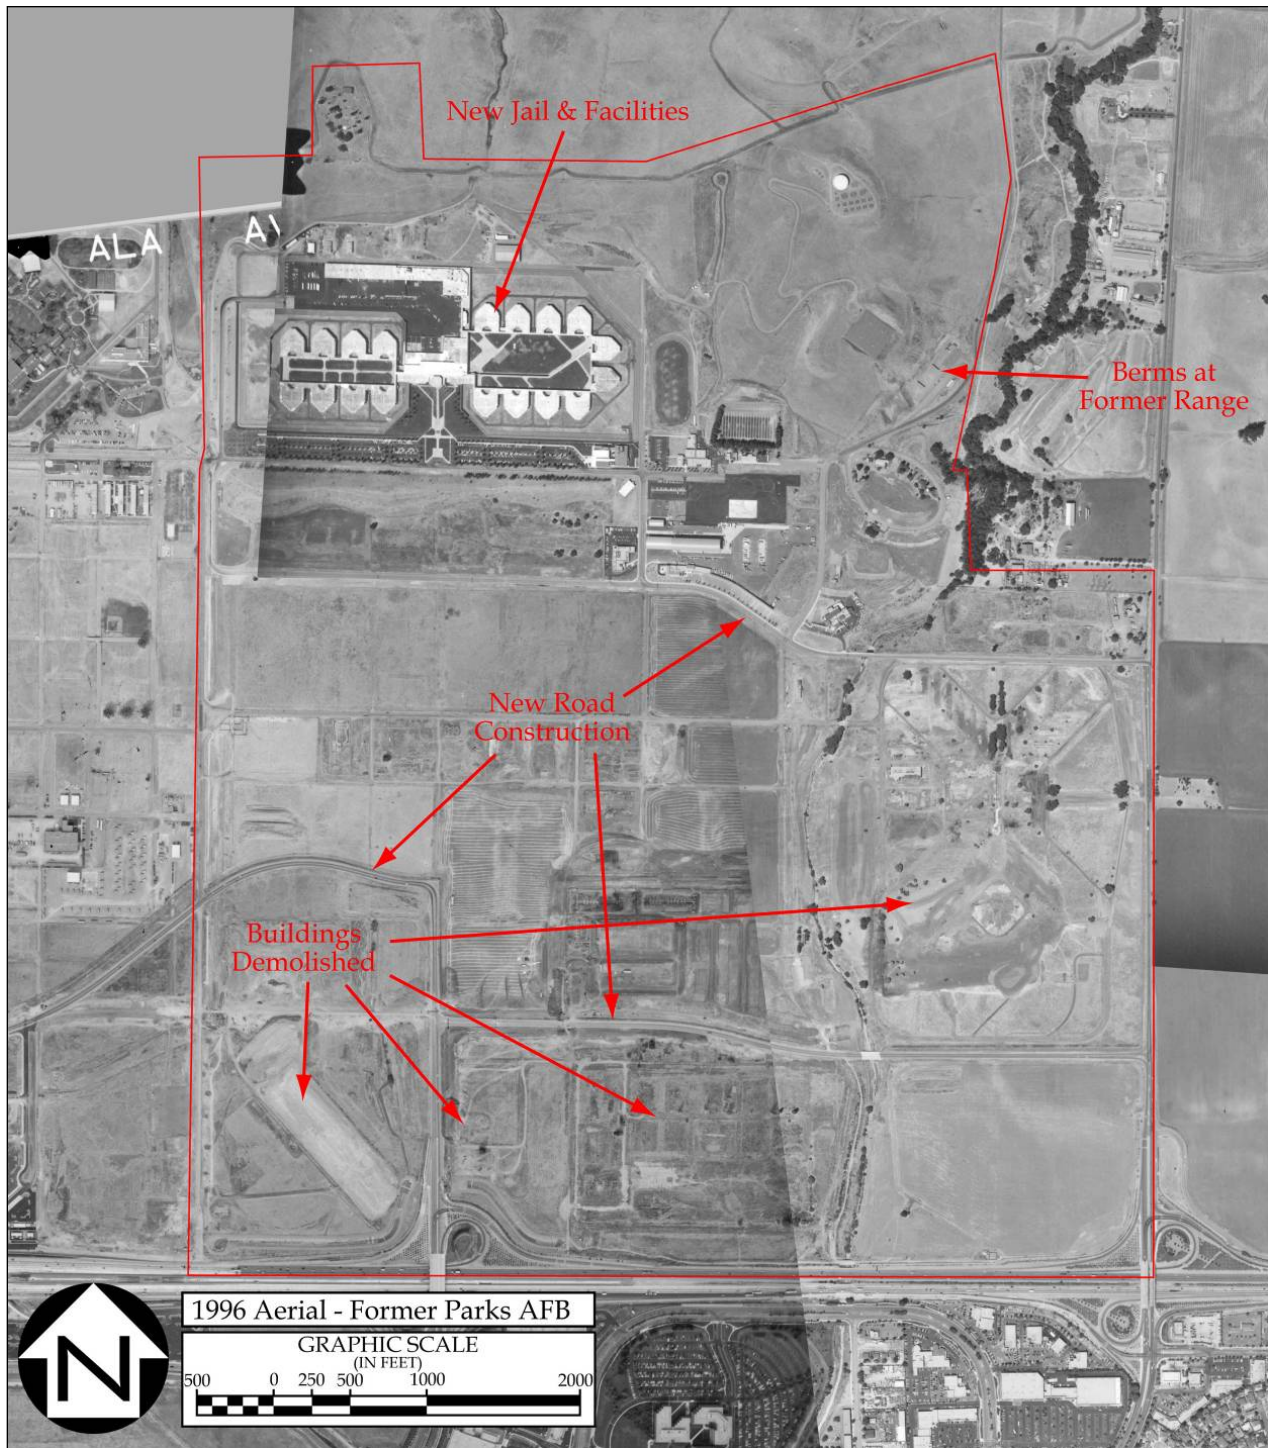
Figure 3-17 Historical Aerial Photograph of Former Camp Shoemaker Dated 1996

The historical aerial photograph dated 1996 (Figure 3-17) shows several new east-west roads have been constructed through the Site. The buildings at the former U.S. Naval Hospital have been demolished, along with buildings at the rail yard in the southwest corner and the former Alameda County Prison Farm along the southern boundary of the Site. Berms have been added at the former firing range in the northeast portion of the Site. A new jail facility has been constructed in the northern portion of the Site. The Alameda County Sheriff's Department has constructed a new training facility for northern California. The water tanks atop the hill in the northeast portion of the Site have been removed.

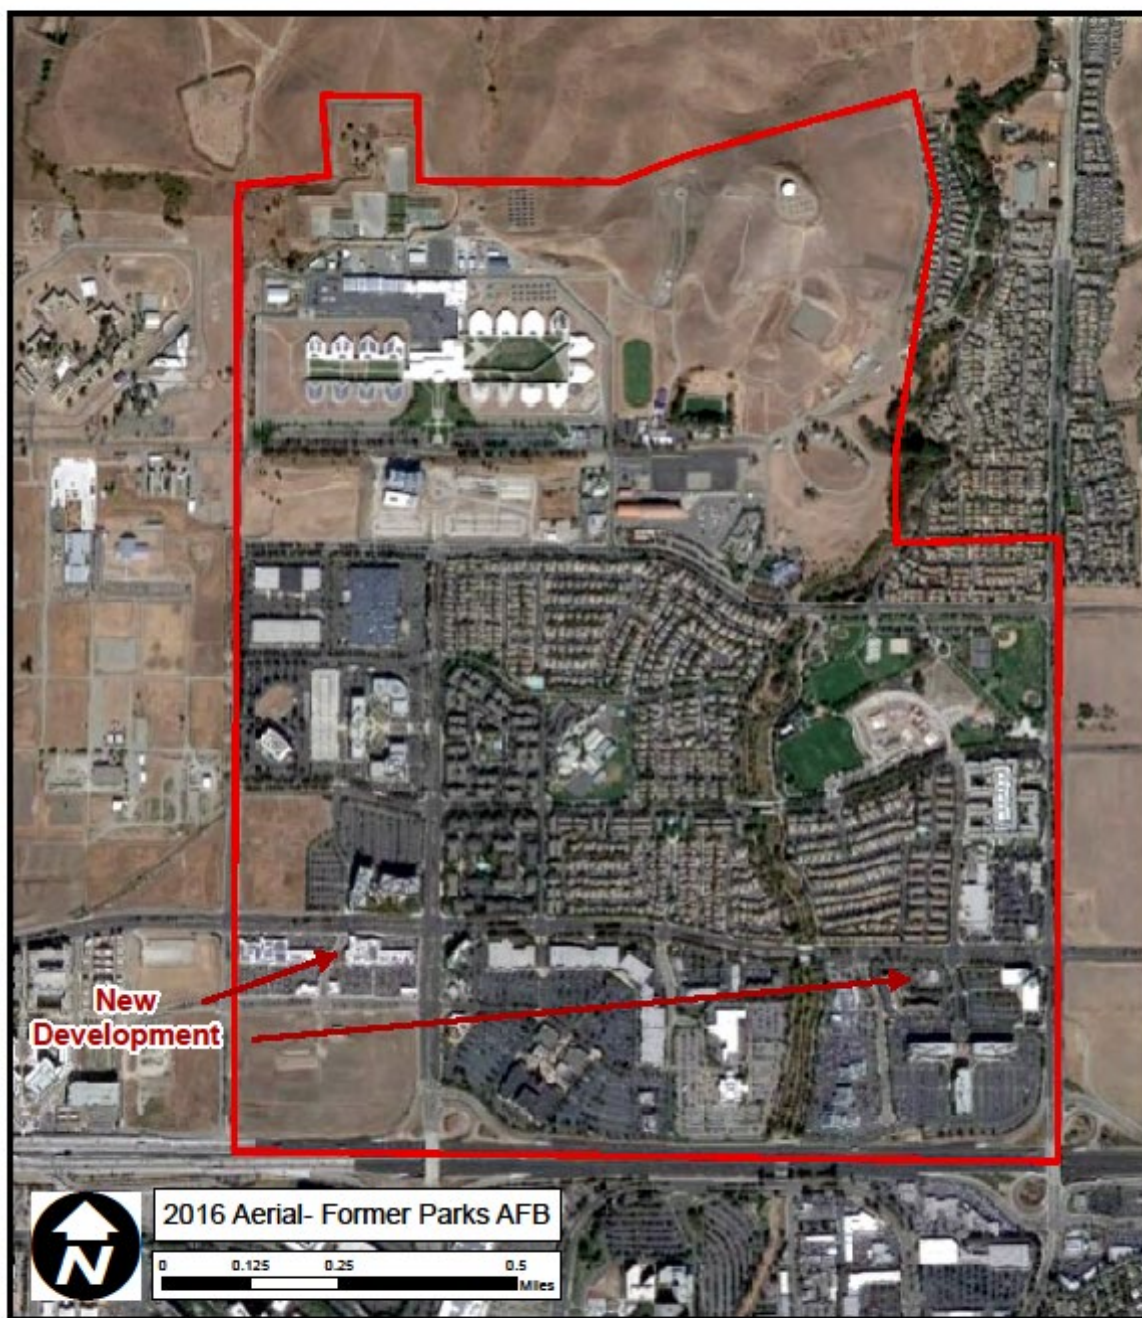
Figure 3-19 Aerial Photograph of Former Camp Shoemaker Dated 2016

The historical aerial photograph dated 2016 (Figure 3-19) shows new development in several areas of the Site. More commercial areas have been developed south of Dublin Blvd and the Emerald Glen Community Park area has been developed further.

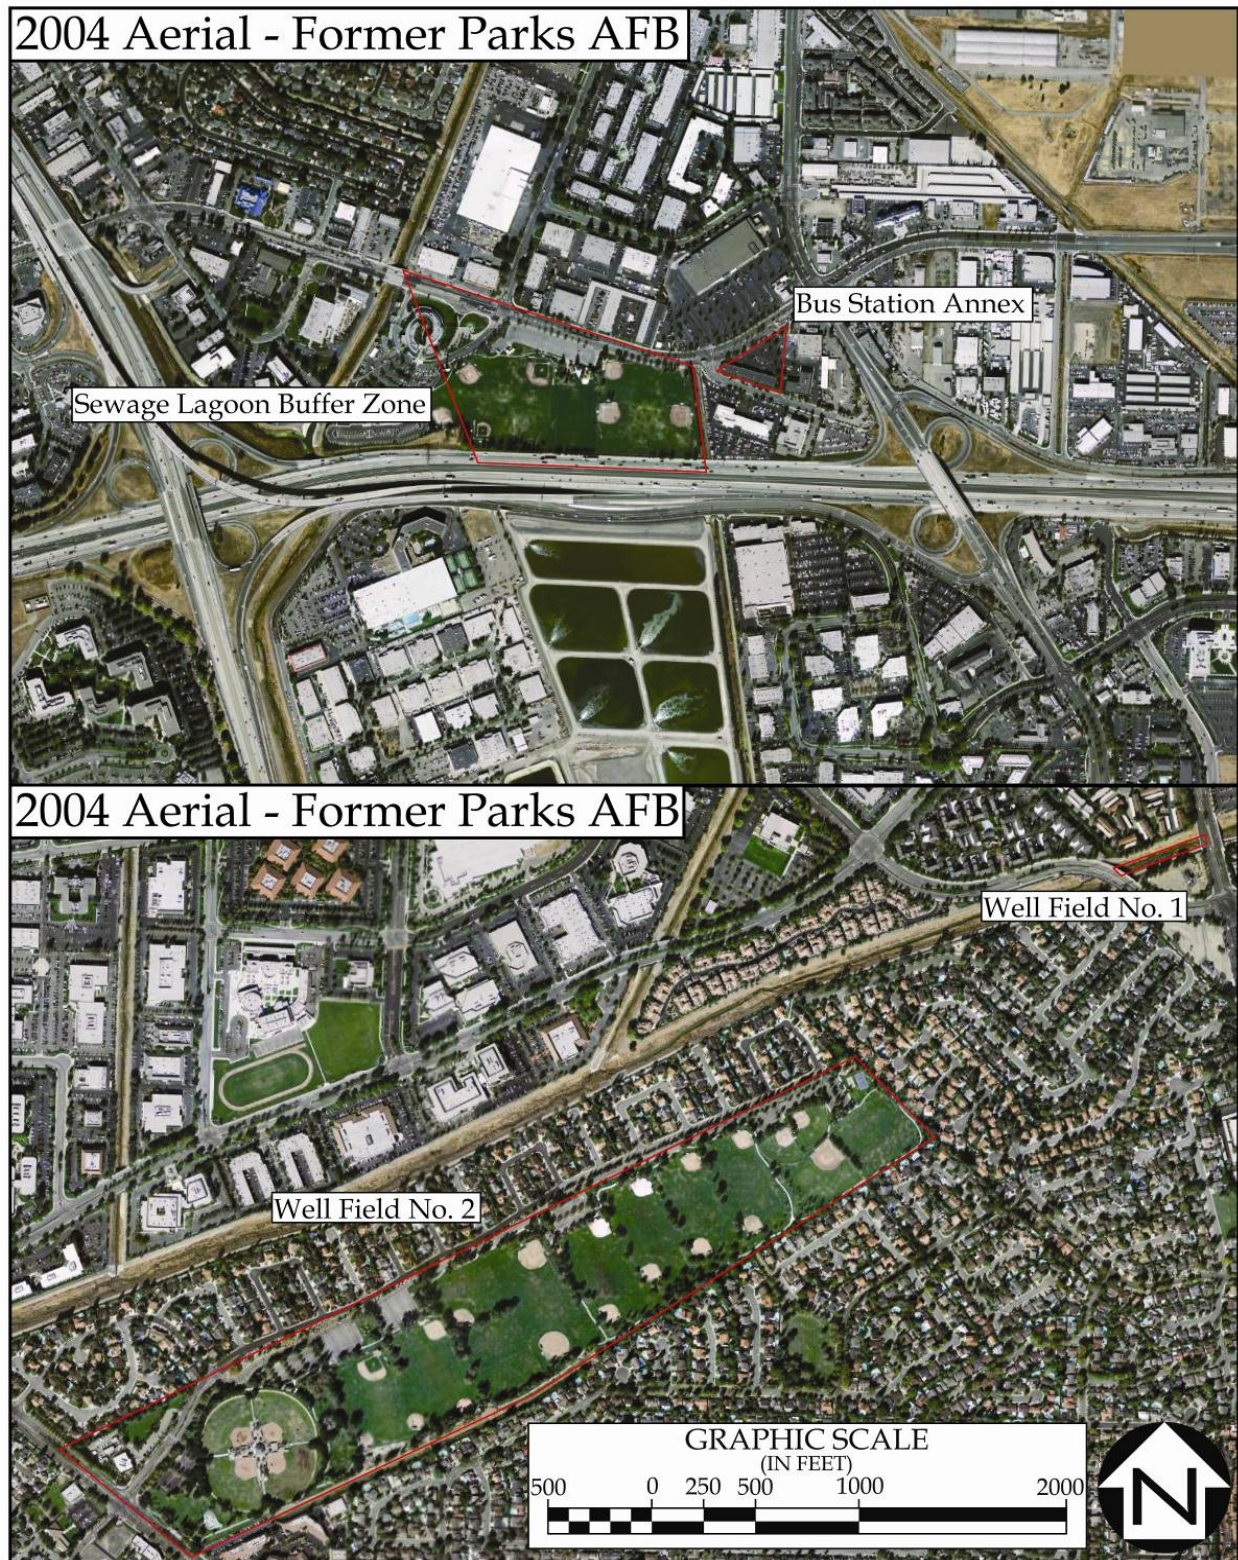
Figure 3-27 Historical Aerial Photograph of the Southern Portion of Former Camp Parks Dated 2004

The historical aerial photographs dated 2004 (Figure 3-27) shows no significant changes from the previous aerial photograph.

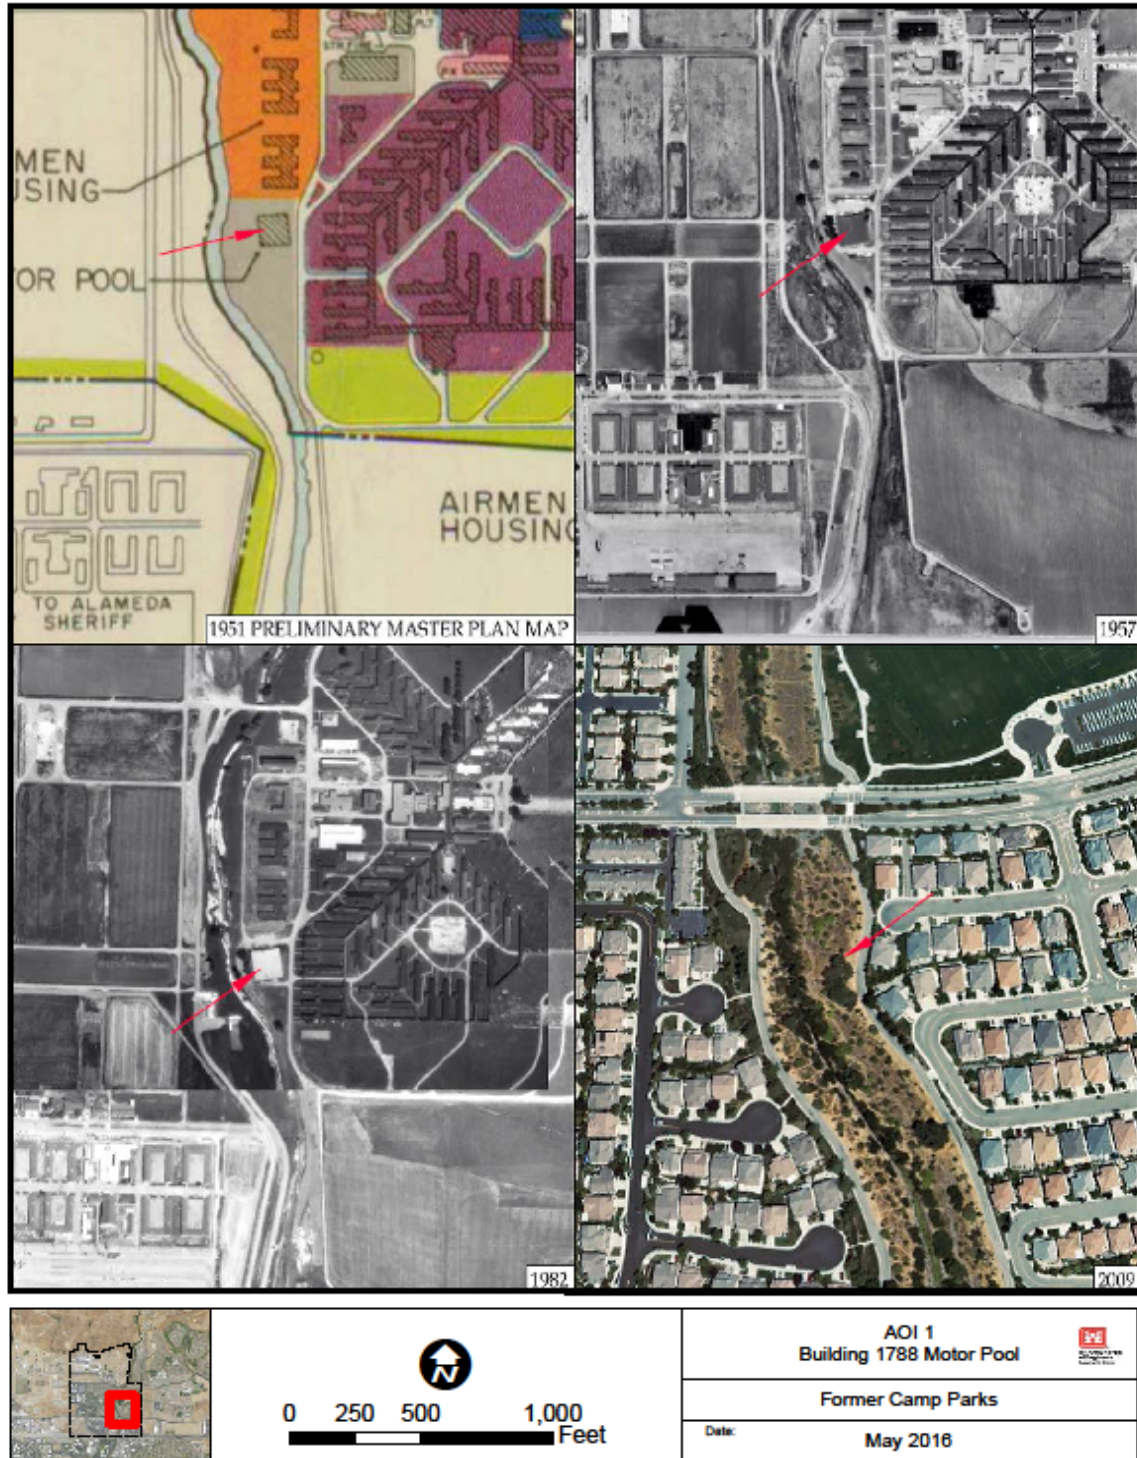
Figure 4-1 AOI 1: Building 1788

In the 1945 Camp Shoemaker Map, building 788 [old building designation] was labeled for use as 'Transportation and Storage.' According to the 1951 Preliminary Master Plan Map, this building was identified as a Motor Pool (Figure 4-1). The 1956 Building Inventory (see Appendix D, page 12 of 14) listed this building as a warehouse. It is unclear if the building was actually used for motor pool activities during this time frame. Per Rod Freitag of the GSA of Alameda County, this was a former wooden structure with a concrete floor, and during the late 1980s to the early 1990s four County environmental consultants inspected the building and none indicated the presence of hazardous materials of concern other than asbestos and lead paint (ineligible under FUDS) associated with the structure and equipment being stored therein. No hazardous chemical storage USTs, ASTs, containers or evidence of chemical contamination were noted. Gregg & Associates inspected the entire Santa Rita property in 1988 for USTs and ASTs; none were noted in this building (Gregg, 1988, Appendix D). Per Rod Freitag, the building was demolished by an environmental contractor (CEC) under observation of the County's environmental consultant (Professional Services Industries). Currently, this area is adjacent to a canal and the majority of it has been graded and developed into residences. In 2018, USACE performed a geophysical investigation of the portion of the area not developed into residences. The magnetic and ground penetrating radar found no indication of any UST at the site. The workplan and report for this geophysical investigation can be found in Appendix J. This AOI is FUDS eligible; however, no potential releases as a result of former DoD motor pool activities is suspected and therefore it is recommended that an NDAI determination be made.

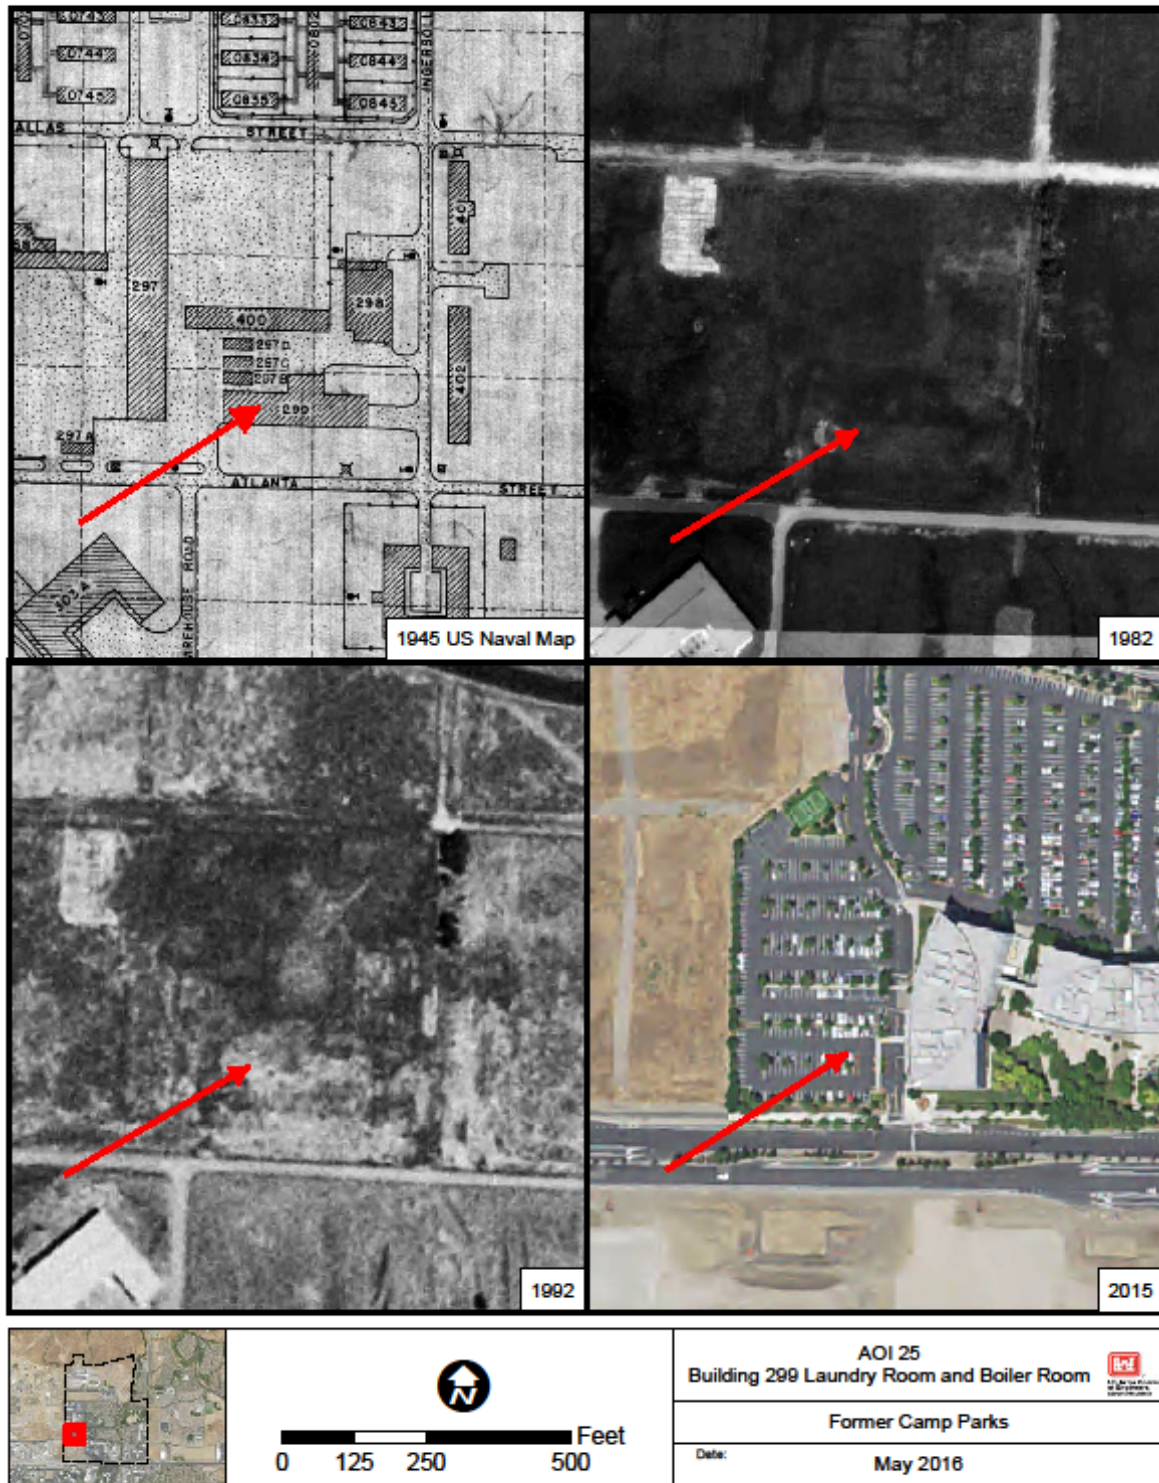
Figure 4-11 AOI 25: Building 299

Previous sampling has been done in this area by Erler and Kalinowski in 1998 and Versar in 1998 and 1999 (Erler & Kalinowski, 1998). During those sampling events, thirteen groundwater samples around Building 299 and to the west contained tetrachloroethylene (PCE) at concentrations ranging from 24 to 440 micrograms per liter ($\mu\text{g/l}$). In May of 2017 Langan Engineering and Environmental Services, Inc performed a Phase II Environmental Site Characterization of nearby AOI 8 (Appendix F), during which they analyzed 5 groundwater samples from 5 borings. Very low levels of the VOCs PCE ($0.8 \mu\text{g/L}$) and chloroform were detected below the San Francisco Bay Regional Water Quality Control Board’s 2016 Tier I and groundwater to soil vapor Environmental Screening Levels (ESLs). The PCE was detected in the approximate location of the former service station at building 468A, where PCE was detected at $120 \mu\text{g/L}$ by Versar in 1999. The remaining groundwater samples were non-detect for VOCs. The nearest water supply well (as identified on the Groundwater Ambient Monitoring and Assessment online mapping tool [GAMA]) is approximately 0.9 miles southeast of the Site. Two fuel oil USTs, one 10,000 gallon and one 1,000 gallon, were removed in this vicinity in March 2000. These tanks were not in the 1988 Alameda County Tank Management Plan (Gregg & Associates, 1988) (Appendix D). Both tanks were full of water and had holes present in them. Based on sampling, some excavated soil was taken to Vasco Road landfill in Livermore, and the rest was used to backfill the excavations. The tanks were considered closed in compliance with Title 23 CCR, with no further action necessary, by Alameda County Health Care Services (Alameda County) in June 2000 (Alameda County, 2000) (Appendix E). This AOI is FUDS-eligible, but due to the closure certification for the USTs, it is recommended that an NDAI determination be made for the USTs. Alameda County worked with the San Francisco Bay Regional Water Quality Control Board (SFBRWQCB) regarding contamination at Parcel 15, which encompasses this AOI, as well as AOIs 8 and 9. The Water Board has determined that groundwater at the site has been impacted by chlorinated solvents, including PCE, TCE, chloroform and carbon tetrachloride, and that non detectable to trace concentrations of fuel hydrocarbons and chlorinated solvents have been found in soil vapor. However, they have determined that all contaminants at the site are below health based screening levels, and that the site meets the criteria for case closure under the Waterboards Assessment Tool for Closure of Low-Threat Chlorinated Solvent Sites. On December 3, 2018 the SFBRWQCB issued case closure with a no further action ruling for this parcel (see Appendix E AOIs 8, 9, and 25 closure document). This AOI is FUDS-eligible, but due to the case closure by the Waterboard, it is recommended that an NDAI determination be made for this AOI.
