Final Preliminary Assessment and Site Inspection Work Plan

Parks Air Force Base
Formerly Used Defense Site
Alameda County, Dublin, California

FUDS Property No. J09CA0083
FUDS Project No. J09CA0083-01 and J09CA0083-02

**Environmental Design Section
Sacramento District**

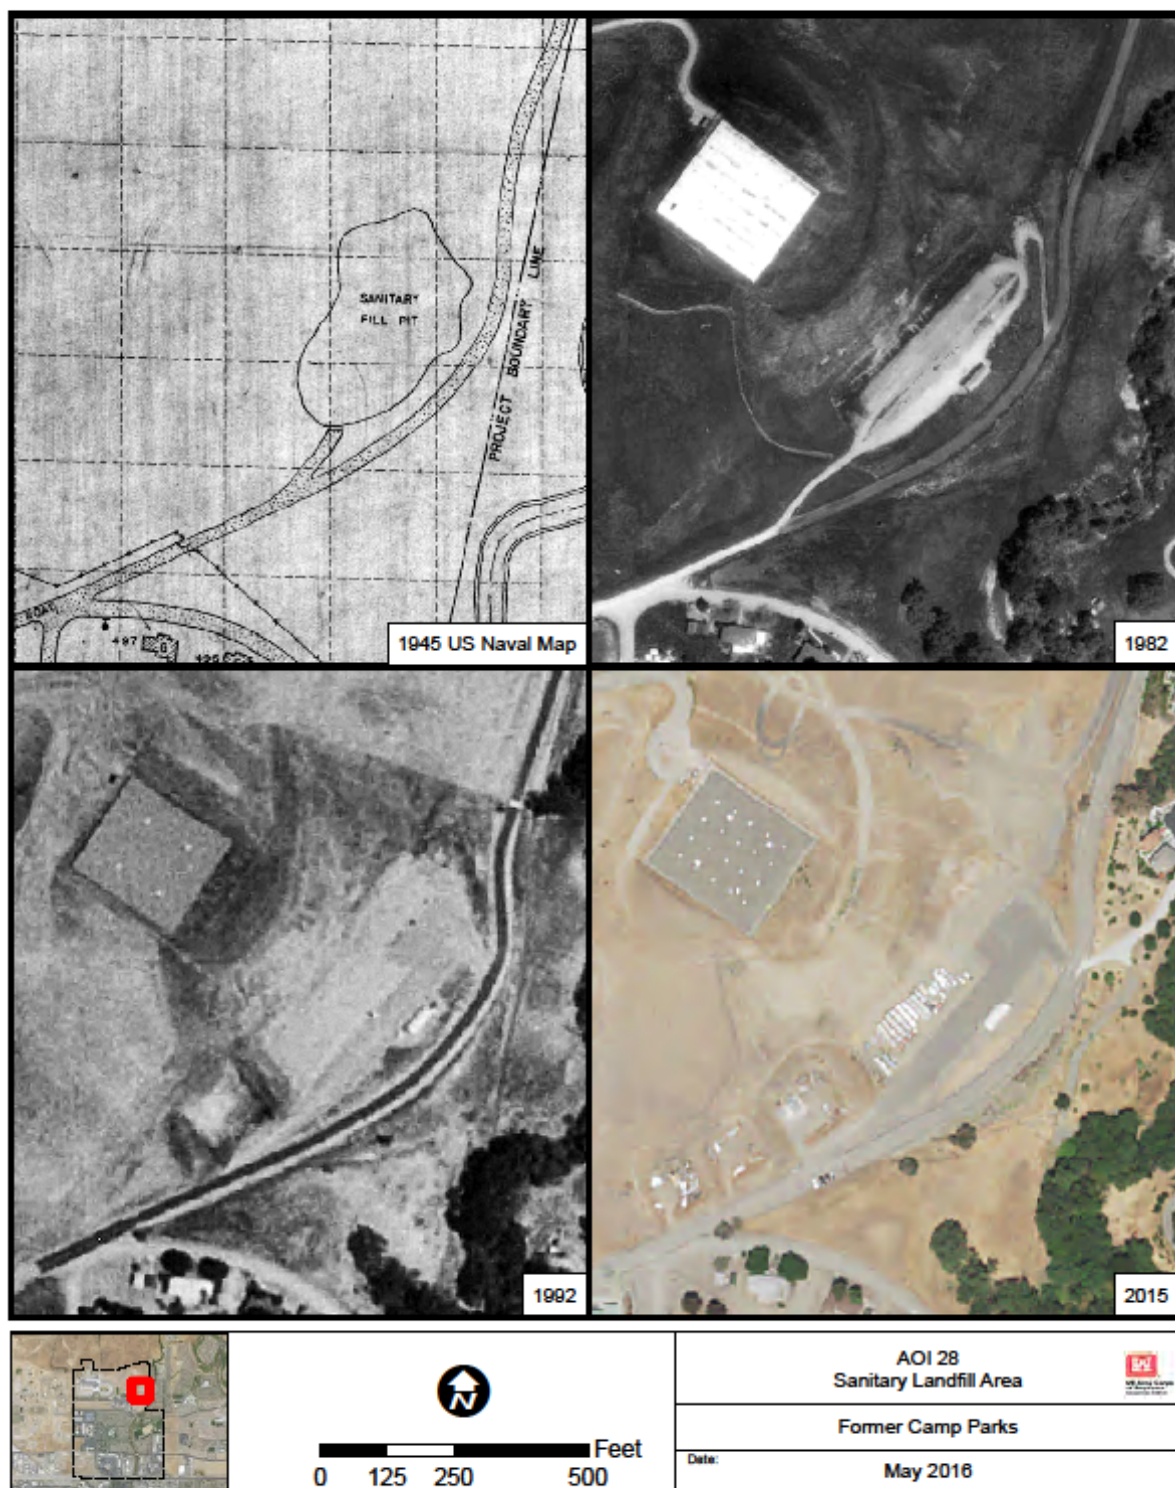
Figure 4-12 AOI 28: Sanitary Landfill Area

According to the 1945 Naval Shoemaker Map and the 1951 Parks AFB Preliminary Master Plan, a sanitary fill area was located in the northeast portion of former Camp Shoemaker (Appendix D and Figure 4-12). No further documentation was found regarding this area. The nearby hillside currently has evidence of past use as a firing range by both the military and the local parties (see AOI 6). If it exists, the sanitary fill portion of this area would be considered FUDS-eligible and is included in the Site Inspection Work Plan.

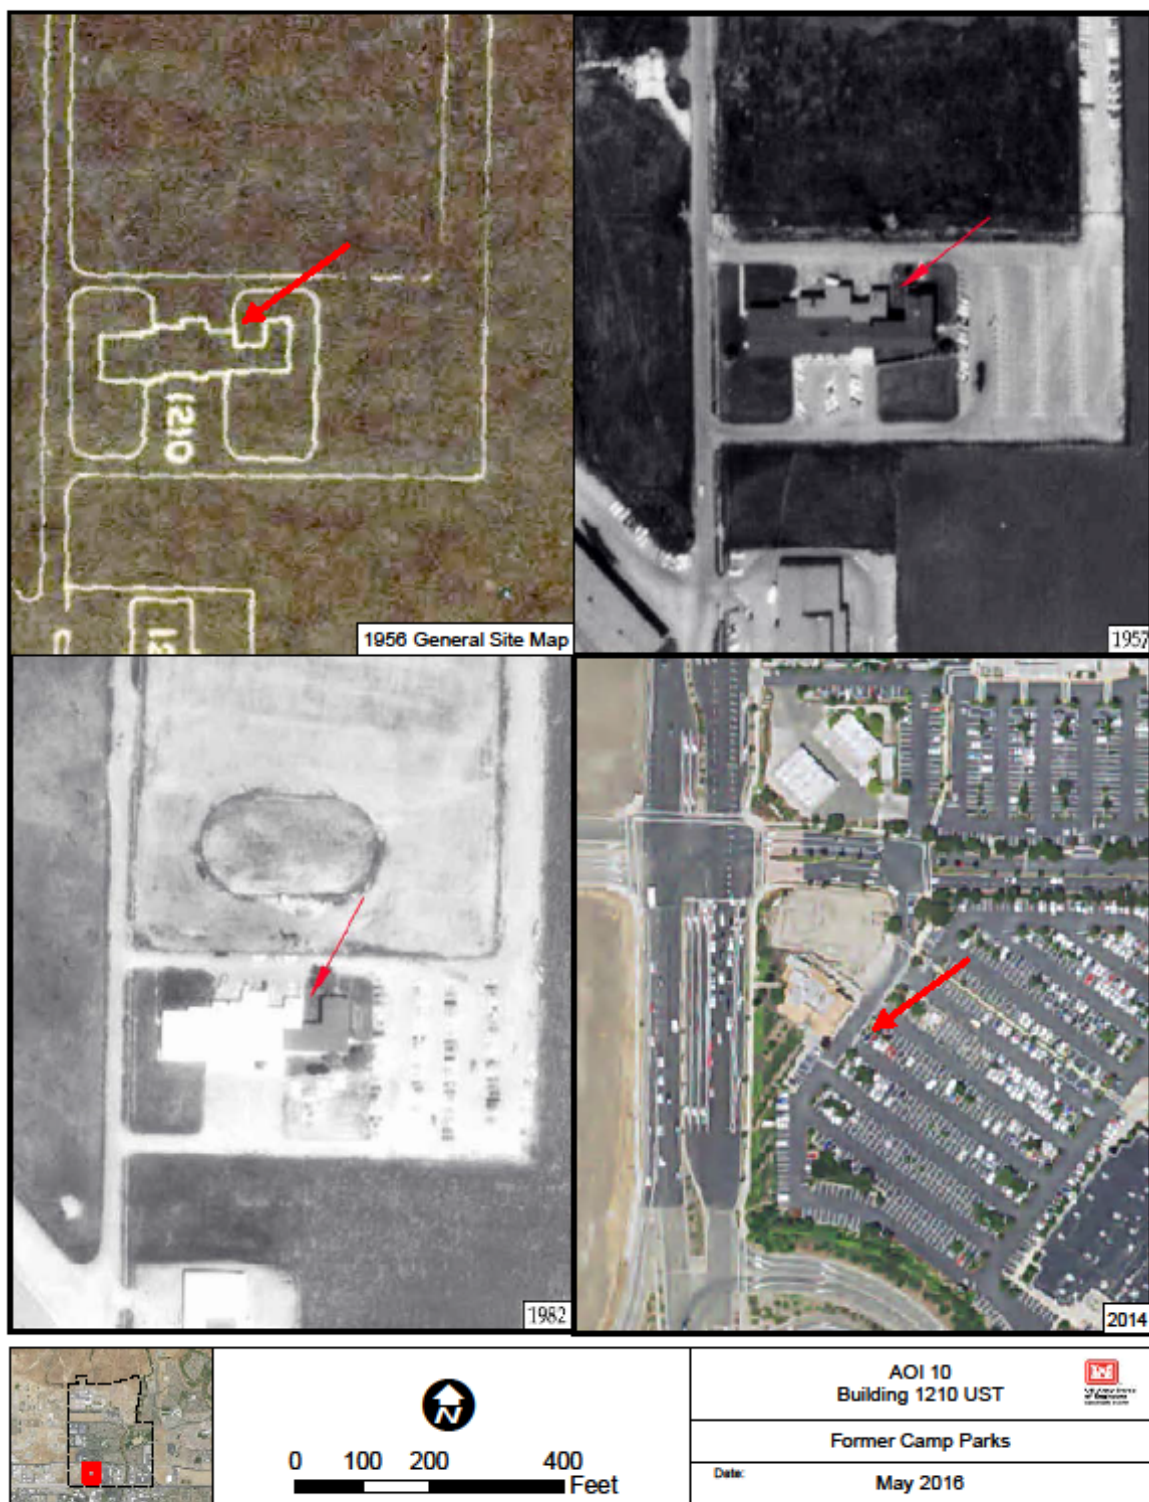
Figure 4-14 AOI 10 Building 1210

As shown on the 1956 Heating Plan Map (Tab G-6, Sheet 4 of 5, Appendix D) for the Non-Commissioned Officer's Club (Building 1210), a 1,000-gallon fuel oil UST was located on the north side of the building beside the eastern wing (Figure 4-14). The map states that the UST was abandoned.

According to Sergeant McElroy of the Alameda County Sheriff's Department, at least one gasoline UST was located at former Building 1210 (also known as the Madigan Building). The 1988 Alameda County Tank Management Plan identified this tank as being installed in 1950 and not currently in use (Gregg, 1988) (Appendix D).

The tank was removed by Environmental Science and Engineering, May 18, 1992, who was contracted by Alameda County GSA. At that time the tank was empty and showed no visible holes. The report states that no noteworthy release of petroleum hydrocarbons has occurred. Closure was accepted by the county January 25, 1995 (Alameda County, 1995a). Two restaurants and their parking lots have been constructed at its former location. This AOI is FUDS-eligible, however, due to the closure certification, it is recommended that no further investigation be done as part of this PA/SI and that an NDAI determination be made.

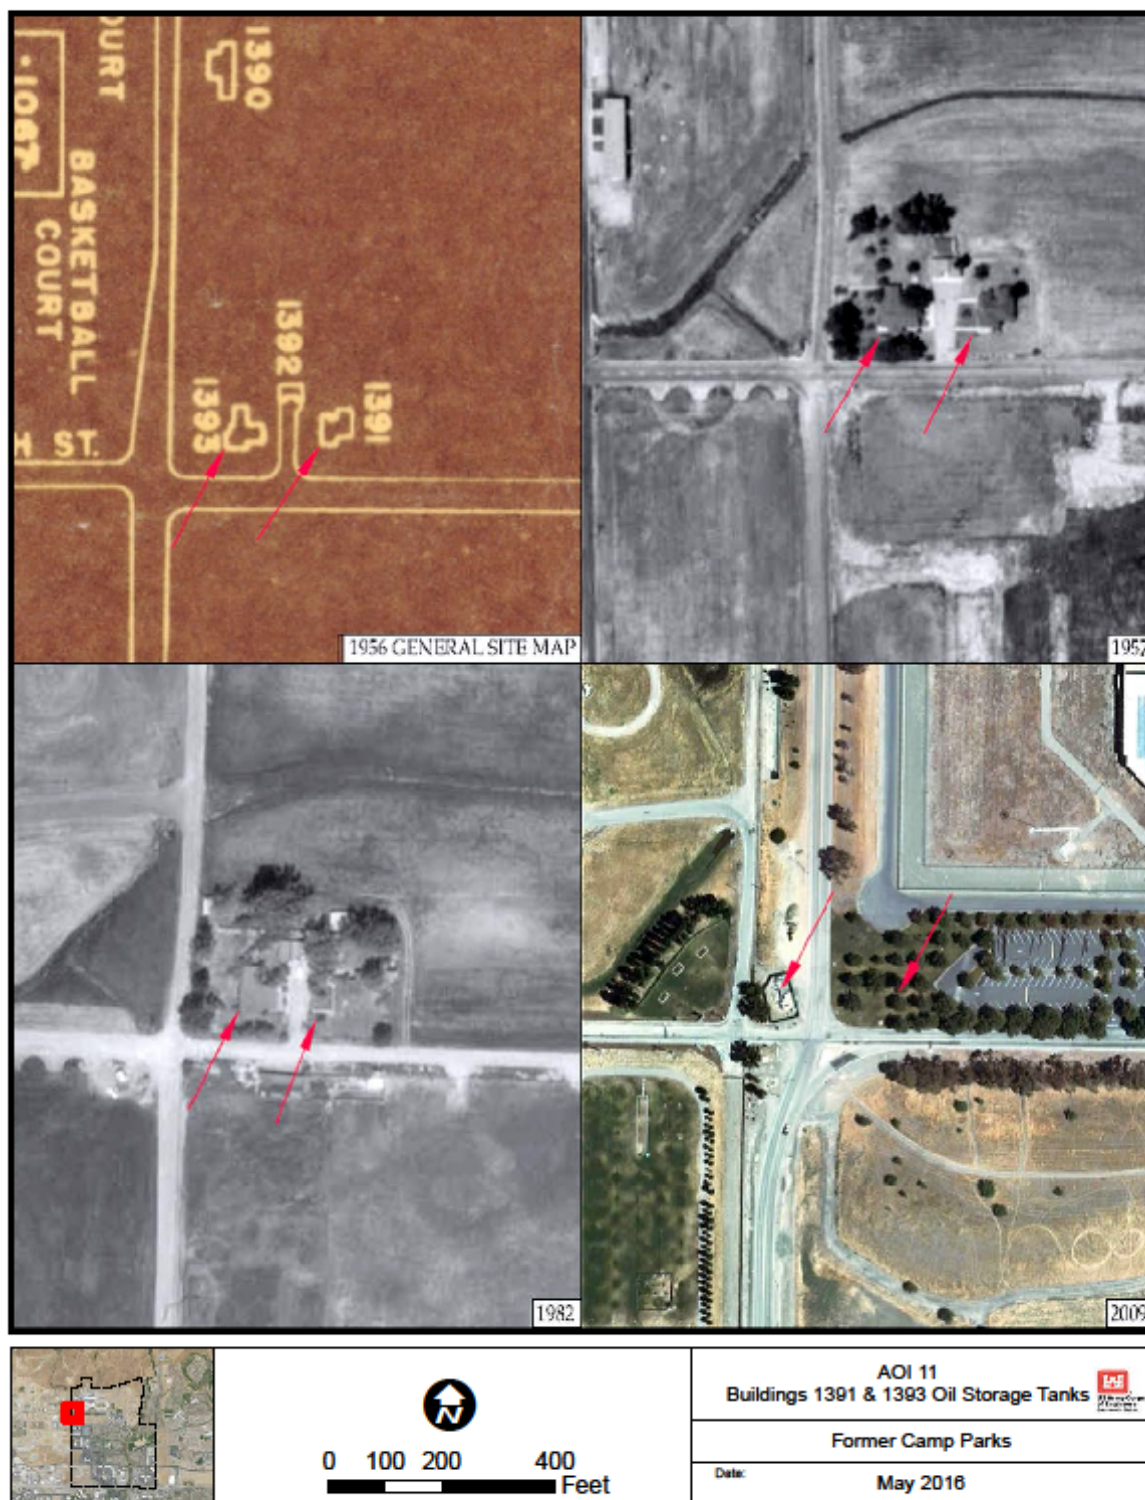
Figure 4-15 AOI 11: Buildings 1391 and 1393 Oil Storage Tanks

The Master Plan Central Heating System listing for Parks AFB (Tab G-6, Sheet 2 of 5, Appendix D) identified Officer's Family Housing Buildings (Buildings 1391 and 1393) as having oil-heating systems (Figure 4-15). These tanks were not on the 1988 Alameda County Tank Management Plan. No information pertaining to the location or size of the oil tanks was found during research. It is unknown whether these tanks were USTs or ASTs, however similar officer family housing were equipped with ASTs. Currently, the Santa Rita Jail property is situated in the former location of the two tanks, and no evidence of the former tanks is currently present.

No information regarding demolition of these buildings or removal of any tanks that may have been present has been located. Alameda County Environmental Program Manager Rod Freitag was the County's project manager for construction of a waste screening plant located at the northwest corner of the Arnold/Broder intersection, the approximate location of building 1393 based on historical maps (see Figure 4-15, lower right quadrant). Per Mr. Freitag, excavations for the plant and associated sewer lines extended more than 10 feet bgs. Construction involved excavation of the northwest quadrant of the intersection and trenching across Arnold, and no fuel tanks or evidence of fuel contamination was observed. Considering this and other development in the immediate area, it's unlikely that any tanks remain or that significant soil contamination exists. Given that the location of these tanks relative to the buildings is unknown, and that the buildings have been completely removed, there would be a high amount of uncertainty in performing any sampling, as the location of the tanks is unknown. Also, past excavations and construction in the area have shown no sign of contamination. This AOI is FUDS-eligible, however, due to no evidence of remaining tanks or contamination and the uncertainty of sampling, it is recommended that no further investigation be done as part of this PA/SI and that an NDAI determination be made.

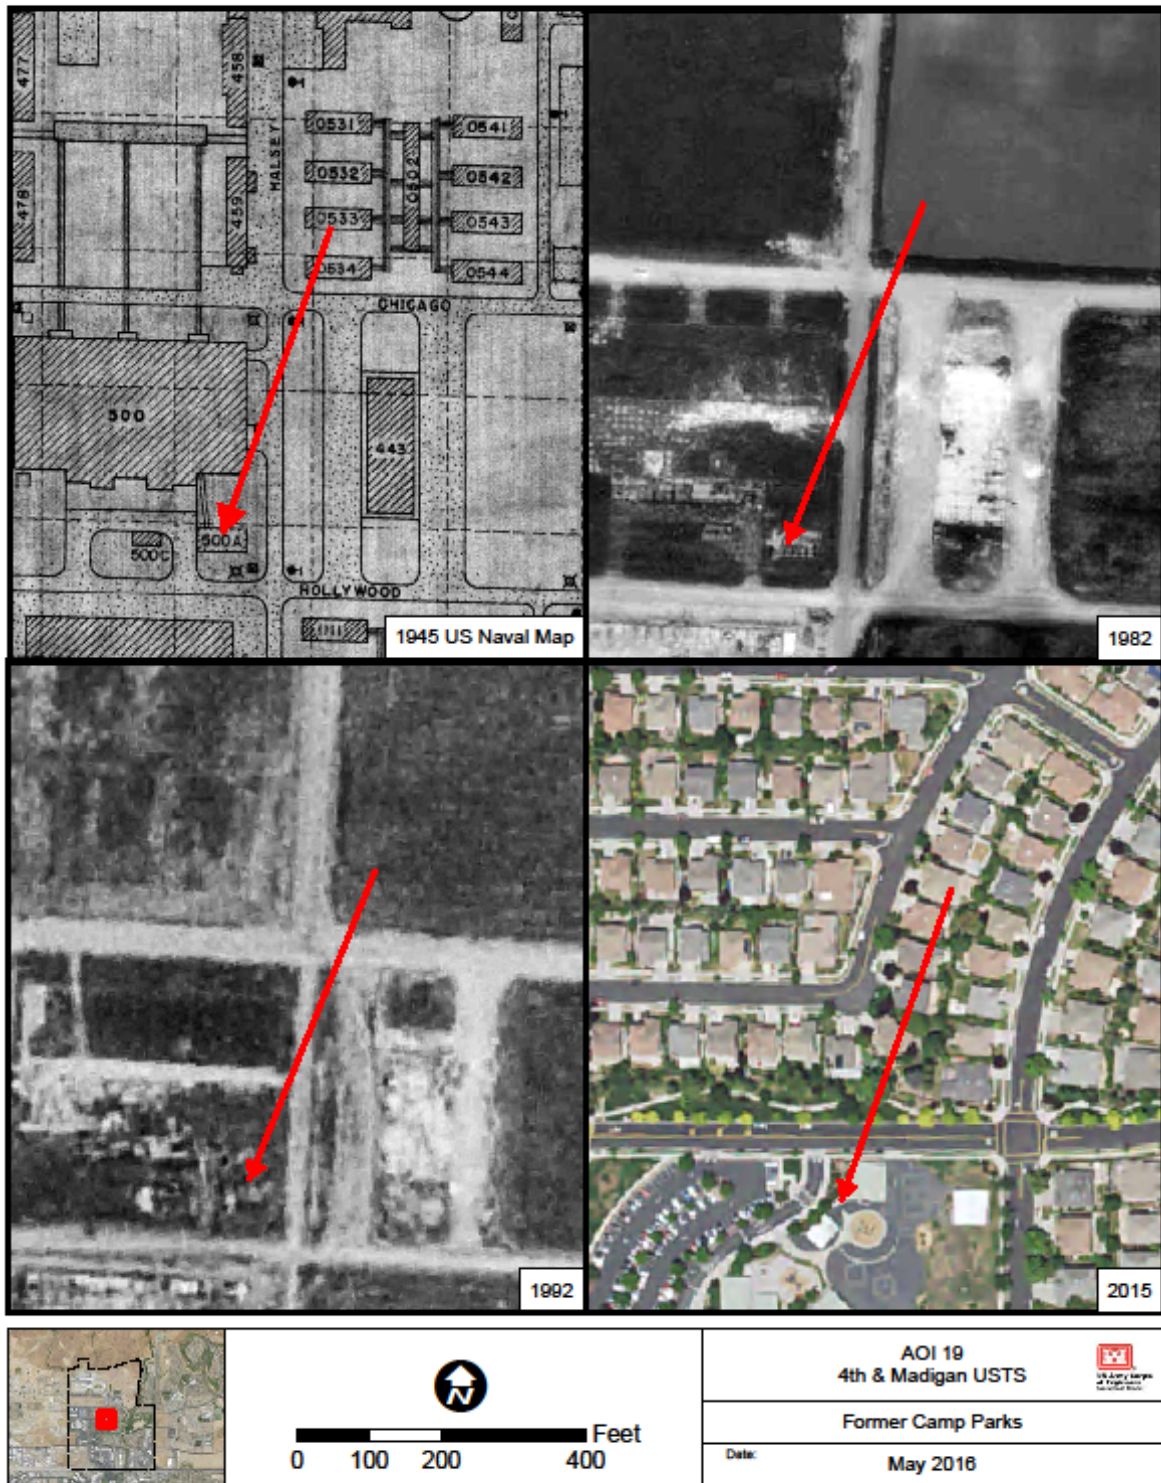
Figure 4-24 AOI 19: 4th and Madigan USTs

Three tanks were associated with Building 500-A, identified as a boiler house on the 1945 Naval Map (Figure 4-24). These tanks are identified as Tanks 4, 4A and 4B, and were 10,000-gallon, approximately 8,000-gallon, and approximately 3,000-gallon fuel oil USTs. Only the 3,000 gallon tank is listed in the 1988 Tank Management plan, and it is described as installed in 1955, containing Bunker C oil, and abandoned (Gregg, 1988). The tanks were removed by Alameda County on 18 May 1992. The case was closed by Alameda County in March 1996 (Alameda County, 1996) (Appendix E). This AOI is FUDS-eligible, however, due to the closure certification, it is recommended that no further investigation be done as part of this PA/SI and that an NDAI determination be made.
