APPENDIX B
Wetland Delineation Report

UTAH LAKE RESTORATION PROJECT

DRAFT WETLAND DELINEATION

Project Number DE0475

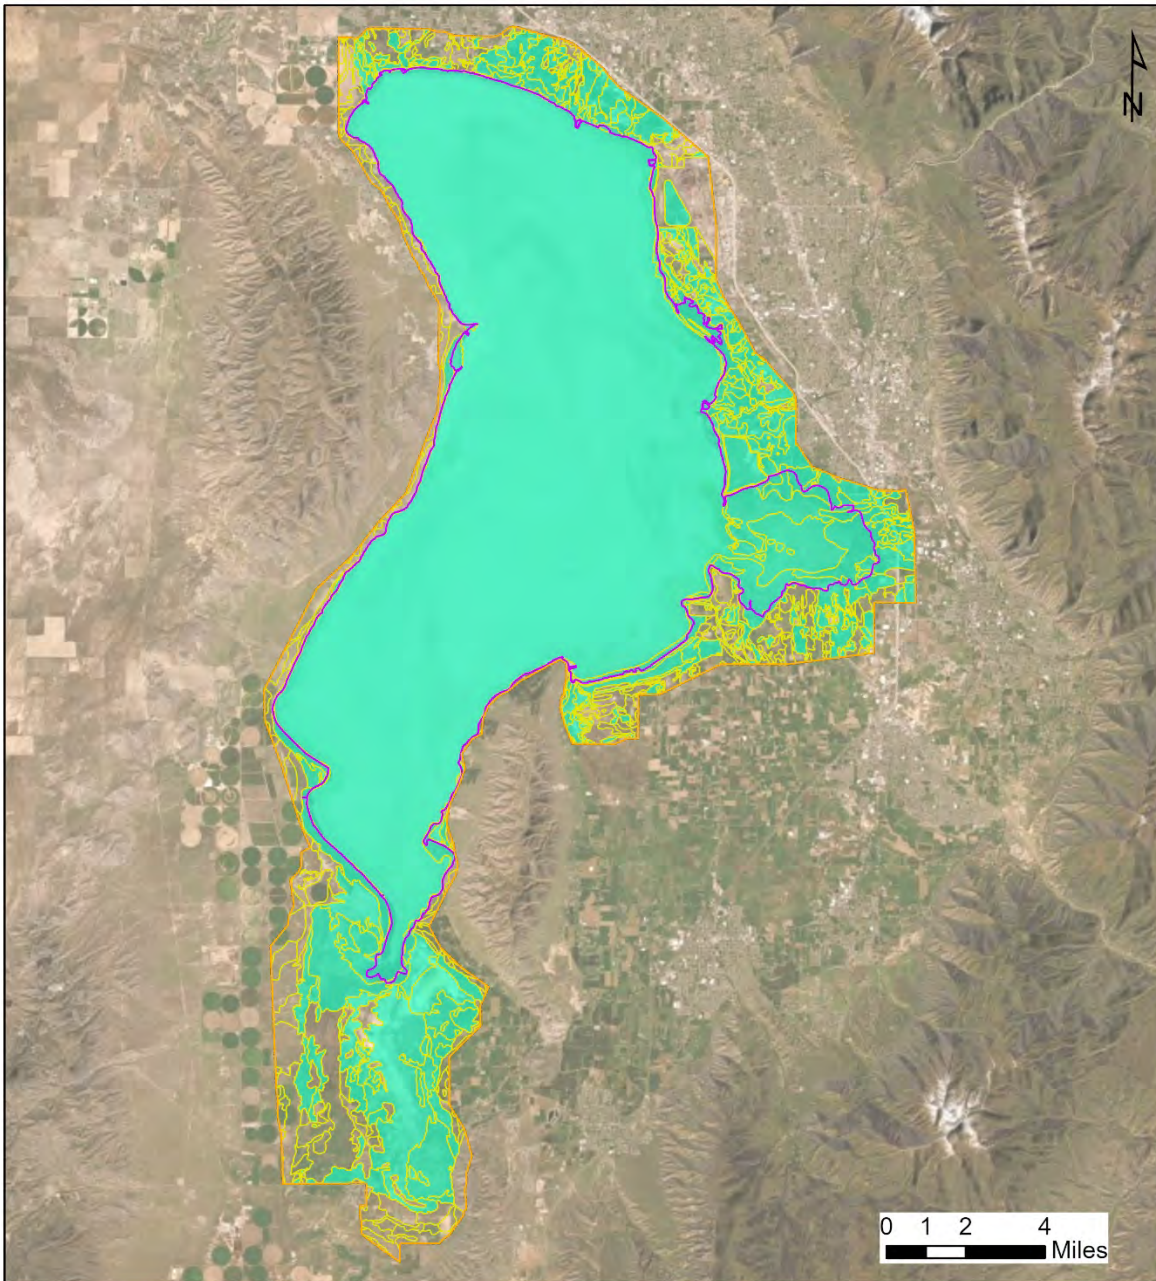
<ul style="list-style-type: none"> ▮ Area of Analysis - Wetlands Desktop Assessment Boundary ▮ Utah Lake at Compromise Line ▮ NRCS Soil Series ▮ NRCS Hydric Soil Series 	NRCS Soil Series Map Utah Lake Restoration Project Utah County, UT	
		Figure 2
	Austin, TX	November 2021

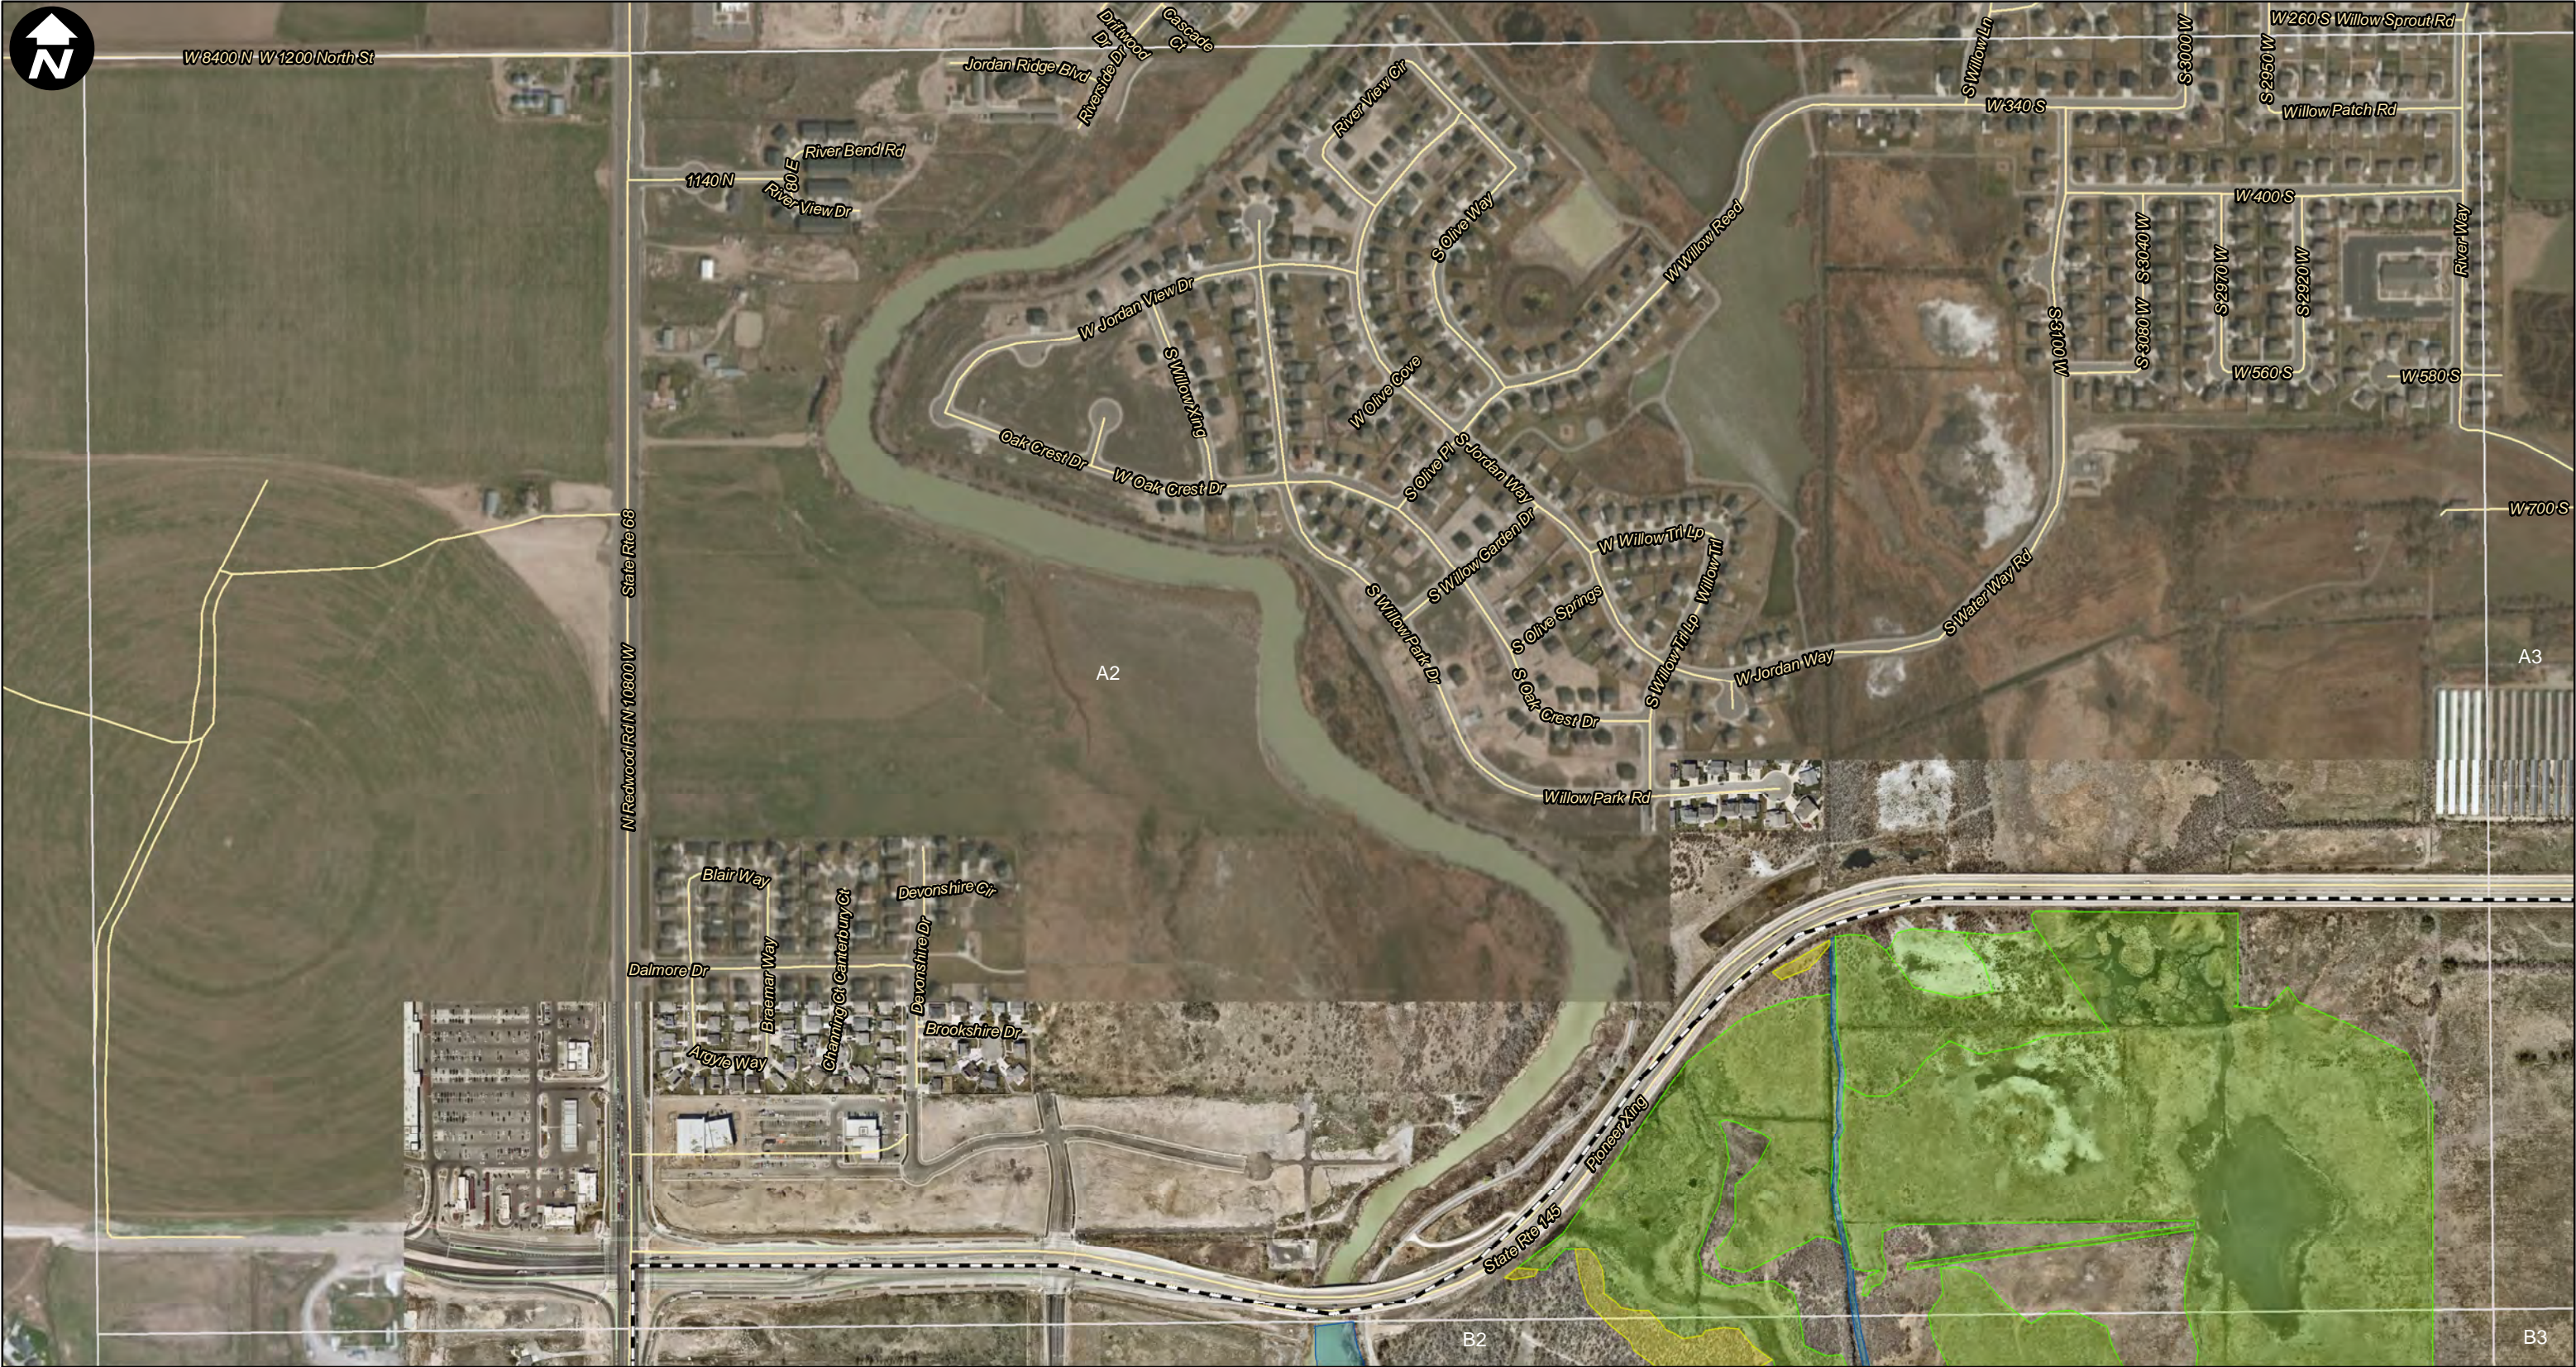
Legend	
Grid Map	Freshwater Shrub Wetland
Wetlands Desktop Assessment Boundary	Riverine
Streets	
Wetland Type	
Freshwater Emergent Wetland	
Datasource: -Imagery provided by ESRI World Imagery (Clarity) feature service and Nearmaps (date of imagery capture: 3/12/2021) -Imagery feature service accessed on 11/17/2021	
Utah Lake Restoration Project Lake Restoration Solutions, Inc. Utah County, Utah	
Wetlands Desktop Assessment	
Geosyntec consultants	
Grid Map	
A2	
DE0475	November 2021

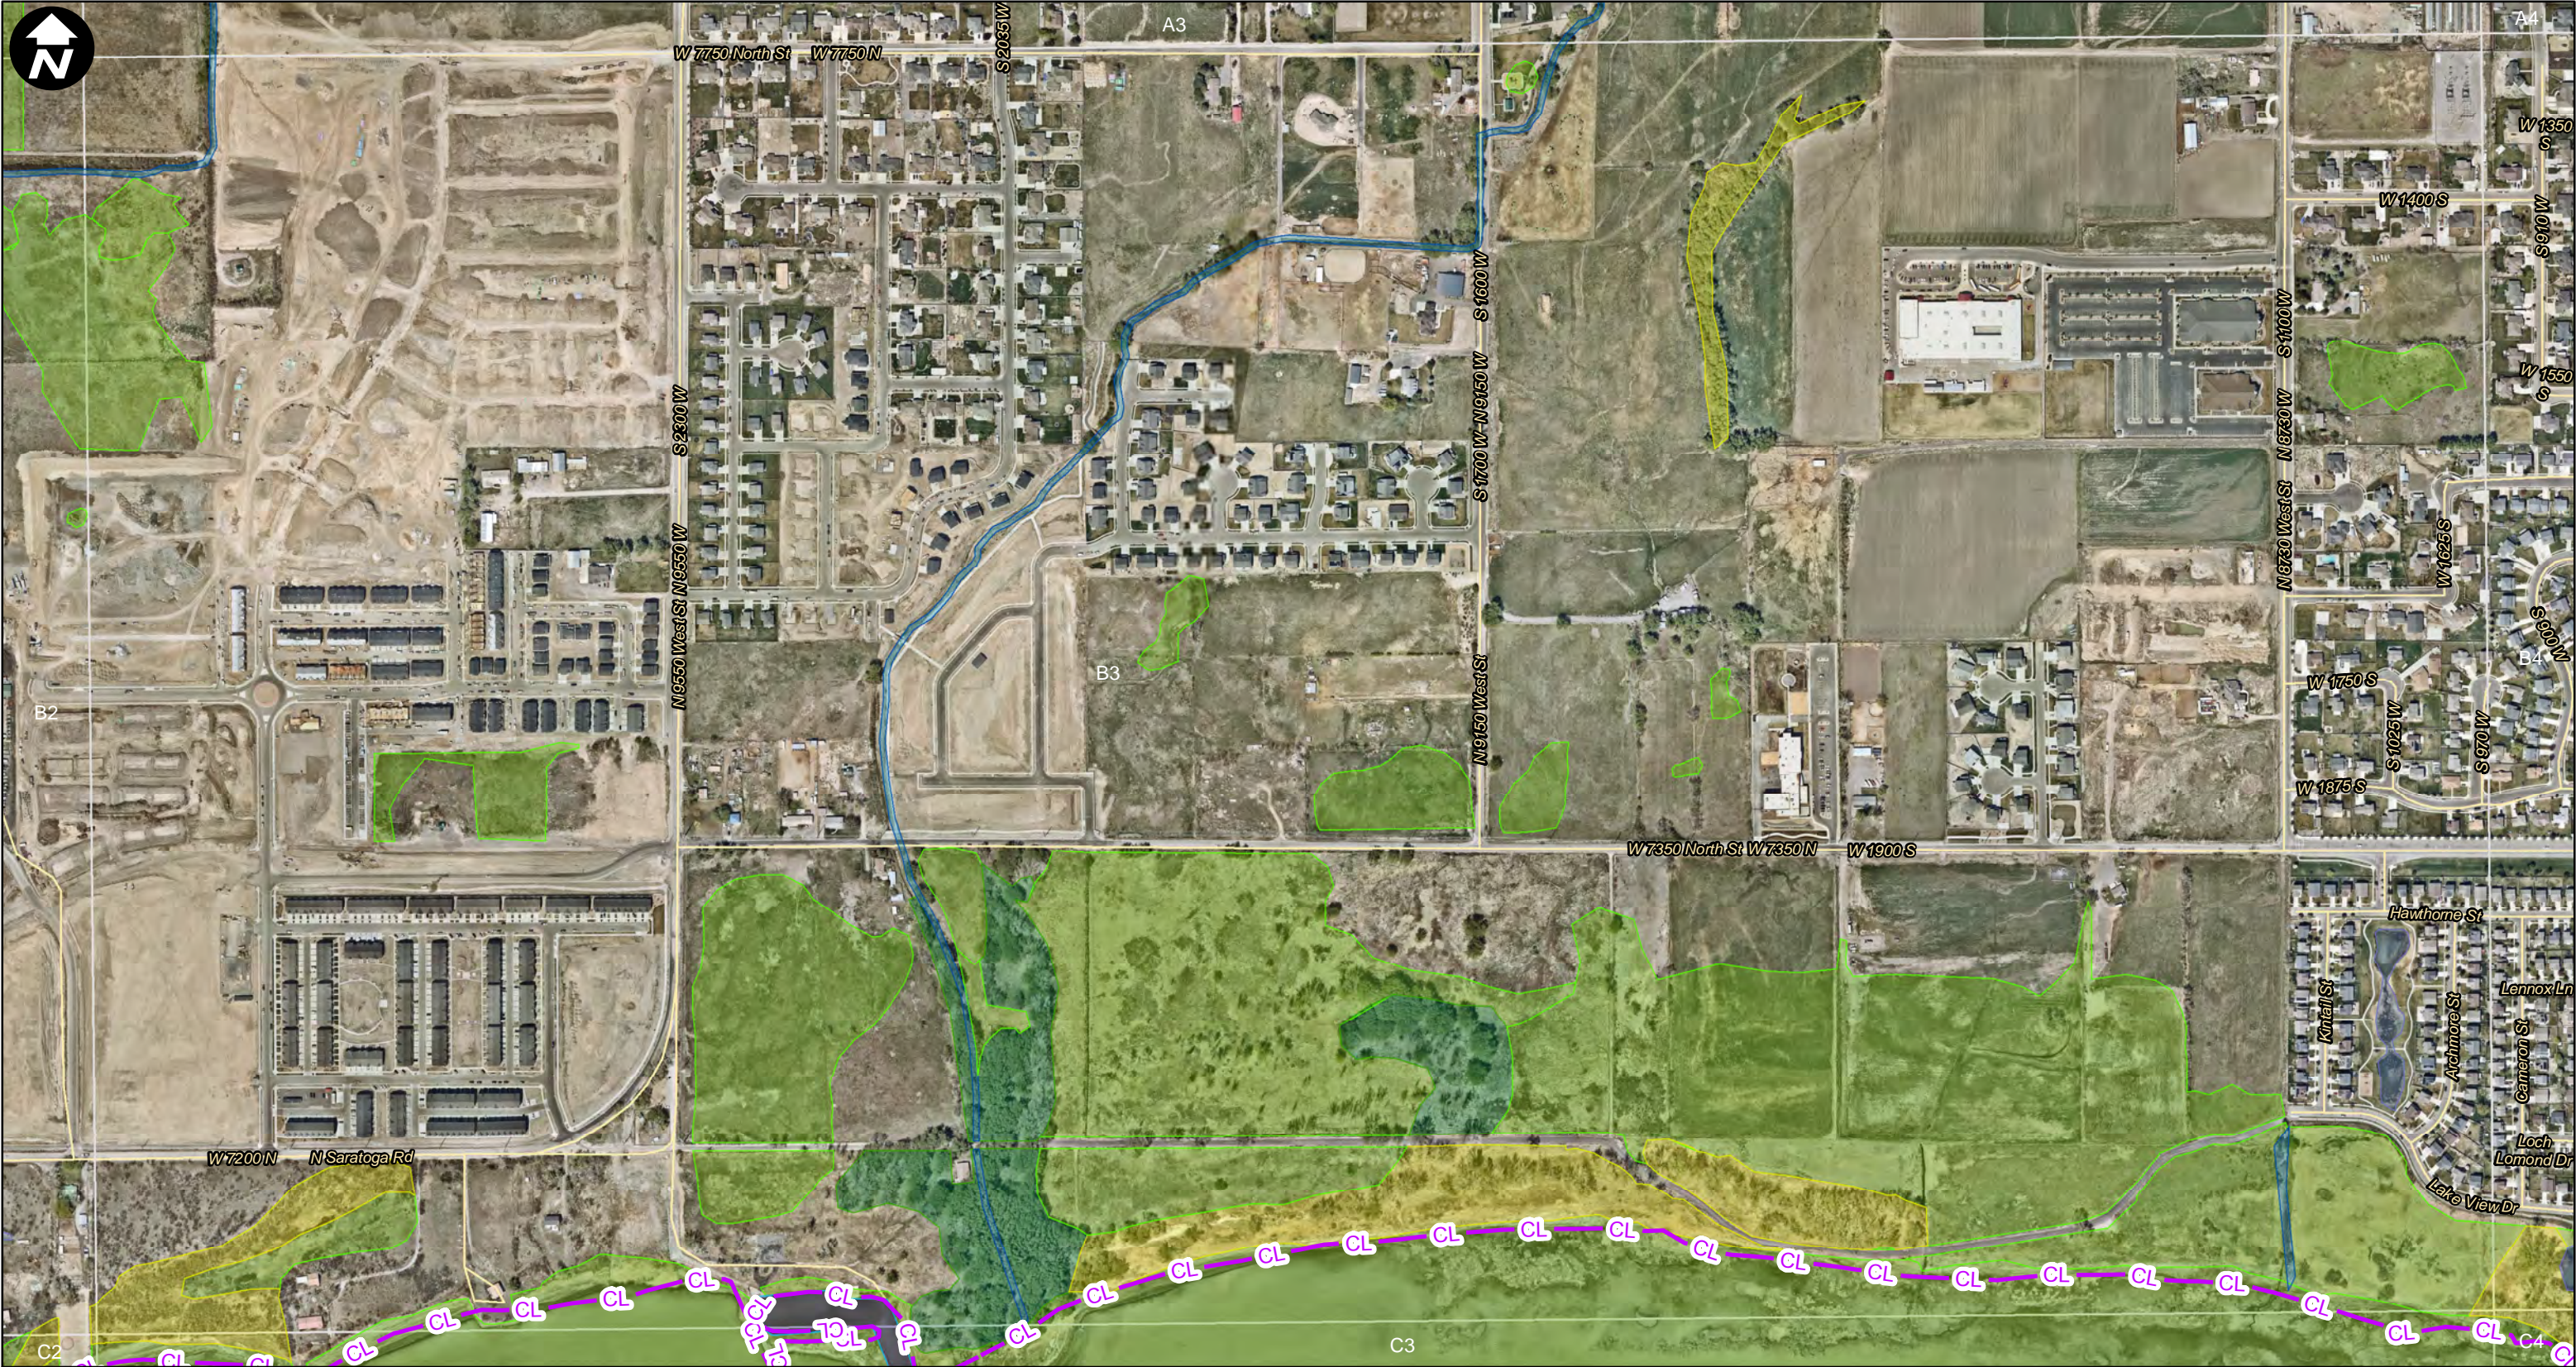
Legend		Wetland Type		Water	
	Grid Map		Freshwater Emergent Wetland		Lake
	Wetlands Desktop Assessment Boundary		Freshwater Shrub Wetland		Riverine
	Compromise Line Boundary		Freshwater Forested Wetland		
	Streets		Freshwater Pond

Utah Lake Restoration Project Lake Restoration Solutions, Inc. Utah County, Utah	
Wetlands Desktop Assessment	
Geosyntec consultants	
Grid Map	
B3	
DE0475	November 2021

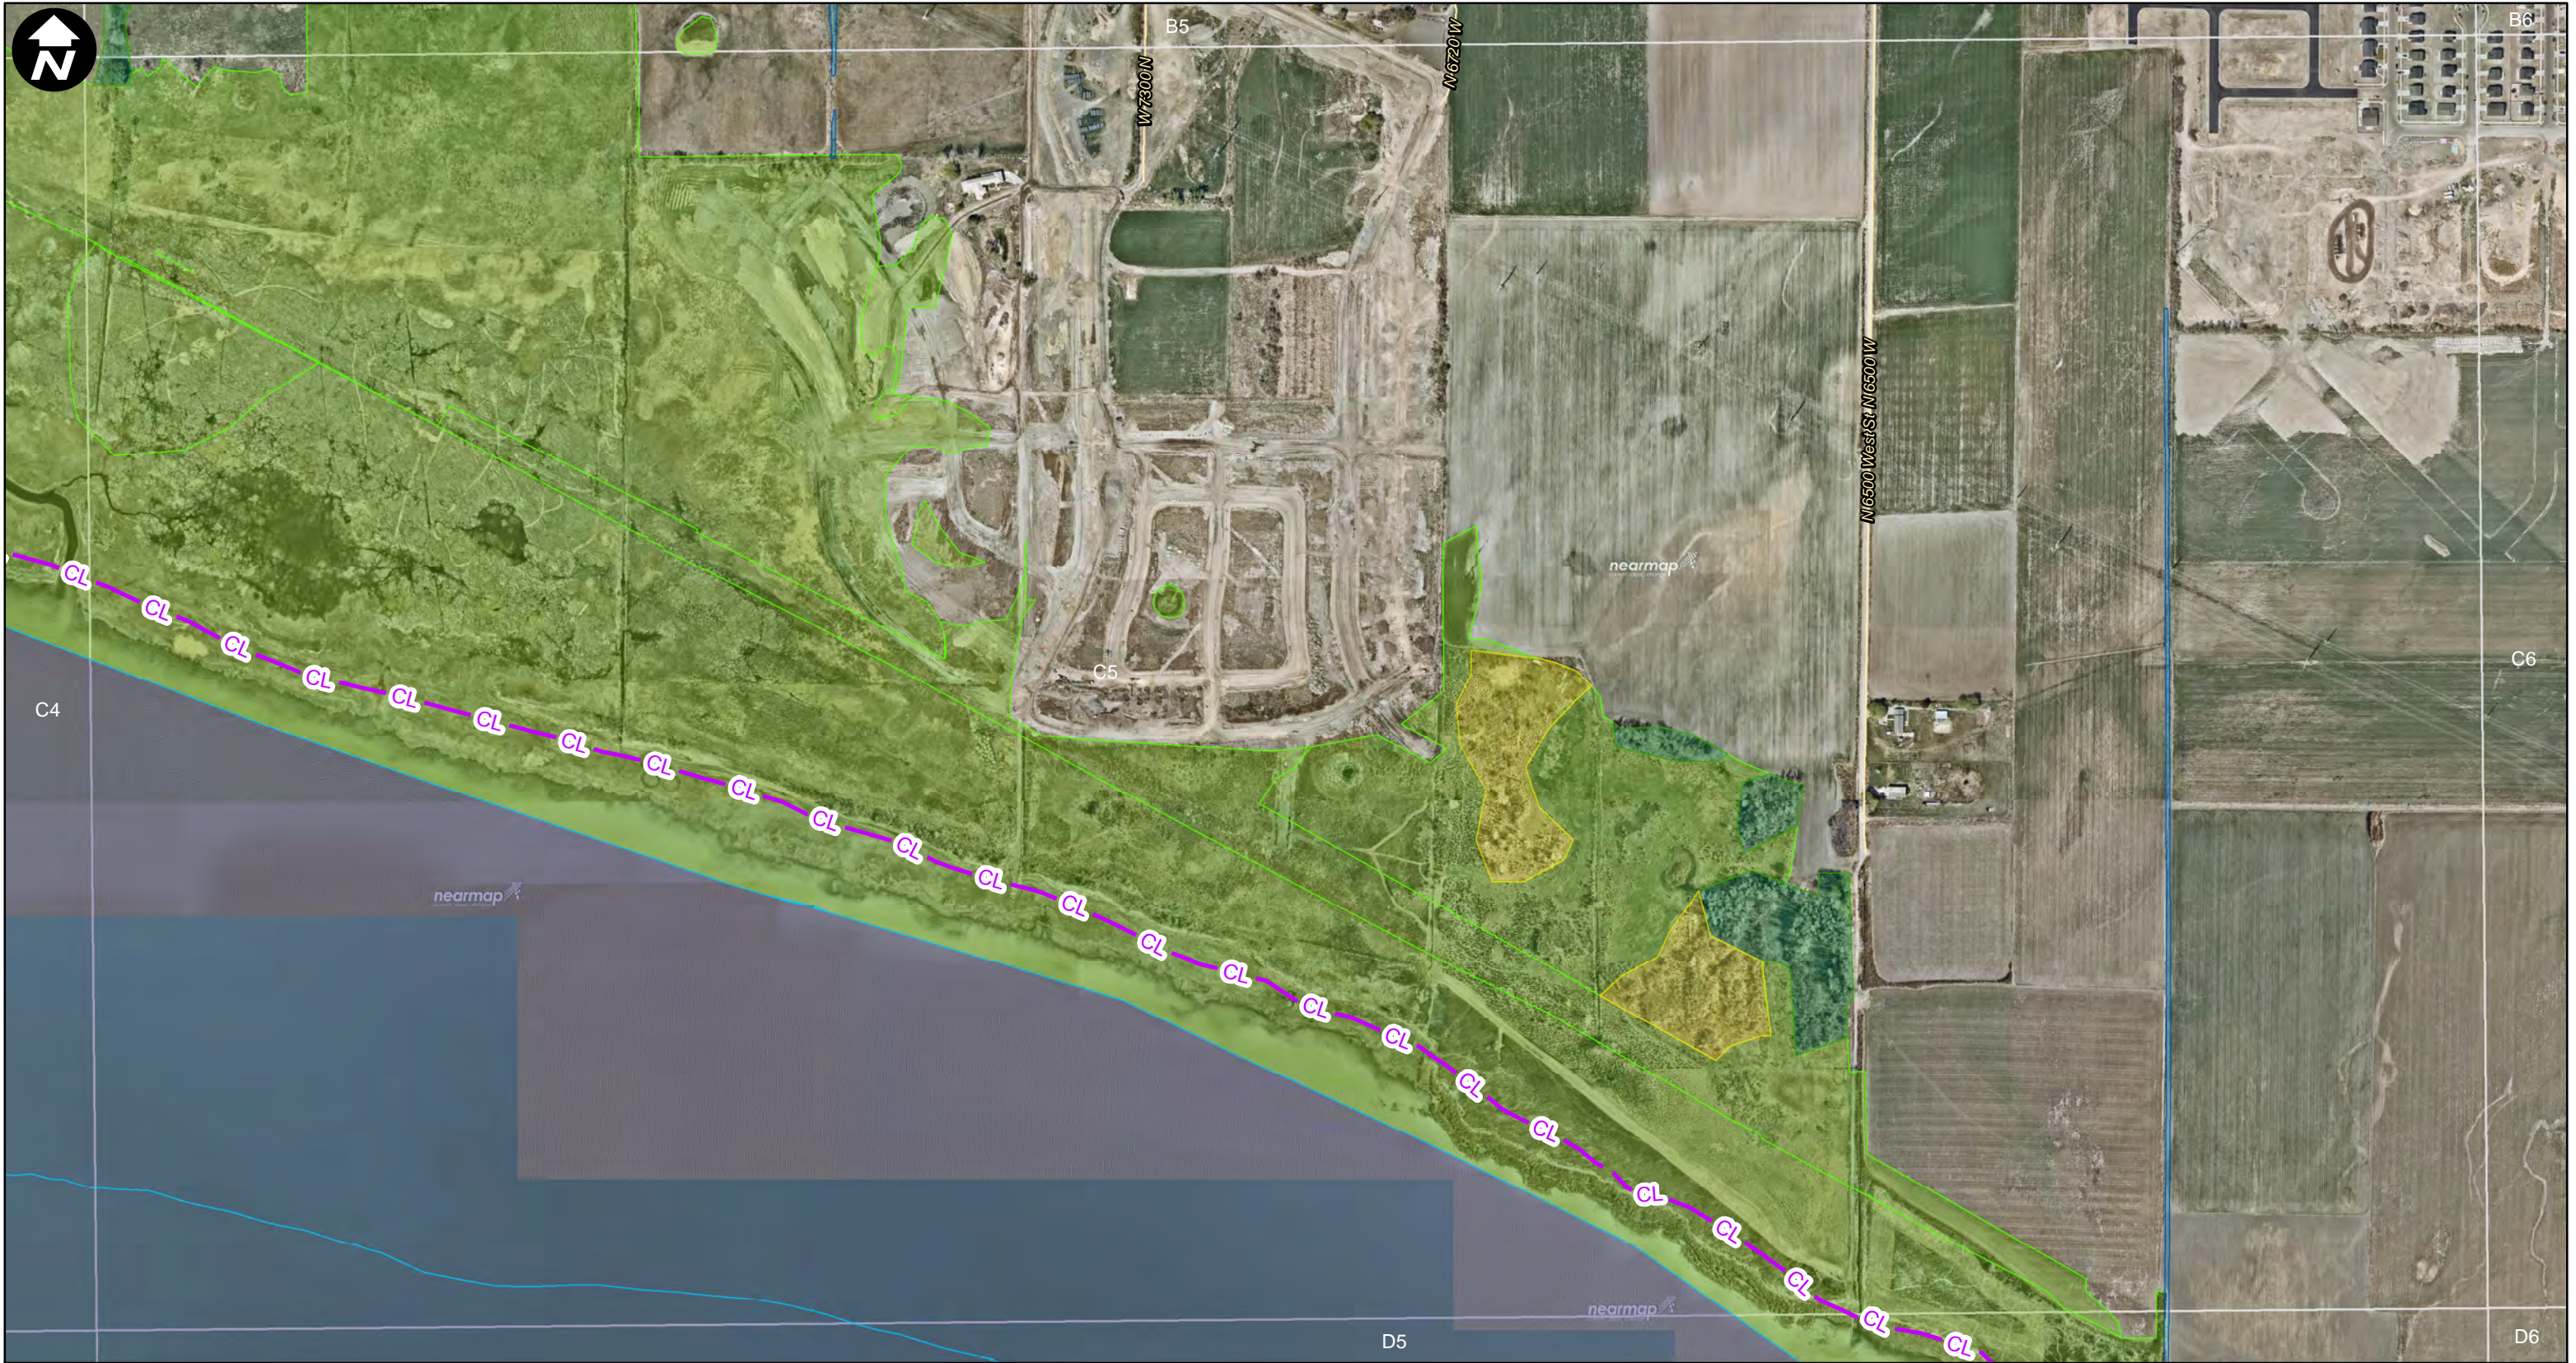
Legend		Wetland Type		Riverine	
Grid Map		Freshwater Emergent Wetland			
Wetlands Desktop Assessment Boundary		Freshwater Shrub Wetland			
CL - Compromise Line Boundary		Freshwater Forested Wetland			
Streets		Lake

Utah Lake Restoration Project Lake Restoration Solutions, Inc. Utah County, Utah	
Wetlands Desktop Assessment	
Geosyntec consultants	
Grid Map	
C5	
DE0475	November 2021

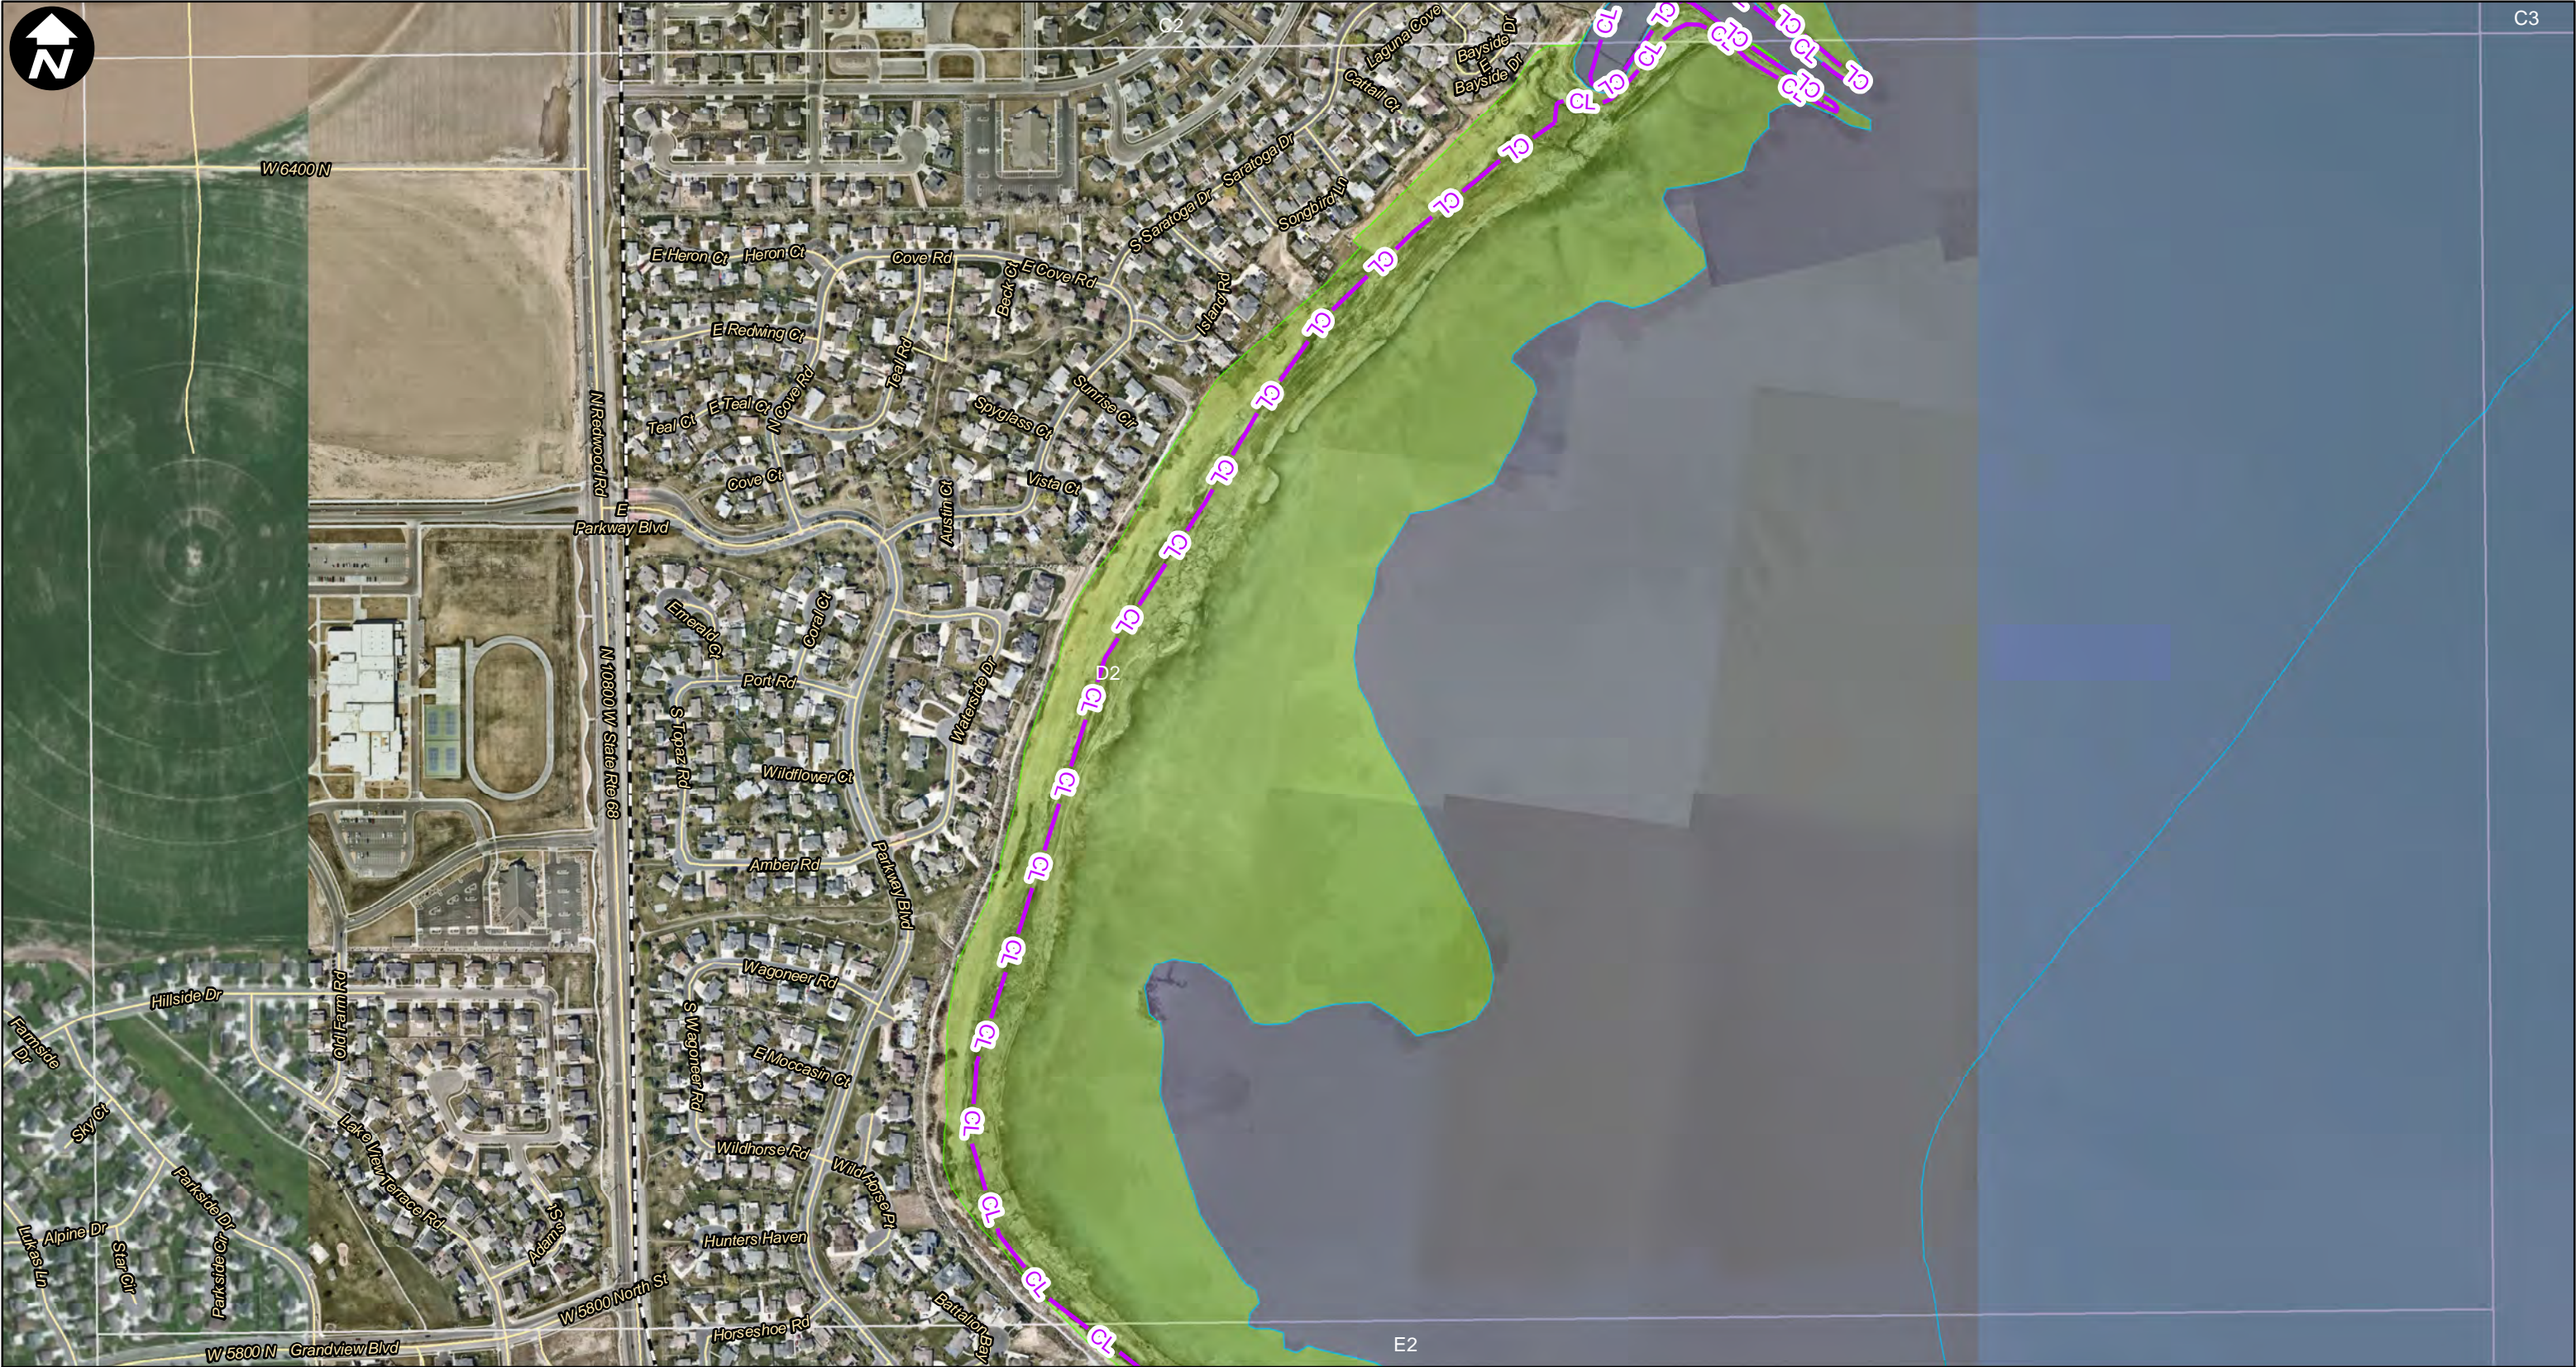
Legend		Wetland Type	
	Grid Map		Freshwater Emergent Wetland
	Wetlands Desktop Assessment Boundary		Lake
	Compromise Line Boundary		
	Streets

Utah Lake Restoration Project Lake Restoration Solutions, Inc. Utah County, Utah	
Wetlands Desktop Assessment	
Geosyntec consultants	
DE0475	November 2021
Grid Map	
D2

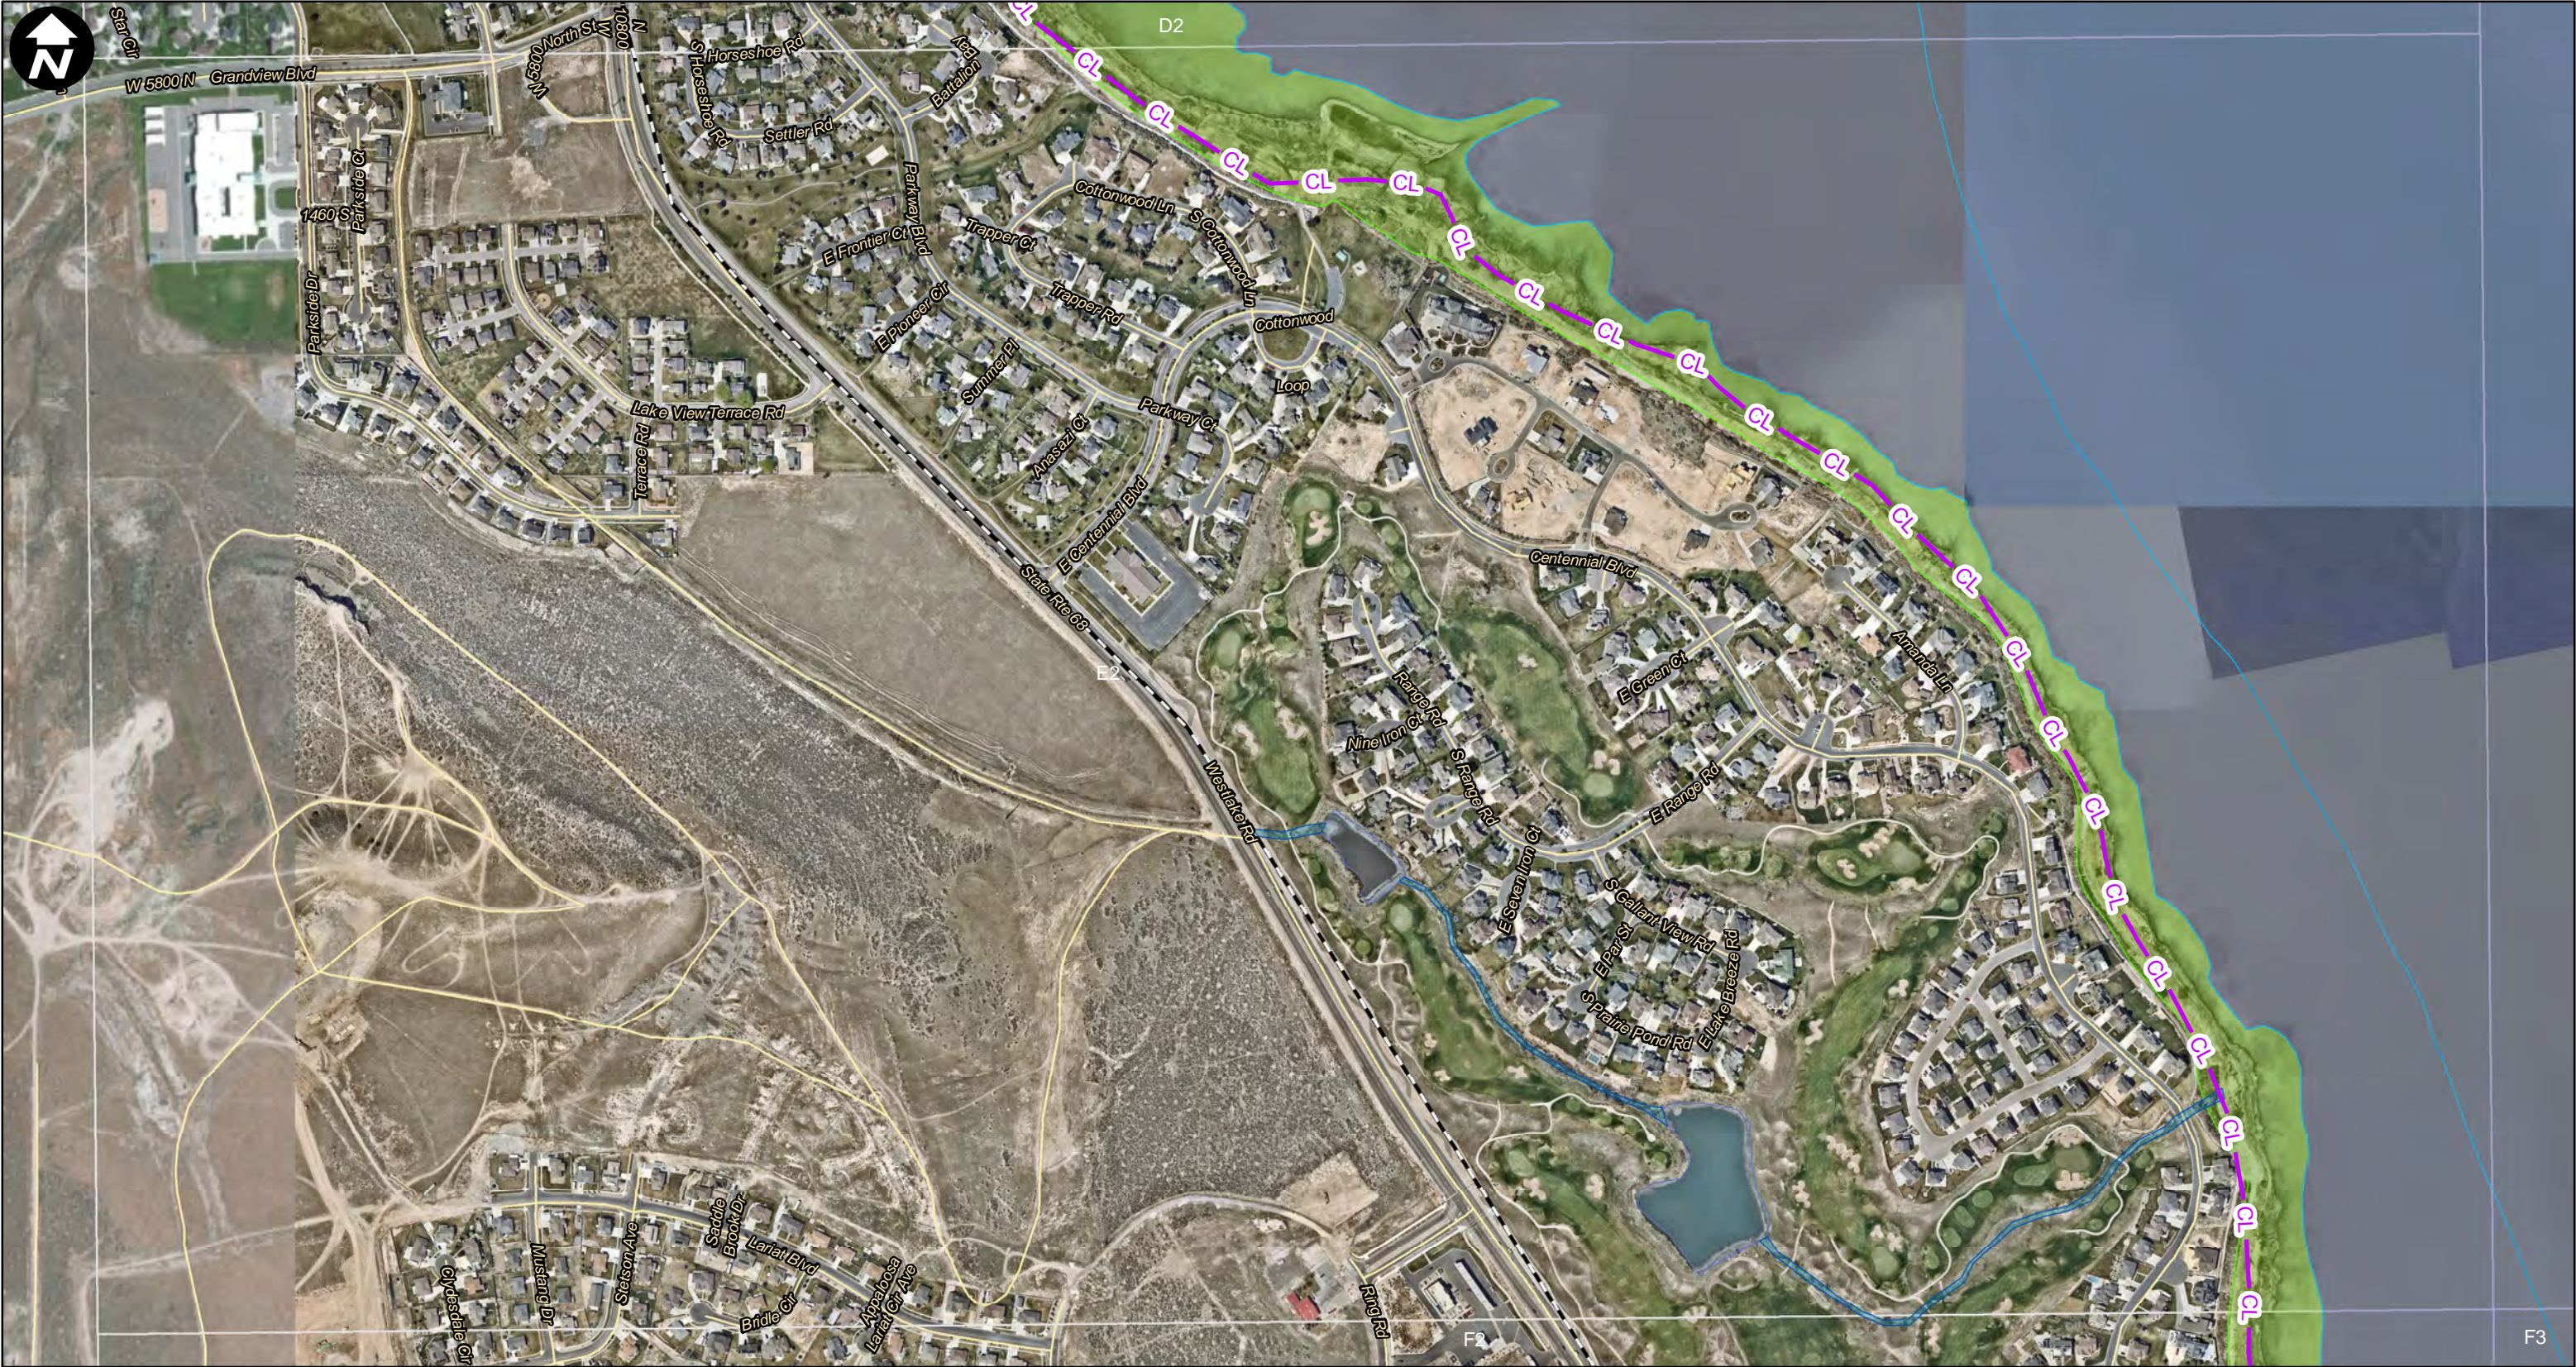
Legend		Wetland Type	
	Grid Map		Freshwater Emergent Wetland
	Wetlands Desktop Assessment Boundary		Freshwater Pond
	Compromise Line Boundary		Lake
	Streets		Riverine

Utah Lake Restoration Project Lake Restoration Solutions, Inc. Utah County, Utah	
Wetlands Desktop Assessment	
Geosyntec consultants	
Grid Map	
E2	
DE0475	November 2021

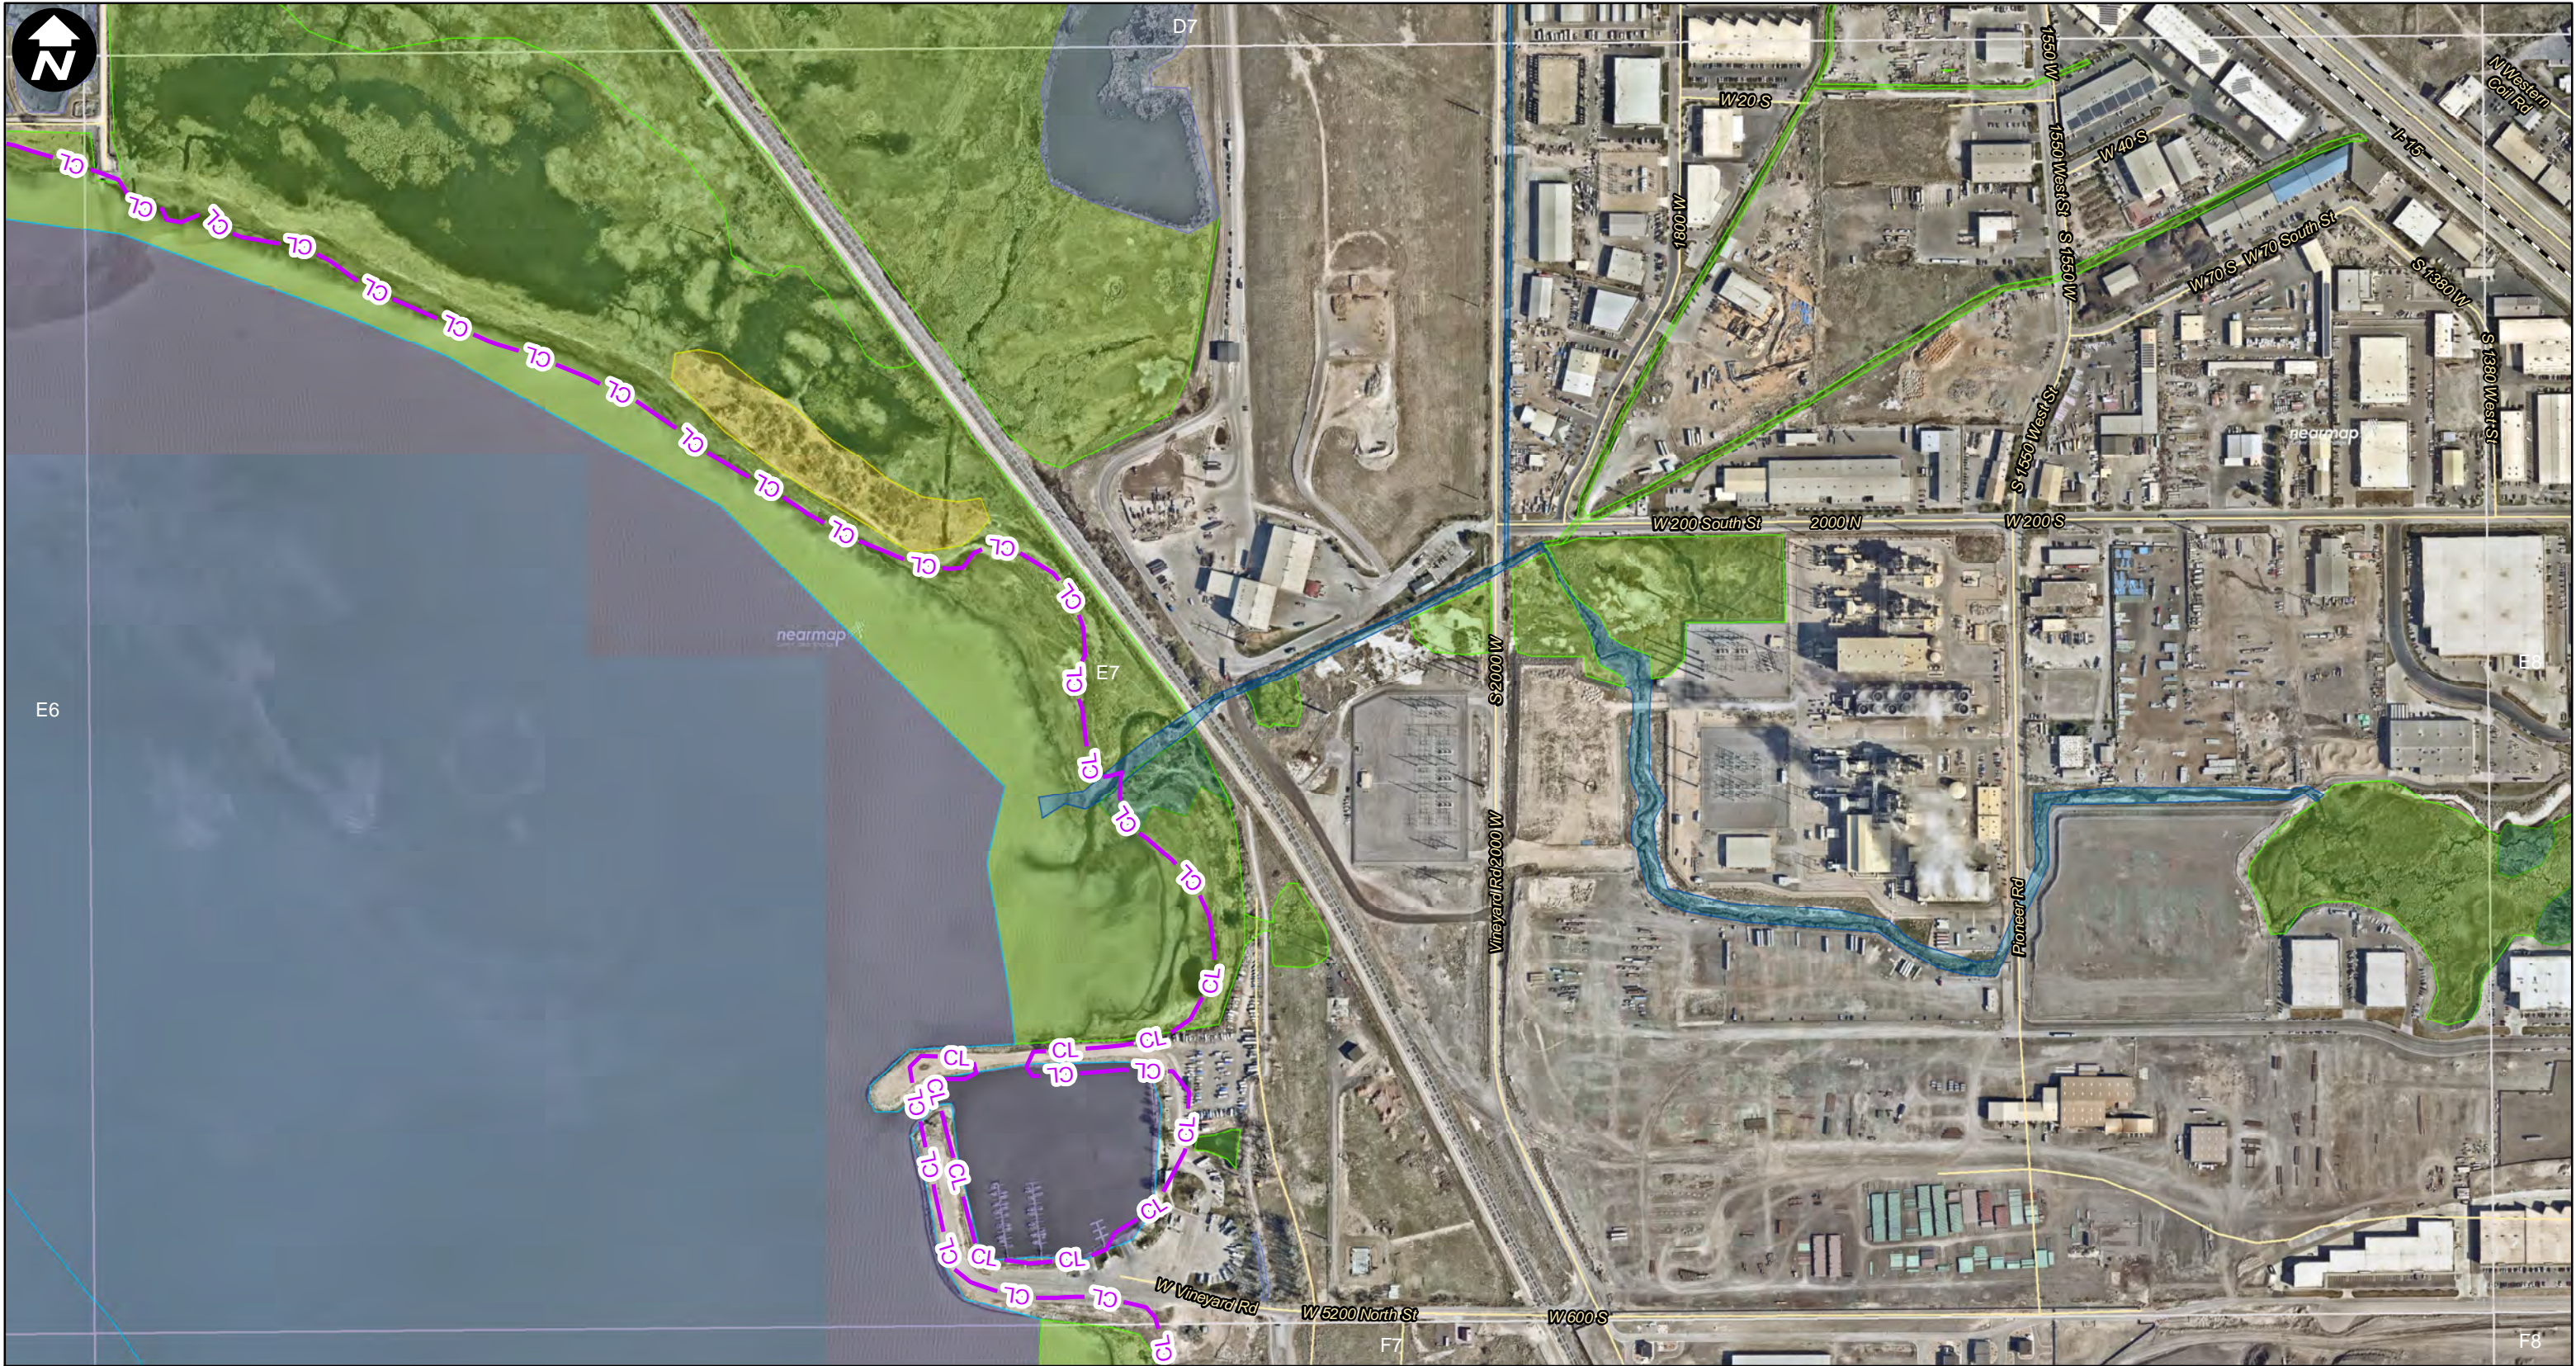
Legend		Wetland Type	
Grid Map	Streets	Freshwater Pond	
Rails	Freshwater Emergent Wetland	Lake	
Wetlands Desktop Assessment Boundary	Freshwater Shrub Wetland	Riverine	
CL - Compromise Line Boundary	Freshwater Forested Wetland

Utah Lake Restoration Project Lake Restoration Solutions, Inc. Utah County, Utah	
Wetlands Desktop Assessment	
Geosyntec consultants	Grid Map
DE0475	E7
November 2021
