APPENDIX B
Wetland Delineation Report

UTAH LAKE RESTORATION PROJECT

DRAFT WETLAND DELINEATION

Project Number DE0475

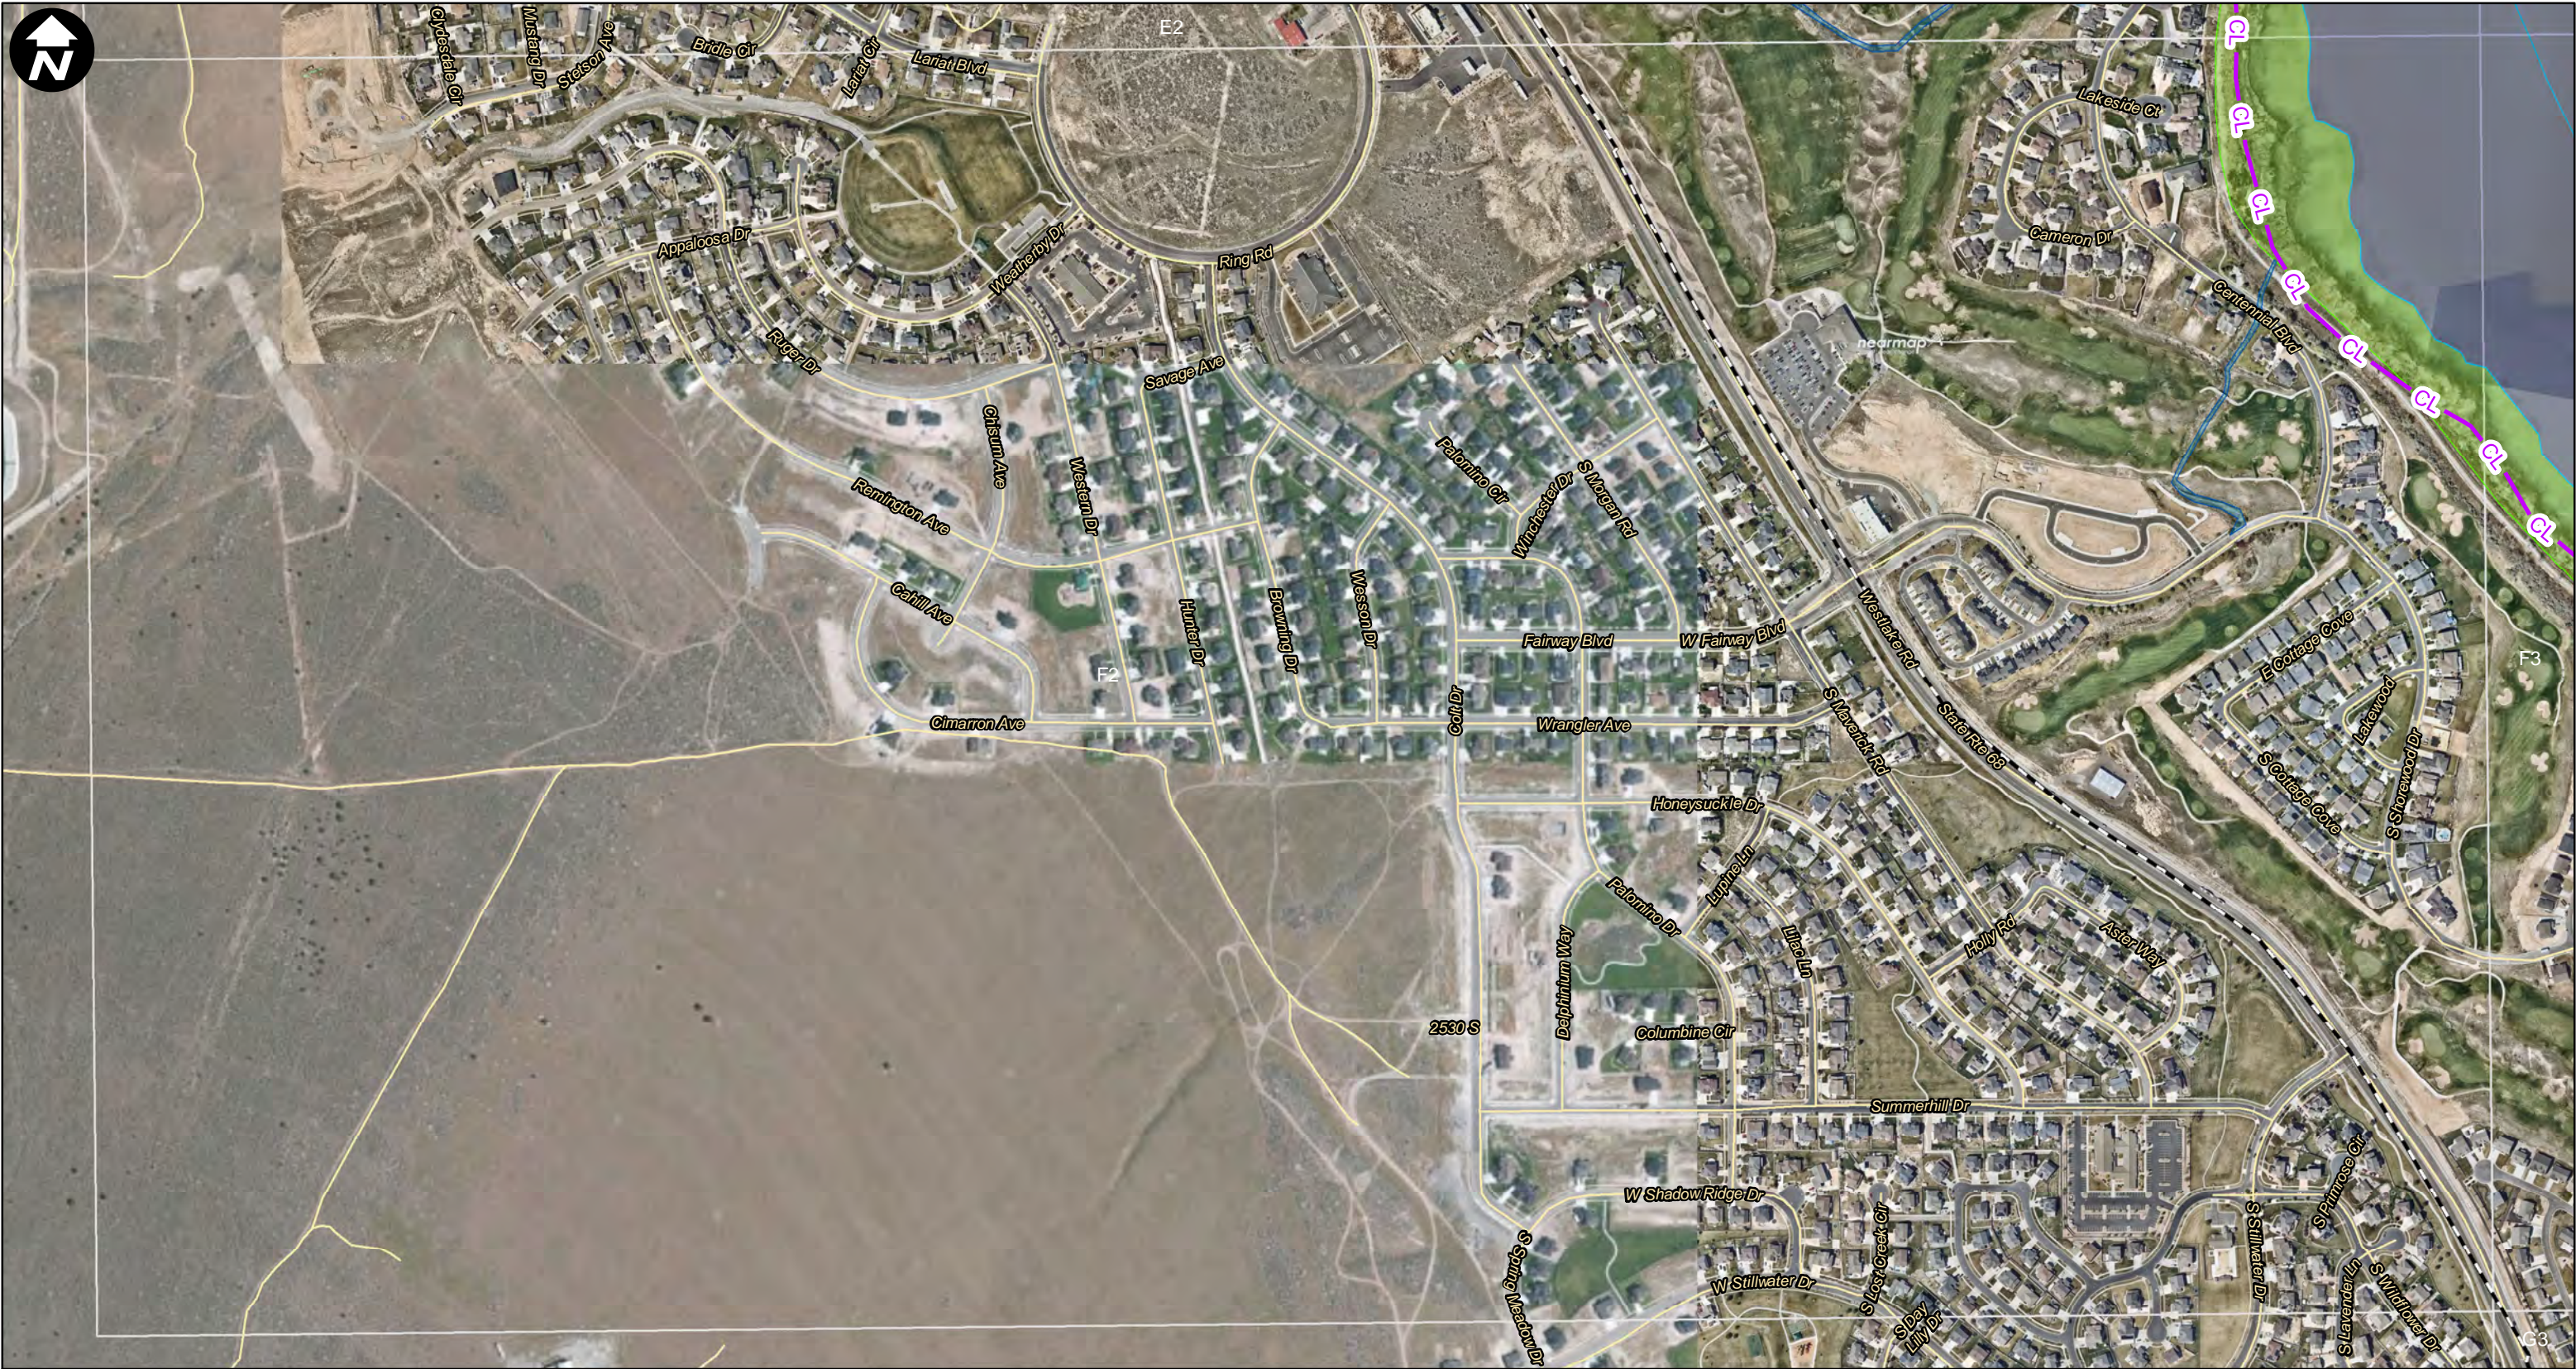
Legend		Wetland Type	
	Grid Map		Freshwater Emergent Wetland
	Wetlands Desktop Assessment Boundary		Lake
	Compromise Line Boundary		Riverine
	Streets

Utah Lake Restoration Project Lake Restoration Solutions, Inc. Utah County, Utah	
Wetlands Desktop Assessment	
Geosyntec consultants	
DE0475	November 2021
Grid Map	
F2

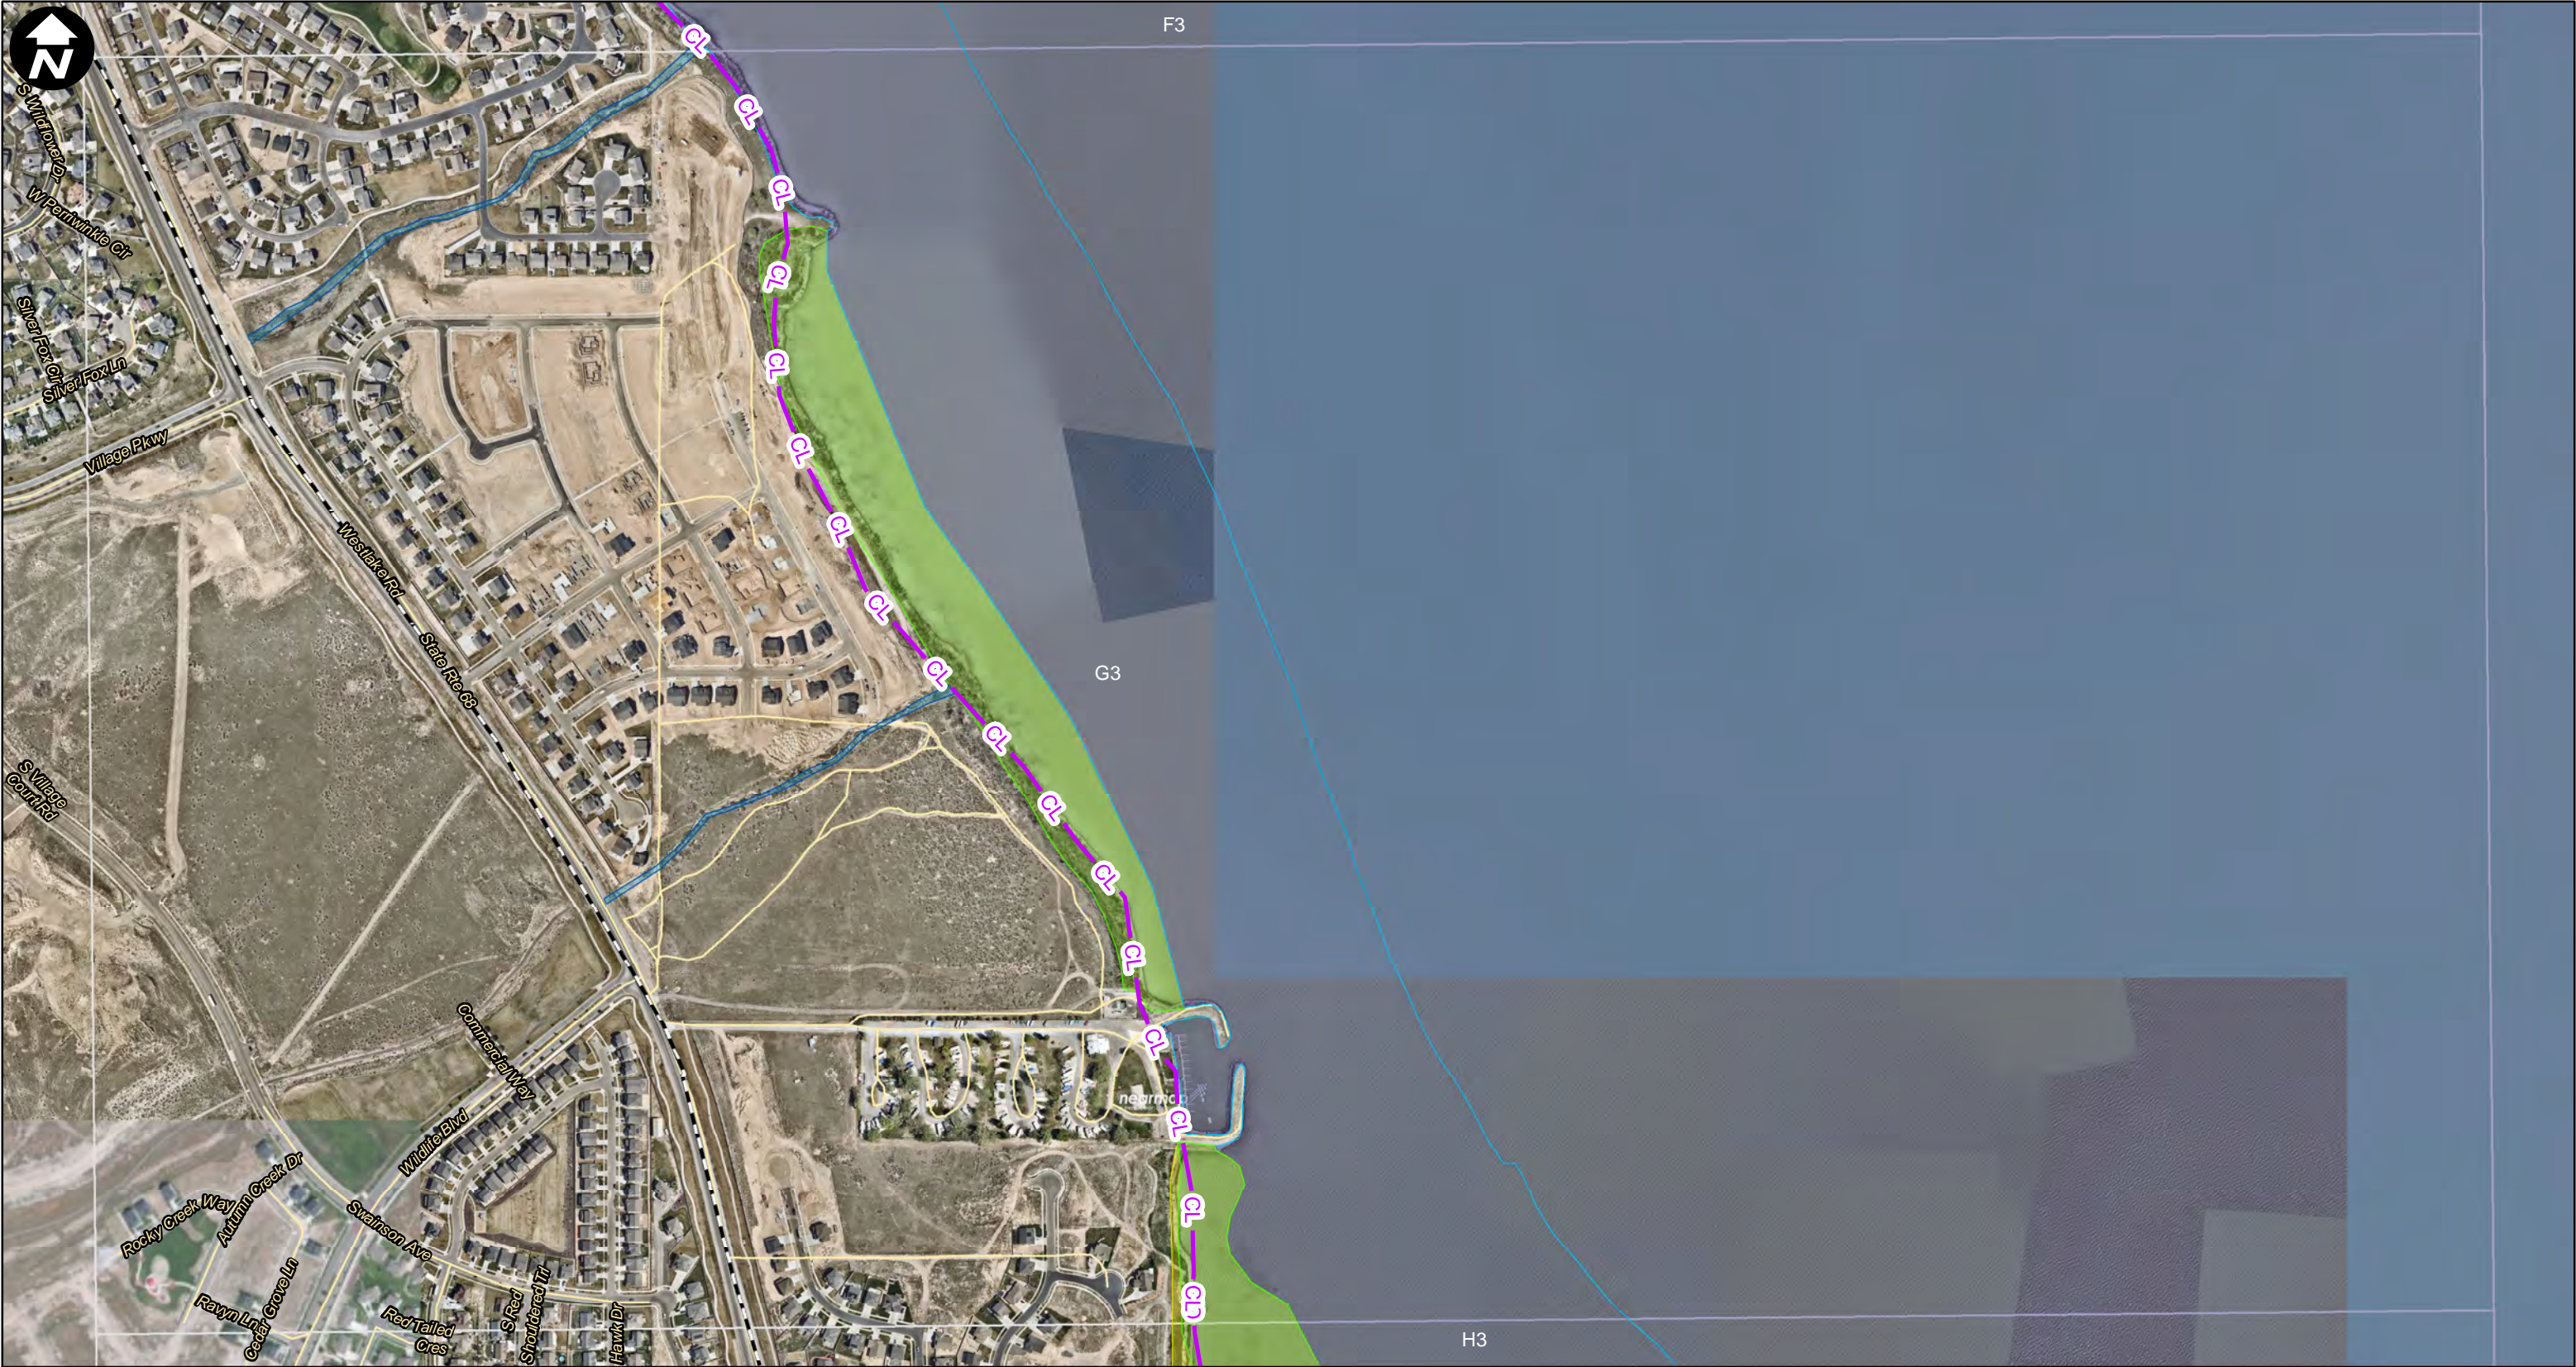
Legend			
	Grid Map		
	Wetlands Desktop Assessment Boundary		
	Compromise Line Boundary		
	Streets		
Wetland Type			
	Freshwater Emergent Wetland		
	Freshwater Shrub Wetland		
	Lake		
	Riverine		
		<p>Datasource: -Imagery provided by ESRI World Imagery (Clarity) feature service and Nearmaps (date of imagery capture: 3/12/2021) -Imagery feature service accessed on 11/17/2021</p>	
Utah Lake Restoration Project Lake Restoration Solutions, Inc. Utah County, Utah			
Wetlands Desktop Assessment			
		Grid Map	
DE0475		November 2021	
		G3

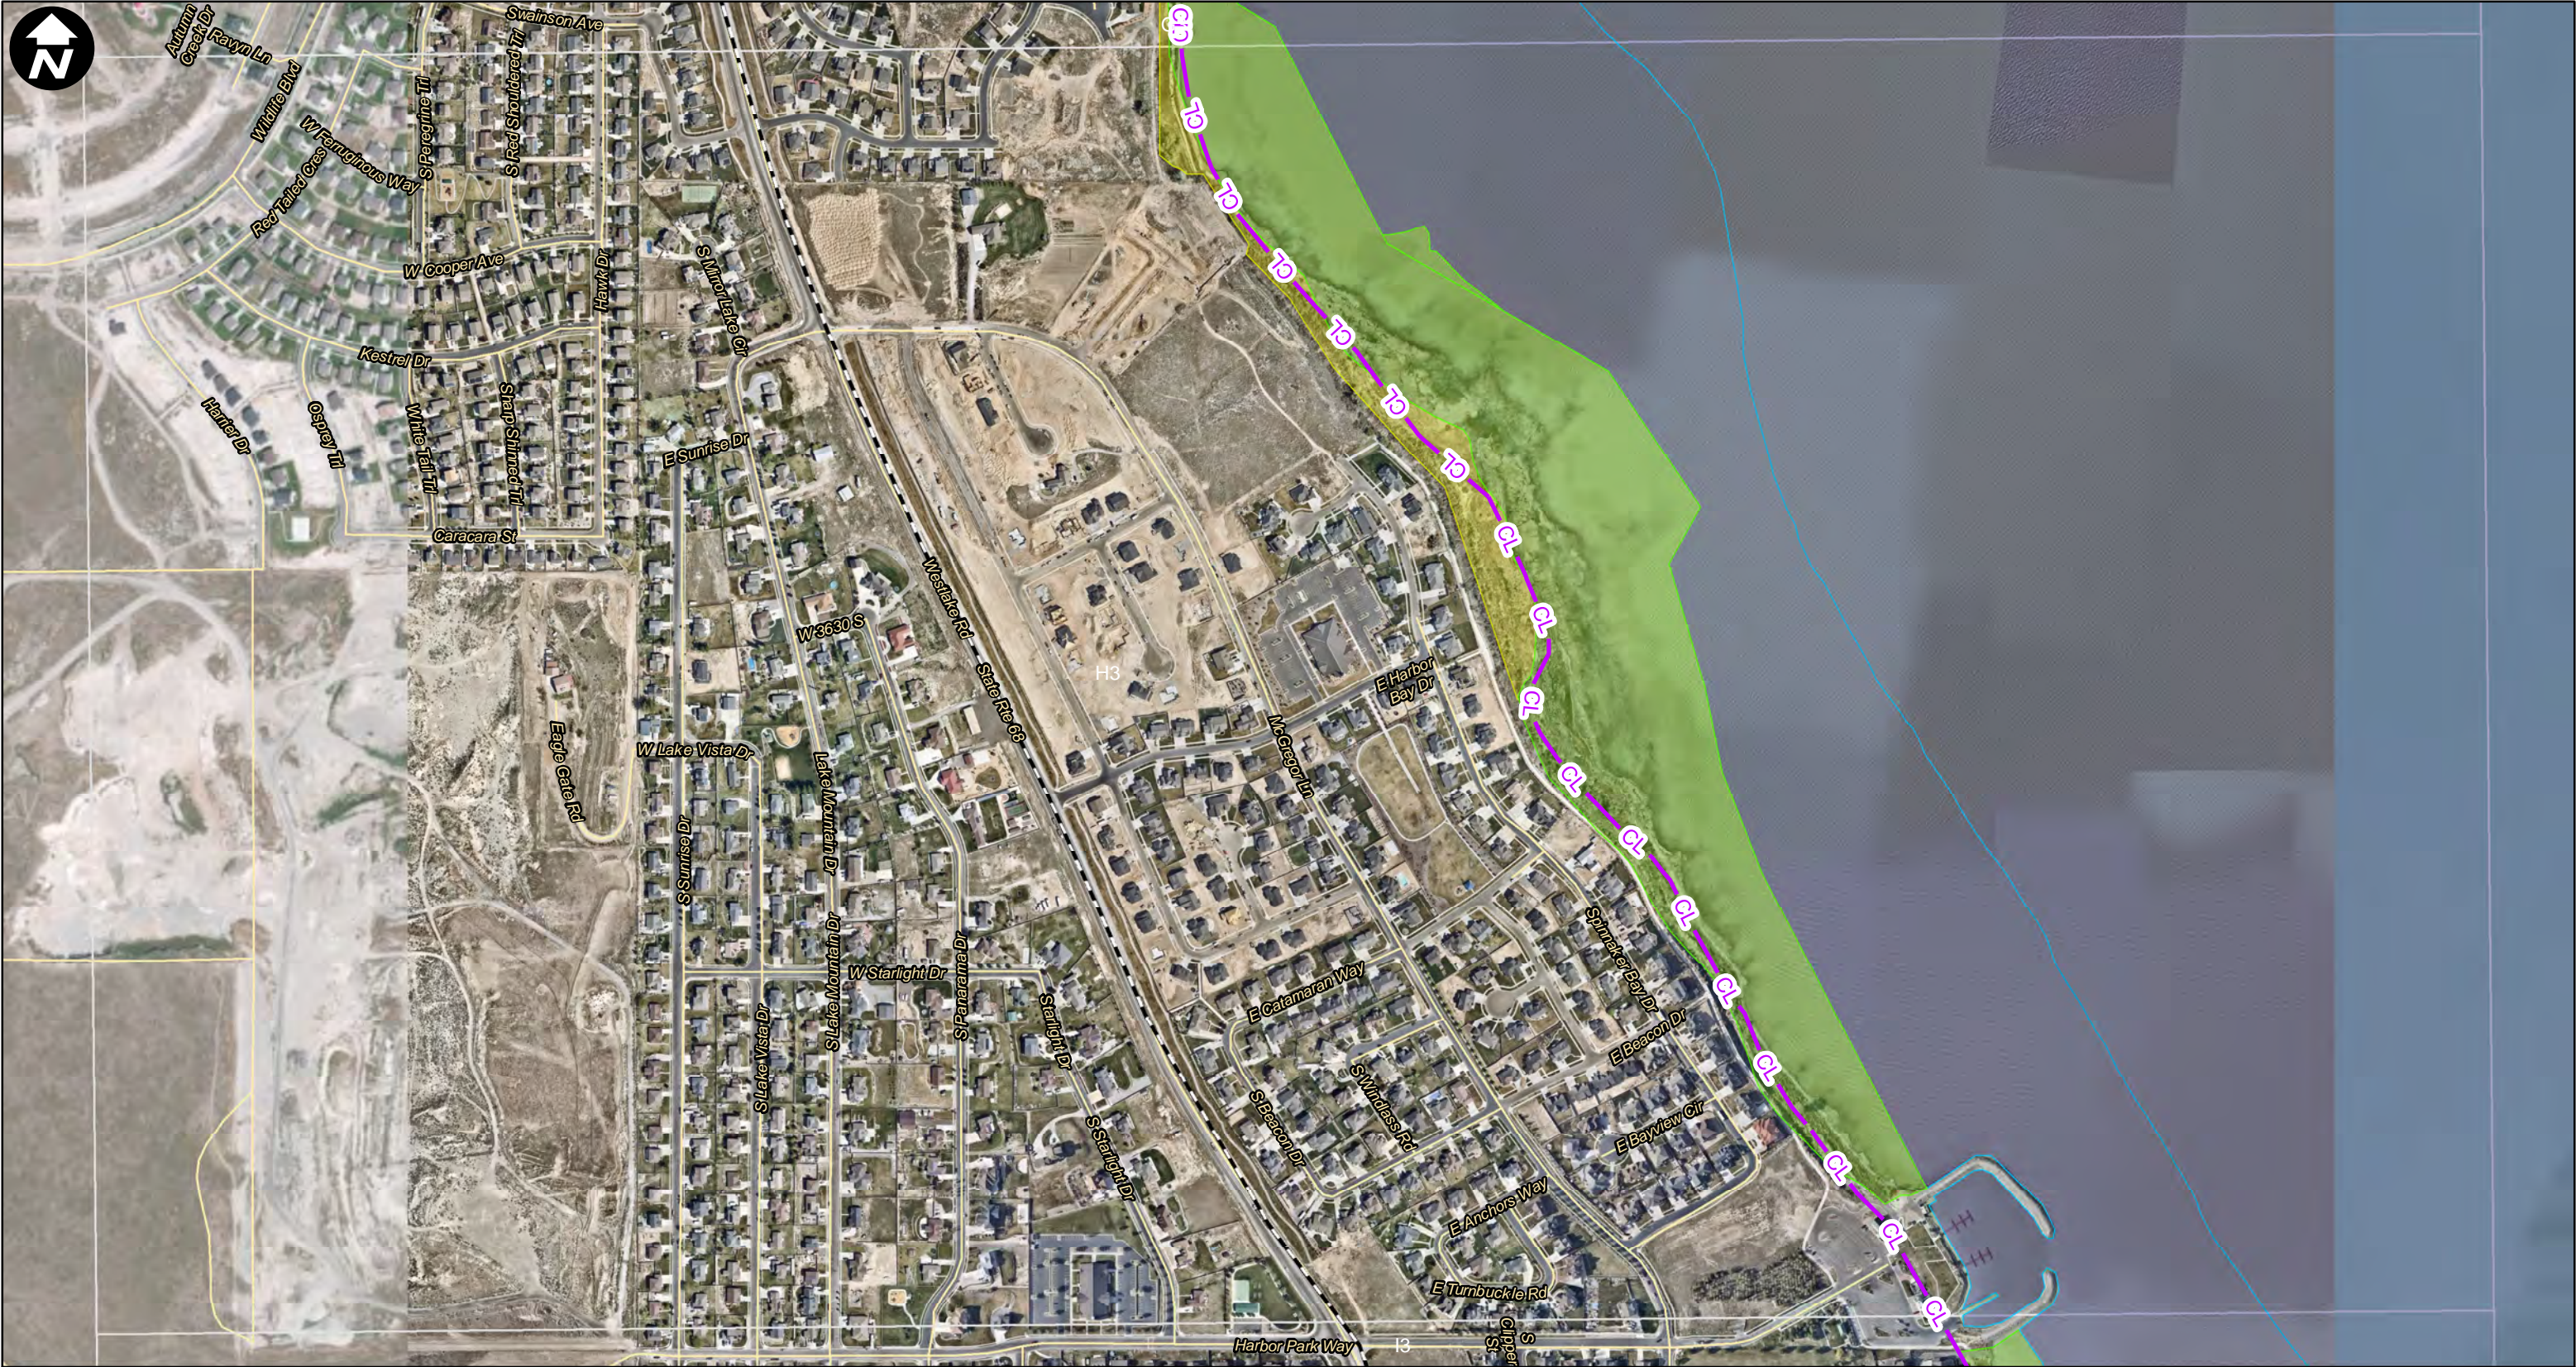
Legend	
Grid Map	Wetland Type
Wetlands Desktop Assessment Boundary	Freshwater Emergent Wetland
CL - Compromise Line Boundary	Freshwater Shrub Wetland
Streets	Lake

Utah Lake Restoration Project Lake Restoration Solutions, Inc. Utah County, Utah	
Wetlands Desktop Assessment	
Geosyntec consultants	Grid Map
DE0475	H3
November 2021

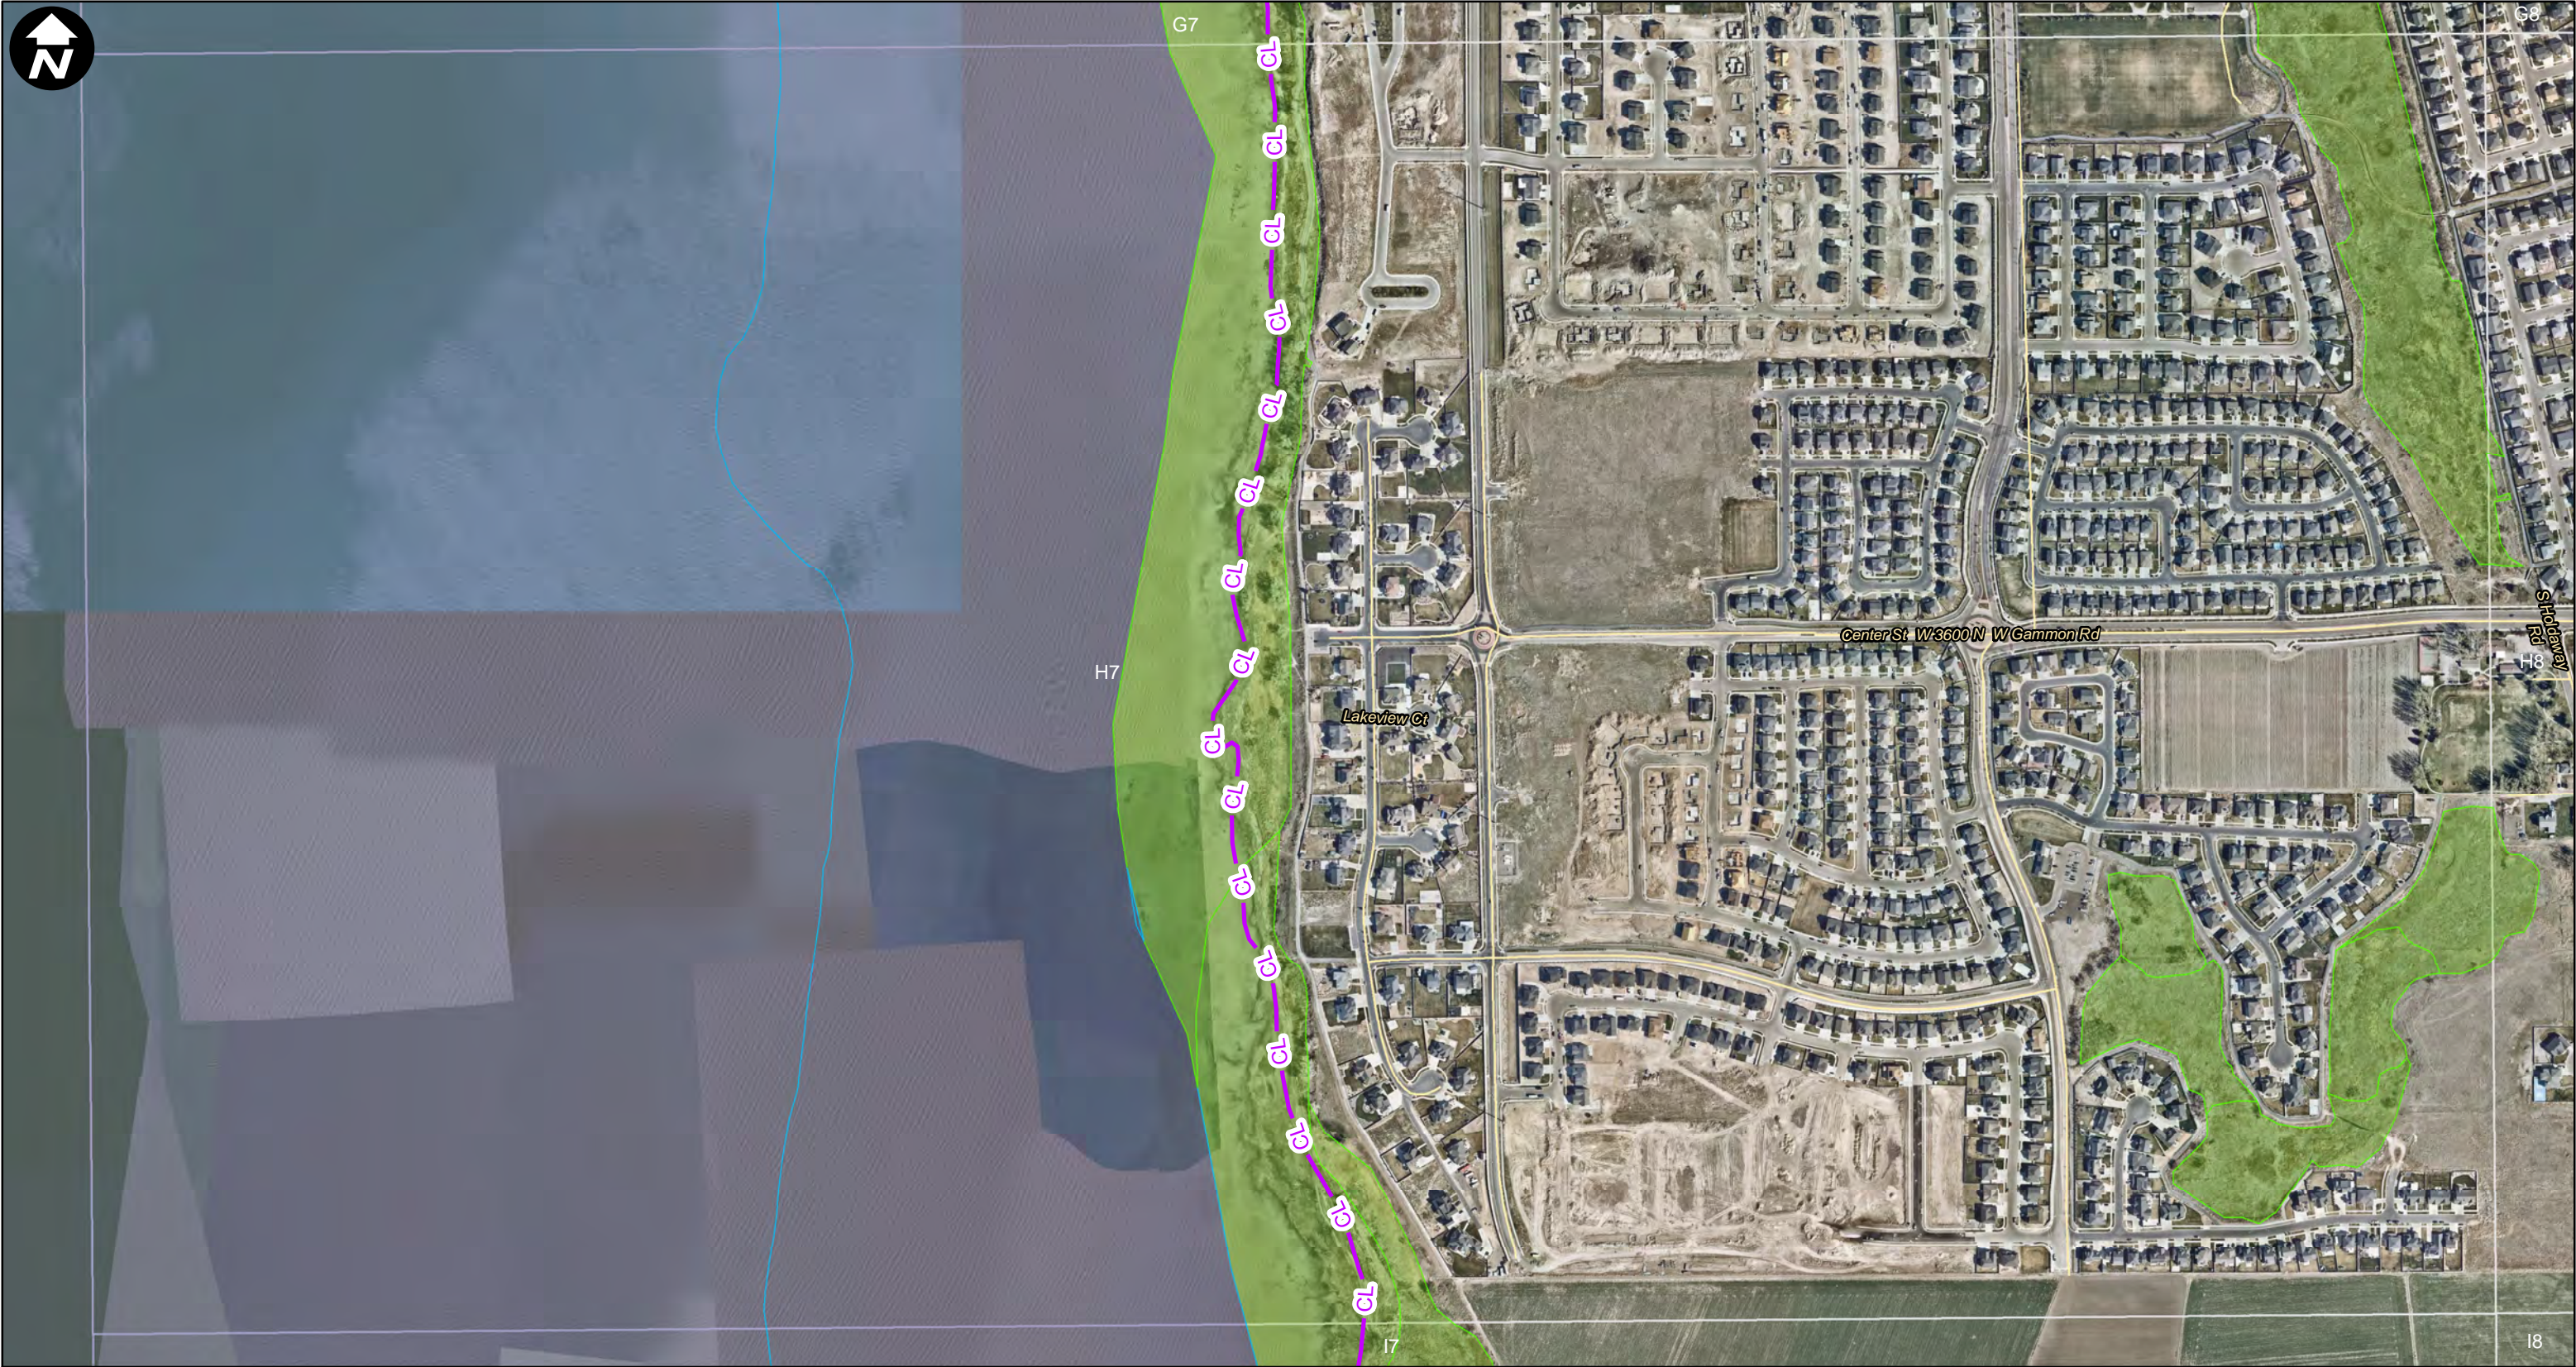
Legend		Wetland Type	
	Grid Map		Freshwater Emergent Wetland
	Wetlands Desktop Assessment Boundary		Lake
	Compromise Line Boundary		
	Streets

Utah Lake Restoration Project Lake Restoration Solutions, Inc. Utah County, Utah	
Wetlands Desktop Assessment	
Geosyntec consultants	
Grid Map	
H7	
DE0475	November 2021

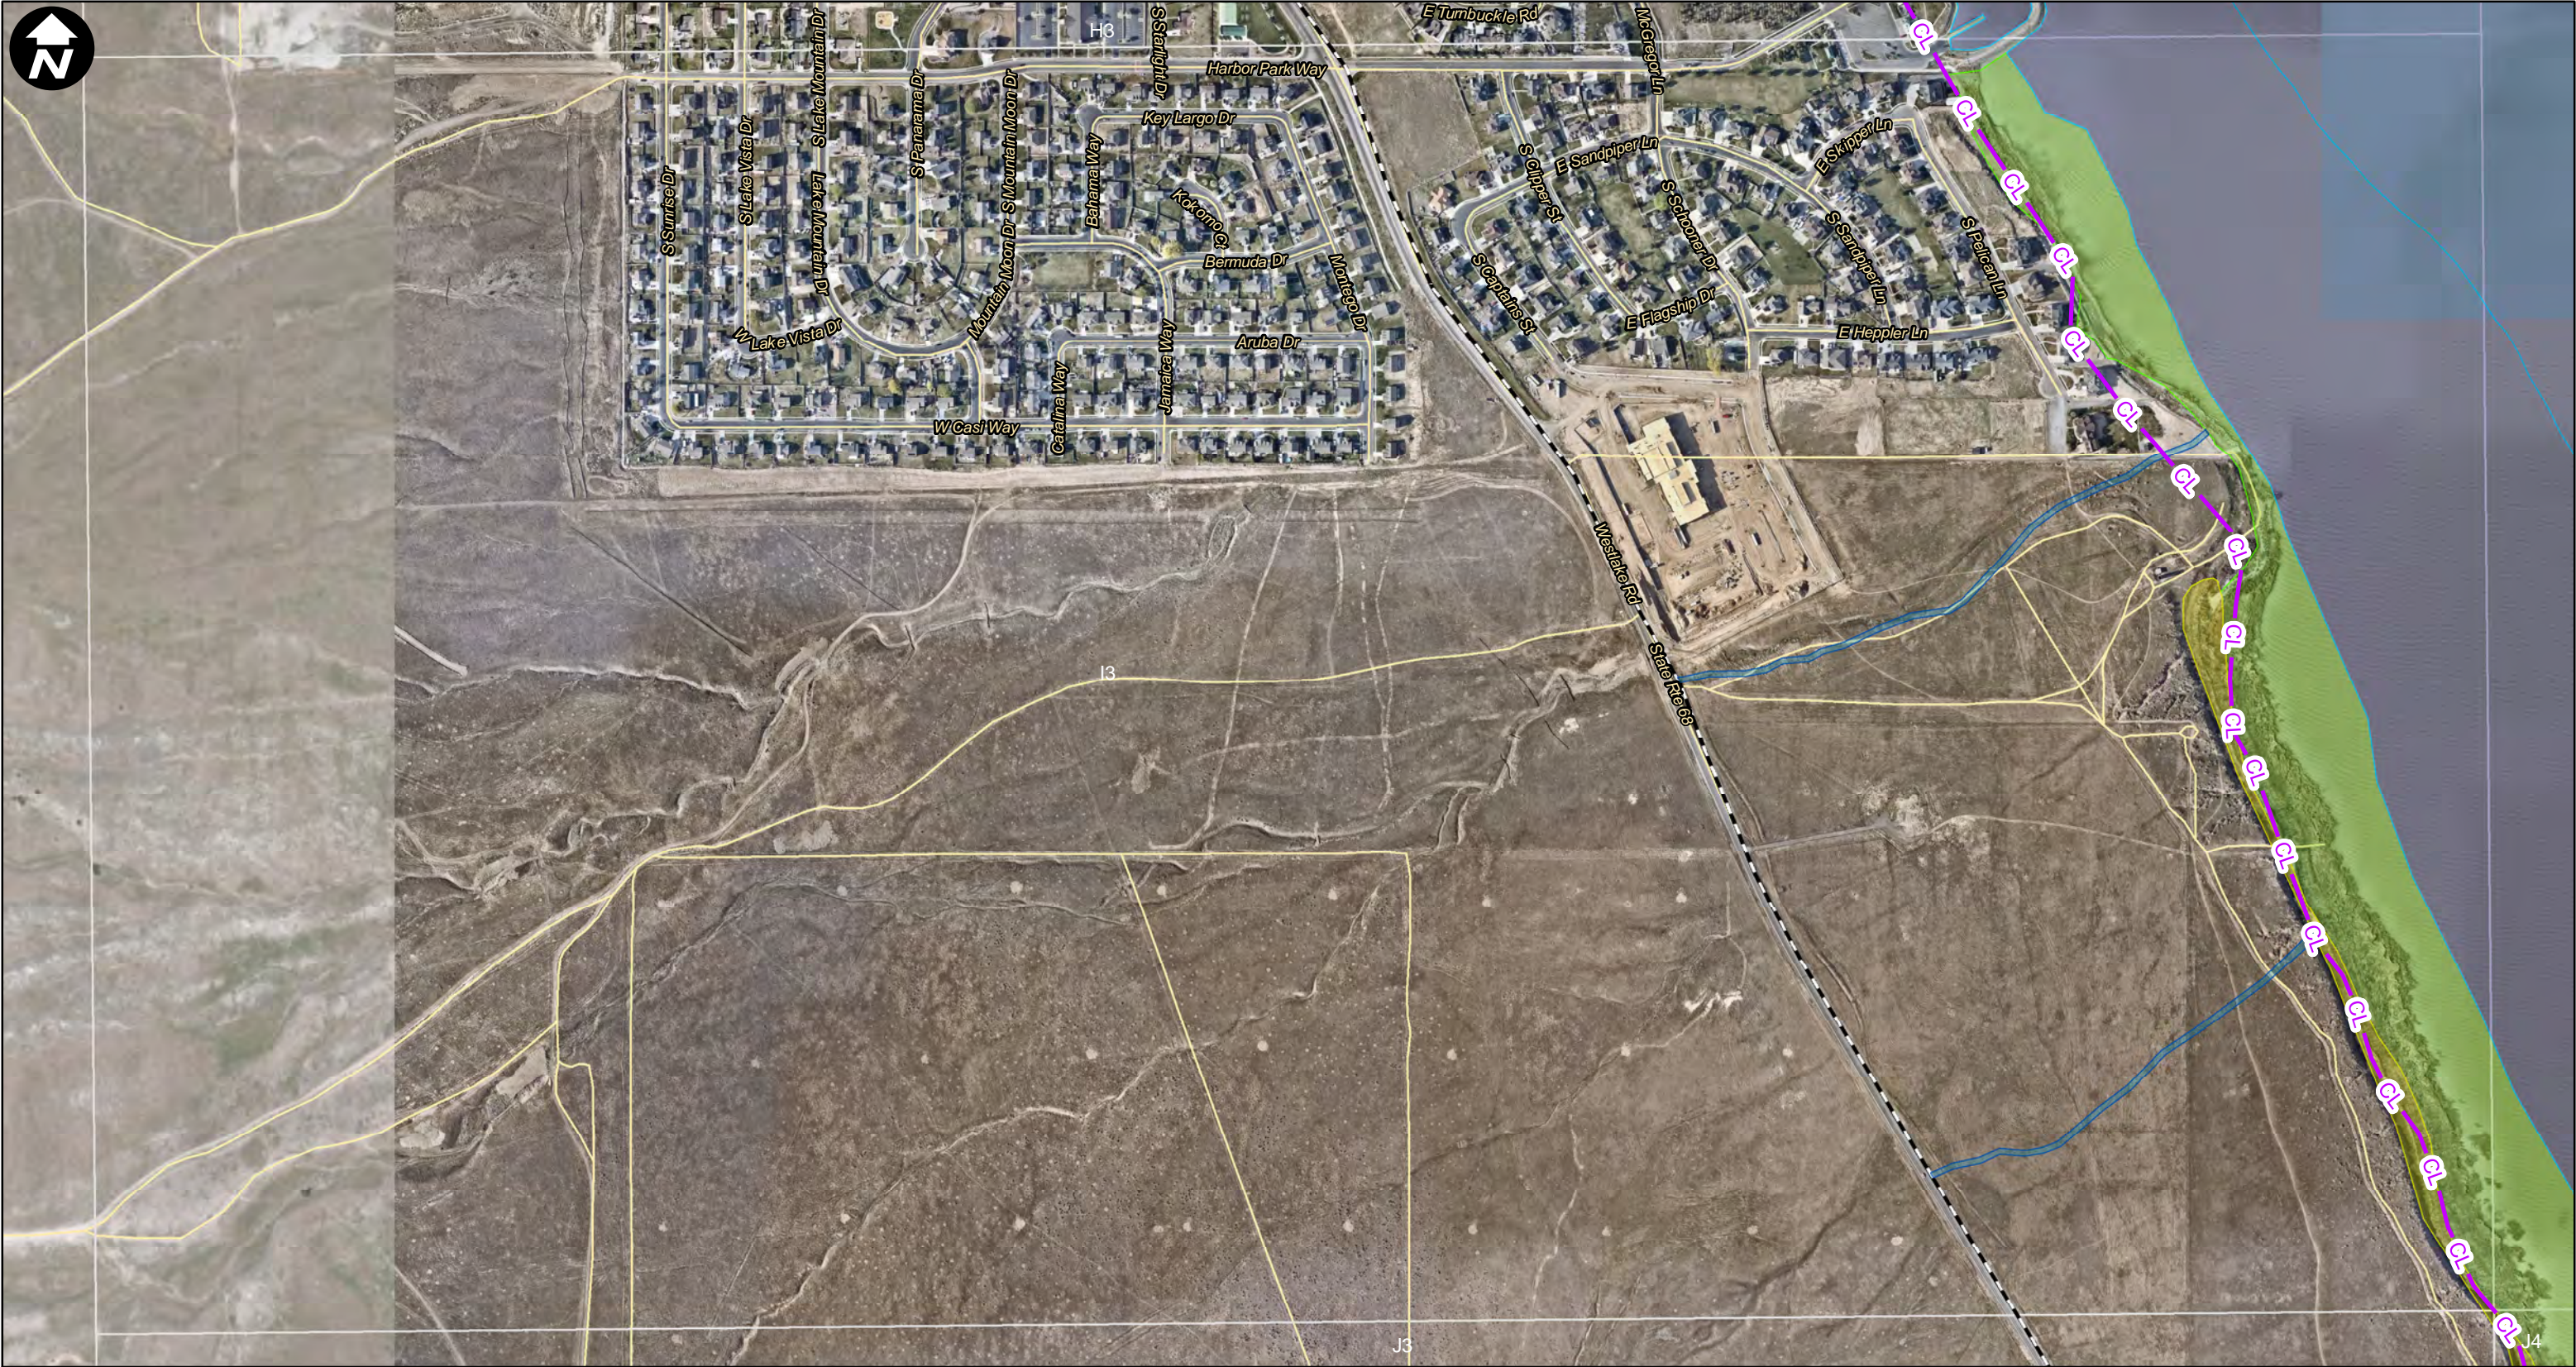
Legend		Wetland Type	
	Grid Map		Freshwater Emergent Wetland
	Wetlands Desktop Assessment Boundary		Freshwater Shrub Wetland
	Compromise Line Boundary		Lake
	Streets		Riverine

Utah Lake Restoration Project Lake Restoration Solutions, Inc. Utah County, Utah	
Wetlands Desktop Assessment	
Geosyntec consultants	Grid Map
DE0475	November 2021
I3

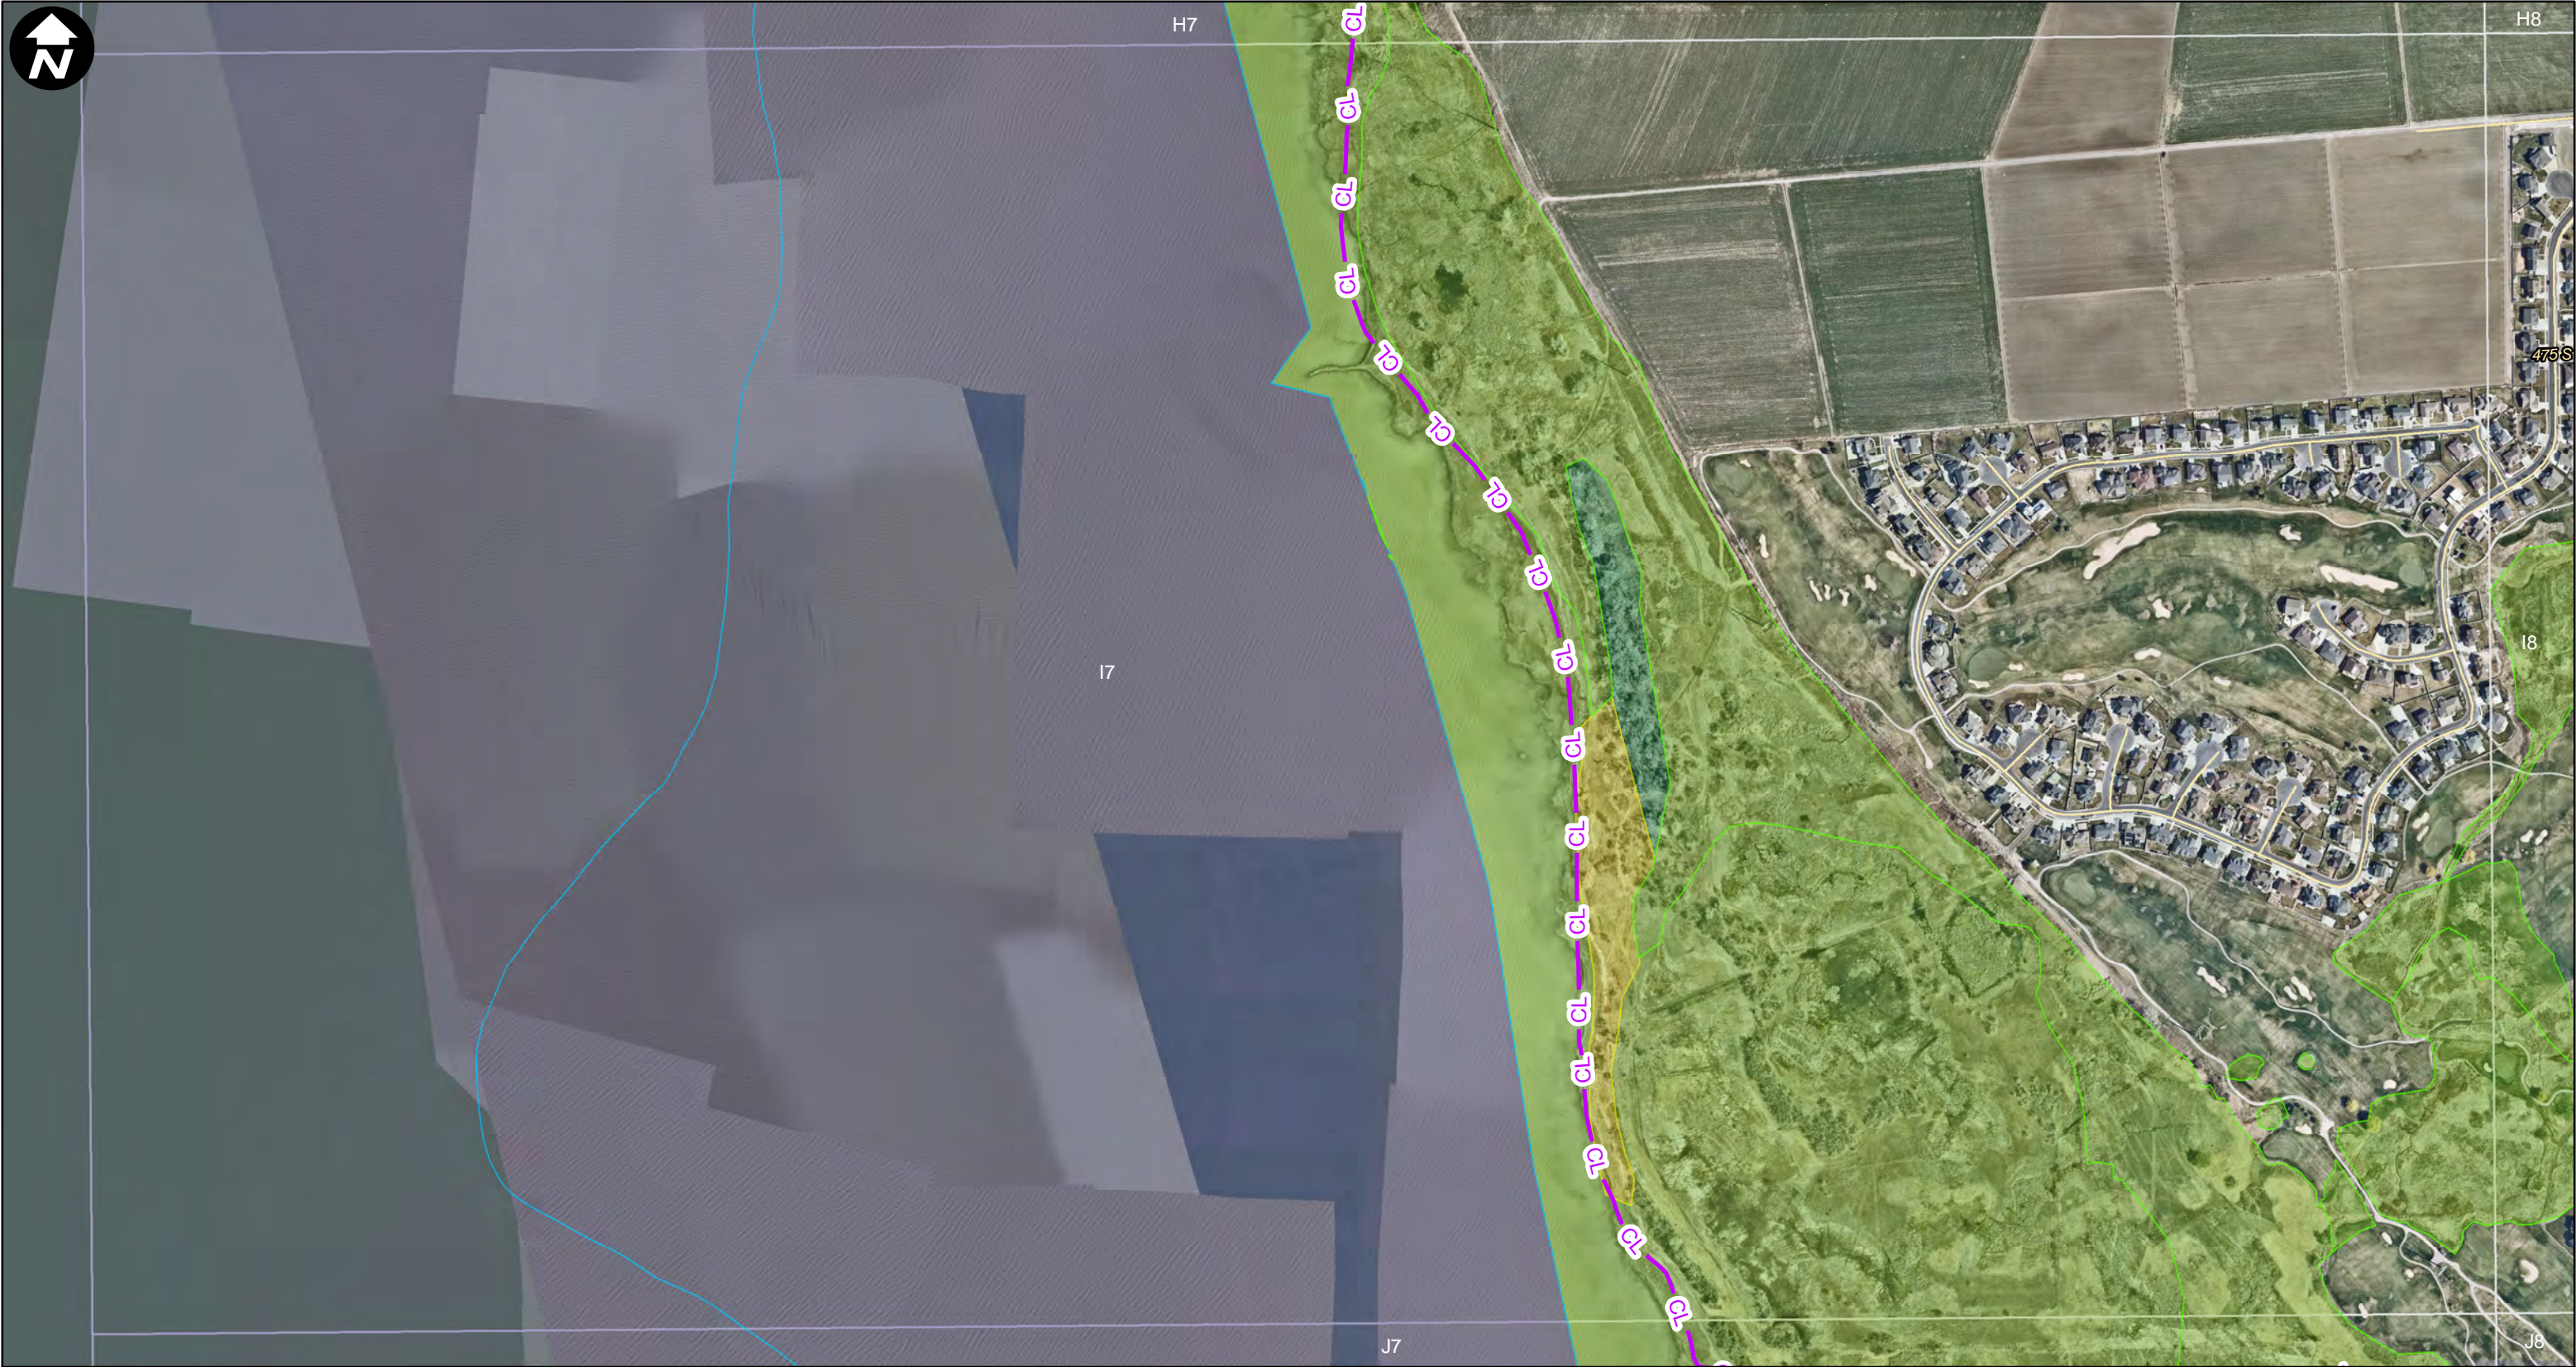
Legend		Wetland Type	
	Grid Map		Freshwater Emergent Wetland
	Wetlands Desktop Assessment Boundary		Freshwater Shrub Wetland
	Compromise Line Boundary		Freshwater Forested Wetland
	Streets		Lake

Utah Lake Restoration Project Lake Restoration Solutions, Inc. Utah County, Utah	
Wetlands Desktop Assessment	
	Grid Map
DE0475	I7
November 2021
