APPENDIX B
Wetland Delineation Report

UTAH LAKE RESTORATION PROJECT

DRAFT WETLAND DELINEATION

Project Number DE0475

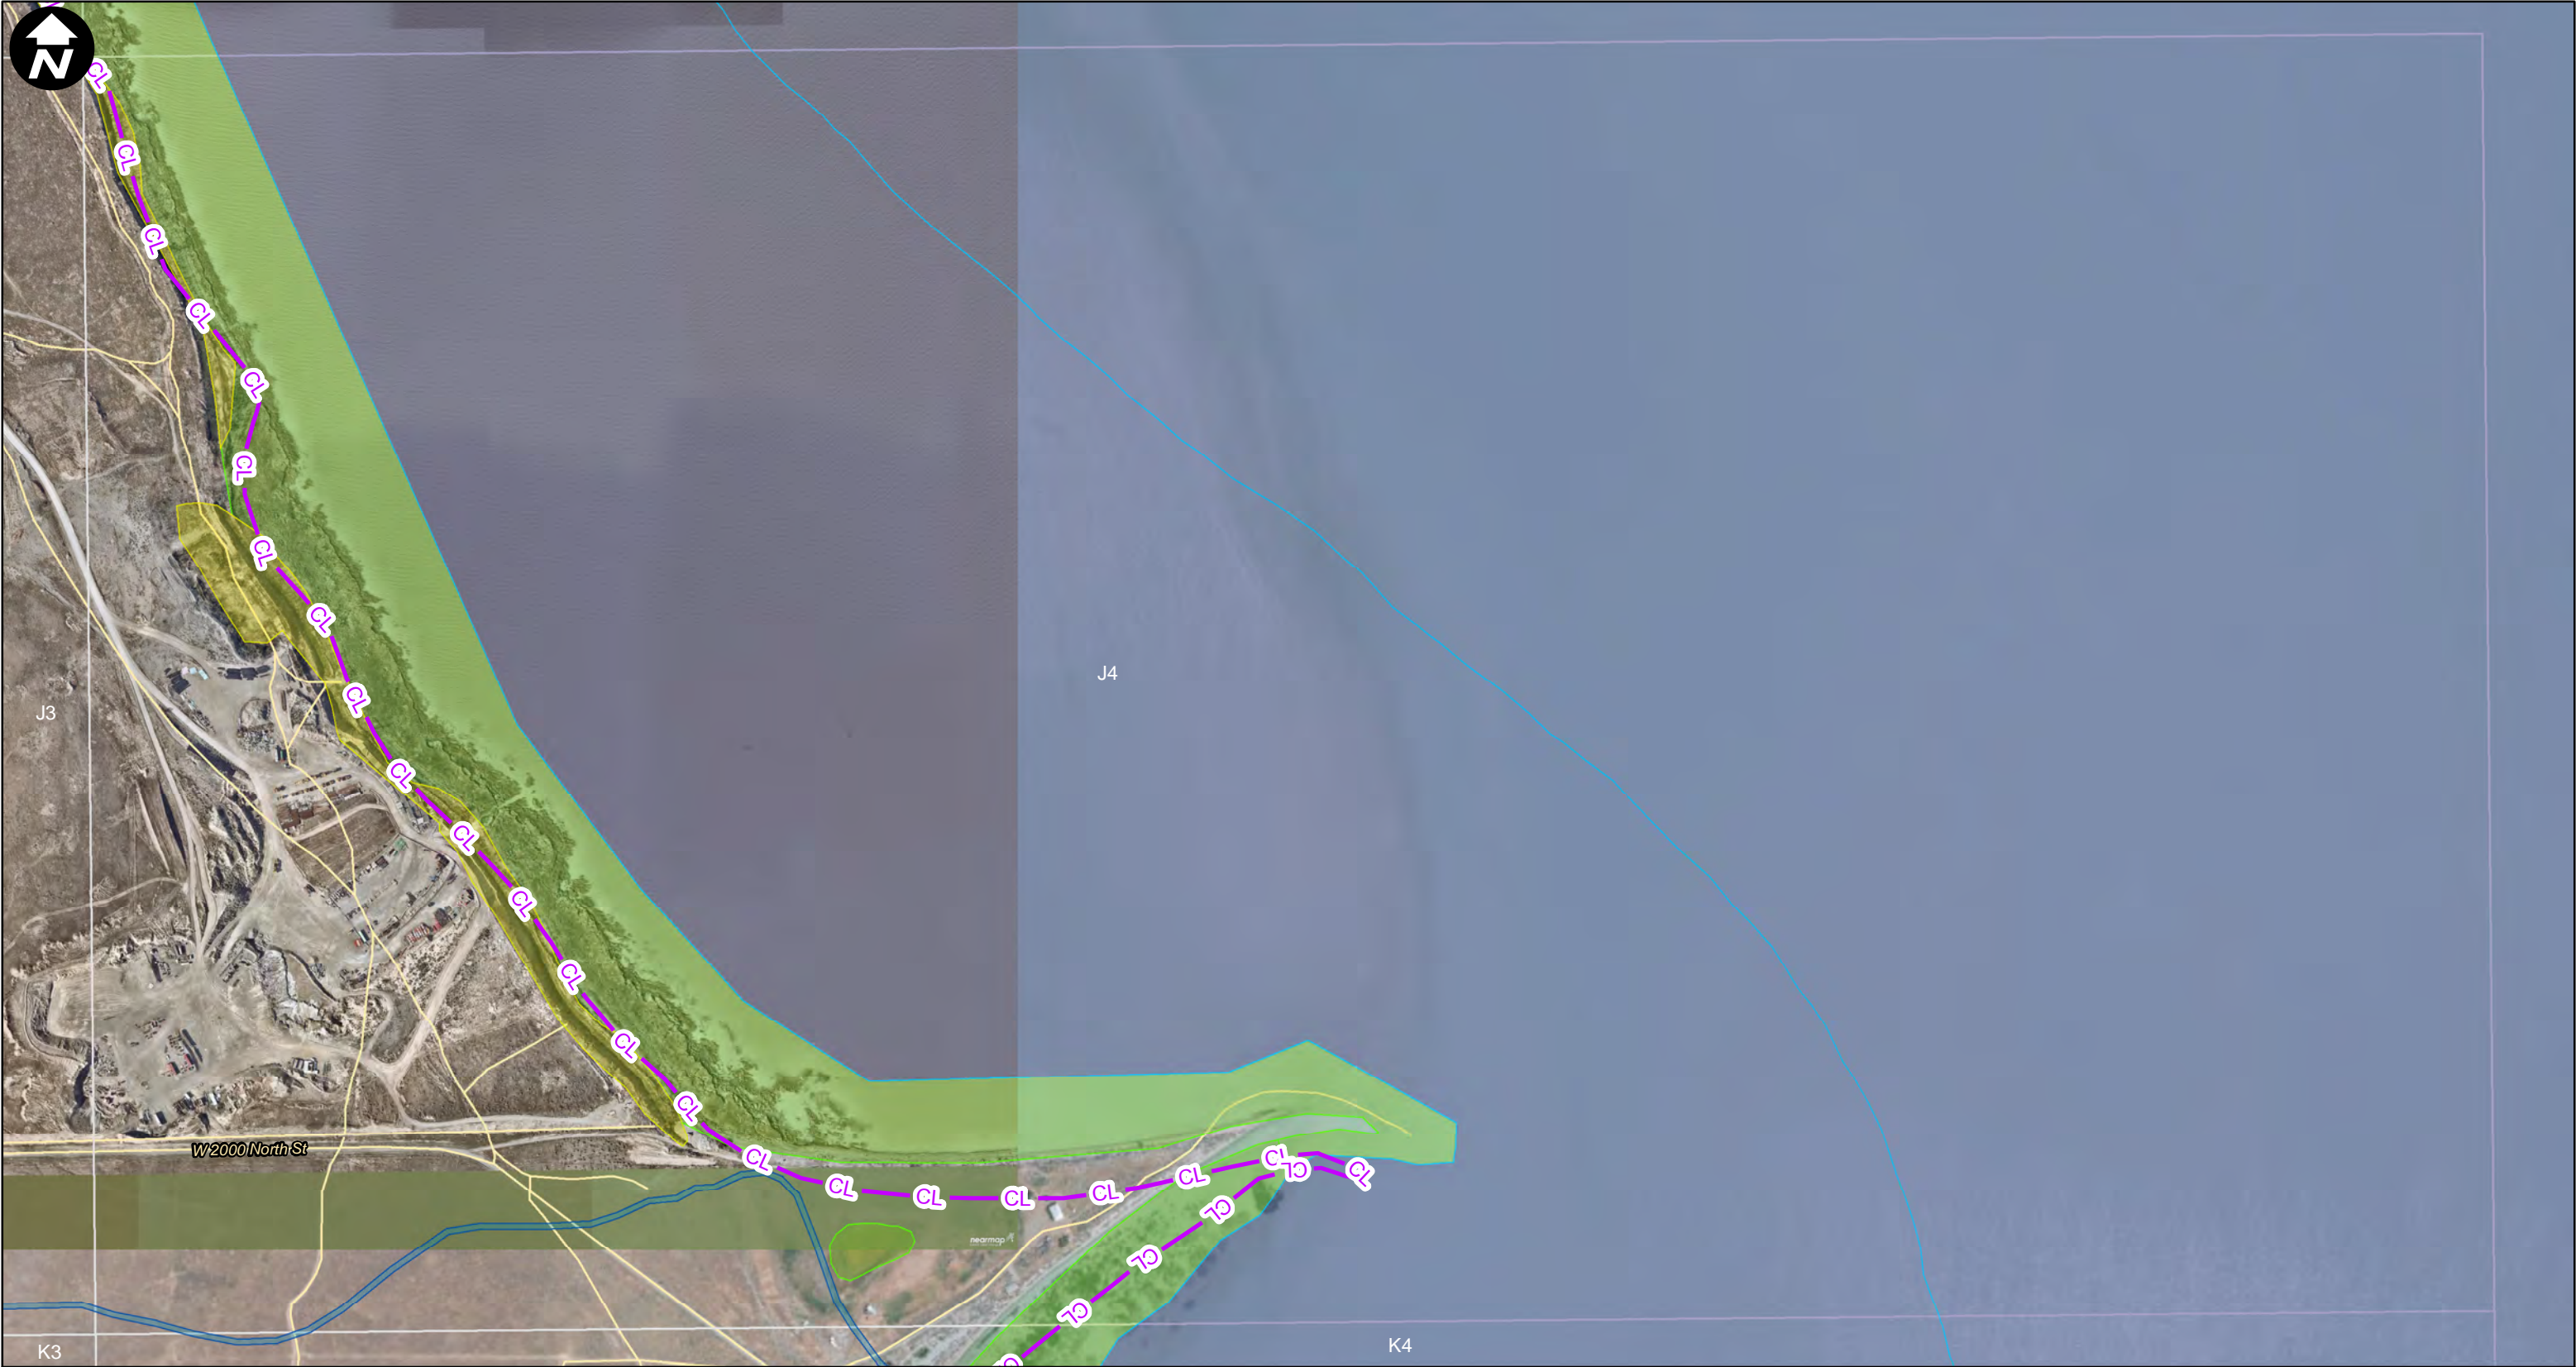
Legend		Wetland Type	
	Grid Map		Freshwater Emergent Wetland
	Wetlands Desktop Assessment Boundary		Freshwater Shrub Wetland
	Compromise Line Boundary		Lake
	Streets		Riverine

Utah Lake Restoration Project Lake Restoration Solutions, Inc. Utah County, Utah	
Wetlands Desktop Assessment	
	Grid Map
DE0475	November 2021
J4

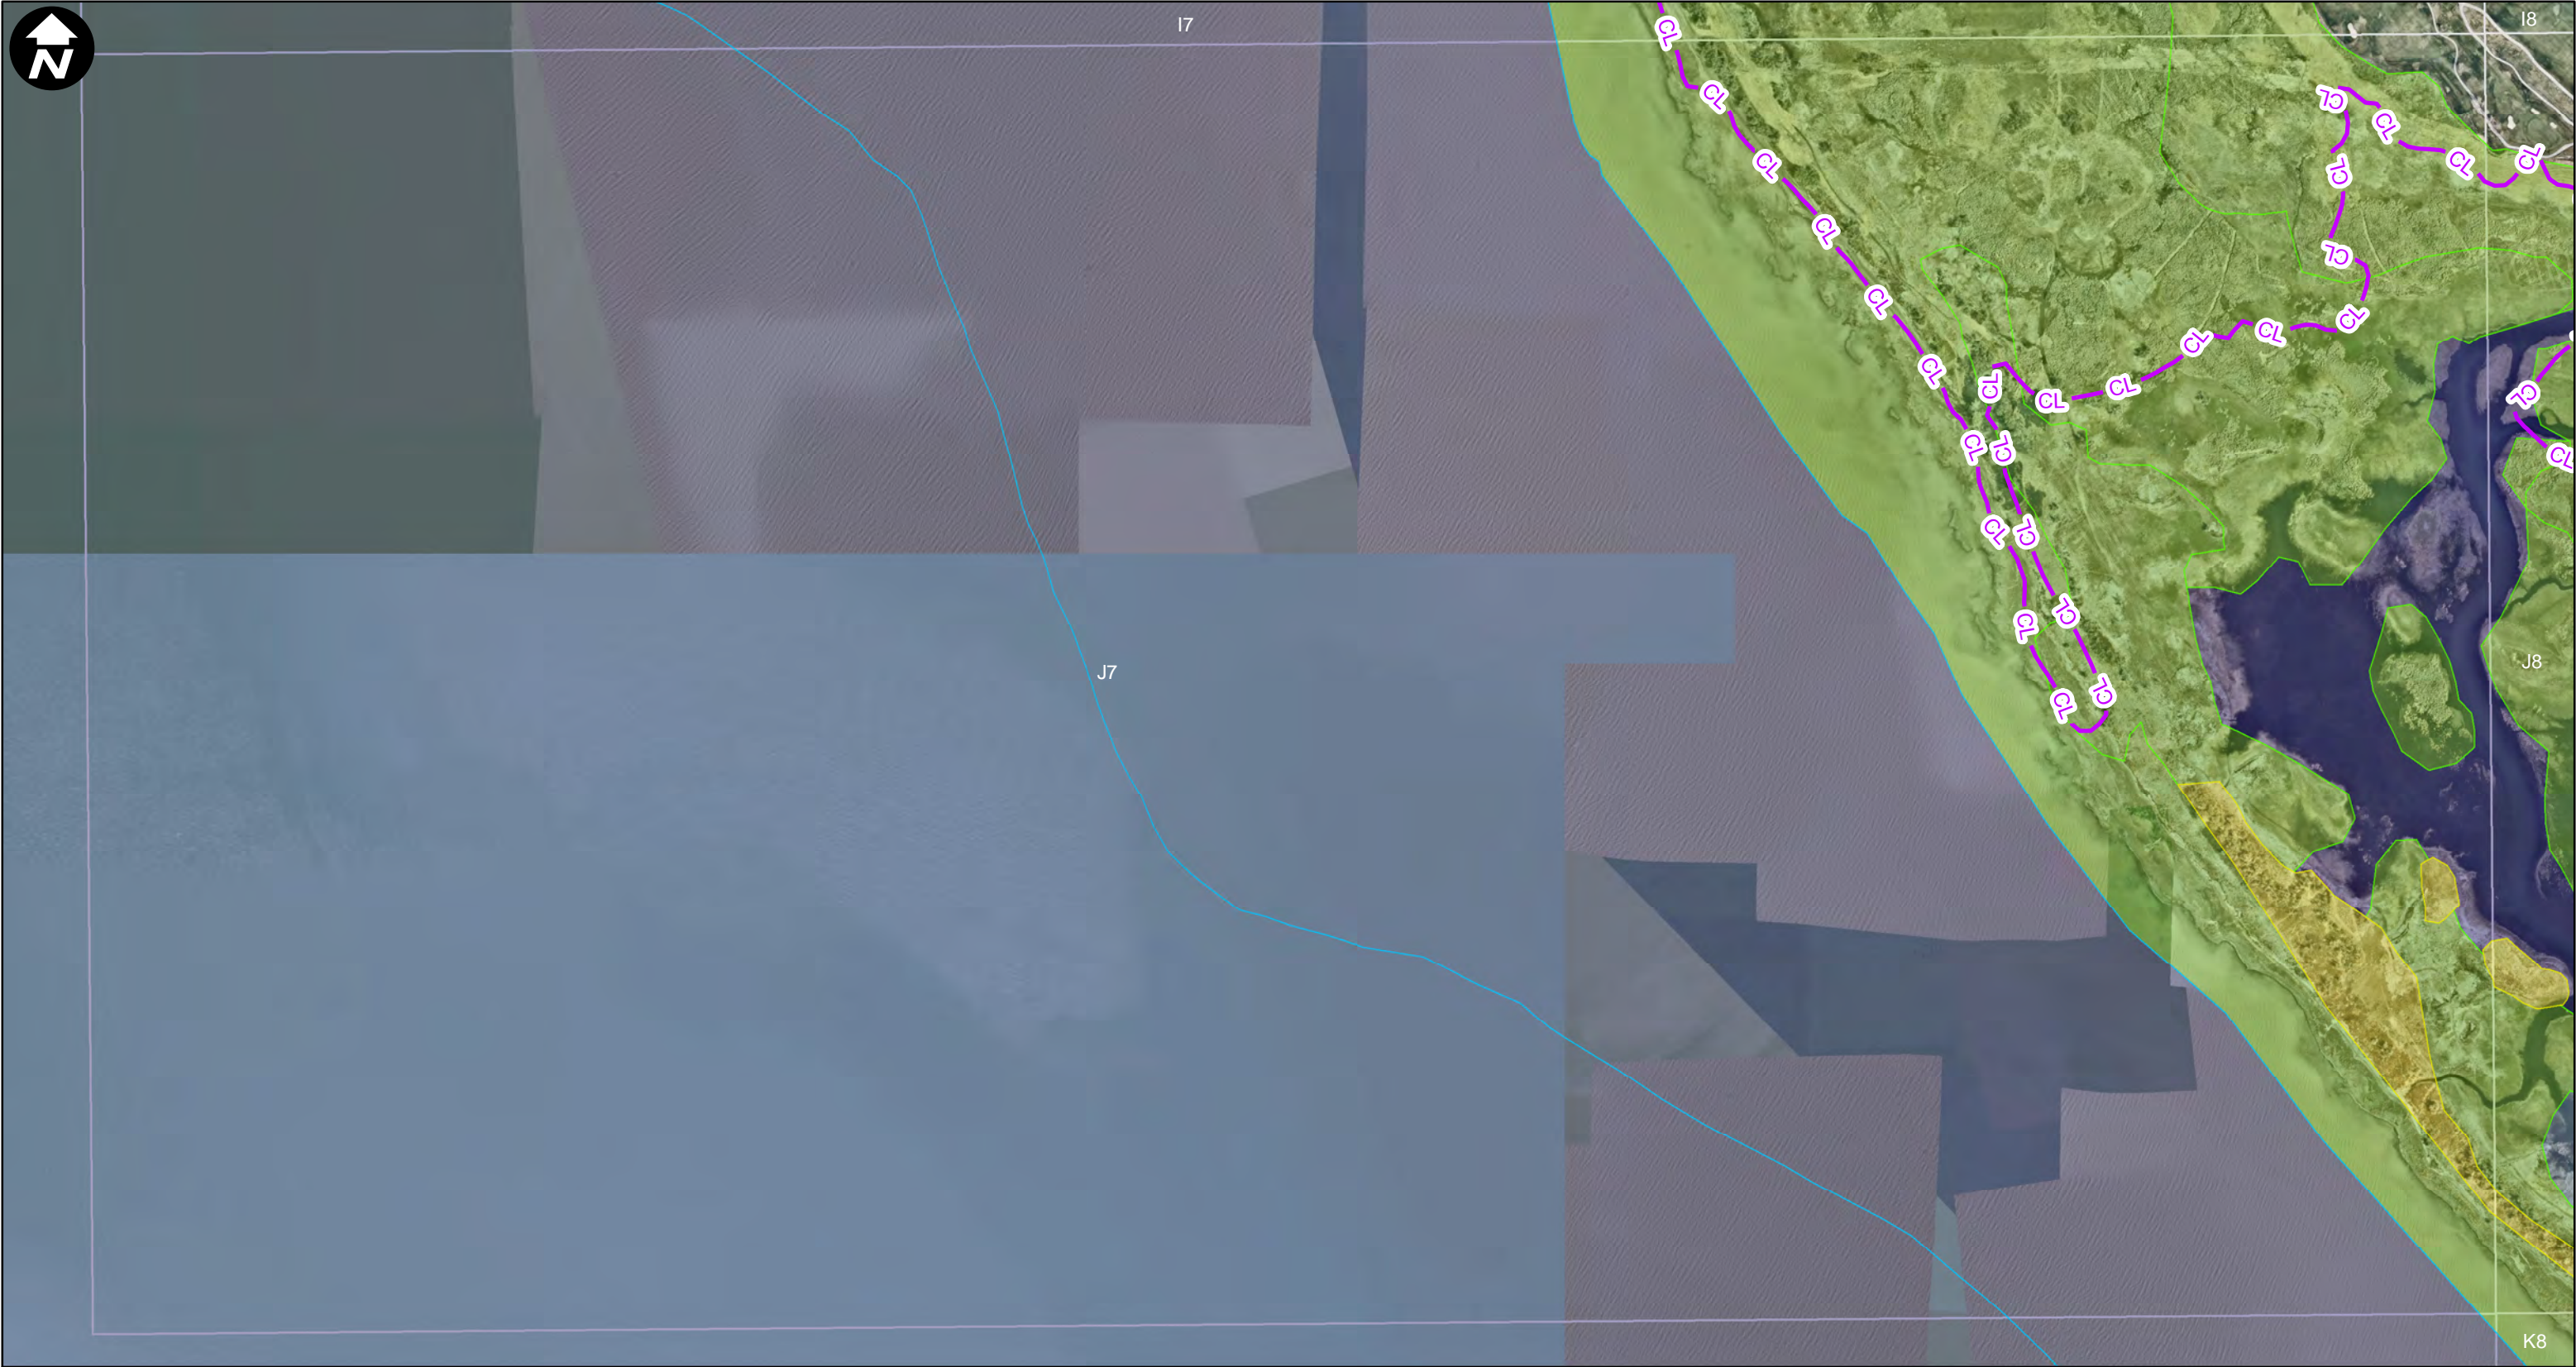
Legend		Wetland Type	
	Grid Map		Freshwater Emergent Wetland
	Wetlands Desktop Assessment Boundary		Freshwater Shrub Wetland
	Compromise Line Boundary		Freshwater Pond
			Lake

Utah Lake Restoration Project Lake Restoration Solutions, Inc. Utah County, Utah	
Wetlands Desktop Assessment	
DE0475	November 2021

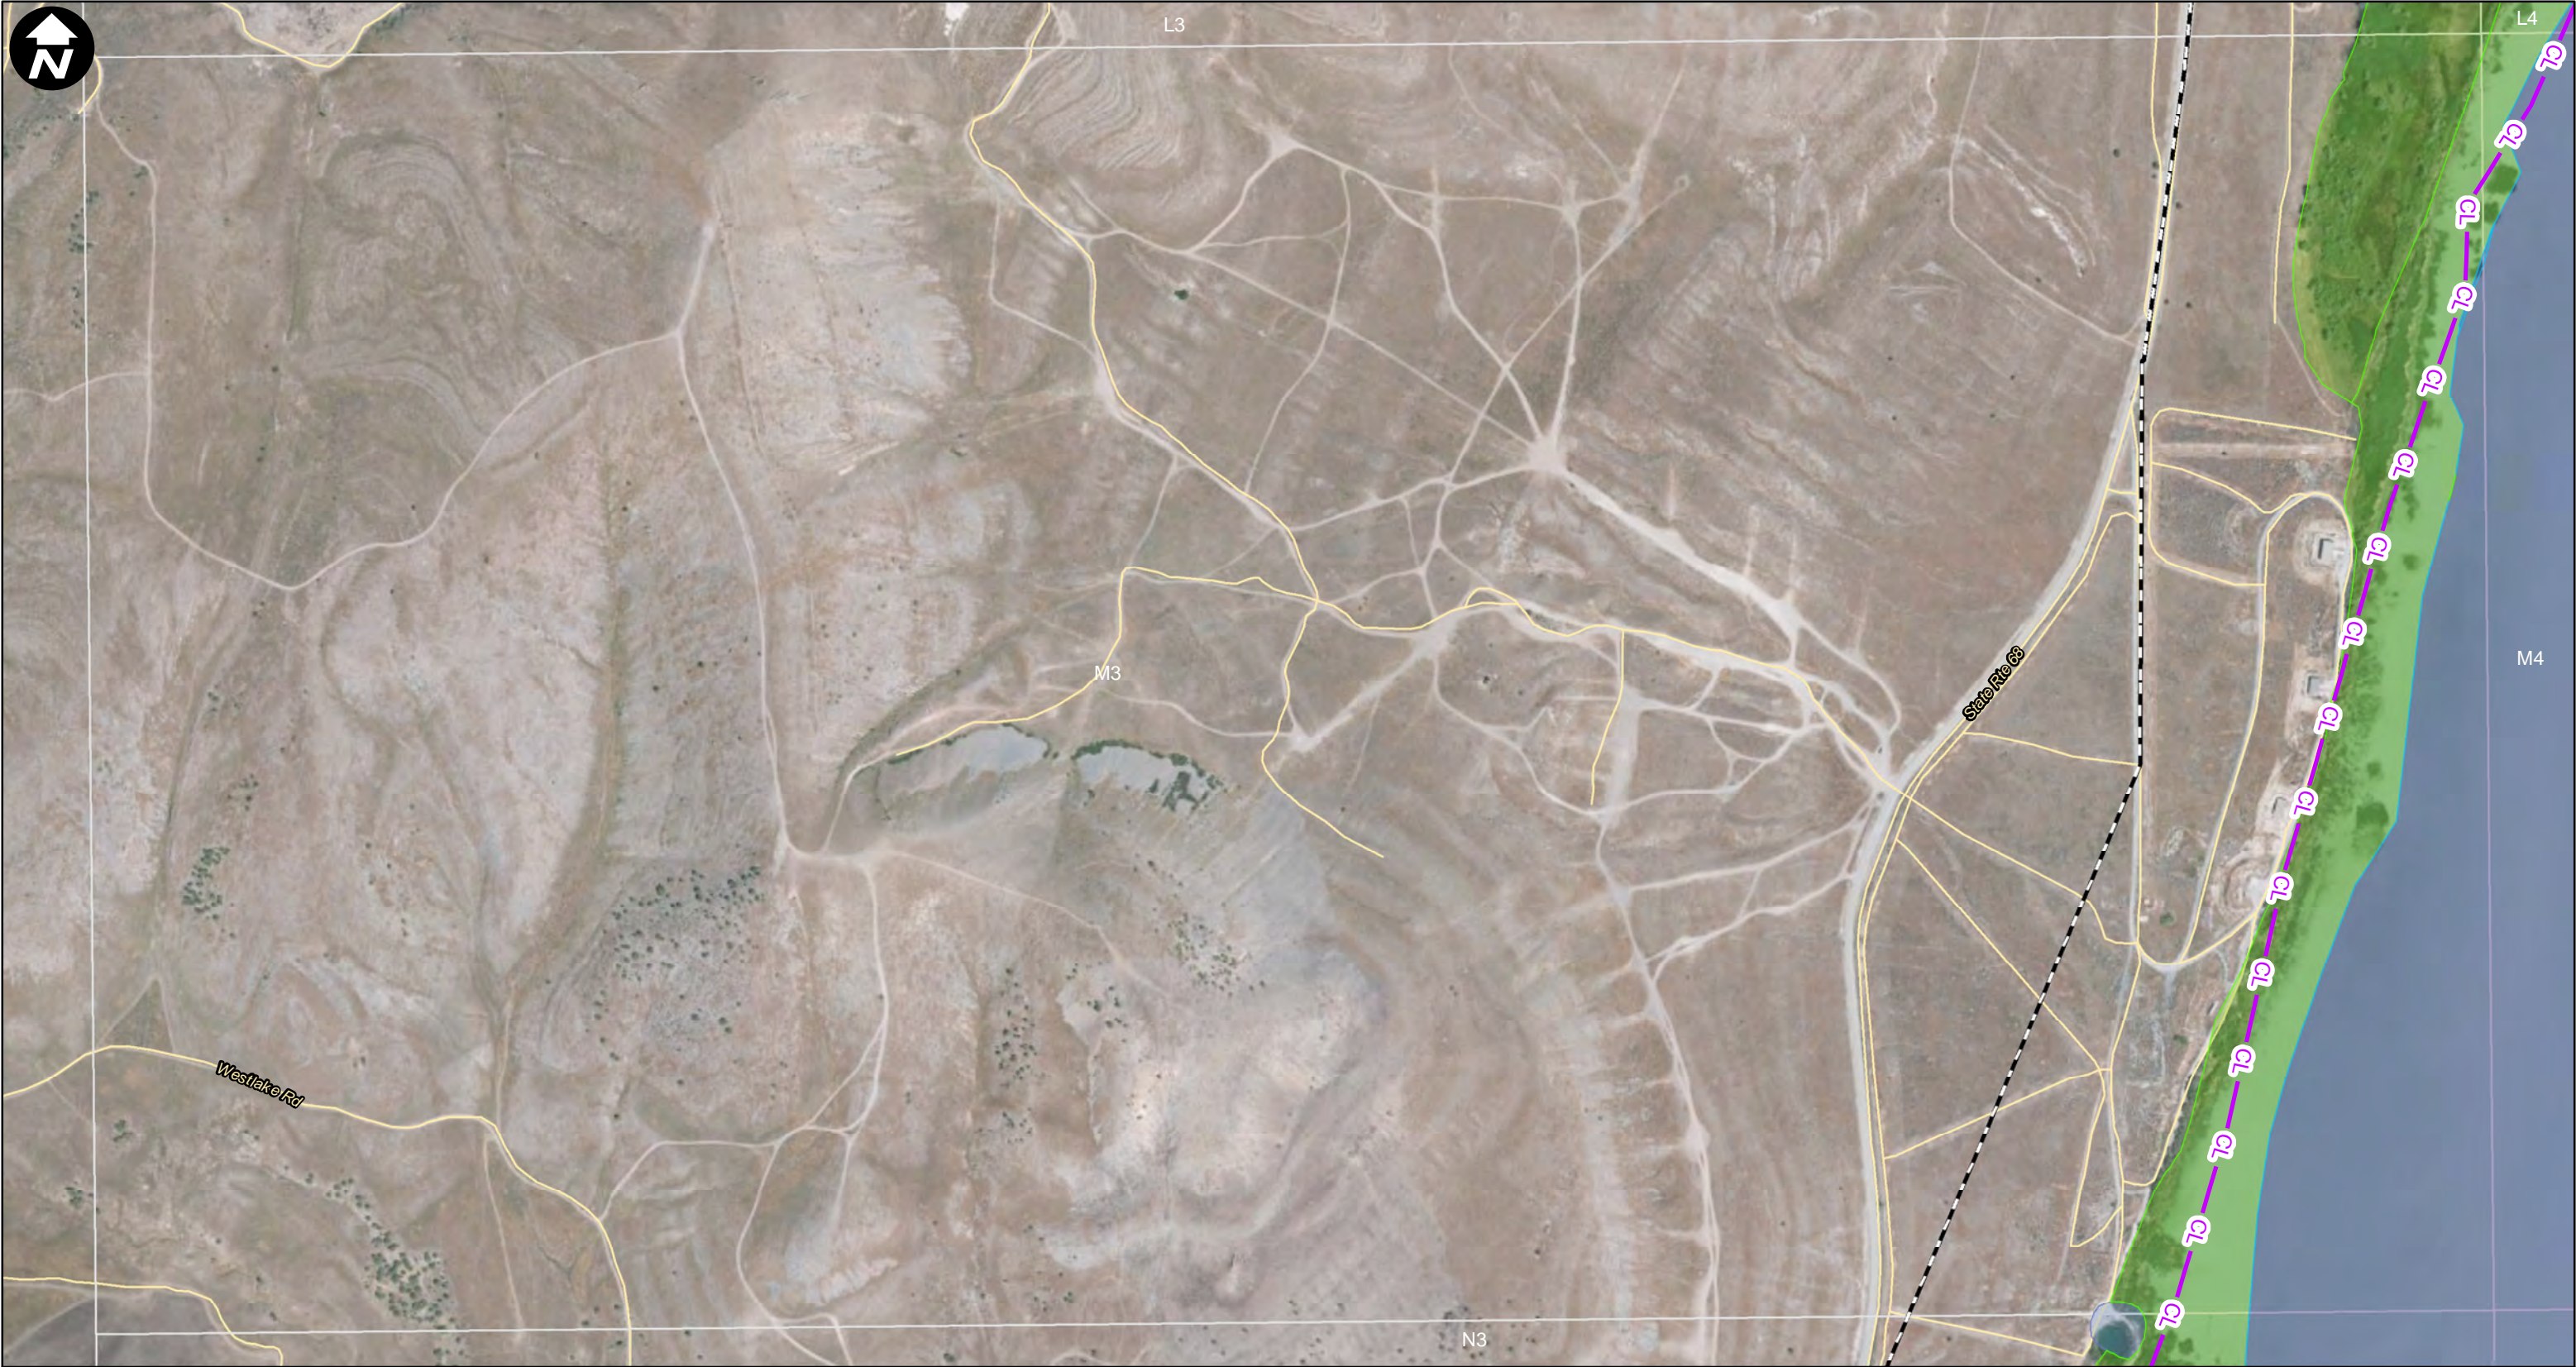
Legend		Wetland Type	
	Grid Map		Freshwater Emergent Wetland
	Wetlands Desktop Assessment Boundary		Freshwater Pond
	Compromise Line Boundary		Lake
	Streets

Utah Lake Restoration Project Lake Restoration Solutions, Inc. Utah County, Utah	
Wetlands Desktop Assessment	
Geosyntec consultants	
DE0475	November 2021
Grid Map M8

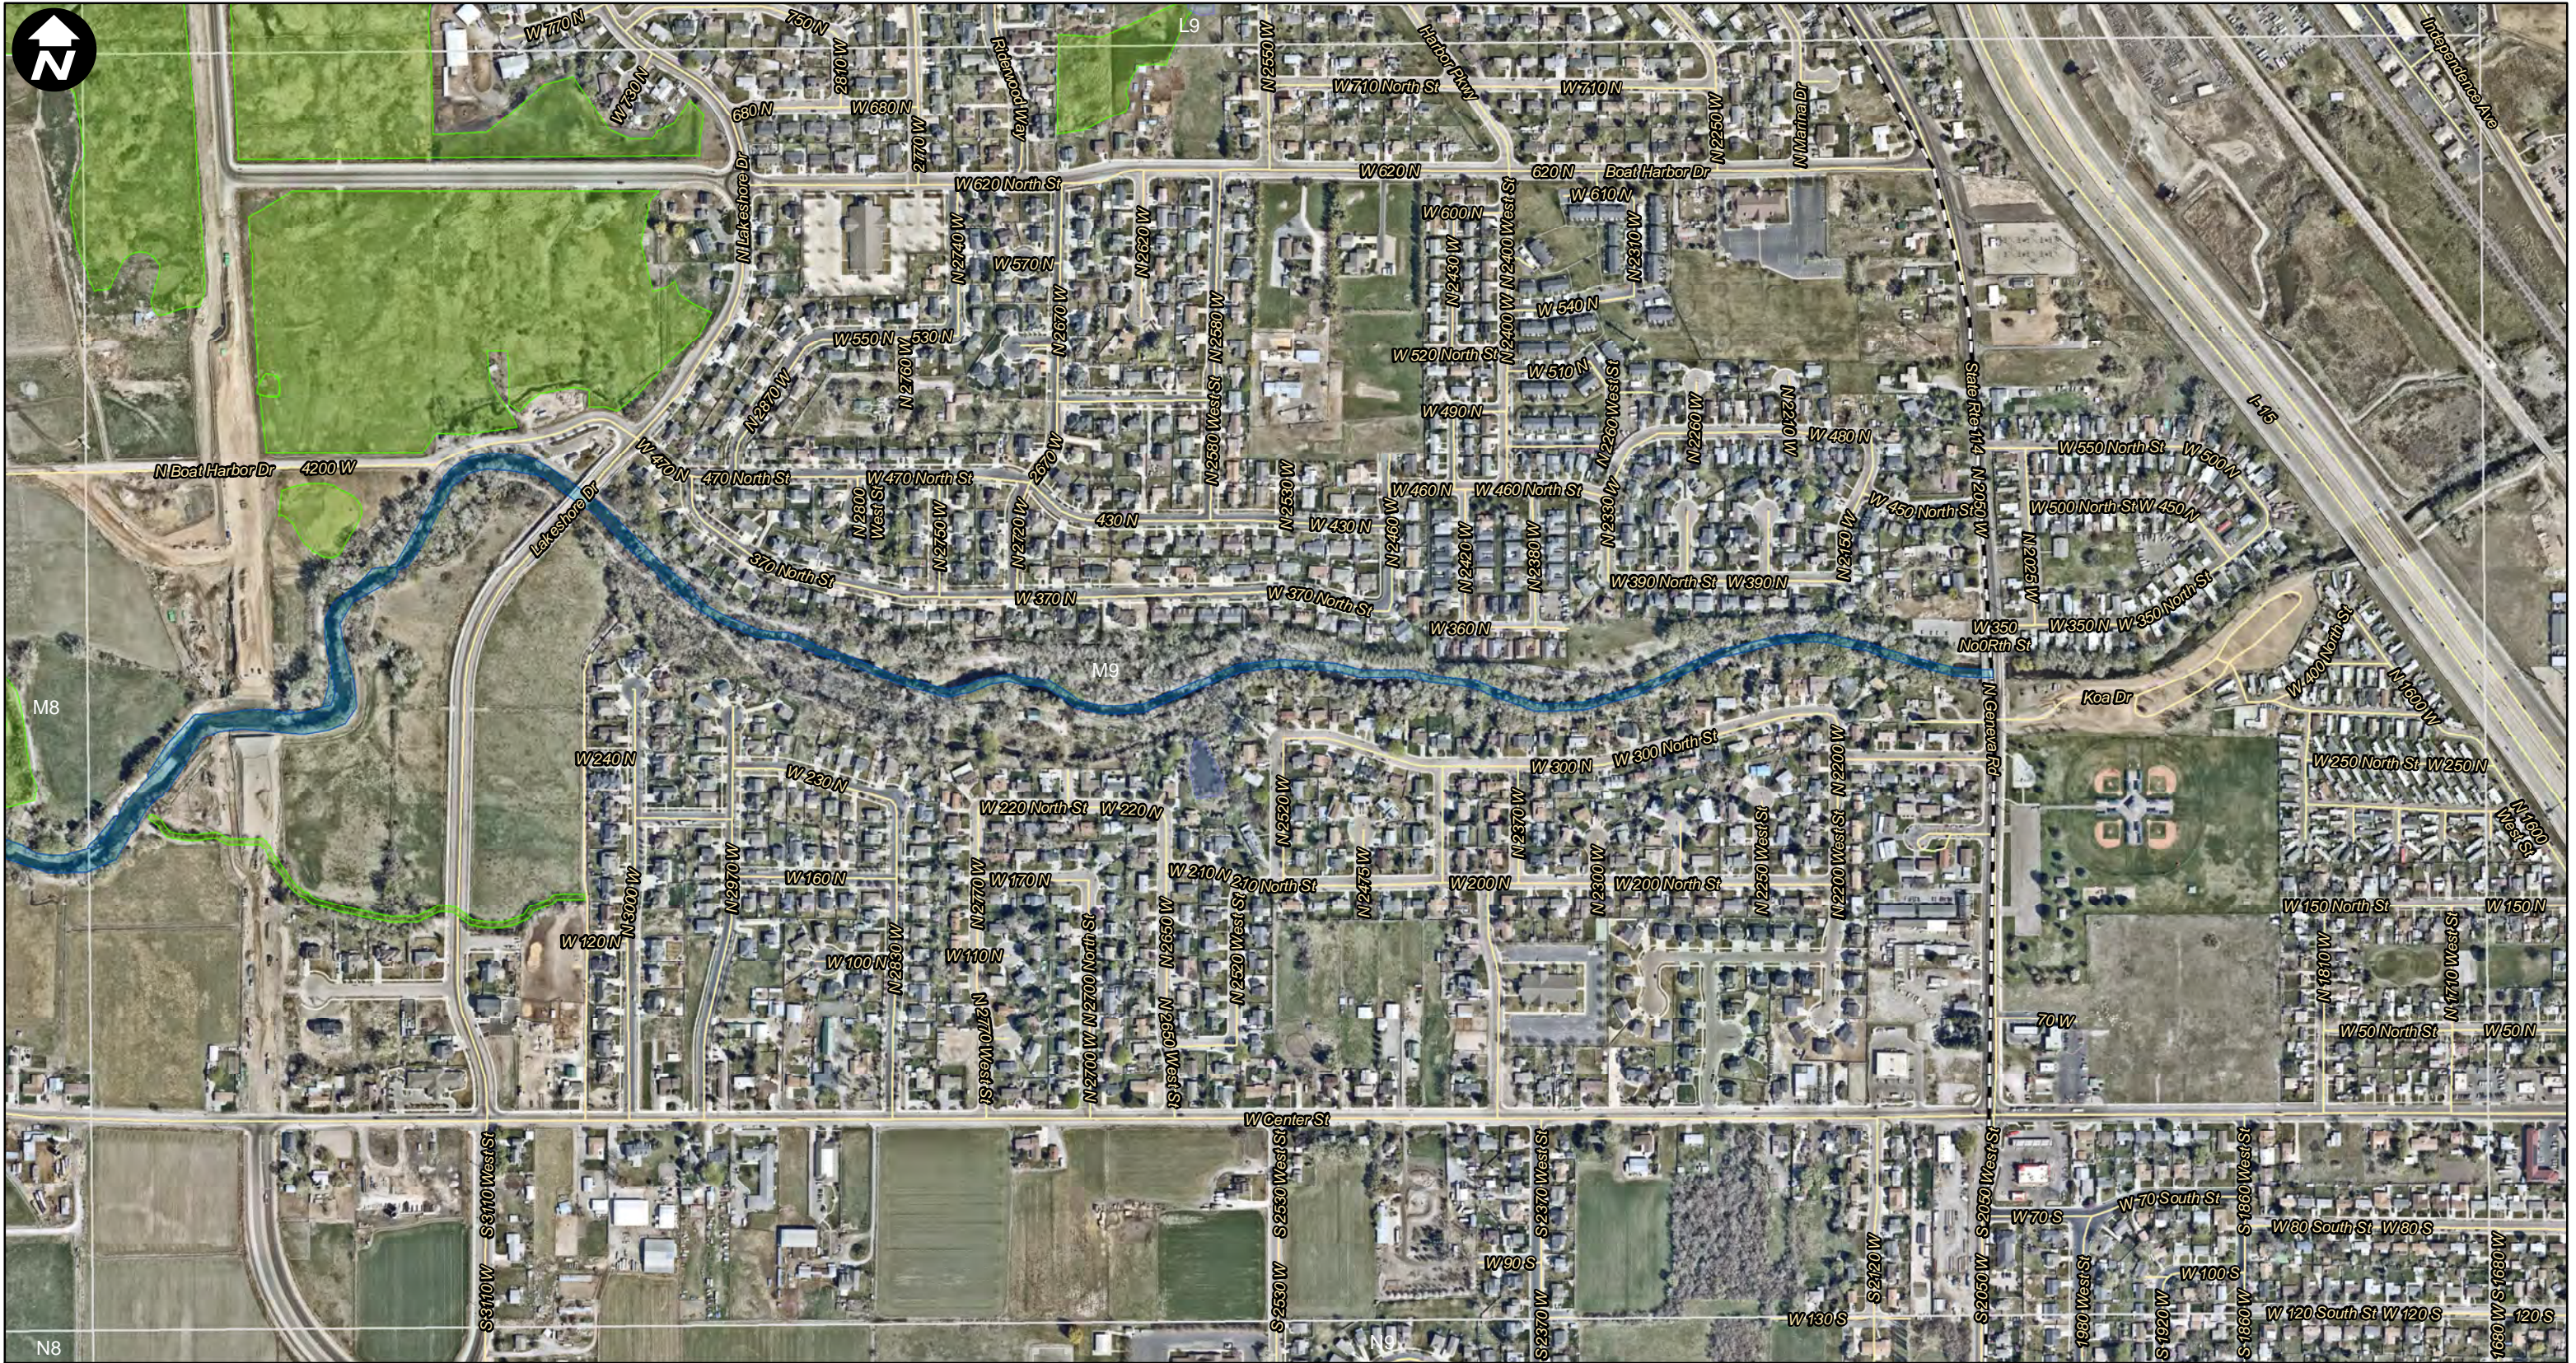
Legend		Wetland Type	
	Grid Map		Freshwater Emergent Wetland
	Rails		Freshwater Pond
	Wetlands Desktop Assessment Boundary		Riverine
	Streets

Utah Lake Restoration Project Lake Restoration Solutions, Inc. Utah County, Utah	
Wetlands Desktop Assessment	
Geosyntec consultants	
DE0475	November 2021
Grid Map N3
