DEPARTMENT OF THE ARMY
U.S. ARMY CORPS OF ENGINEERS, SACRAMENTO DISTRICT
1325 J STREET
SACRAMENTO CA 95814-2922

SUBJECT: US Army Corps of Engineers (Corps) Approved Jurisdictional Determination in accordance with the "Revised Definition of 'Waters of the United States'"; (88 FR 3004 (January 18, 2023) as amended by the "Revised Definition of 'Waters of the United States'; Conforming" (8 September 2023),¹ SPK-2021-00475

3. REVIEW AREA. The approximately 271.81-acre review area is primarily located west of the intersection of Latrobe Road and Royal Oaks Drive in El Dorado Hills, El Dorado County, California. The review area extends north along Latrobe Road, ending near the El Dorado Irrigation Water Treatment Plant. The approximate center of the review area is located at Latitude 38.61445, Longitude -121.05216 (Enclosures 1 and 2).

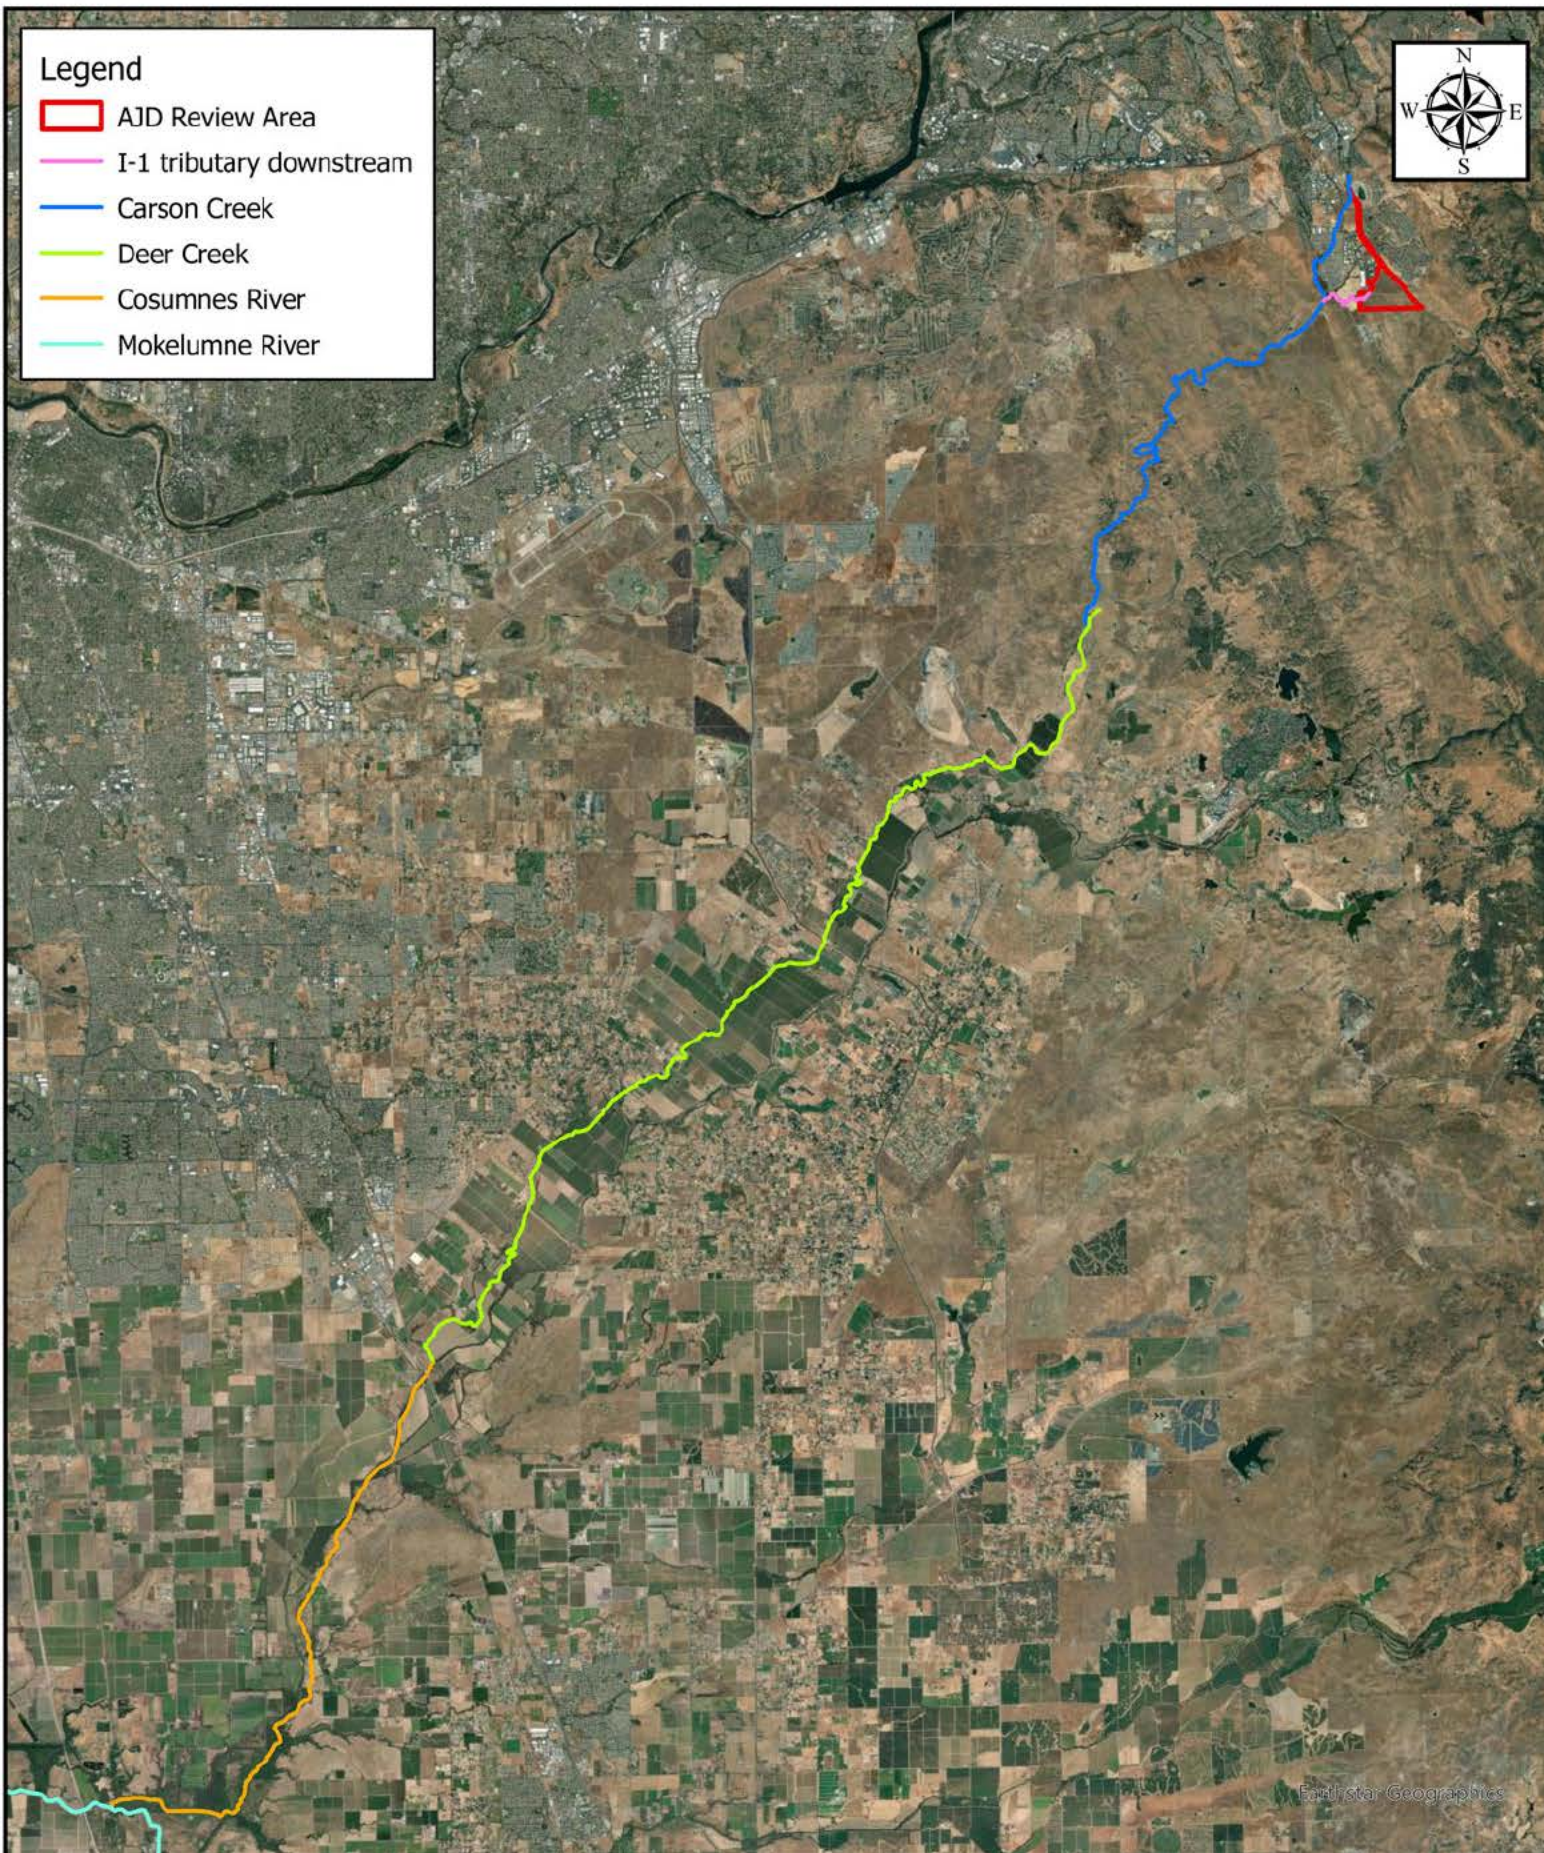
- AJD Review Area
- I-1 tributary downstream
- Carson Creek
- Deer Creek
- Cosumnes River
- Mokelumne River

5. FLOWPATH FROM THE SUBJECT AQUATIC RESOURCES TO A TNW, THE TERRITORIAL SEAS, OR INTERSTATE WATER. Aquatic resources within the review area flow into Carson Creek, a relatively permanent tributary to the Mokelumne River. Carson Creek flows southwest into Deer Creek, which subsequently merges with the Cosumnes River. The Cosumnes River ultimately discharges into the Mokelumne River within the Sacramento-San Joaquin Delta. The Mokelumne River is classified as a TNW under 33 CFR 328.3(a)(1)(i) (Enclosure 3).
