FINAL
HABITAT MITIGATION AND MONITORING PLAN
PERMIT NO. SPL-2008-00816-MB
Rosemont Copper Project

Revised September 12, 2017
Project Number: 1049.112

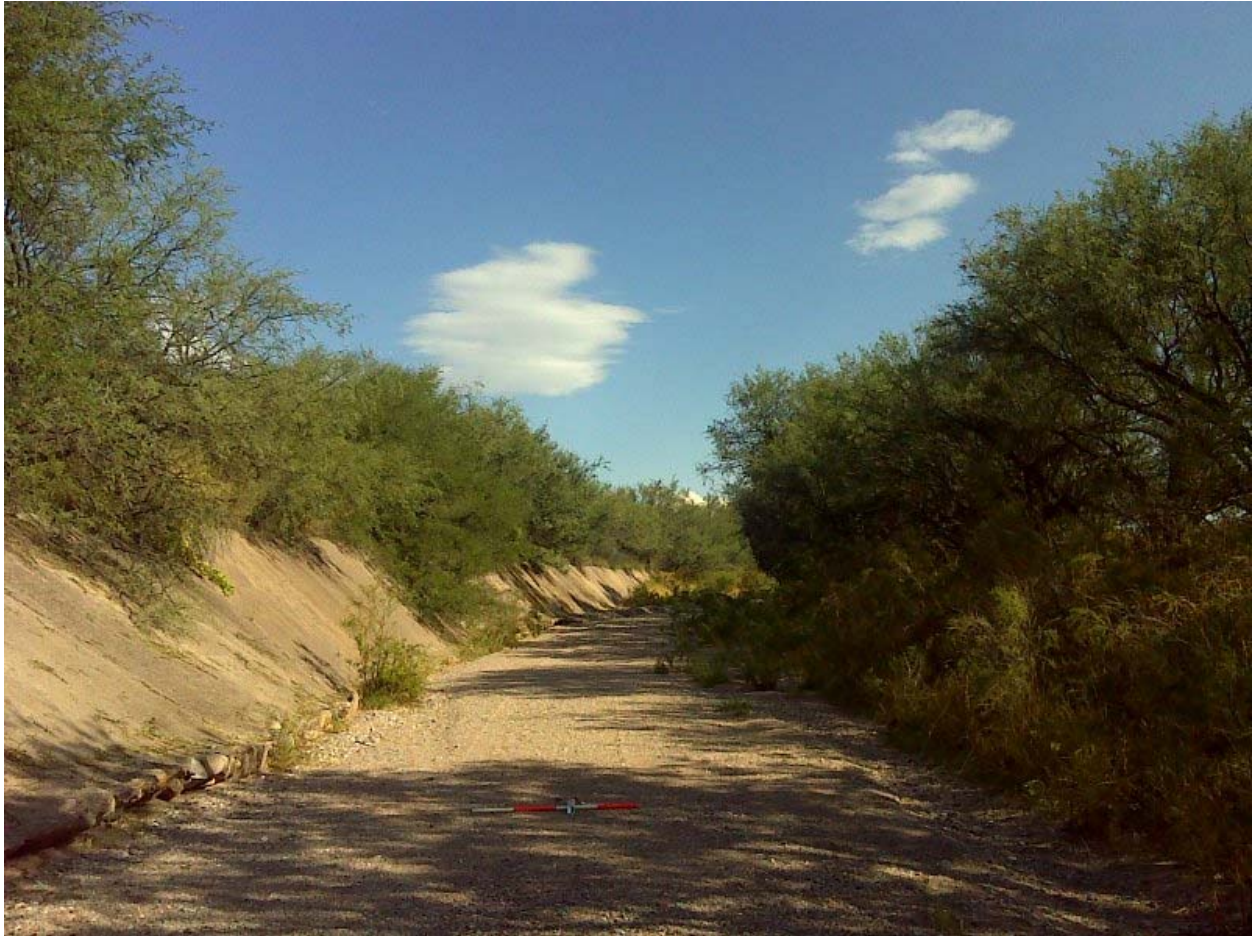
Figure 1. Straightened Reach of Sonoita Creek (looking upstream) with Concrete Armored Streambank (Courtesy of Westland Resources)

The reaches of Sonoita Creek that will be restored through the SCR Project have been altered by historic and/or ongoing manipulation of the valley landform and the channel (Figure 1). At the Rail X Ranch, Sonoita Creek lies on the far side of the valley from Highway 82, beyond an expanse of land that is no longer actively cultivated but which appears to have been leveled in the past. Vegetation in this area includes non-native species. It is likely that the channel was straightened and relocated to its current location at the base of the hills. Two small, artificial ponds, which also include invasive species (bullfrogs) on the RX property, will be removed (backfilled) as part of the SCR Project. These two ponds are fed by Cottonwood Spring. There will be no impact to Monkey Spring by removing and reclaiming these two ponds.

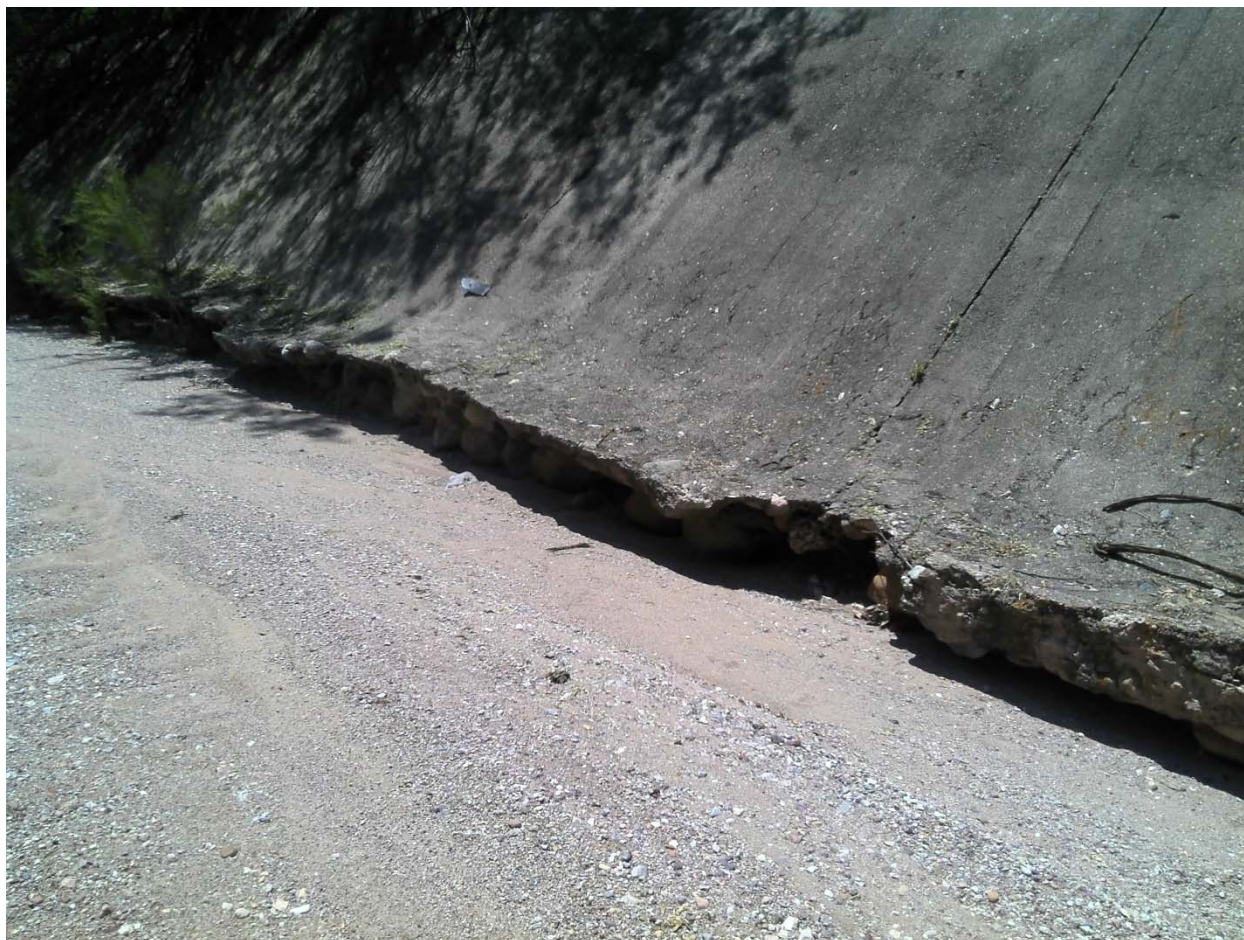
Figure 2. Sonoita Creek Armored Bank with Toe Scour and Limited Ecological Function (Courtesy of Westland Resources)

On the SCR Property, the existing Sonoita Creek is constrained on both sides: by an active agricultural field and a buried 4.5-inch steel high-pressure gas transmission line on one side and by Highway 82 on the other side. Sonoita Creek flows through an impaired, incised, straightened, bermed and armored reach along the edge of the agricultural field with little ability to provide ecological function. High, steep or near vertical channel banks result in limited to nonexistent riparian area, artificially elevated specific stream power, and artificially limited channel infiltration/recharge (Figure 2). Sonoita Creek has been completely disconnected from three of its east-bank tributaries as well as a functional floodplain.

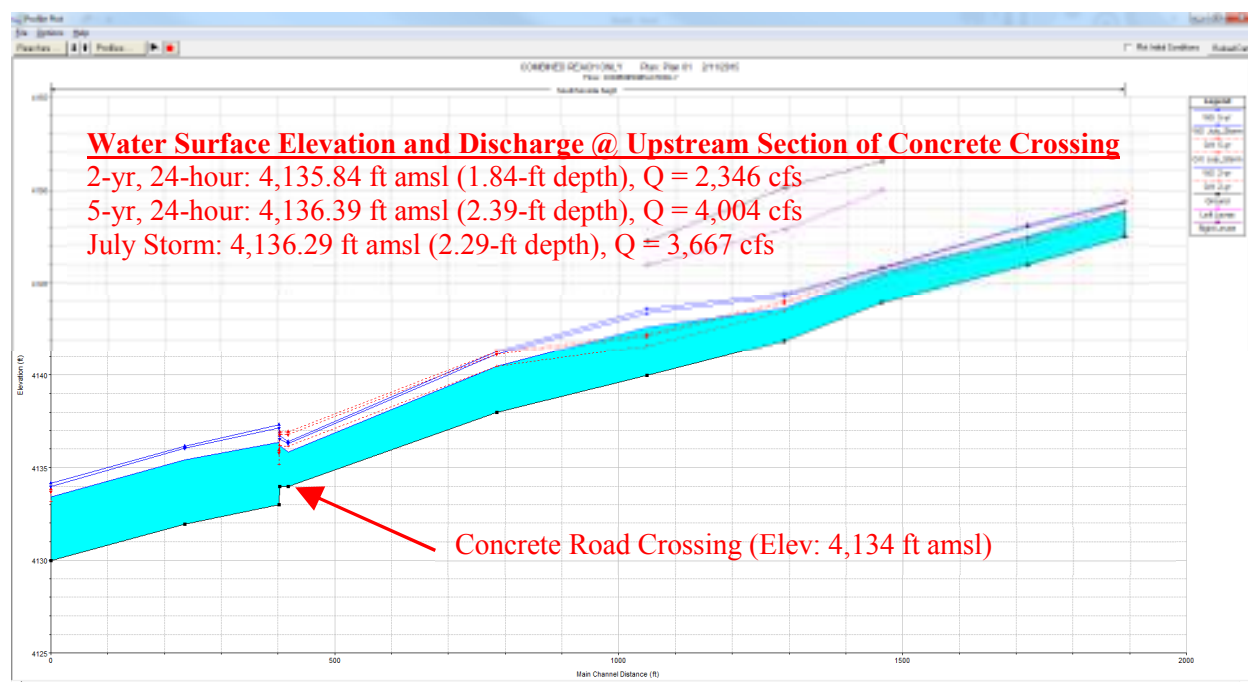
Figure 6. HEC-RAS Model Output: Water Surface Elevation Profile Plots

- The point precipitation value of 2.76 inches was reduced by applying an aerial reduction factor of 0.747 to get a value of 2.06 inches.
- The adjusted rainfall was modeled in SEDCAD to determine the associated peak discharge. The SEDCAD-predicted discharge through the section from the July rainfall was 3,667 cubic feet per second (cfs).
- The peak discharge estimated by SEDCAD was simulated using the HEC-RAS hydraulic model and the resulting depth of flow in the cross section was compared to the observed depth of flow based upon the high water marks. The 2-year, 24-hour discharge of 2,346 cfs and the 5-year, 24-hour discharge of 4,004 cfs were also modeled. The profile view of the water surface elevations through the modeled reach are shown for all three discharges in (Figure 6).

The depth of flow for the modeled peak discharge corresponds closely with the flow depth inferred from high water marks observed in the field, even though the peak discharge was determined independently through hydrologic modeling of the gage-recorded rainfall. The close correlation between the hydraulic model and field observations of high water marks also lends confidence to the determination that the July storm was indeed between a 2-year and 5-year event.

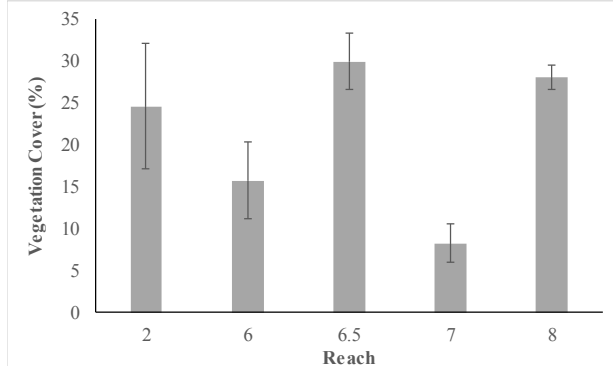
Figure 4: Average Vegetation Cover Across Reaches (Mean \pm Standard Error)

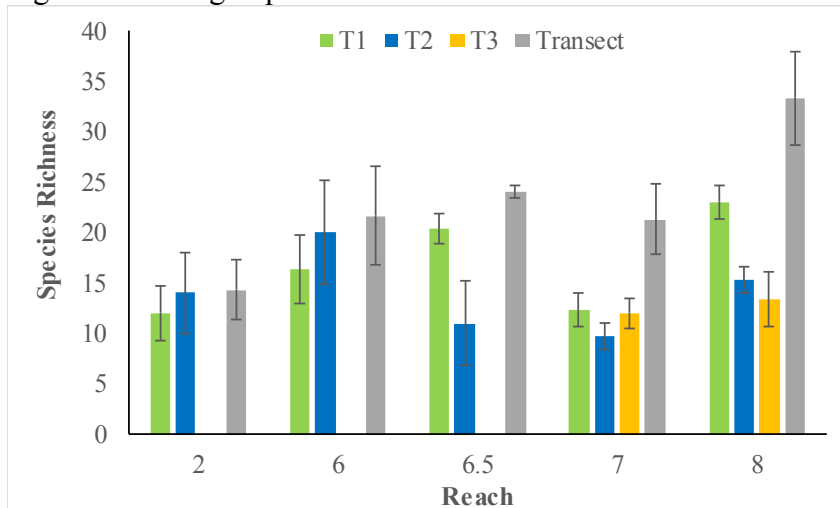
Figure 9: Average Species Richness Across Reaches and Terraces

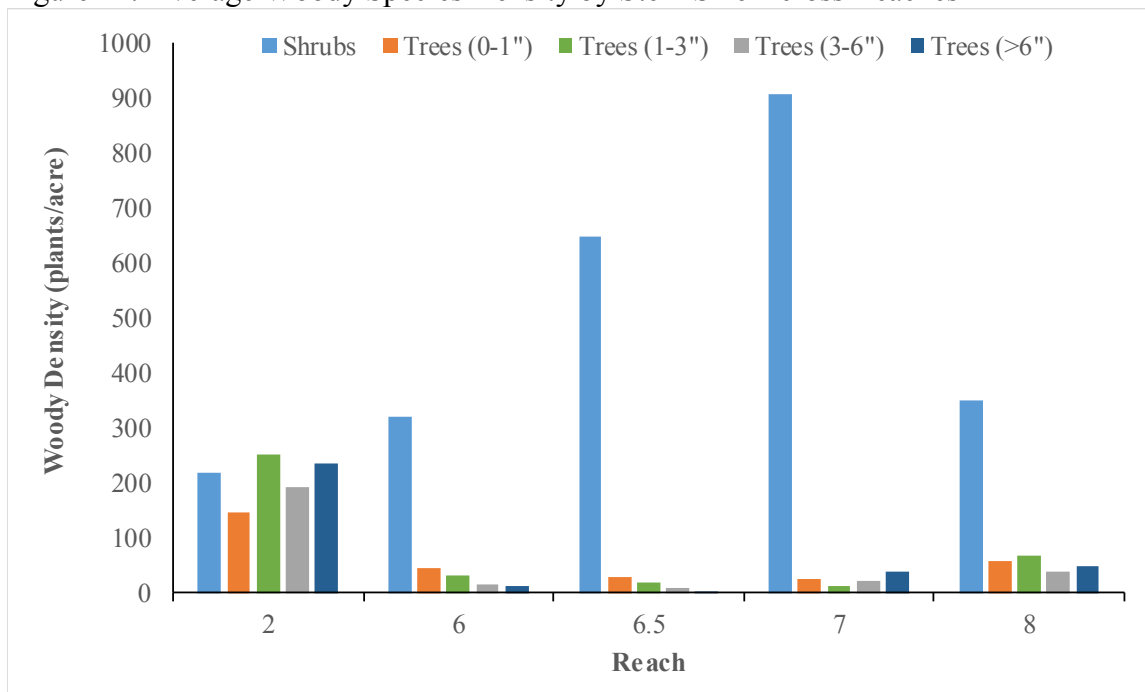
Figure 12: Average Woody Species Density by Stem Size Across Reaches

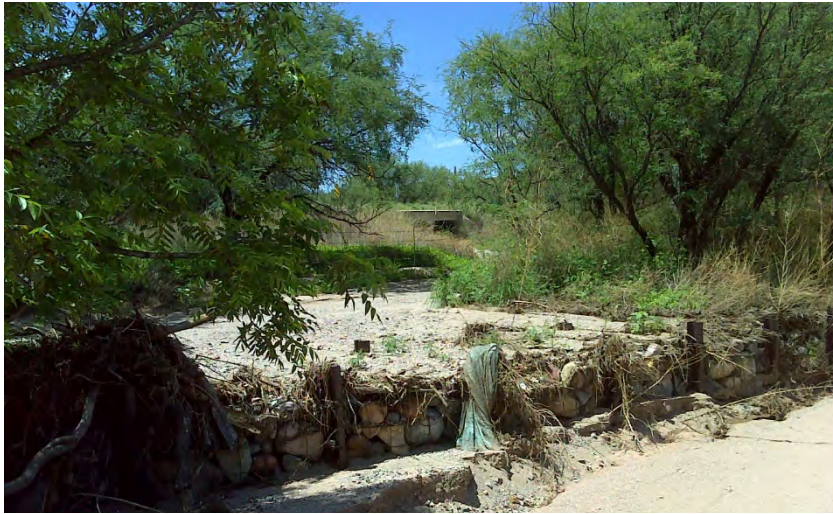
Photo 9
Feature Name: N/A

Note: Looking eastward at upland swale east of Highway 82 at the terminus of Wood Canyon. Little to no evidence of flow was observed in this swale.

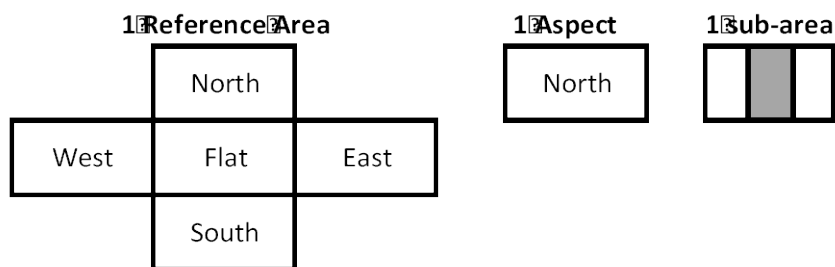
Illustration 1. Sampling Locations.

For each selected ecological site, a minimum of three (3) replicates of undisturbed reference areas will be selected to describe the baseline vegetation conditions that will eventually be used to determine reclamation success on the respective areas of the Landform. Each of the selected reference areas will encompass about 100 acres. Within each reference area, four (4) slope aspects will be selected to represent the reclaimed Landform (north-, south-, and east-, and west facing slopes). If present, a relatively flat area will also be delineated within the reference area to compare with the gentle slopes planned for the top of the Landform. Each slope aspect will encompass approximately three (3) acres. Approximately one (1) acre areas will be sufficient for a flatter slope aspect. Each slope aspect will be stratified, or divided, into sub-areas, which is the sampling unit where the data will be collected (Illustration 1). An example of a reference area in the Granitic Hills and in the Limy Slopes ecological sites can be seen in Figure 1. As noted in Figure 1, the location indicated for a Limy Slopes reference area has topography supporting all five (5) aspects while the potential Granitic Hills reference area has topography that supports only four (4) of the five (5) aspects.
