MARYSVILLE HISTORIC COMMERCIAL DISTRICT

Historic Structure Impact Report

Prepared for
HDR, Inc.

Prepared by
Garavaglia Architecture, Inc
30 January 2013

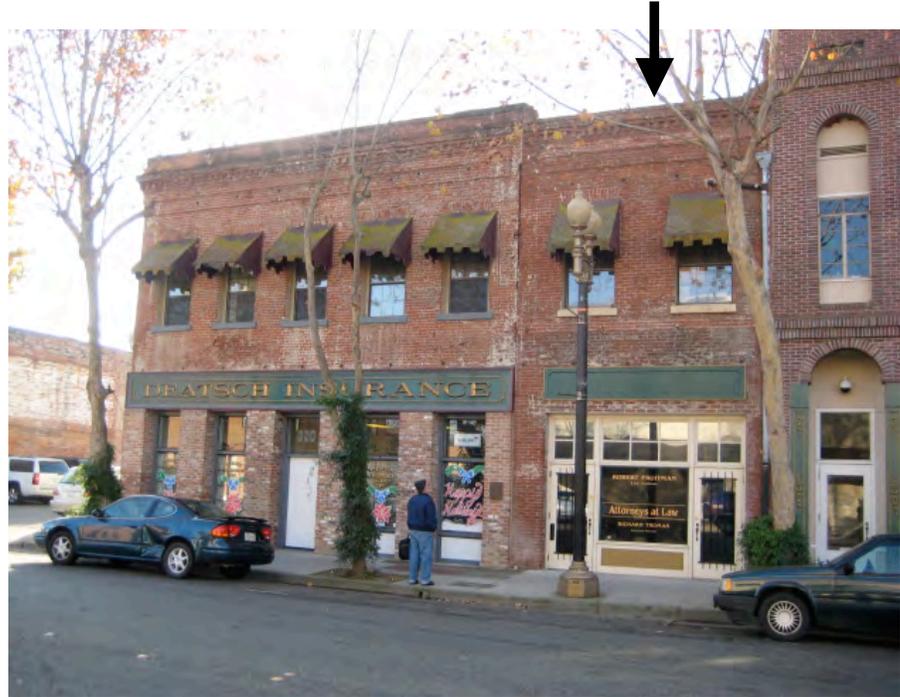
- Walls
 - Exterior brick walls
- Floors
 - Wood framed (suspected)
- Roof
 - n/a
- Foundation
 - n/a
- Seismic or other strengthening
 - No seismic retrofit work apparent.
- Other
 - Parapet bracing is unknown
 - Arched windows filled in
 - CMU rear wall
 - 2 party walls – appears building was an infill between neighboring structures

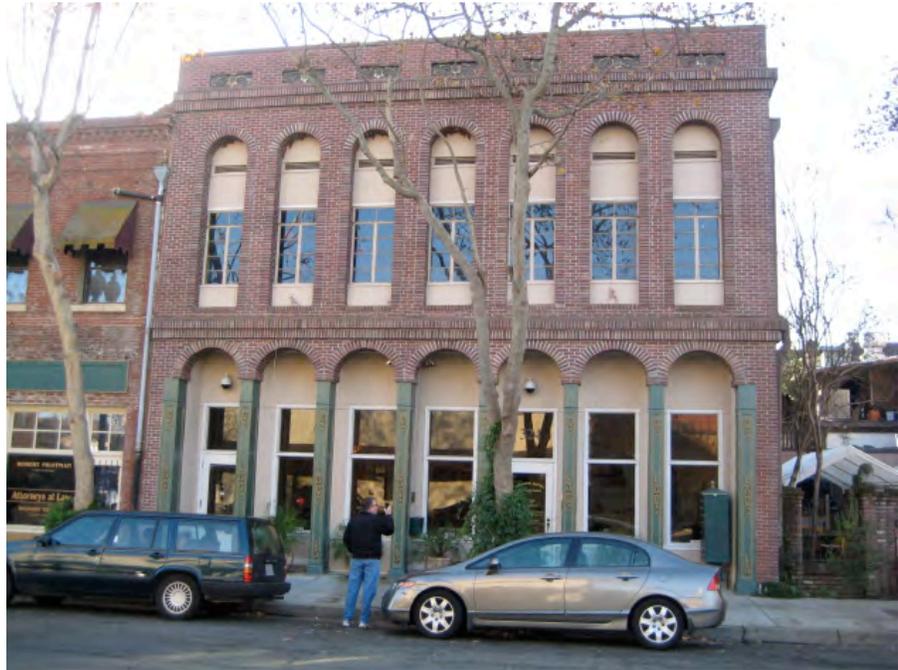
- Walls
 - Exterior brick walls furred out
 - Finished with modern brick
 - Central masonry partition wall
- Floors
 - Wood frame
 - Partial mezzanine level
- Roof
 - n/a
- Foundation
 - n/a
- Seismic or other strengthening
 - No seismic retrofit work apparent.
- Other
 - Original first floor was cast iron storefront
 - Only columns remain
 - Front elevation finished in stucco c.1920s, likely sandblasted since

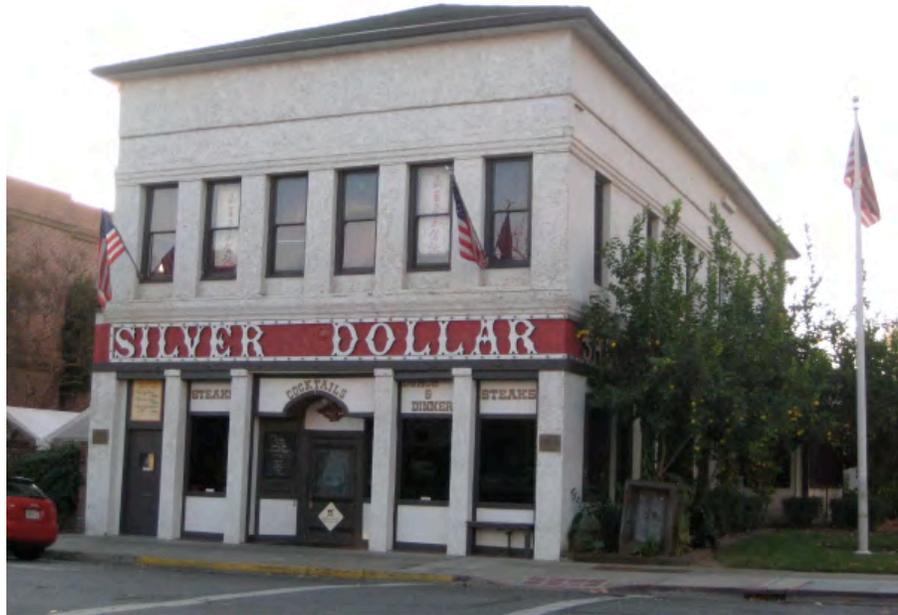
- Walls
 - Interior and exterior walls furred out
 - Finished with modern materials
 - Brick construction
- Floors
 - Wood finish on wood framing
- Roof
 - Hip
 - Wood framed
- Foundation
 - No basement (according to owner information). Access was allowed to the first floor dining area only.
- Seismic or other strengthening
 - No seismic retrofit work apparent.
- Other
 - n/a

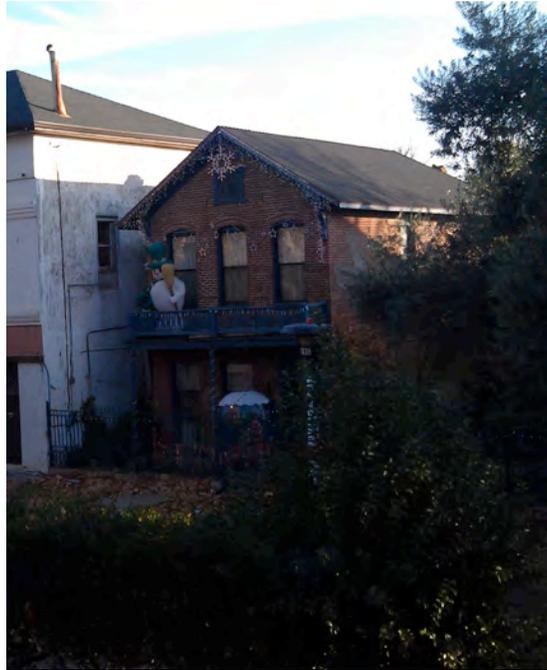
- Walls
 - Brick masonry
 - Plaster finish on interior
- Floors
 - Wood finish on wood framing, carpet
- Roof
 - Replaced c.2005
- Foundation
 - none observed
- Seismic or other strengthening
 - No seismic retrofit work apparent.
- Other
 - Minor interior plaster cracking, mostly original trim and details
 - Brick sandblasted
