# 2012 ANNUAL EROSION RECONNAISSANCE ENGINEERING REPORT

Sacramento River Bank Protection Project  
Sacramento River and Tributaries

**February 2013**

**SACRAMENTO DISTRICT**

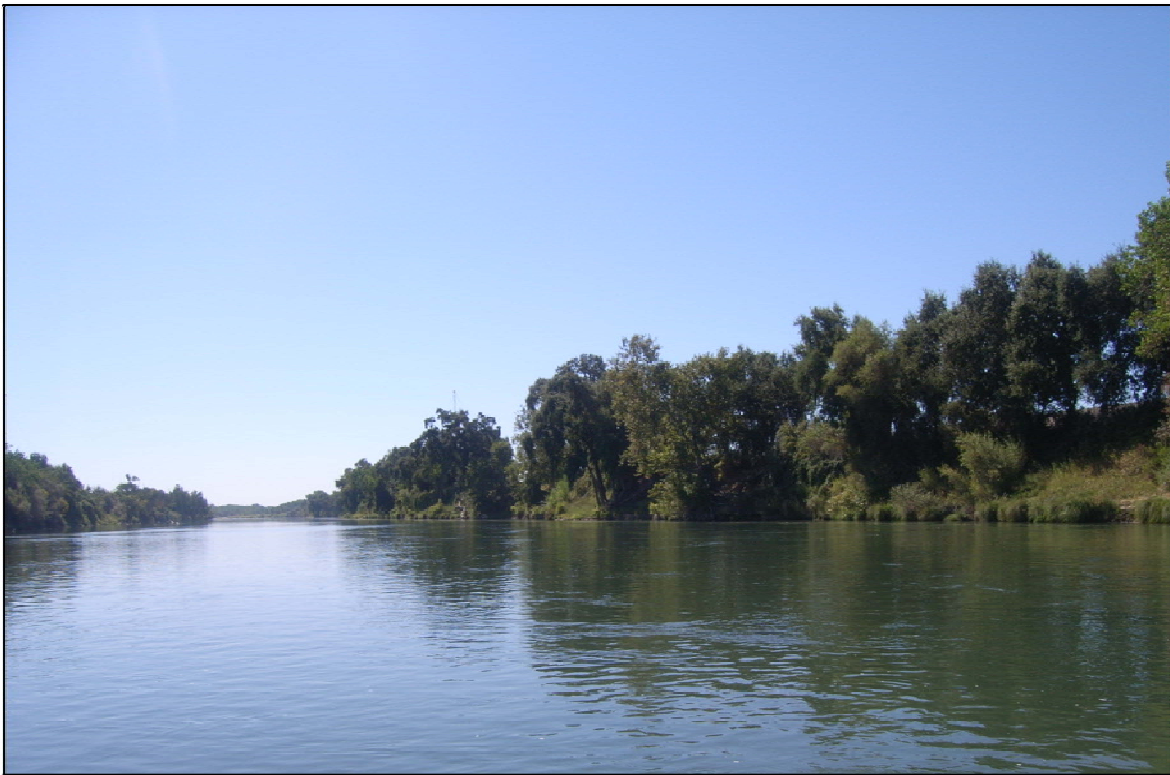
Upper Reach of the Sacramento River – Ord Bend to Colusa (RM 185 to 144) – The upper reach of the Sacramento River is unique in that the levees are setback and the channel naturally meanders and erodes. A typical picture of the Upper Sacramento River is shown in **Figure 4**. In general, the river has become somewhat sediment starved due to upstream reservoirs reducing the bedload from upstream. The river is highly erosive and erosion of the outer banks of the meandering bends and the development of sandbars are evident throughout the reach. The natural erosion of the banks is considered good for a healthy river system and environmental factors. However, when the erosion creeps into the projection of the levee slope, it can threaten the integrity of the SRFCS. There are currently 9 erosion sites in this reach.

**Figure 4. Typical View of the Upper Reach of the Sacramento River.**

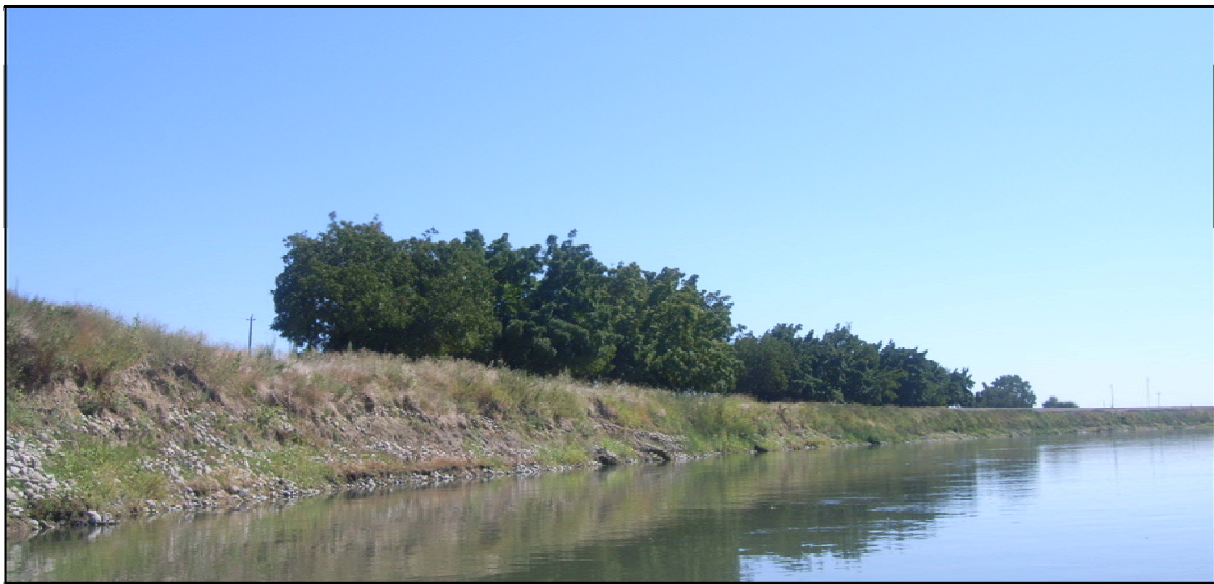
Middle Reach of the Sacramento River – Colusa to Sacramento (RM 144 to RM 61) – The middle reach of the Sacramento River has the levees close to the river and multiple diversion structures to move flow into the bypass system. This reach was intentionally designed with the levees close to the banks to help move some of the bedload and debris that remained from the days of hydraulic mining. In addition, the USACE was responsible for keeping the river navigable up to the city of Colusa. As a result of this design, much of the reach is protected with rock, especially the outsides of bends. The majority of the rock in this reach is cobbles placed prior to the 1960's and some areas with more recent quarry stone. The cobble sites are reaching the end of their design life and starting to fail. Roughly one-third of the sites in this reach are from failed cobble sites. **Figure 5** shows a typical view of the Middle Sacramento River. There are currently 40 erosion sites in this reach.

**Figure 5. Typical View of the Middle Reach of the Sacramento River.**

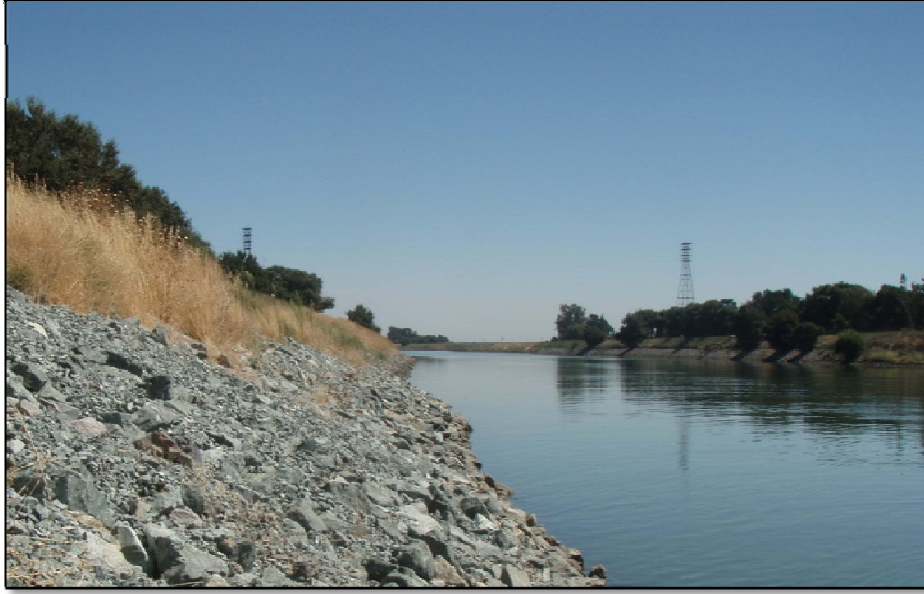
Sacramento River – Delta Section (RM 61 to RM 15) – The delta reach of the Sacramento River has levees close to the banks and is tidally influenced. The location of the channel has been relatively stable for the past 150 years. A large percentage of this reach is already rock. This area has heavy action from recreational boating, wind wave run-up, and the banks are heavily used by the public. Many of the levees are constructed of deposited dredge tailings from the bottom of the river. **Figure 6** shows a typical view of the Delta section of the Sacramento River. The causes of erosion in this reach are boat wake, wind wave, mass slope failure, fluvial processes, and human usage. There are currently 37 erosion sites in this reach, of which one (1) is new, two (2) are critical, and three (3) are under construction.

**Figure 6. Typical View of the Sacramento River – Delta Section.**

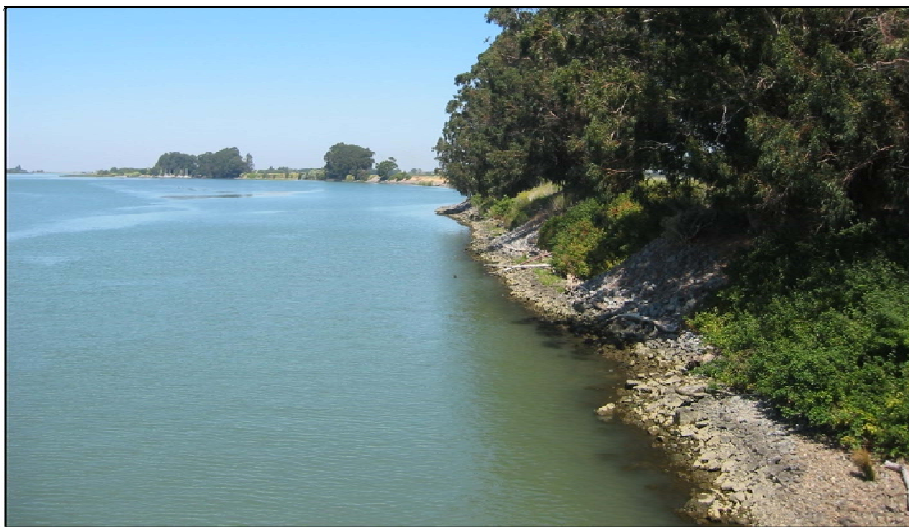
Lower Reach of the Sacramento River (RM 15 to RM 3) – The lower reach of the Sacramento River is very wide and the water surface is controlled by the tides. Only the left bank is leveed in this reach; the right bank is considered high ground. There is a narrow highway with no shoulder on top of the levee for half of the reach. Ocean-going cargo ships travel through this reach creating large wakes. The area is also subject to high winds and wind waves. Wind waves and boat wakes are the main cause of erosion in this reach. Bank stability is also an issue; the slopes of the levees are steep and constructed of poor (non-cohesive) soils; however the toe often contains some clay. **Figure 7** shows a typical view of the lower section of the Sacramento River. There are currently eight (8) erosion sites in this reach, of which four (4) are critical.

**Figure 7. Typical View of the Lower Reach of the Sacramento River.**

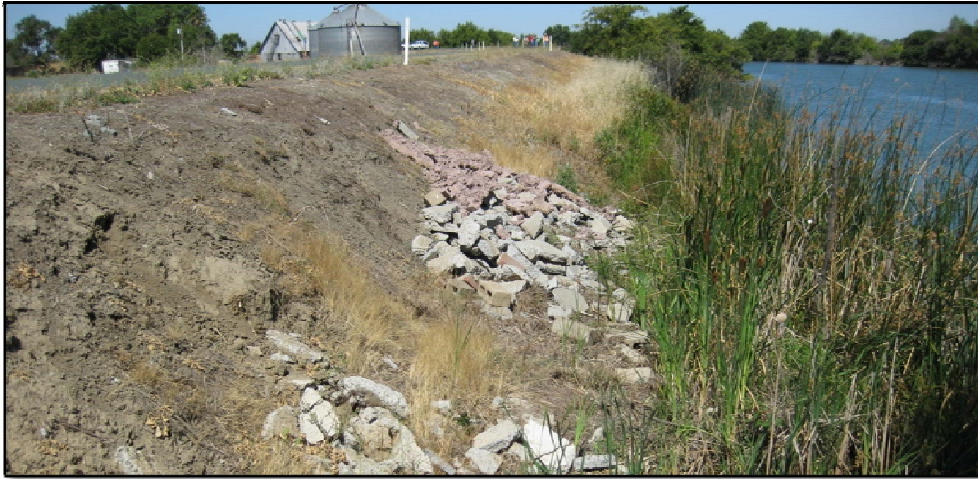
Georgiana Slough – Georgiana Slough is unique in that it flows from the Sacramento River System into the San Joaquin River System. Until recently there was a no-wake zone for the entire slough, now only the upstream most two miles are regulated as a no wake zone. Georgiana Slough is completely influenced by the tides and subject to severe winds. The majority of the levee and bank slopes are steep with no berm. The banks are composed of poor soils, which do not meet current design standards. The left bank is in worse shape and contains 90% of the sites. Biotechnical repairs in the form of brush boxes have been used to try and protect the banks from wind waves and boat wakes; however, the majority of them have had limited to no success. The primary erosion factors are from wind wave, boat wake, tidal influence, and poor soils. Many of the sites along the left bank have started to merge together and soon the entire bank may be considered an erosion site. **Figure 11** shows a typical view of a Georgiana Slough levee. This reach may benefit from a reach-wide repair. There are currently fifteen (15) erosion sites, of which four (4) are critical.

**Figure 11. Typical View of Georgiana Slough.**

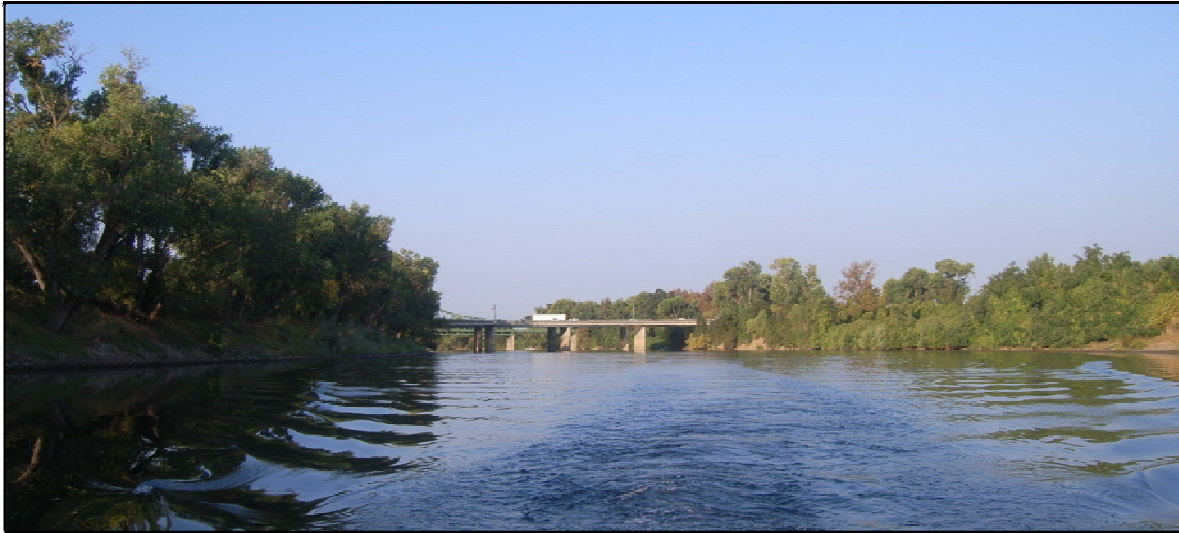
American River – The American River is fed by Folsom Dam and is therefore generally sediment starved and has been eroding and transporting the fine materials from the channel bed. Once the fines have been removed and the bed armors, the channel is expected to move laterally and erode the banks. The right bank is setback from the channel for the lower 5 miles. Boat wake is not a concern as there is a no wake zone for the entire river. The main causes of erosion are fluvial, tree pop-outs, and public use. This river is generally well maintained and has had many bank repairs in the recent years. **Figure 13** shows a typical view of the American River. There is currently one erosion site on the American River, and it is new.

**Figure 13. Typical View of the American River.**

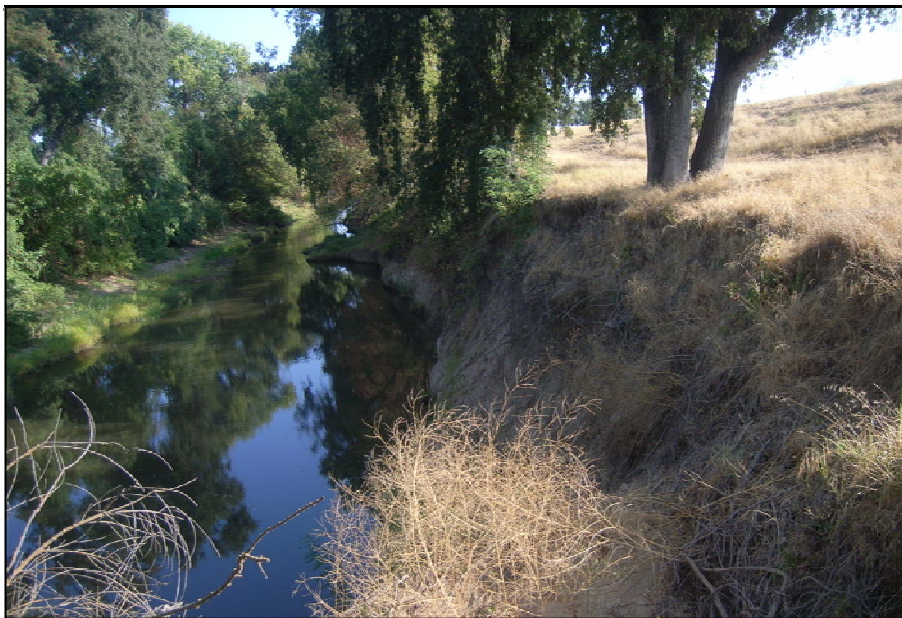
Bear River – The Bear River is an incised channel due to the loss of sediments from the Camp Far West Dam and historic sand and gravel mining. The levees are setback a short distance from the slightly meandering channel. **Figure 16** shows a typical view of the Bear River. A setback levee was recently constructed for the first two miles on the right bank. There are currently five (5) erosion sites on this river.

**Figure 16. Typical View of Bear River.**

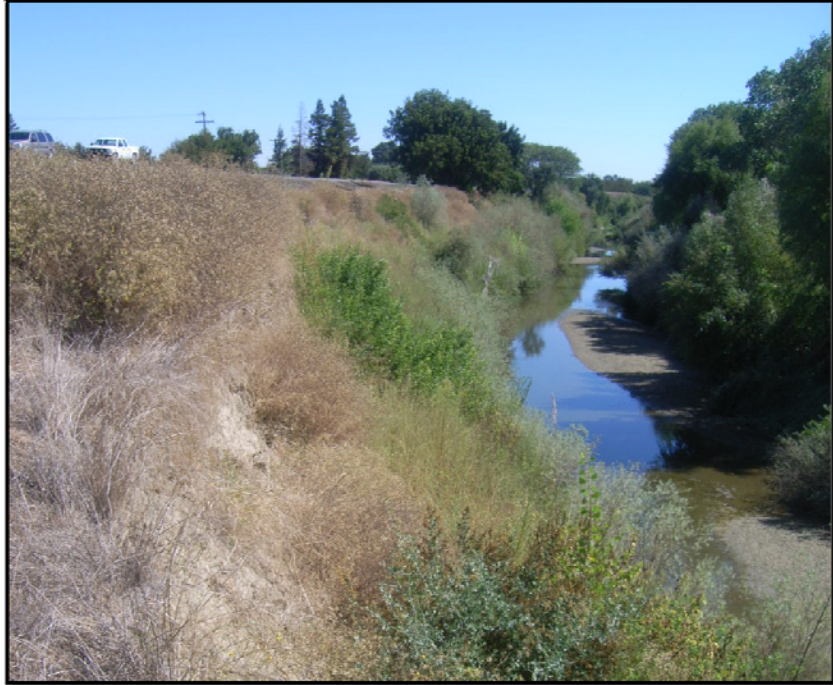
Cache Creek – The Cache Creek levees start near the town of Yolo and terminate at the Yolo Bypass. Cache Creek is a deeply incised channel with near vertical banks (over 20 ft in height) for the entire leveed reach. The channel is sediment starved from excessive in-stream gravel mining. Some sand and gravel are present in the channel bed, indicating that the channel may be starting to recover and become more stable. **Figure 19** shows a typical view of Cache Creek. The erosional mechanisms in this reach are toe erosion, fluvial and mass failure. The natural banks are too steep and the channel is too narrow for a traditional bank protection repair; setback levees have been the selected option for repair. This creek may benefit from a reach-wide repair. There are currently seven (7) erosion sites on Cache Creek, three (3) of which are considered critical. DWR currently has plans to repair four (4) of these erosion sites with setback levees, two (2) of which are critical.

**Figure 19. Typical View of Cache Creek.**

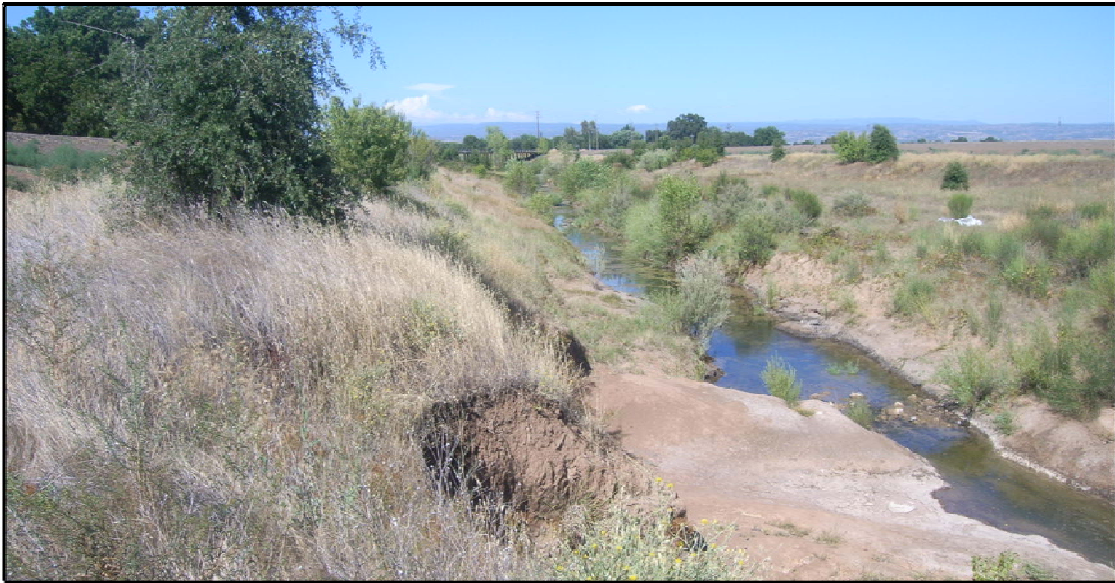
Big Chico Creek, Sycamore Creek, and Mud Creek – These three creeks drain from the Mount Lassen/Cascade Range and terminates at the Sacramento River at RM 196. Only a small portion of Big Chico Creek is leveed to protect the City of Chico. The levee is heavily used for running, biking, and horseback riding. The channel is braided and incised with a sand/gravel/cobble bed and an occasional tree. Sycamore Creek is a straightened channel that becomes more natural as it approaches Mud Creek. Mud Creek is a narrow channel, with incised portions and levees set close to the channel. **Figure 22** shows a typical view of Mud Creek. There is only one erosion site in this section and it is on Mud Creek.

**Figure 22. Typical View of Mud Creek.**
