## 4.0 CHANNEL EROSION AND BASIN GEOMORPHOLOGY

### 4.2 Direct Comparison of Measured Cross Sections

#### 4.3.1 Evaluation of Continuous Stream Lengths (Stream Walks)

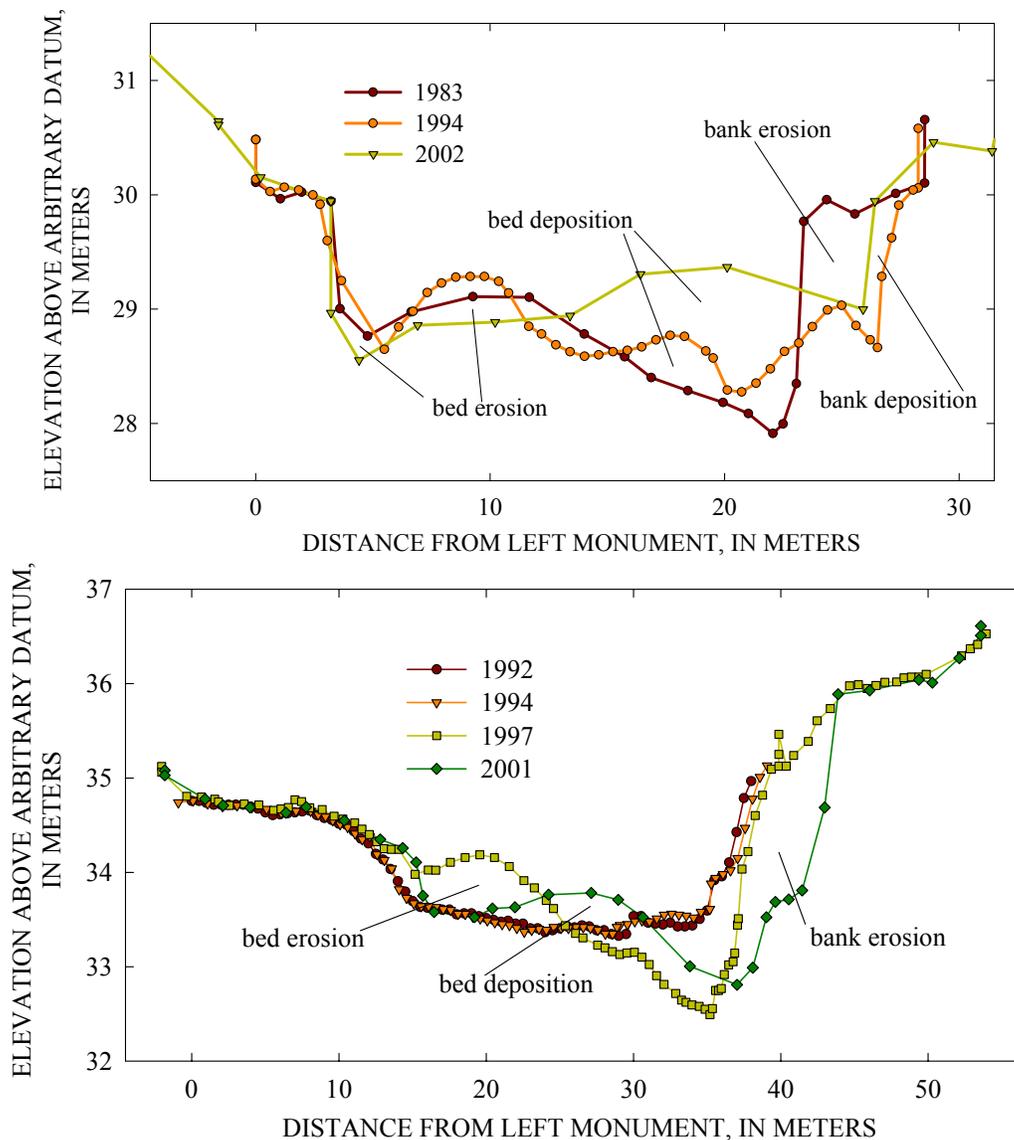
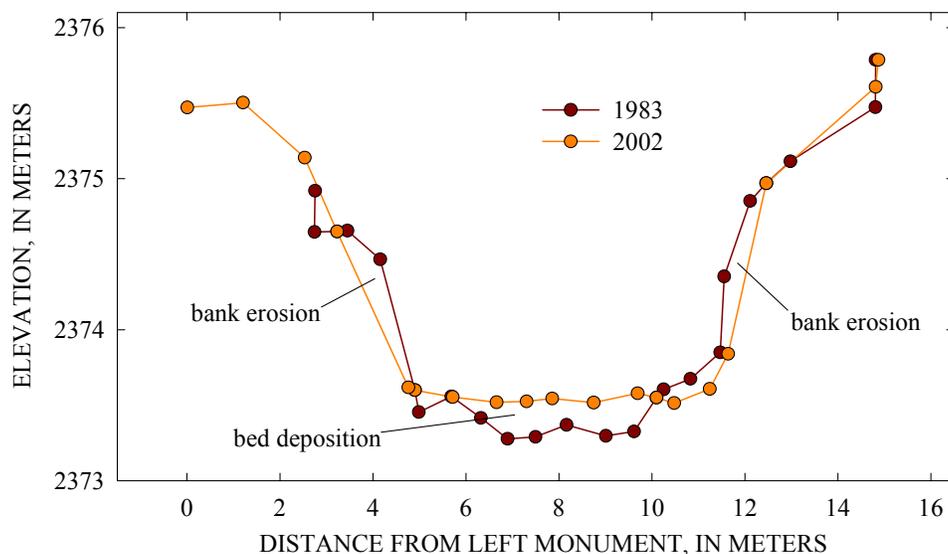
**Figure 4-2. Examples of overlain surveys from Blackwood Creek, Upper Truckee River and General Creek.**

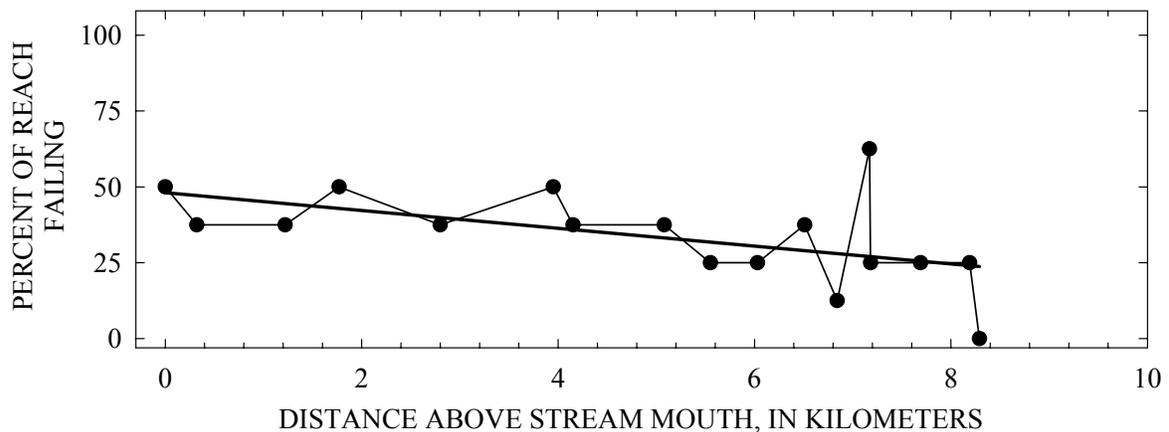
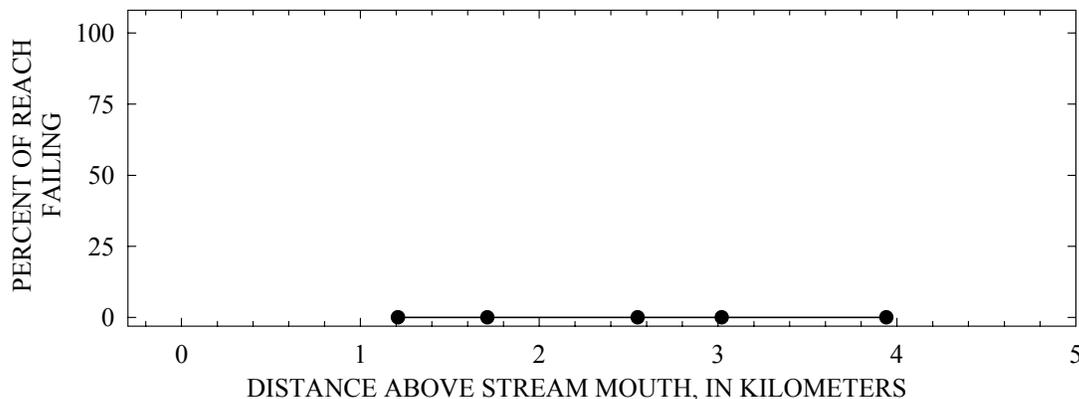
- (1) except for the upstream-most site which is upstream of a headcut, 25-50% of the longitudinal extent of all assessed banks were unstable;
- (2) there is a general trend of decreasing bank instability with distance upstream (Figure 4-6); and
- (3) a knickpoint at about km 8.1 marks the headward advance of an instability moving through the Blackwood Creek network.

Compare Figure (4-6) for Blackwood Creek, with RGA results from Logan House Creek, where extremely low sediment yields and net bank deposition have been calculated from past and present surveys (Figure 4-6), and the importance of streambank erosion in delivering suspended sediment can be appreciated.

**Figure 4-6. Percentage of left and right banks that are unstable along Blackwood Creek (upper) and along Logan House Creek (zero) (lower).**

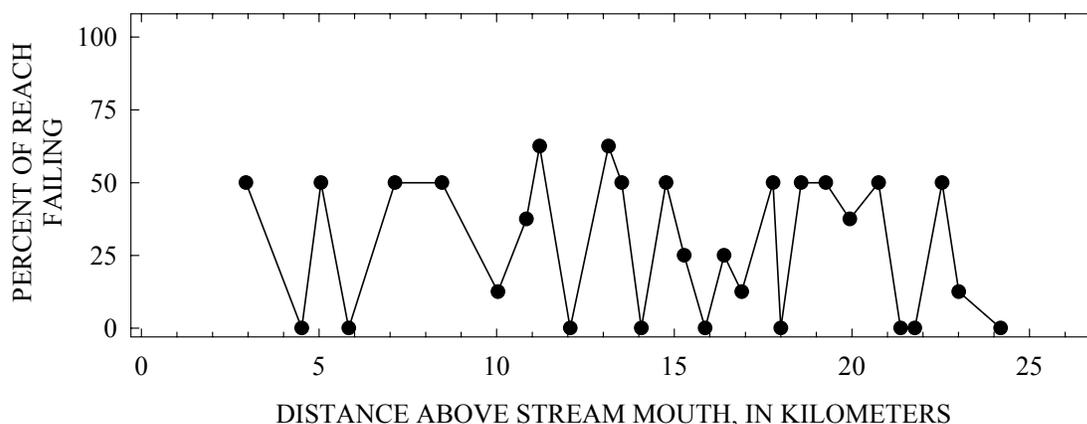
In the sinuous reaches of Washoe Meadows and further downstream, the outsides of meander bends are particularly active. This is evident from RGA data on the percent of each reach having failing banks (Figure 4-7). Here, the recurrence of 50% values reflect a geotechnically stable inside bend and an outside bend that is unstable along its entire length. Values of 0% failing reflect boulder reaches and other protected areas. Bank-erosion rates compared between 1992-1994 and 1997-2002 have increased 2 to 3 times, most likely a function of toe scour and lateral retreat of bank toes during the large January 1997 flow event. In fact, the 1997 surveys in the reach post-date the rain on snow event indicating that hydraulically-induced channel changes during the event resulted in geotechnical instabilities that have affected channel processes for at least the next five years. To place these results in a historical perspective, analysis of the lateral migration of this reach of river was conducted.

**Figure 4.7. Percentage of left and right banks failing along the Upper Truckee River.**

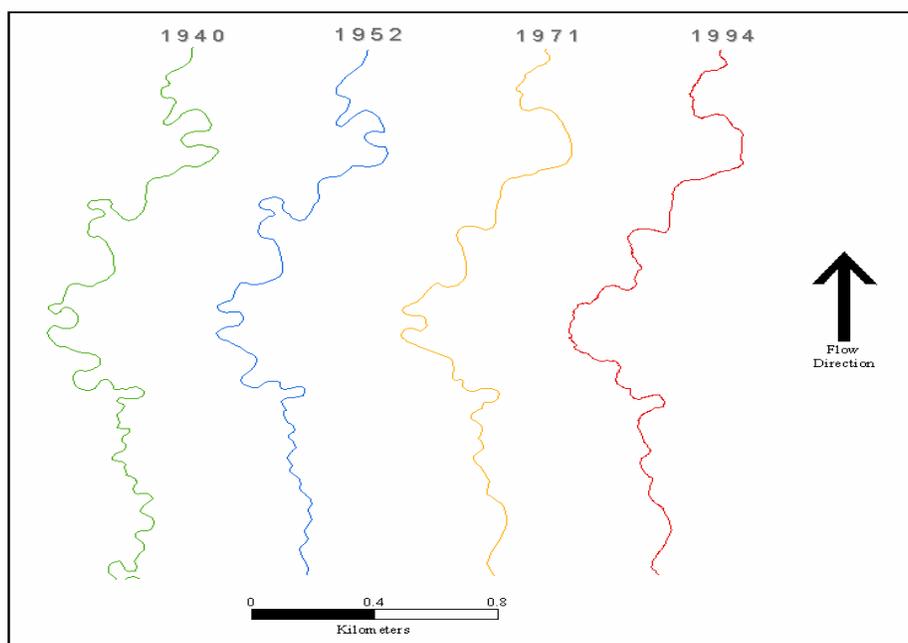
**Figure 4-8. Successive centerlines of the Upper Truckee River, 1941 – 1994.**

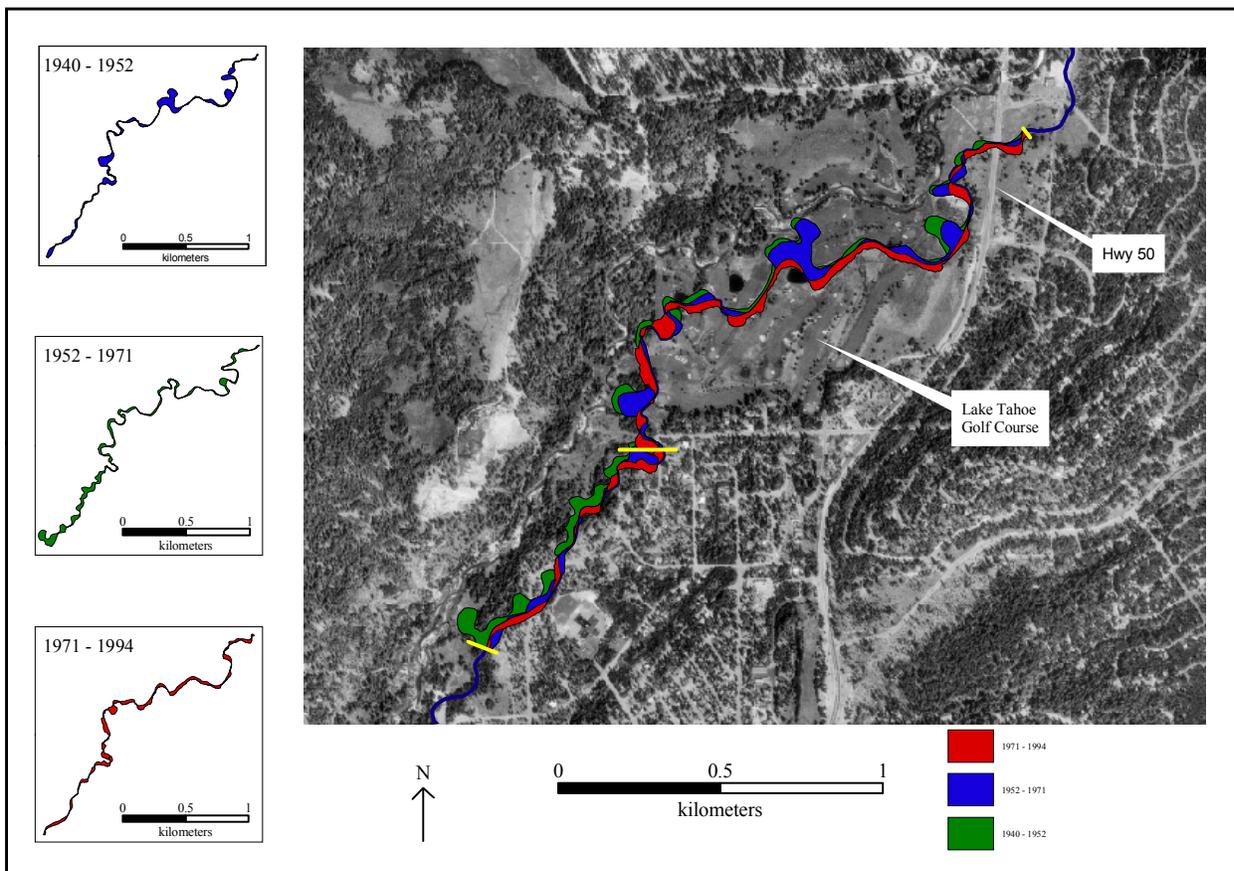
**Figure 4-9. Map of polygons resulting from analysis of time-series channel centerlines along a reach of the Upper Truckee River.**

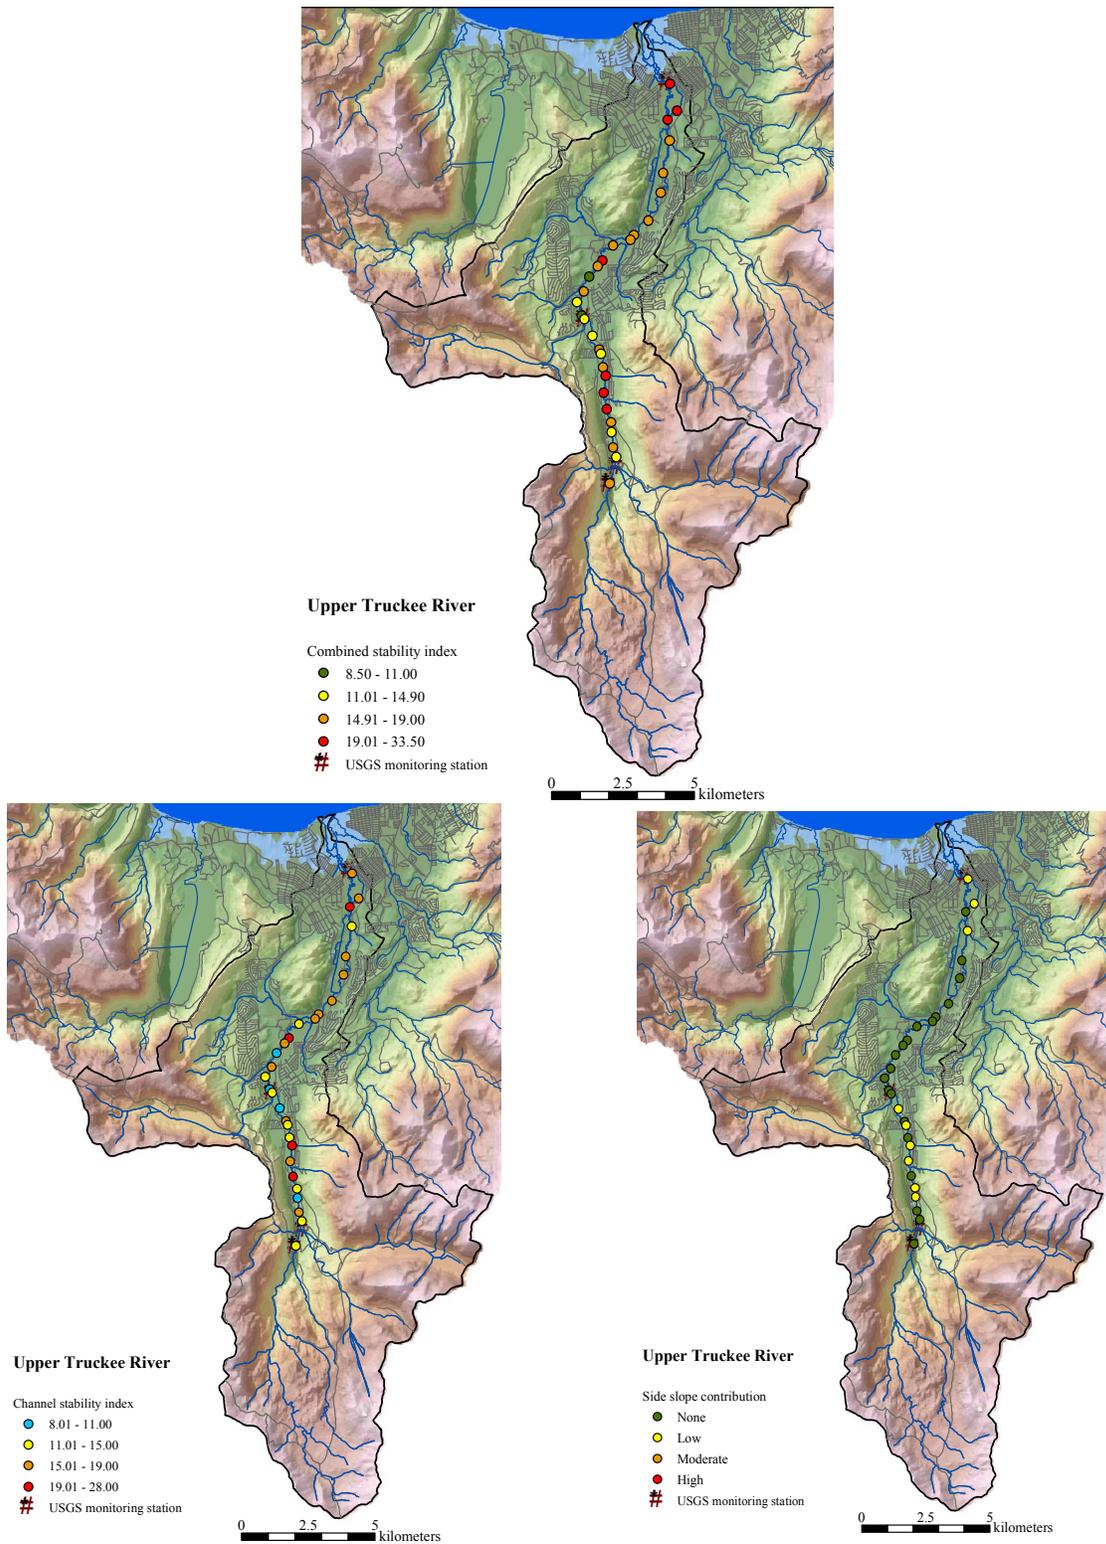
**Figure 4-18. Results of rapid geomorphic assessments of the Upper Truckee River showing the relative contributions of channel- and side-slope indexes to the combined stability index, and critical erosion areas.**

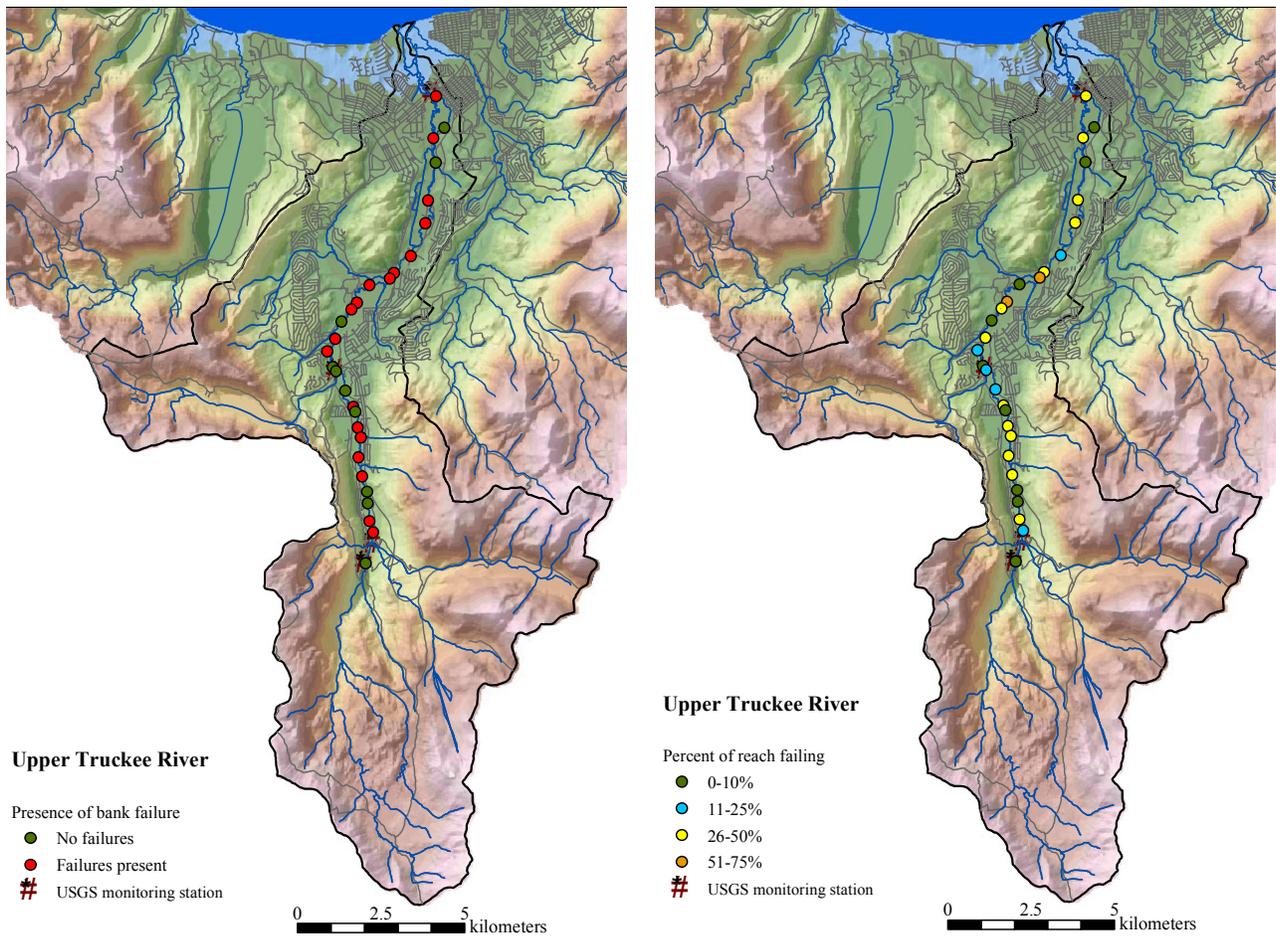
**Figure 4-19. Presence or absence of bank failures and the percent of the longitudinal extent of left and right banks undergoing active mass-wasting processes along the Upper Truckee River.**

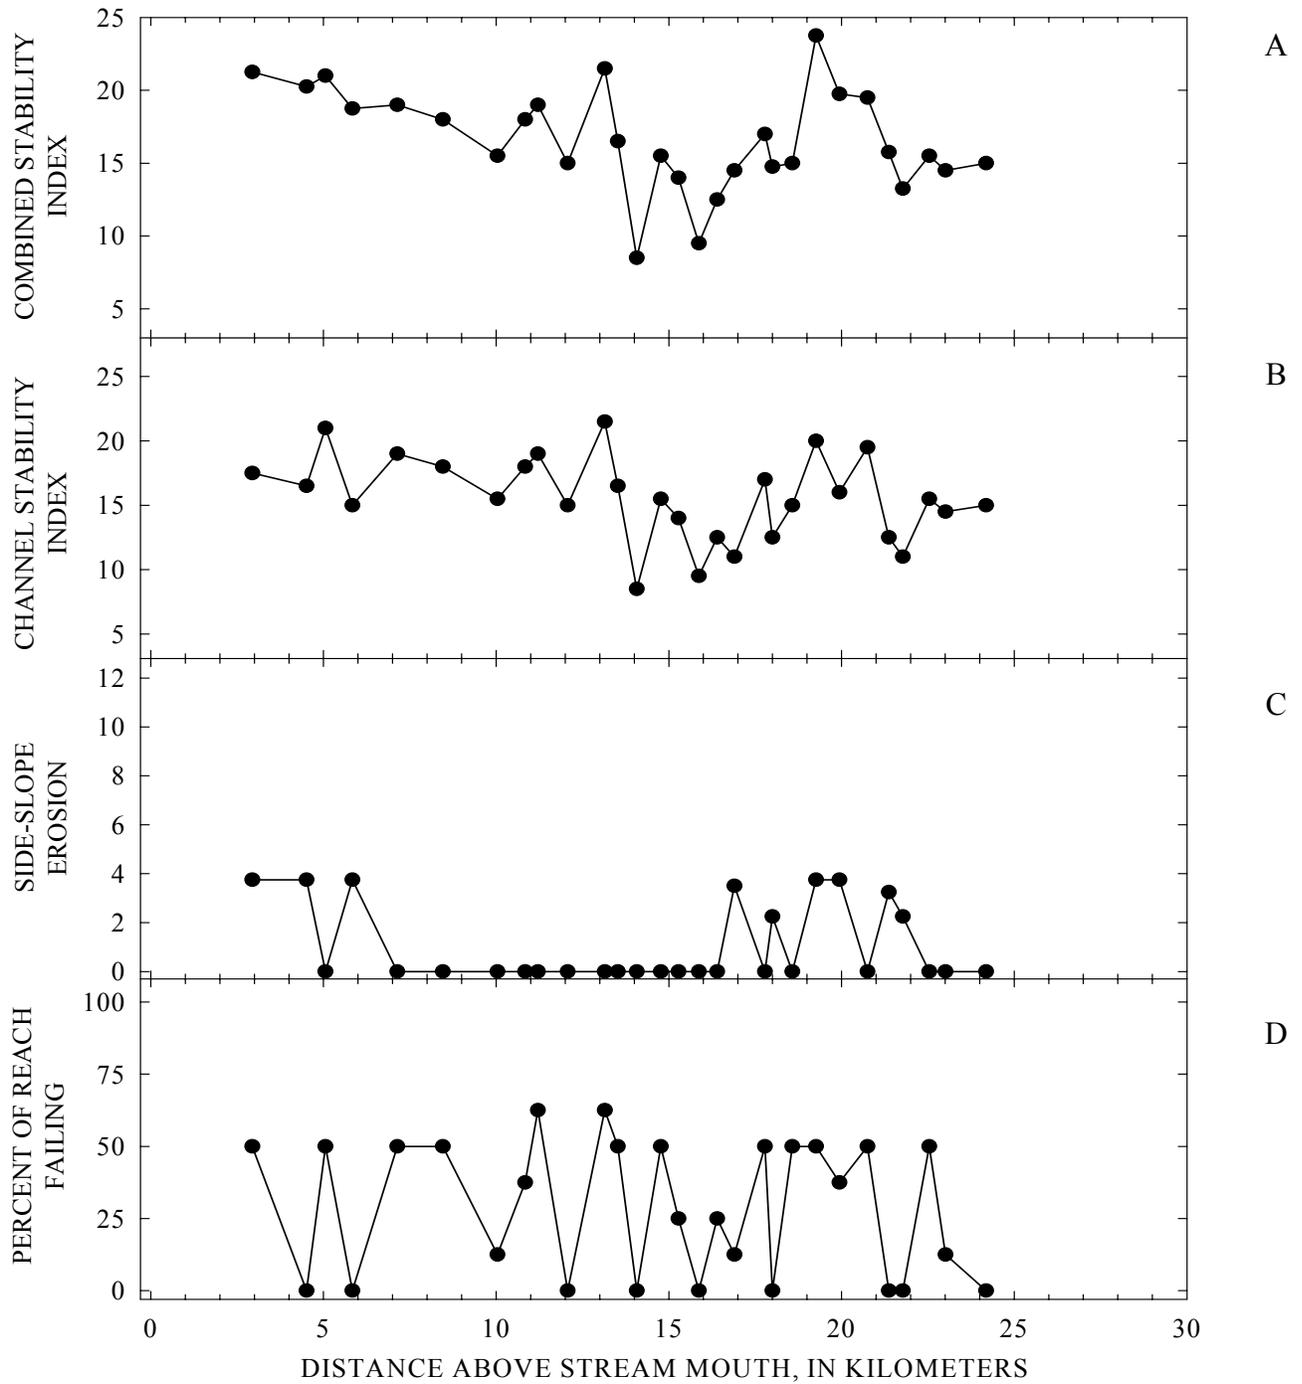
The Upper Truckee River exhibits a general trend of increasing stability with distance upstream, indicative of a channel undergoing adjustment to disturbance(s) (Figure 4-20 A). The lowest reaches, from the Upper Truckee Marsh to the golf course, have a greater available supply of fine sediment due to bank heights being high enough to slough off when undercut, the lack of root penetration through to the bank toe, and the lack of coarse material to protect the bank toes. Upstream of the golf course the channel has little fine sediment as it passes through a moraine. The meadow reaches between moraines provide silt/sand sediments from banks that are susceptible to erosion by sloughing. However, unlike from golf course downstream, the banks in this reach are not as high, and they contain greater quantities of sand and gravel, thereby reducing the available amount of erodible fine sediment.

**Figure 4-20. Results of RGAs conducted along the Upper Truckee River showing the longitudinal distribution of the combined, channel and side-slope erosion indexes, and the percent of reaches undergoing streambank bank failures.**

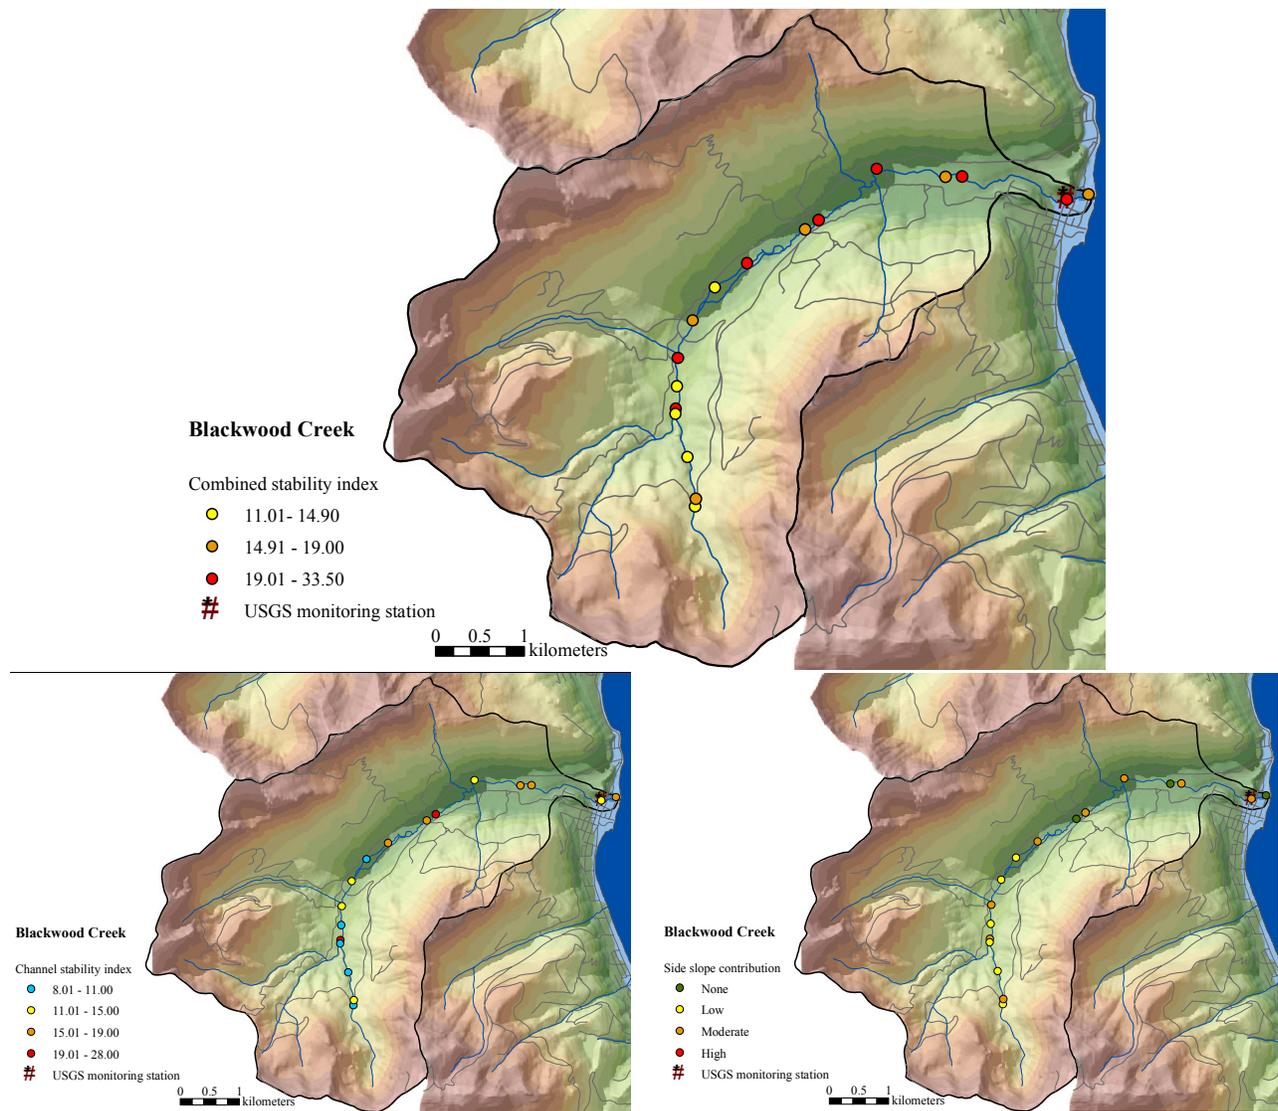
**Figure 4-24. Results of rapid geomorphic assessments of Blackwood Creek showing the relative contributions of channel- and side-slope indexes to the combined stability index and critical erosion areas.**

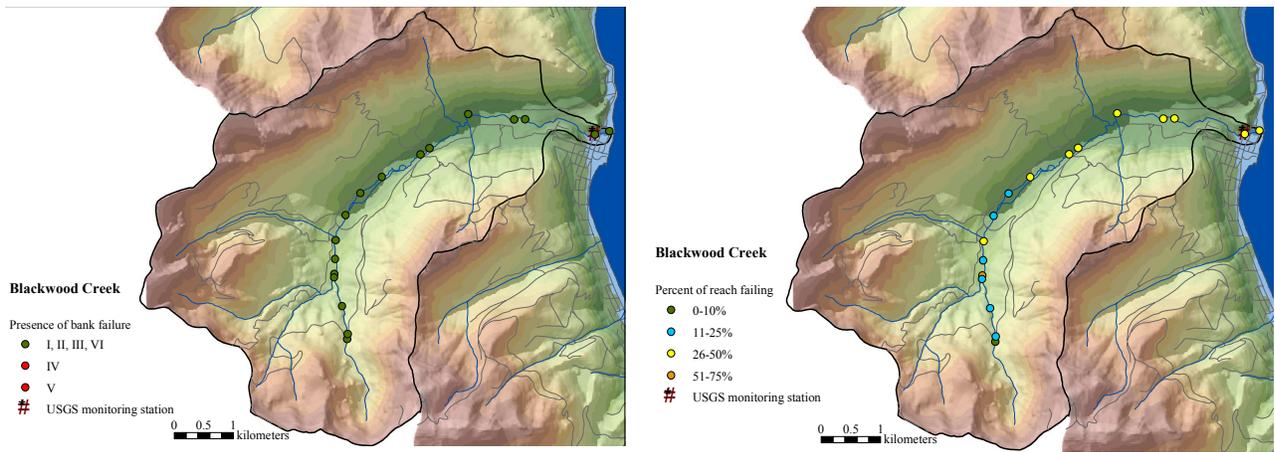
**Figure 4-25. Presence or absence of bank failures and the percent of the longitudinal extent of left and right banks undergoing active mass-wasting processes along Blackwood Creek.**

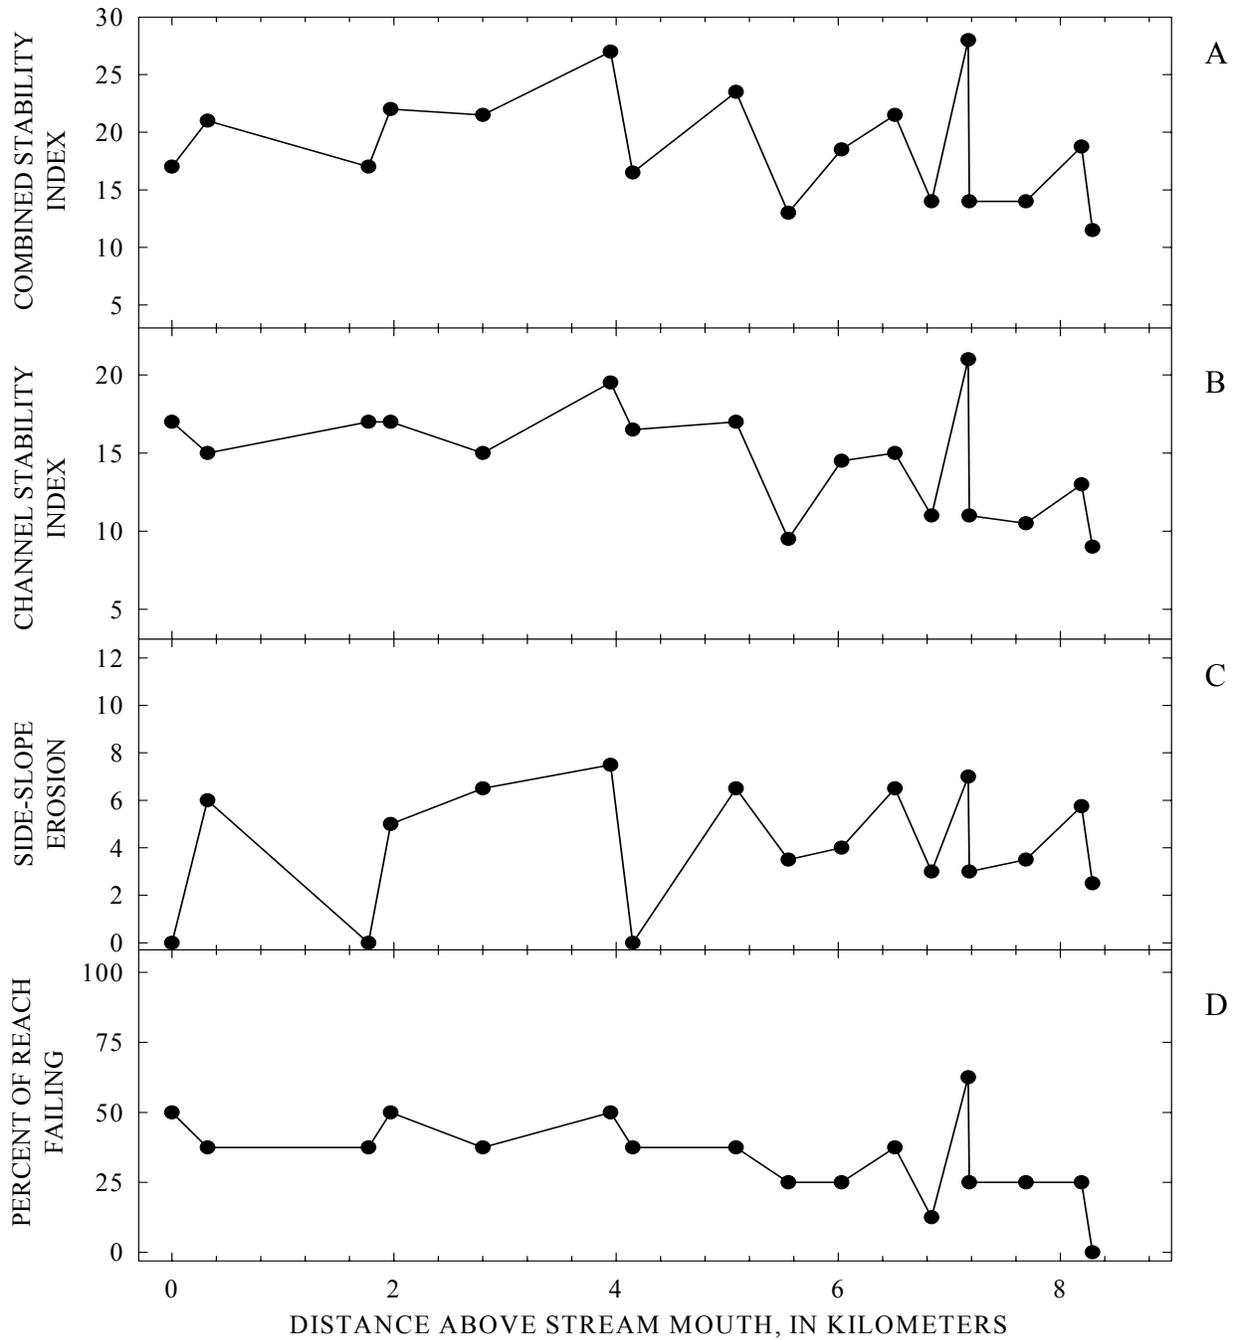
**Figure 4-26. Results of RGAs conducted along Blackwood Creek showing the longitudinal distribution of the combined, channel and side-slope erosion indexes, and the percent of reaches undergoing streambank failures.**

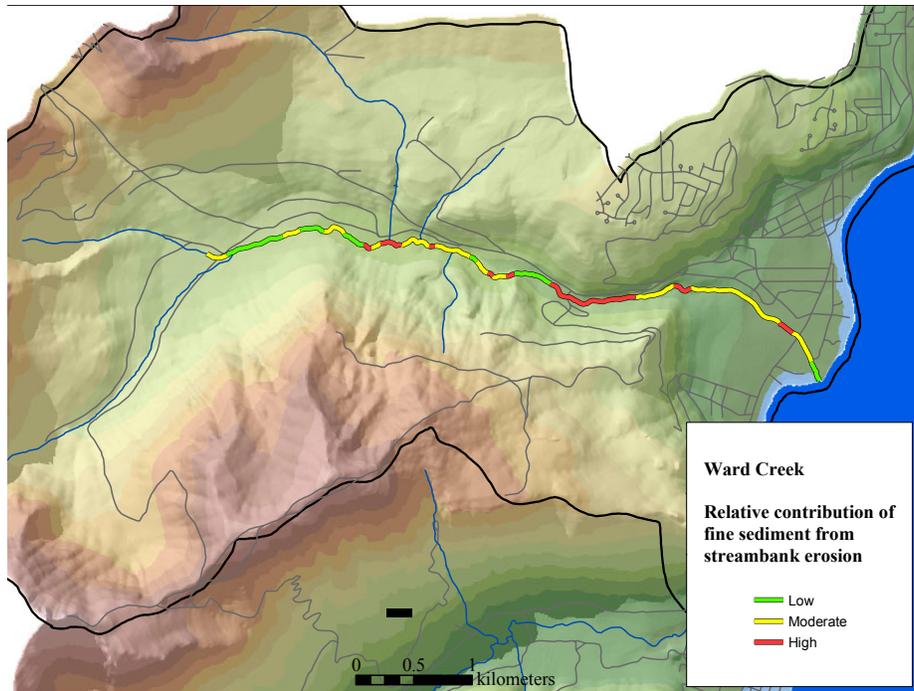
**Figure 4-29. Map of the relative contribution of fine sediment from streambank erosion for Ward Creek.**

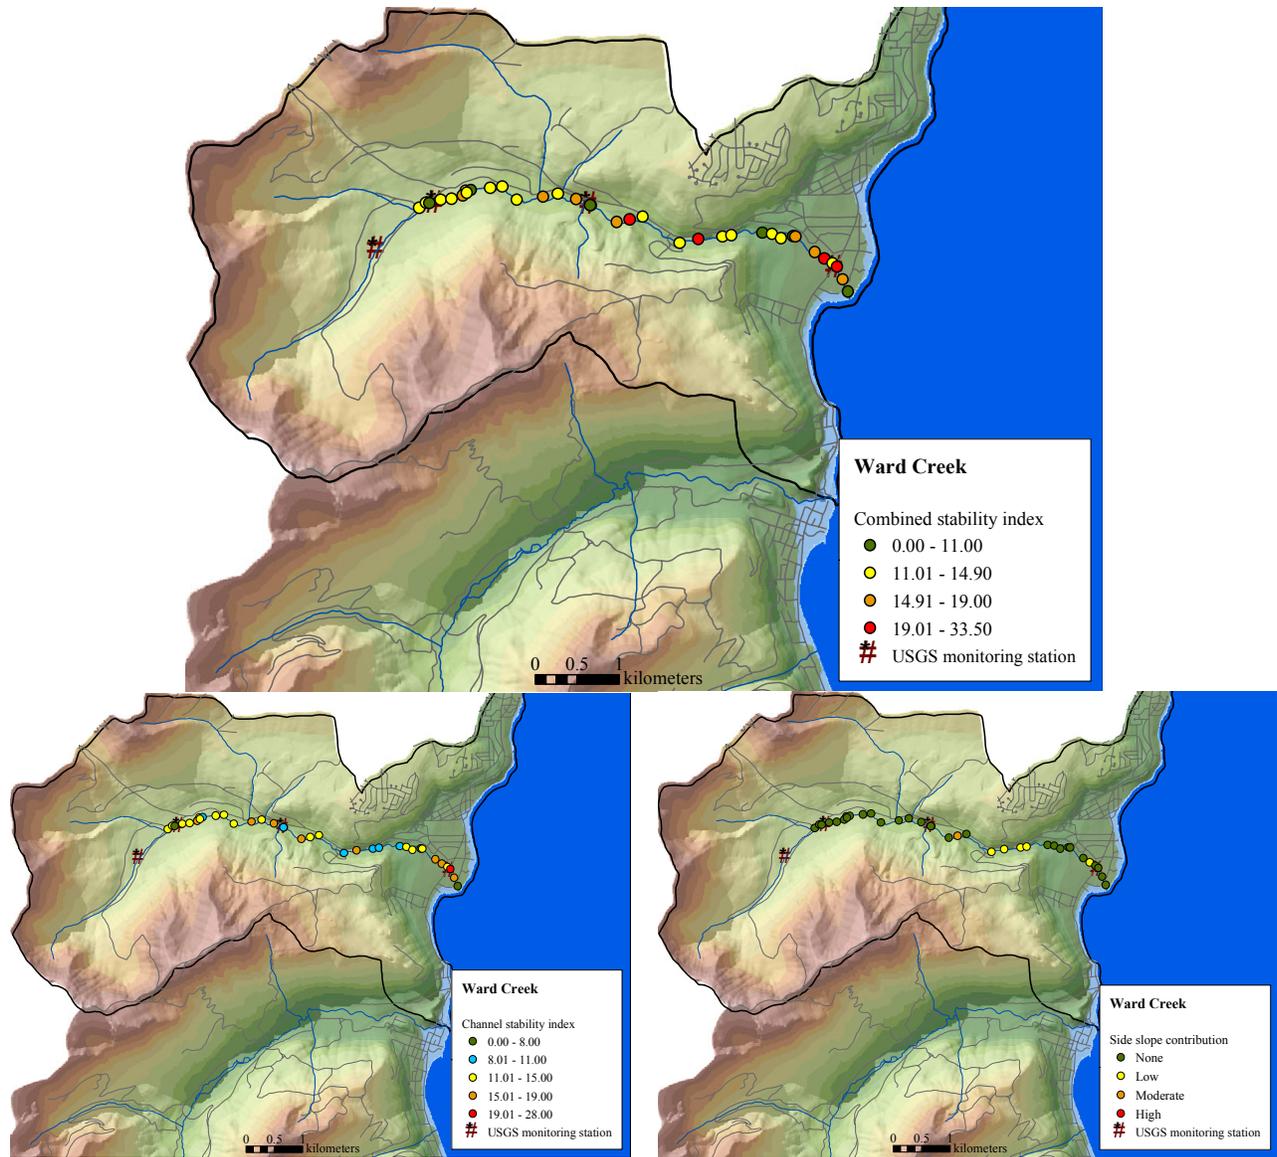
**Figure 4-30. Results of rapid geomorphic assessments of Ward Creek showing the relative contributions of channel- and side-slope indexes to the combined stability index and critical erosion areas.**

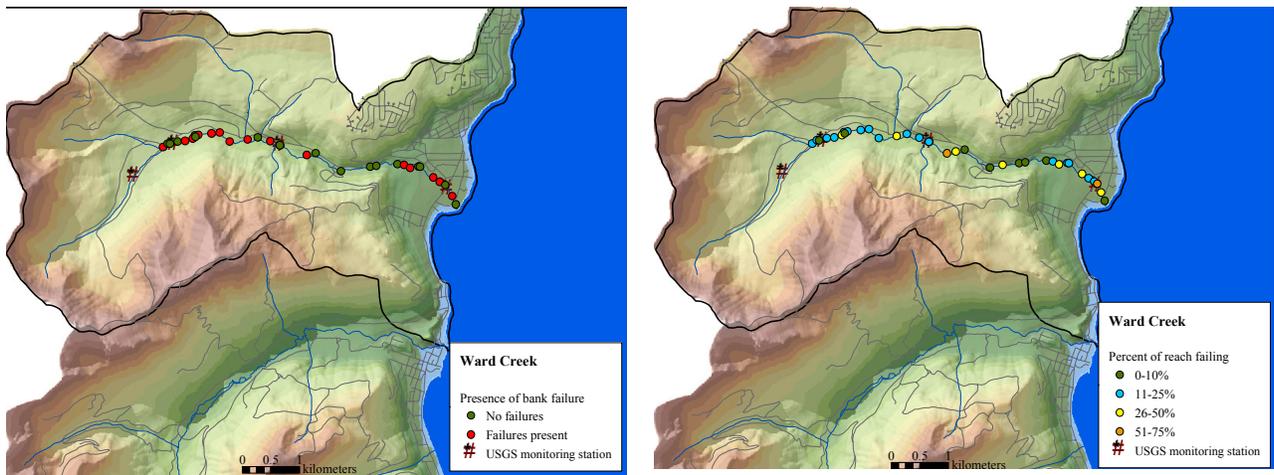
**Figure 4-31. Presence or absence of bank failures and the percent of the longitudinal extent of left and right banks undergoing active mass-wasting processes along Ward Creek.**

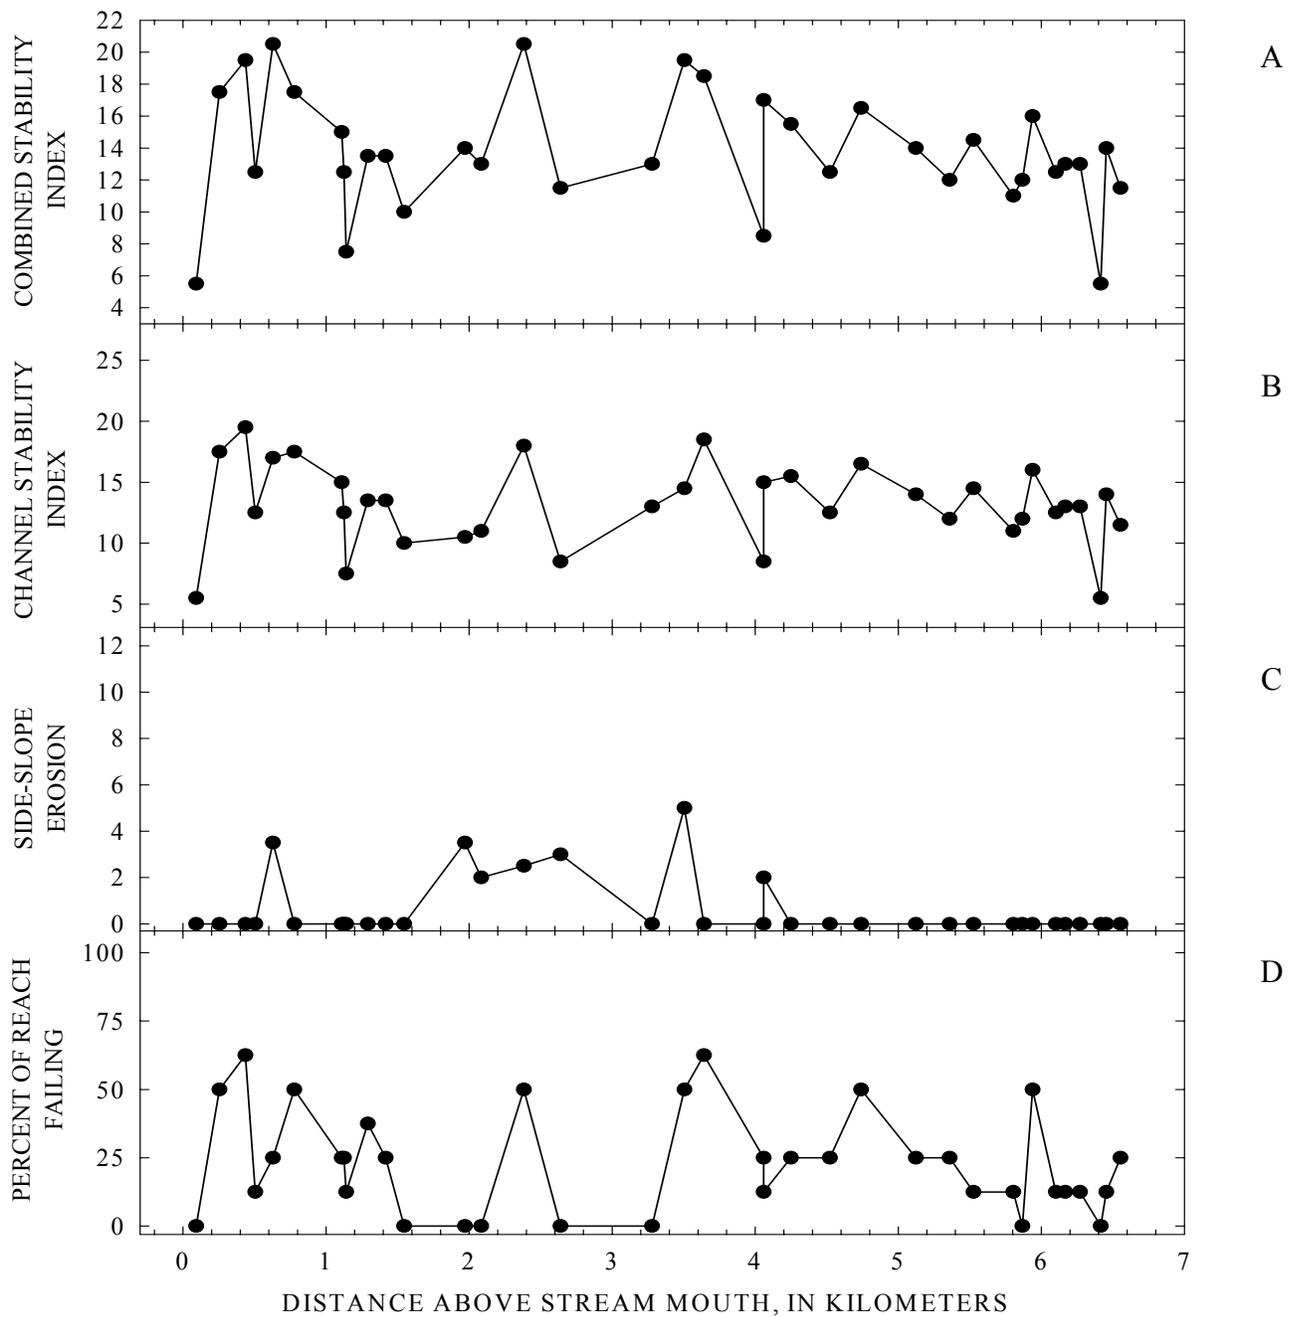
**Figure 4-32. Results of RGAs conducted along Ward Creek showing the longitudinal distribution of the combined, channel and side-slope erosion indexes, and the percent of reaches undergoing streambank failures.**

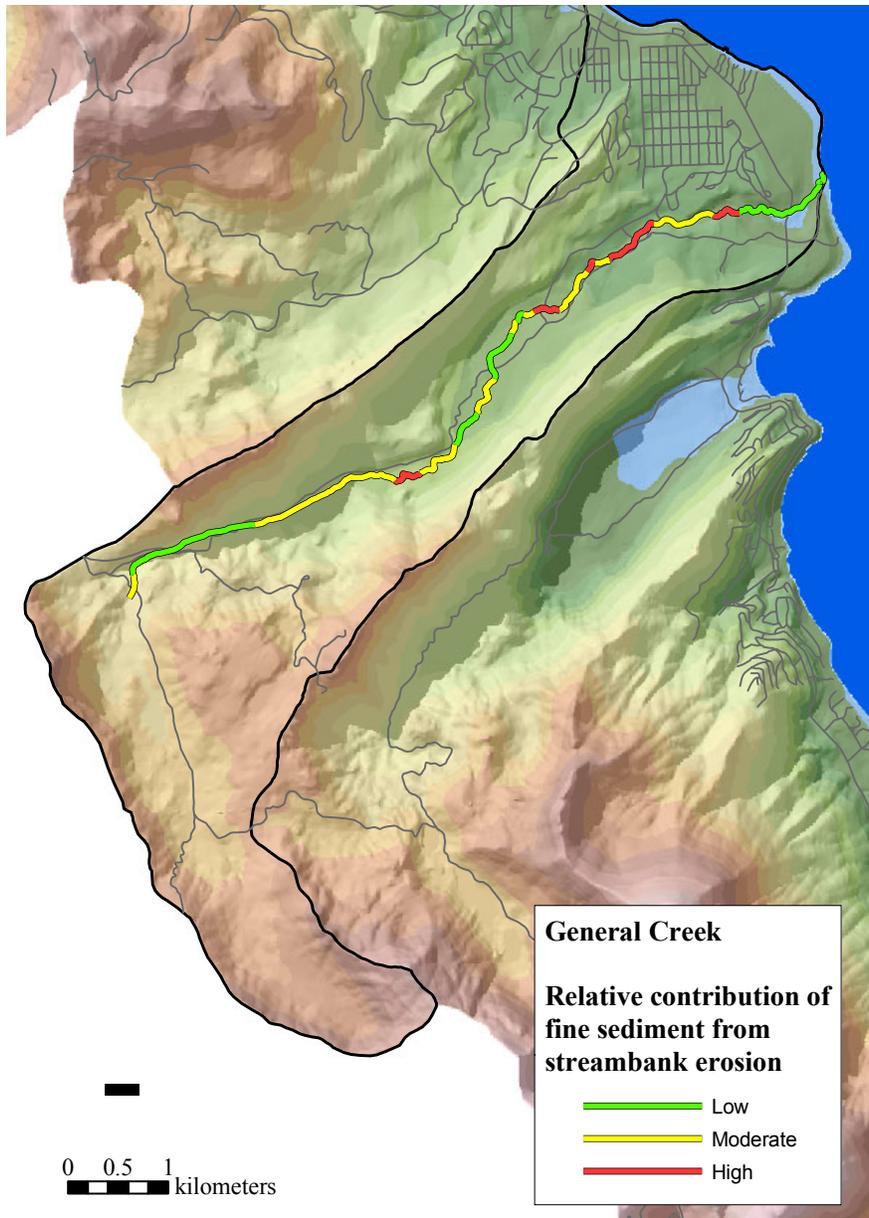
Figure 4-35. Map of the relative contribution of fine sediment from streambank erosion for General Creek.

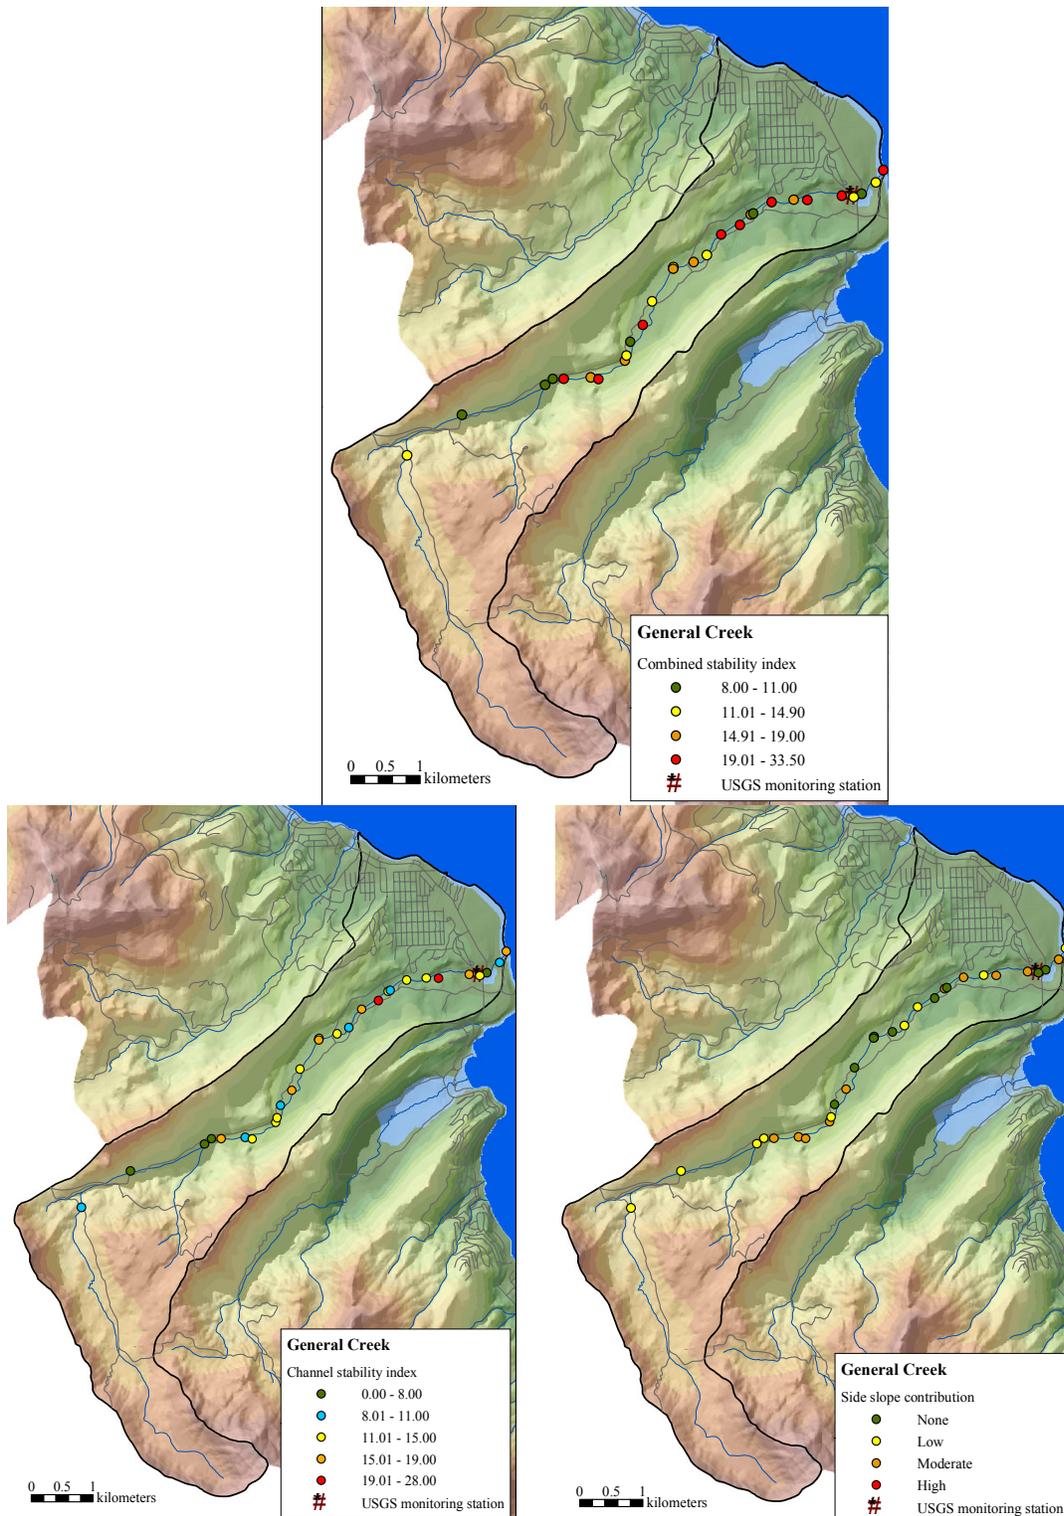
**Figure 4-36. Results of rapid geomorphic assessments of General Creek showing the relative contributions of channel- and side-slope indexes to the combined stability index and critical erosion areas.**

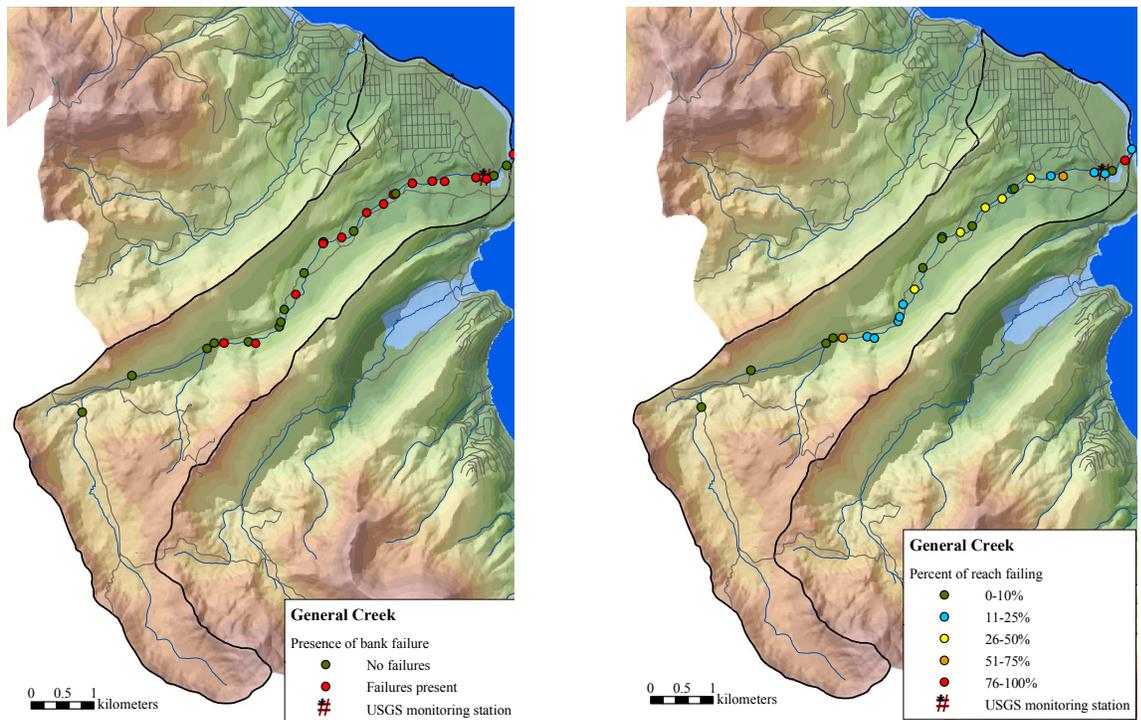
**Figure 4-37. Presence or absence of bank failures and the percent of the longitudinal extent of left and right banks undergoing active mass-wasting processes along General Creek.**
