## 4.0 CHANNEL EROSION AND BASIN GEOMORPHOLOGY

### 4.2 Direct Comparison of Measured Cross Sections

#### 4.3.1 Evaluation of Continuous Stream Lengths (Stream Walks)

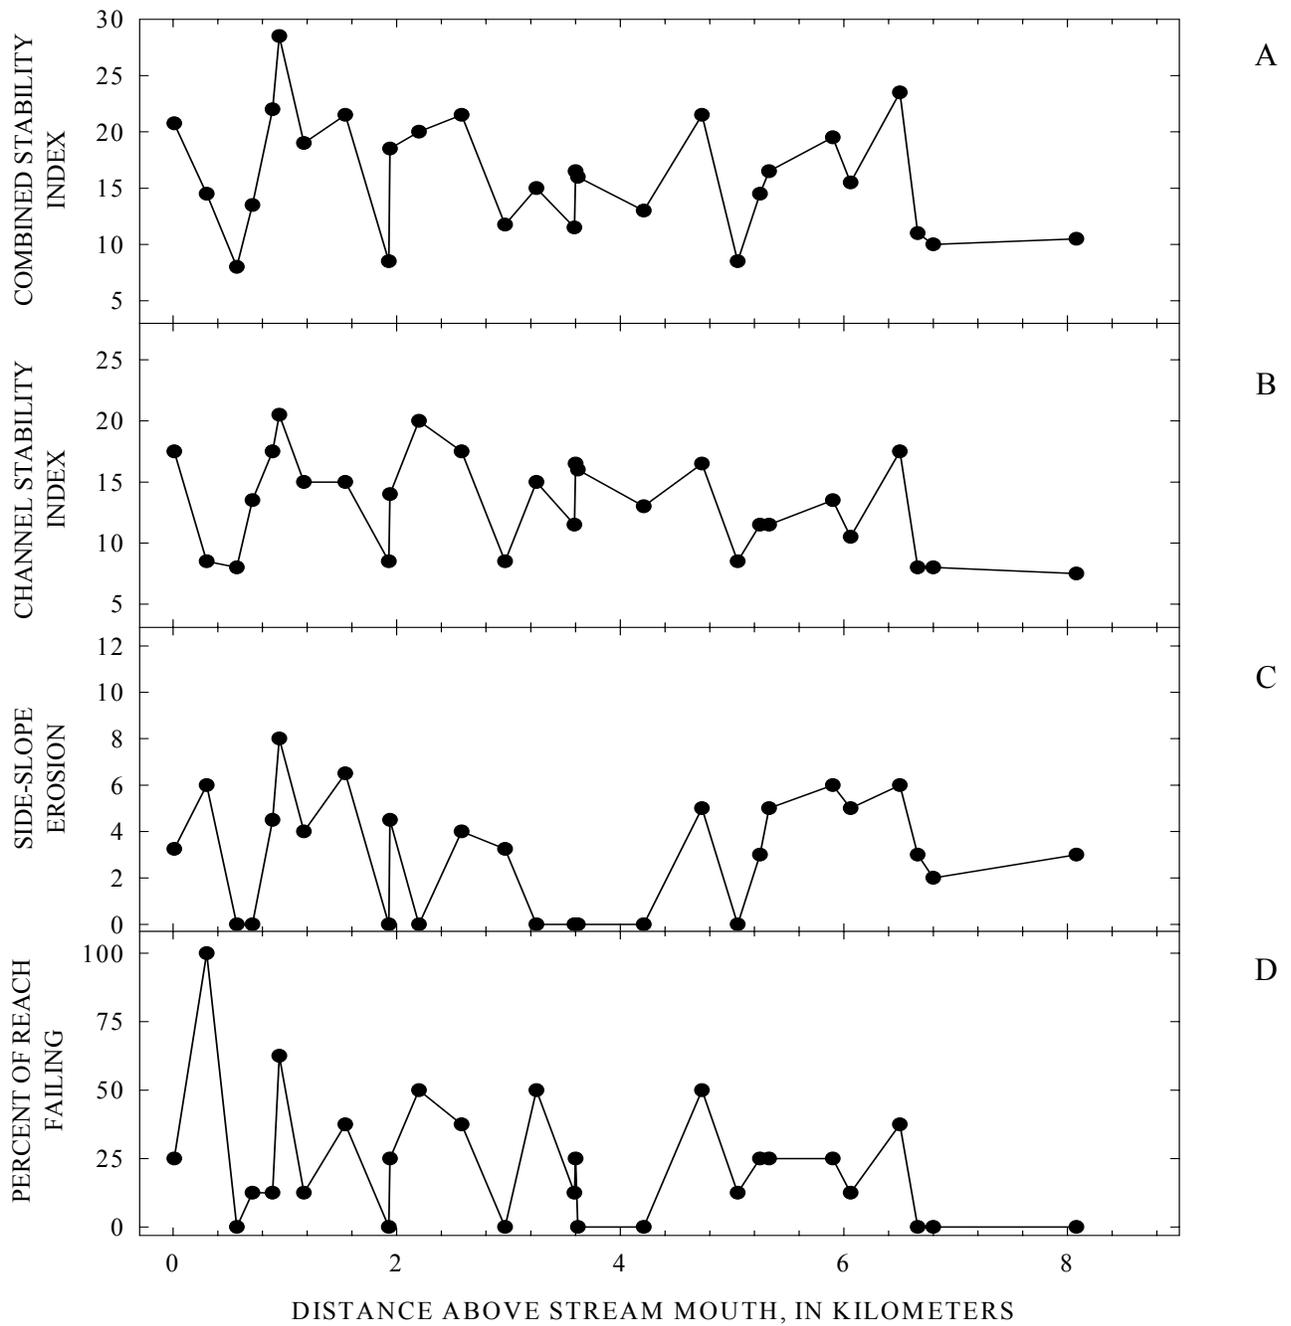
**Figure 4-38. Results of RGAs conducted along General Creek showing the longitudinal distribution of the combined, channel and side-slope erosion indexes, and the percent of reaches undergoing streambank failures.**

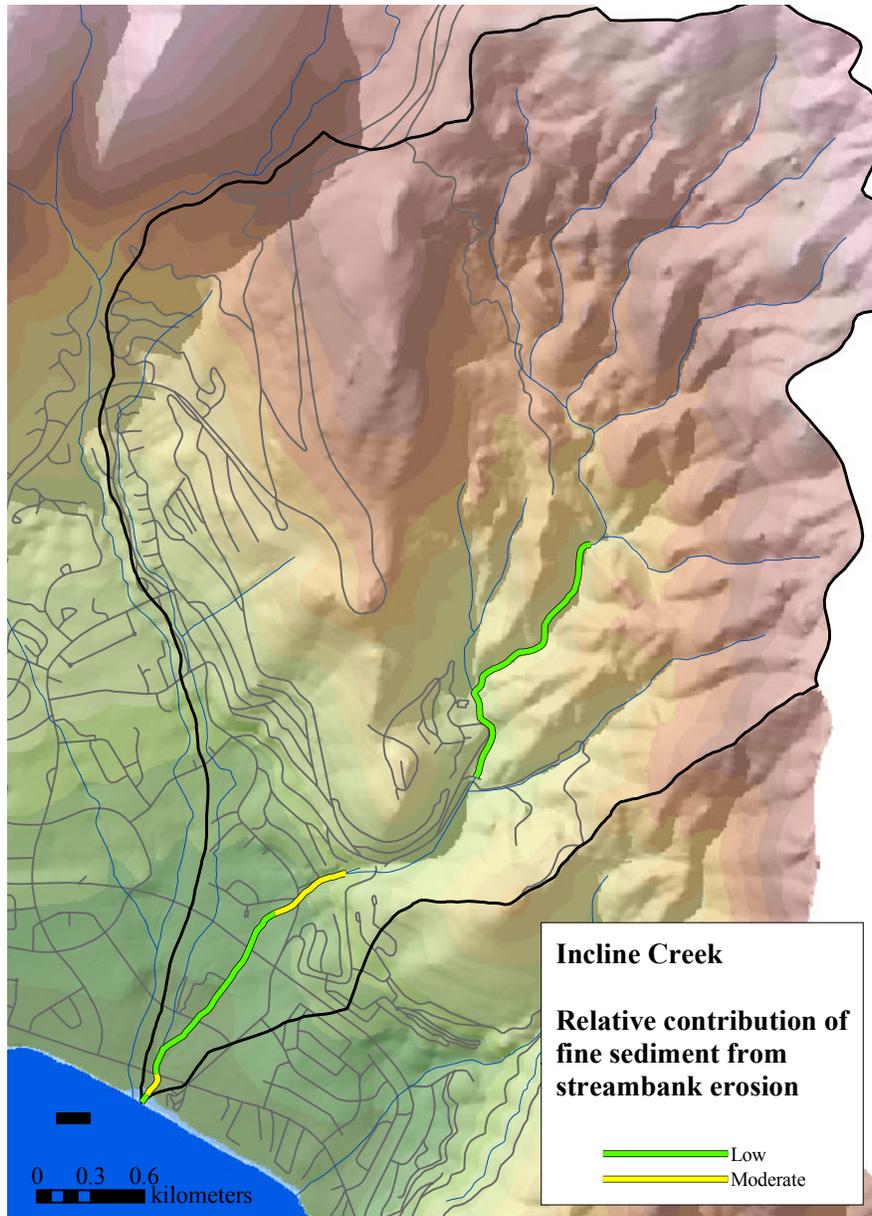
**Figure 4-41. Map of the relative contribution of fine sediment from streambank erosion for Incline Creek.**

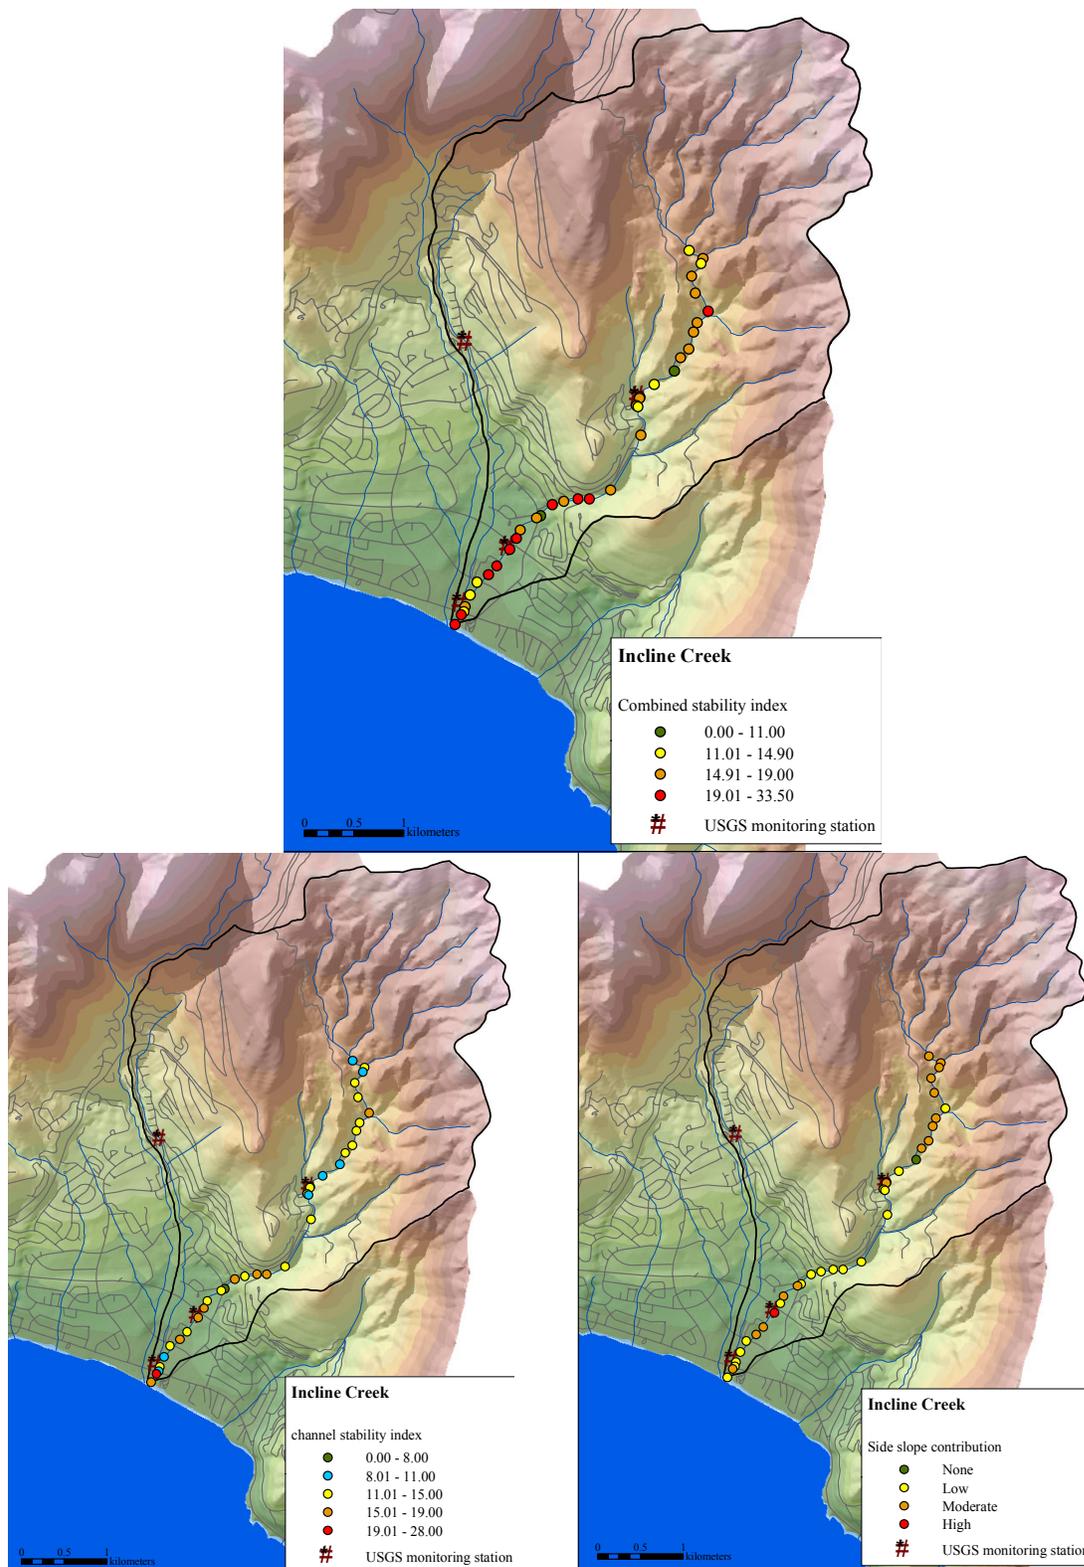
**Figure 4-42. Results of rapid geomorphic assessments of Incline Creek showing the relative contributions of channel- and side-slope indexes to the combined stability index and critical erosion areas.**

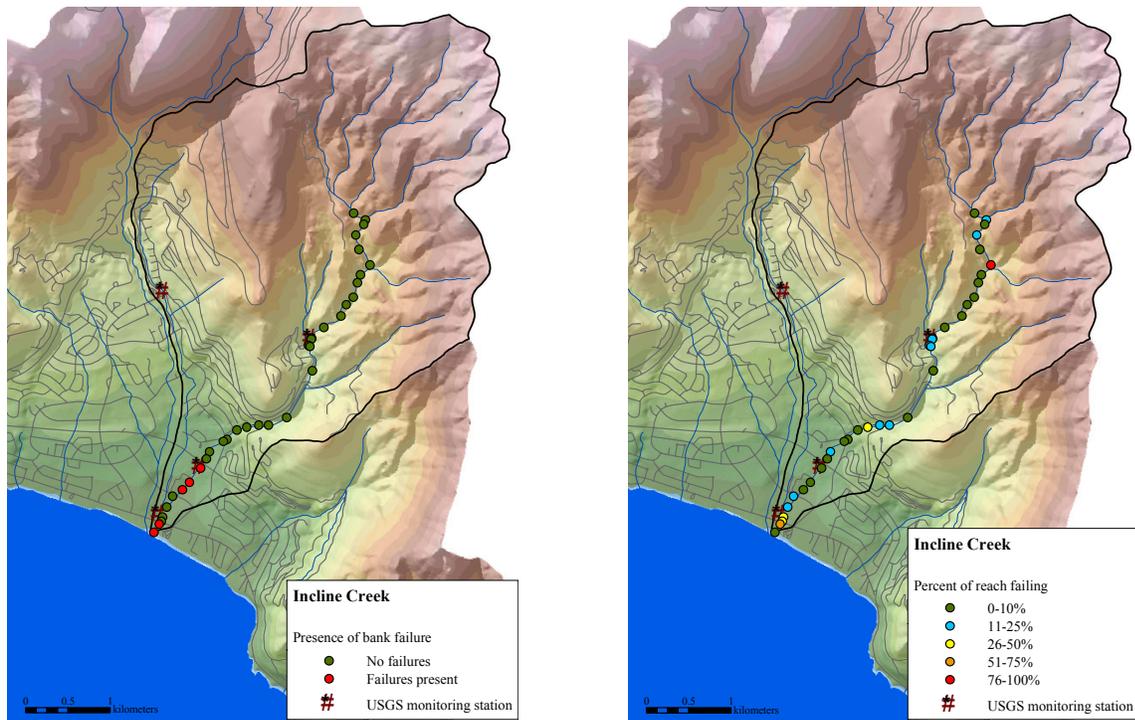
**Figure 4-43. Presence or absence of bank failures and the percent of the longitudinal extent of left and right banks undergoing active mass-wasting processes along Incline Creek.**

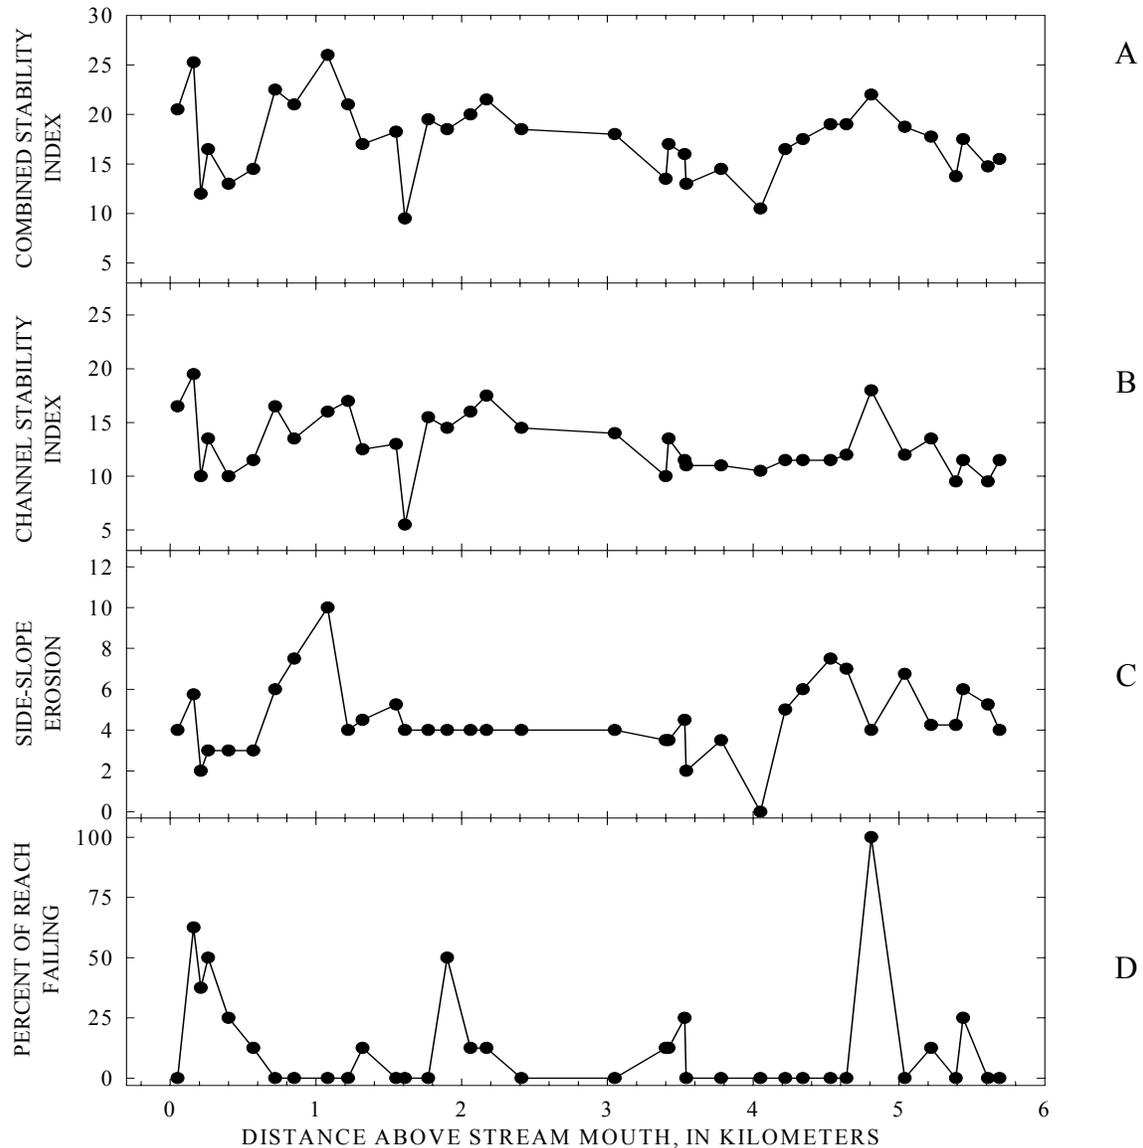
**Figure 4-44. Results of RGAs conducted along Incline Creek showing the longitudinal distribution of the combined, channel and side-slope erosion indexes, and the percent of reaches undergoing streambank failures.**

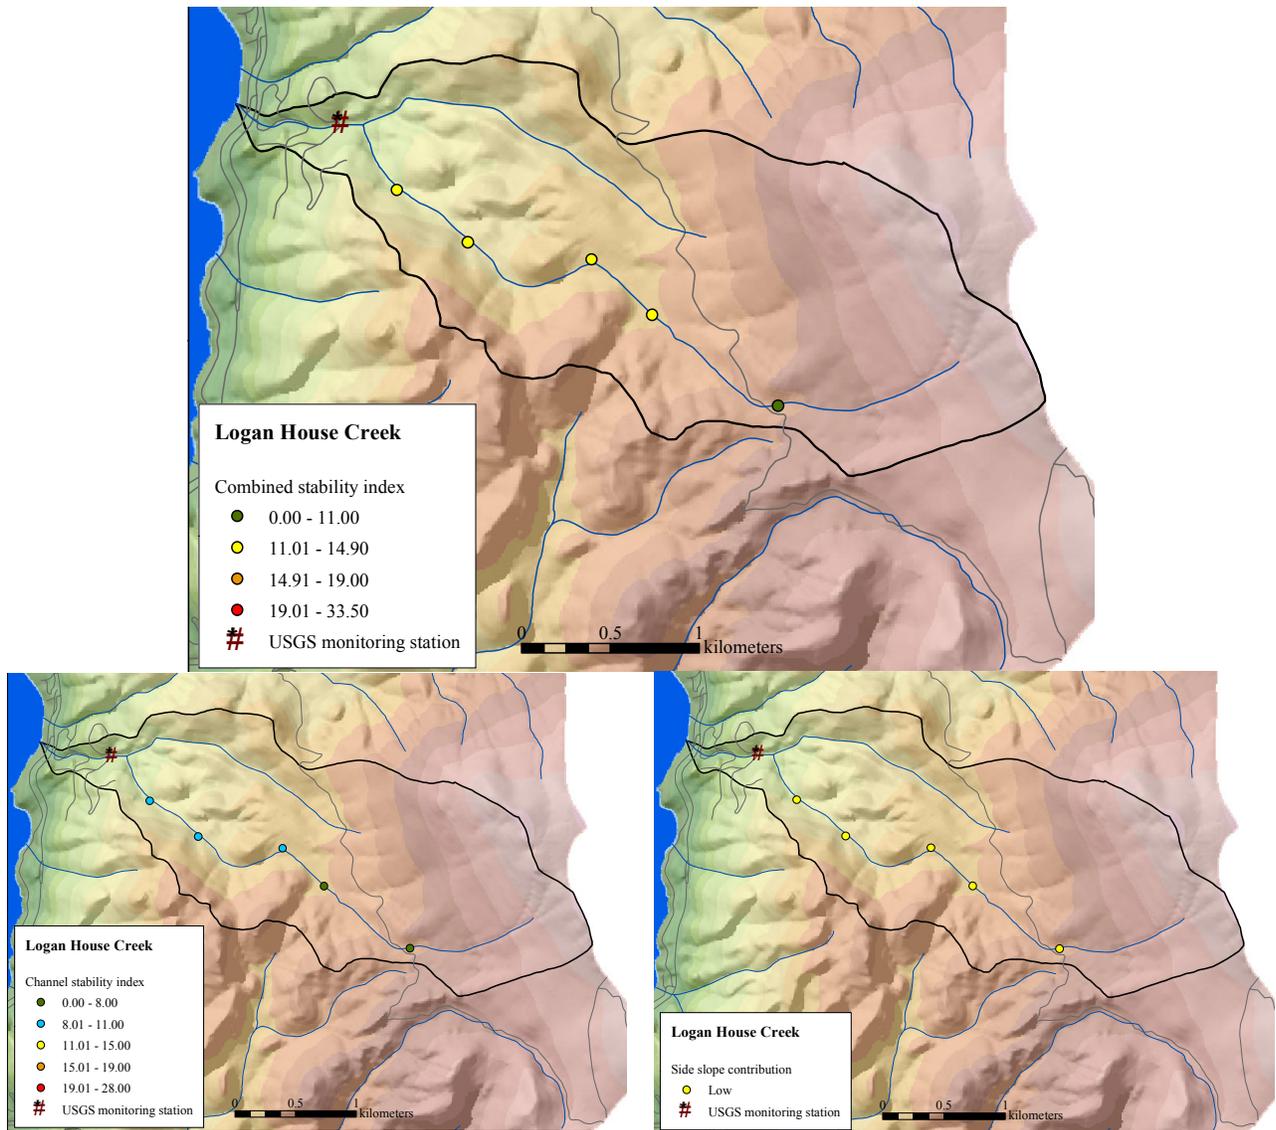
**Figure 4-46. Results of rapid geomorphic assessments of Logan House Creek showing the relative contributions of channel- and side-slope indexes to the combined stability index and critical erosion areas.**

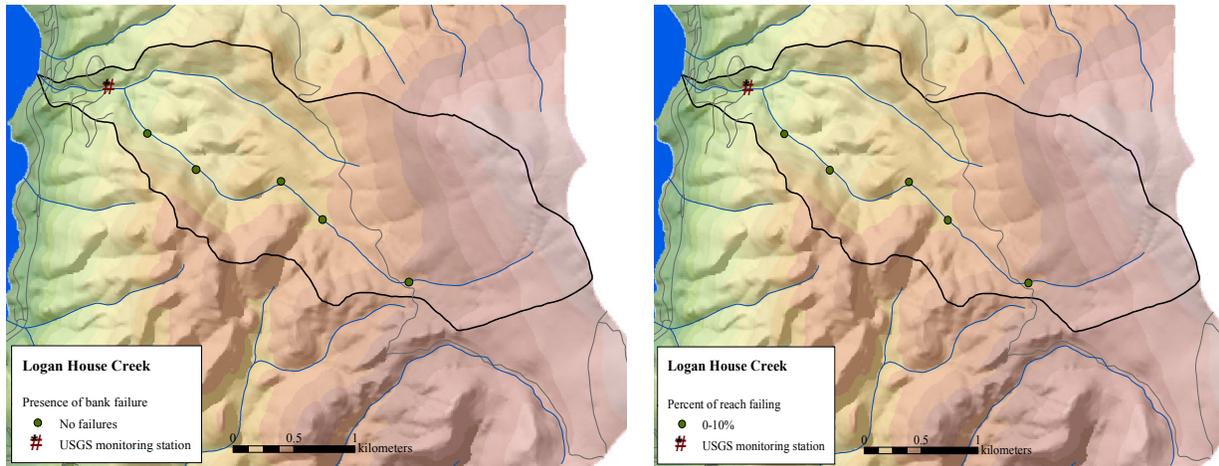
**Figure 4-47. Presence or absence of bank failures and the percent of the longitudinal extent of left and right banks undergoing active mass-wasting processes along Logan House Creek.**

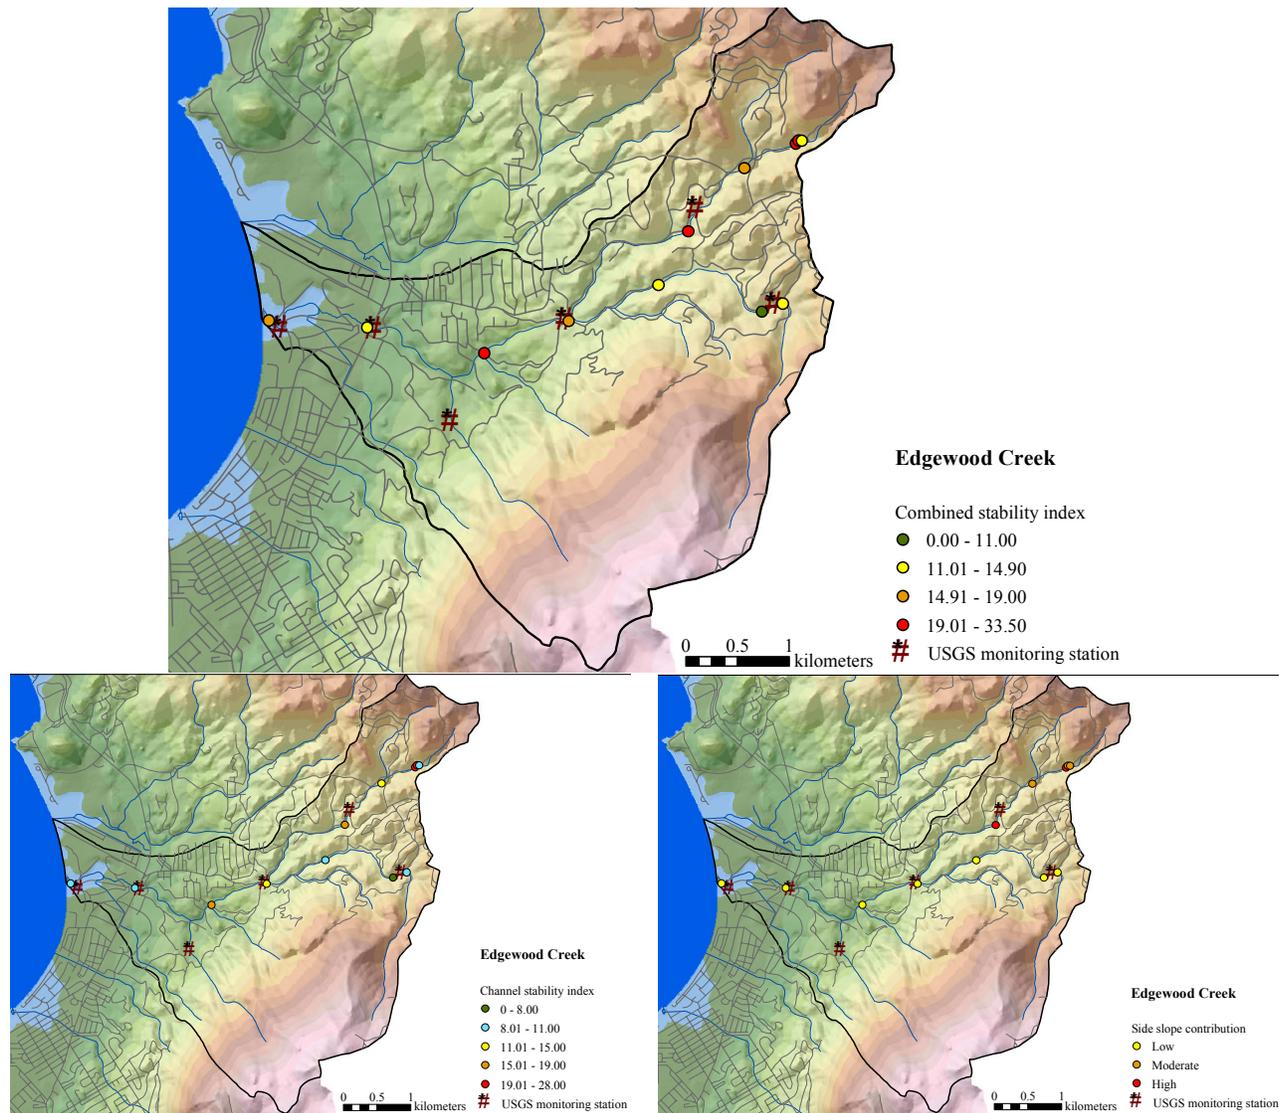
**Figure 4-50. Results of rapid geomorphic assessments of Edgewood Creek showing the relative contributions of channel- and side-slope indexes to the combined stability index and critical erosion areas.**

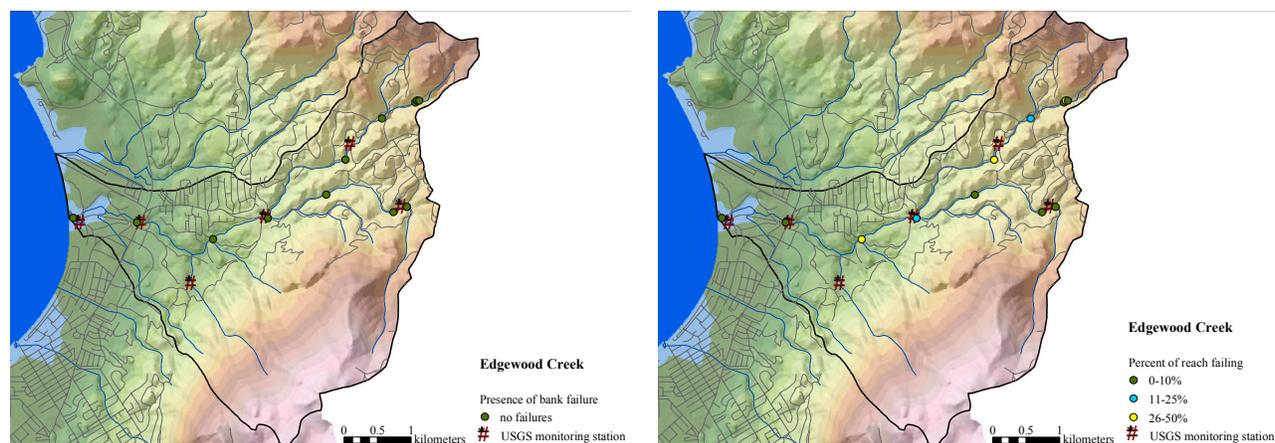
**Figure 4-51. Presence or absence of bank failures and the percent of the longitudinal extent of left and right banks undergoing active mass-wasting processes along Edgewood Creek.**

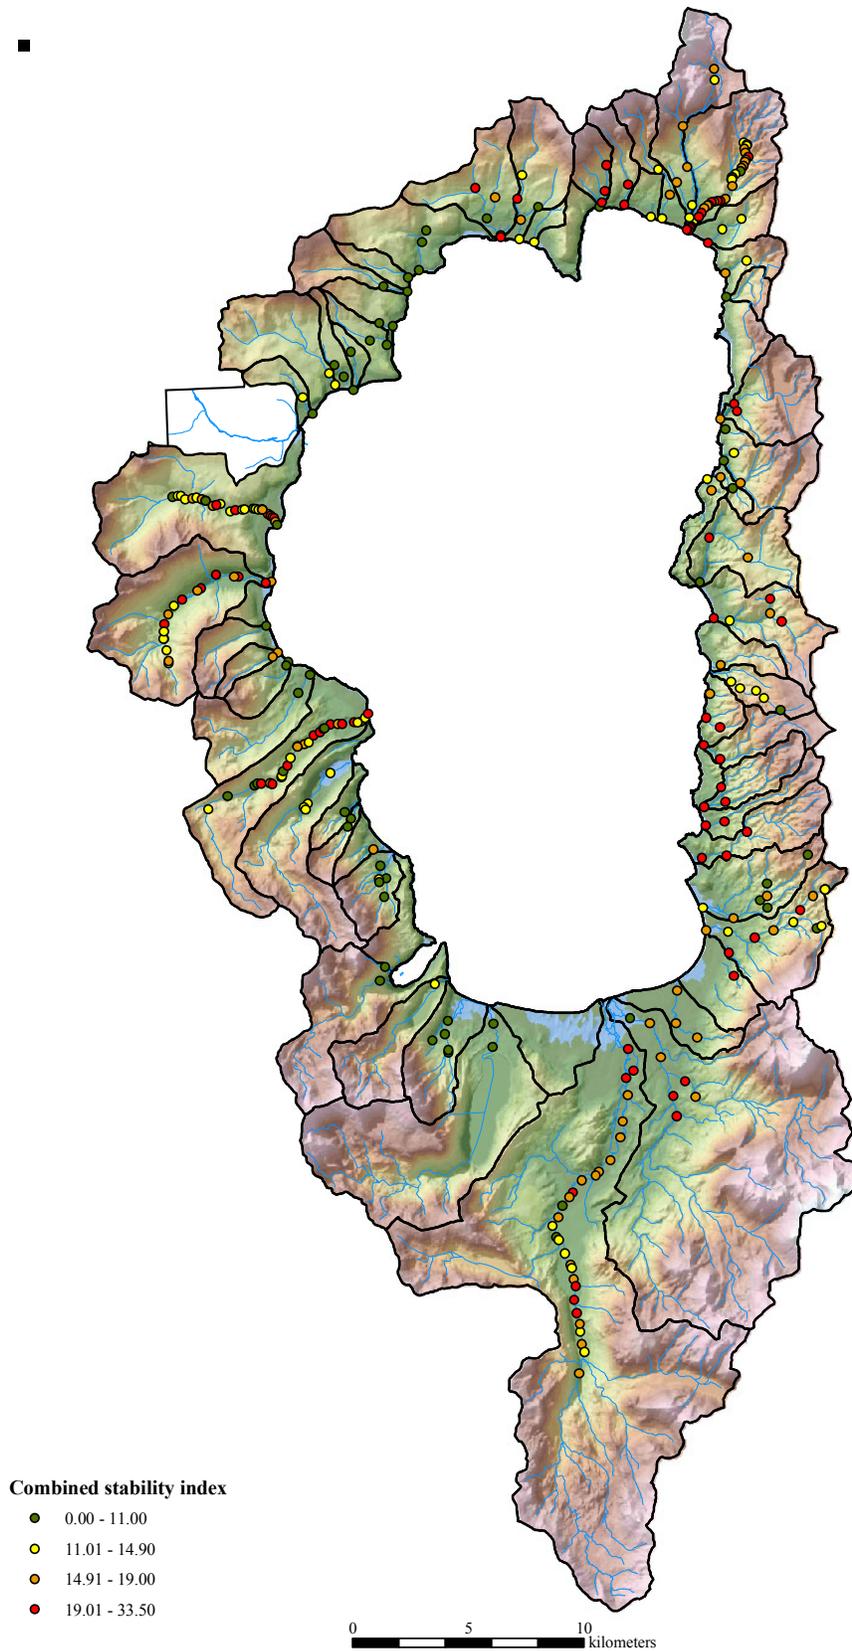
Figure 4-52. Spatial distribution of combined stability index for 304 sites.

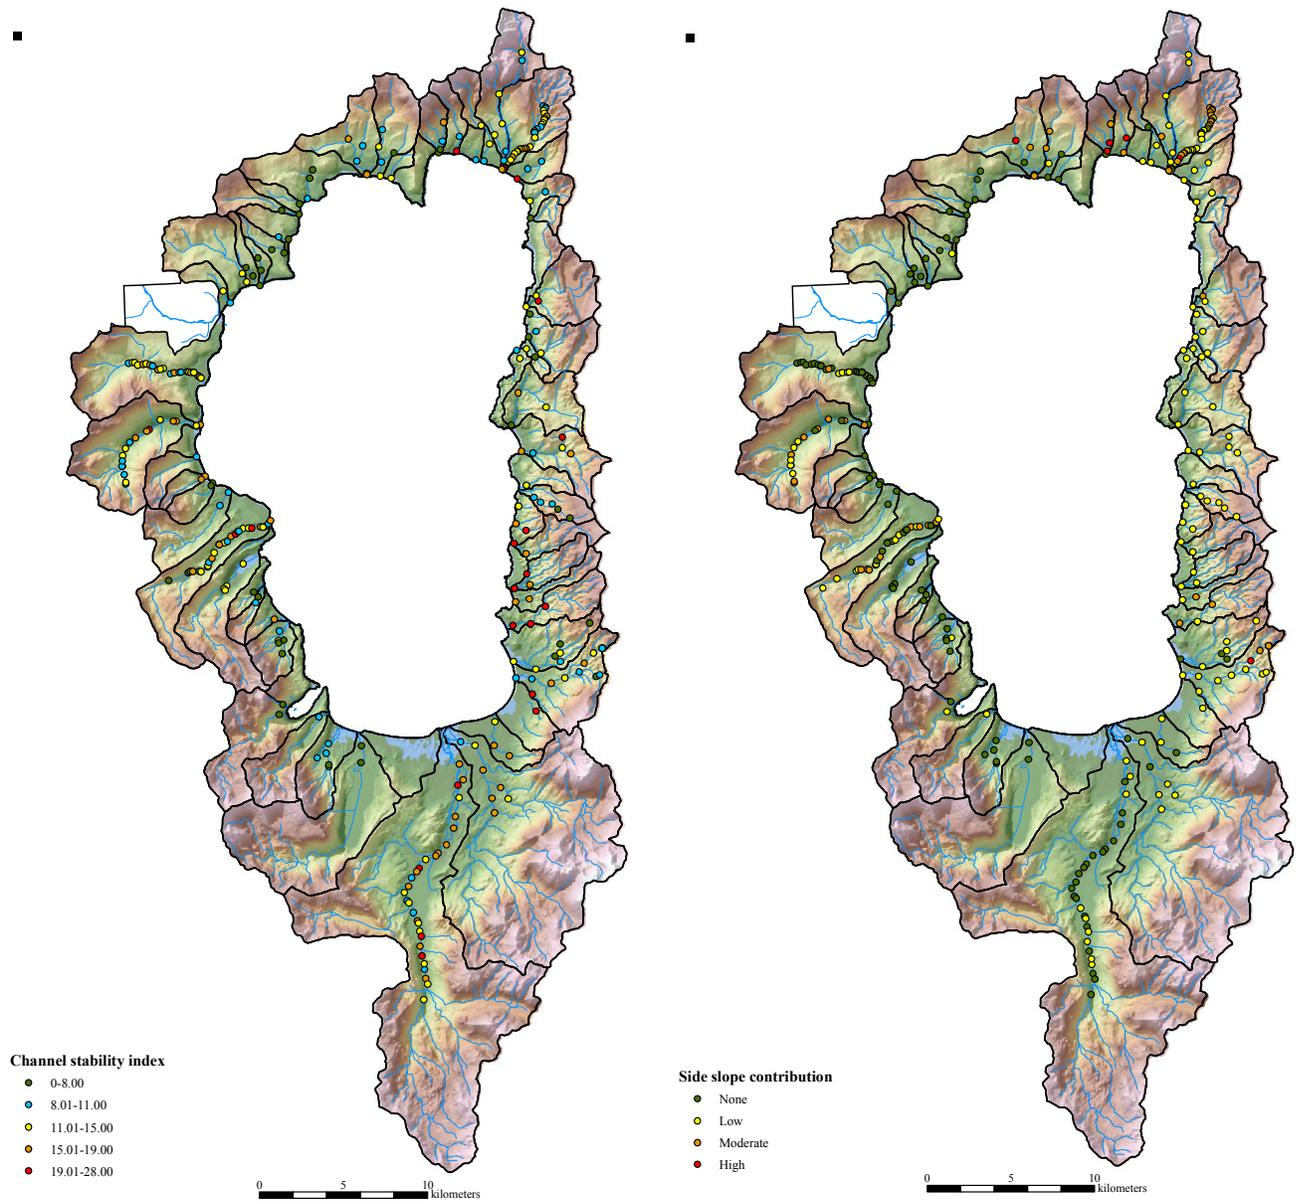
**Figure 4-53. Channel-stability (left) and side-slope erosion indexes (right) used to distinguish relative contributions of sediment.**

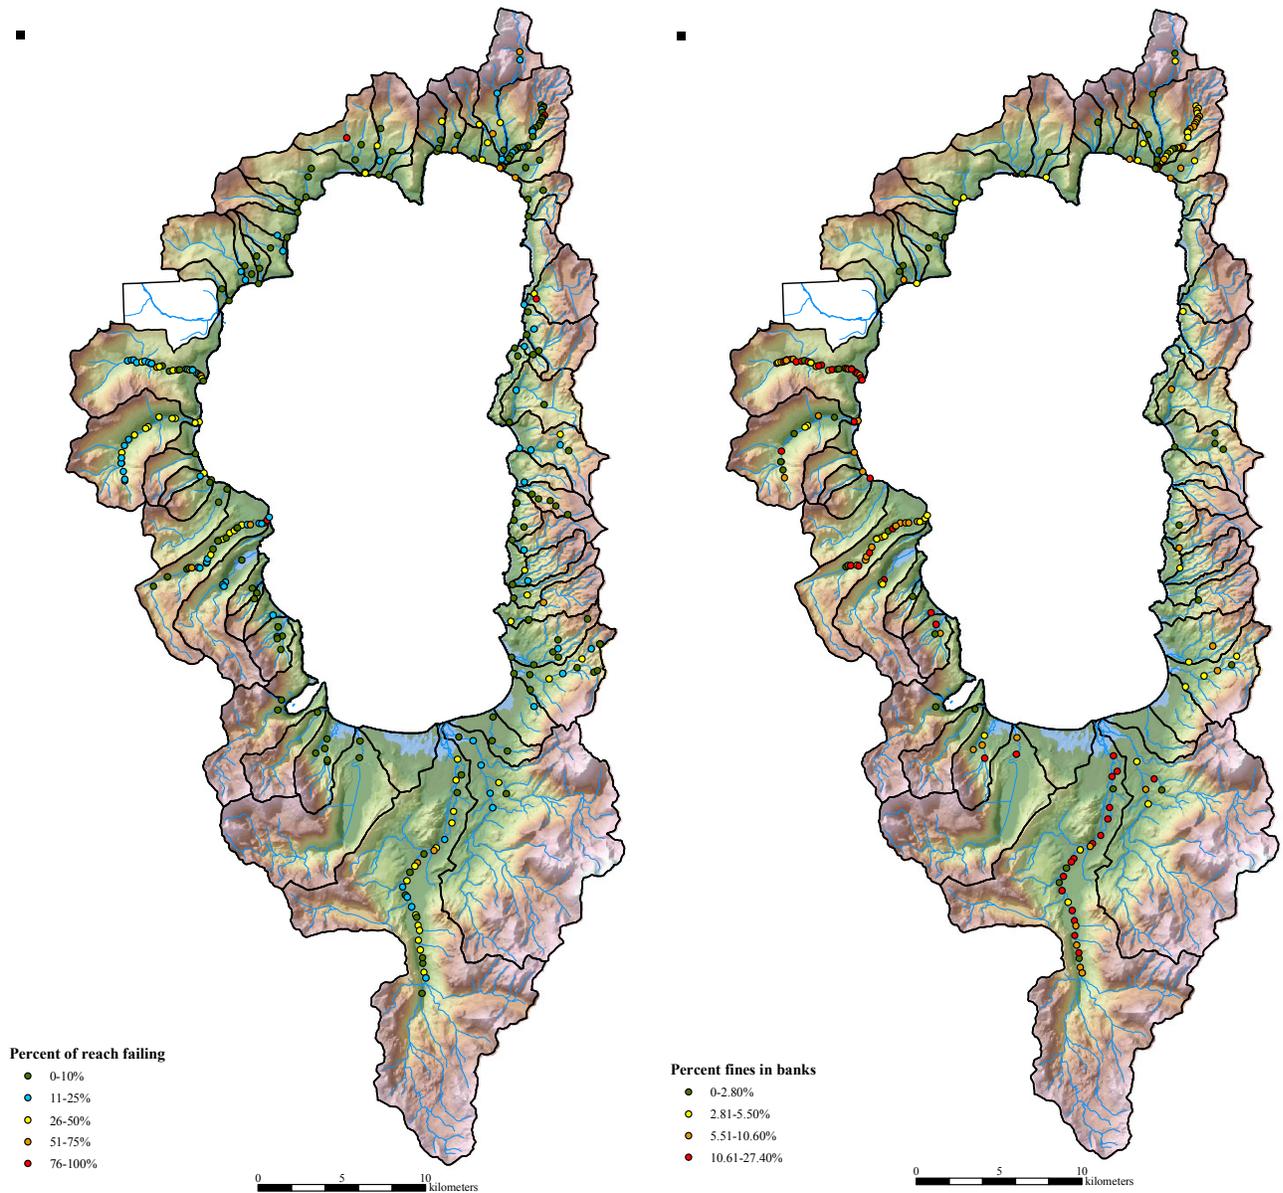
**Figure 4-54. Percent of left and right banks that are failing (left), and the relative fine-grained (silt plus clay) content in the streambanks (right) to be used collectively as a measure of fine-sediment contributions from eroding streambanks.**

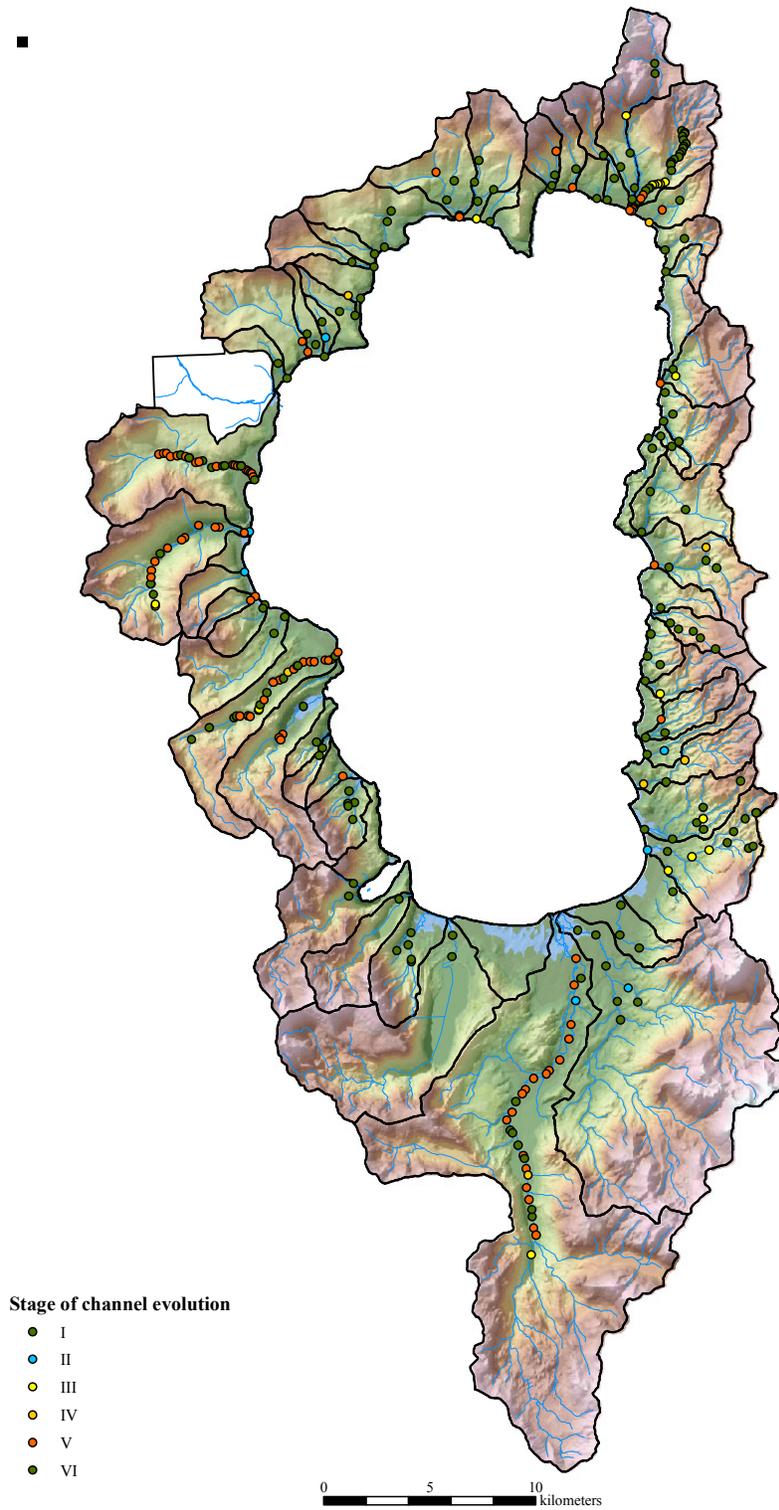
along the western streams, including General Creek. The majority of the unstable streams in the basin are stage V, characterized by widening and deposition on the bed.

**Figure 4-55. Spatial distribution of stages of channel evolution. Stages I and VI are indicative of stability; stages IV and V are indicative of degradation and widening, and aggradation and widening, respectively.**
