**BANK PROTECTION WORKING GROUP
DRAFT EROSION ASSESSMENT
SACRAMENTO RIVER EAST BANK EROSION ASSESSMENT
AMERICAN RIVER (RM 60.1) TO FREEPORT (RM 45.2)**

DRAFT REPORT

9 August 2019

NHC Ref. No. 5004539

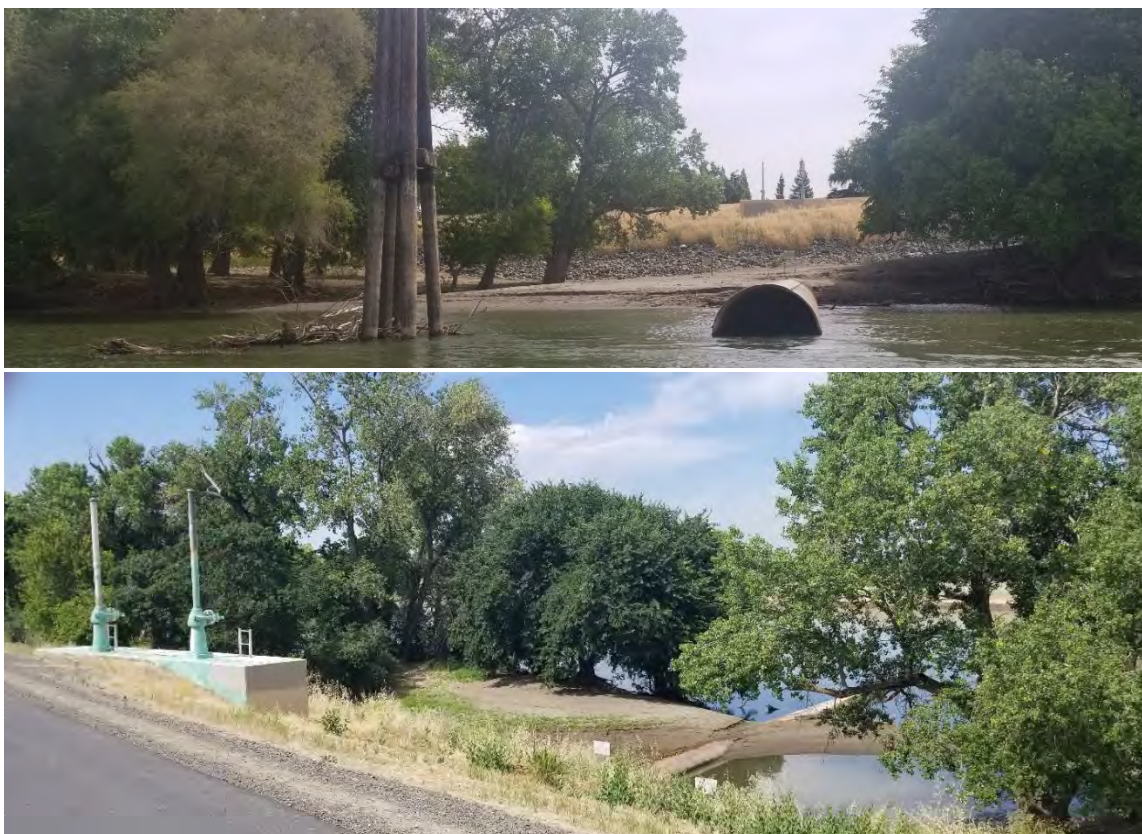
Figure 2-6a and 2-6 b - RM 56.5 Views from boat (top) and levee top (bottom) of erosion around storm drain outlet.

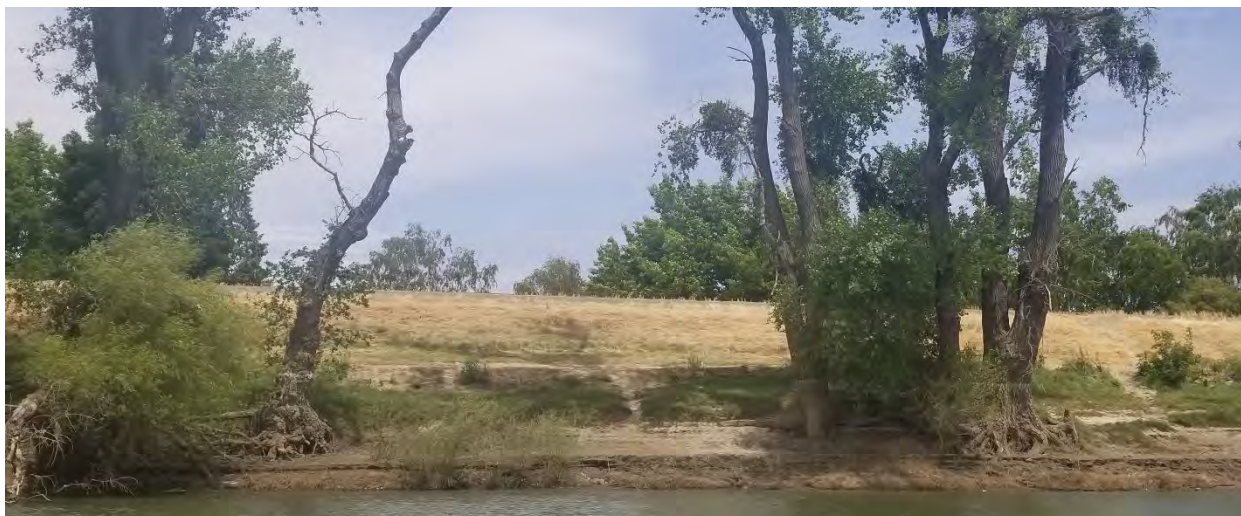
Figure 2-11 - RM 48.8 shows an unprotected erosion area with limited vegetation. Note large tree roots being undermined.

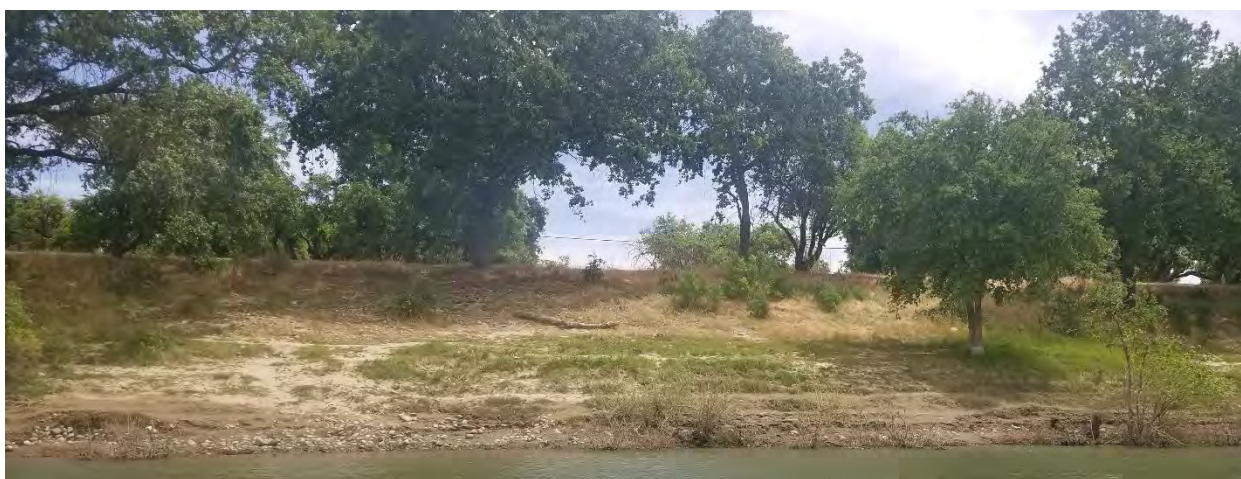
Figure 2-14 - RM 46.0 has both bank and levee slope erosion.

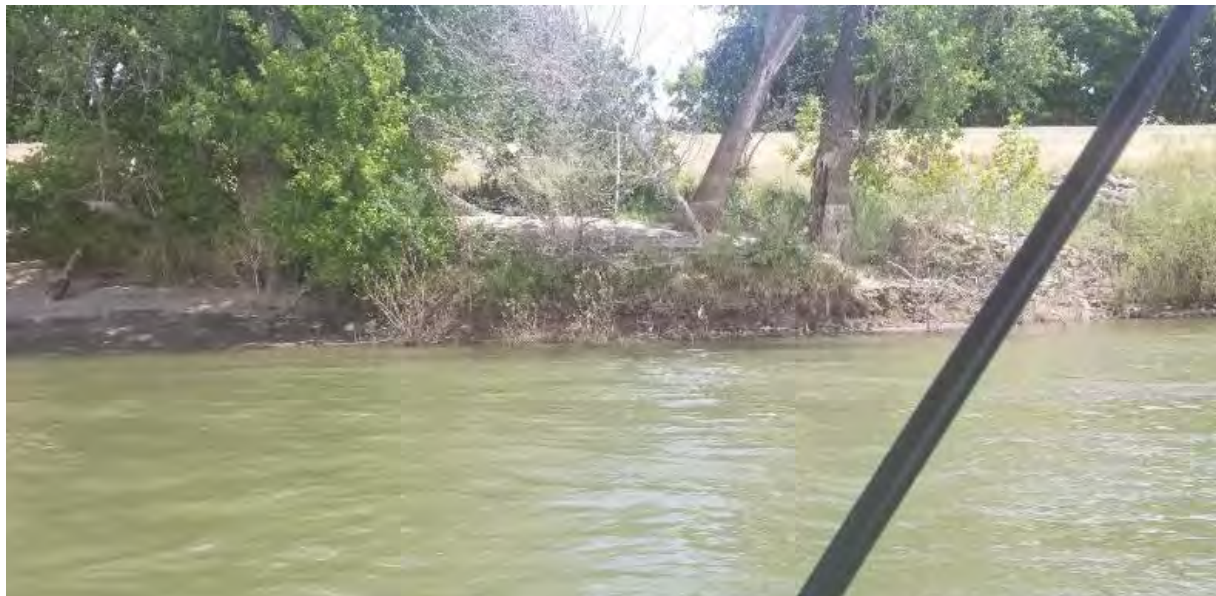
like cut banks by subsequent floods (Figure 3-18) and possibly boat and wind waves. Some areas show cycles of burial and exhumation of trees (Figure 3-19).

Figure 3-18 Recent Sand Deposits Placed During High Flow Events Then Eroded By Subsequent Flows (RM 58.5 on May 14, 2019 Flow at 30,000 cfs) (Source: NHC 2019).

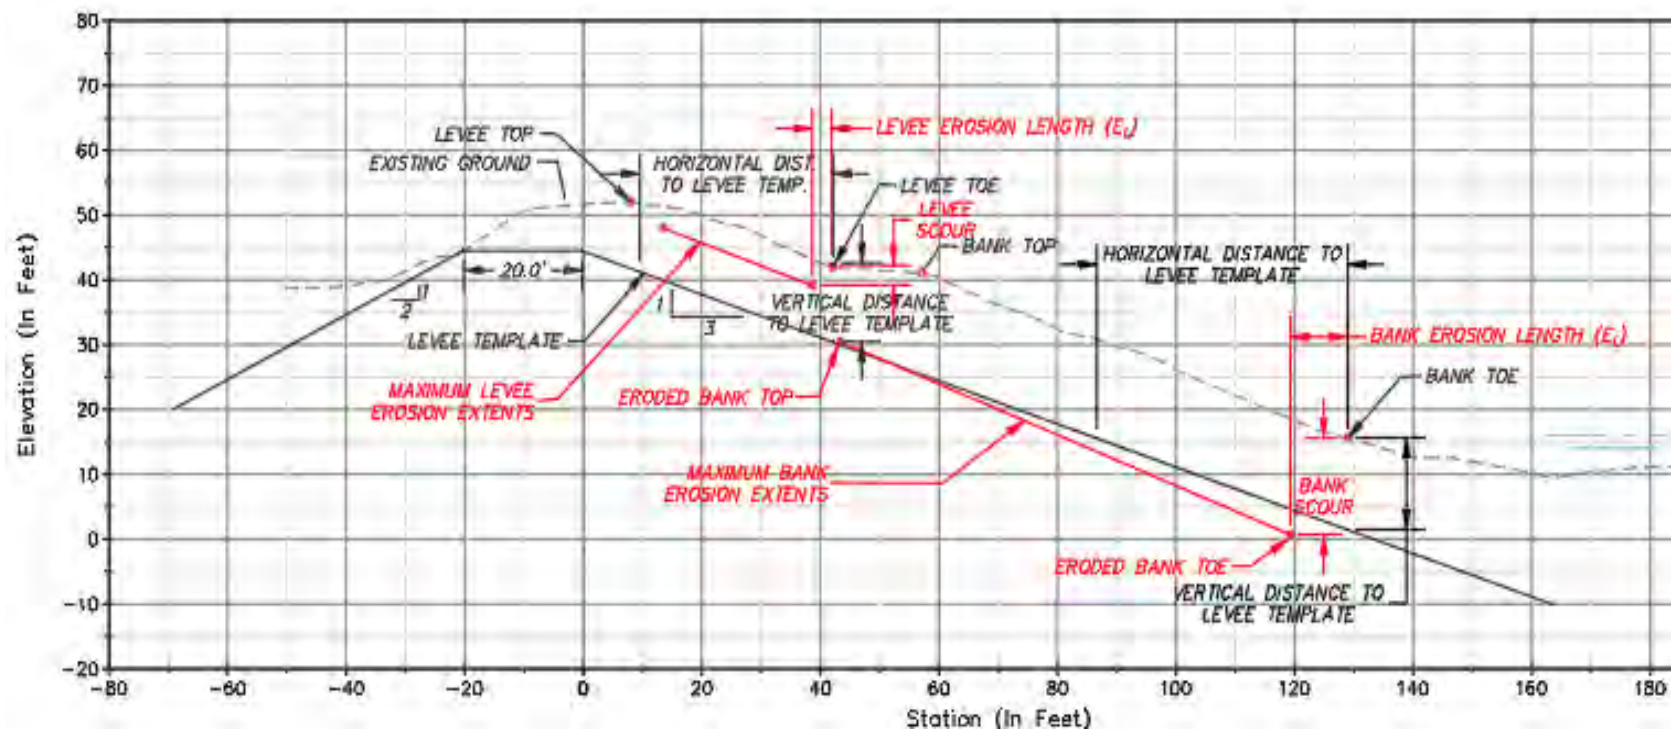
Figure 4-6. Cross-section showing maximum bank erosion extents as computed for a single flow event at the bank and at the levee face. In this example, the bank erosion encroaches into the minimum levee template, but the levee erosion does not.

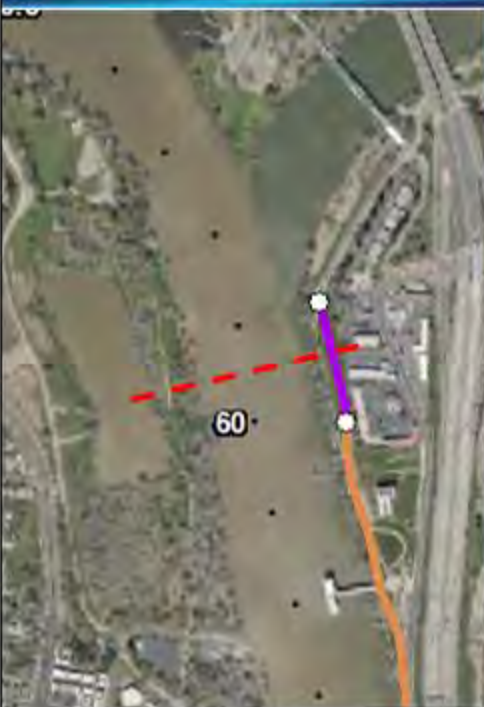
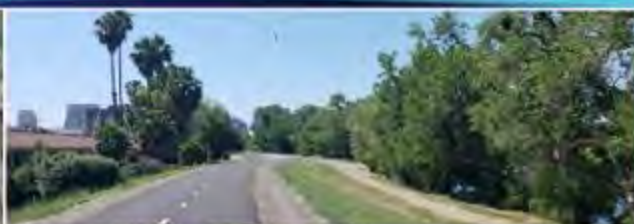
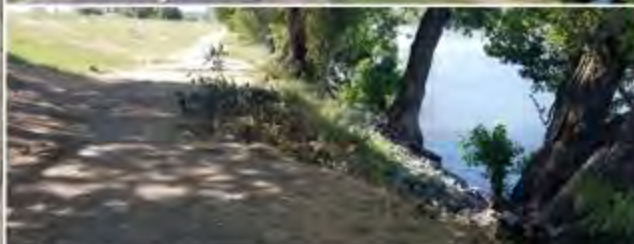
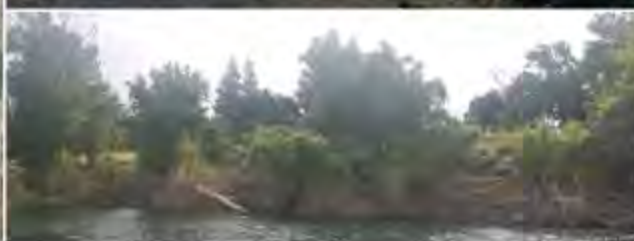
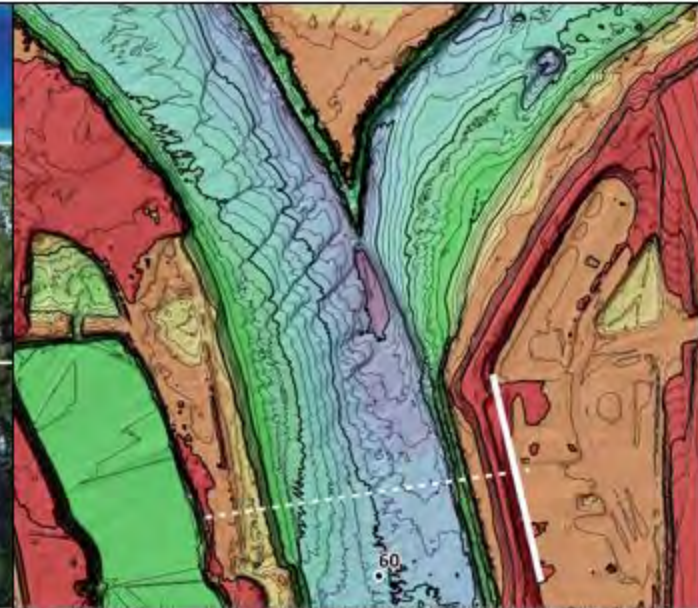
Segment 1: RM 60.0 to 60.1

Segment 1 (Figure 5.1) covers 850 feet +/- from the mouth of the American River at Discovery Park to a waterside levee access ramp. This location is on the apex outside bank of a 2.0 mile long bend. The thalweg is along the toe of bank at elevation -10.0 to -15.0 feet. The channel bank height is about 45 feet with roughly a 1.5H:1V slope. The berm is generally 50 feet wide but in spot locations with recent erosion it is less than 10 feet. The berm has a barren access road extending out 10 + feet from the levee toe; other areas of the berm and levee face have adequate grass cover. The bank has sparse to moderate vegetation cover with large trees, mostly older cottonwoods, some shrubs and a mix of 2006-era and older rip rap, cobble and broken concrete. Large tree roots are exposed due to a combination of erosion and foot traffic (the area is heavily traveled and used for recreation and temporary homeless encampments).

Flow	50 kcfs	100 kcfs	110 kcfs	115 kcfs
Avg Vel Chnl (ft/s)	3.19	3.88	3.98	4.04
Soil Type	Channel bar deposits; fine gravel, sand, and silt.			
Bench Width	< 50 ft			
Existing Revetment	Sparse concrete, cobble, and rock from 2006 repairs.			
Distinction	Start of reach US; Levee moves towards river DS

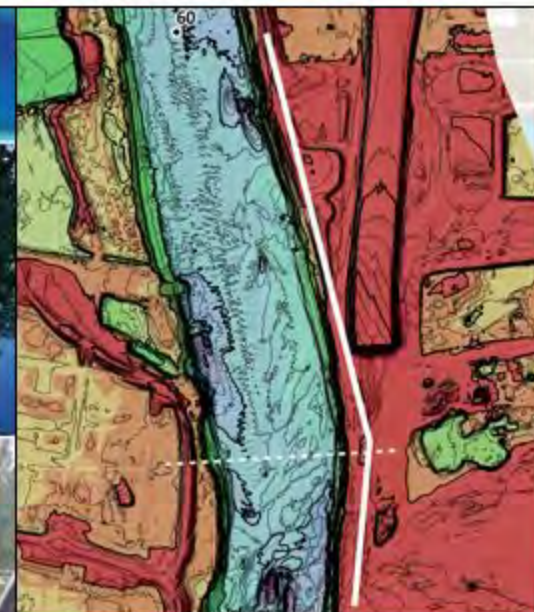
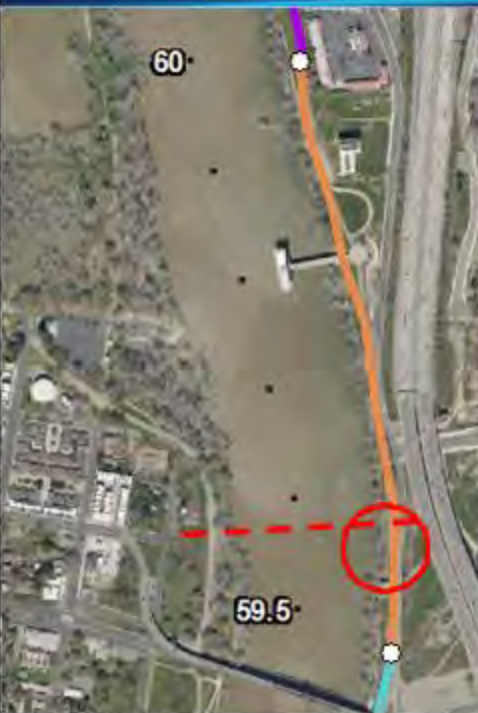
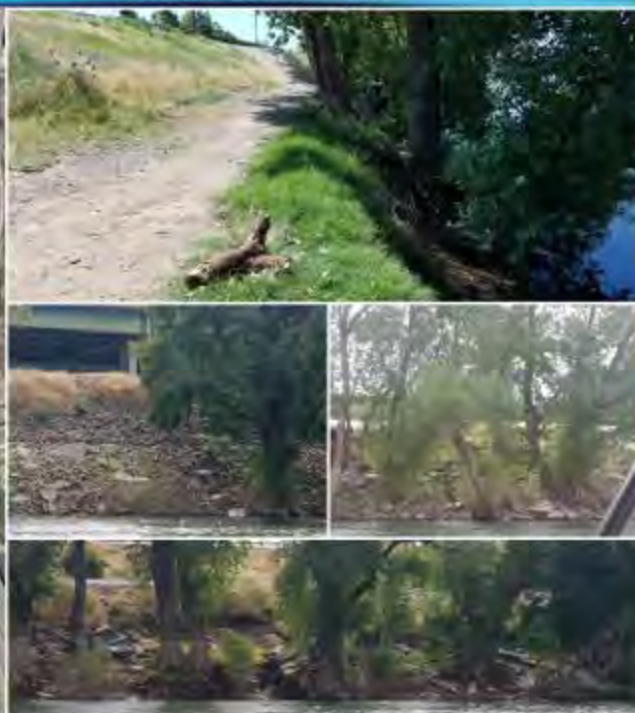
Segment 2: RM 59.45 to 60.0

The bank along this section is steep, highly degraded and includes old buildings, pipes, an old water intake structure and a variety of old bank protection, including cobble, rip rap and concrete rubble. The underlying bank soils are silty sands. The vegetation cover is predominately large individual cottonwoods with sparse understory and many barren areas. The channel bed at the toe of the bank is around -8 to -10.0 feet. The LMA (City of Sacramento Public Works Department) reports that maintenance equipment access to the lower part of segment 2 is difficult to none. The downstream end of segment 2 near the I street Bridge is the upstream end of the 1.2 mile long Old Sacramento Floodwall and Promenade.

Flow	50 kcfs	100 kcfs	110 kcfs	115 kcfs
Avg Vel Chnl (ft/s)	3.00	4.13	4.29	4.39
Soil Type	Marsh deposits; silt and clay, likely organic-rich			
Bench Width	< 50 ft			
Existing Revetment	Concrete rubble, cobble, and rock from 2006 repairs.			
Distinction	Levee moves away from river US; Floodwalls start DS

- 1) The old concrete post and beam structure located just upstream of the Tower Bridge should be examined to determine how it is tied into the floodwall and whether it is slumping in the river and pulling the floodwall with it. The possible actions could included modifying or removing the old structure, cutting the structural ties with the floodwall or strengthening the floodwall.

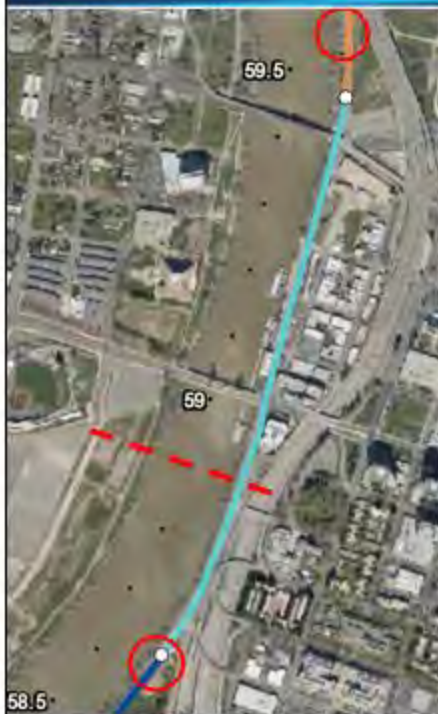
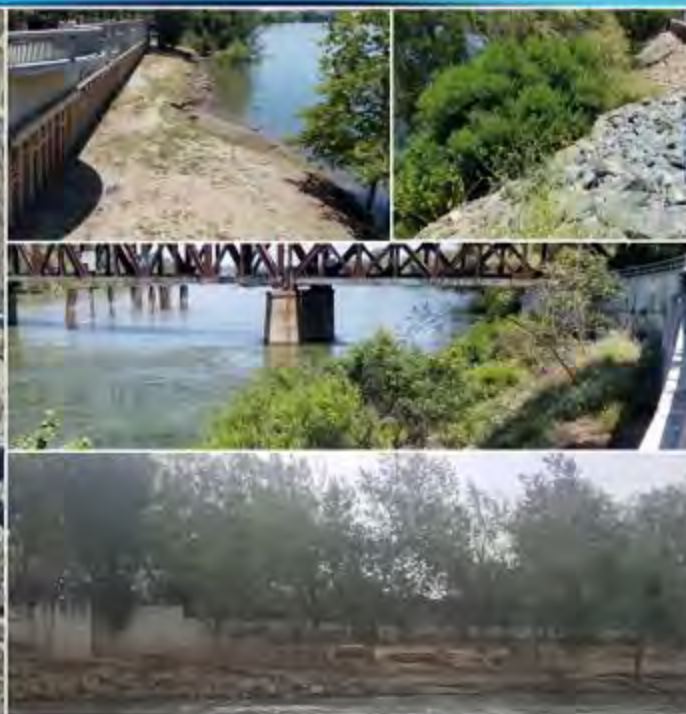
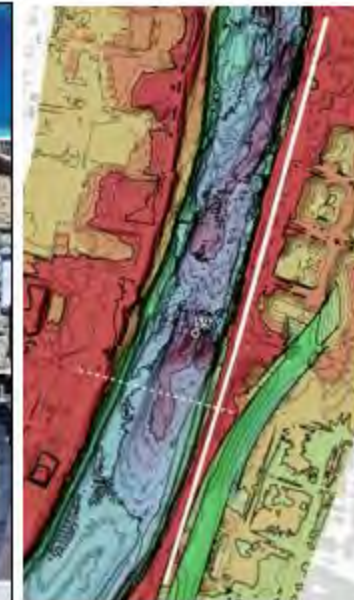
Segment 3: RM 58.65 to 59.45

Flow	50 kcfs	100 kcfs	110 kcfs	115 kcfs
Avg Vel Chnl (ft/s)	3.08	3.97	4.11	4.19
Soil Type	Alluvial and channel deposits undifferentiated; sand, silt, and minor lenses of gravel; fining upward.			
Bench Width	< 50 ft			
Existing Revetment	Floodwalls, retaining walls, rock, cobble, rubble.			
Distinction	Start of floodwalls US; End of floodwalls DS.

The bank materials are silty sands (critical shear 0.045) and vegetation cover is sparse and absent in many places. Modeled shear stress ranges between 0.10 and 0.17 lbs/ft² which exceeds critical shear of bank materials in all flows. Slope failure susceptibility is high due to existing steepness and even with minor scour depth. Vegetation cover protection and existing rip rap are rated inadequate. The levee prism is already encroached and projected scour and lateral erosion progression is farther into the levee. As a result, the segment 4 bank is rated high for overall erosion potential. The consequence of lateral bank erosion on levee stability is high upstream of Highway 50 where active erosion is occurring along an overly steep bank and there is no berm (although the levee crown width is greater than 20 foot

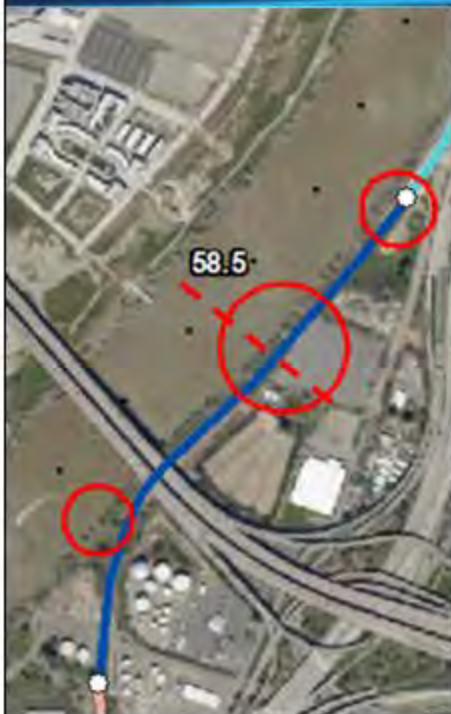
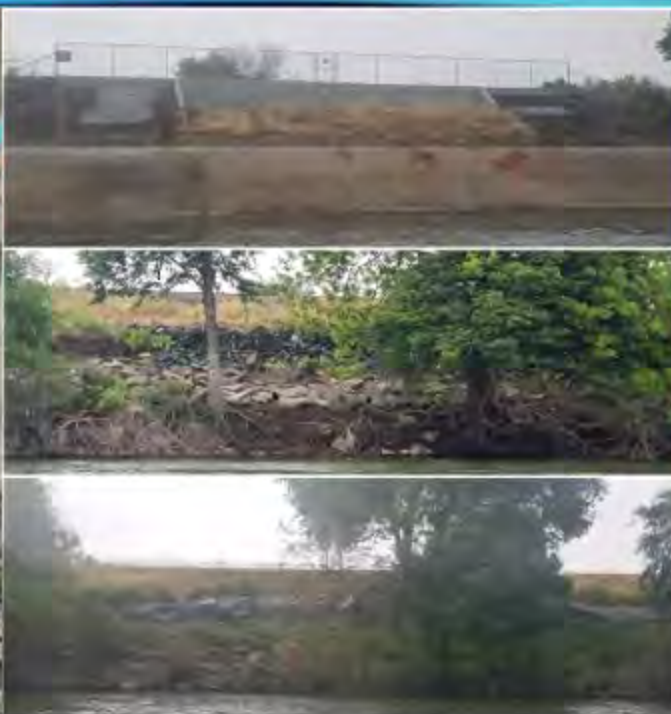
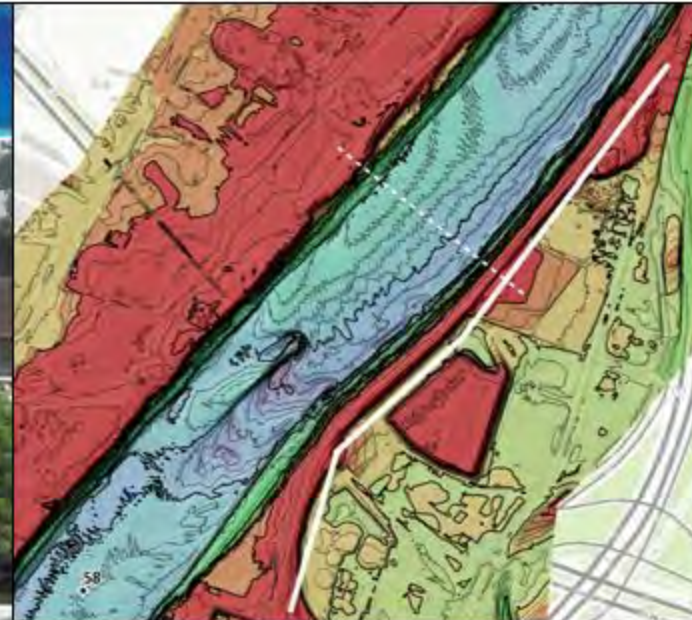
Segment 4: RM 58.0 to 58.65

Flow	50 kcfs	100 kcfs	110 kcfs	115 kcfs
Avg Vel Chnl (ft/s)	3.06	4.04	4.18	4.27
Soil Type	Alluvial and channel deposits undifferentiated; sand, silt, and minor lenses of gravel; fining upward.			
Bench Width	50-100 ft			
Existing Revetment	Rubble, emergency rock (SCDU-01, -02, -03), Pioneer Reservoir.			
Distinction	End of floodwalls US; Marina starts DS.

The overall erosion susceptibility of the levee is rated low due to adequate grass cover and below threshold slope gradient, however all scour and lateral erosion extents impinge into the levee prism.

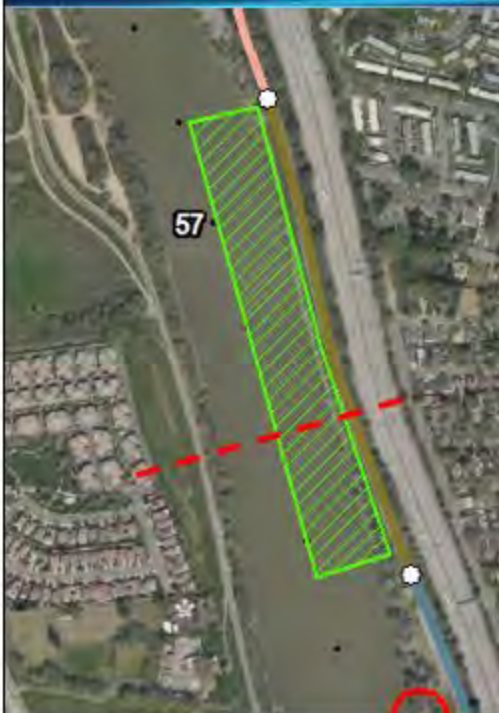
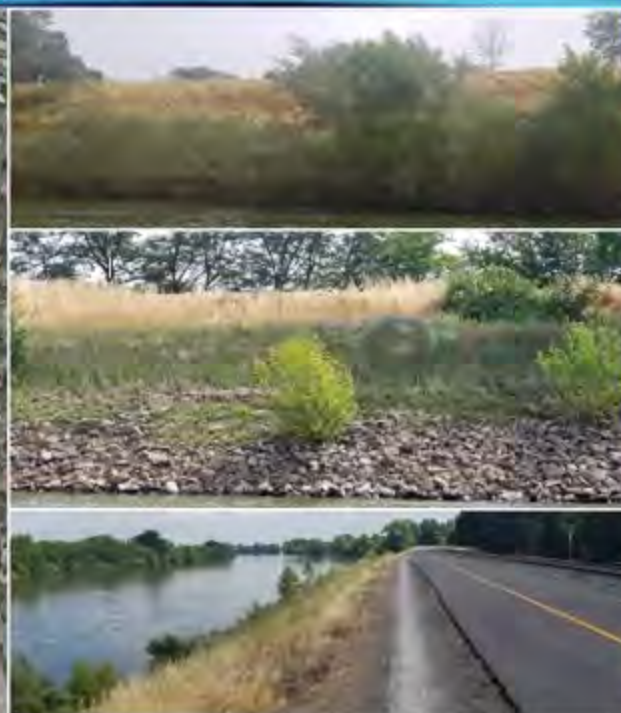
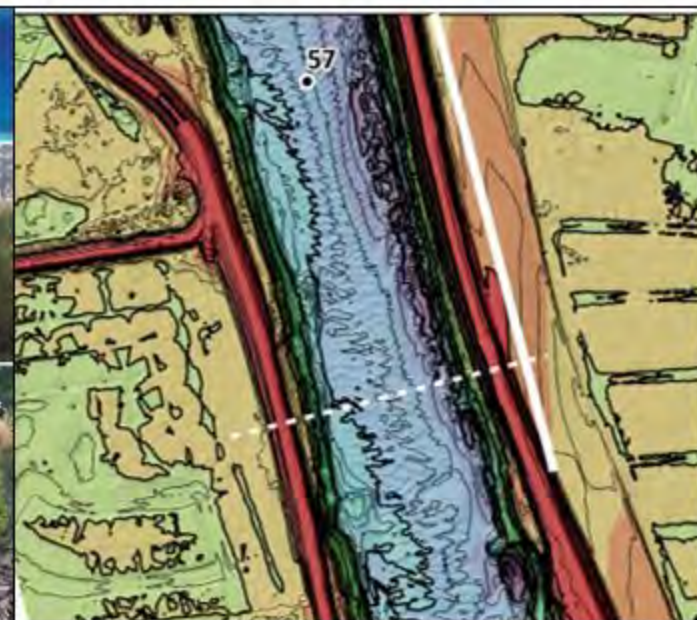
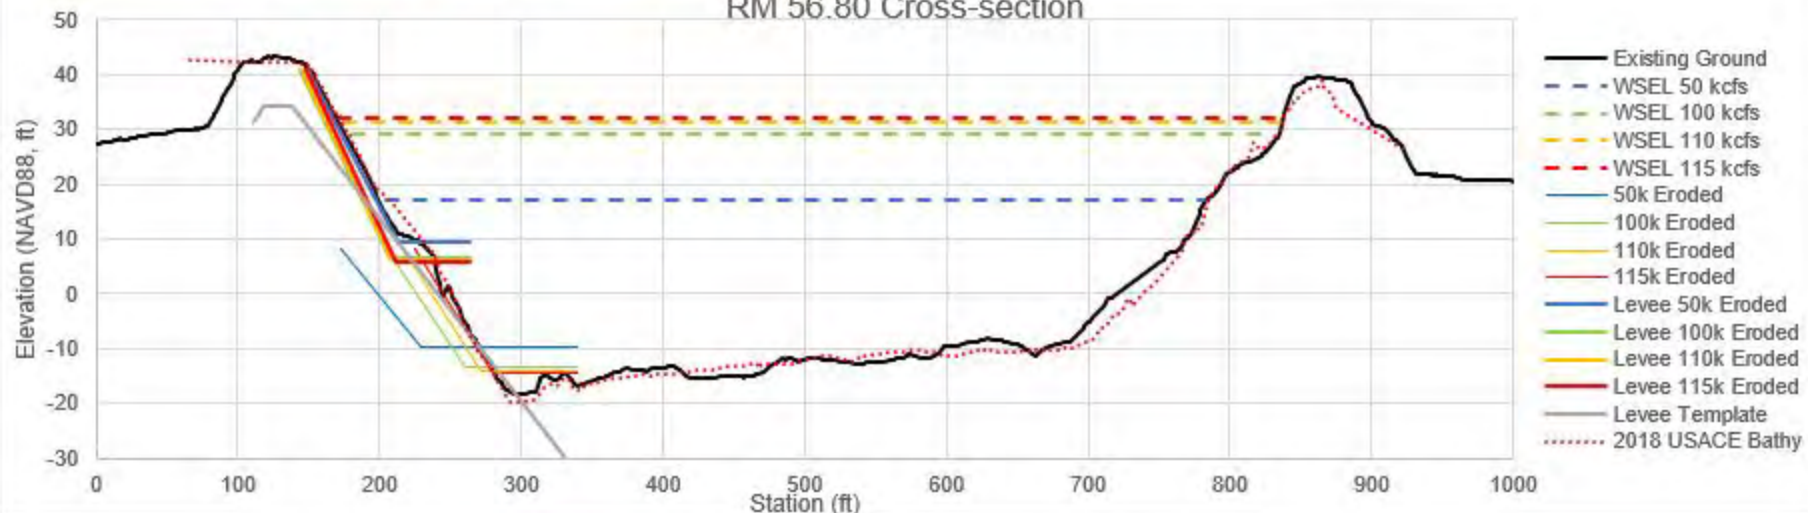
Segment 6: RM 56.65 to 57.1

Flow	50 kcfs	100 kcfs	110 kcfs	115 kcfs
Avg Vel Chnl (ft/s)	3.24	4.30	4.45	4.53
Soil Type	Overbank deposits; sand, silt, and clay.			
Bench Width	~25 ft			
Existing Revetment	Modern revetment - Site RM 56.7L (2004).			
Distinction	Marina US; Modern revetment ends DS.

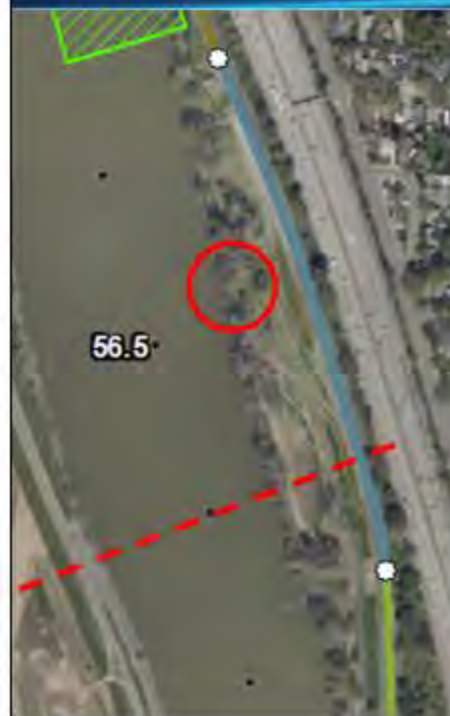
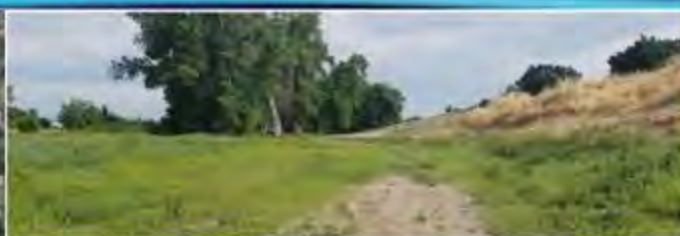
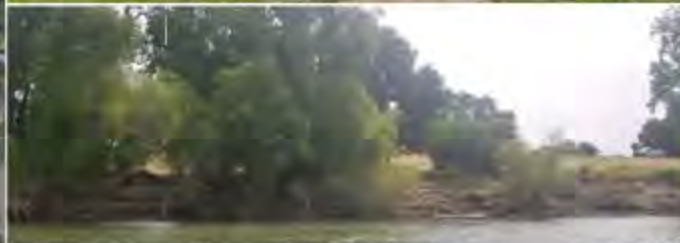
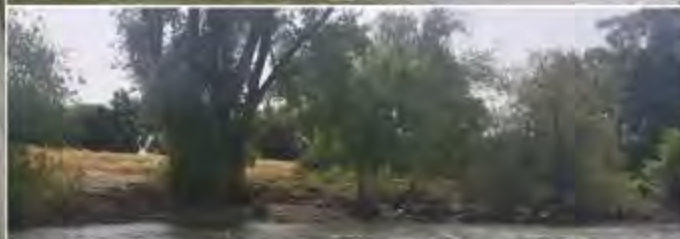
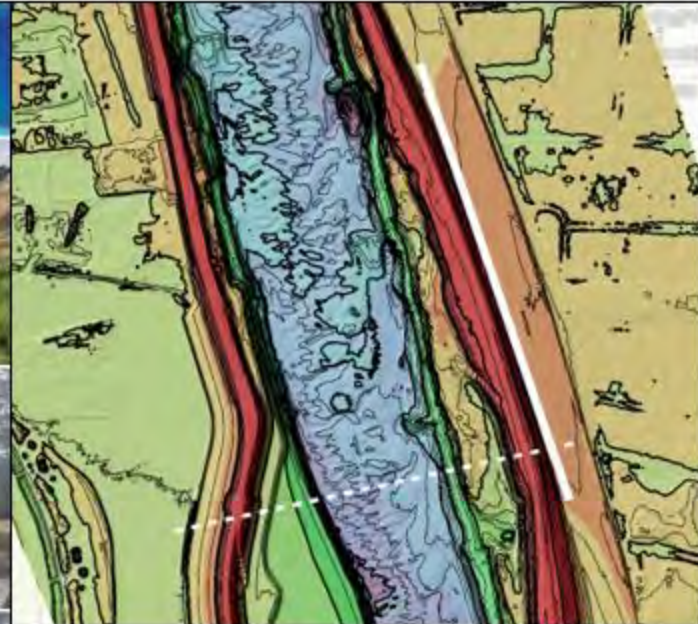
Segment 7: RM 56.35 to 56.65

Segment 7 is 1,600 feet long with variable berm width (less than 50 feet to 200 feet) and a wide levee crown (40 feet +/-). The berm has large mature trees along the bankline and landward up to a cleared maintenance road at the toe of levee. Many tree trunks show evidence of being buried in fine silty sediments (presumably in larger floods) and exhumed by erosion (in smaller floods) multiple times. The levee toe and waterside face have been repaired with rip rap likely within the last 20 years. There is a long corrugated metal pipe storm drain outfall at RM 56.35.

The bank slope failure susceptibility and erodibility are rated high for all flows. Bank scour depths and erosion extents do not reach the levee prism. The overall bank erosion potential is rated high for all flows.

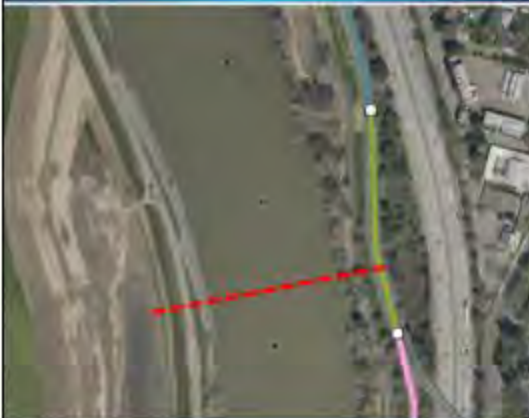
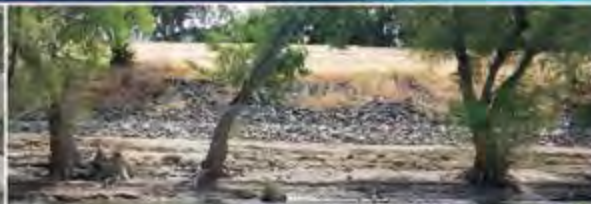
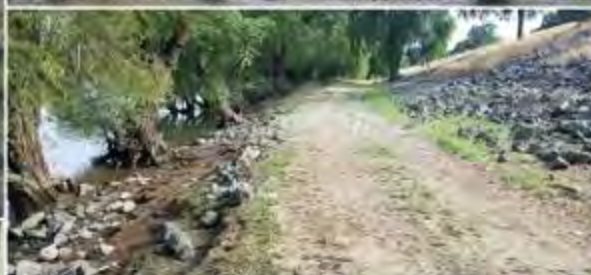
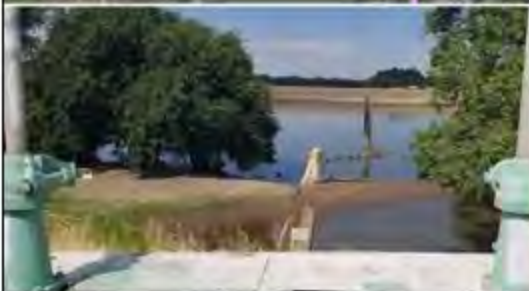
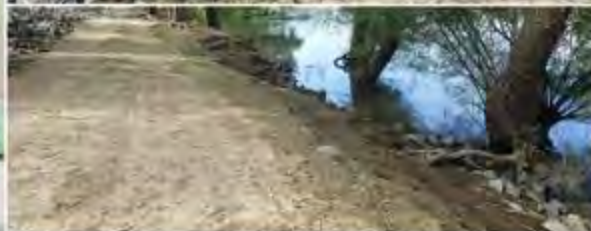
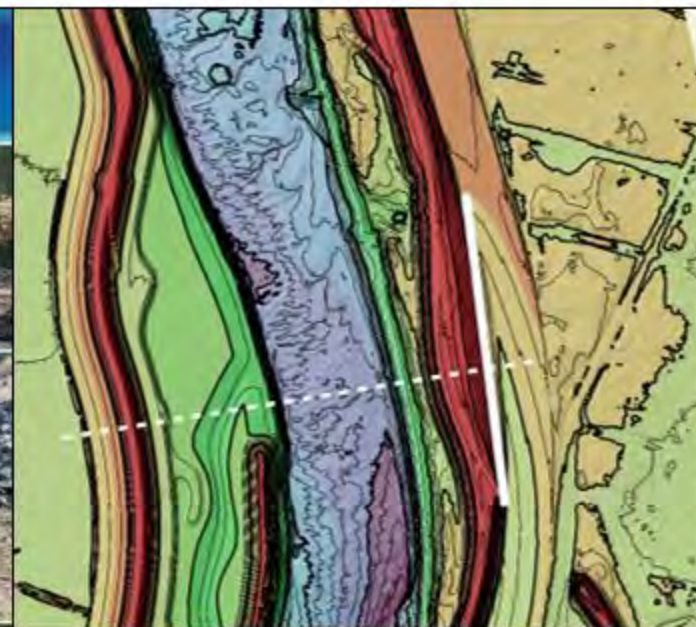
Segment 8: RM 56.2 to 56.35

Segment 8 is short with a narrow berm (less than 20 feet) that is actively eroding. The bank is unprotected and levee slope has been actively repaired (2006 era rip rap). Vegetation and rock placements are sparse along the steep and eroding bank. The berm is a terrace and is barren due to the maintenance road extending from the levee toe. The bank and levee slope are nearly coincident and about 65 feet above the toe of bank (at – 30 feet).

planform location and the outside of a bend, and lateral erosion impinge into the levee prism. The levee overall erosion potential is rated low, however the projected scour and lateral erosion extents encroach

the levee prism. The presence of extensive rip rap on the levee face and evidence of recent and ongoing erosion suggests that risk may be higher.

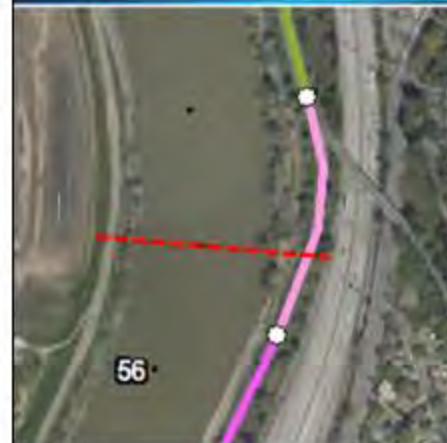
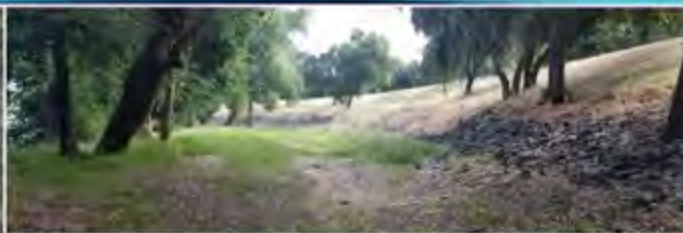
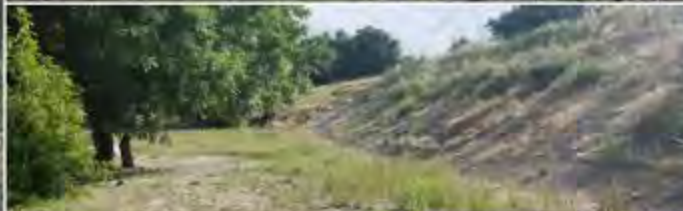
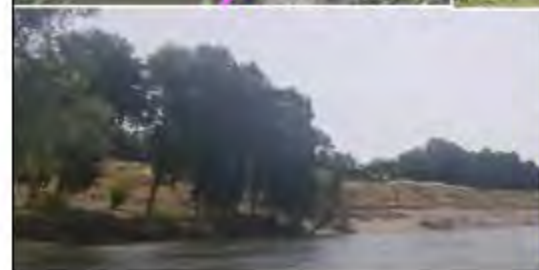
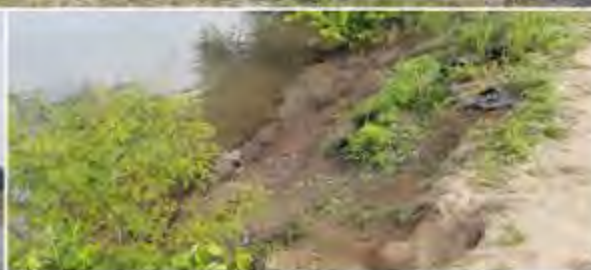
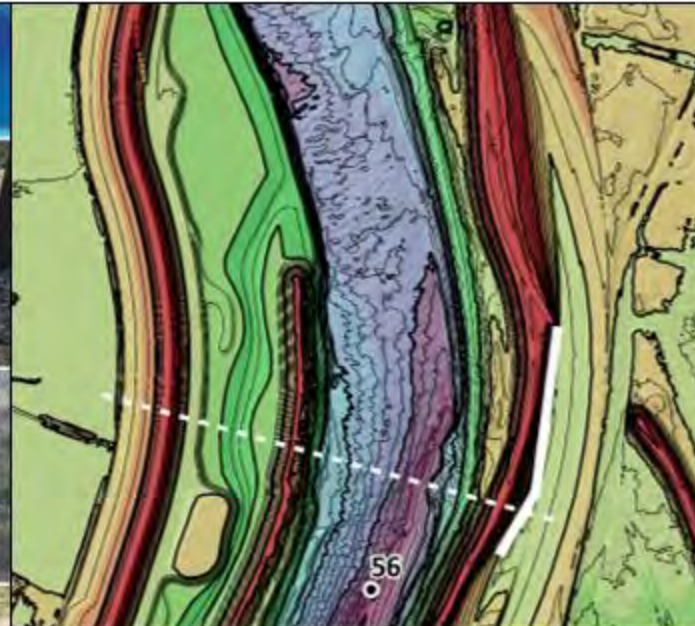
Segment 9: RM 56.07 to 56.2

Segment 9 has a relatively wide berm (greater than 50 feet) and gently sloping and sparsely vegetated cut bank⁹. The berm has large trees and grass understory. The waterside levee face has many patches of 2006-era rip rap and the lower 200 feet has gunite (concrete) cover which extends into segment 10 downstream (built in the 1920s). The levee section is relatively wide (crown width over 30 feet) and has good grass coverage but there are extensive patches of rip rap repairs on the levee waterside face.

The levee overall erosion rating is high for flows 100,000 cfs and 115,000 scour and lateral erosion at these flows extend into the levee prism. This is the result of high slope failure potential enhanced by scour and its location along the outside of the bend. The projected maximum shear stress at the levee toe is 0.040 lbs/ft² which is close to the critical shear of 0.050 lbs/ft² and the patches of rip rap repair indicates exceedance of erosion thresholds in the recent past. The downstream 200 feet of levee slope is protected by gunite which has been in place since the 1920s.

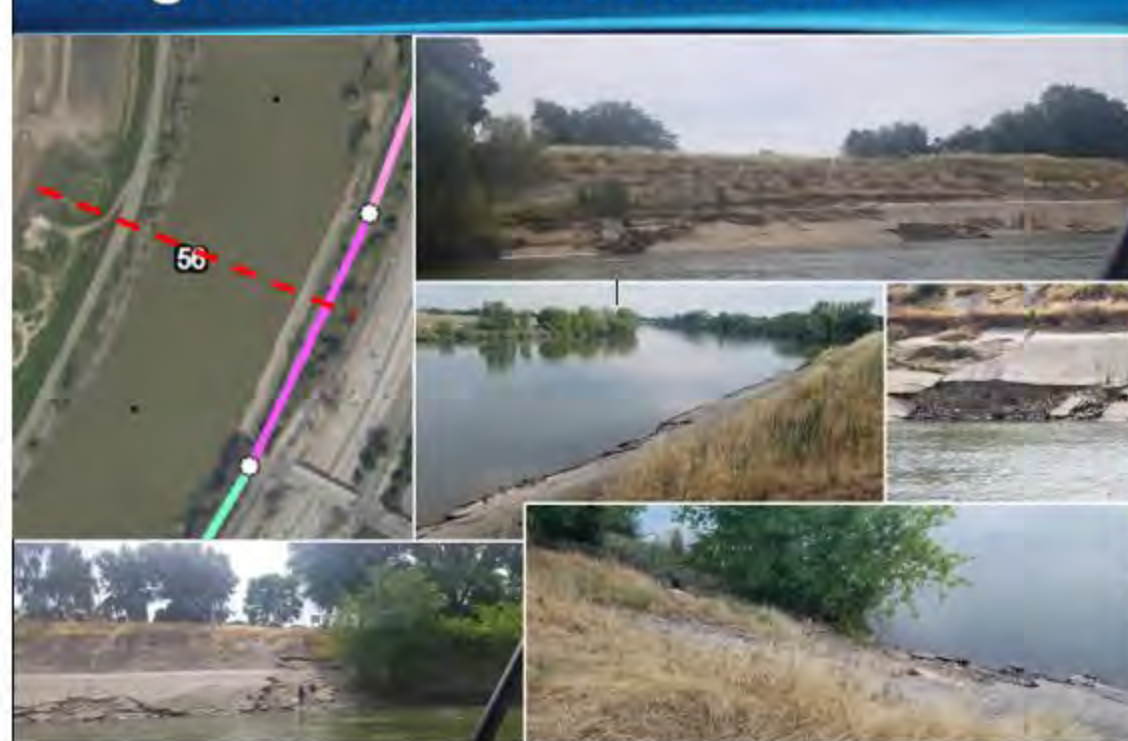
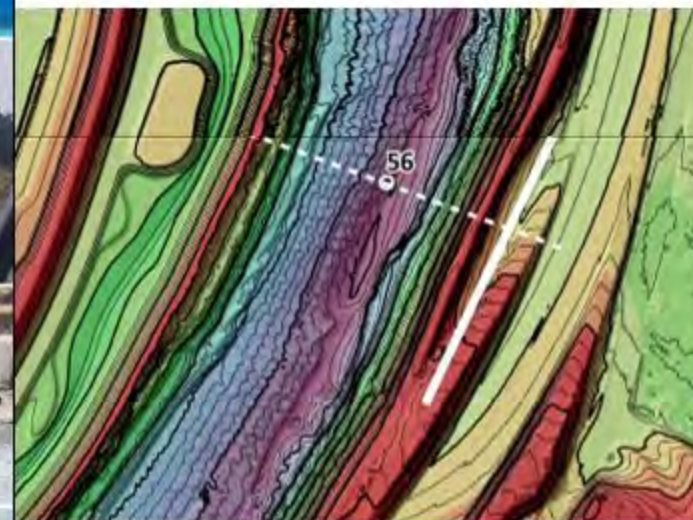
Segment 10: RM 55.9 to 56.07

The bank and levee rates high overall for erosion potential due to enhanced deep scour at outside of bend, oversteepend slopes, and failing protection. The scour and lateral erosion for nearly all flows extend well into the levee prism for both levee and bank. The presence of a scalped slope below elevation -10.0 feet suggests that toe erosion is progressing perhaps into or under the timber wall. The overall slope geometry suggests that mass failure during a large flood is a possibility if toe erosion increases.

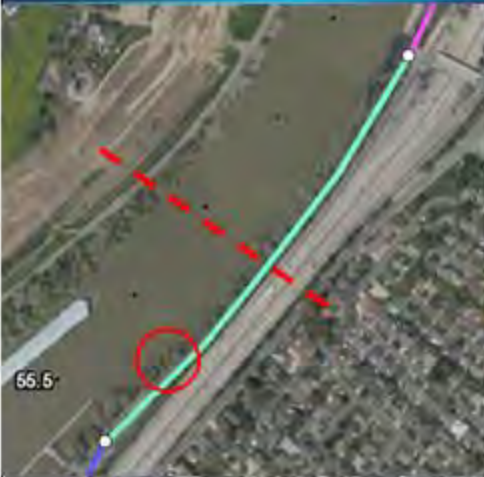
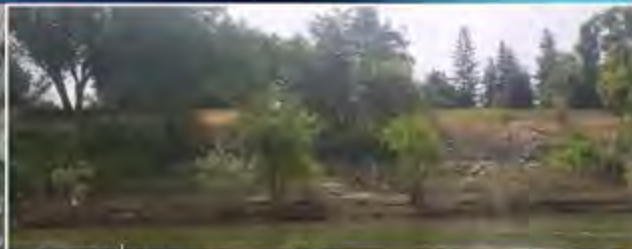
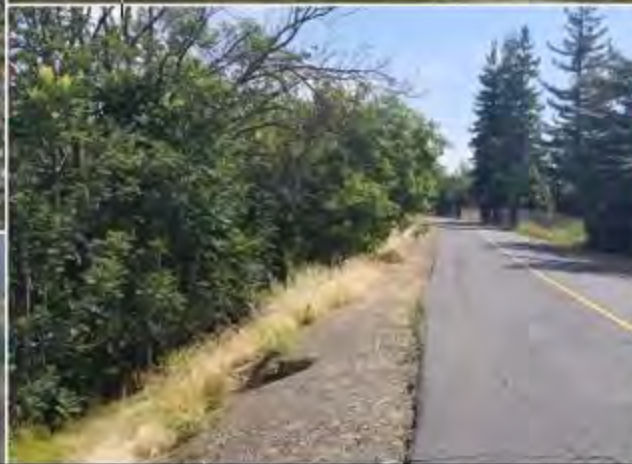
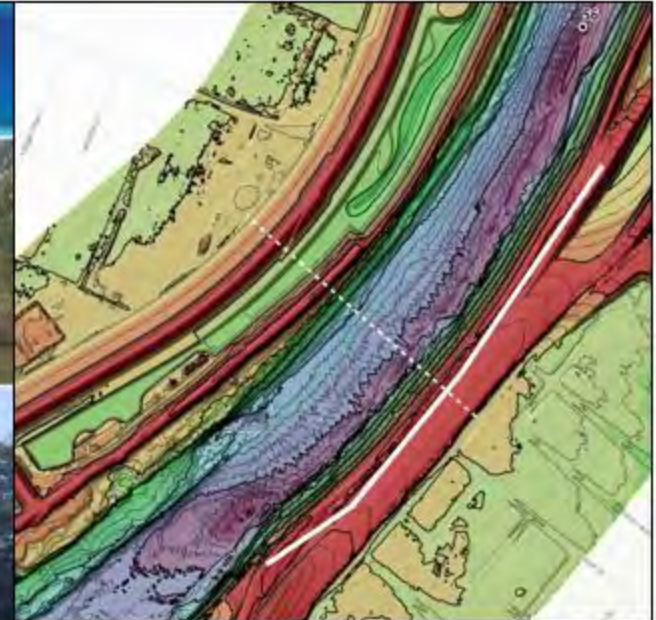
Segment 11: RM 55.5 to 55.9

Segment 11 extends from Sutterville Road to the upstream end of the Westin Hotel. The bank and levee slope are coincident as there is no berm and it is located on the outside of the bend. Similar to Segment 10, the levee prism is already encroached, the bank is very steep and it appears that progressive toe erosion is ongoing. The bank levee height is 65 feet from the toe of bank at elevation -25 feet to 40 feet at the levee top. The levee crown is wide. The reach between RM 55.5 and 55.6 show indications of slump failures up to the levee crown as there are tension cracks spot repairs in the bike path asphalt pavement. There appears to be a small slump involving about half of the levee slope just upstream of the marina pier.

The overall bank erosion potential is rated high for all flows above 50,000 cfs due to high slope failure susceptibility. The presence of evidence for recent mass failure / slumping supports the high rating. The projected scour and lateral erosion extends well into the already encroached levee prism.

The levee overall erosion rating is low for all flows and scour and lateral erosion is minimal due to very low shear stress (0.02 lbs/ft² maximum). However, any failure to the bank could change the levee stability quickly since it appears that potential mass failure plane extends into the levee crown as evidenced by tension cracks in the crown. The levee section in this segment is very wide which could limit the consequences of levee failure.

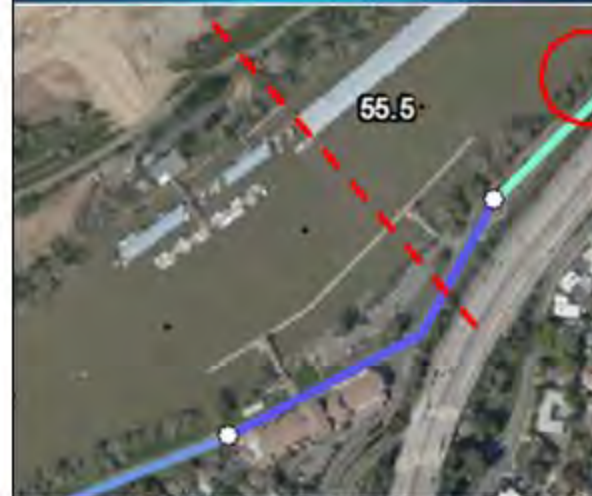
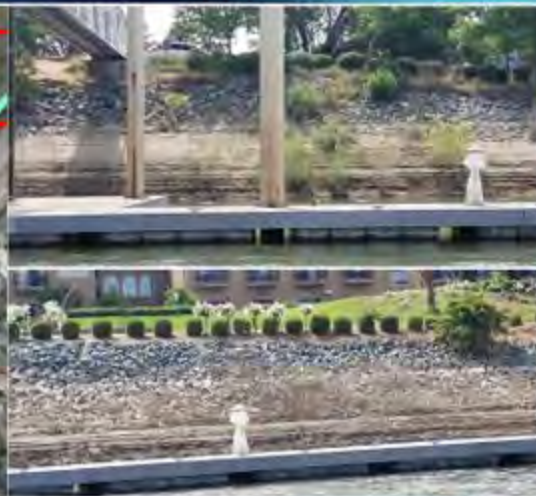
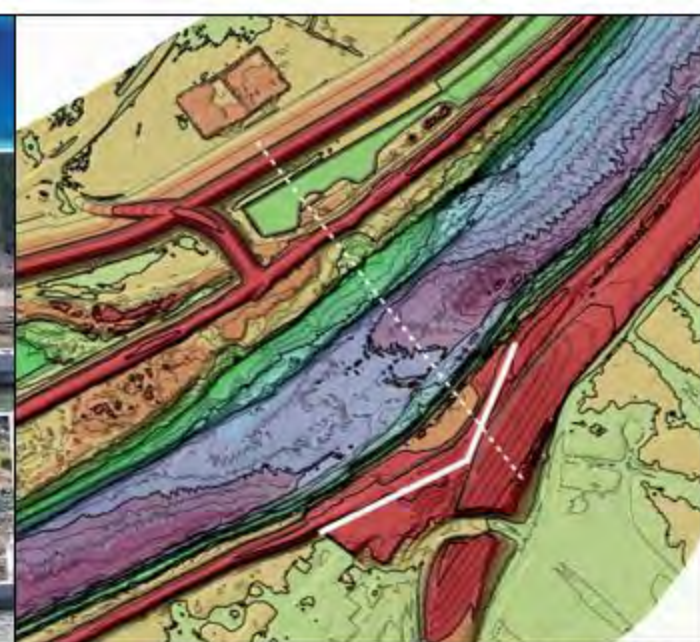
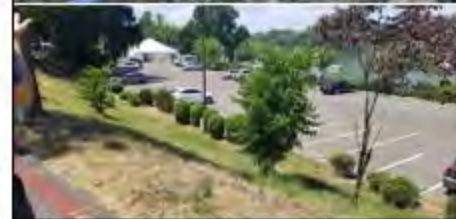
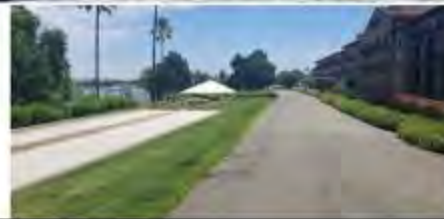
Segment 12: RM 55.3 to 55.5

The consequences of erosion are very low due to the depth of fill from the bank to under the hotel property. Any erosion issues would only threaten the hotel parking lot and lawn area. The levee prism is well behind the existing bank, but projected scour and lateral erosion of bank encroach. The bank is rated overall high potential. The levee is rated low. There is no impingement into the levee prism.

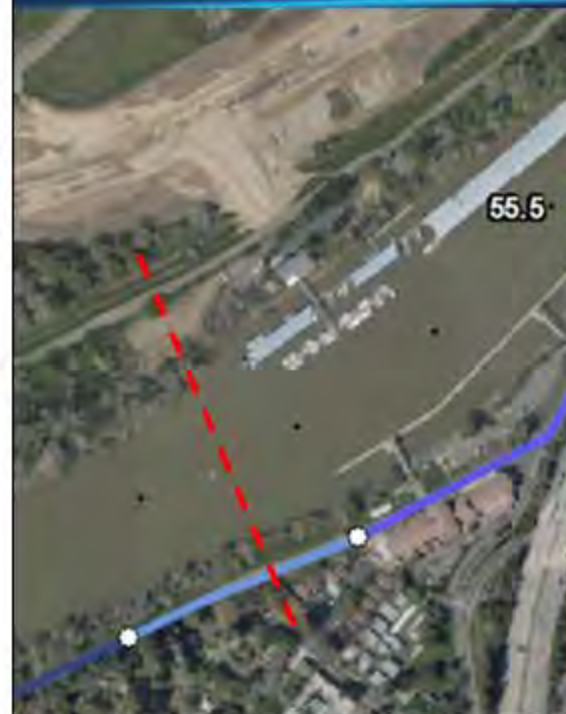
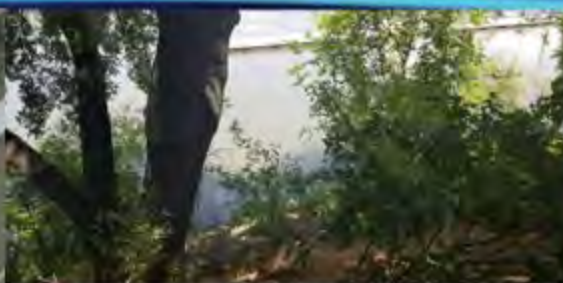
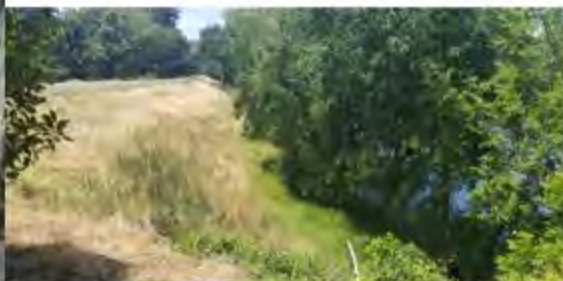
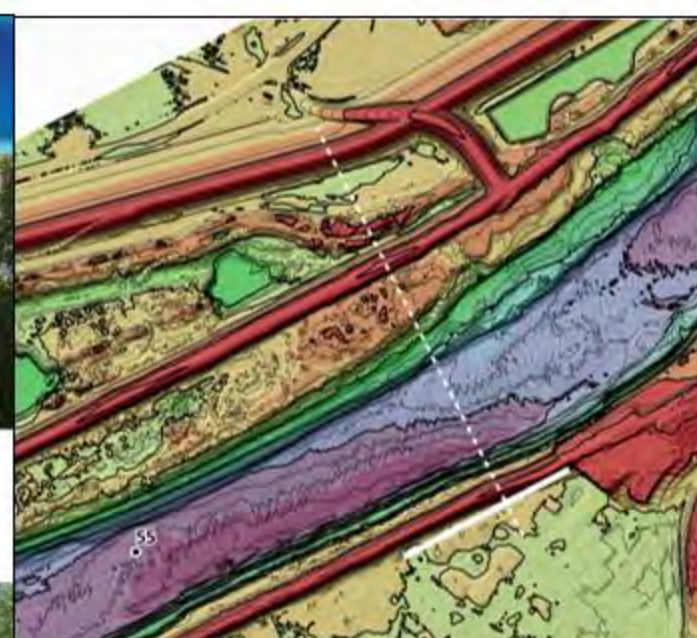
Segment 13: RM 55.15 to 55.3

Segment 13 is a recognized erosion location that is currently in design and projected for construction soon with the USACE Sacramento District (Site 55.2). The proposed project will be a modern rip rap design with a soil trench for riparian vegetation.

The bank is natural with a erosion cut within the 50,000 cfs stage range. The bank is lined with older large cottonwoods with patches of scrub willow. The thalweg at elevation – 40 feet is aligned along the west bank 300+ feet away from the east bank; as a result the bank is gently sloping and about 65 feet high.
