**BANK PROTECTION WORKING GROUP
DRAFT EROSION ASSESSMENT
SACRAMENTO RIVER EAST BANK EROSION ASSESSMENT
AMERICAN RIVER (RM 60.1) TO FREEPORT (RM 45.2)**

DRAFT REPORT

9 August 2019

NHC Ref. No. 5004539

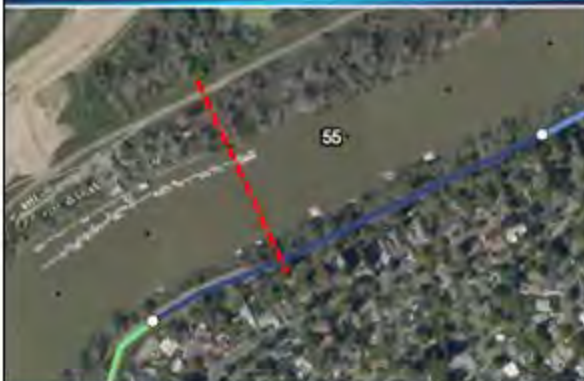
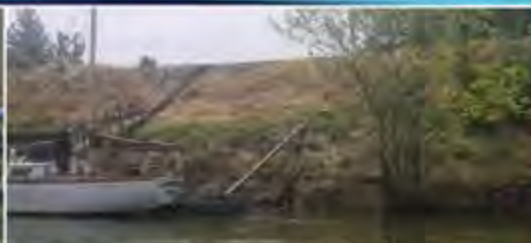
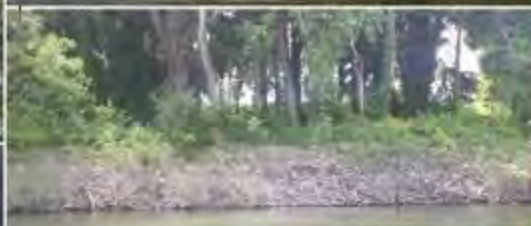
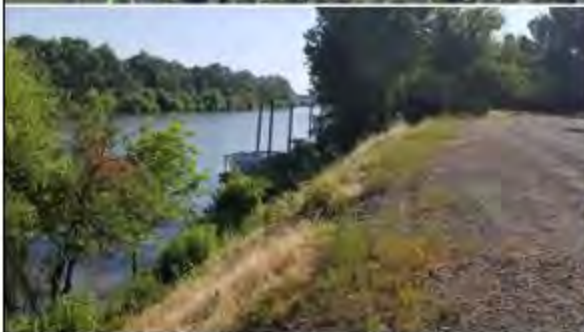
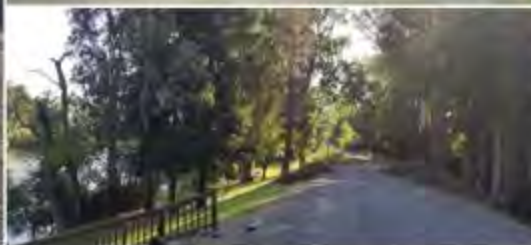
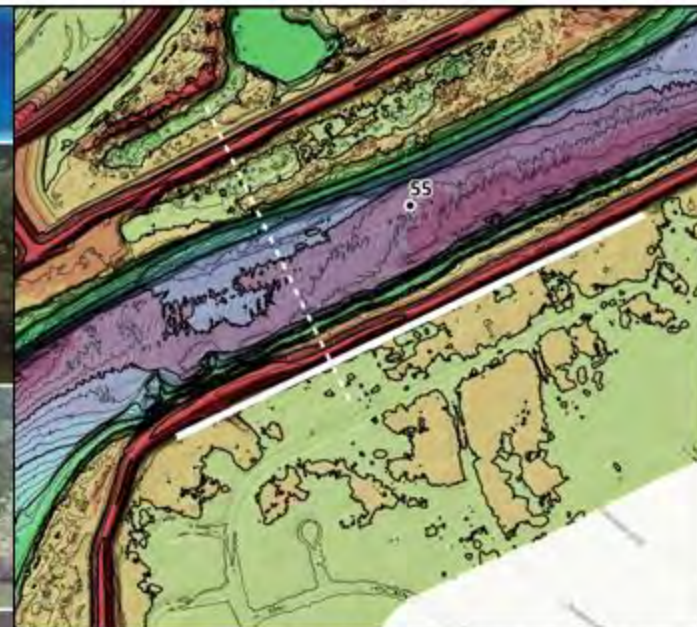
Segment 14: RM 54.75 to 55.15

Segment 14 is located within a straight reach section with a narrow to no berm, steep slopes and a moderate density and diversity of vegetation. The bank and levee slopes coincide. There are large trees along the bank with undermined roots and some gaps in the bank treeline indicate past tree fall and rip rap repairs. The existing bank is steep and encroached into the levee prism. The thalweg aligned along the toe of bank at elevation - 22.0 feet 65 feet below the top of levee. The levee top elevation is around 42 feet while the floodplain behind the landside levee toe is around 20 feet .

The levee prism is already impinged under existing conditions and is further impinged by scour and lateral erosion. The overall bank erosion potential is rated high for all flows due to the steep slope and high slope failure potential, high erodibility and lack of adequate cover.

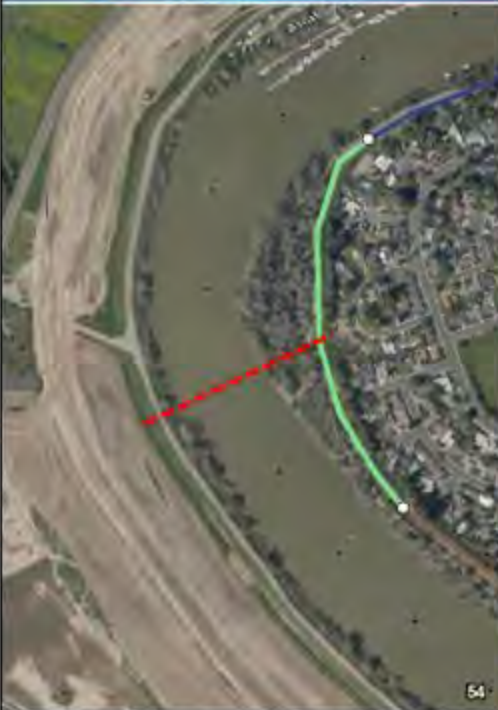
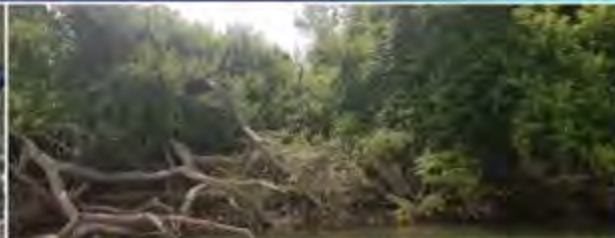
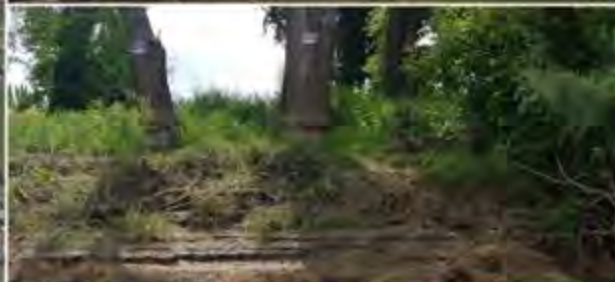
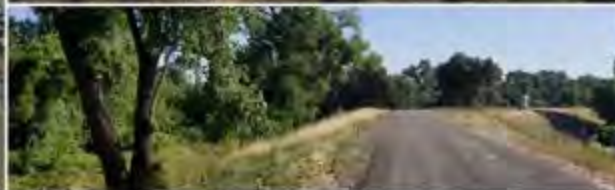
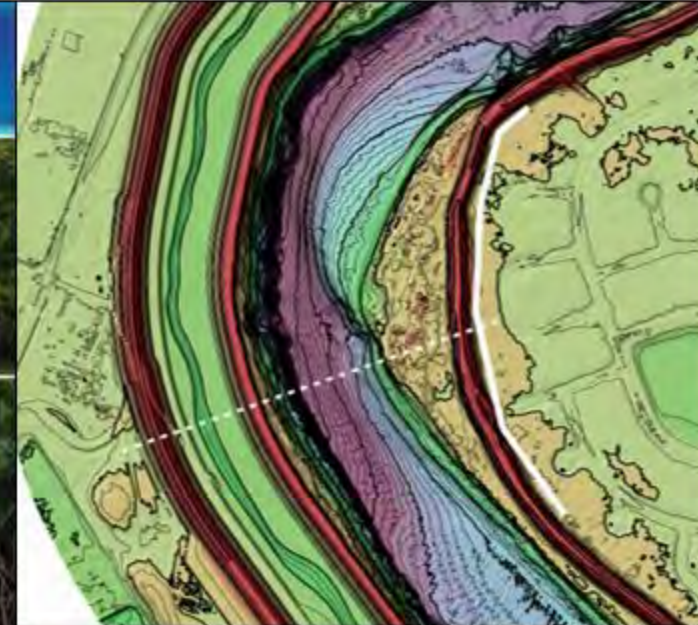
Segment 15: RM 54.2 to 54.75

The overall bank erosion potential is rated low due to gentle slope, good cover and good erosion resistance overcoming high erodibility. The scour or lateral erosion extents do not encroach into the levee prism.

The levee toe and face are subject to some erosion as the maximum shear stress of 0.06 lbs/ ft² is slightly higher than the critical shear of 0.050 lbs/ft². But the projected scour depths and lateral erosion does not encroach into the levee prism. With adequate grass cover, the overall erosion rating for the levee is low.

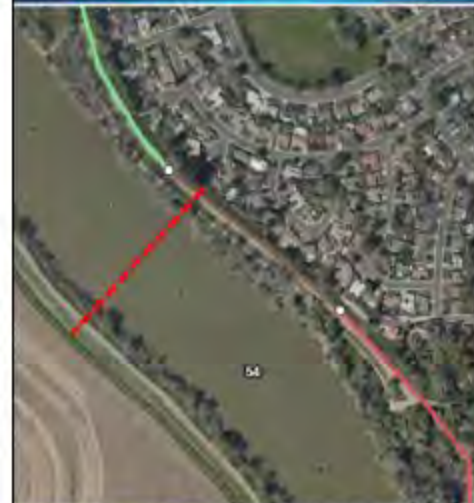
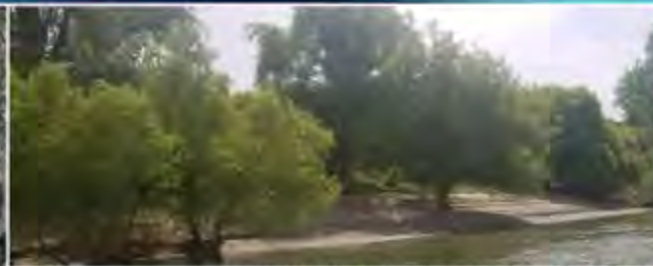
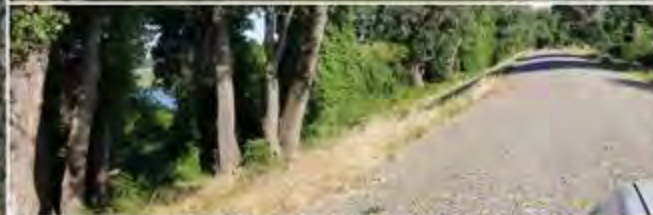
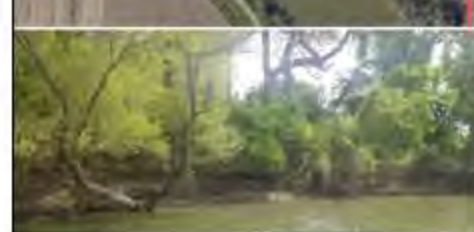
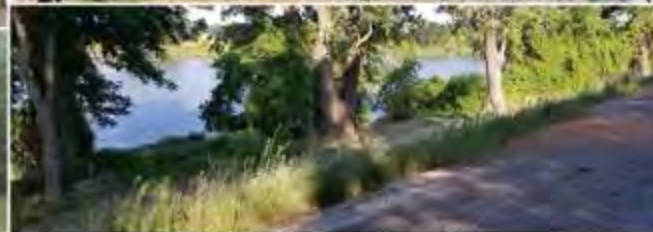
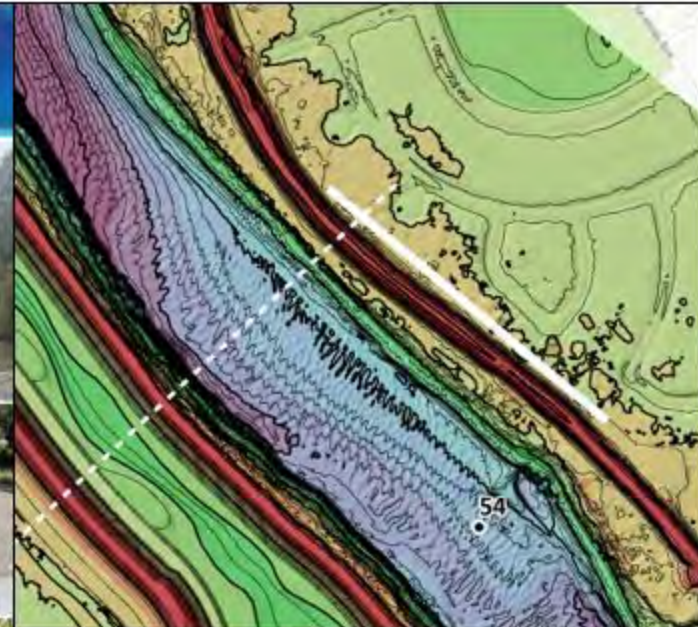
Segment 16: RM 54.0 to 54.2

Segment 16 is situated along a straight channel segment between bends in the river. The berm width is consistently less than 50 feet. The thalweg is aligned along the opposite bank 400 feet away from the toe of bank which rests at elevation – 25.0 feet. The bank vegetation cover consists of large, mature cottonwoods generally aligned along the top of bank and in a single row. The erosion cut elevation indicates the berm surface is a terrace above the 50,000 cfs effective discharge range. Examination of historic aerial photographs and field conditions indicate that loss of large individual cottonwood trees and their roots systems instantly removes 10-15 feet of berm width and creates a critical condition that the local LMA patches with rip rap. The vegetation free zone from the toe of levee and 12 feet +/- towards the bank is kept clear as a maintenance access. There is a mix of old cobble, concrete rubble and rip rap with patches of 2006 era rip rap where trees were lost.

The channel section is relatively narrow (600 feet +/-) and as a result hydraulic force along the bank is relatively high (maximum 0.22 lbs/ft²) which exceeds critical shear stress for bank materials. Vegetation cover is rated inadequate and loss of large, single trees removes all protection and usually prompts placement of rip rap to preserve the berm. As a result, the overall erosion potential of the bank is rated high and all projected scour depths encroach into the levee prism. Lateral erosion is additive.

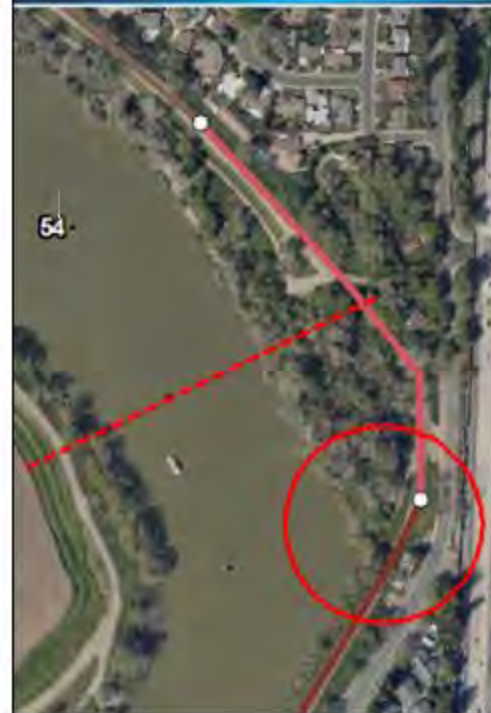
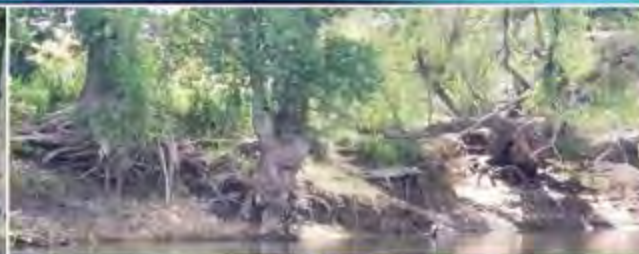
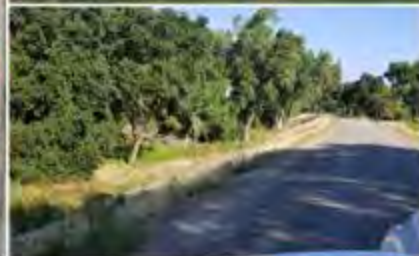
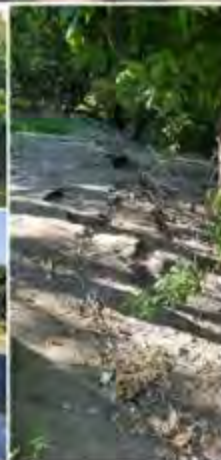
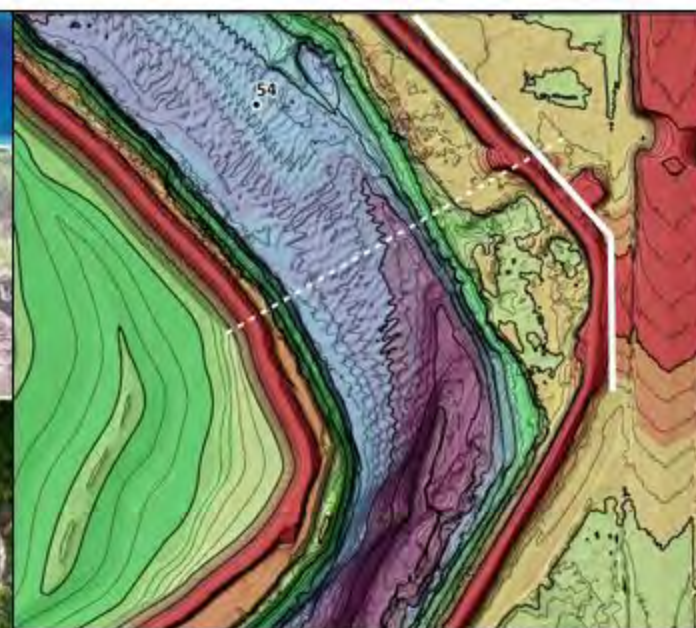
Segment 17: RM 53.81 to 54.0

Segment 17 is located just upstream of a sharp bend in the channel. It has a relatively wide berm (100+ feet) and is densely vegetated. There is a stormwater outfall at RM 53.98 that is damaged. The remaining bank has older cobble, rip rap and concrete rubble cover that have partially eroded away. The levee is around elevation 40 feet and the land behind the levee at around 15 feet. The thalweg is aligned along the toe of bank at elevation -23 feet but is over 100 feet from the top of bank.

The bank erosion potential is high due high slope failure susceptibility and mass loading by large trees along top of bank. The projected depth of scour and lateral erosion are well away from the levee prism.

The levee erosion potential is low for flows below 100,000 cfs, but high for 115,000 cfs due to scour depth and oversteepening of the levee waterside slope. The projected erosion extents encroach into the levee prism for all flows above 50,000 cfs.

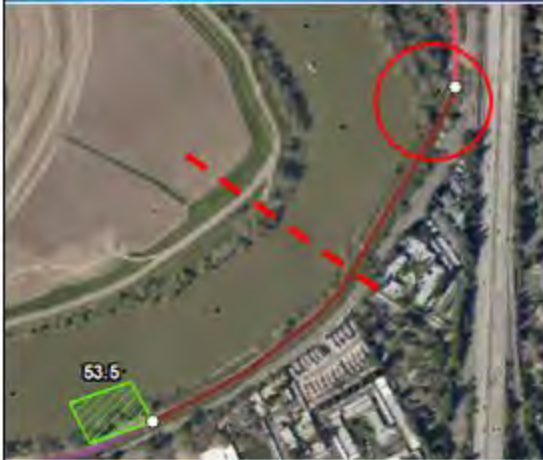
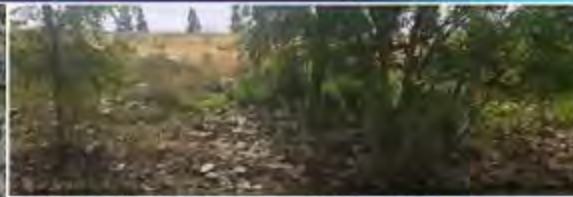
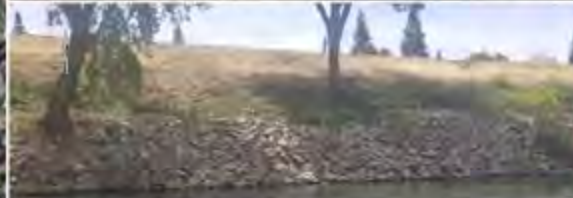
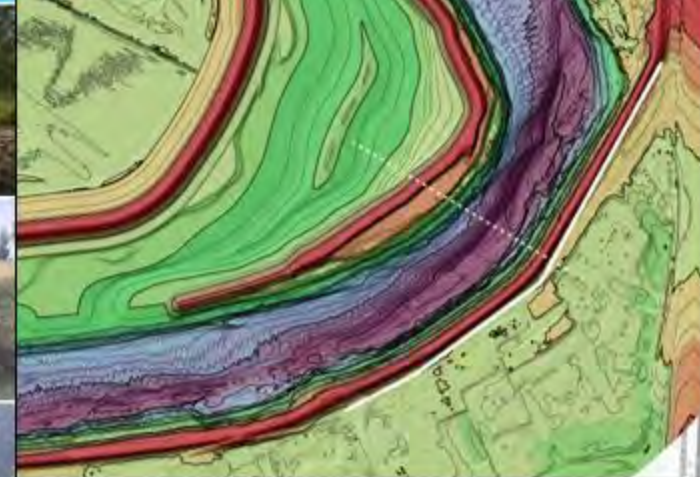
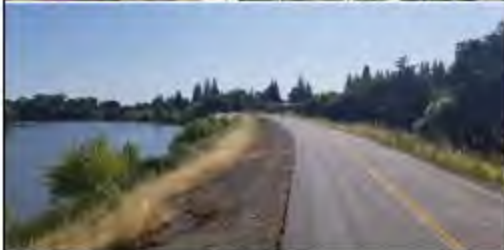
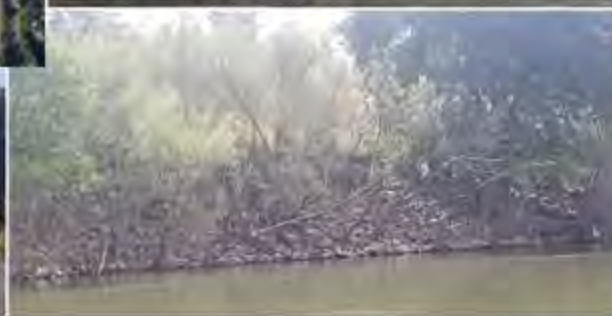
Segment 18: RM 53.5 to 53.81

Due to slope failure susceptibility and location along the outside of the bend, the overall erosion potential for the bank is rated high for flows above 50,000 cfs. The overall erosion potential for the levee is high at 115,000 cfs. This is due to deep scour of the bank and levee toe that over steepens slopes. Scour and lateral bank erosion extents are well into the levee prism and the long duration, 50,000 cfs flow lateral bank erosion projection is through the levee.

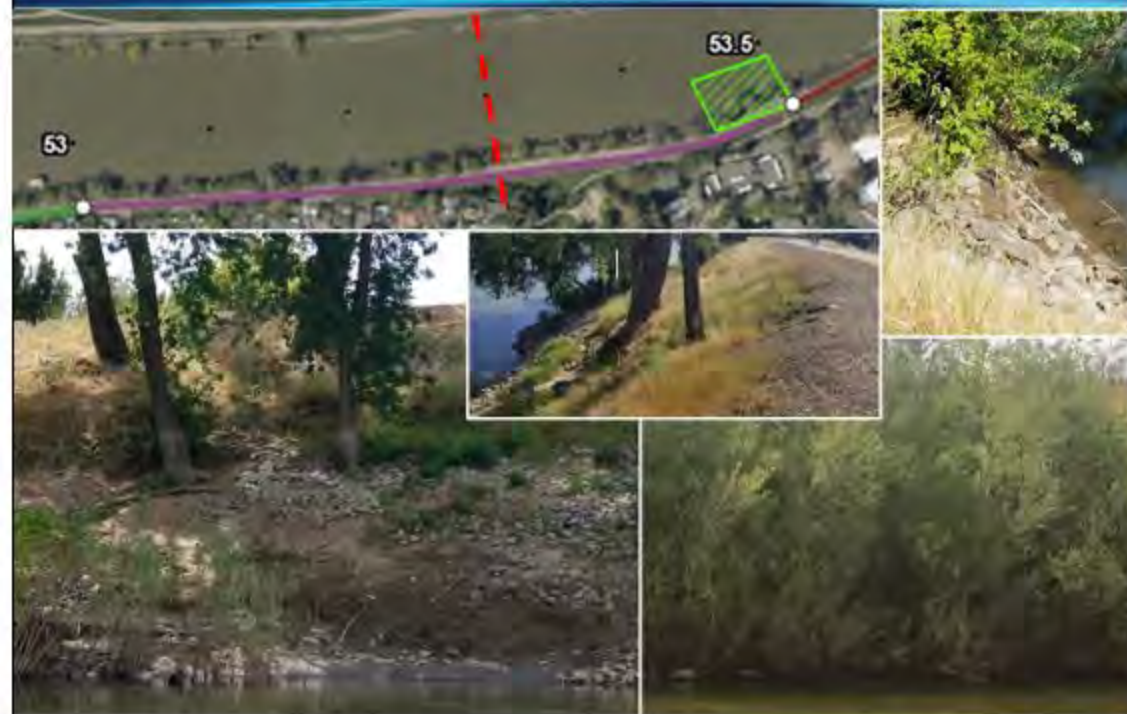
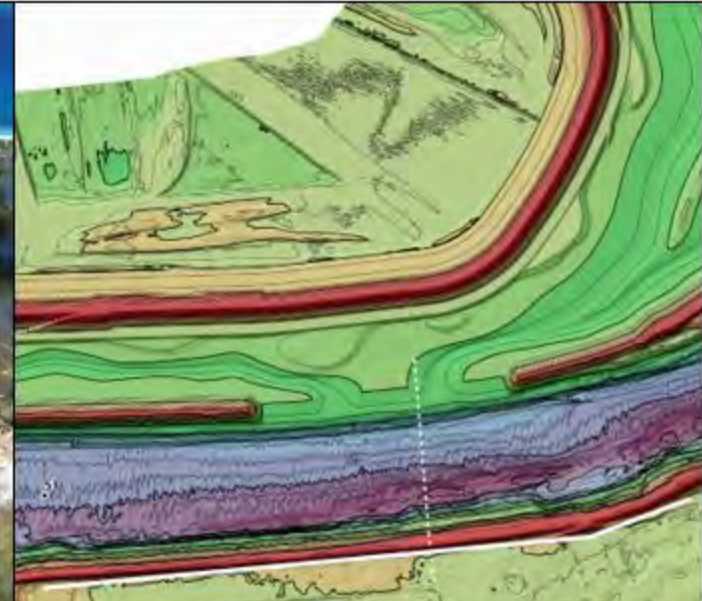
Segment 19: RM 53.0 to 53.5

Segment 19 is situated at the downstream end of the sharp bend and the upstream end of The Pocket, a low floodplain area (most below elevation 10 feet) that is densely urbanized. Berm widths between 0 and 50 feet. The thalweg is aligned along the toe of bank at elevation -28 feet. The existing bank slope is steep and already encroached within the levee prism. The bank and berm (where present) vegetation consists of some large trees and a fairly continuous shoreline cover of shrub willows (some appear planted). There is a very short 200 foot long modern revetment at RM 53.47 which appears to have adequate rock volume, but this only covers less than 10% of the segment.

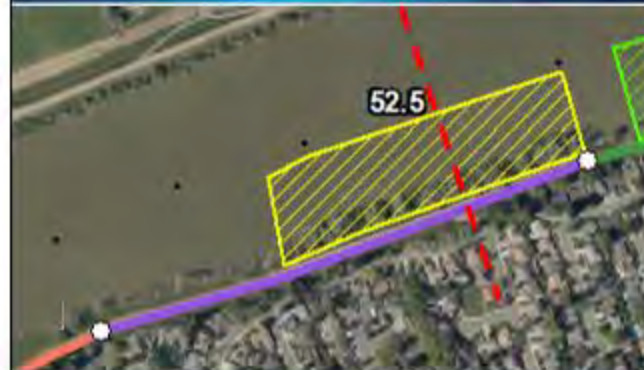
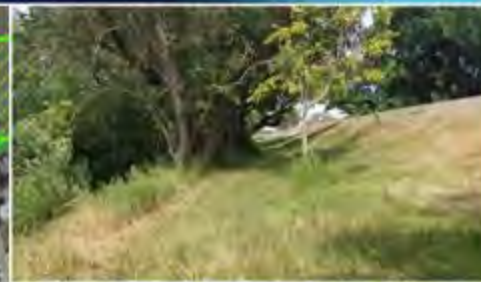
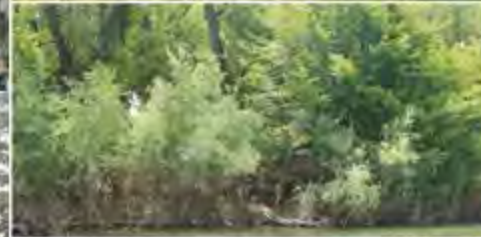
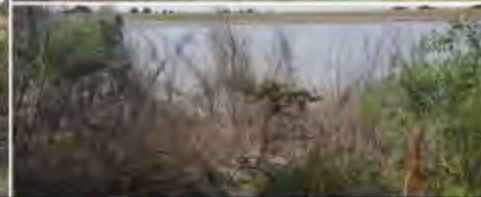
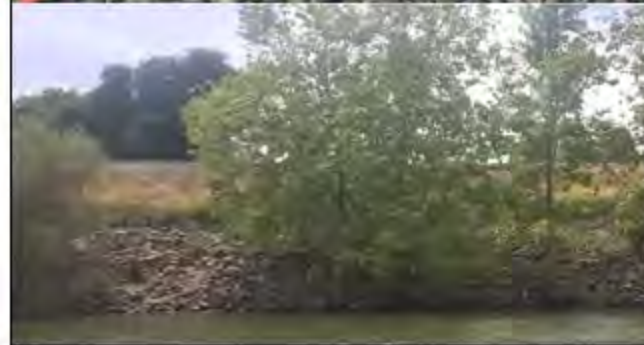
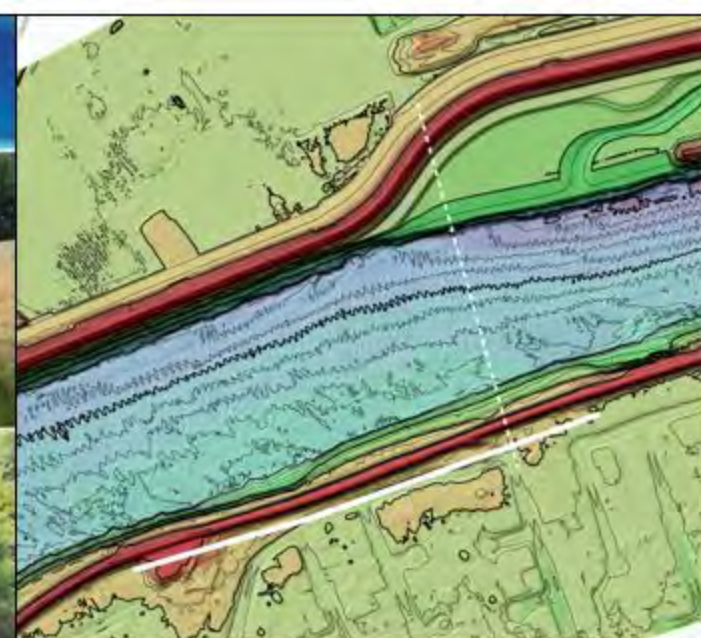
Segment 21: RM 52.2 to 52.6

Segment 21 has a narrow to nonexistent berm with 1,200 feet (70 percent of the bankline) of modern revetment and 800 feet of patchy 2006-era repairs. Outside the modern revetment, the bank is very steep and already encroached into the levee prism. The thalweg is aligned along the west bank and the toe of bank is at elevation 5.0 feet and the bank is 40 feet high to the top of the levee.

The overall bank erosion potential is rated low for the revetment section (1,200 feet) but the unprotected 800 feet is rated high due to inadequate cover. This yields an overall high erosion potential for the segment all flows. The bank scour and lateral erosion extents encroach into the levee at all flows.

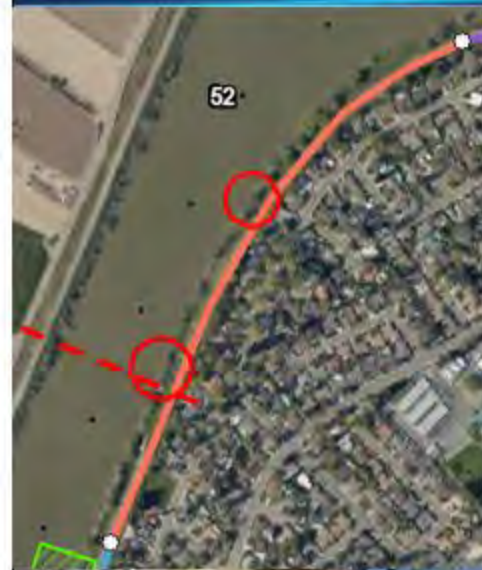
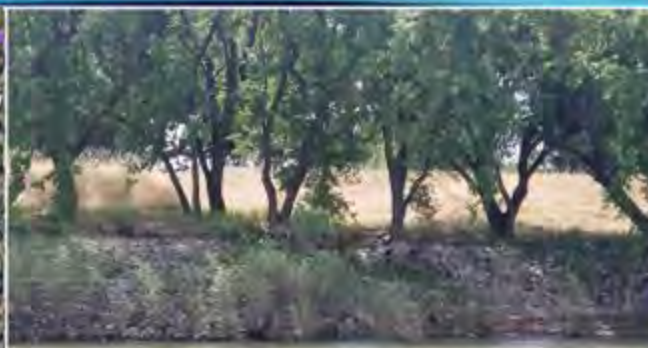
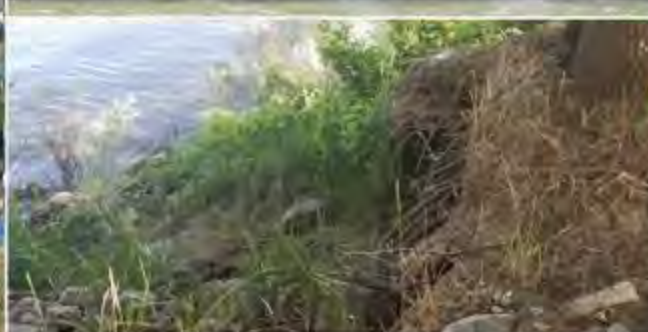
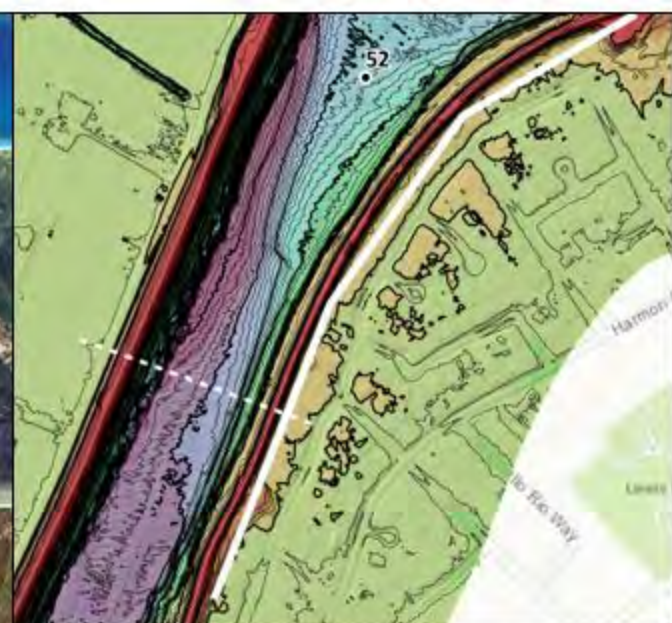
Segment 22: RM 51.6 to 52.2

The overall erosion potential of the bank is rated high for all flows due to steep slopes, erodibility and high slope failure susceptibility. Loss of large trees significantly reduces berm width. Scour and lateral bank erosion for all flows encroaches into the levee prism.

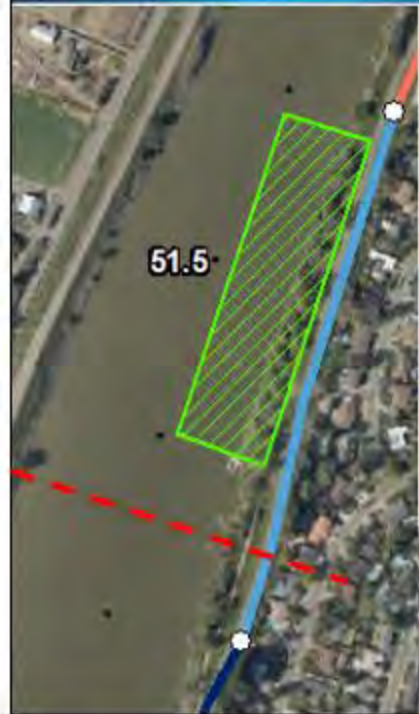
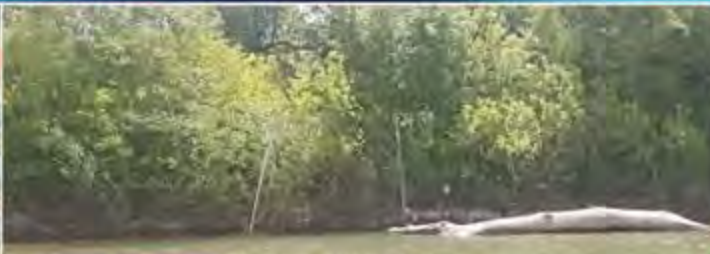
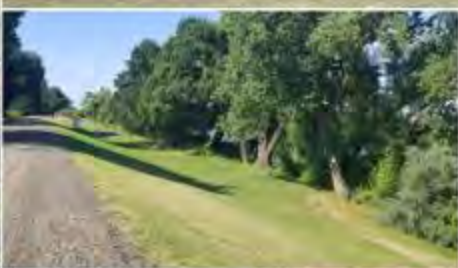
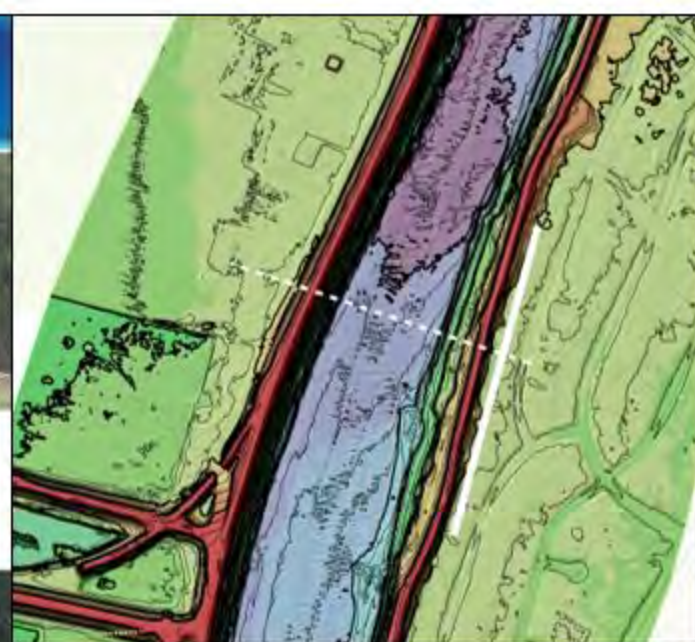
Segment 23: RM 51.3 to 51.6

Segment 23 has a continuous berm that is less than 50 feet wide. There is modern revetment from RM 51.4 to 51.6 that was built in 2006. Vegetation cover along the bank is discontinuous with patches of scrub willow where large trees have fallen. Similar to other areas, loss of large trees diminishes berm width to the point of needing repair to maintain the toe of levee access. The thalweg is aligned along the opposite bank. The toe of bank elevation is - 8 feet and the bank toe-to-levee top height is 40 feet.

Since the modern revetment only covers a portion of the segment, the segment is rated for the unprotected part. The overall bank erosion potential rating is high for all flows due to high slope failure susceptibility. Scour and lateral erosion extents encroach into levee prism for all flows.

The levee rating is low for all flows primarily due to good vegetation cover, below critical shear stress and low slope failure potential.

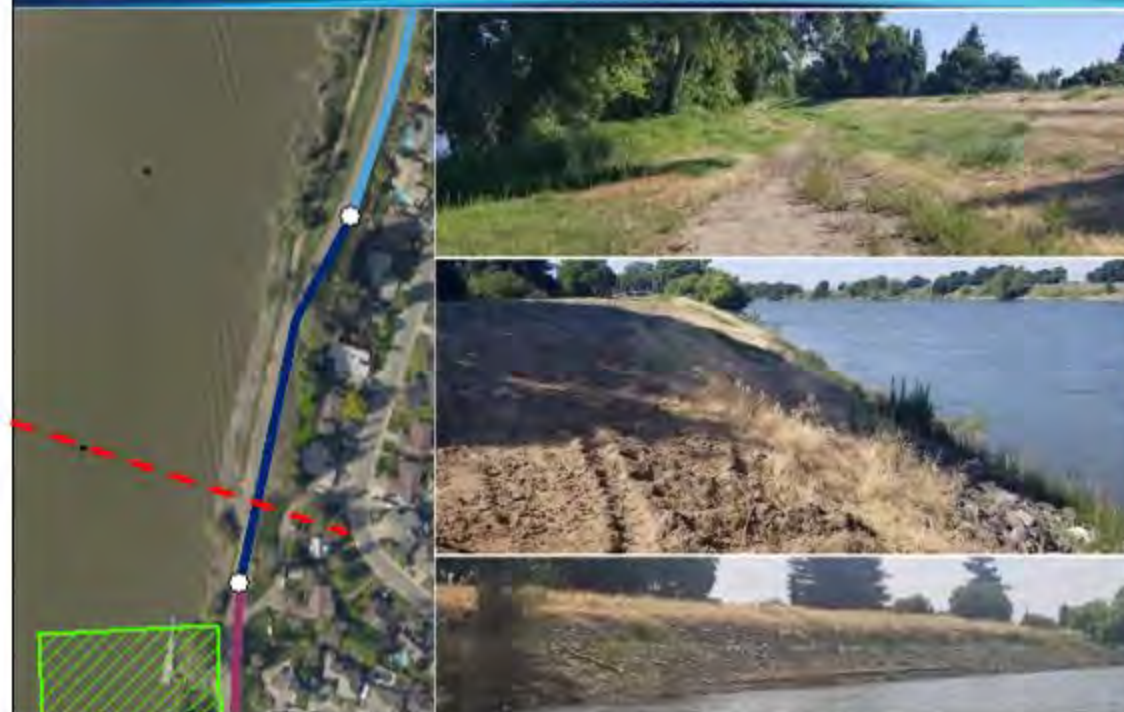
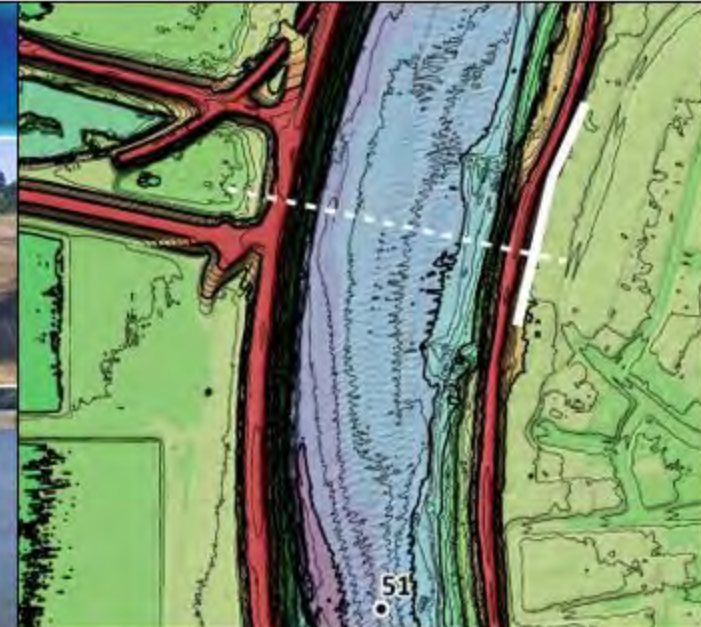
Segment 24: RM 51.15 to 51.3

Segment 24 is a short gap between modern revetments. The berm width is less than 50 feet in the upper 100 feet and zero over the remainder. Vegetation is sparse with large widely spaced trees along the section with berm. The section without berm is barren with 2006 era rip rap repair. The existing bank is

The overall bank erosion potential is rated high for all flows due to deep scour and high slope failure potential. All projected scour and lateral erosion extents encroach into the levee prism.

The overall levee erosion potential is rated low for all flows due to low slope failure susceptibility. The projected scour and lateral erosion extents into the levee prism in all flows.

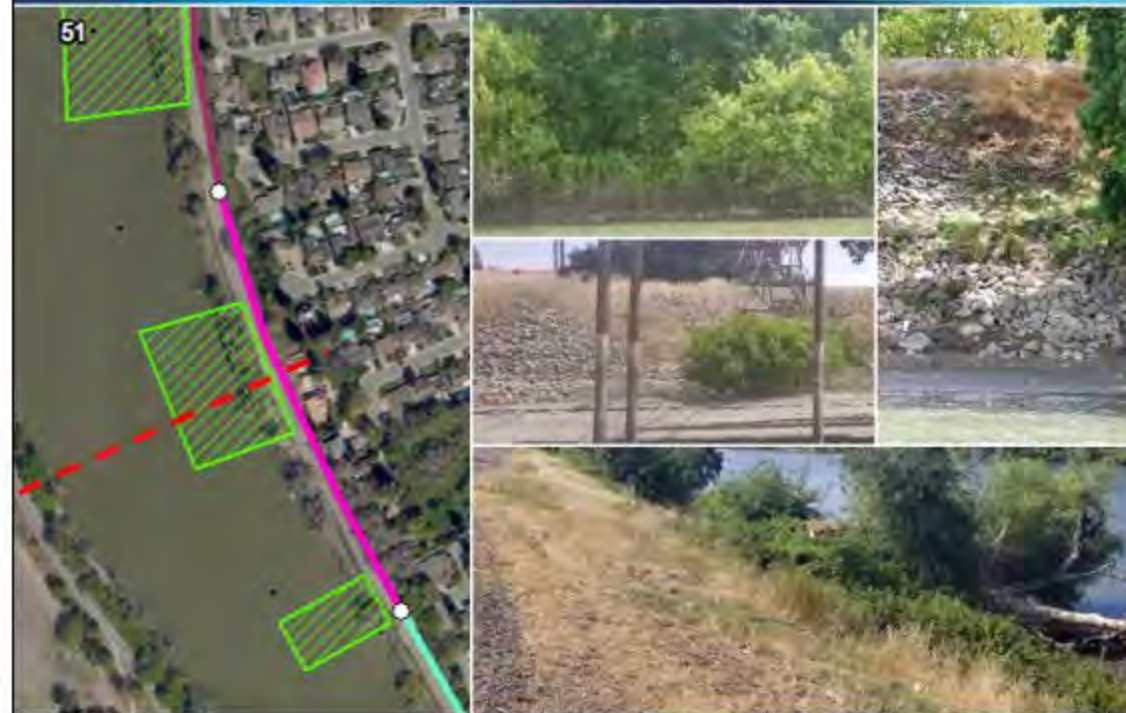
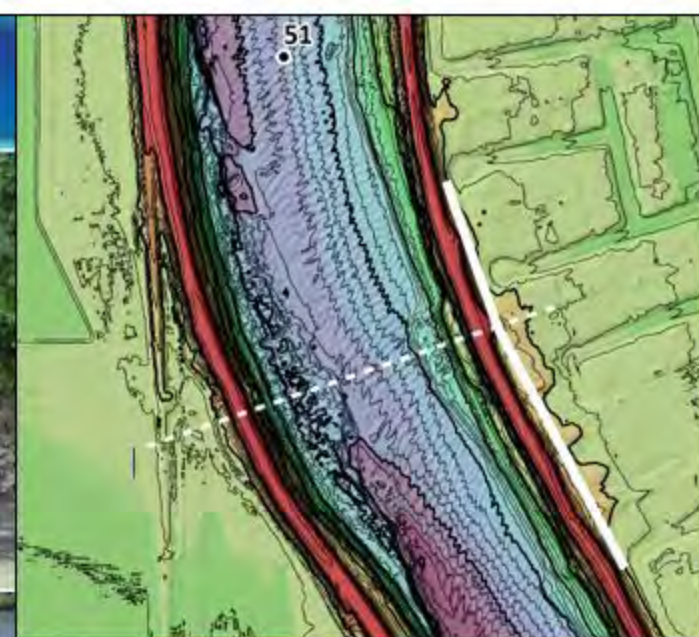
Segment 26: RM 50.66 to 50.9

Segment 26 is located within a relatively narrow and straight reach of the Sacramento River. The berm width is generally 0 feet and there are widely spaced large trees with fairly contiguous willow scrub cover. The levee and bank slopes have many 2006 era rip rap repairs and there are scattered older revetments. The process of large tree loss and spot repair is common. The bank and levee slopes are encroached within the levee prism without projected scour. There are indications of past large mass bank failures in the 2008 and 2018 bathymetric surveys.

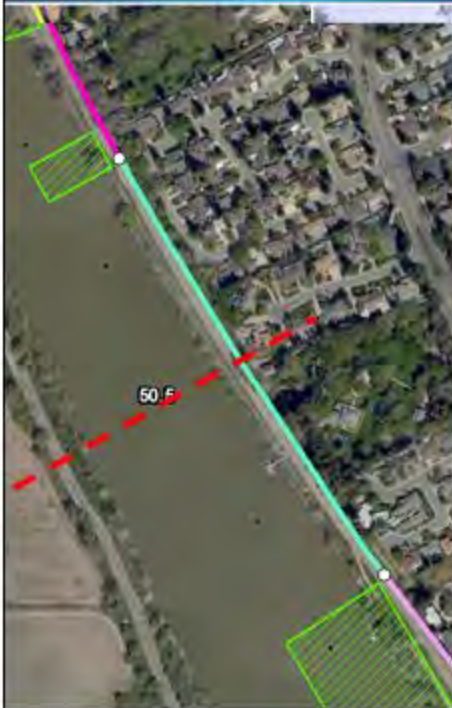
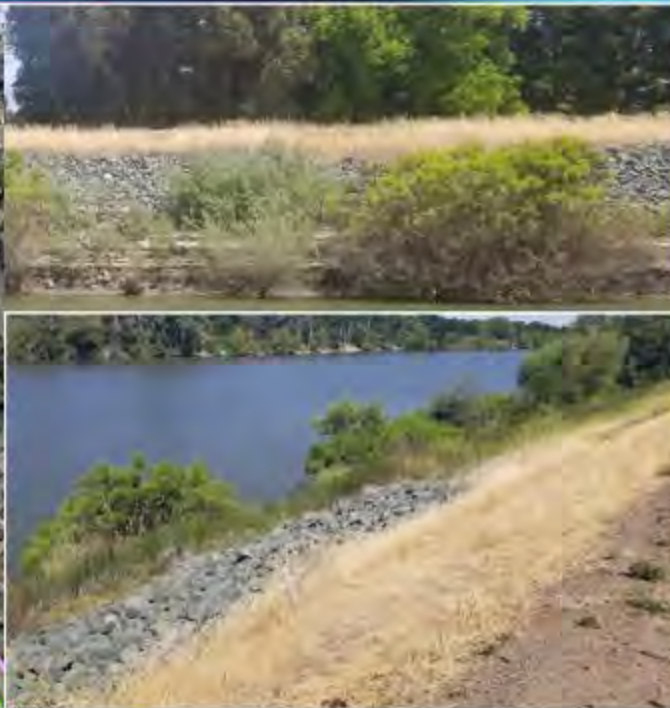
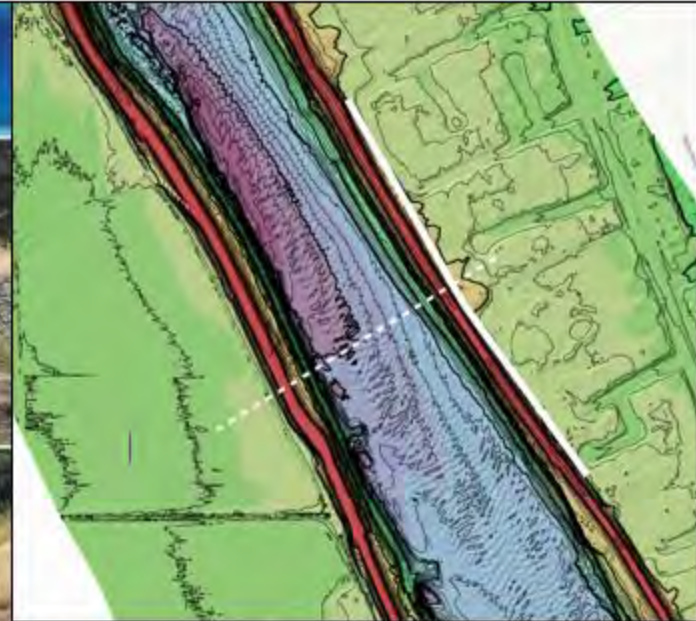
Segment 27: RM 50.32 to 50.66

Segment 27 is a continuation of Segment 26 but with nearly continuous 2006 era rip rap along the lower levee slope and toe and the upper bank. The levee/bank slope is very steep and encroached within the

levee prism. Scrub vegetation along the shoreline is fairly contiguous. The 2006 era rip rap appears to have been placed in an excess volume so as to launch when the lower bank eroded. None of this rip rap is found along the lower bank shoreline, although there are patches of older repairs in cobble, rubble and rip rap.

The overall bank erosion potential is rated high for all flows due to high slope failure susceptibility. The projected scour and lateral erosion extends farther into the levee prism.

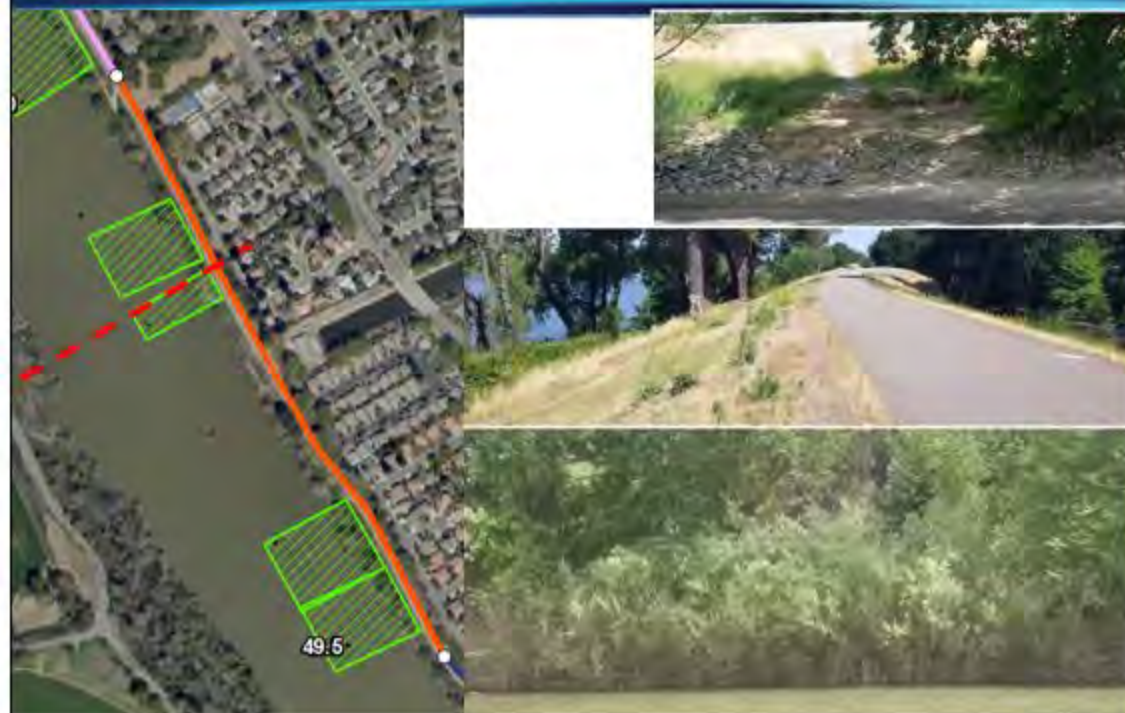
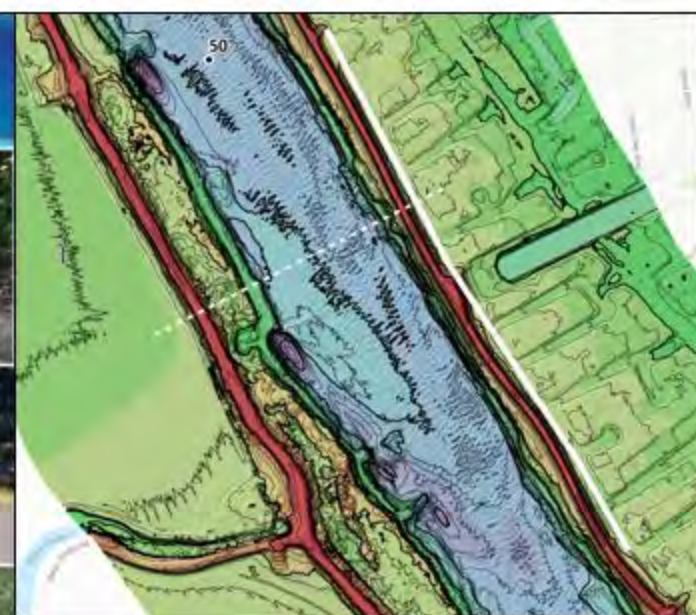
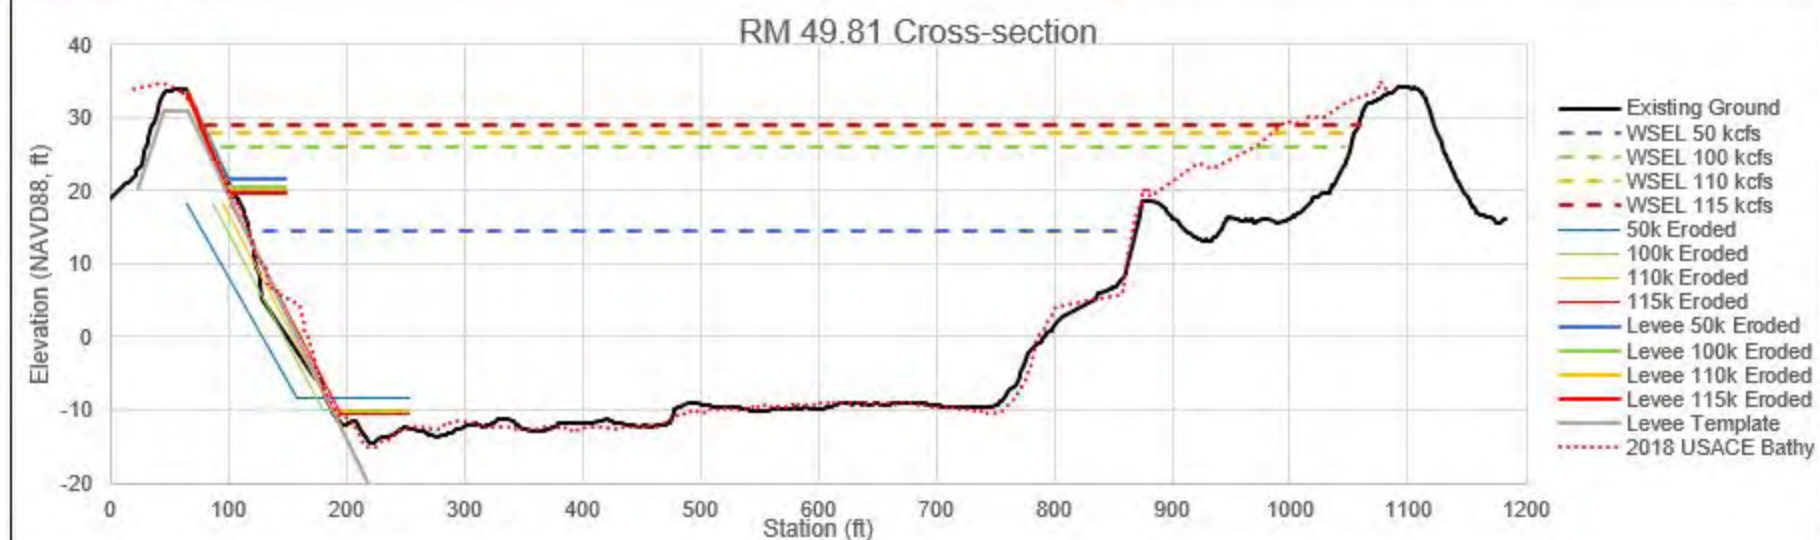
Segment 29: RM 49.45 to 49.98

Flow	50 kcfs	100 kcfs	110 kcfs	115 kcfs
Avg Vel Chnl (ft/s)	3.23	4.24	4.38	4.45
Soil Type	Overbank and Crevasse splay deposits; fine to coarse sand, silt, and clay.			
Bench Width	< 100 ft			
Existing Revetment	Old cobble and rock, Modern revetments - Sites RM 49.6L (2006), RM 49.7L (2008), and RM 49.9L (2006)			
Distinction	Bank protection ends US; Garcia Bend boat launch DS.

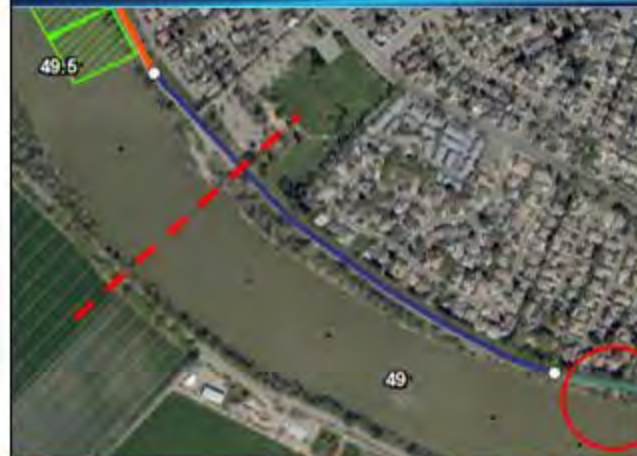
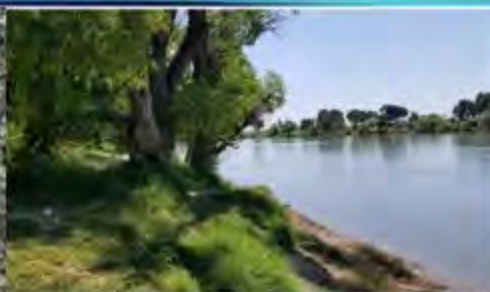
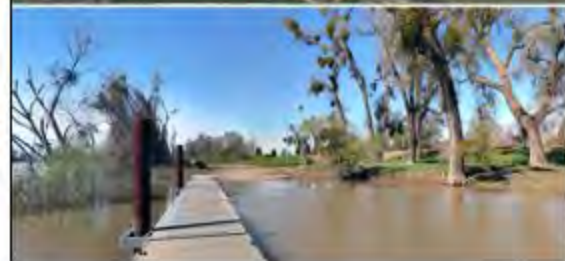
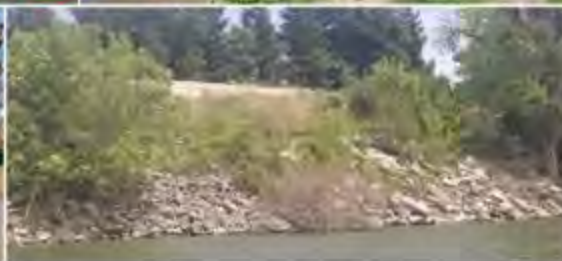
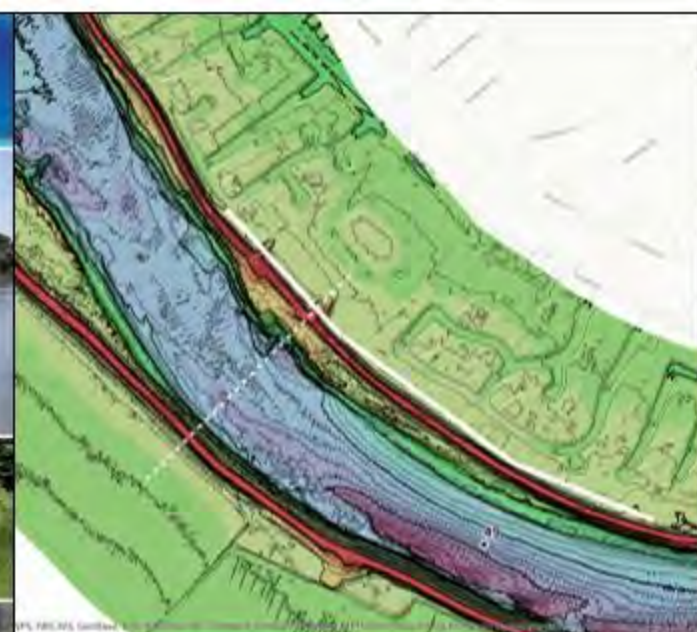
Segment 30: RM 48.85 to 49.45

Segment 30 is aligned along the inside of a broad bend and includes the Garcia Park and Boat Launch area. The berm width ranges for zero to over 50 feet in places and the levee section is relatively wide. The overall bank height is over 40 feet from levee top to toe of bank. There is significant land between the bank, levee face and the levee prism.

Bank vegetation is highly variable consisting of patches of large cottonwoods and oaks with a moderate shrub cover. There is a variety of older bank protection including rip rap, cobble and rubble. There are significant patches of 2006 era rip rap along the levee face, toe and where there is no berm on the upper bank. Large trees are found mostly along the top of bank and similar to other locations along The Pocket, single tree fall usually prompts patch repairs. Most of the large trees have undermined roots.

The overall bank erosion susceptibility is high for all flows due to slope failure susceptibility and projected scour and lateral erosion extents do not impinge into the levee prism.

Flow	50 kcfs	100 kcfs	110 kcfs	115 kcfs
Avg Vel Chnl (ft/s)	3.42	4.56	4.72	4.82
Soil Type	Channel bar and meander scoli deposits; fine gravel, sand, silt, and clay.			
Bench Width	50-100 ft			
Existing Revetment	Old cobble, concrete, rock; boat launch pavement.			
Distinction	Boat launch starts US. Change in bench width DS.

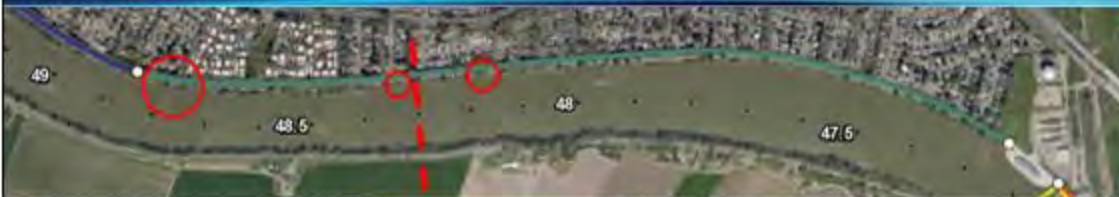
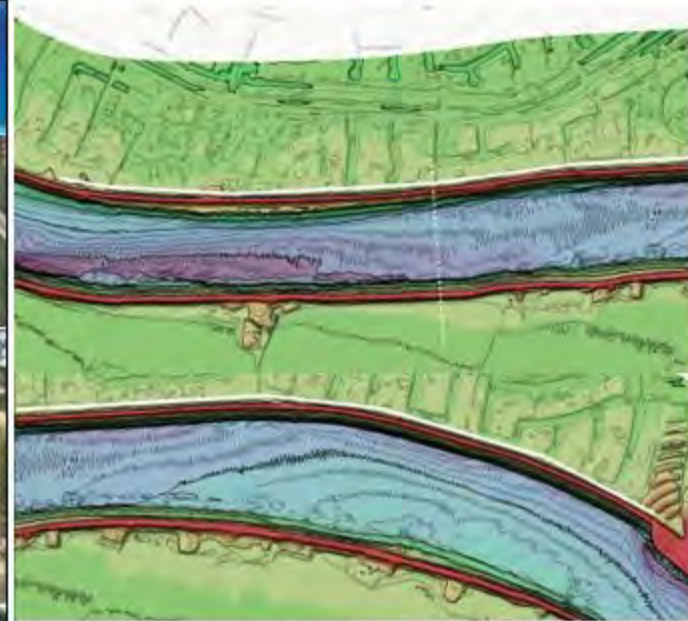
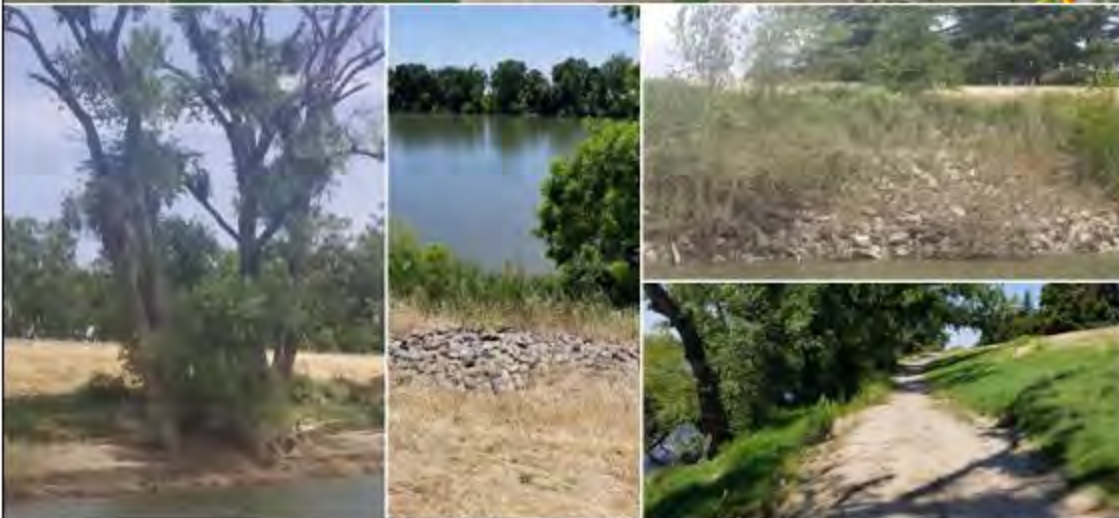
Segment 31: RM 47.25 to 48.85

Segment 31 covers the remaining frontage along The Pocket up to the Freeport Water Intake at RM 47.25. The berm width is less than 50 feet and is zero in many places. The history of this segment includes extensive rip rap installations in the 1970s when development took place and many repairs since. Over the past 20 years +/-, many large trees have been lost and the gaps are filled with rip rap. There are several critical areas where there is old or no bank protection and ongoing erosion is progressing into the narrow berm and towards the levee toe.

Flow	50 kcfs	100 kcfs	110 kcfs	115 kcfs
Avg Vel Chnl (ft/s)	3.23	4.22	4.37	4.45
Soil Type	Overbank deposits; sand, silt, and clay.			
Bench Width	< 50 ft			
Existing Revetment	Old cobble, concrete, rock.			
Distinction	Change in bench width US; Water intake structure DS.
