**BANK PROTECTION WORKING GROUP
DRAFT EROSION ASSESSMENT
SACRAMENTO RIVER EAST BANK EROSION ASSESSMENT
AMERICAN RIVER (RM 60.1) TO FREEPORT (RM 45.2)**

DRAFT REPORT

9 August 2019

NHC Ref. No. 5004539

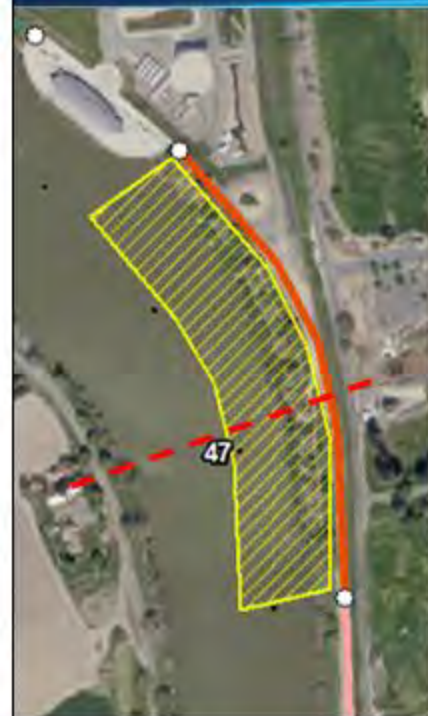
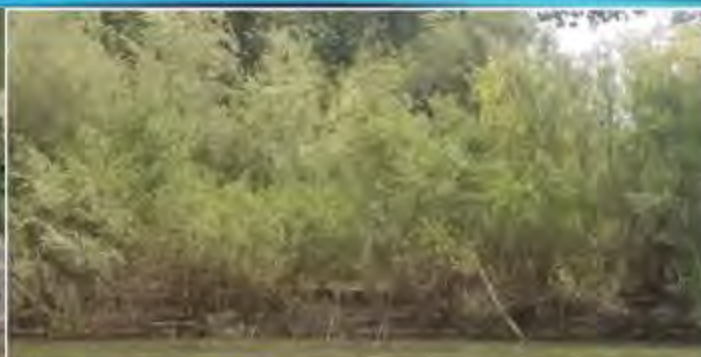
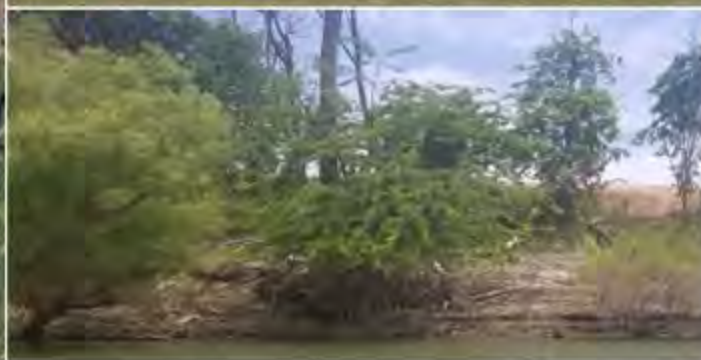
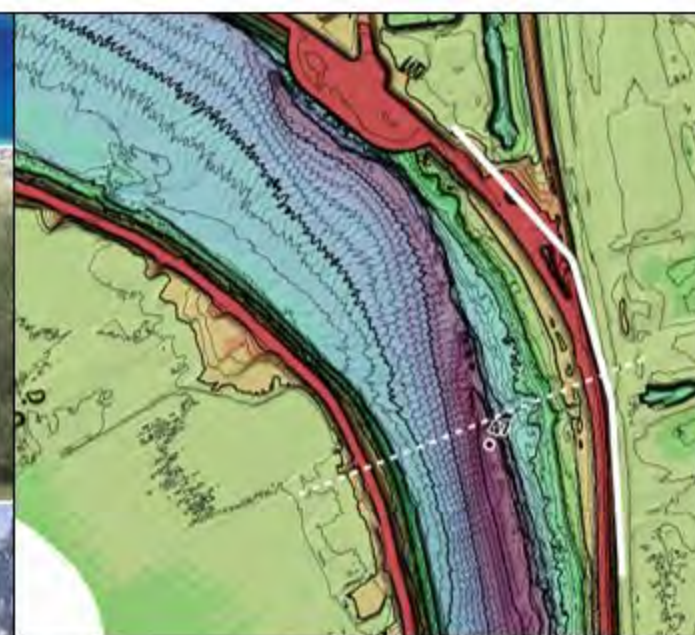
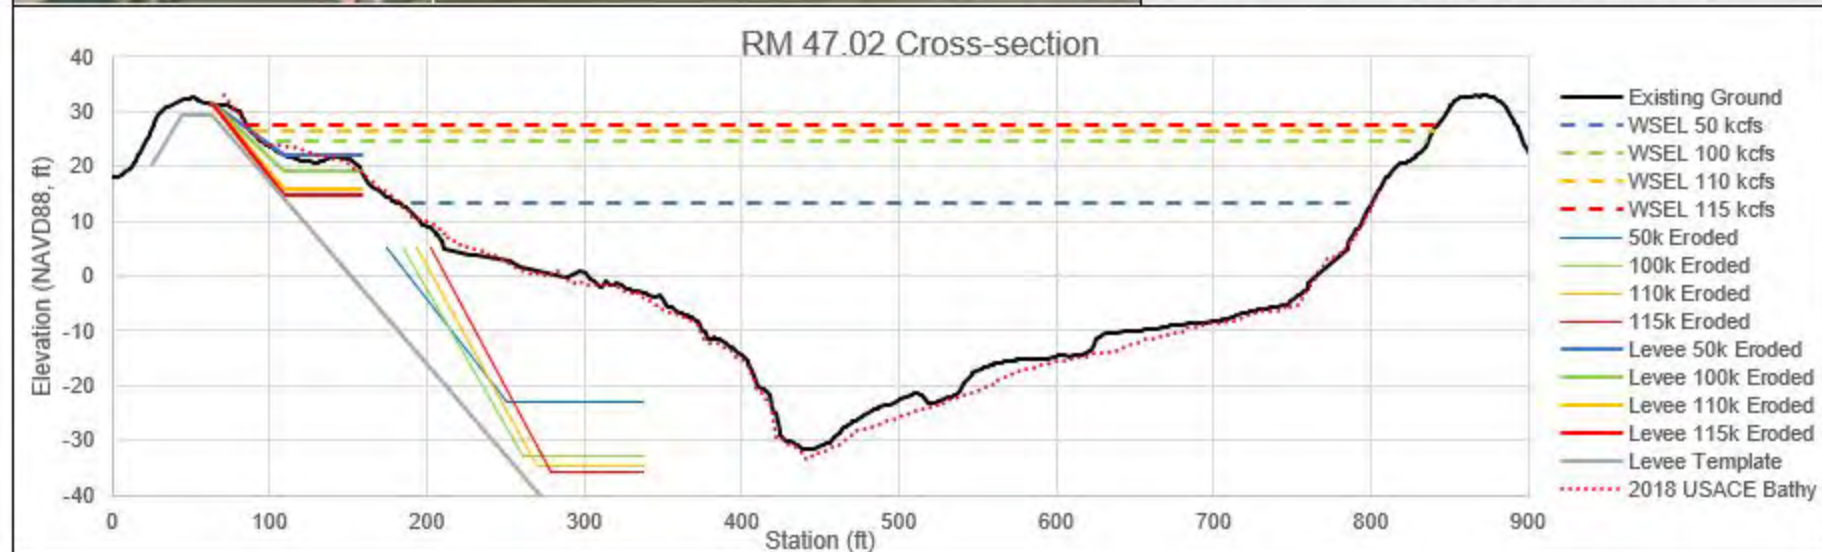
Segment 32: RM 46.9 to 47.15

Segment 32 has modern revetment that was installed in the early 2000s. The berm is relatively wide in most places with moderate coverage of large trees. The shoreline vegetation is continuous as a result of the soil trench in the modern revetment and is predominately willow scrub with small trees. The thalweg

Flow	50 kcfs	100 kcfs	110 kcfs	115 kcfs
Avg Vel Chnl (ft/s)	3.47	4.94	5.16	5.28
Soil Type	Overbank deposits; sand, silt, and clay.			
Bench Width	50-100 ft			
Existing Revetment	Modern revetment – Site RM 47.0 (2007)			
Distinction	Water intake structure US; Bank protection ends DS.

is at elevation – 30 and is situated in the middle of the channel approximately 100 feet from the toe of the revetment which ends at elevation 0 feet .

The overall bank erosion potential rating is low for all flows due to modern revetment and adequate rock volume. The projected bank scour and lateral erosion depths do not encroach into the levee prism.

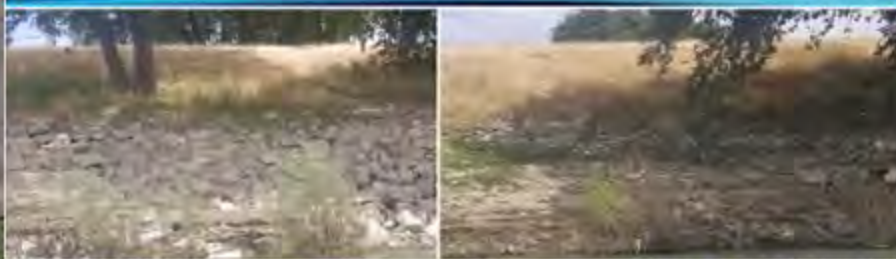
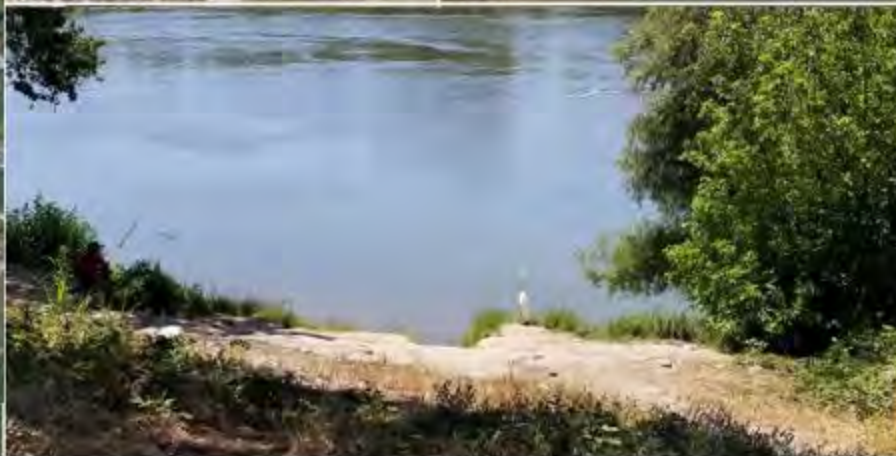
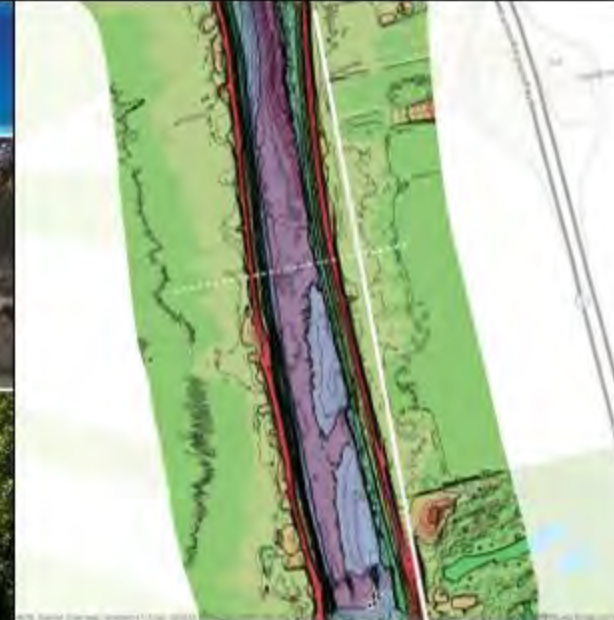
Segment 33: RM 45.2 to 46.9

Segment 33 is a long straight reach that covers the rural area of Freeport up to the downstream end of the study reach at the Morrison Creek cross levee. This downstream location was selected to assess erosion hazards that could affect the cross levee which protects floodplains to the north; any levee break upstream would allow flow into the urban area of Sacramento. Any break downstream would not significantly affect Sacramento.

The overall erosion potential for banks is rated high for all flows. Scour encroaches into the levee prism and lateral erosion extends farther. The levee rates low for overall erosion potential and projected scour and lateral erosion do not extend into the prism.

Flow	50 kcfs	100 kcfs	110 kcfs	115 kcfs
Avg Vel Chnl (ft/s)	2.75	3.95	4.13	4.22
Soil Type	Overbank deposits; sand, silt, and clay.			
Bench Width	< 50 ft			
Existing Revetment	Old cobble, rock, bare banks.			
Distinction	Bank protection ends US; End of reach DS.
