2015 ANNUAL EROSION INVENTORY ENGINEERING REPORT

SACRAMENTO RIVER BANK PROTECTION PROJECT SACRAMENTO RIVER AND TRIBUTARIES

**U.S. Army Corps
of Engineers**
Sacramento District

JULY 2015

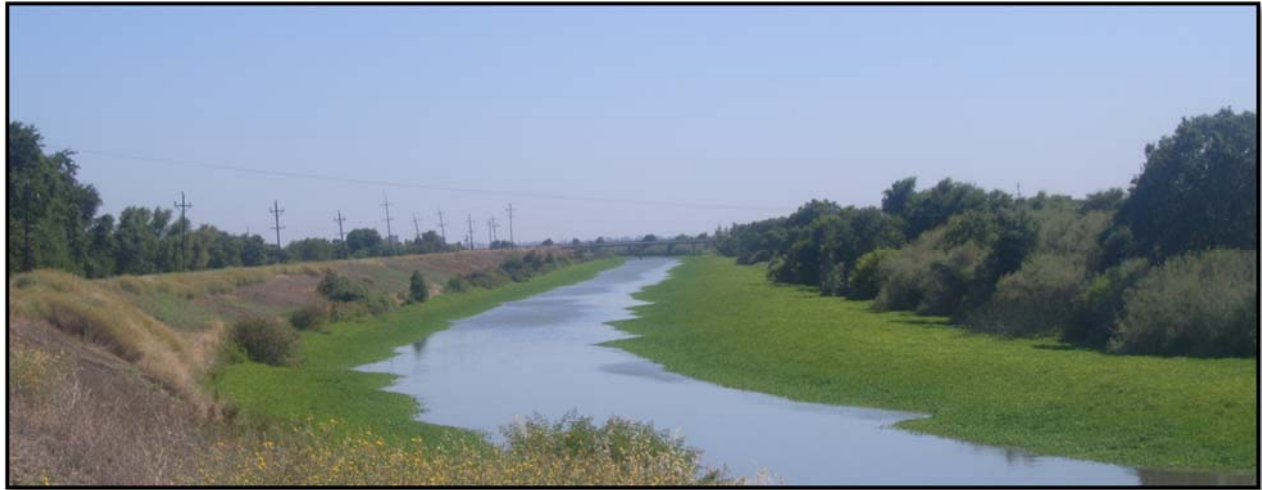
Knights Landing Ridge Cut – The Knights Landing Ridge Cut runs from the Colusa Basin Drainage Canal to the Yolo Bypass. The levees are in poor condition with steep slopes and slumping of the toe throughout most of the system. There are cracks along the middle of the left levee crest that may indicate potential mass movement and further slumping. **Figure 24** shows a typical view of the Knights Landing Ridge Cut. There are seven (7) erosion sites in this reach.

Figure 24. Typical View of the Knights Landing Ridge Cut.
