2017 ANNUAL EROSION RECONNAISSANCE FIELD REPORT

Sacramento River Bank Protection Project

SACRAMENTO RIVER AND TRIBUTARIES

September 2018

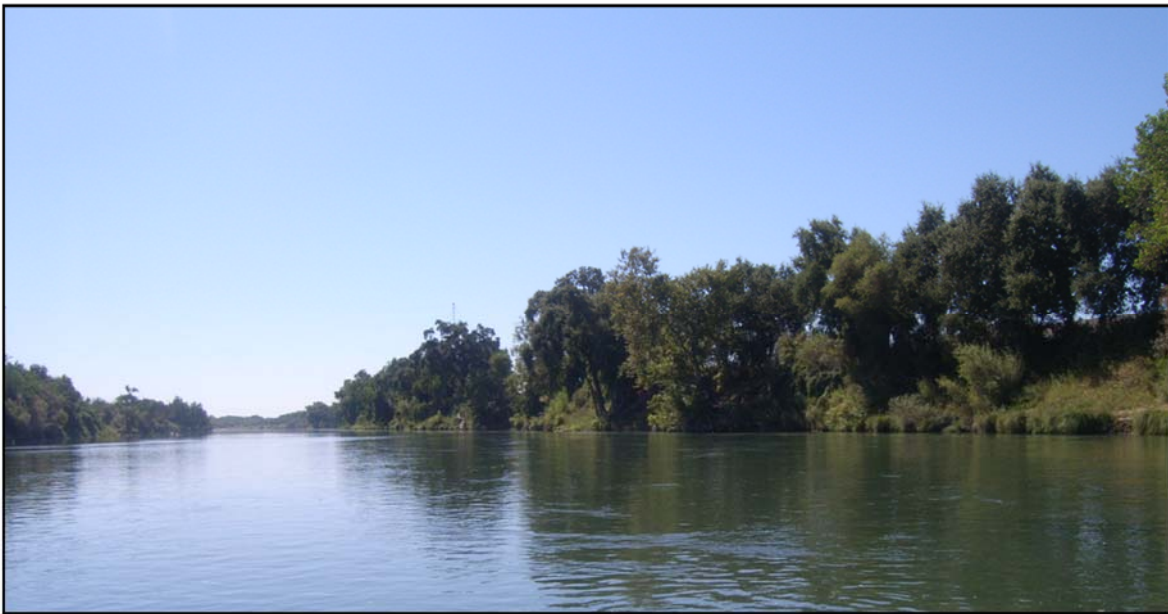
Figure 4. Typical View of the Upper Reach of the Sacramento River.

Upper Reach of the Sacramento River – Ord Bend to Colusa (RM 185 to 144) – The upper reach of the Sacramento River is unique because the levees are setback and the channel meanders and erodes more naturally than in other reaches. A typical picture of the Upper Sacramento River is shown in **Figure 4**. In general, the river has become somewhat sediment starved due to reservoirs reducing the bedload from upstream. The river is highly erosive and erosion of the outer banks of the meandering bends and the development of sandbars are evident throughout the reach. The natural erosion of the banks is considered good for a healthy river system and environmental factors. However, when the erosion creeps into the projection of the levee slope, it can threaten the integrity of the SRFCS. The 2017 storms cause minor impacts throughout this reach, with the exception of the site at RM 172, which had significant erosion. There are currently 6 erosion sites in this reach, one of which was upgraded to critical. Two (2) sites were removed from the inventory.

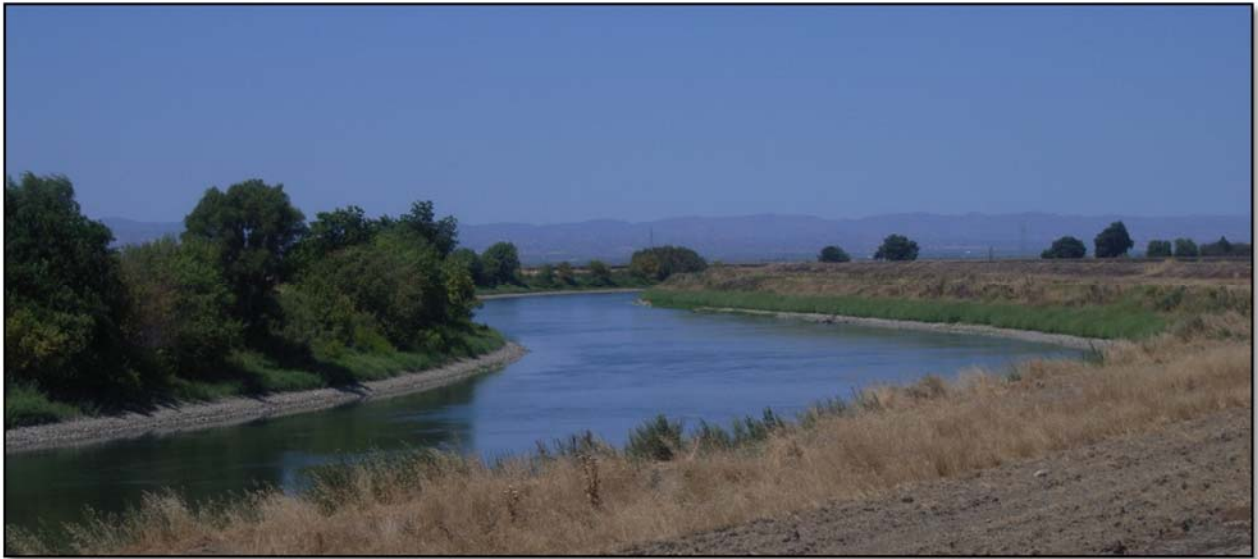
Figure 5. Typical View of the Middle Reach of the Sacramento River.

Middle Reach of the Sacramento River – Colusa to Sacramento (RM 144 to RM 61) – The middle reach of the Sacramento River has the levees close to the river and multiple diversion structures to move flow into the bypass system. This reach was intentionally designed with the levees close to the banks to keep velocities higher to help transport some of the bedload and debris that remained from the days of hydraulic mining. An additional aspect for the close levees was that the USACE was responsible for keeping the river navigable up to the city of Colusa. As a result of this design, much of the reach is protected with rock, especially the outsides of bends. The majority of the rock in this reach is cobbles placed prior to the 1960's. Some areas have more recent quarry stone. The cobble sites are reaching the end of their design life and are starting to fail. Roughly one-third of the erosion sites in this reach are from failed cobble. **Figure 5** shows a typical view of the Middle Sacramento River. There are currently 33 erosion sites in this reach, of which two (2) are new and one (1) is under construction. Six (6) sites in this reach were either removed or repaired.

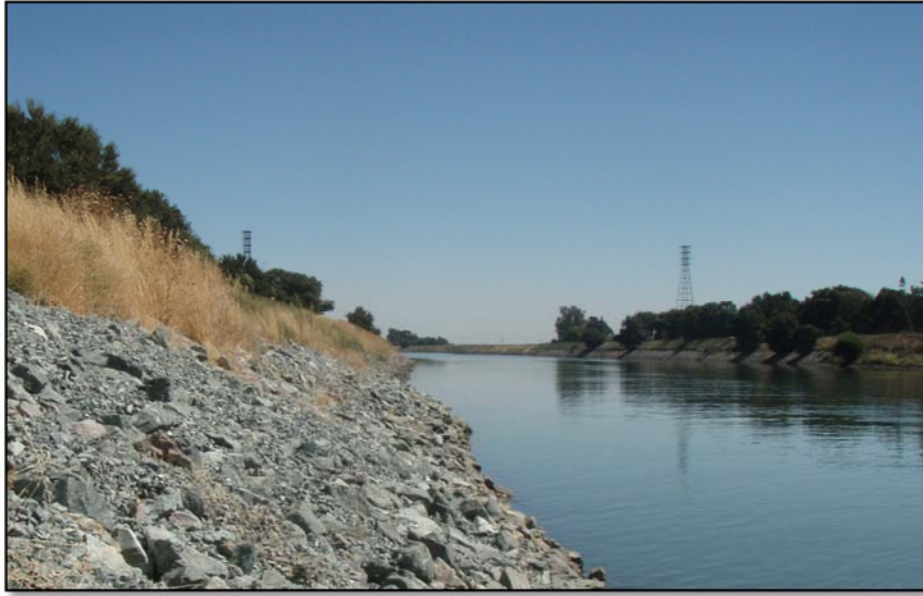
Figure 6. Typical View of the Sacramento River – Delta Section.

Sacramento River – Delta Section (RM 61 to RM 15) – The delta reach of the Sacramento River has levees close to the banks and is tidally influenced. The location of the channel has been relatively stable for the past 150 years. A large percentage of this reach is already protected by quarry stone. This area has heavy action from recreational boating, wind wave run-up, and the banks are heavily used by the public. Many of the levees are constructed of deposited dredge tailings from the bottom of the river. **Figure 6** shows a typical view of the Delta section of the Sacramento River. The causes of erosion in this reach are boat wake, wind wave, mass slope failure, fluvial processes, and human usage. The 2017 storm events had a significant impact on erosion in this reach of the river with 6 sites being upgraded to critical. There are currently 29 erosion sites in this reach, of which three (3) are new, and six (6) are critical. Eight (8) sites in this reach have been removed or repaired.

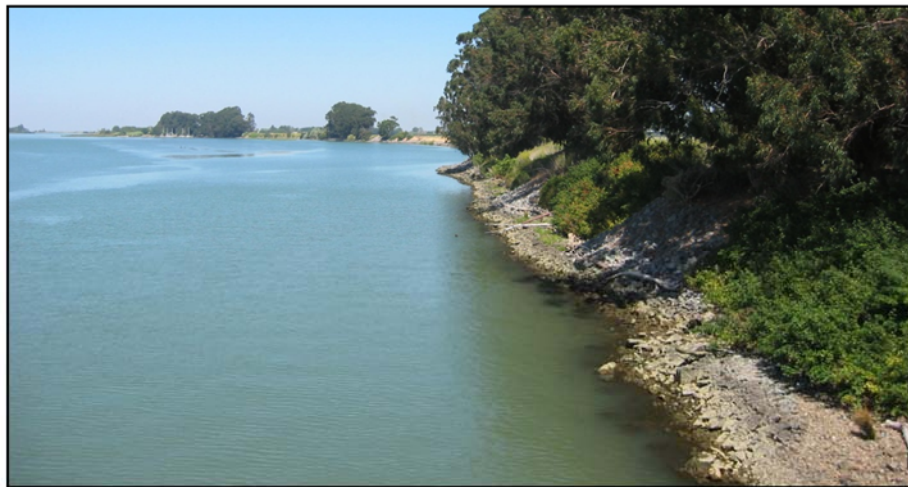
Figure 7. Typical View of the Lower Reach of the Sacramento River.

Lower Reach of the Sacramento River (RM 15 to RM 3) – The lower reach of the Sacramento River is very wide and the water surface is controlled by the tides. Only the left bank is leveed in this reach; the right bank is considered high ground. There is a narrow highway with no shoulder on top of the levee for half of the reach. Ocean-going cargo ships travel through this reach creating large wakes. The area is also subject to high winds and wind waves. Wind waves and boat wakes are the main cause of erosion in this reach. Bank stability is also an issue; the slopes of the levees are steep and constructed of poor (non-cohesive) soils; however the toe often contains some clay. The 2017 storm event caused increased erosion throughout this reach with one site upgraded to critical, one site added, and increased erosion at the current sites. **Figure 7** shows a typical view of the lower section of the Sacramento River. There are currently nine (9) erosion sites in this reach, of which six (6) are critical, and one (1) is new.

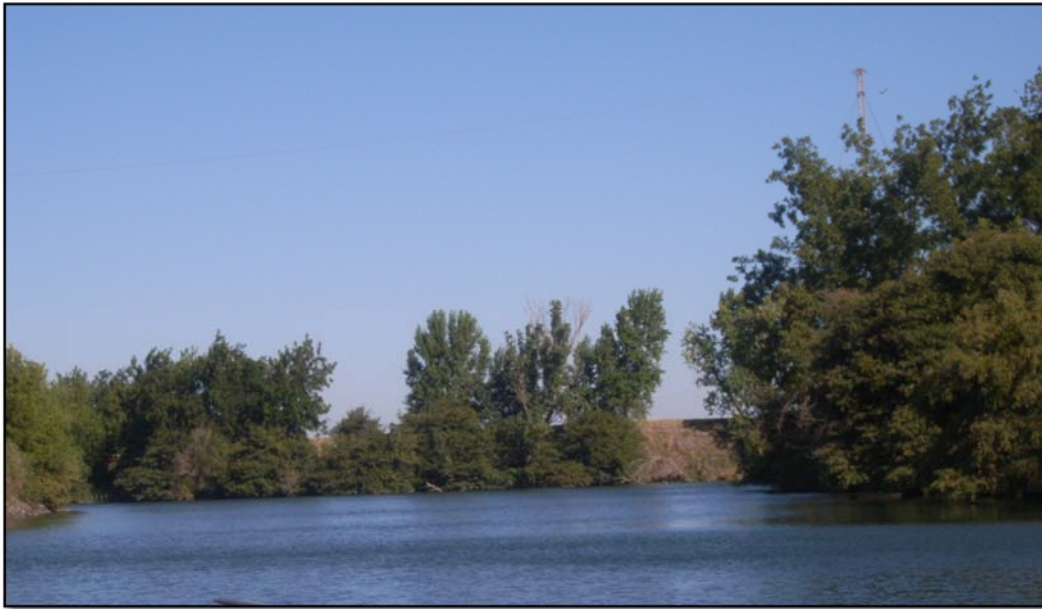
Figure 8. View of the confluence of Miner and Sutter Sloughs.

Steamboat Slough, Miner Slough, Sutter Slough, and Cache Slough – These distributary channels in the Sacramento Delta are predominately backwater channels with low velocities that are controlled by the tides. The erosion mechanism in these sloughs comes from wind wave, boat wake, tidal influences, slumping, human use, and tree pop-outs. The 2017 storm events had minimal impacts on Steamboat, Sutter, and Miner Sloughs, and a more significant impact on Cache Slough, where increased erosion connected 4 sites into one long site. **Figure 8** shows the confluence of Sutter and Miner Sloughs. Steamboat currently has twelve (12) erosion sites, of which four (4) are critical, and two (2) are new. Miner Slough currently does not have any erosion sites and has had no identified erosion sites since the beginning of the inventory. Sutter Slough currently has seven (7) erosion sites, of which one is critical. A portion of Cache Slough is used by cargo ships to enter the Deep Water Ship Channel and therefore is subject to larger boat wakes. Cache Slough currently has three (3) erosion sites, of which one is critical. On Steamboat Slough, two (2) sites were removed, on Sutter Slough two (2) sites were removed, and on Cache Slough, one (1) site was removed.

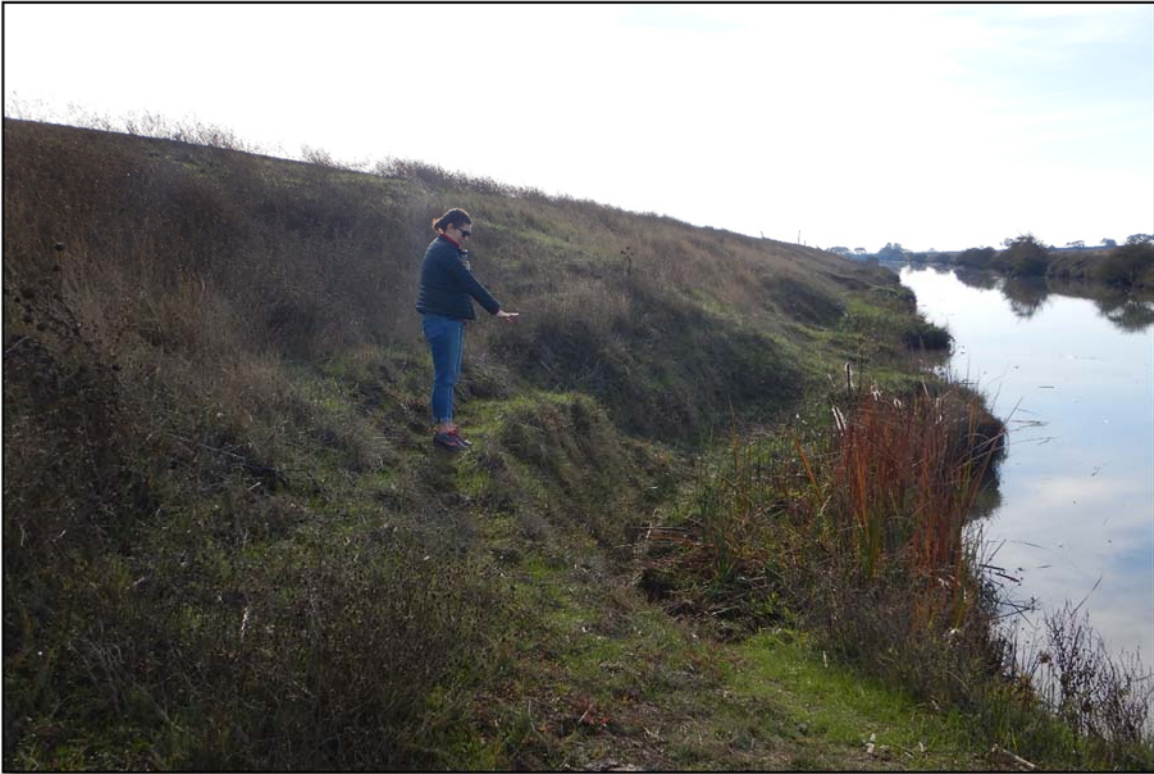
Figure 9. Typical View of Haas Slough.

Lindsey Slough, Haas Slough, Shag Slough, and Ulatis Creek Bypass – These channels are in the western Delta side of the SRFCS and they all conclude at Cache Slough. Lindsey Slough is a wide shallow channel with the levees set close to the banks. Haas Slough, Shag Slough, and Ulatis Creek Bypass are small channels that primarily carry agricultural runoff. The velocities in these channels are low and tidally influenced. The erosion mechanism in these channels comes from wind wave, tidal influences, and tree pop-outs. Haas Slough also has issues with the banks being trampled by cattle. The 2017 storms had a large impact to Lindsey and Haas Slough with new erosion (720 ft on Lindsey and 1,514 ft on Haas), new slump failures, and sites upgraded to critical. **Figures 9 and 10** show a typical view of Haas Slough and

Lindsey Slough, respectfully. Lindsey Slough has four (4) erosion sites, of which one is critical and one is new. Haas Slough has three (3) erosion sites, of which one is critical and one is new. There are no erosion sites on Shag Slough and Ulatis Creek Bypass.

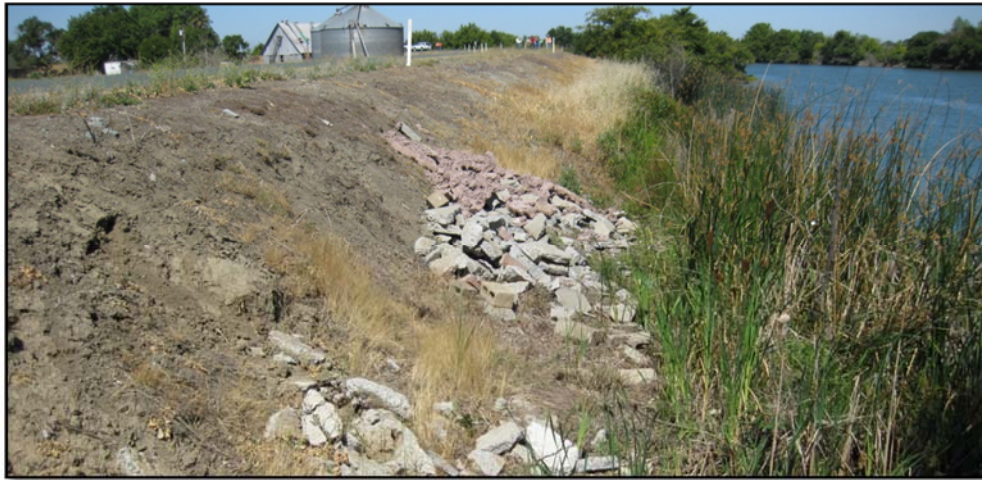
Figure 11. Typical View of Georgiana Slough.

Georgiana Slough – Georgiana Slough is unique in that it flows from the Sacramento River System into the San Joaquin River System. The upstream most two miles are regulated as a no wake zone. Georgiana Slough is completely influenced by the tides and subject to severe winds. The majority of the levee and bank slopes are steep with no berm. The banks are composed of poor soils, which do not meet current design standards. The left bank is in worse shape and contains 75% of the sites. Biotechnical repairs in the form of brush boxes have been used to try and protect the banks from wind waves and boat wakes; however, the majority of them have had limited to no success. The primary erosion factors are from wind wave, boat wake, tidal influence, and poor soils. Many of the sites along the left bank have started to merge together and soon the entire bank may be considered an erosion site. **Figure 11** shows a typical view of a Georgiana Slough levee. It is important to note that the local LMA (RD 563) has been working hard to repair the worst erosion pockets, however the levees were hit hard by the 2017 event. The 2017 storm event caused major impacts to the Georgiana Slough levees with significant erosion, slumping, and tree pop-outs. An additional 19,297 ft of erosion was added to the inventory, almost doubling the amount of erosion from the previous year. There are currently twenty-four (24) erosion sites, of which four (4) are critical and nine (9) are new. This reach may benefit from a reach-wide repair.

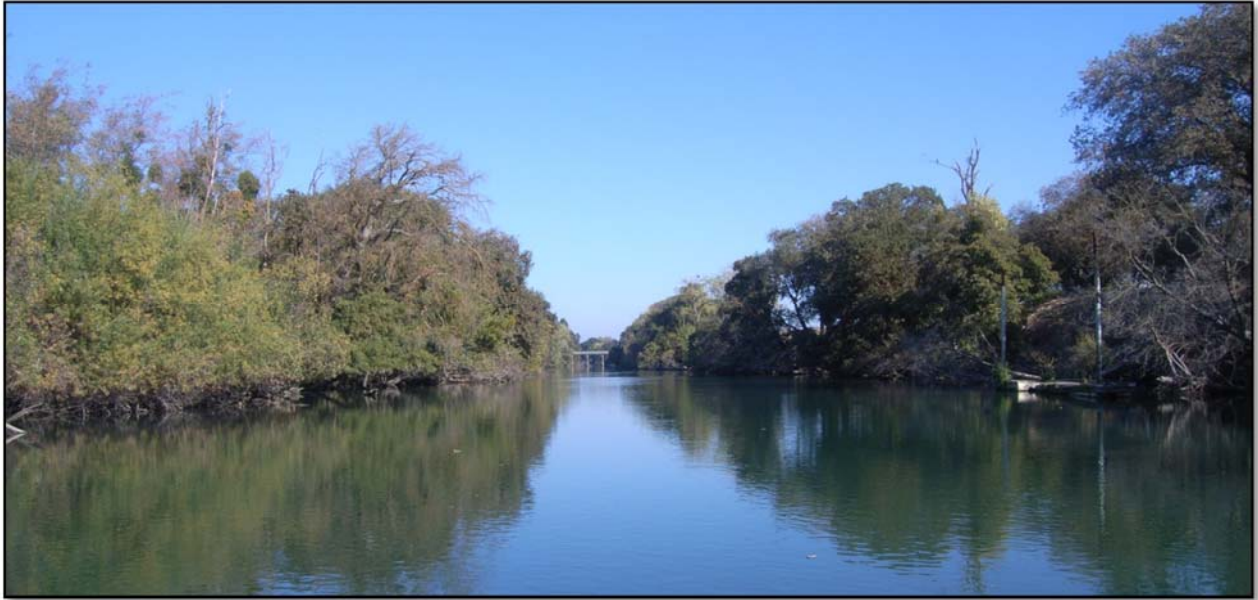
Figure 12. Typical View of Elk Slough.

Elk Slough – Elk Slough was cut off from the Sacramento River on the upstream end by the Sacramento River levee and therefore has no inflow, it is purely a backwater channel with some tidal influence. The channel is shallow, and the banks are full of vegetation and heavily used by humans. The levee slopes are over-steepened and built out of non-cohesive dredge material. The entire levee reach is in poor condition, with slumping, holes, and slope stability problems. **Figure 12** shows a typical view of Elk Slough. With the levees being in such poor shape the entire leveed reach (right bank and left bank) is classified as an erosion site. This reach would benefit from a reach wide repair.

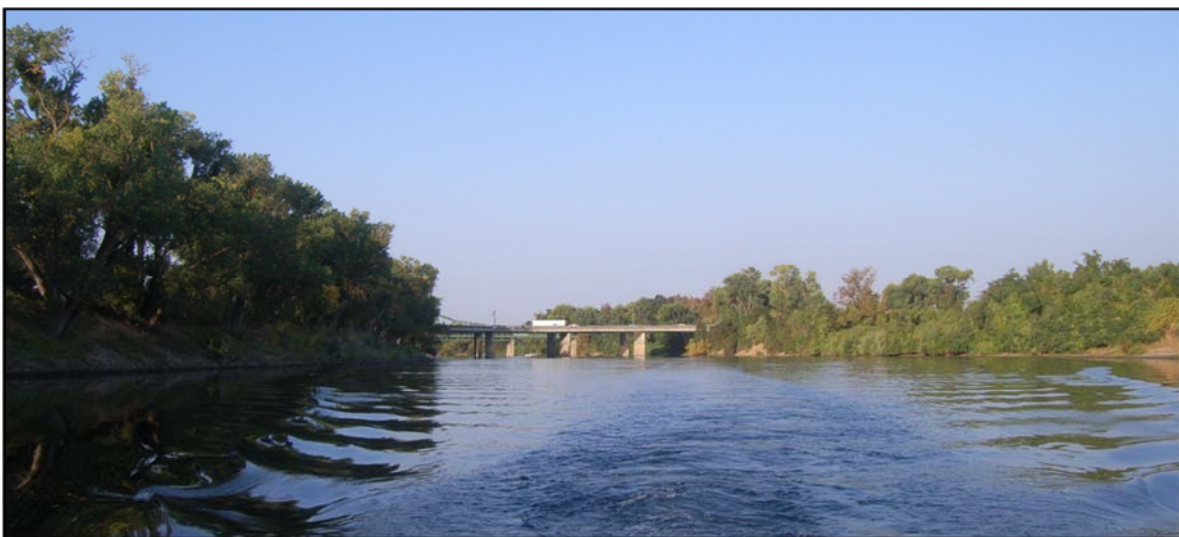
Figure 13. Typical View of the American River.

American River – The American River is fed by Folsom Dam and is therefore generally sediment starved and has been eroding and transporting the fine materials from the channel bed. Once the fines have been removed and the bed armors, the channel is expected to move laterally and erode the banks. The right bank is setback from the channel for the lower 5 miles. Boat wake is not a concern as there is a no wake zone for the entire river. The main causes of erosion are fluvial, tree pop-outs, and public use. This river is generally well maintained and has had many bank repairs in the recent years. The American River levees performed fairly well with the 2017 storm events, with only minimal new erosion. **Figure 13** shows a typical view of the American River. There is currently one erosion site on the American River.

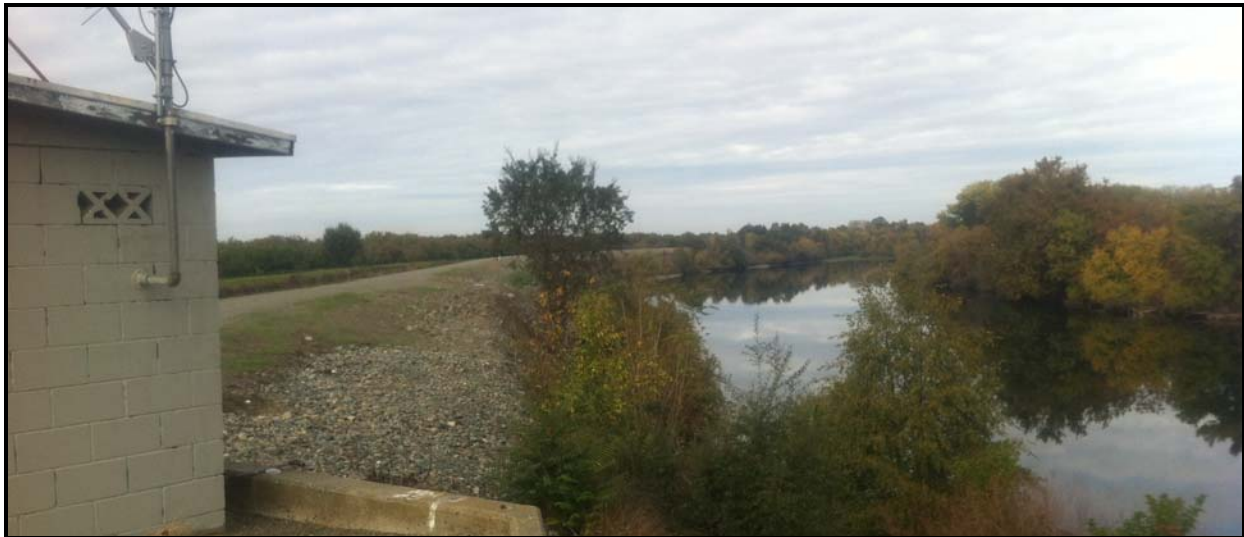
Figure 14. Typical View of the Northern Reach of the Feather River.

Feather River, Northern Reach (RM 62 - 46) – The northern portion of the Feather River has a levee only on the right bank. The channel is meandering and the upstream overbanks still show the impacts of past hydraulic mining, with large gravel and dirt mounds visible throughout. The levees are heavily vegetated and there are places where structures (e.g. houses, canals) have been built into the landside of the levee. **Figure 14** shows a typical view of the northern reach of the Feather River. There is one (1) erosion sites in this reach of the Feather River. One site (FHR 50.9 R) was repaired by DWR.

Upper Reach of Feather River, North of Yuba River (RM 46 to RM 28) - The Feather River upstream of the Yuba River is a meandering river with setback levees on both sides. The channel gets close to the levees at a few of the meandering bends, which have been armored from past repairs. The river appears to have pushed the majority of the sediment leftover from hydraulic mining through this reach and with the construction of Oroville Dam, it has started to become sediment starved. Some active erosion was observed, but it was not close to the levees. There are currently no erosion sites in this reach. Although there are no erosion sites in this reach, the area was hit hard by the 2017 Flood event and rapid drawdown conditions. Significant erosion did occur throughout this reach however, the erosion either does not threaten the levee prism or repairs have already taken place.

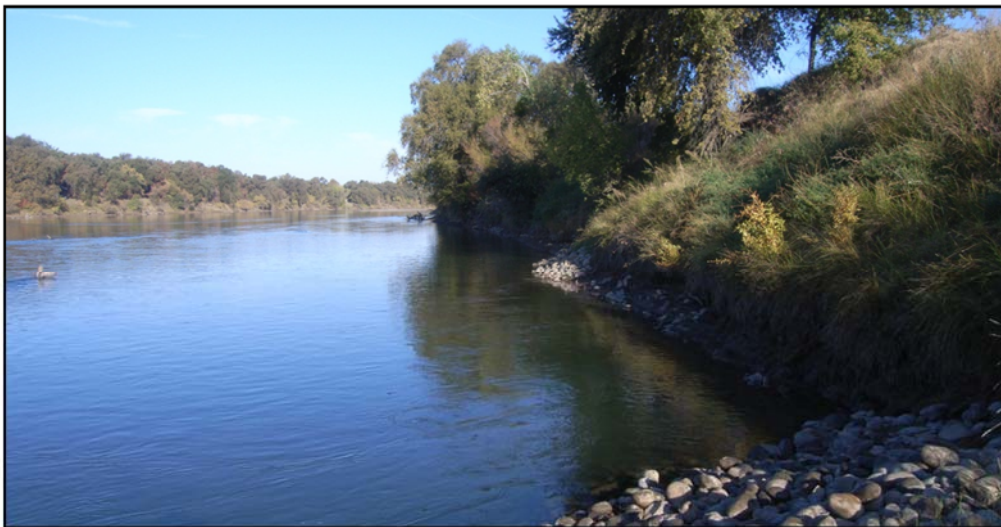
Figure 16. Typical View of lower Feather River.

Lower Feather River (RM7 to RM 0) – The lower reach of the Feather River has a tight levee on the left bank and the Sutter Bypass on the right bank. The river is shallow and wide, with large sandbars throughout the channel. The primary causes of failure in this reach are fluvial and mass failure of eroded banks. **Figure 16** shows a typical view of the lower Feather River. There are currently seven (7) erosion sites in this reach of the river, of which two (2) were upgraded to critical from the damages sustained from the 2017 storm events.

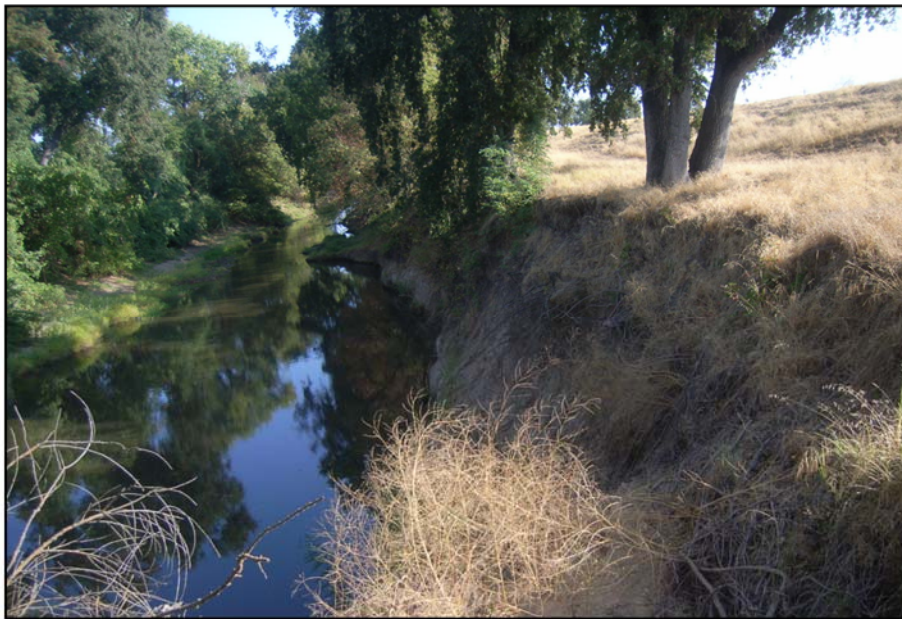
Figure 17. Typical View of Bear River.

Bear River – The Bear River is an incised channel due to the loss of sediments from the Camp Far West Dam and historic sand and gravel mining. The levees are setback a short distance from the slightly meandering channel. **Figure 17** shows a typical view of the Bear River. A setback levee was recently constructed for the first two miles on the right bank. There are currently four (4) erosion sites on this river. One erosion site (BER 0.8 L) was repaired by the local RD after it incurred significant new erosion from the 2017 storm event.

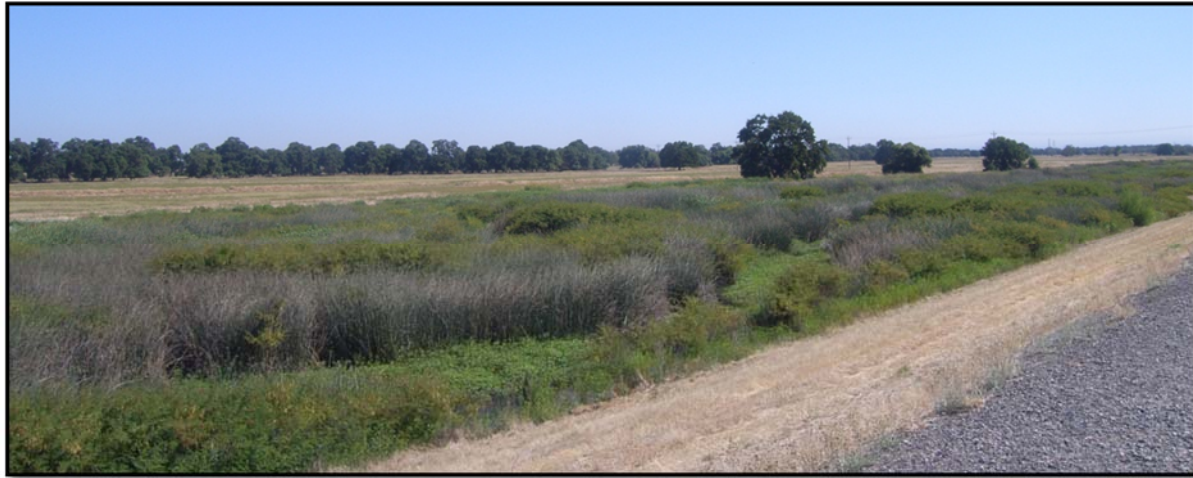
Figure 18. Typical View of Dry (Linda) Creek.

Natomas East Main Drainage Canal, Arcade Creek, and Dry Creek – Arcade Creek and Dry Creek (formerly known as Linda Creek, and now more commonly referred to as South Dry Creek) drain water from the Rio Linda, Roseville, Antelope, Citrus Heights, and Carmichael areas. Arcade Creek has the levees relatively close to the channel, however the small floodplain maintains a healthy riparian habitat. Dry Creek has a large floodplain but relatively little riparian habitat, as the floodplains appear to be used for cattle grazing. **Figure 18** shows a typical view of Dry Creek. The Natomas East Main Drainage Canal (NEMDC) directs the flow from Arcade and Dry creeks and sends it south to the American River. NEMDC is a man-made channel that runs north-south and protects the east side of Natomas. There are currently no erosion sites in this section of the system.

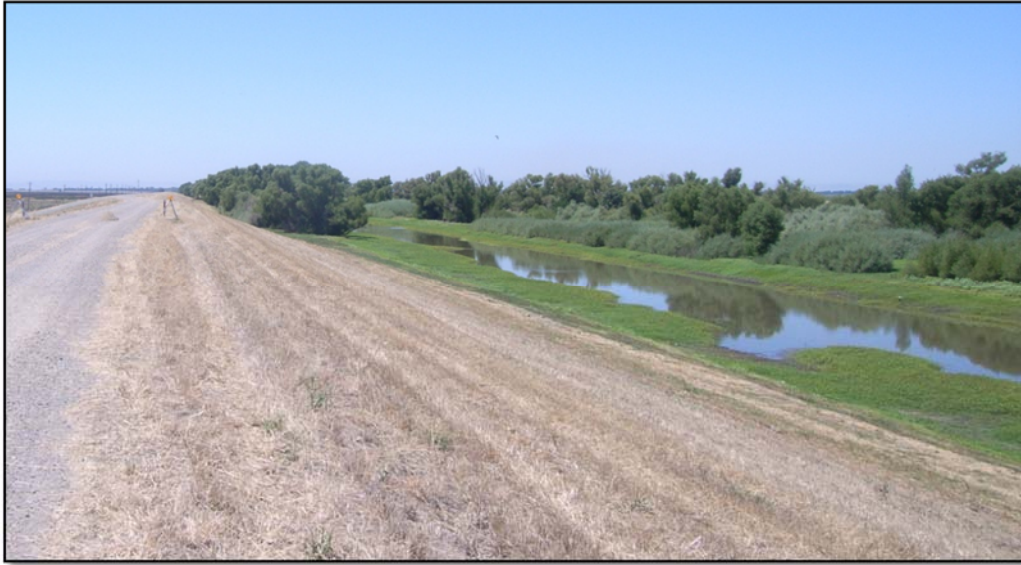
Figure 19. Typical View of the Natomas Cross Canal.

Natomas Cross Canal, Pleasant Grove Canal, and Coon Creek Interceptor – Pleasant Grove Canal and Coon Creek Interceptor collect water from the east foothills and communities of Lincoln and Pleasant Grove. These flows are then directed into the Natomas Cross Canal which moves the water down to the Sacramento River. Pleasant Grove Canal and Coon Creek only have levees on the east side. The levees are steep with some grass and shrub vegetation. The Natomas Cross Canal is man-made and the levee on the south side was recently rebuilt. The south levee is mowed and grazed by sheep in the summer while the north levee is tall grasses with shrubs/trees on the lower bank. **Figure 19** shows a typical view of the Natomas Cross Canal. There are three (3) erosion sites on the Natomas Cross Canal, of which two (2) are new.

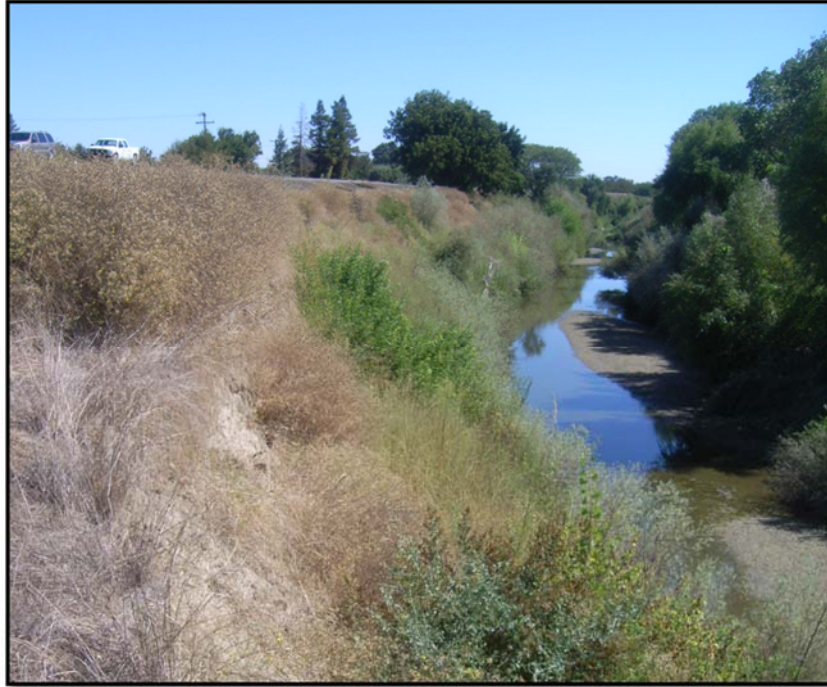
Figure 20. Typical View of Cache Creek.

Cache Creek – The Cache Creek levees start near the town of Yolo and terminate at the Yolo Bypass. Cache Creek is a deeply incised channel with near vertical banks (over 20 ft in height) for the entire leveed reach. The channel is sediment starved from excessive in-stream gravel mining. Some sand and gravel are present in the channel bed, indicating that the channel may be starting to recover and become more stable. **Figure 20** shows a typical view of Cache Creek. The erosional mechanisms in this reach are toe erosion, fluvial and mass failure. The natural banks are too steep and the channel is too narrow for a traditional bank protection repair; setback levees have been the selected option for repair. This creek may benefit from a reach-wide repair. There are currently three (3) erosion sites on Cache Creek, one (1) is considered critical. DWR repaired two (2) of these erosion sites with setback levees in 2016.

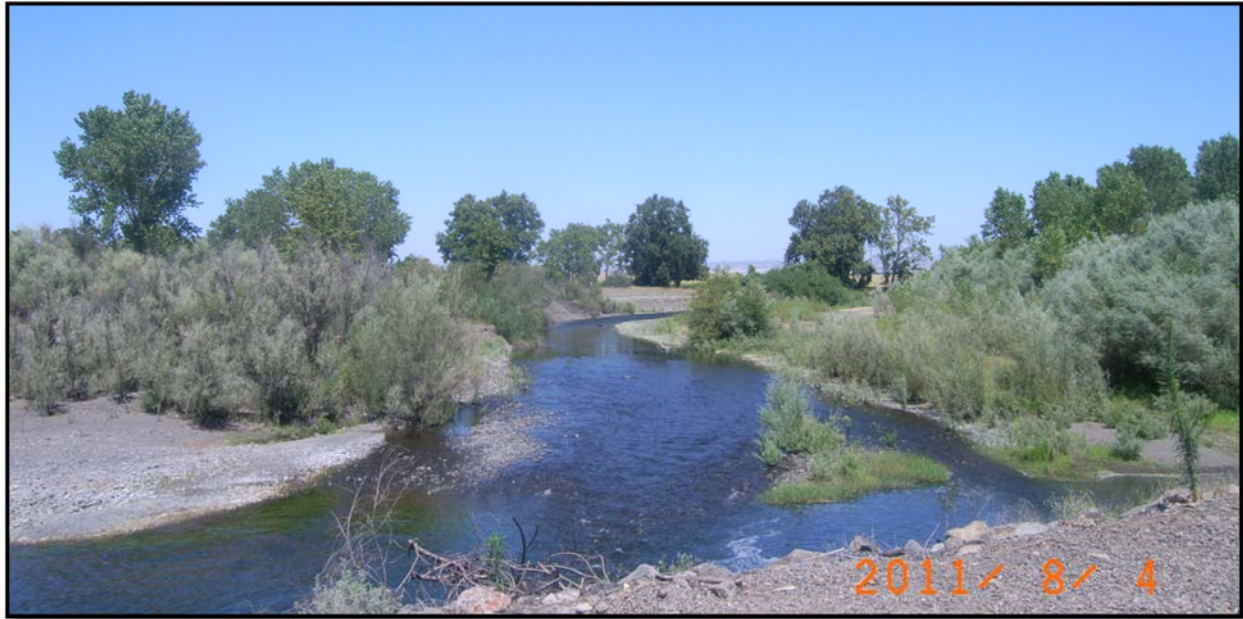
Figure 22. Typical View of Deer Creek.

Deer Creek – Deer Creek is located in the upper Sacramento Valley, it drains water from Lassen Mountain/Cascade Range and ends at the Sacramento River near RM 220. Only portions of the lower end are leveed and in most of the places where the creek is close to the levee, it is already rocked. Deer Creek is a natural stream with a boulder/cobble bottom and a riparian habitat. **Figure 22** shows a typical view of Deer Creek. The primary mechanisms of erosion are fluvial, whole bank failure, and tree pop-outs. There is currently one (1) erosion sites on this creek. One site (DEC 2.4 L) was removed from the inventory due to cobble deposition in the eroded area and the levee is no longer threatened. The Deer Creek Watershed Conservancy is planning a reach wide repair and restoration to the lower portion of Deer Creek.

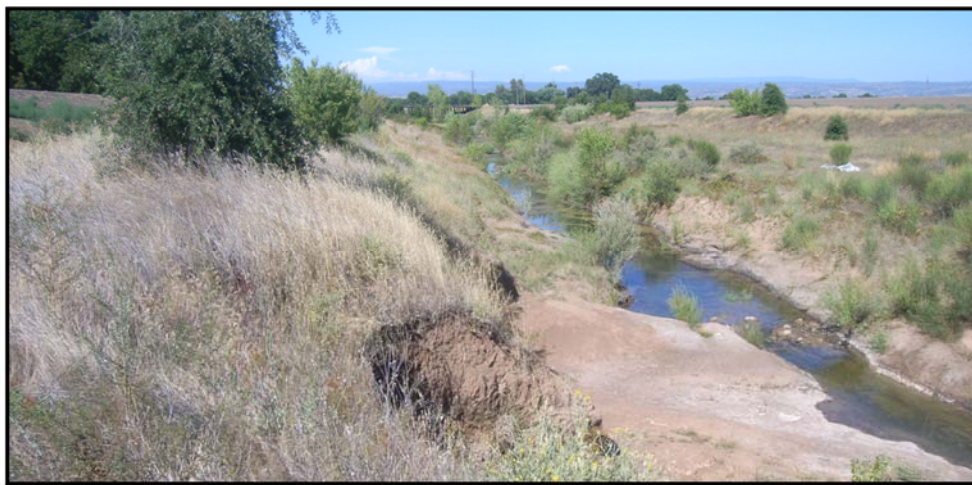
Figure 23. Typical View of Mud Creek.

Big Chico Creek, Sycamore Creek, and Mud Creek – These three creeks drain from the Mount Lassen/Cascade Range and terminates at the Sacramento River at RM 196. Only a small portion of Big Chico Creek is leveed to protect the City of Chico. The levee is heavily used for running, biking, and horseback riding. The channel is braided and incised with a sand/gravel/cobble bed and an occasional tree. Sycamore Creek is a straightened channel that becomes more natural as it approaches Mud Creek. Mud Creek is a narrow channel, with incised portions and levees set close to the channel. **Figure 23** shows a typical view of Mud Creek. The 2017 flood event has significant impacts to these channels, with new erosion observed and the addition of three new erosion sites. There is one (1) erosion site on Chico Creek and it is new. There is one (1) erosion site on Sycamore Creek. There are currently three (3) erosion sites on Mud Creek and two (2) of them are new.

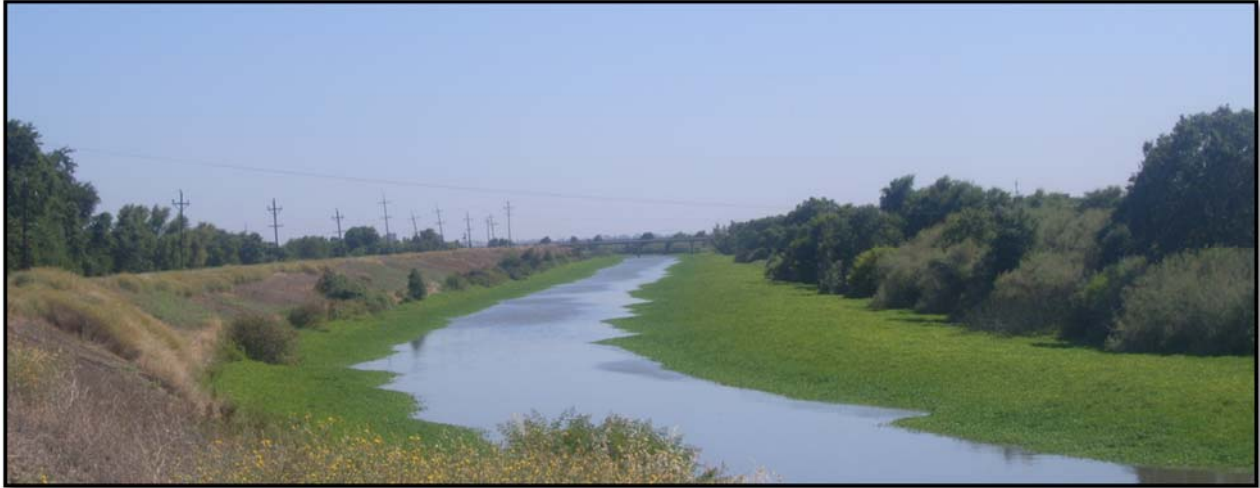
Knights Landing Ridge Cut – The Knights Landing Ridge Cut runs from the Colusa Basin Drainage Canal to the Yolo Bypass. The levees are in poor condition with steep slopes and slumping of the toe throughout most of the system. There are cracks along the middle of the left levee crest that may indicate potential mass movement and further slumping. **Figure 24** shows a typical view of the Knights Landing Ridge Cut. Access issue prevented the team from viewing a portion of these levees. There are seven (7) erosion sites in this reach.

Figure 24. Typical View of the Knights Landing Ridge Cut.

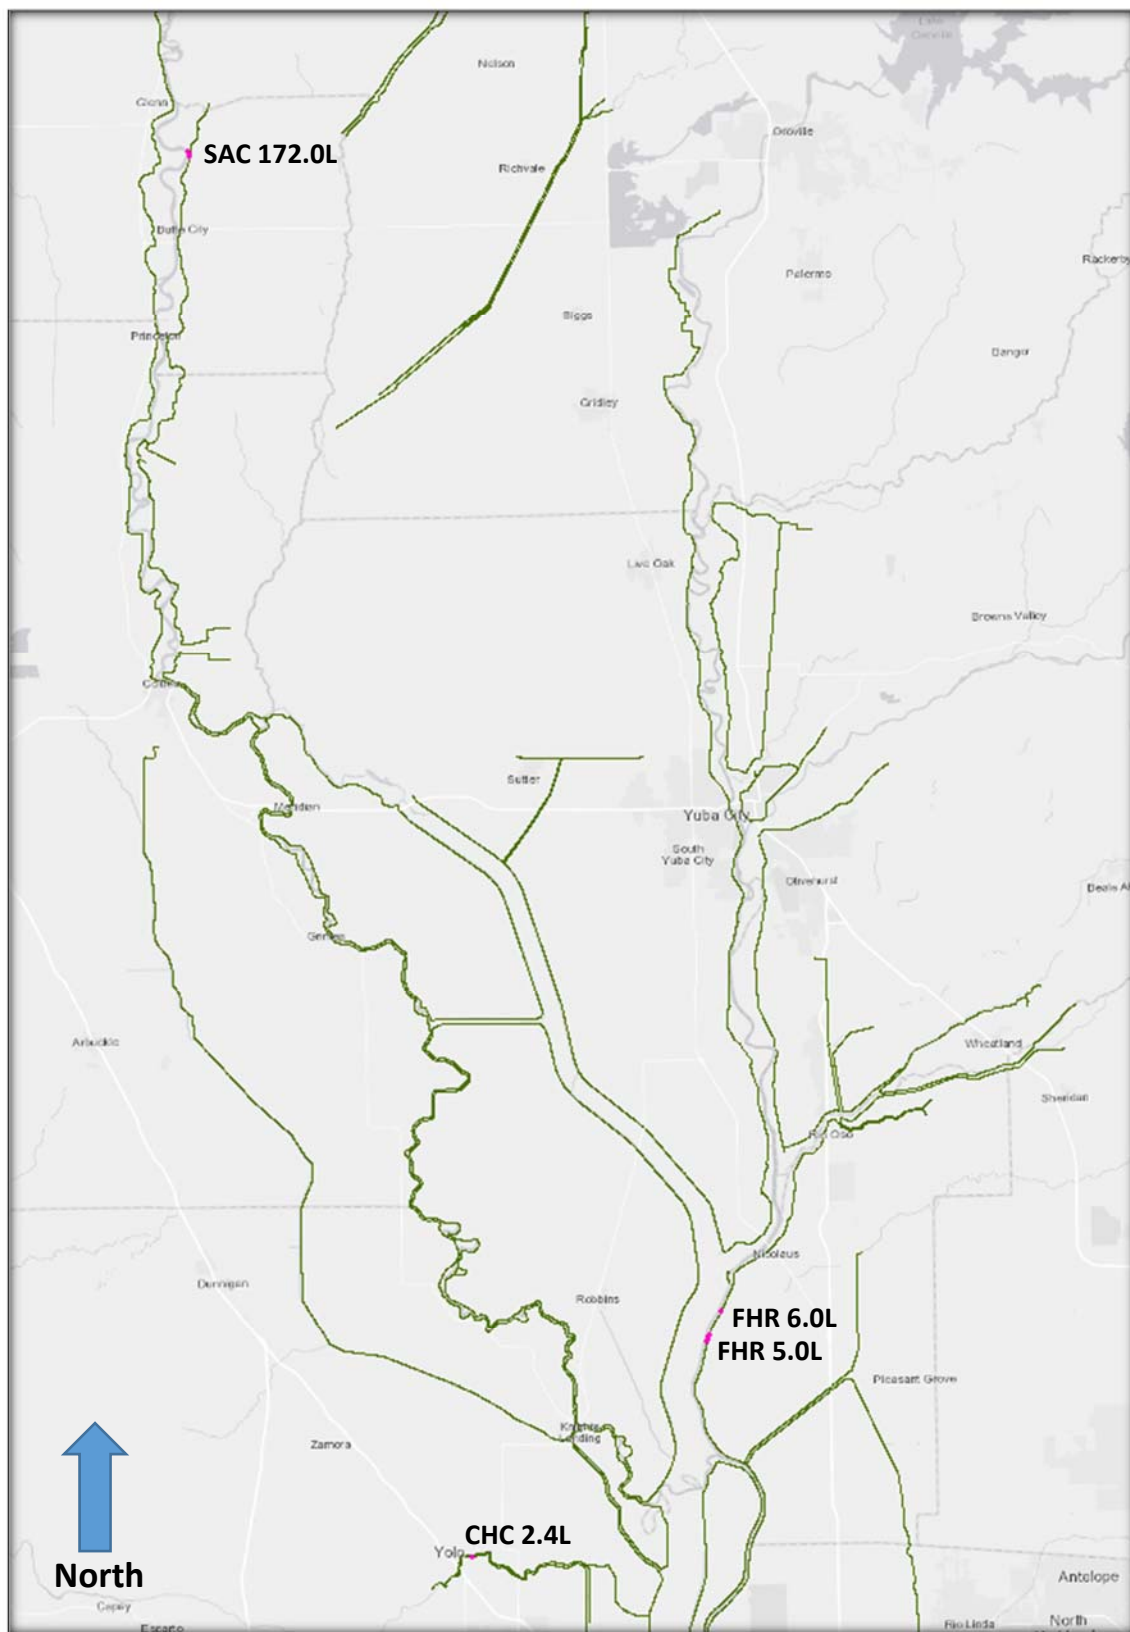
Figure 1- Critical Erosion Sites – Northern Section

The 2017 Erosion Inventory took place from September 18th to December 1st of 2017. **Figures 1 and 2** show the extent of the levees inspected and label the locations of all the critical erosion sites. Field personnel identified 192 erosion sites. Of these sites, 29 sites were labeled as critical. Three (3) of the critical sites (CHS 1.8L, GEO 11.4L, and SAP 1.4R) are also new sites added to the erosion inventory this year (2017). **Table 1** summarizes the number of critical sites and the linear feet per waterway.
