**US Army Corps
of Engineers®**

**Sutter Basin Pilot Feasibility Report -
Environmental Impact Report /
Supplemental Environmental Impacts
Statement**

GEOTECHNICAL APPENDIX

September 2013

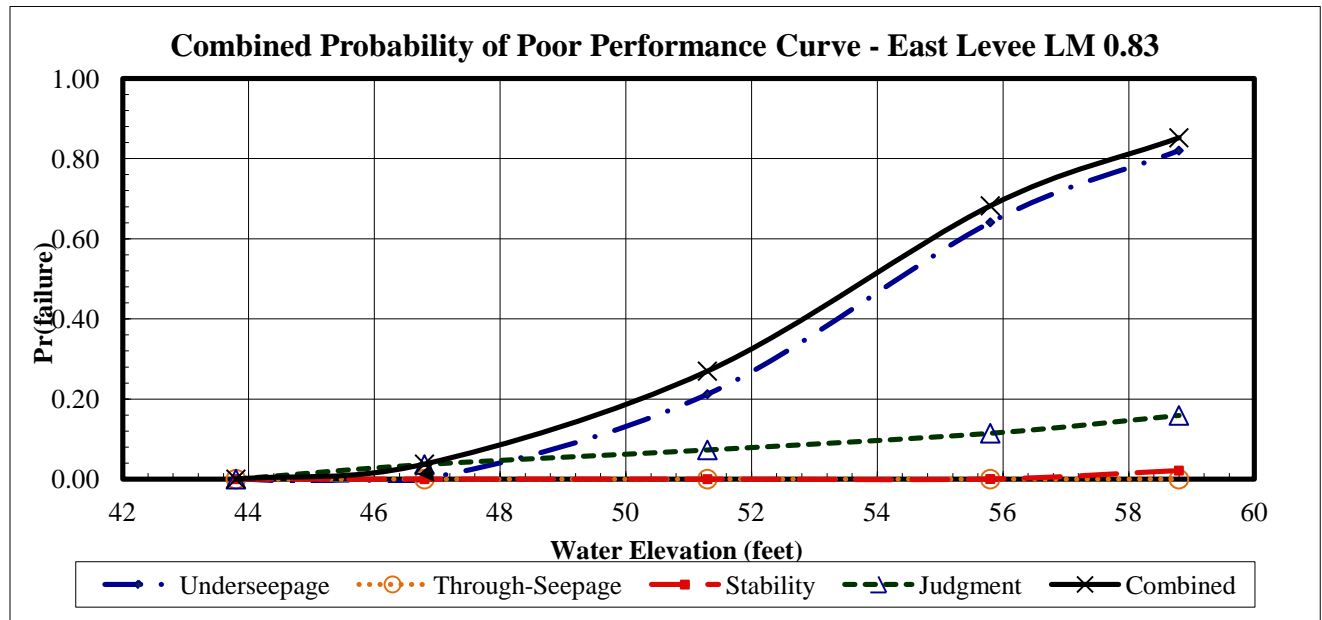
Probability of Failure Curve: The combined fragility curve is shown in Figure 7-1. The underseepage performance mode accounts for most of the risk of failure for this levee segment. This is consistent with the performance history of excessive seepage and boils over the downstream portion of this levee, where it is tallest.

Figure 7-1 Combined R&U, Wadsworth Canal (left)

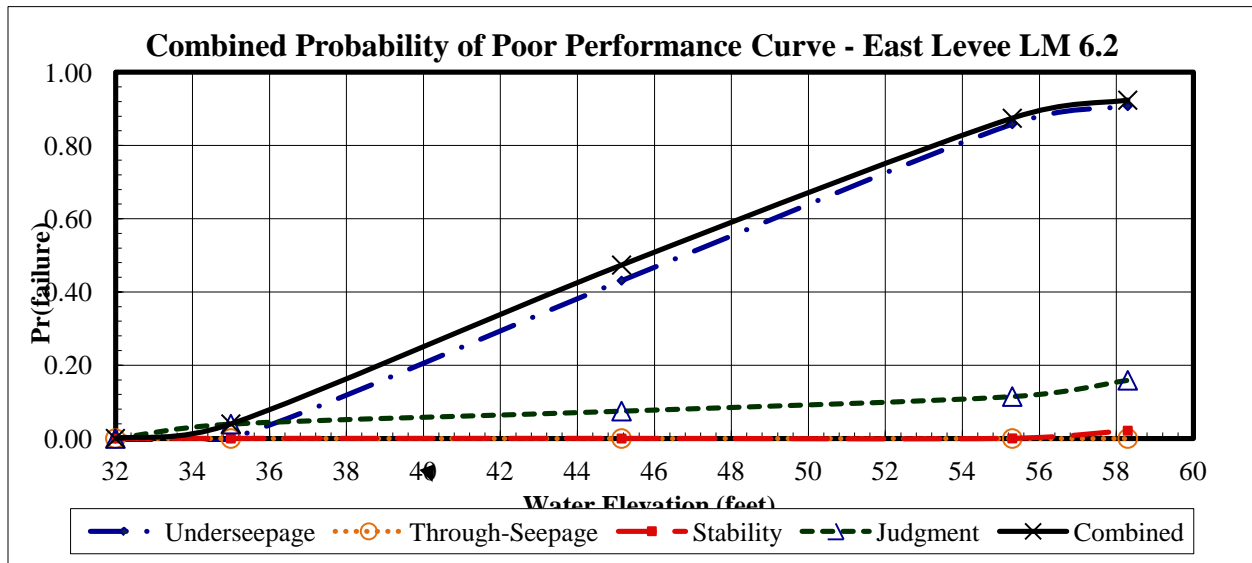
Probability of Failure Curve: The combined fragility curve is shown in Figure 7-2. The underseepage performance mode accounts for most of the risk of failure for this levee reach. This is consistent with the performance history of excessive seepage, boils and ground heaving near the toe of this levee.

Figure 7-2 Combined R&U, Sutter Bypass (Upper)

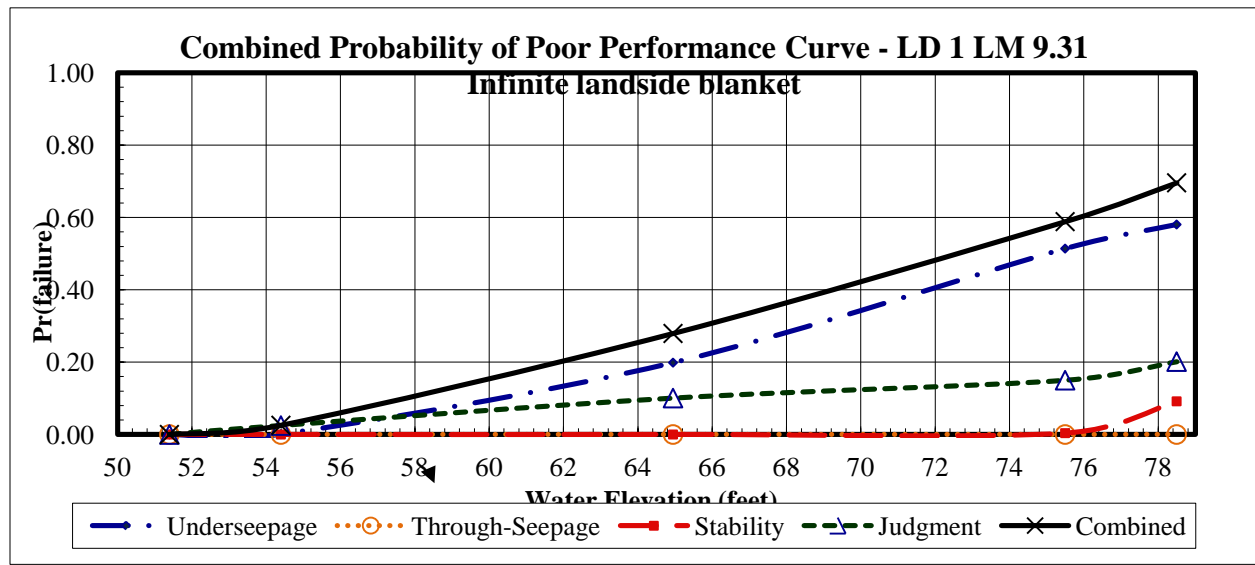
Probability of Failure Curve: The combined fragility curve is shown in Figure 7-5. The underseepage performance mode accounts for much of the risk of failure for this reach. This is consistent with the performance history of excessive seepage and boils during flood events.

Figure 7-5 Combined R&U, Feather River South (Abbott/Connor Lakes)

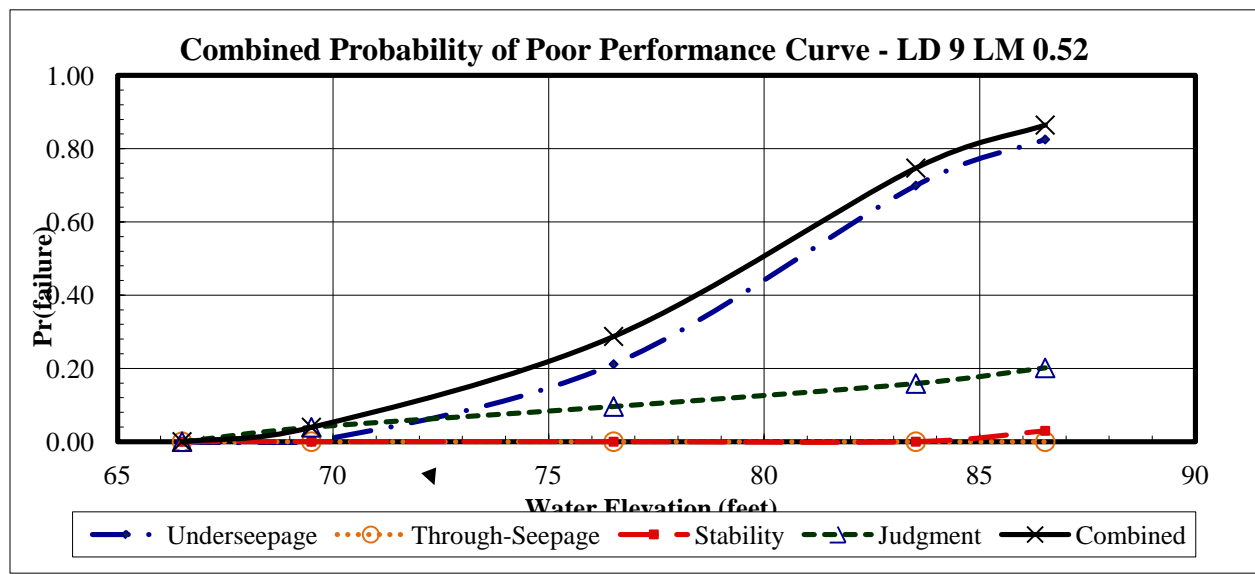
Probability of Failure Curve: The combined fragility curve is shown in Figure 7-7. The underseepage performance mode accounts for much of the risk of failure for this reach. This is consistent with the performance history of excessive seepage, and boils during flood events.

Figure 7-7 Combined R&U, Feather River North – LD9

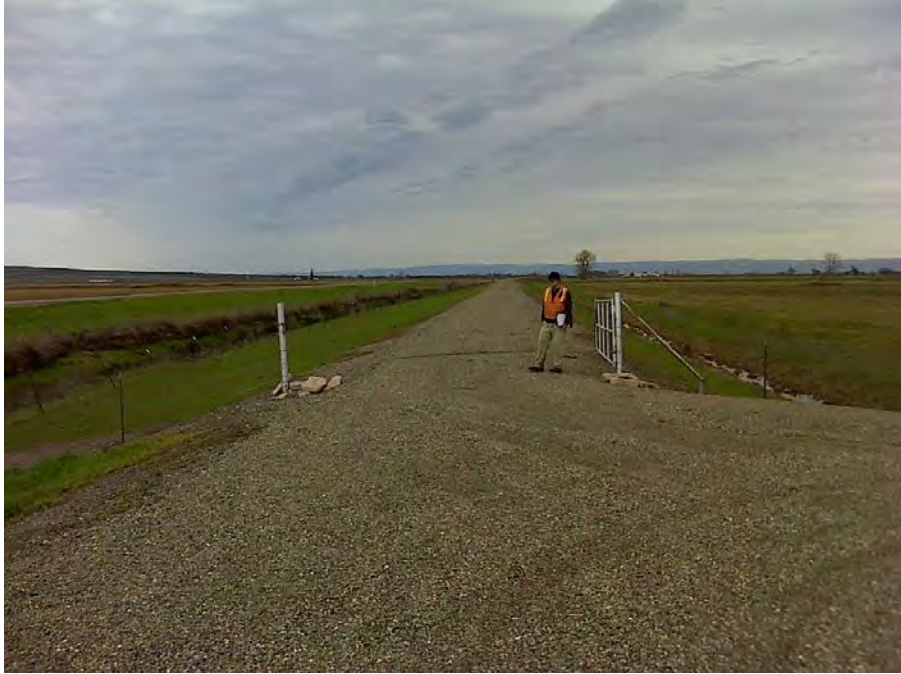
Photo 1. General view of the levee, looking upstream. Canal channel on the left.

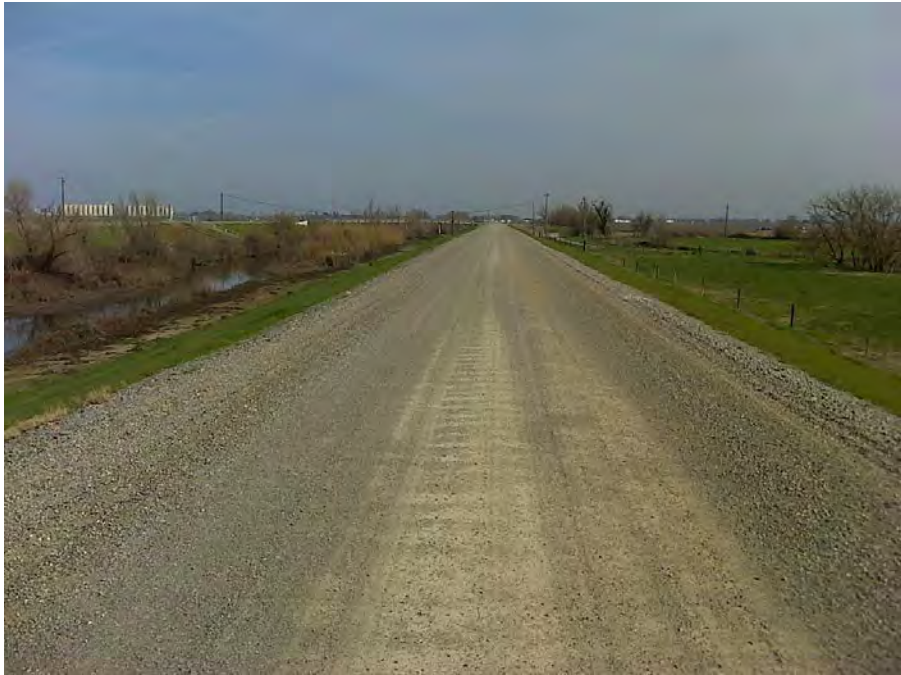
Photo 2. General view of the levee, looking upstream.

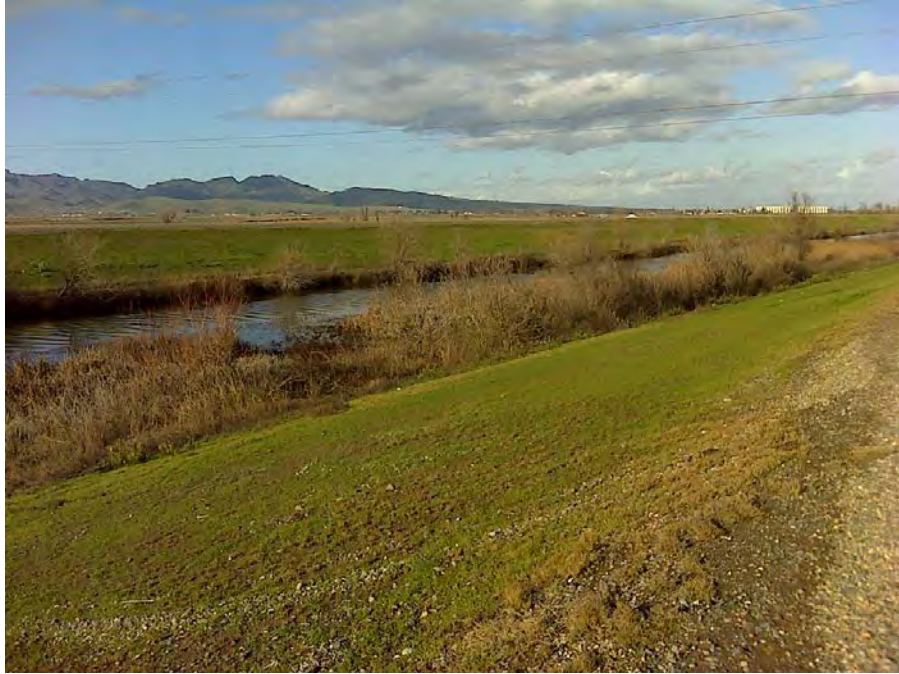
Photo 3. Waterside levee slope and canal, looking north. High ground of Sutter Buttes in the background.

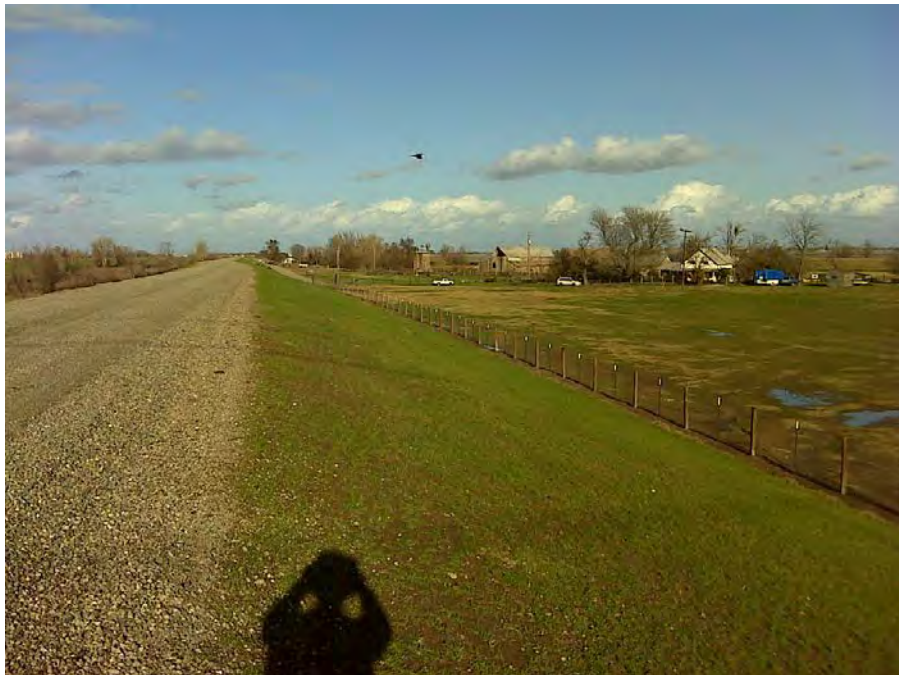
Photo 4. Landside levee slope, looking upstream.

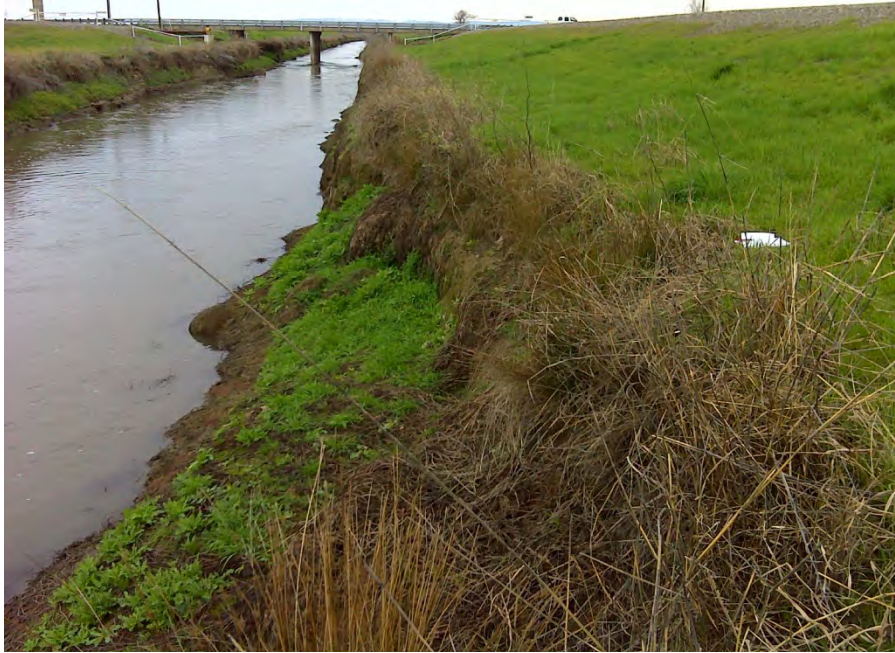
Photo 5. Canal bank erosion, looking upstream.

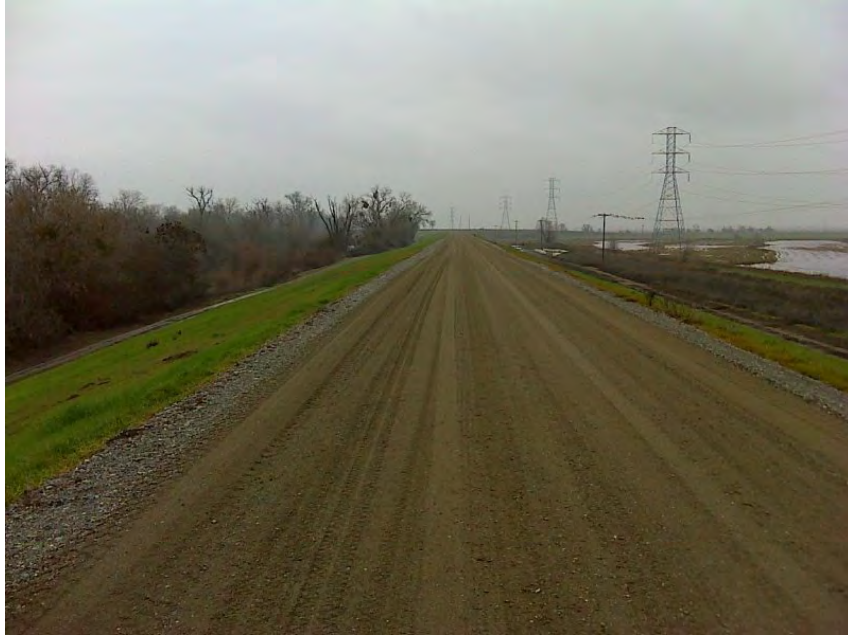
Photo 1. General view of the levee, looking upstream. Bypass channel is on the left

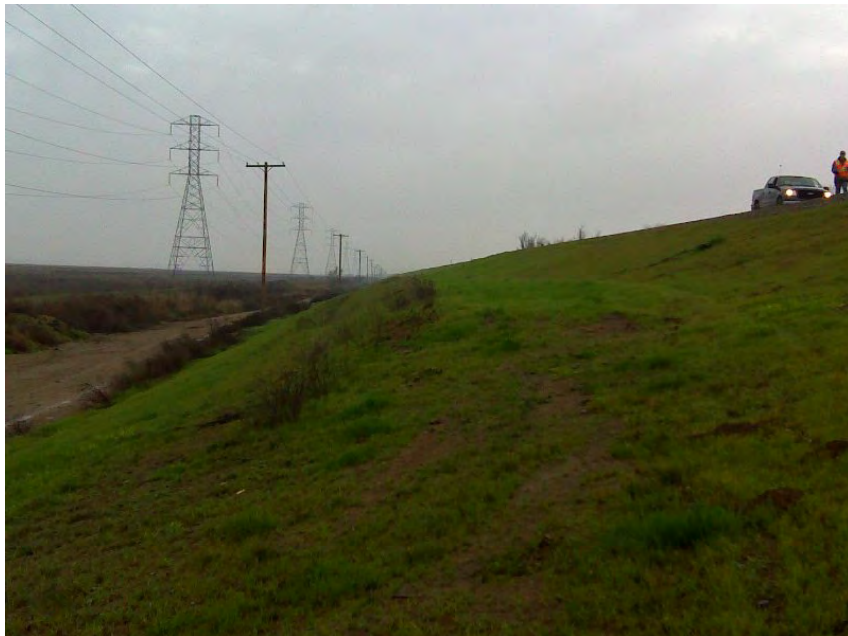
Photo 2. Landside levee slope, looking downstream.

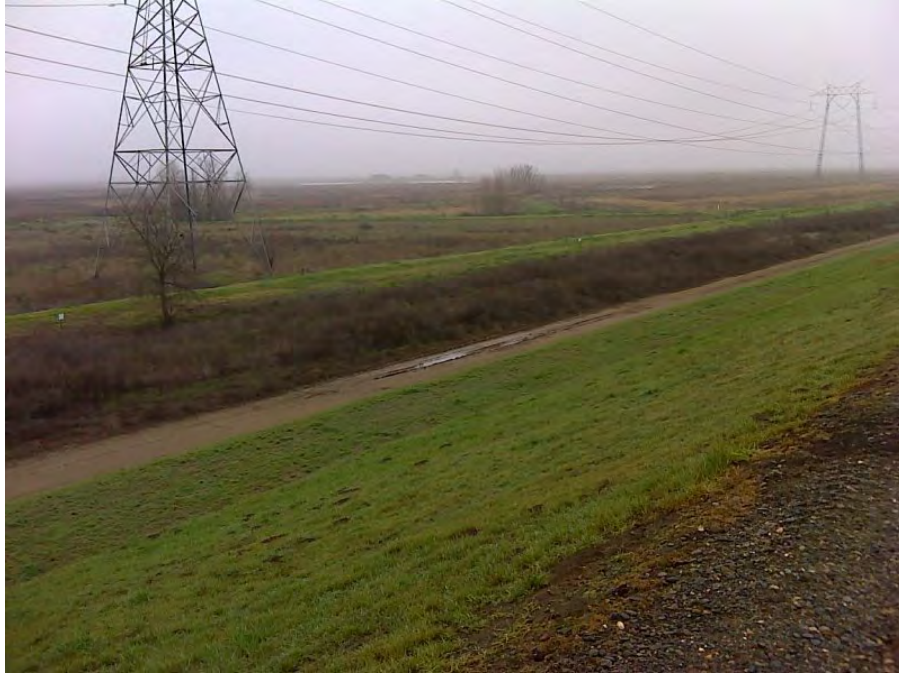
Photo 3 Ditch about 50 feet from the landside toe.

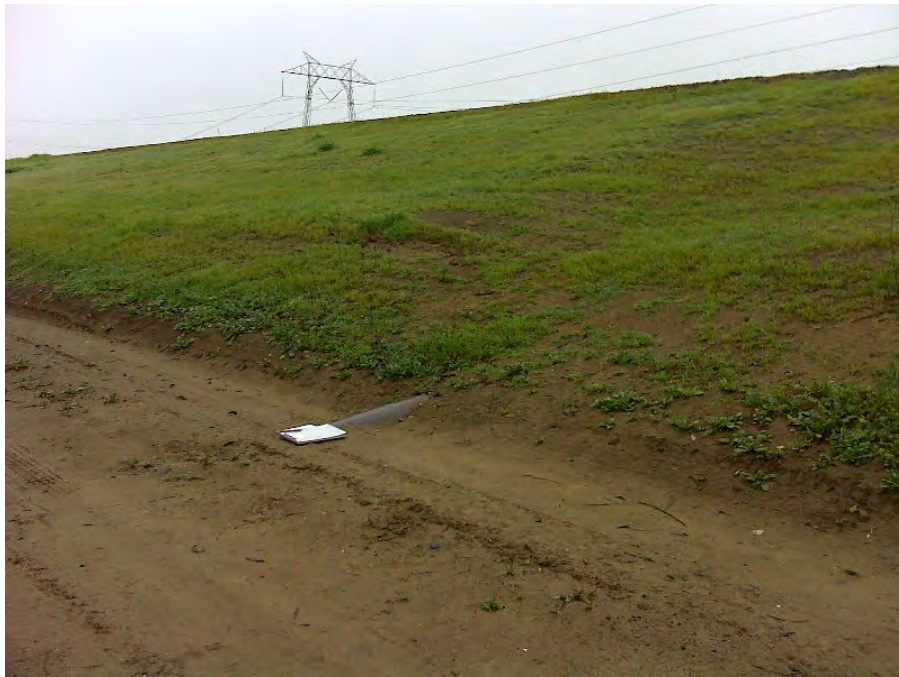
Photo 4. Typical waterside levee slope, looking upstream

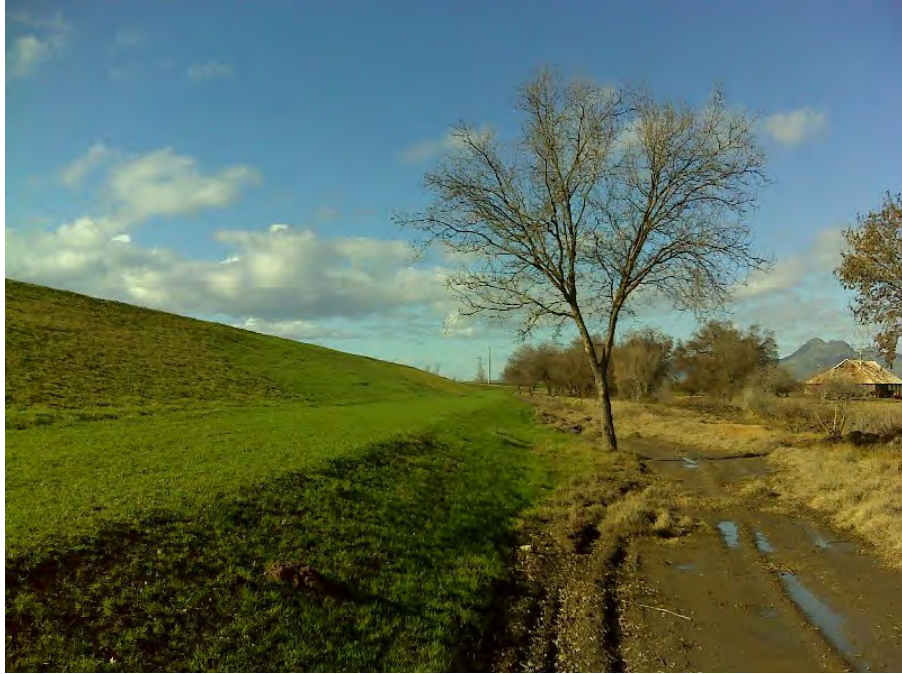
Photo 5. Stability berm at the landside toe, looking upstream

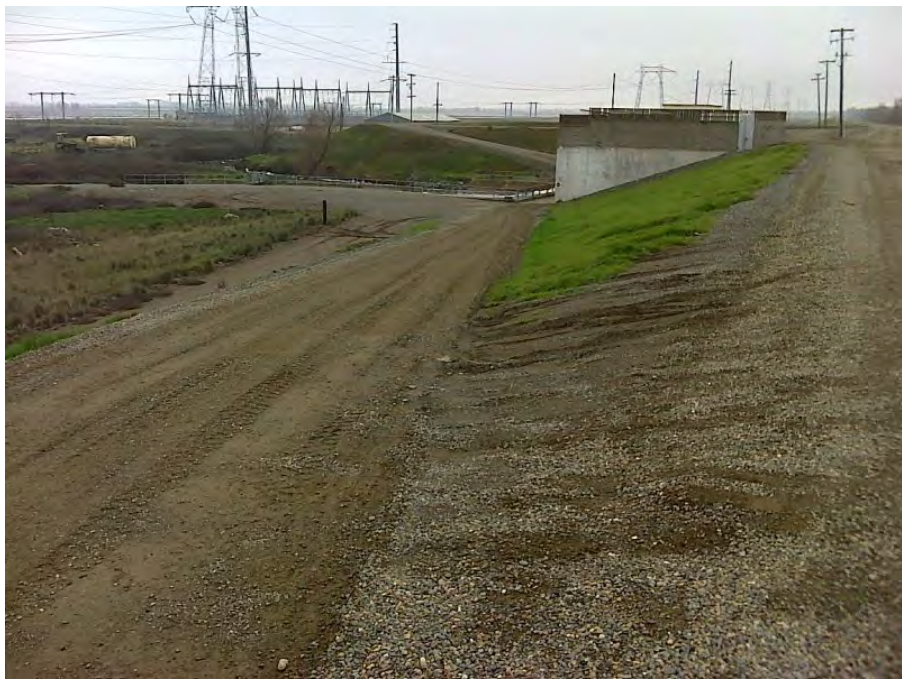
Photo 6. Pump Station No. 2, looking downstream

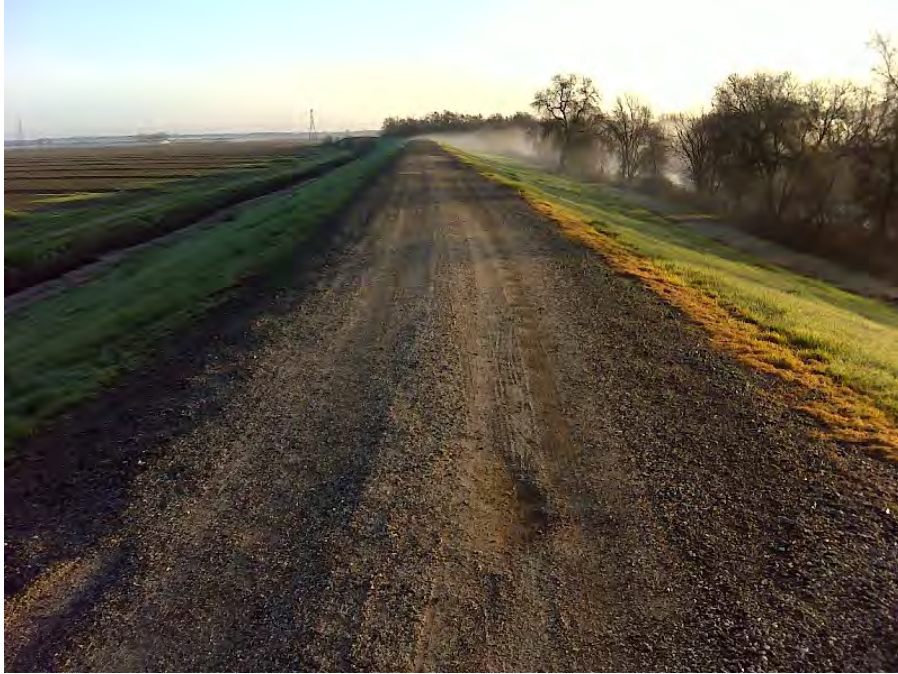
Photo 1. General view of the levee, looking upstream. Feather River channel to the right.

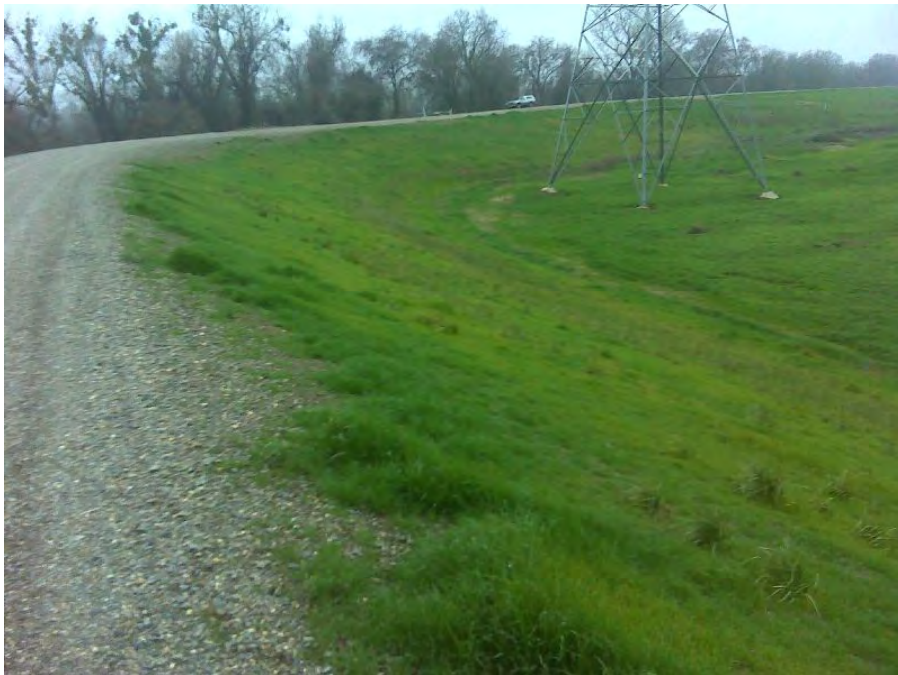
Photo 2. Landside levee slope, looking downstream. Note electrical tower near the toe.

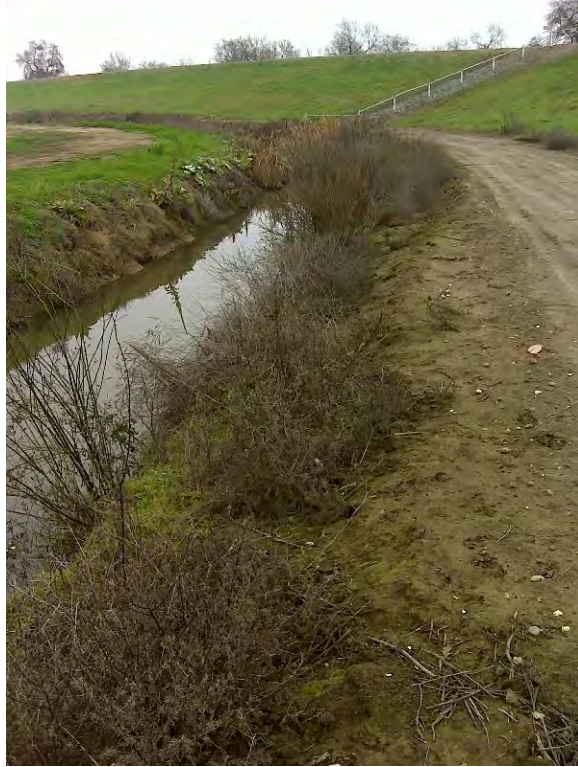
Photo 3. Ditch near the landside toe

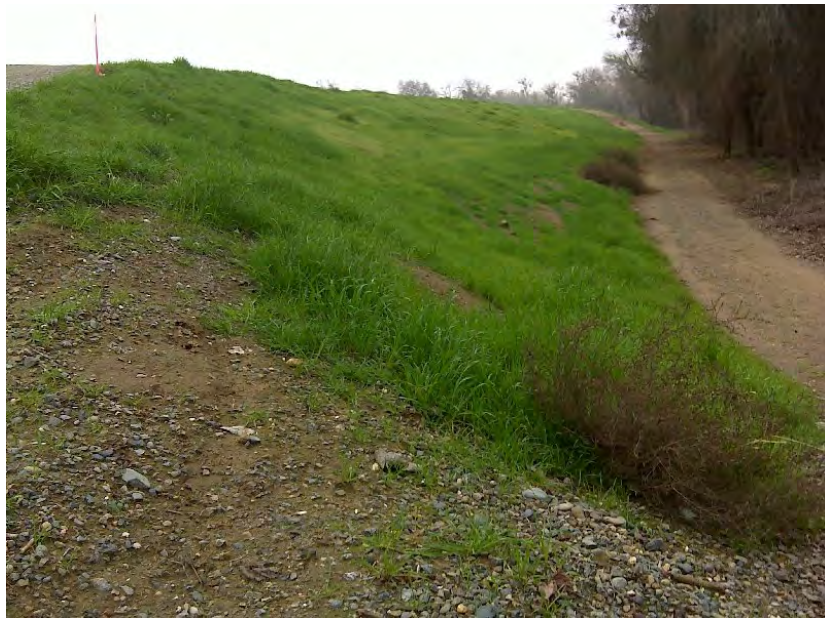
Photo 4. Waterside levee slope, looking upstream.

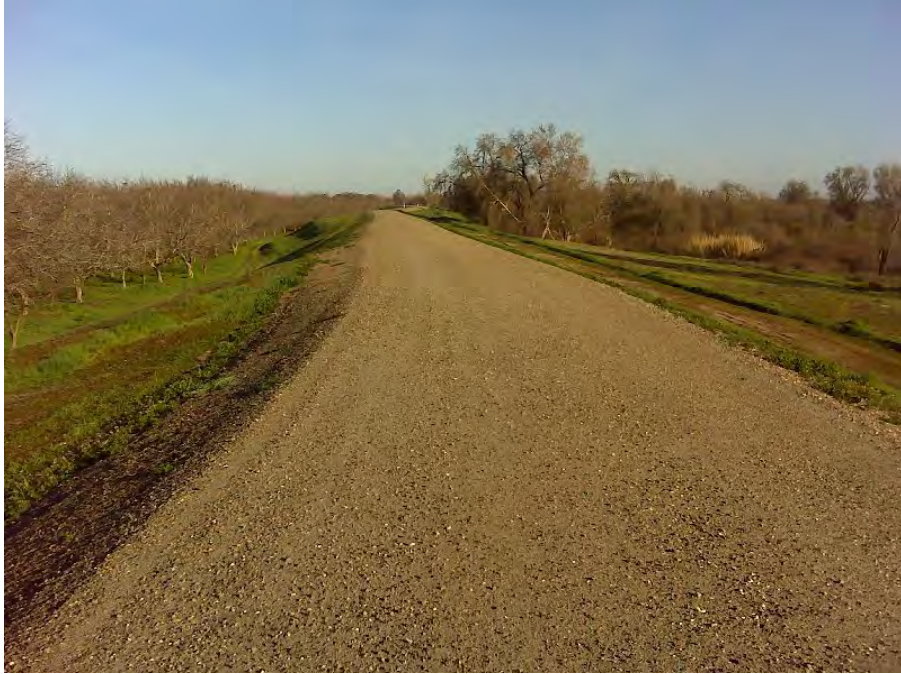
Photo 1. General view of the levee, looking upstream. Feather River channel on the right.

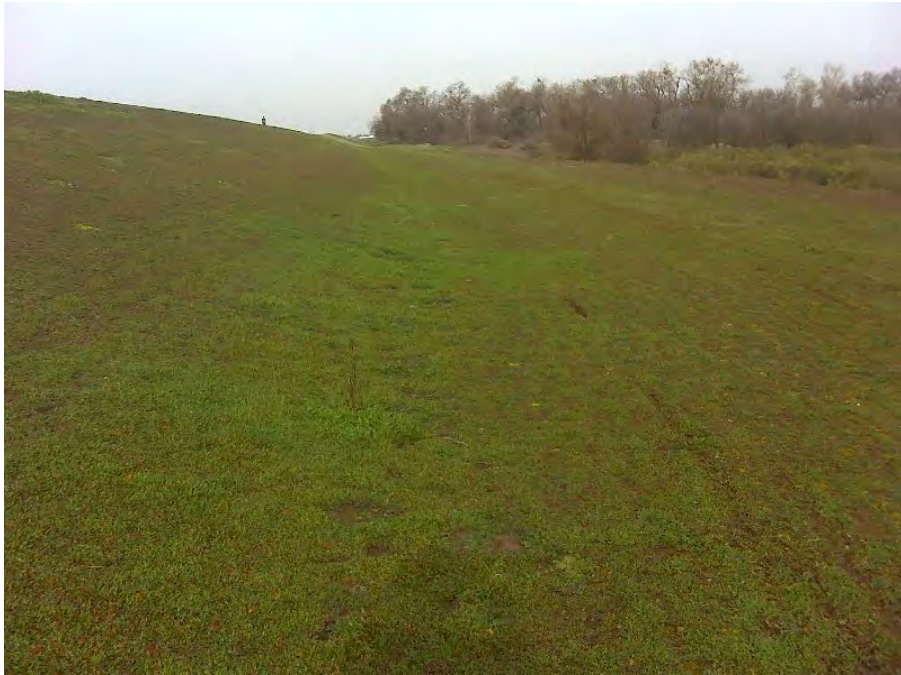
Photo 2. Waterside levee slope, looking upstream.

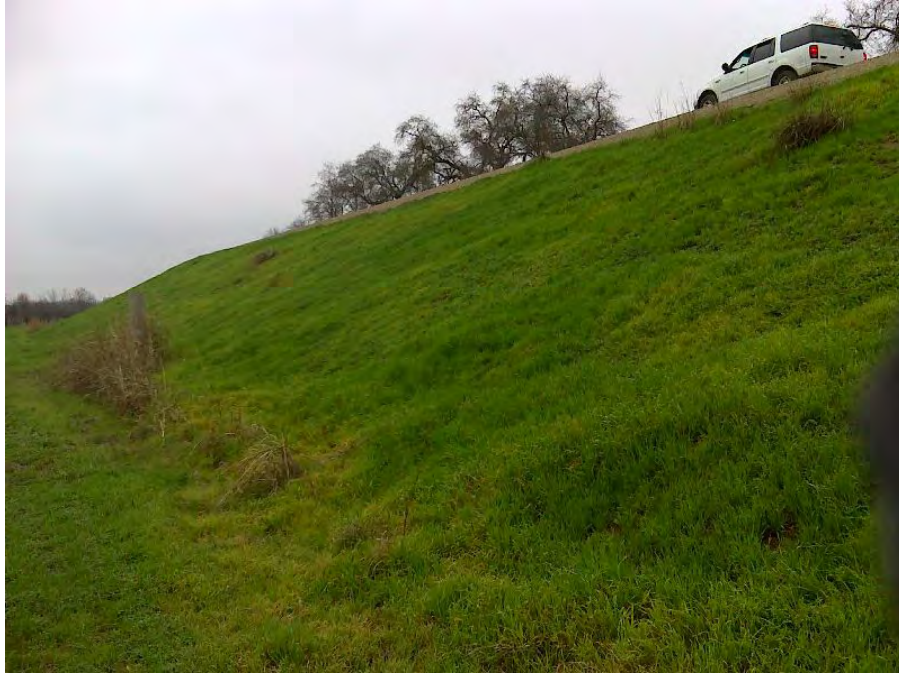
Photo 3. Landside levee slope, looking upstream.

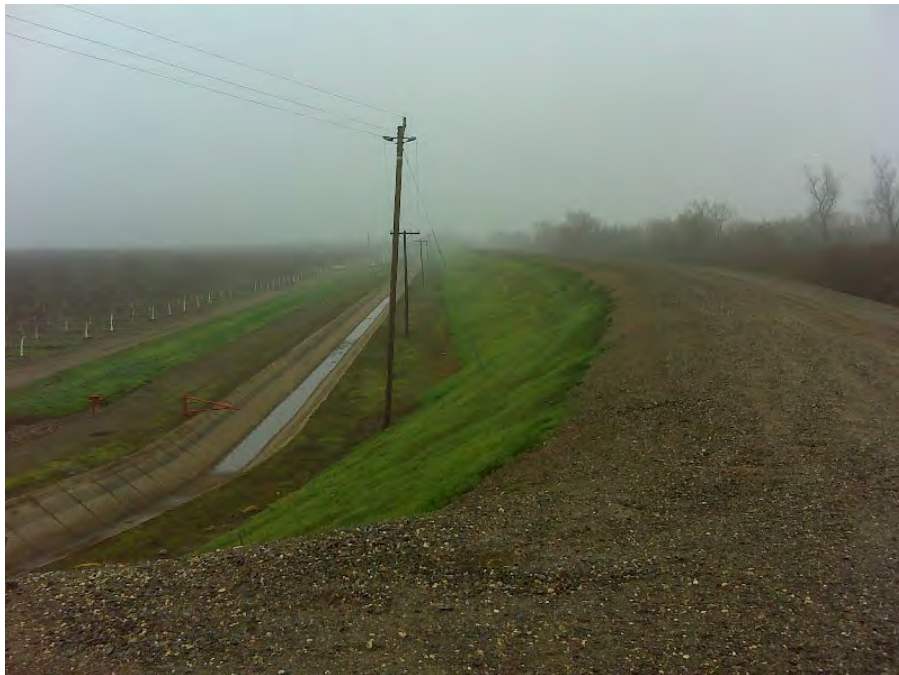
Photo 4. Drainage ditch and power poles near the landside levee toe.

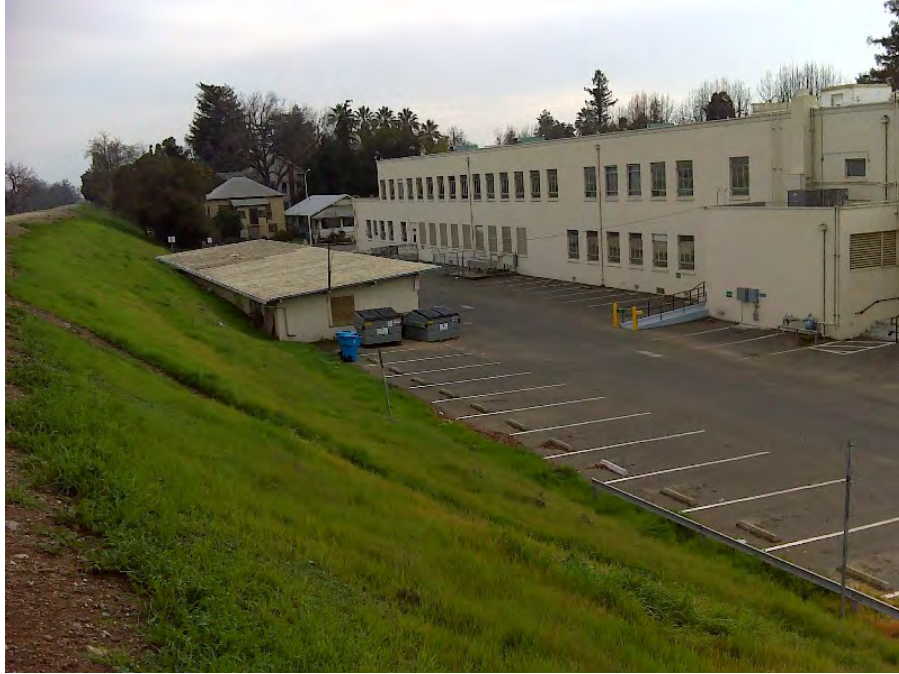
Photo 5. Encroachment into the landside levee slope in Yuba City.

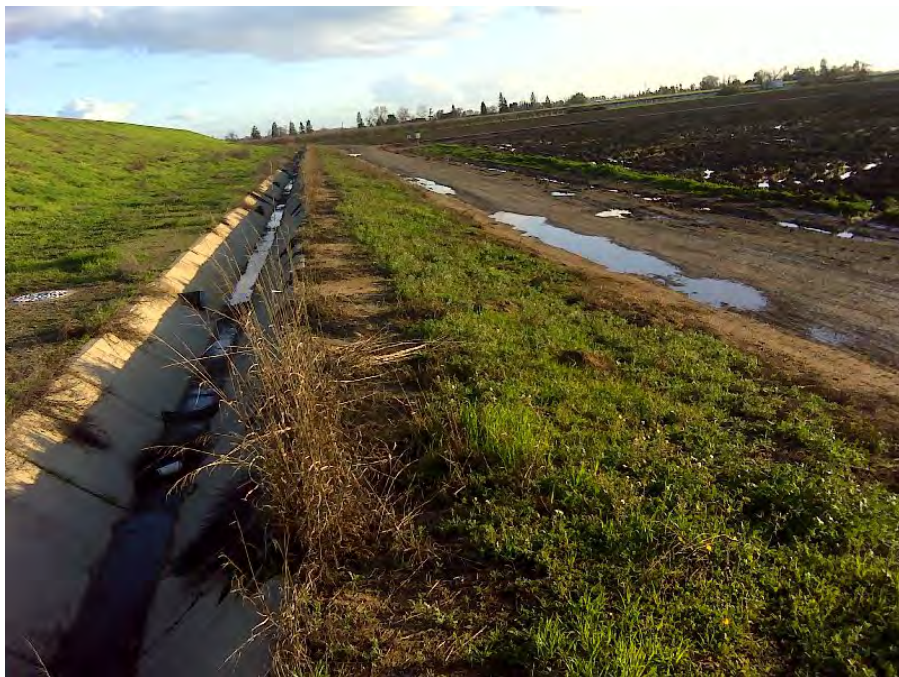
Photo 6. Star Bend relief wells and relief well drainage ditch.

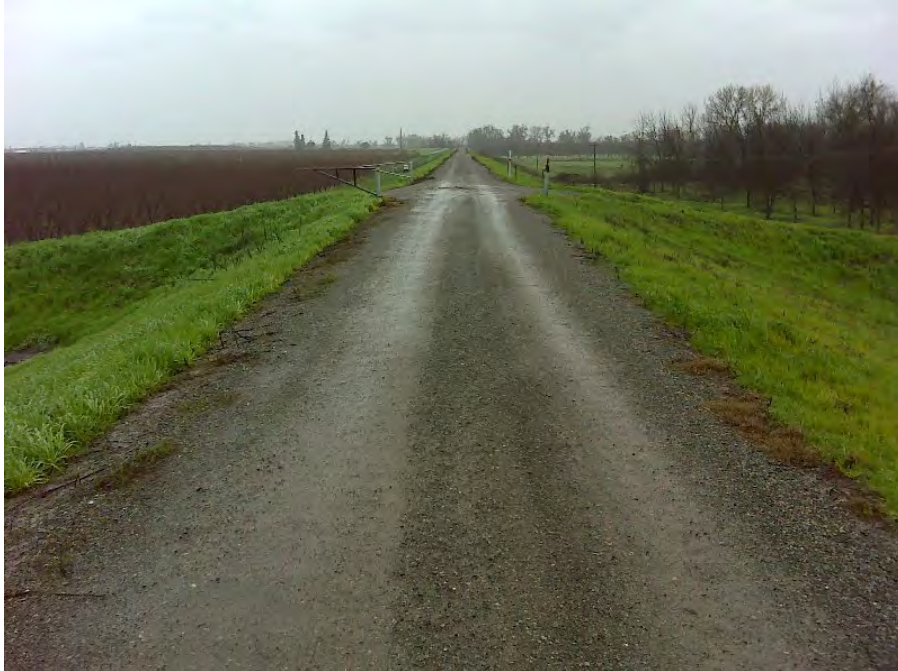
Photo 1. General view of the levee.

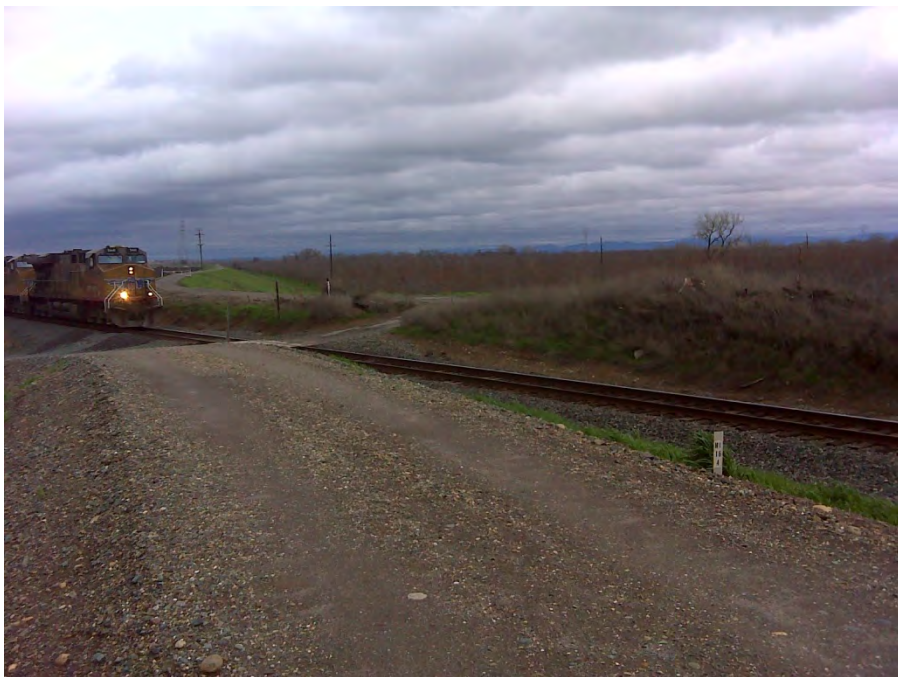
Photo 2. Railroad embankment crossing the levee alignment at the LD1/LD9 boundary.

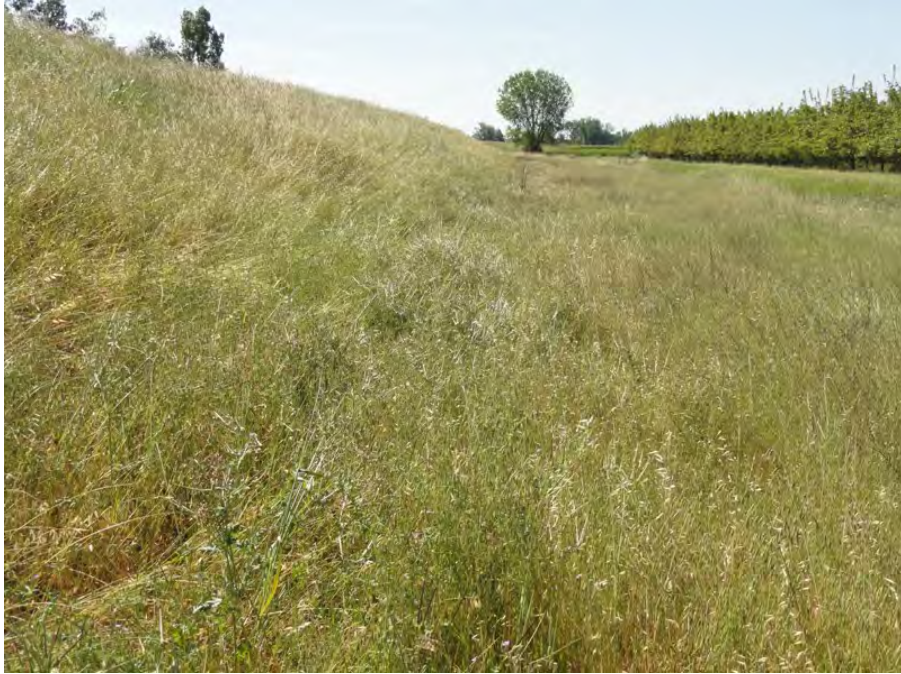
Photo 3. Landside levee slope, looking downstream.

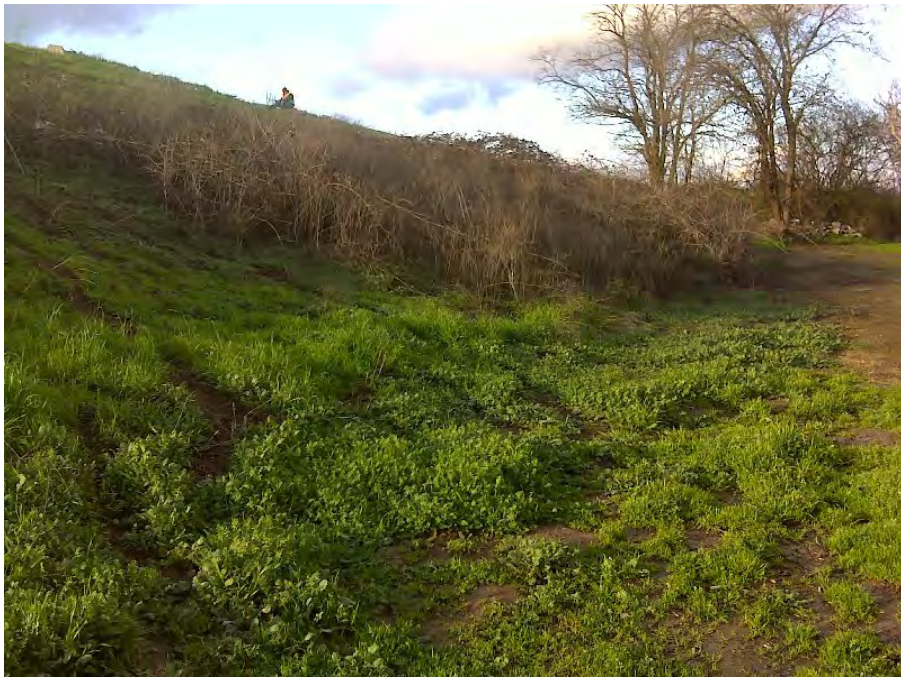
Photo 4. Waterside levee slope, looking upstream.

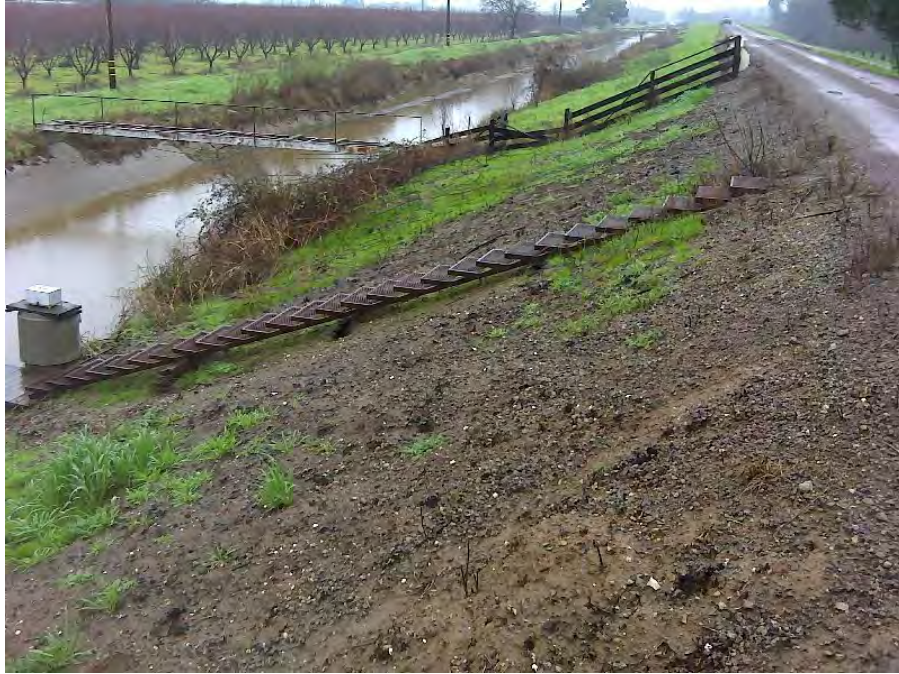
Photo 5. Sutter Butte Canal adjacent to the levee toe.

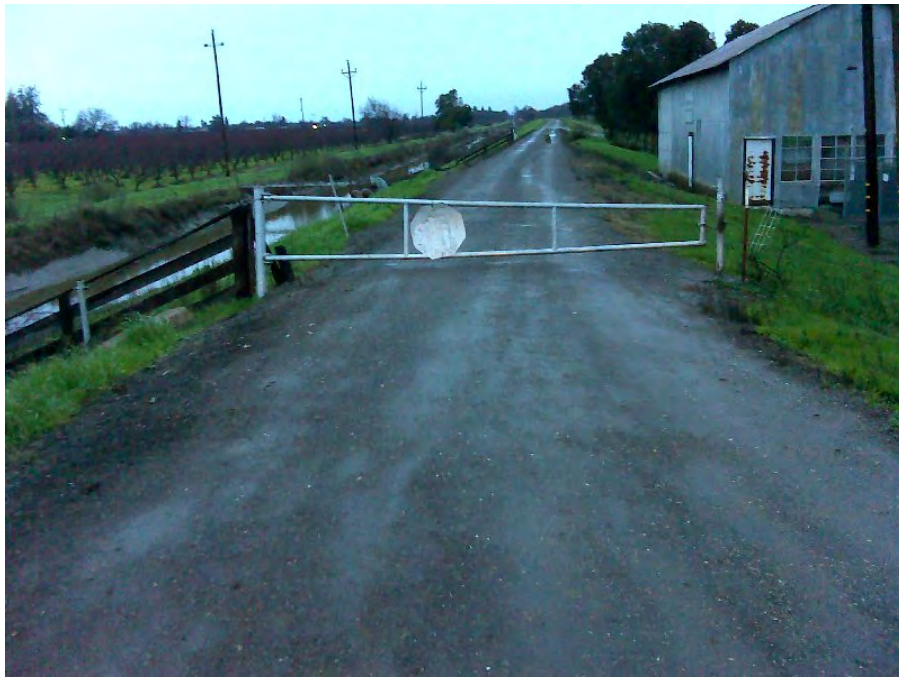
Photo 6. Sutter Butte Canal adjacent to the landside levee toe at the Sunset Pump Plant.

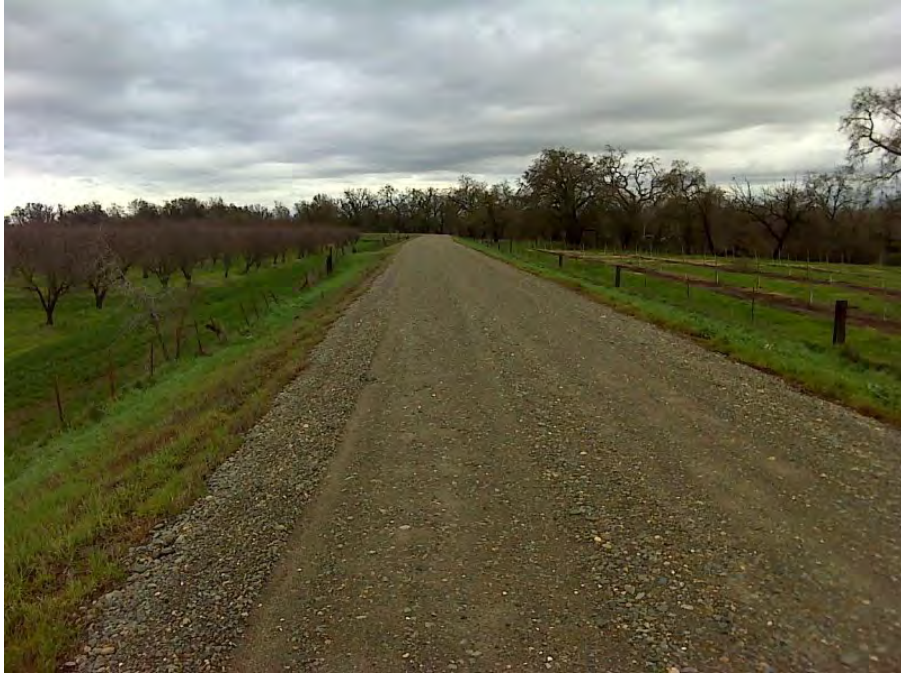
Photo 1. General view of the levee, looking upstream. Feather River channel to the right.

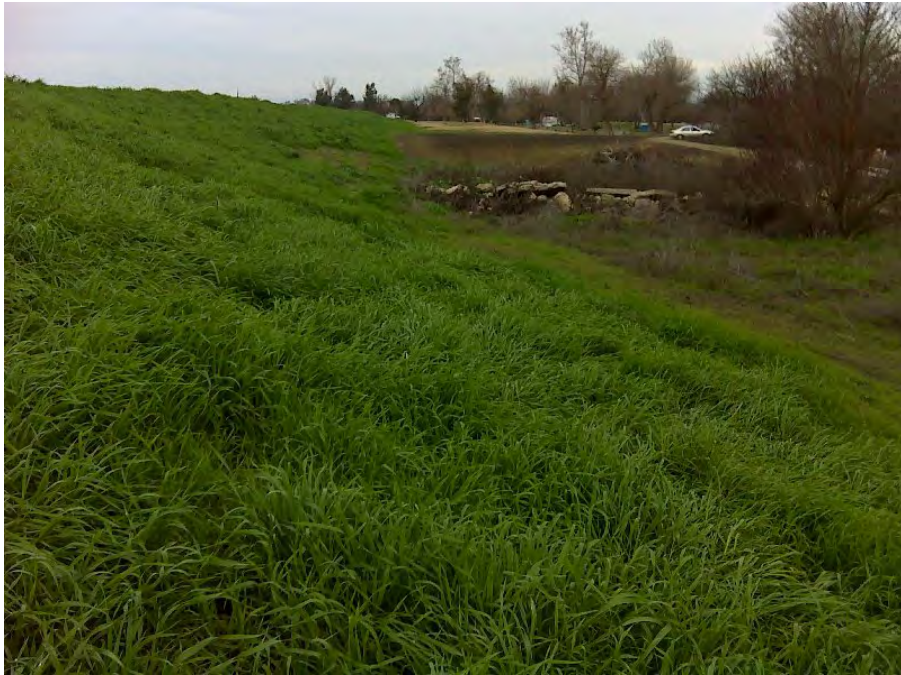
Photo 2. Waterside levee slope, looking upstream.

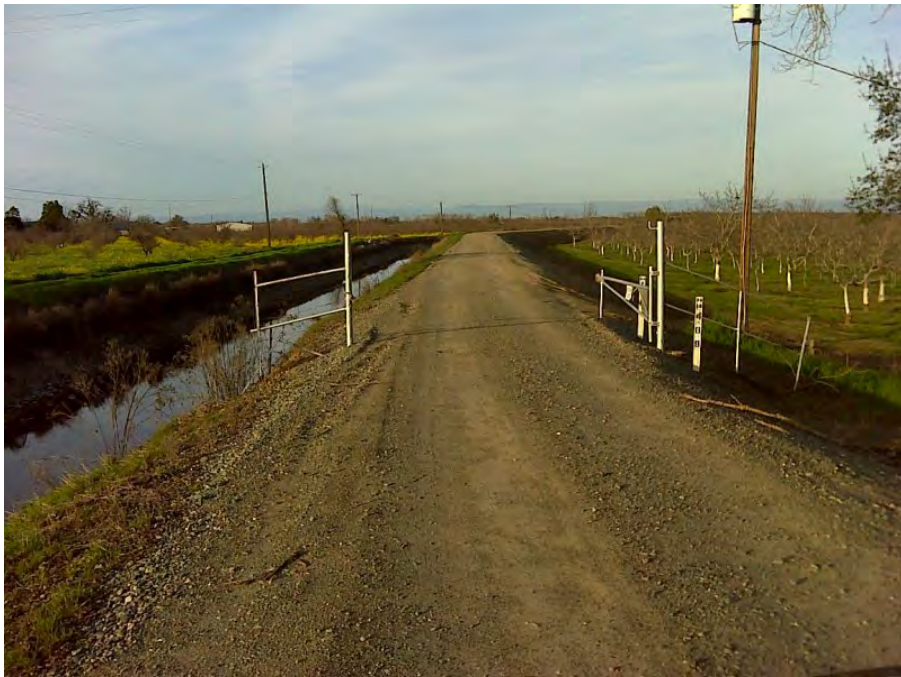
Photo 4. Sutter Butte Canal adjacent to the landside levee toe.

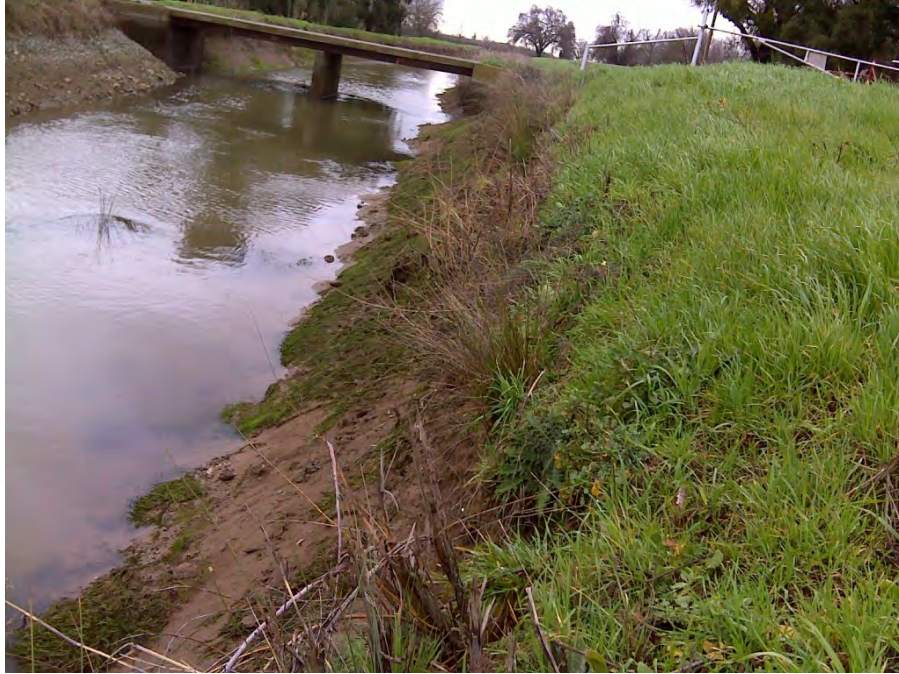
Photo 5. Erosion/sloughing of the landside levee slope into the Sutter Butte Canal.

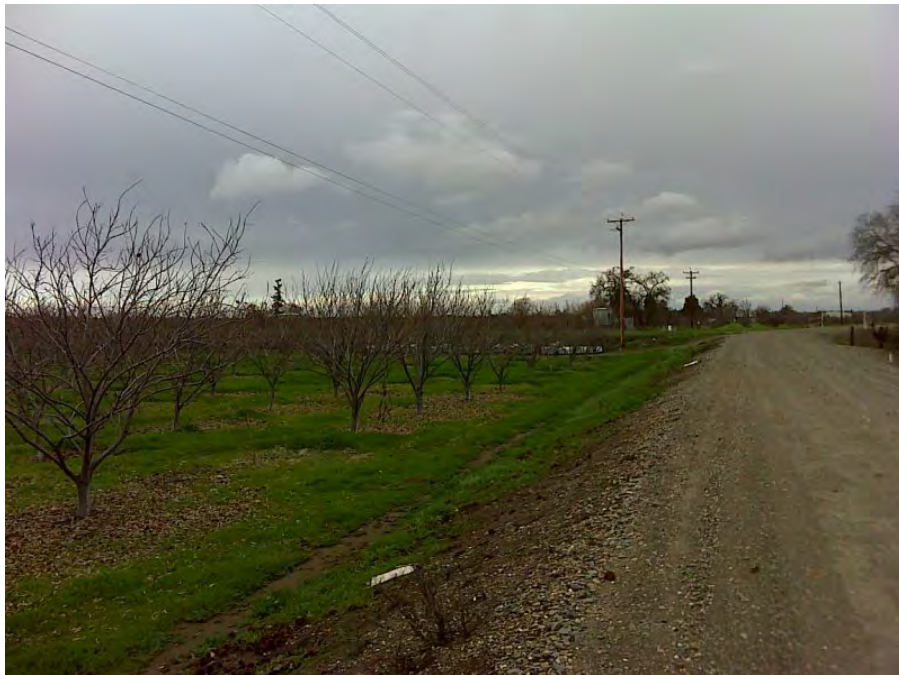
Photo 6. Landside levee slope with powerpoles near the toe, looking upstream.
