**US Army Corps
of Engineers®**

**Sutter Basin Pilot Feasibility Report -
Environmental Impact Report /
Supplemental Environmental Impacts
Statement**

GEOTECHNICAL APPENDIX

September 2013

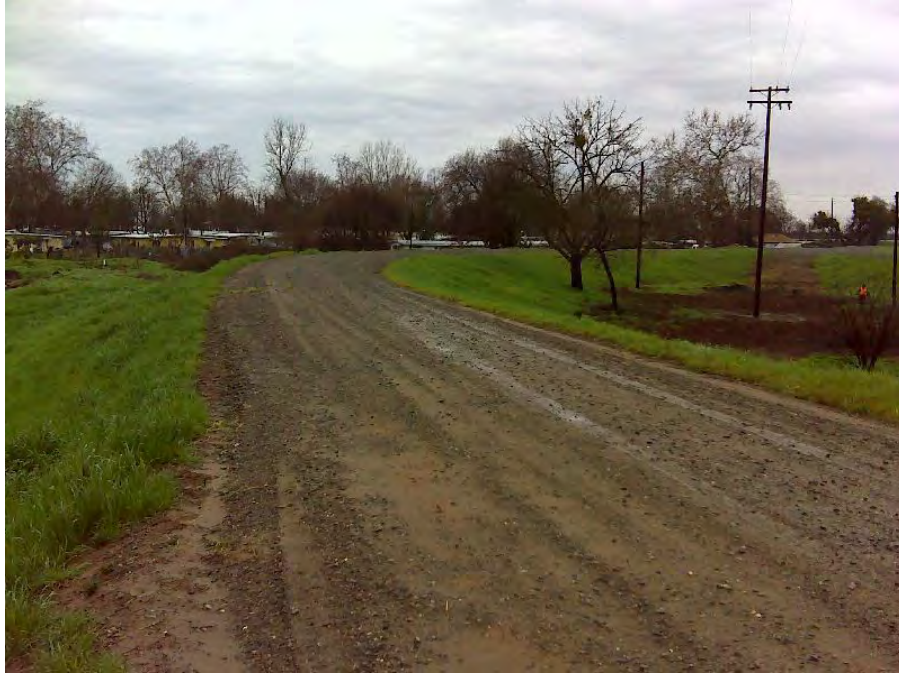
Photo 1. General view of the levee, looking upstream. Feather River channel to the right.

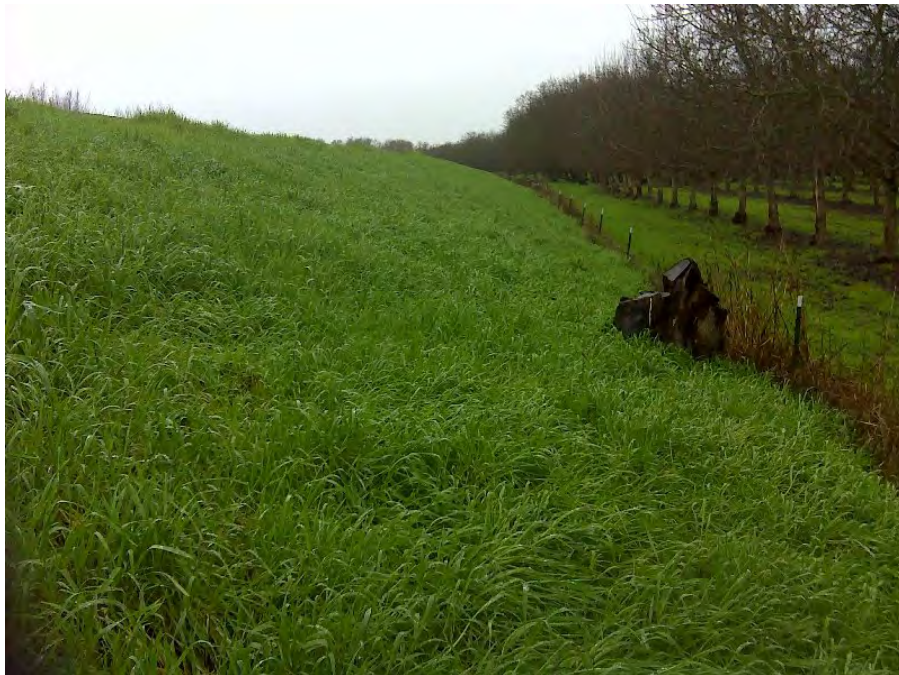
Photo 2. Waterside levee slope, looking upstream.

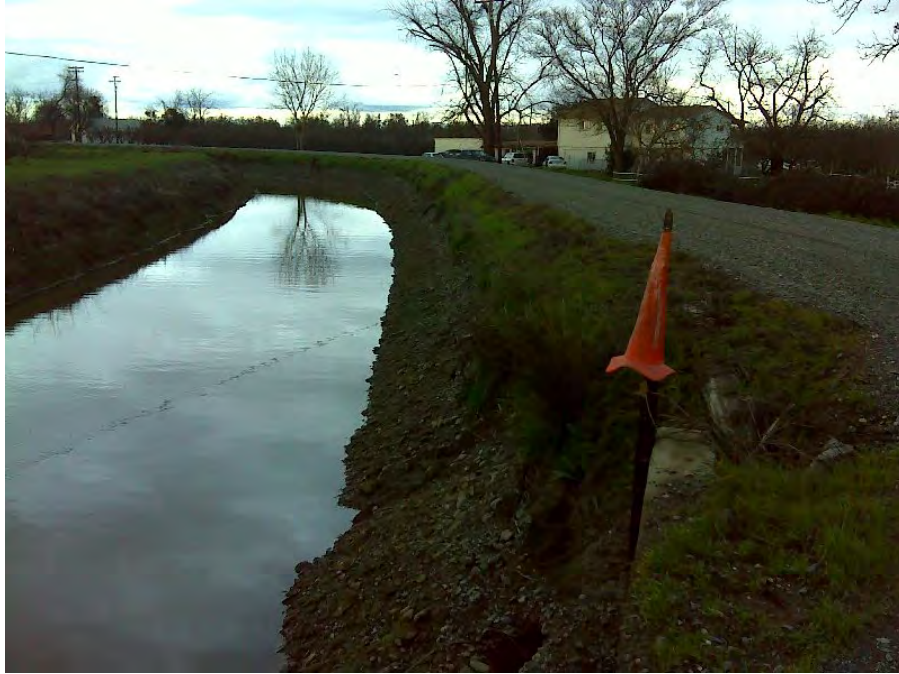
Photo 3. Landside slope erosion/sloughing into the adjacent Sutter Butte Canal; house on waterside of levee.

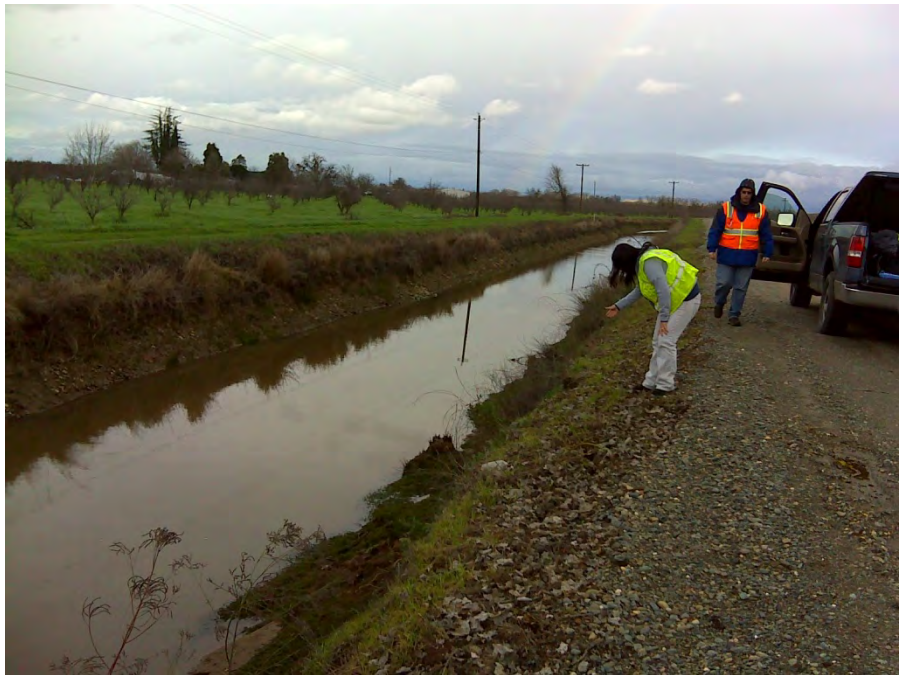
Photo 4. Sutter Butte Canal adjacent to the landside levee toe.

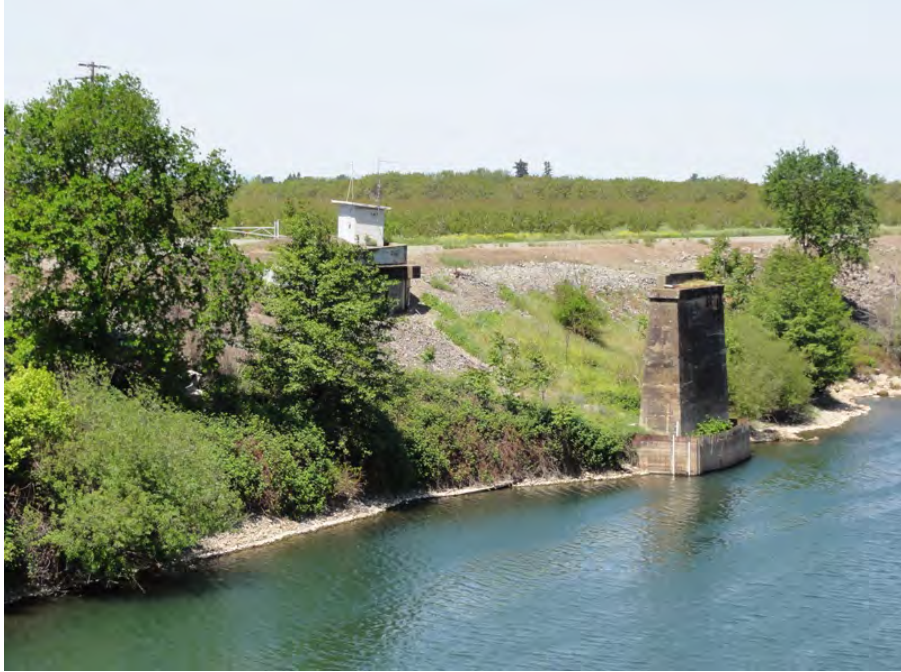
Photo 5. Waterside levee slope at the location of the former Gridley Bridge.

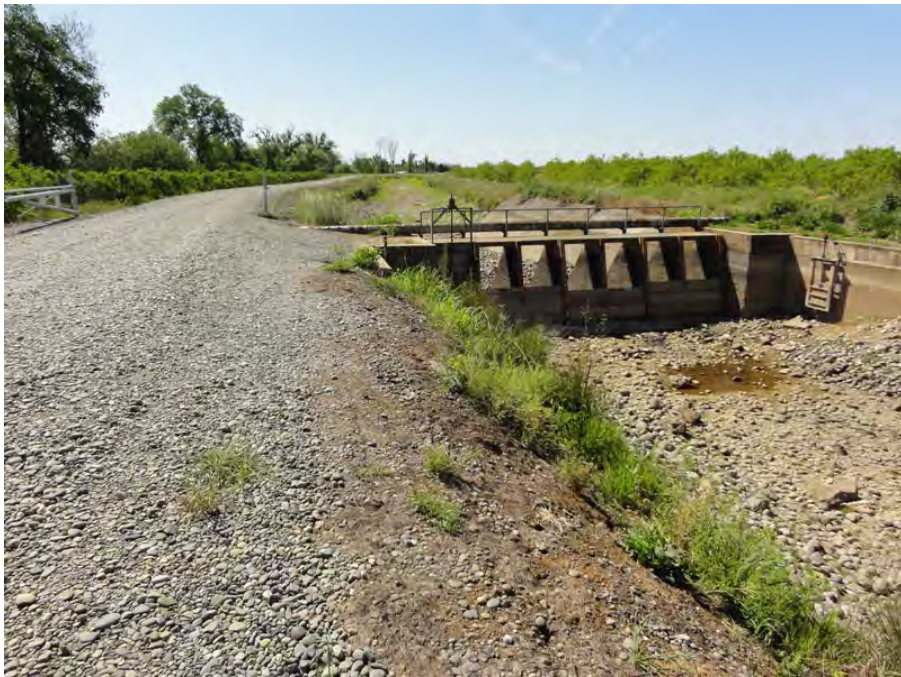
Photo 6. Weir structure in Sutter Butte Canal adjacent to the landside levee toe.

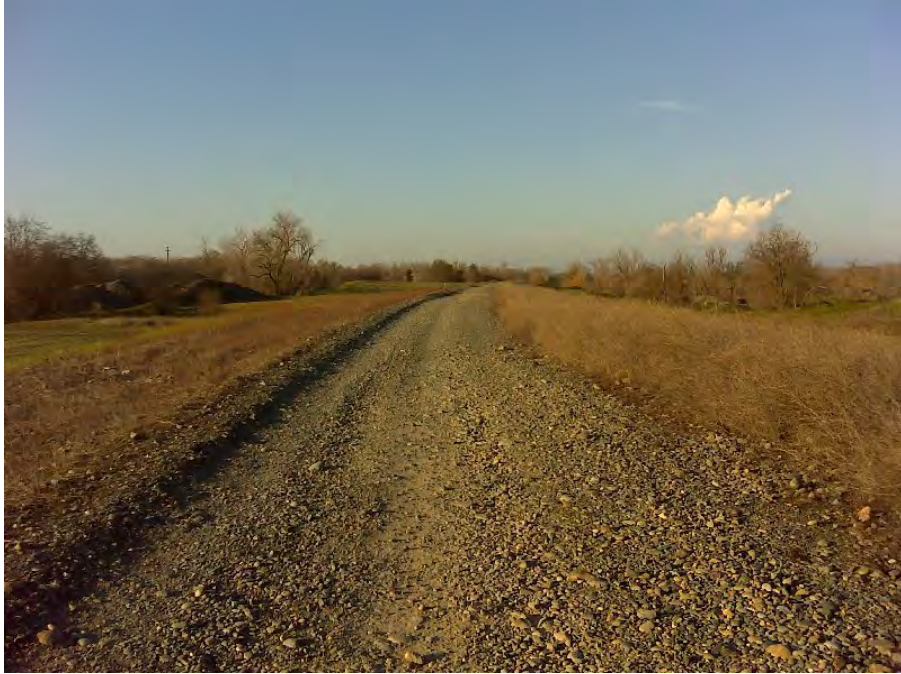
Photo 1. General view of the levee embankment, looking upstream. Feather River channel to the right.

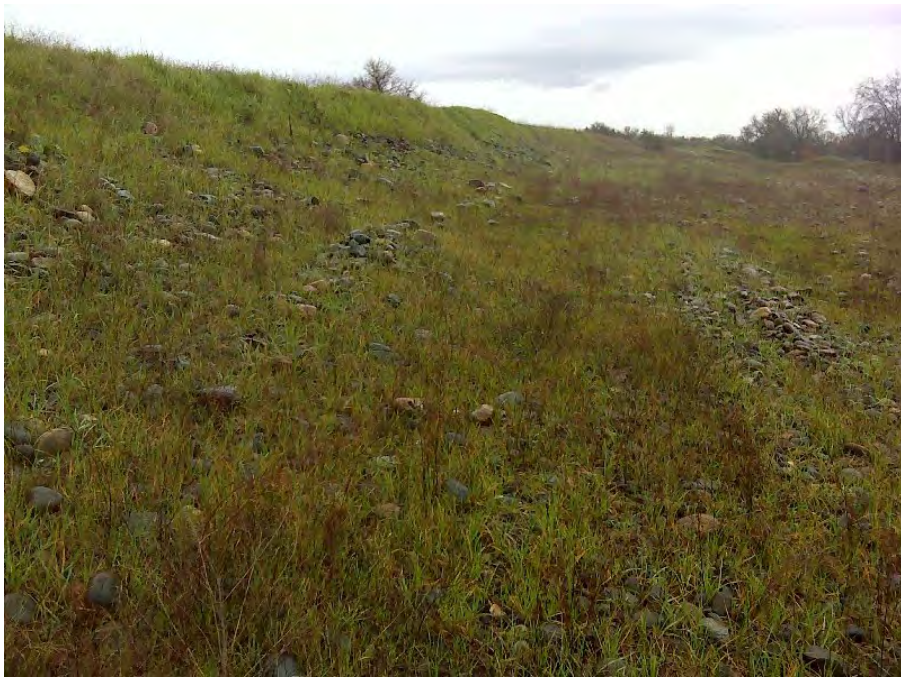
Photo 2. Waterside levee slope, looking upstream.

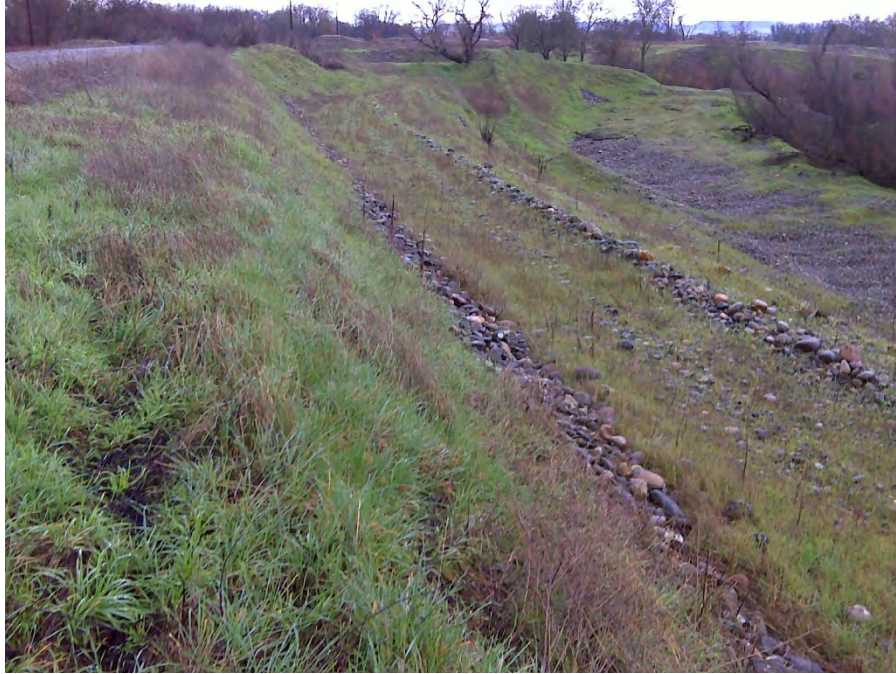
Photo 3. Landside levee slope, looking downstream.

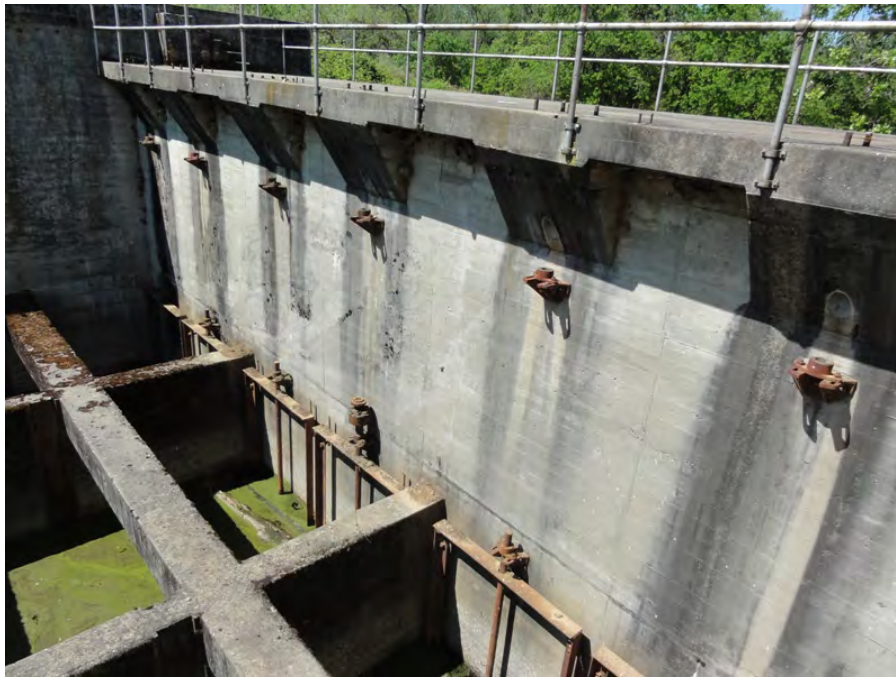
Photo 4. Sutter Butte Canal Headgate Structure. Note gate stems and hoist mechanisms have been removed, leaving the gates “stuck” in the closed position.

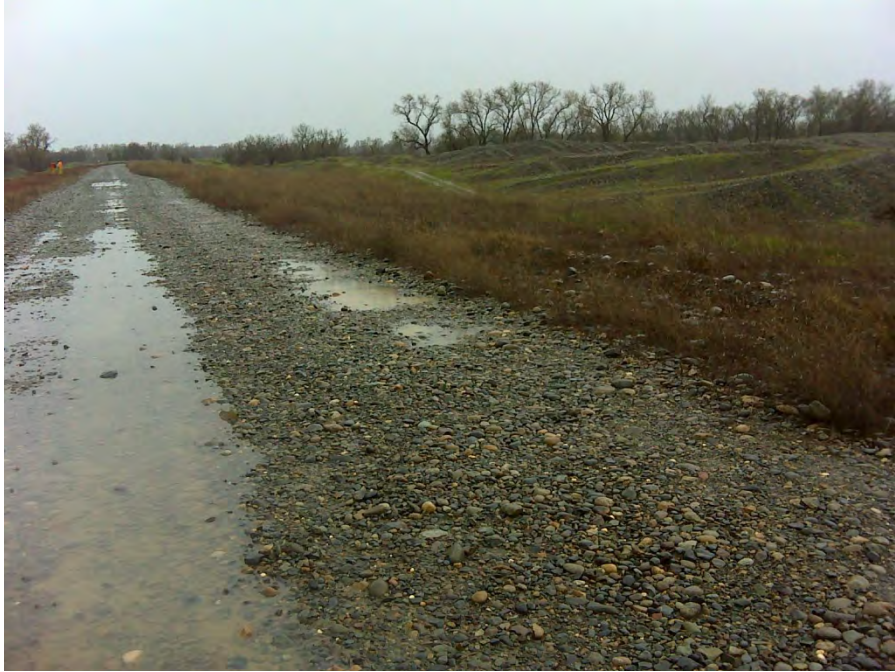
Photo 5. Dredge tailings on the waterside of the levee. Note tailings are higher than the levee crest in some locations.

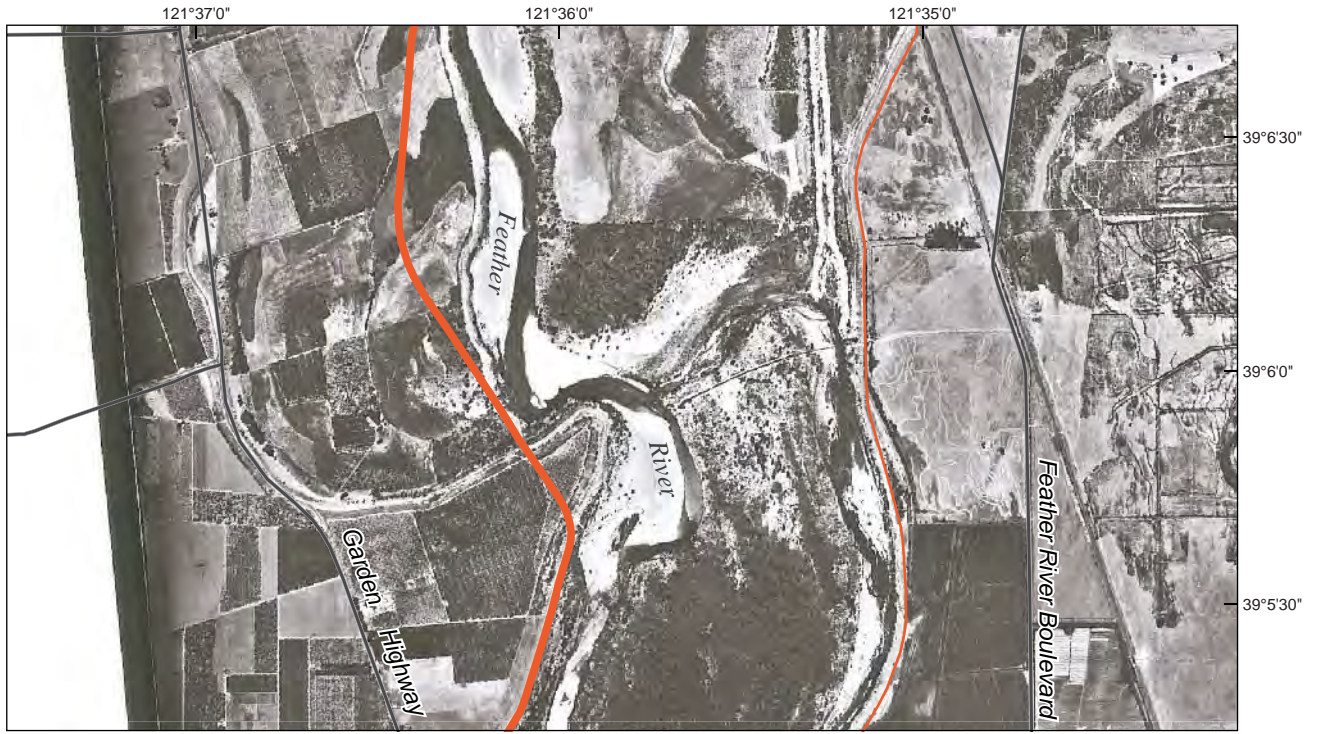
A. 1937 USDA Air Photo

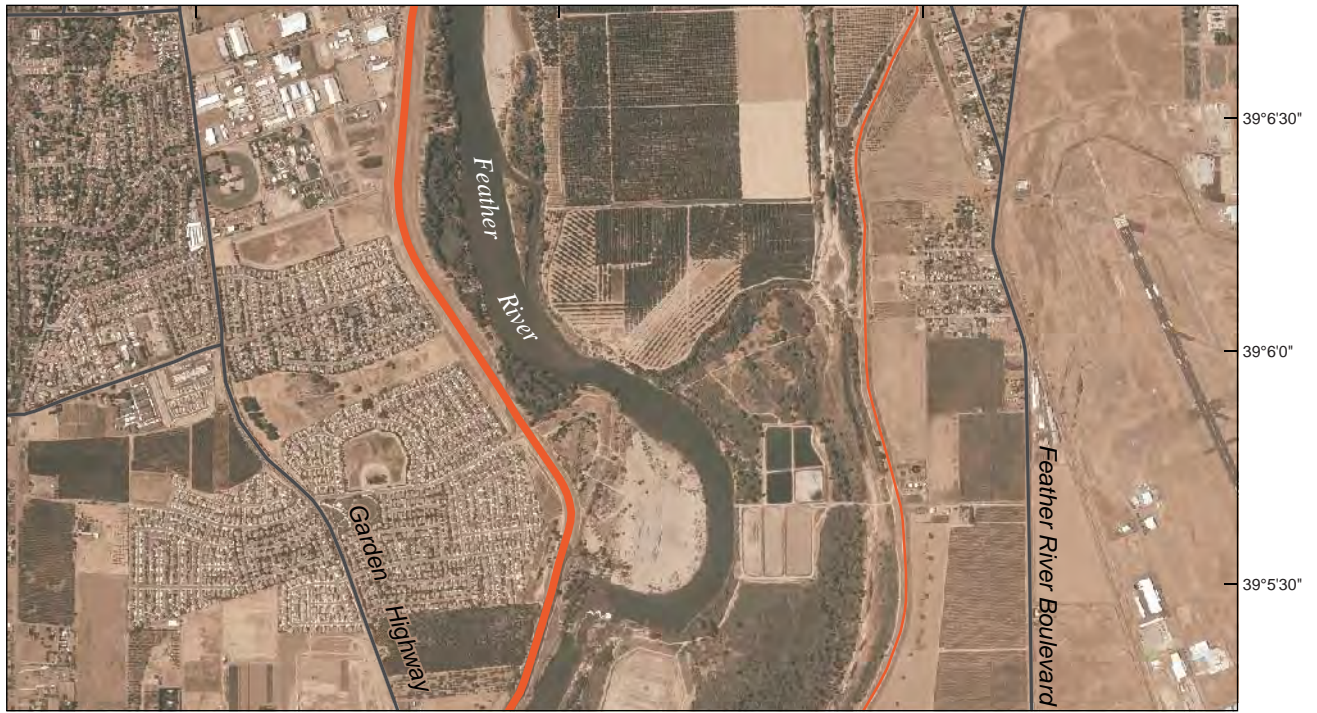
B. 2006 NAIP Ortho Imagery
