**US Army Corps
of Engineers**
Sacramento District

SACRAMENTO DISTRICT FLOOD DAMAGE REDUCTION SEGMENT INSPECTION FLOWCHART

This flowchart was created by the Flood Protection and Navigation Section of the U.S. Army Corps of Engineers (USACE) Sacramento District (SPK) in consultation with the Geotechnical Engineering Branch (SPK). The Department of Water Resources also worked with the Flood Project and Navigation Section to clarify the checklist in creating the inspection flow chart. The intention is to aid USACE inspectors, Department of Water Resource inspectors and contractors to rate levee segments which are a part of the Rehabilitation and Inspection Program in a consistent manner which meets the standards defined by the USACE checklist. This flowchart quantifies the items in the checklist and is intended to improve consistency among inspectors, but it is not intended replace common sense, engineering judgment or the wording used in the checklist.

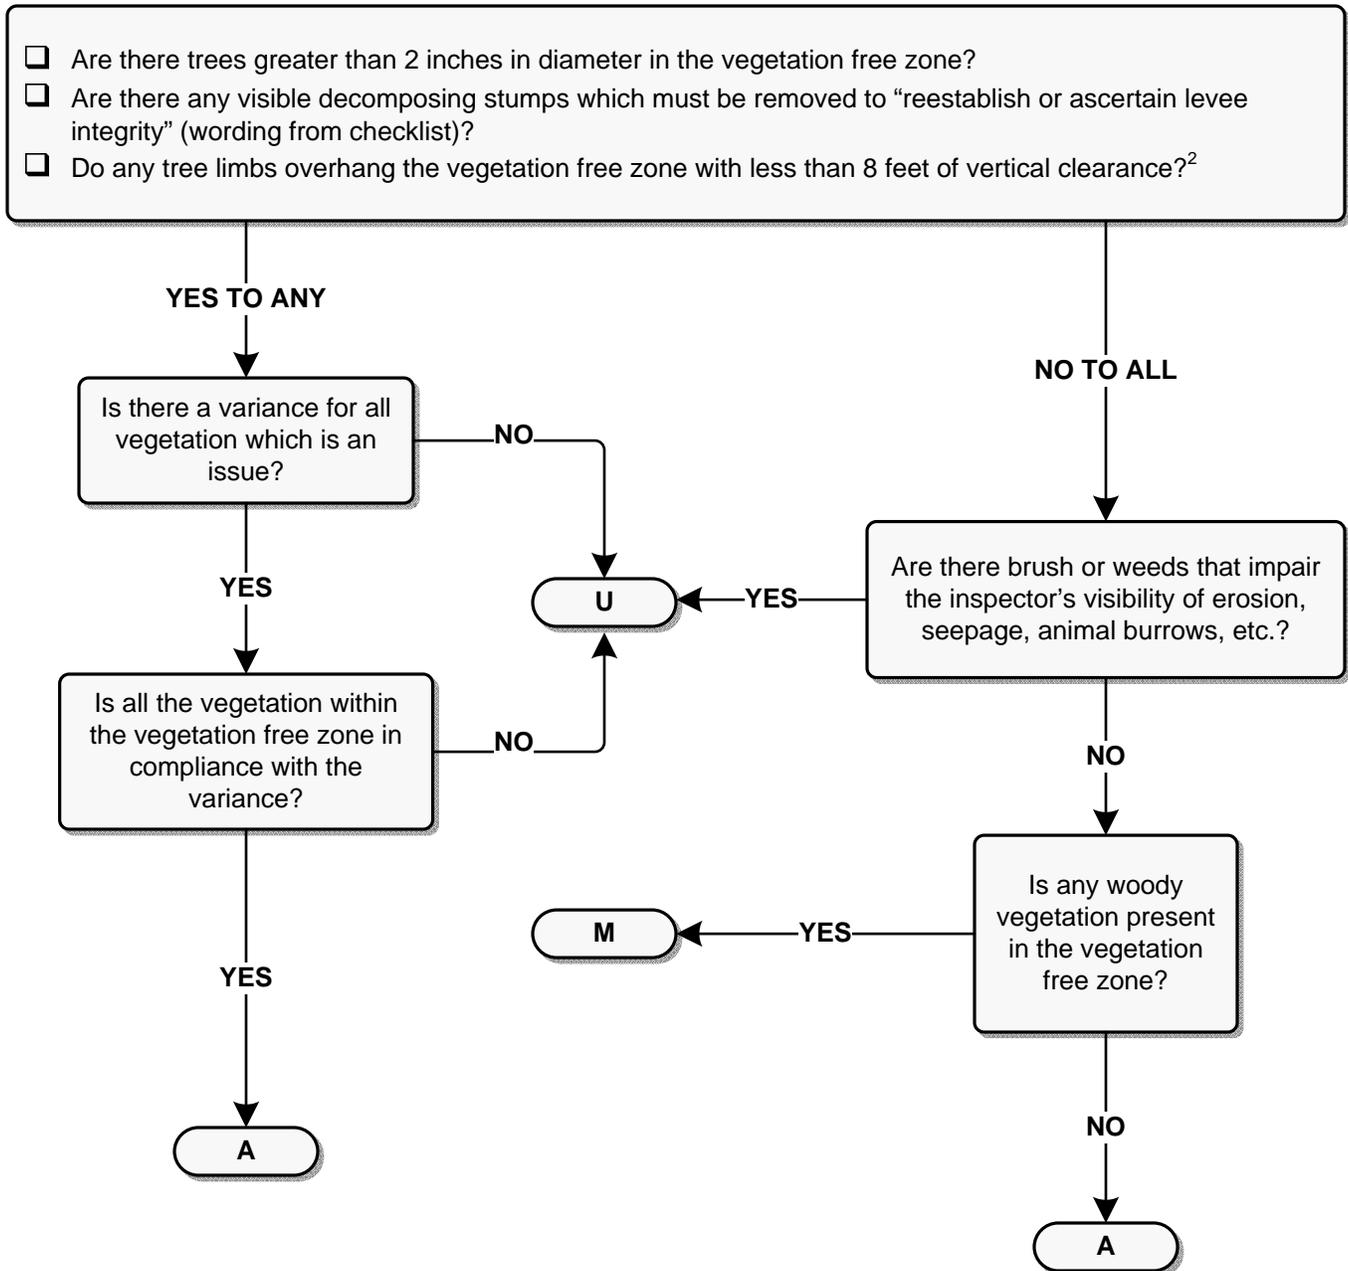
1. UNWANTED VEGETATION GROWTH

The vegetation free zone is described in the USACE checklist as an area which “extends 15 feet from both the landside and riverside levee toes to the centerline of the tree. If the levee access easement doesn’t extend to the described limits, then the vegetation free zone must be maintained to the easement limits.” Reference ETL 1110-2-571¹ for more details.

▪ Stumps and fallen trees should be recorded under vegetation.

² If the only instance of overhanging limbs is from a newly planted tree that is confined within the 4' X 7' transition zone, refer to ETL 1110-2-571 for additional guidance.

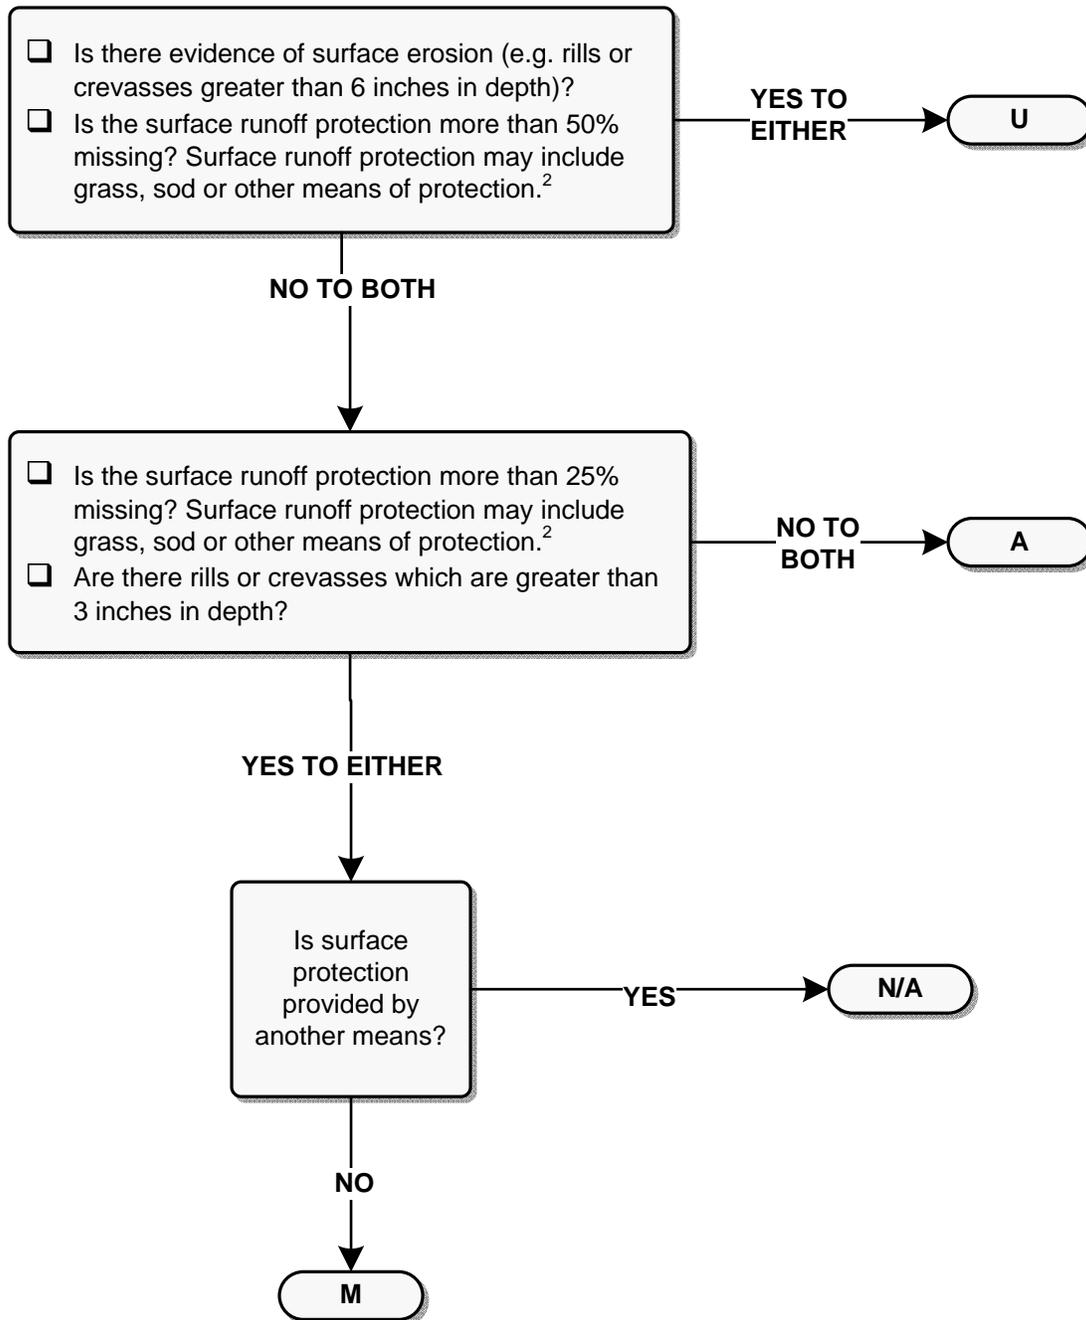
2. SOD COVER¹

¹ "Sod Cover" for the purposes of the Sacramento District Flood Damage Reduction Segment Inspection Flowchart refers to the surface runoff protection of the levee slopes to protect against surface erosion. This includes rating the levee for erosion caused by surface runoff.

² If the vegetation height impairs the inspector's visibility of the levee slopes, this should be rated "U" under Item 1 – Unwanted Vegetation Growth

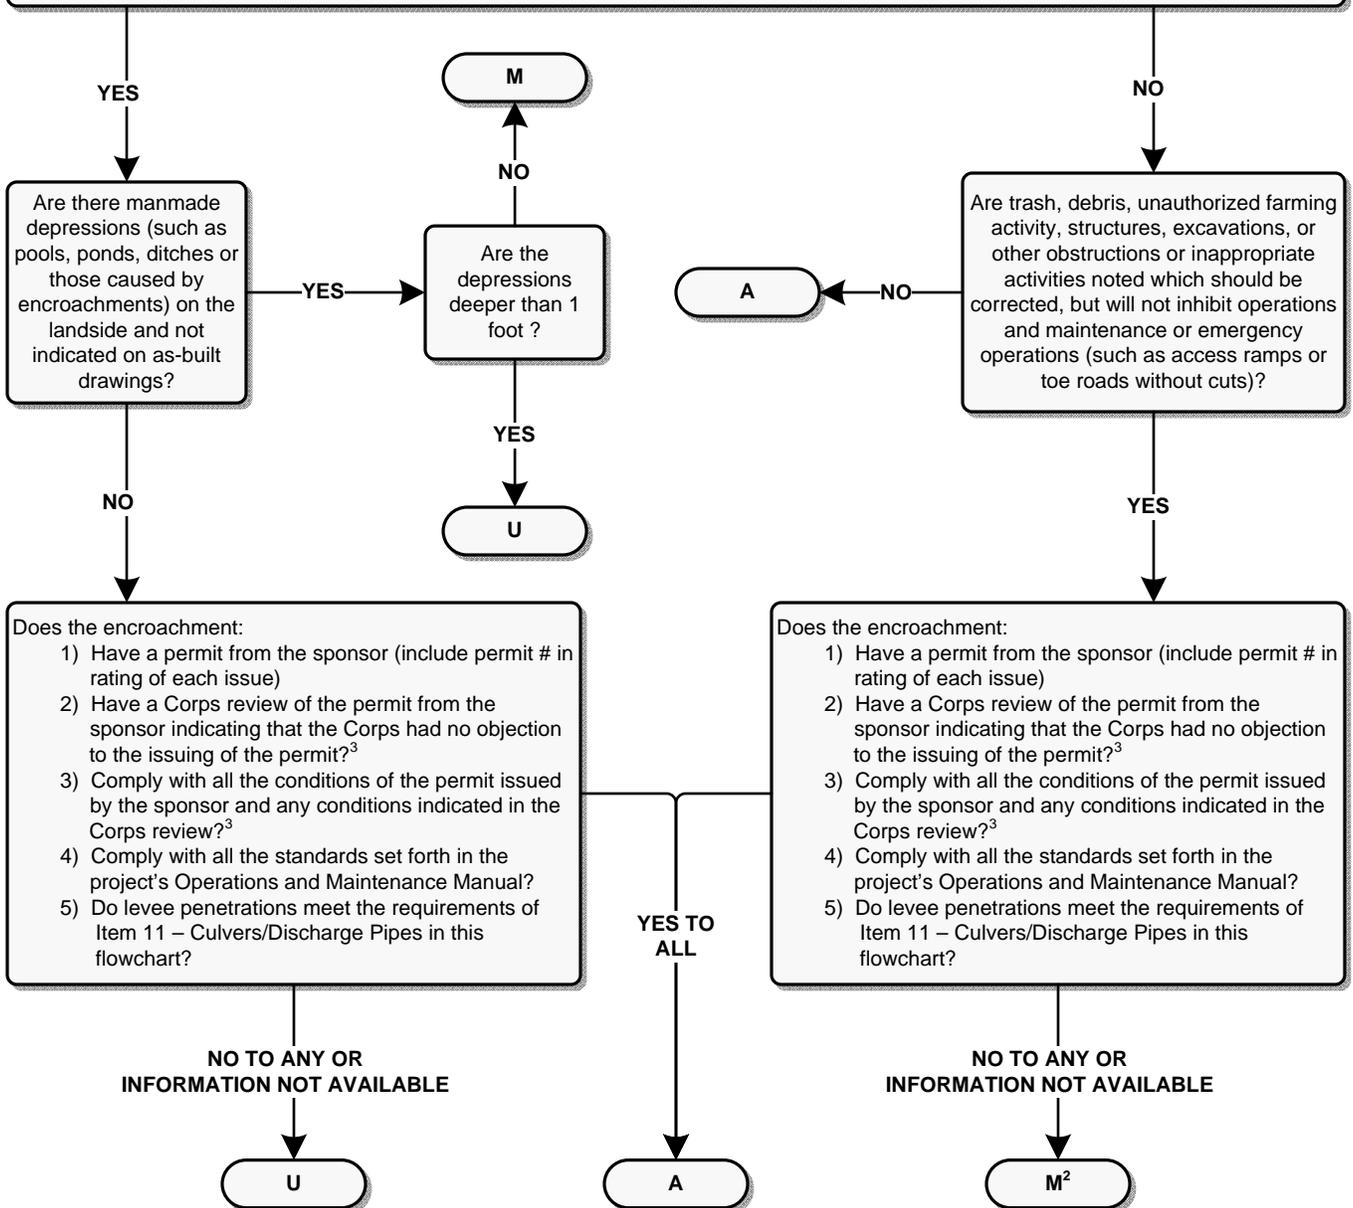
3. ENCROACHMENTS¹

Is there an updated levee log which addresses whether each encroachment complies with conditions 1–5 listed below?
 If not, speak to the sponsor about providing this prior to the next inspection. (Inform them that all encroachments will be rated as if they do not have permits unless the permit is made available by the sponsor or the inspector happens to have the permit on hand. It is the sponsor's responsibility to maintain an updated levee log and show proof of permits during the inspection if requested.)

Are there any encroachments on the levee slopes or in the easement area which are likely to inhibit operations and maintenance, emergency operations, or negatively impact the levee integrity?

These may include, but are not limited to:
 power poles, solid board fences, barbed wire fences, any fence or gate that crosses the levee, excavation into the levee prism, irrigation lines, landside toe roads, trash that has been on the levee more than a year and is likely to provide habitat for rodents, decomposing pipes, pipes without an accessible positive closure device at the waterside hinge, retaining walls, ditches which increase the potential for seepage, and concrete blocks with rebar which pose a safety threat to flood fighters.

¹ If the encroachment in question is a pipe (pipes crossing through the levee or running parallel to the levee toe in the easement area that are not a part of the federal project), determine two ratings using this flow chart and the flow chart for item 11. The issue rating will be the lower of the two ratings. Record this rating under item 3 only.

² If a permit is not available during future inspections, minimally acceptable encroachments risk receiving an unacceptable rating during future inspections.

³ If this is a non-Federal levee then proof of compliance with USACE permitting standards at the time the permit was issued by the sponsor is sufficient. Note that USACE does not have authorization to fund USACE personnel to review non-Federal permit applications.

- Do not rate paving on the levee crown as an encroachment.
- Toe ditches will be rated "M" for seepage if seepage cannot be ascertained due to water in the ditch or "U" if active seepage or evidence of past seepage is observed.
- Encroachments causing issues severe enough to receive a "U" rating under other items (e.g. Depressions/Rutting, Slope Stability, Erosion) should also be rated "U" for those items.

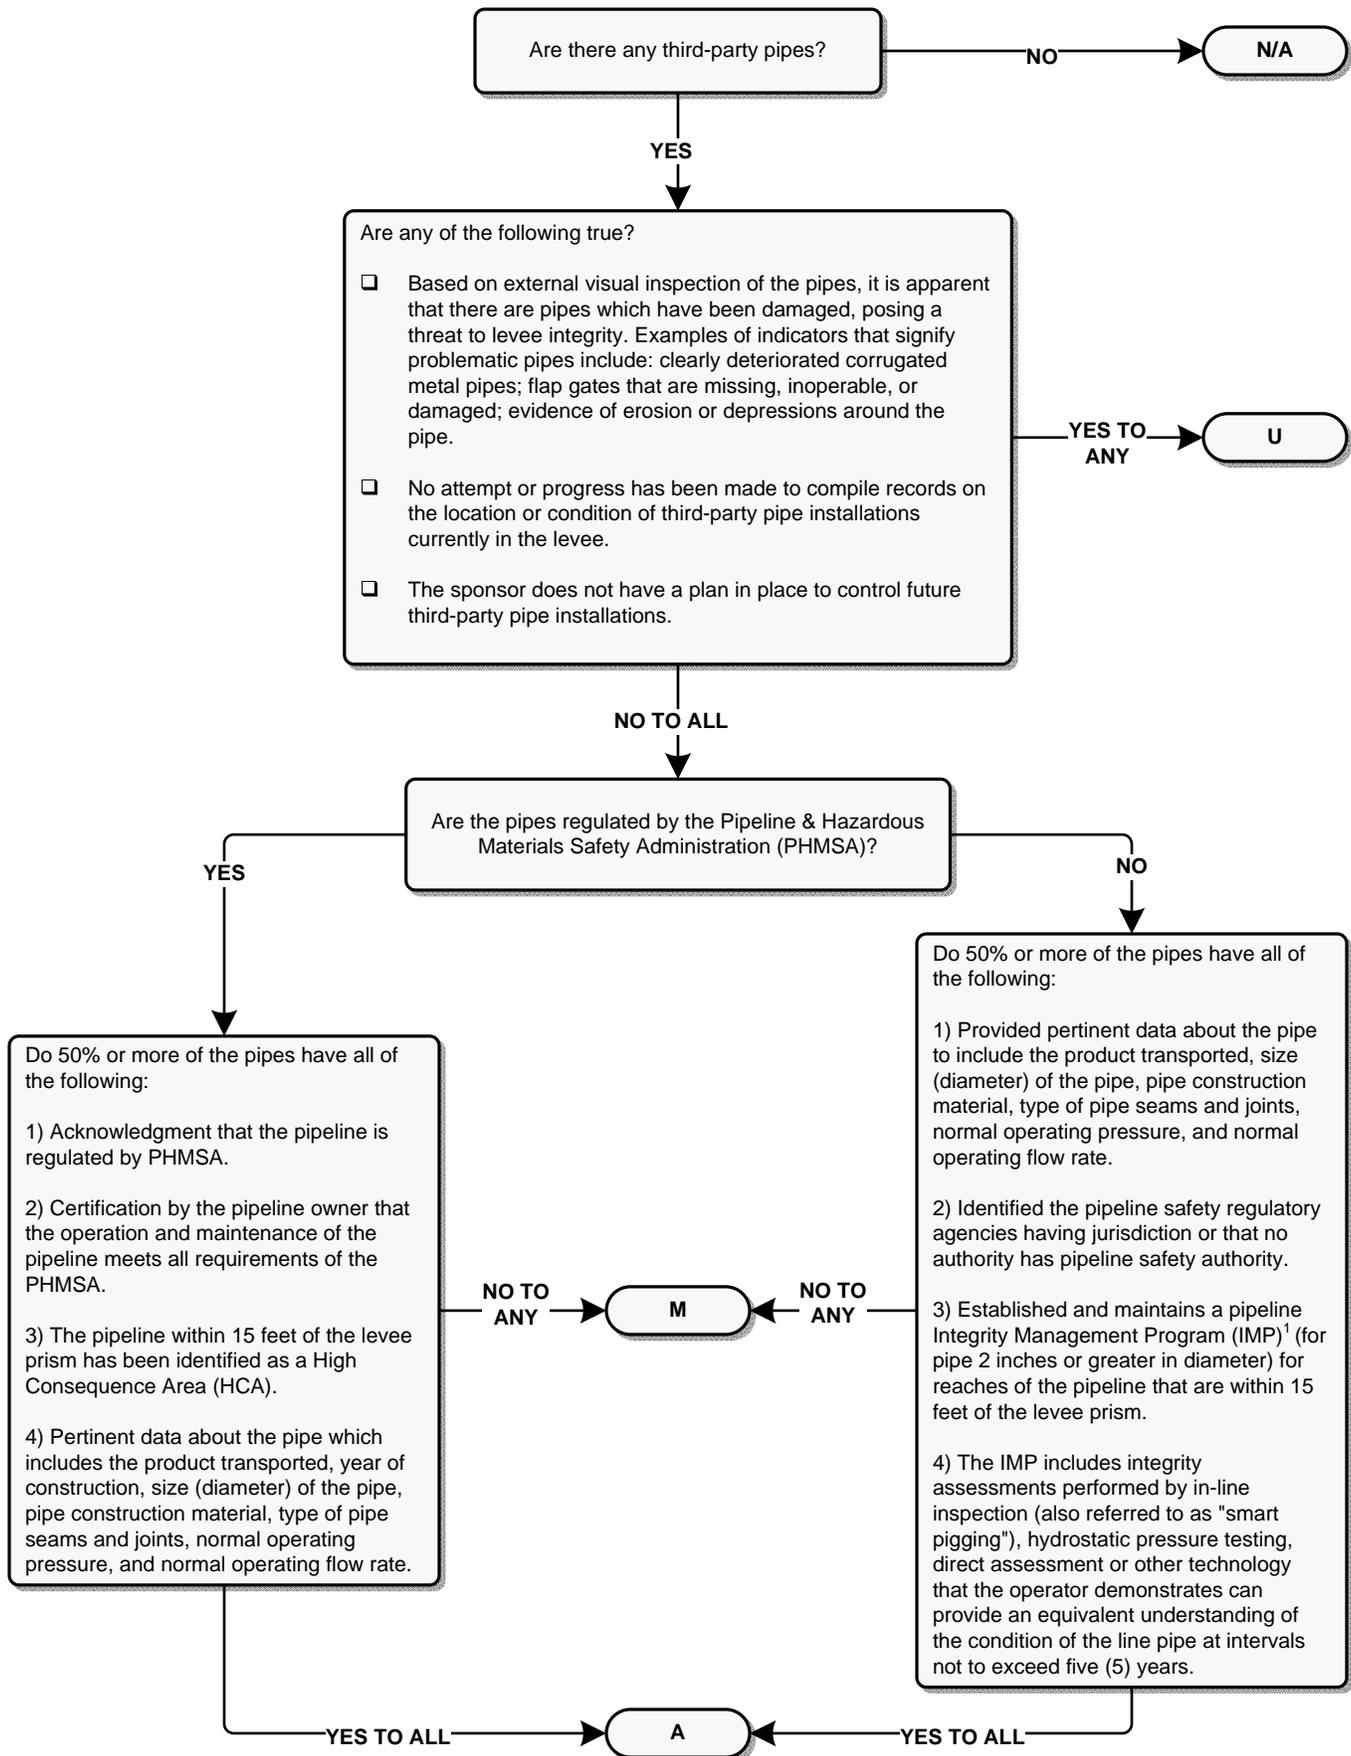
3. ENCROACHMENTS: PIPES

¹ Reference the inspection checklist for IMP requirements.

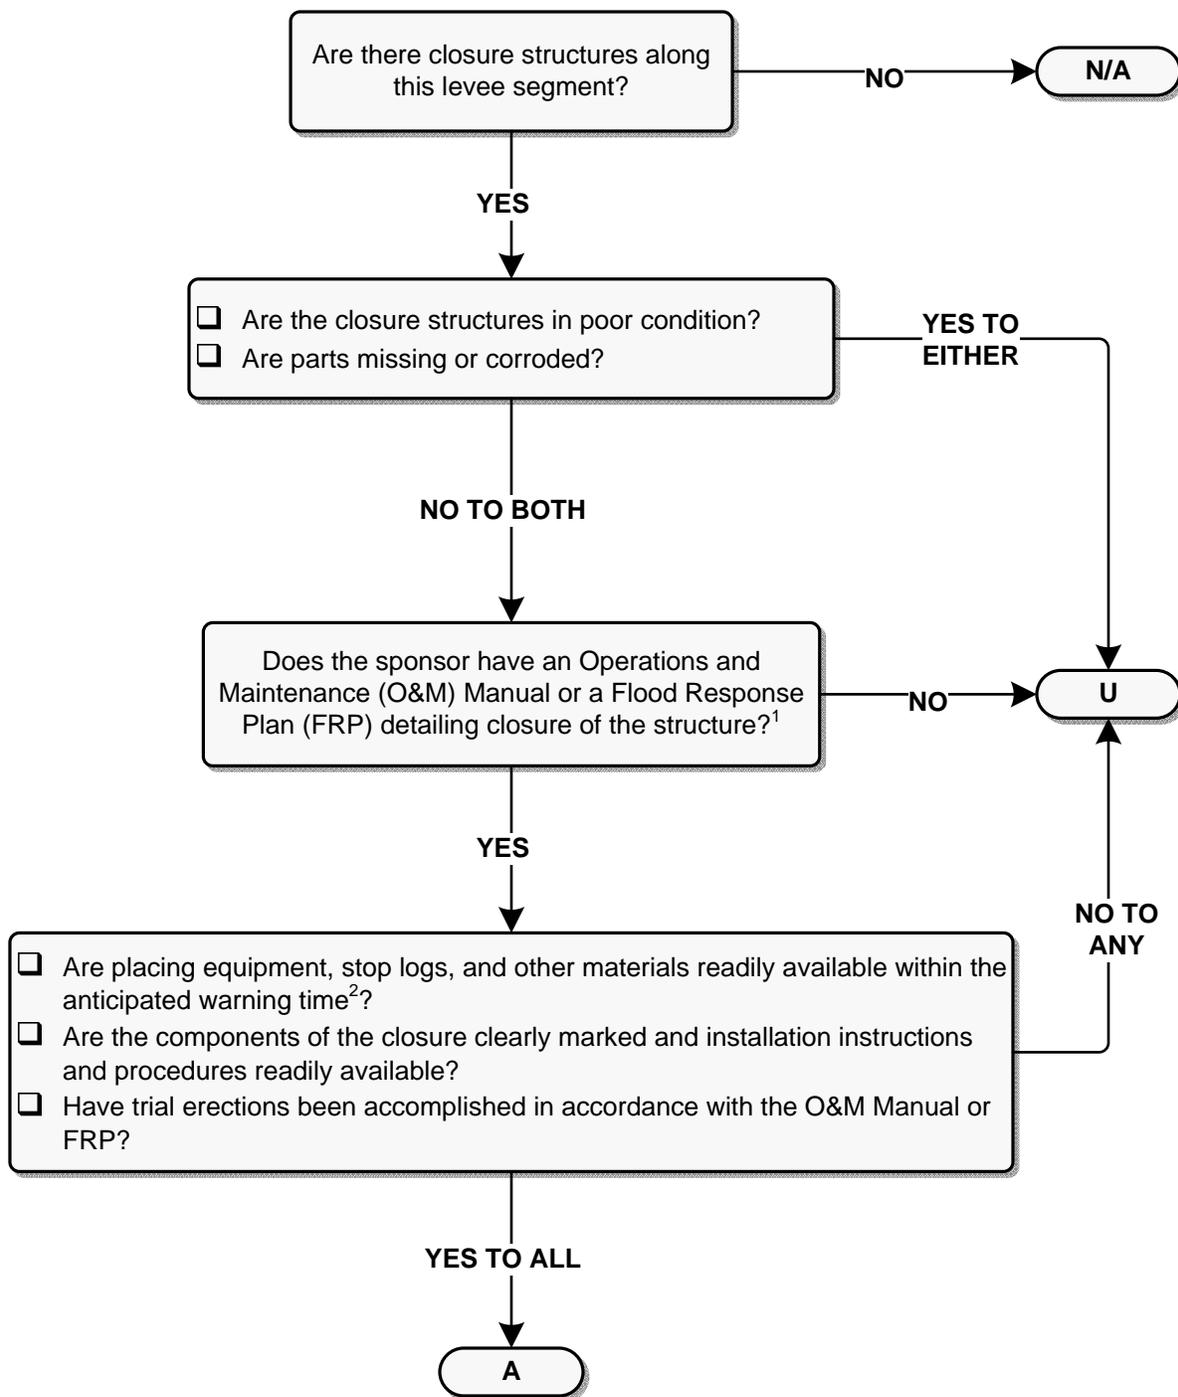
4. CLOSURE STRUCTURES

¹ If the sponsor does not have an O&M Manual or a FRP detailing closure of the structure, also assign an M rating in General Items: Item 3 – Flood Preparedness and Training.

² Anticipated warning time and material acquisition can be found in either the O&M Manual or the FRP.

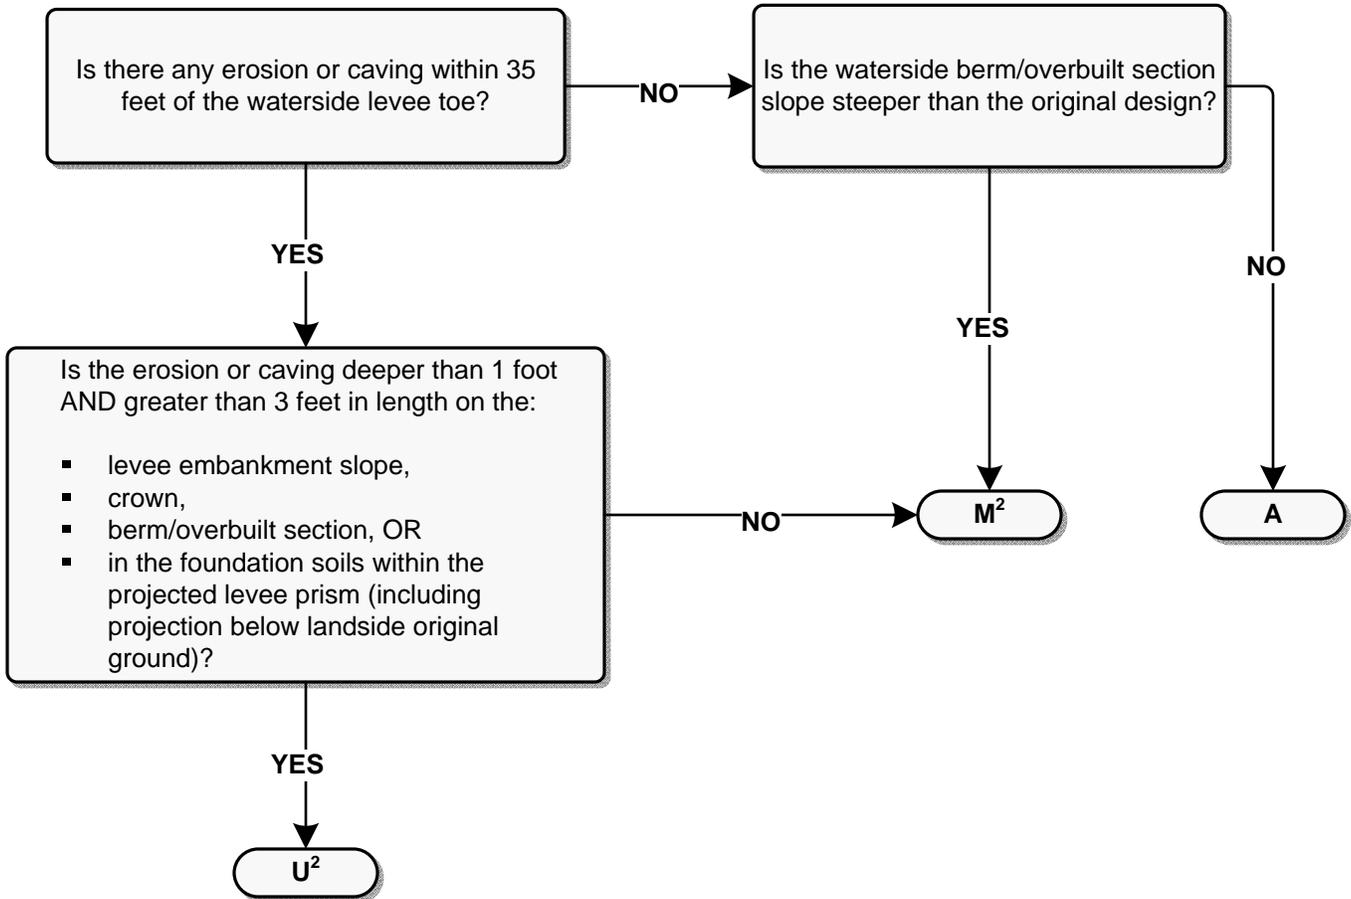
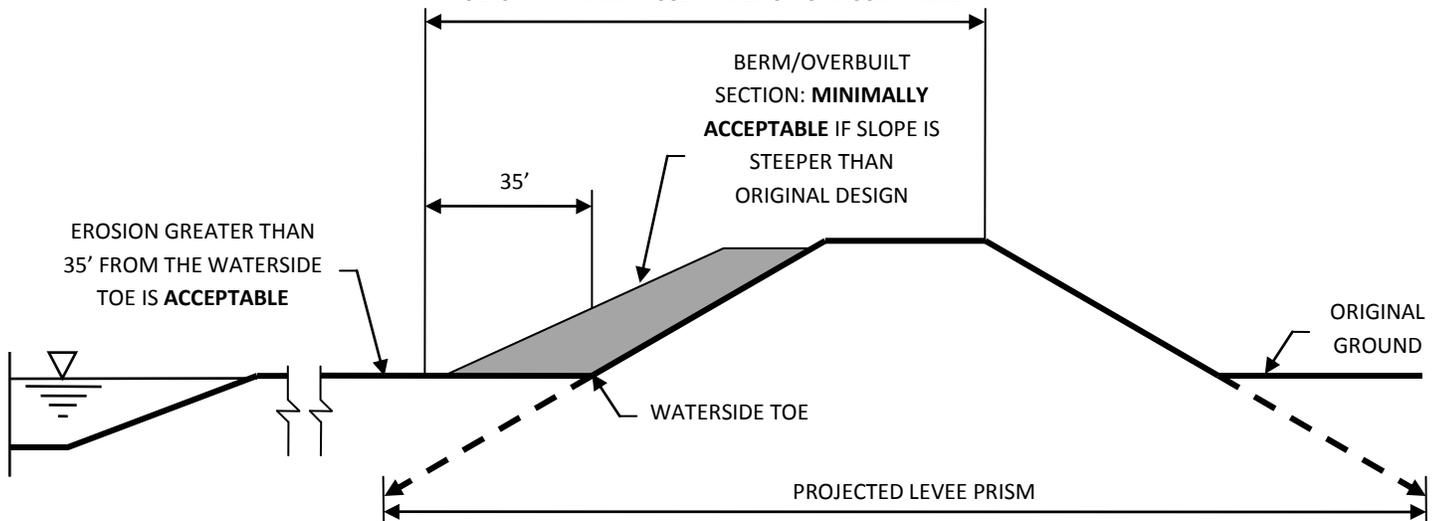
6. EROSION/BANK CAVING¹

EROSION ON THE SLOPE, CROWN, BERM/OVERBUILT SECTION, OR PROJECTED LEVEE PRISM WITHIN 35' FROM THE WATERSIDE TOE IS **MINIMALLY ACCEPTABLE** OR **UNACCEPTABLE**

¹ Erosion due to surface runoff is recorded under *Item 2. Sod Cover*.

² Oversteepening of the waterside berm is rated under this item (*Erosion*) alone. Oversteepening of the embankment slopes is also rated M under *Item 5. Slope Stability*.

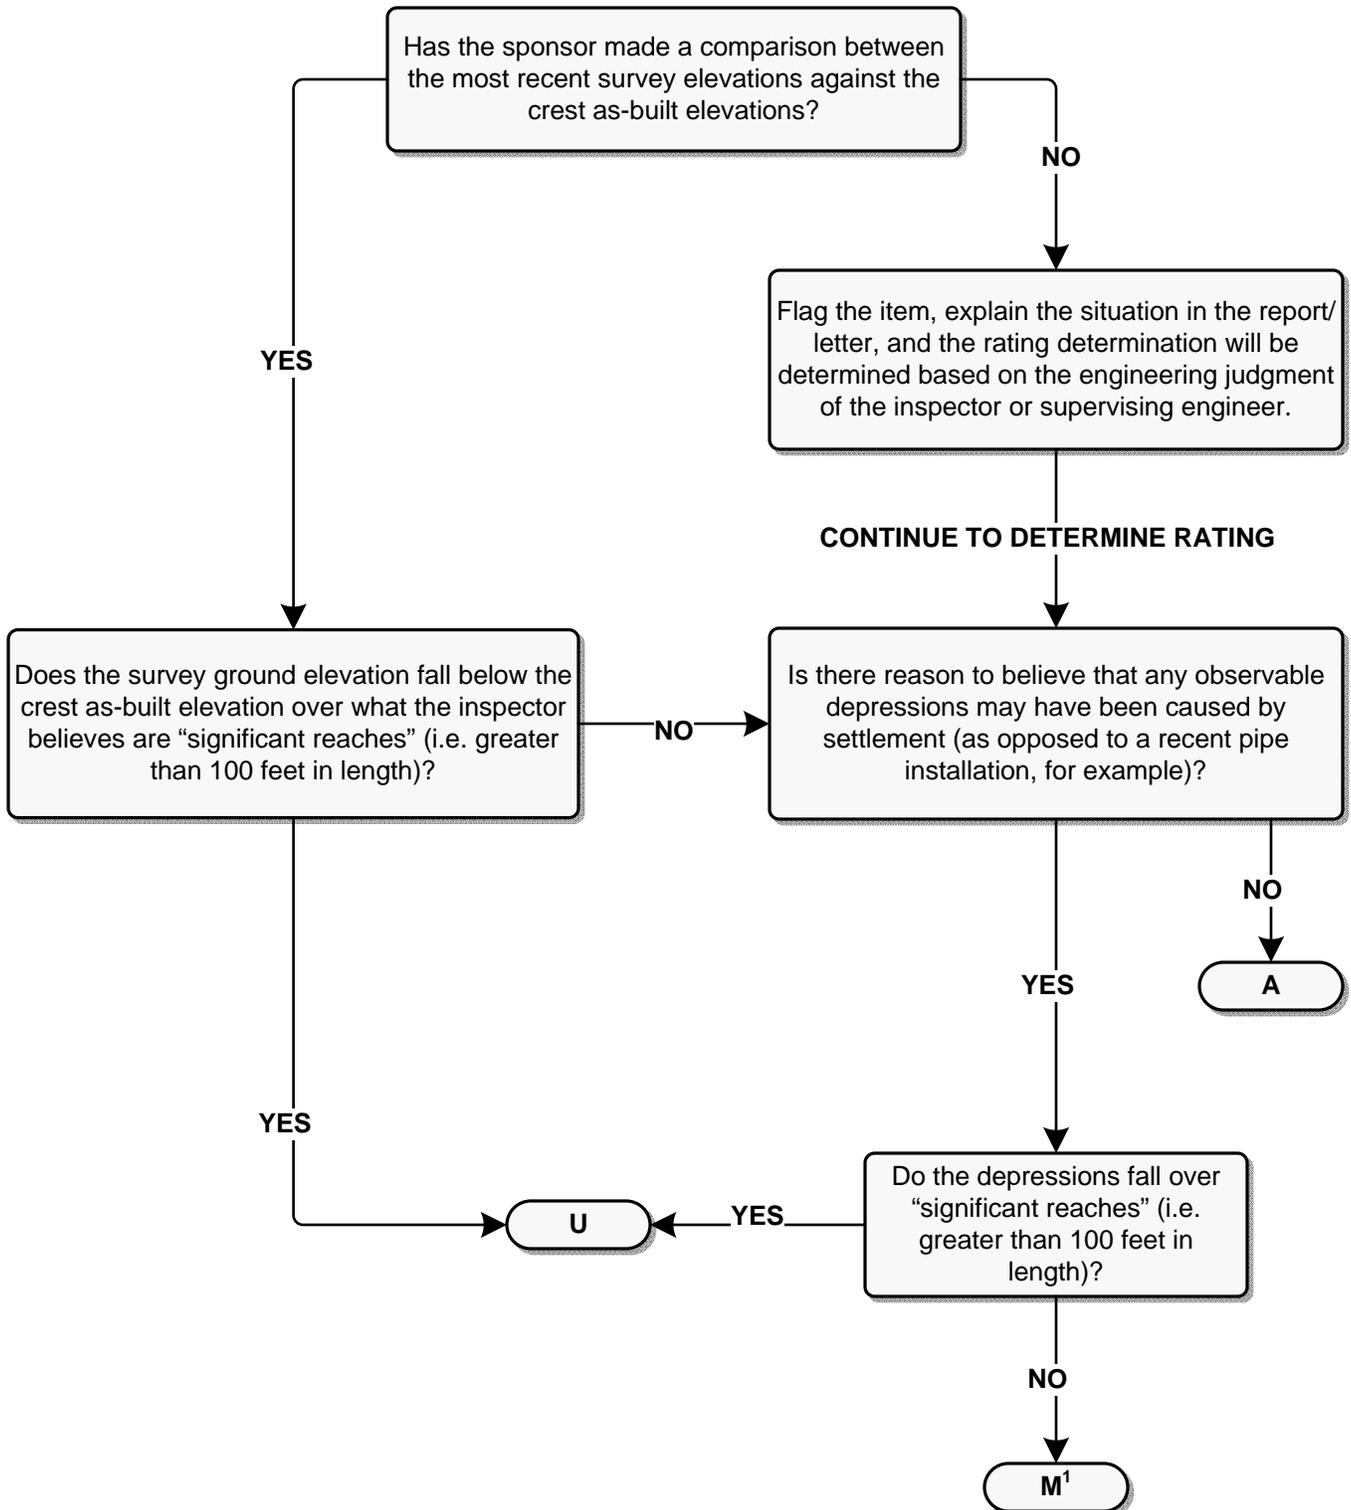
7. SETTLEMENT

¹ Depressions less than 100 feet in length should be rated under *Item 8. Depressions/Rutting*

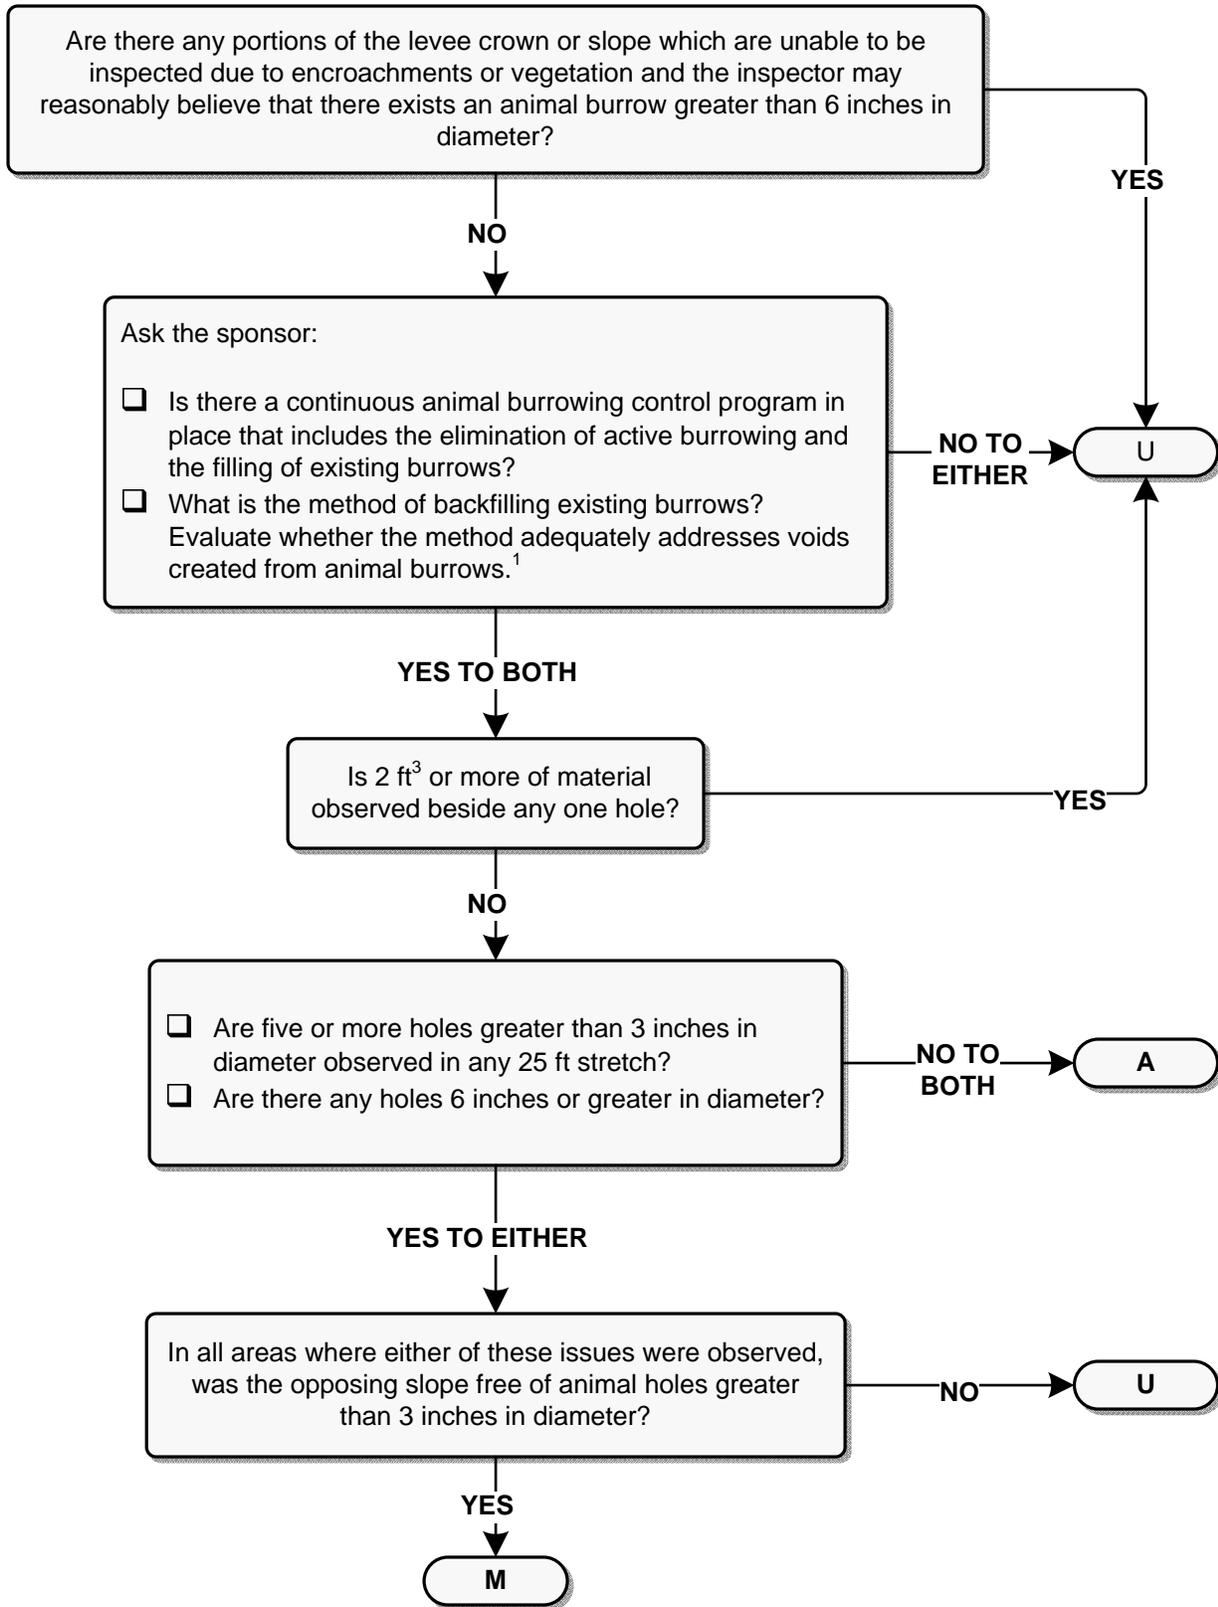
10. ANIMAL CONTROL

¹ During past inspections, we have observed that the following methods have been effective: 1) digging and backfilling (4-6 inch lifts with 98% compaction), 2) grouting (however, there are concerns regarding the interface between the grout and soil and its effectiveness). Experience has also shown that the following methods caused instability issues: 1) Any technique that involves collapsing the burrows (e.g. Rodenator, road roller), 2) shoveling.

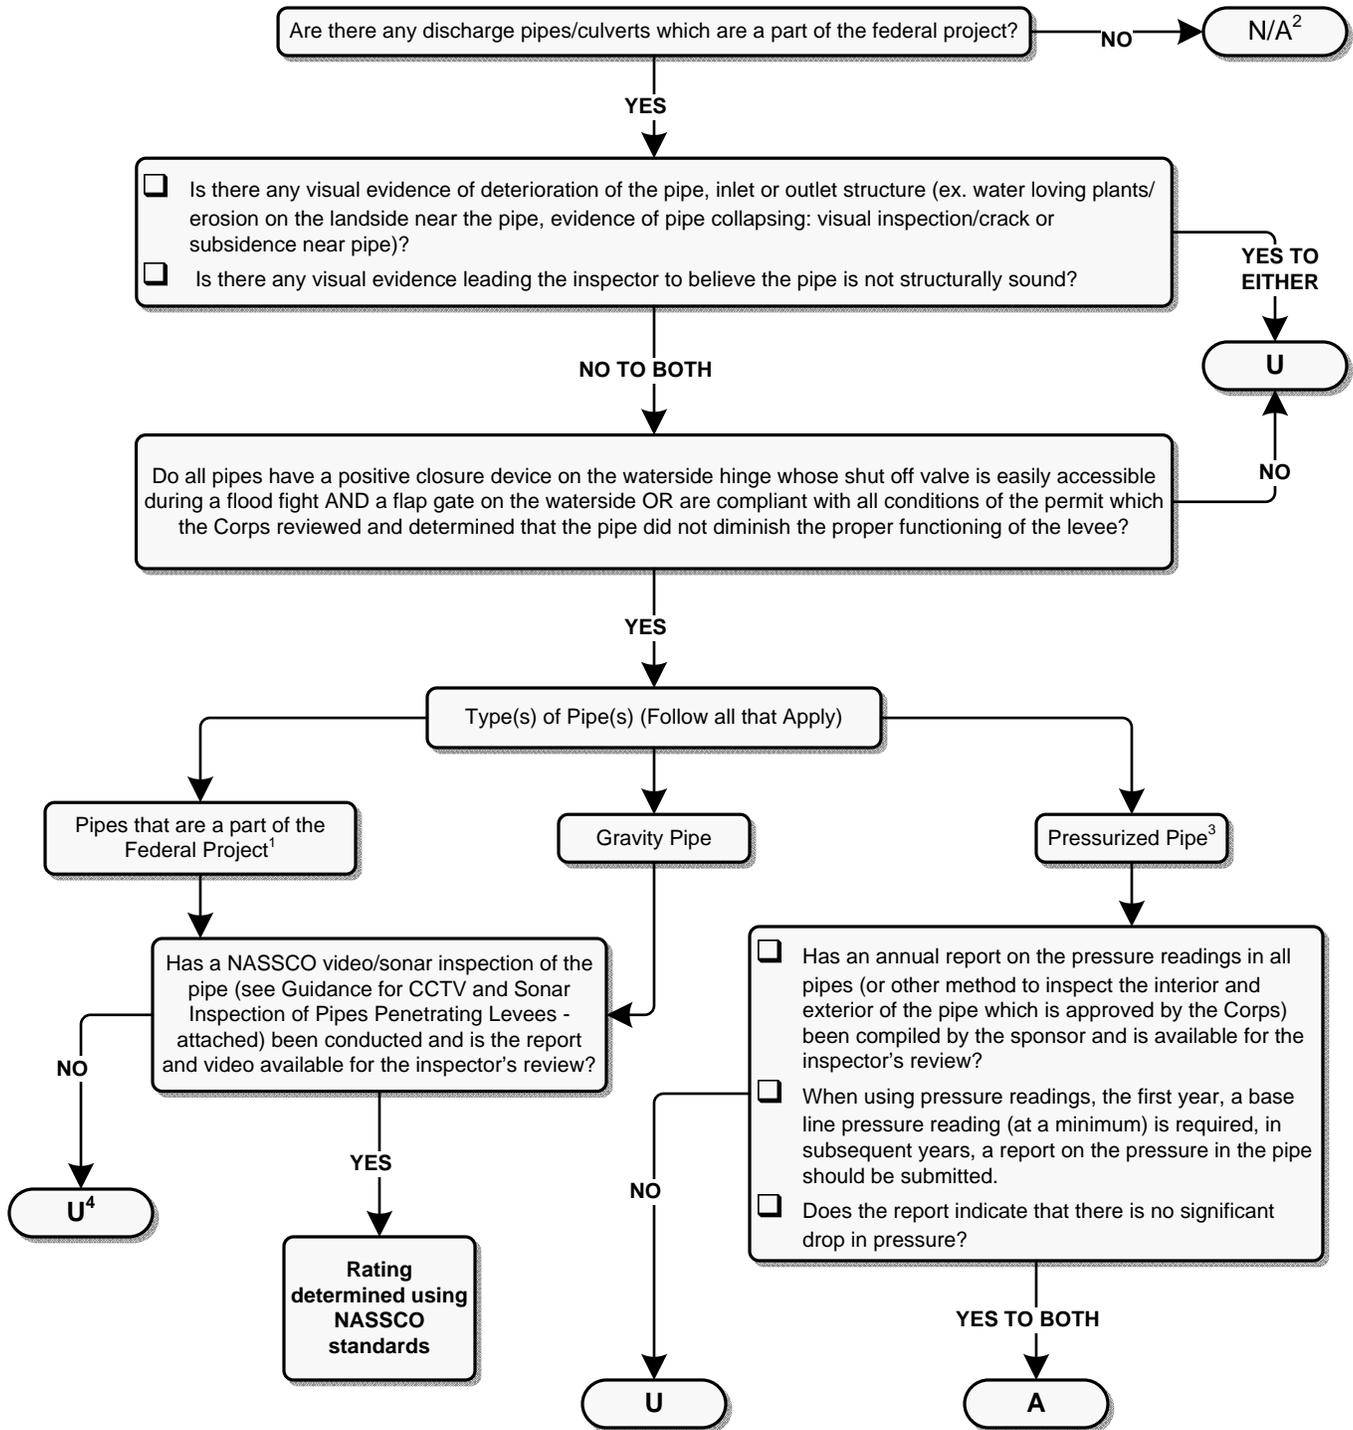
11. CULVERTS/DISCHARGE PIPES

¹ This item is used to evaluate any pipe passing through the levee cross section that is part of the Federal flood control project. If the O&M Manual specified that a pipe is attached to a pump station or is to be used for interior drainage, then it is also evaluated in the "Pump Station" or "Interior Drainage" Checklist. Drainage canals would also be covered in the interior drainage checklist.

² If there are any discharge pipes/culverts that are not part of the federal project, this flow chart should be followed, in addition to the flow chart in item 3. "Encroachments" and the issue will receive the lower of the two ratings, but the rating should be entered under item 3. "Encroachments".

³ Pressurized pipes – all pipes subject to pressure (continuous or intermittent) this includes irrigation pipes, gas lines and water lines.

⁴ Not having a video inspection, or the intent therein met (e.g. sonar inspection, pressure report), will lead to an unacceptable *item* rating. However, if this is the only issue (not having the video inspection) which could lead to an overall unacceptable *segment* rating it is SPK Policy that this alone does not imply an unacceptable *segment* rating. However, if a video inspection is not submitted within an acceptable period of time, not to exceed two years, an unacceptable *segment* rating will result.

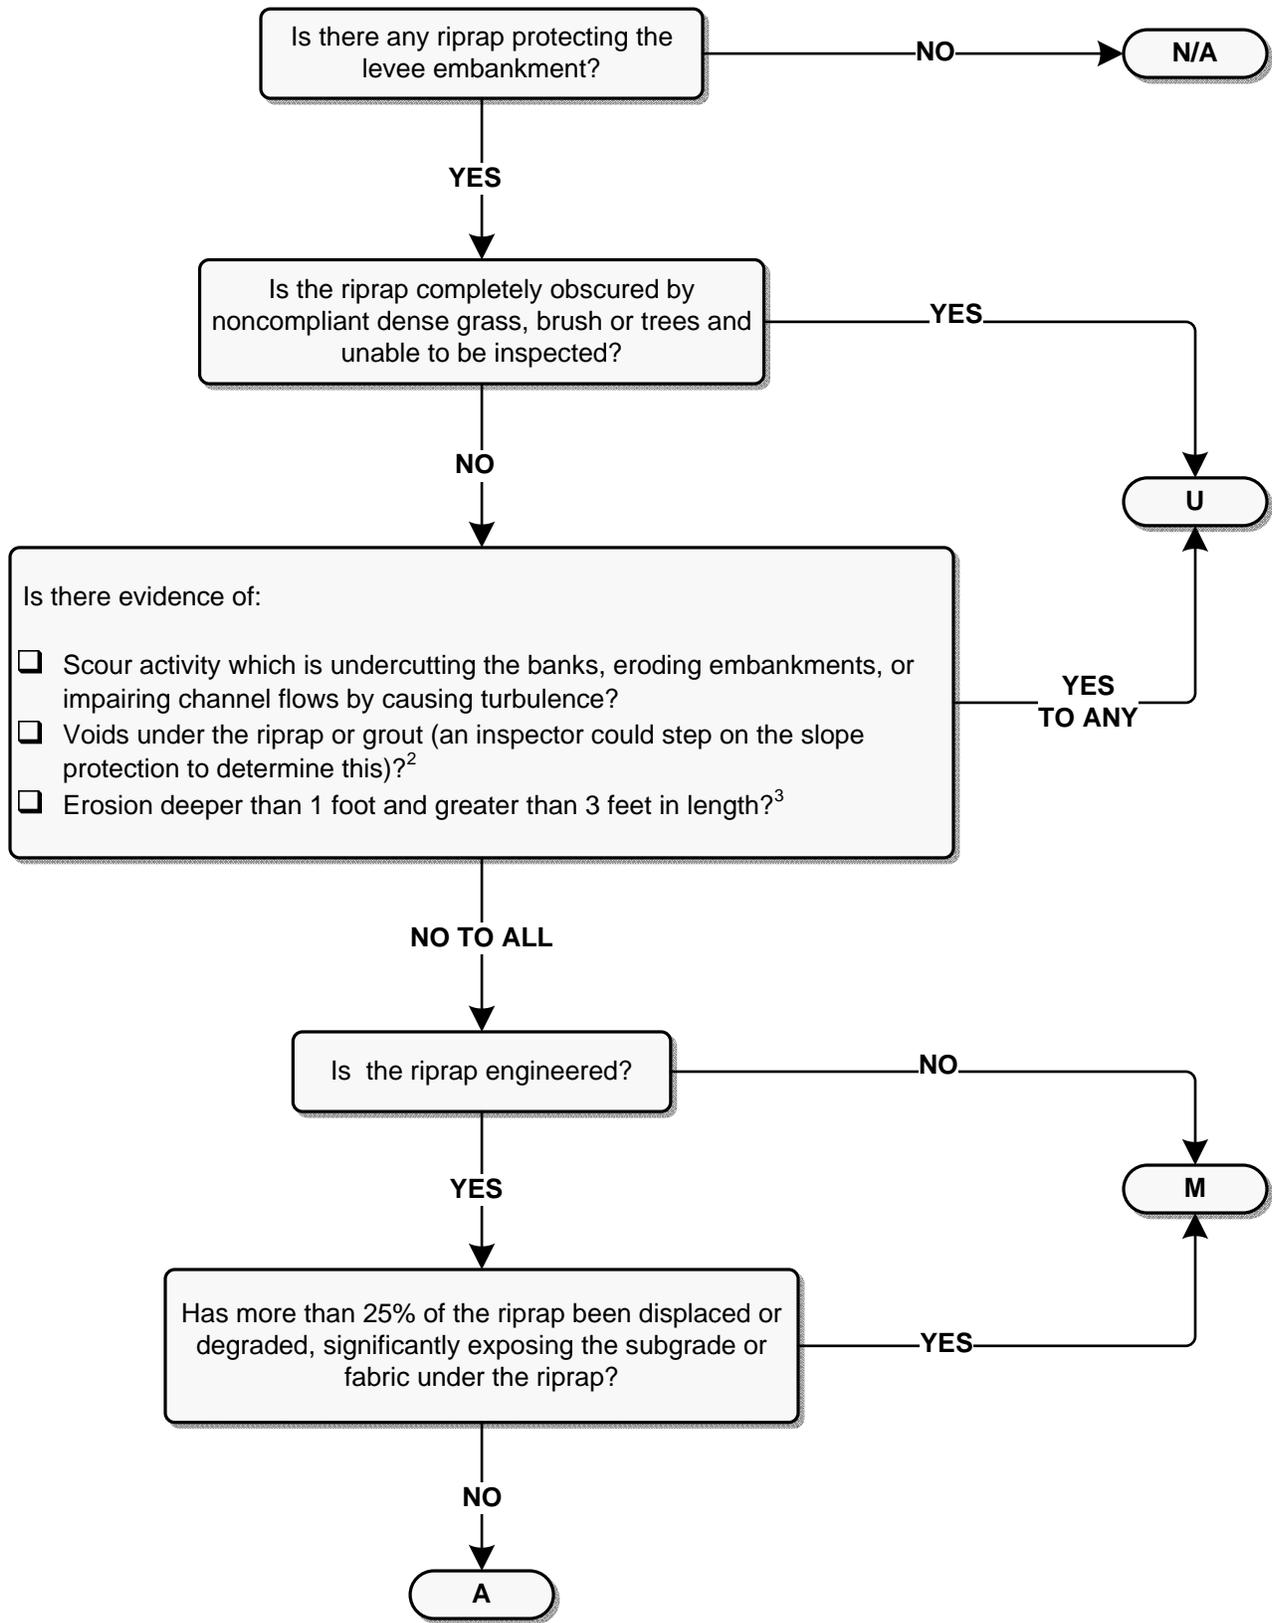
12. RIPRAP REVETMENTS & BANK PROTECTION (ARMORING USING STONE)¹

¹ Includes grouted riprap

² If there is any grout cracking or voids in grouted riprap, recommend that the sponsor repair the crack or void.

³ If there is erosion deeper than 1 foot and greater than 3 feet in length, also rate as U under *Item 6. Erosion*

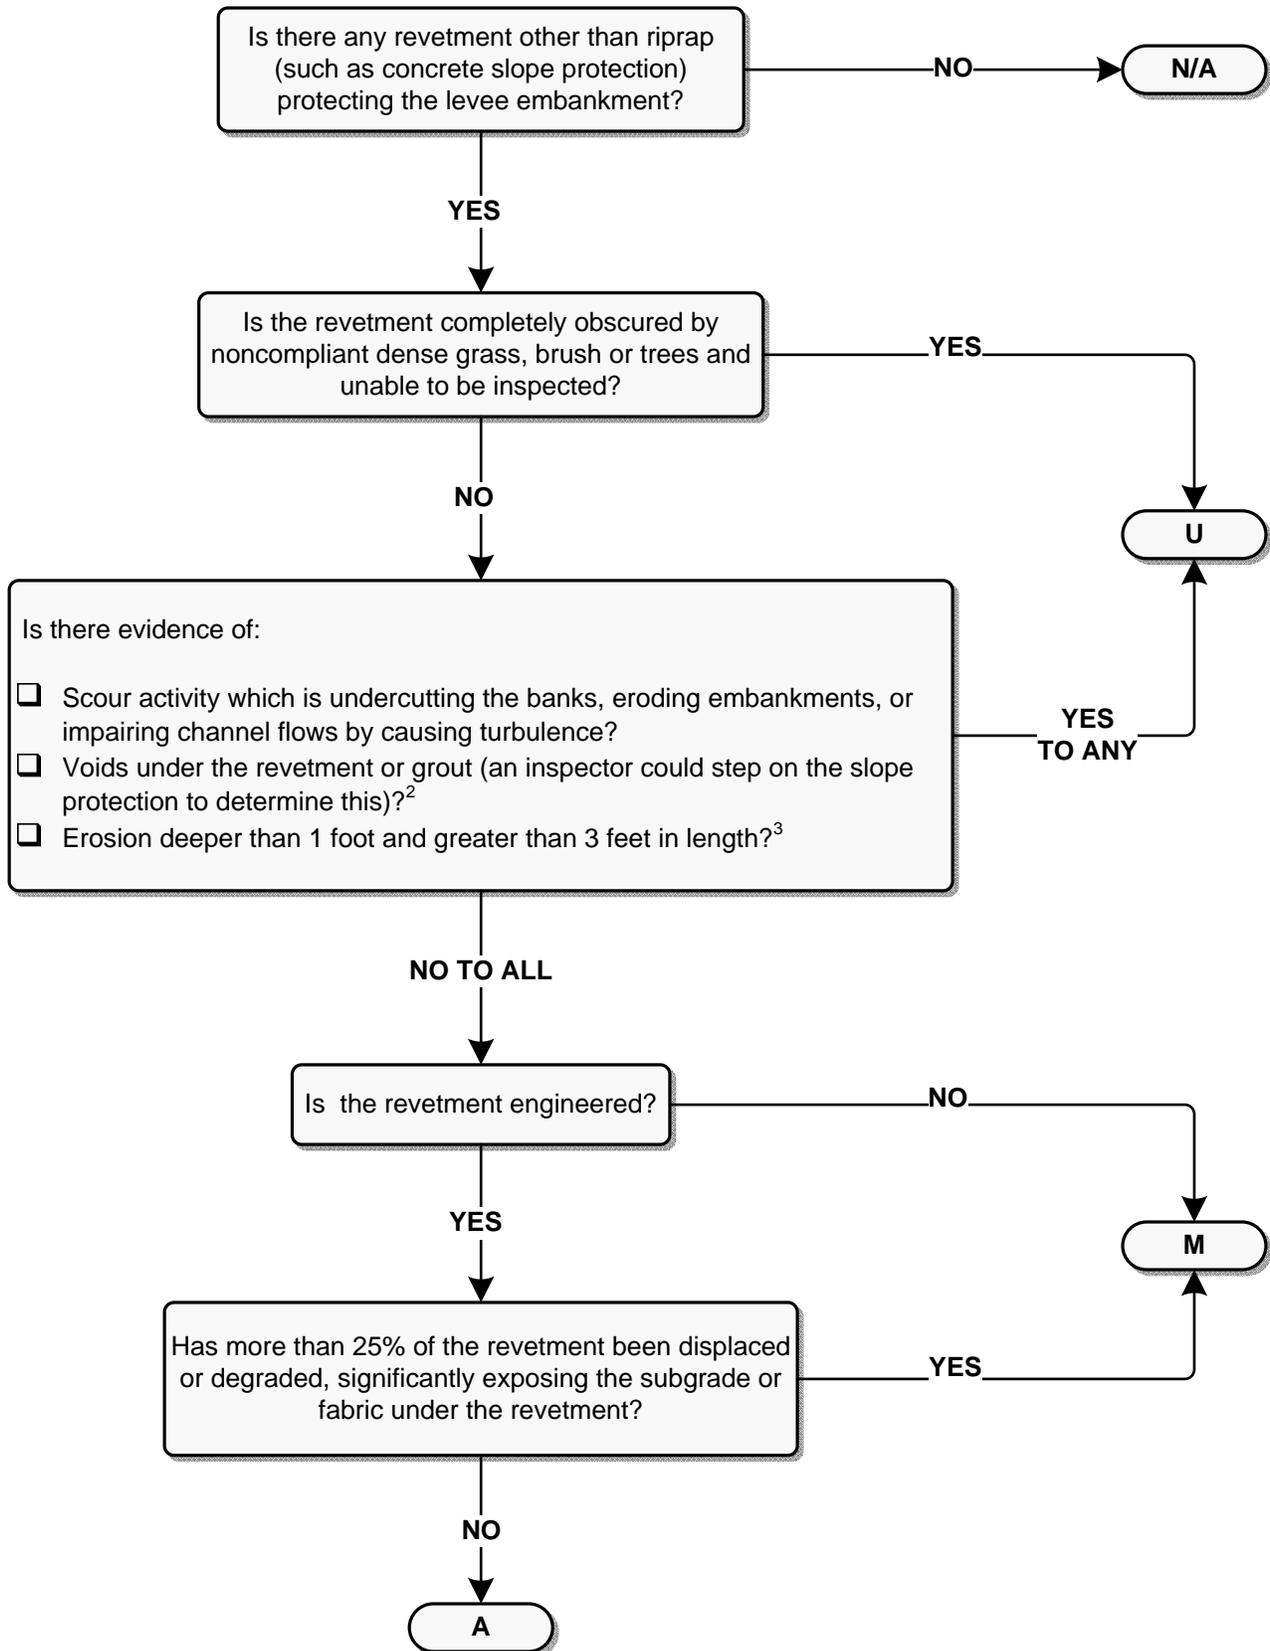
13. REVETMENTS OTHER THAN RIPRAP¹

¹ Includes grouted revetment

² If there is any grout cracking or voids in grouted revetment, recommend that the sponsor repair the crack or void.

³ If there is erosion deeper than 1 foot and greater than 3 feet in length, also rate as U under *Item 6. Erosion*
