**US Army Corps
of Engineers**
Sacramento District

SACRAMENTO DISTRICT FLOOD DAMAGE REDUCTION SEGMENT INSPECTION FLOWCHART

This flowchart was created by the Flood Protection and Navigation Section of the U.S. Army Corps of Engineers (USACE) Sacramento District (SPK) in consultation with the Geotechnical Engineering Branch (SPK). The Department of Water Resources also worked with the Flood Project and Navigation Section to clarify the checklist in creating the inspection flow chart. The intention is to aid USACE inspectors, Department of Water Resource inspectors and contractors to rate levee segments which are a part of the Rehabilitation and Inspection Program in a consistent manner which meets the standards defined by the USACE checklist. This flowchart quantifies the items in the checklist and is intended to improve consistency among inspectors, but it is not intended replace common sense, engineering judgment or the wording used in the checklist.

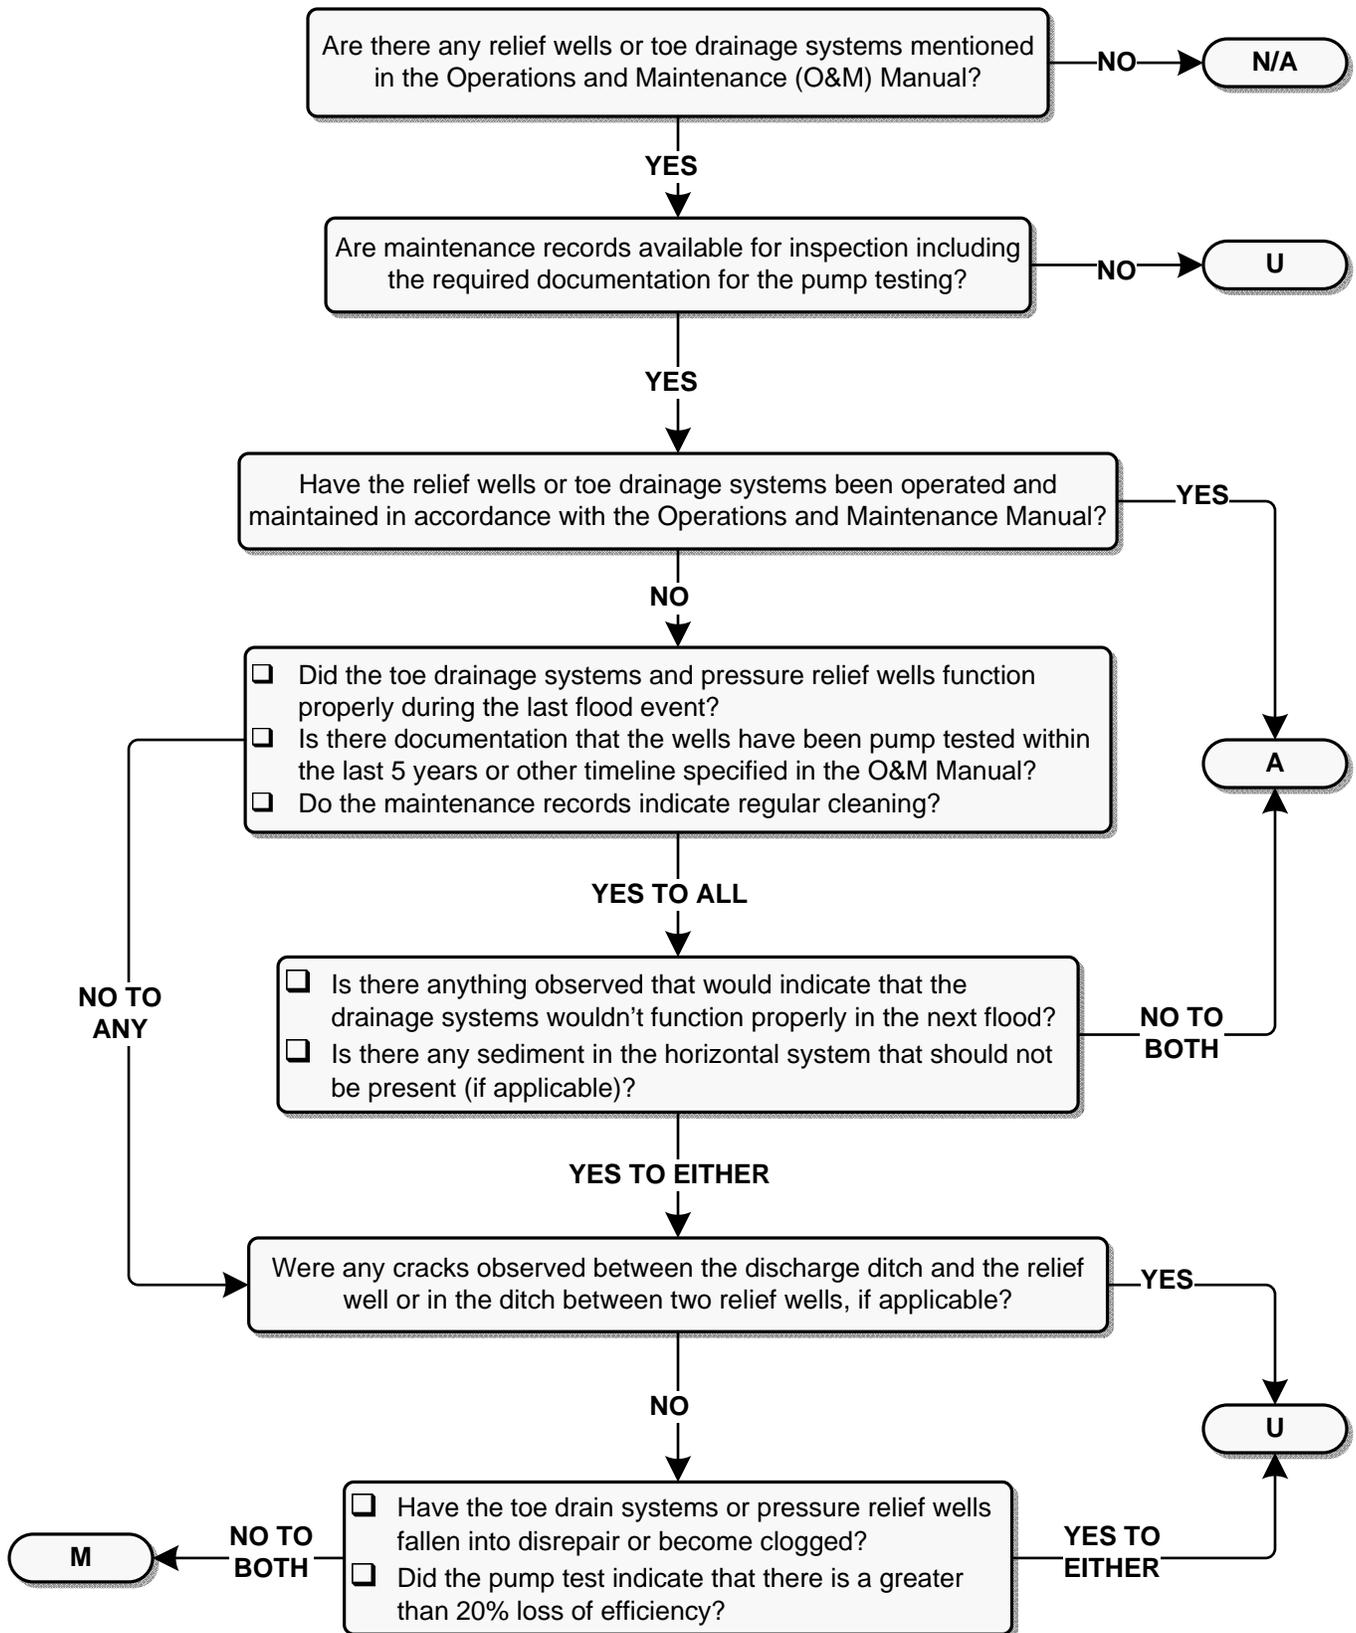
14. UNDERSEEPAGE RELIEF WELLS/TOE DRAINAGE SYSTEM

For guidance on pump testing see EM 1110-2-1914, which can be found on the Corps Publications Page (<http://140.194.76.129/publications/index.html>).
