Environmental Baseline Survey Main Airfield Parcel Hamilton Army Airfield

Prepared for
U.S. Army Corps of Engineers

June 2003

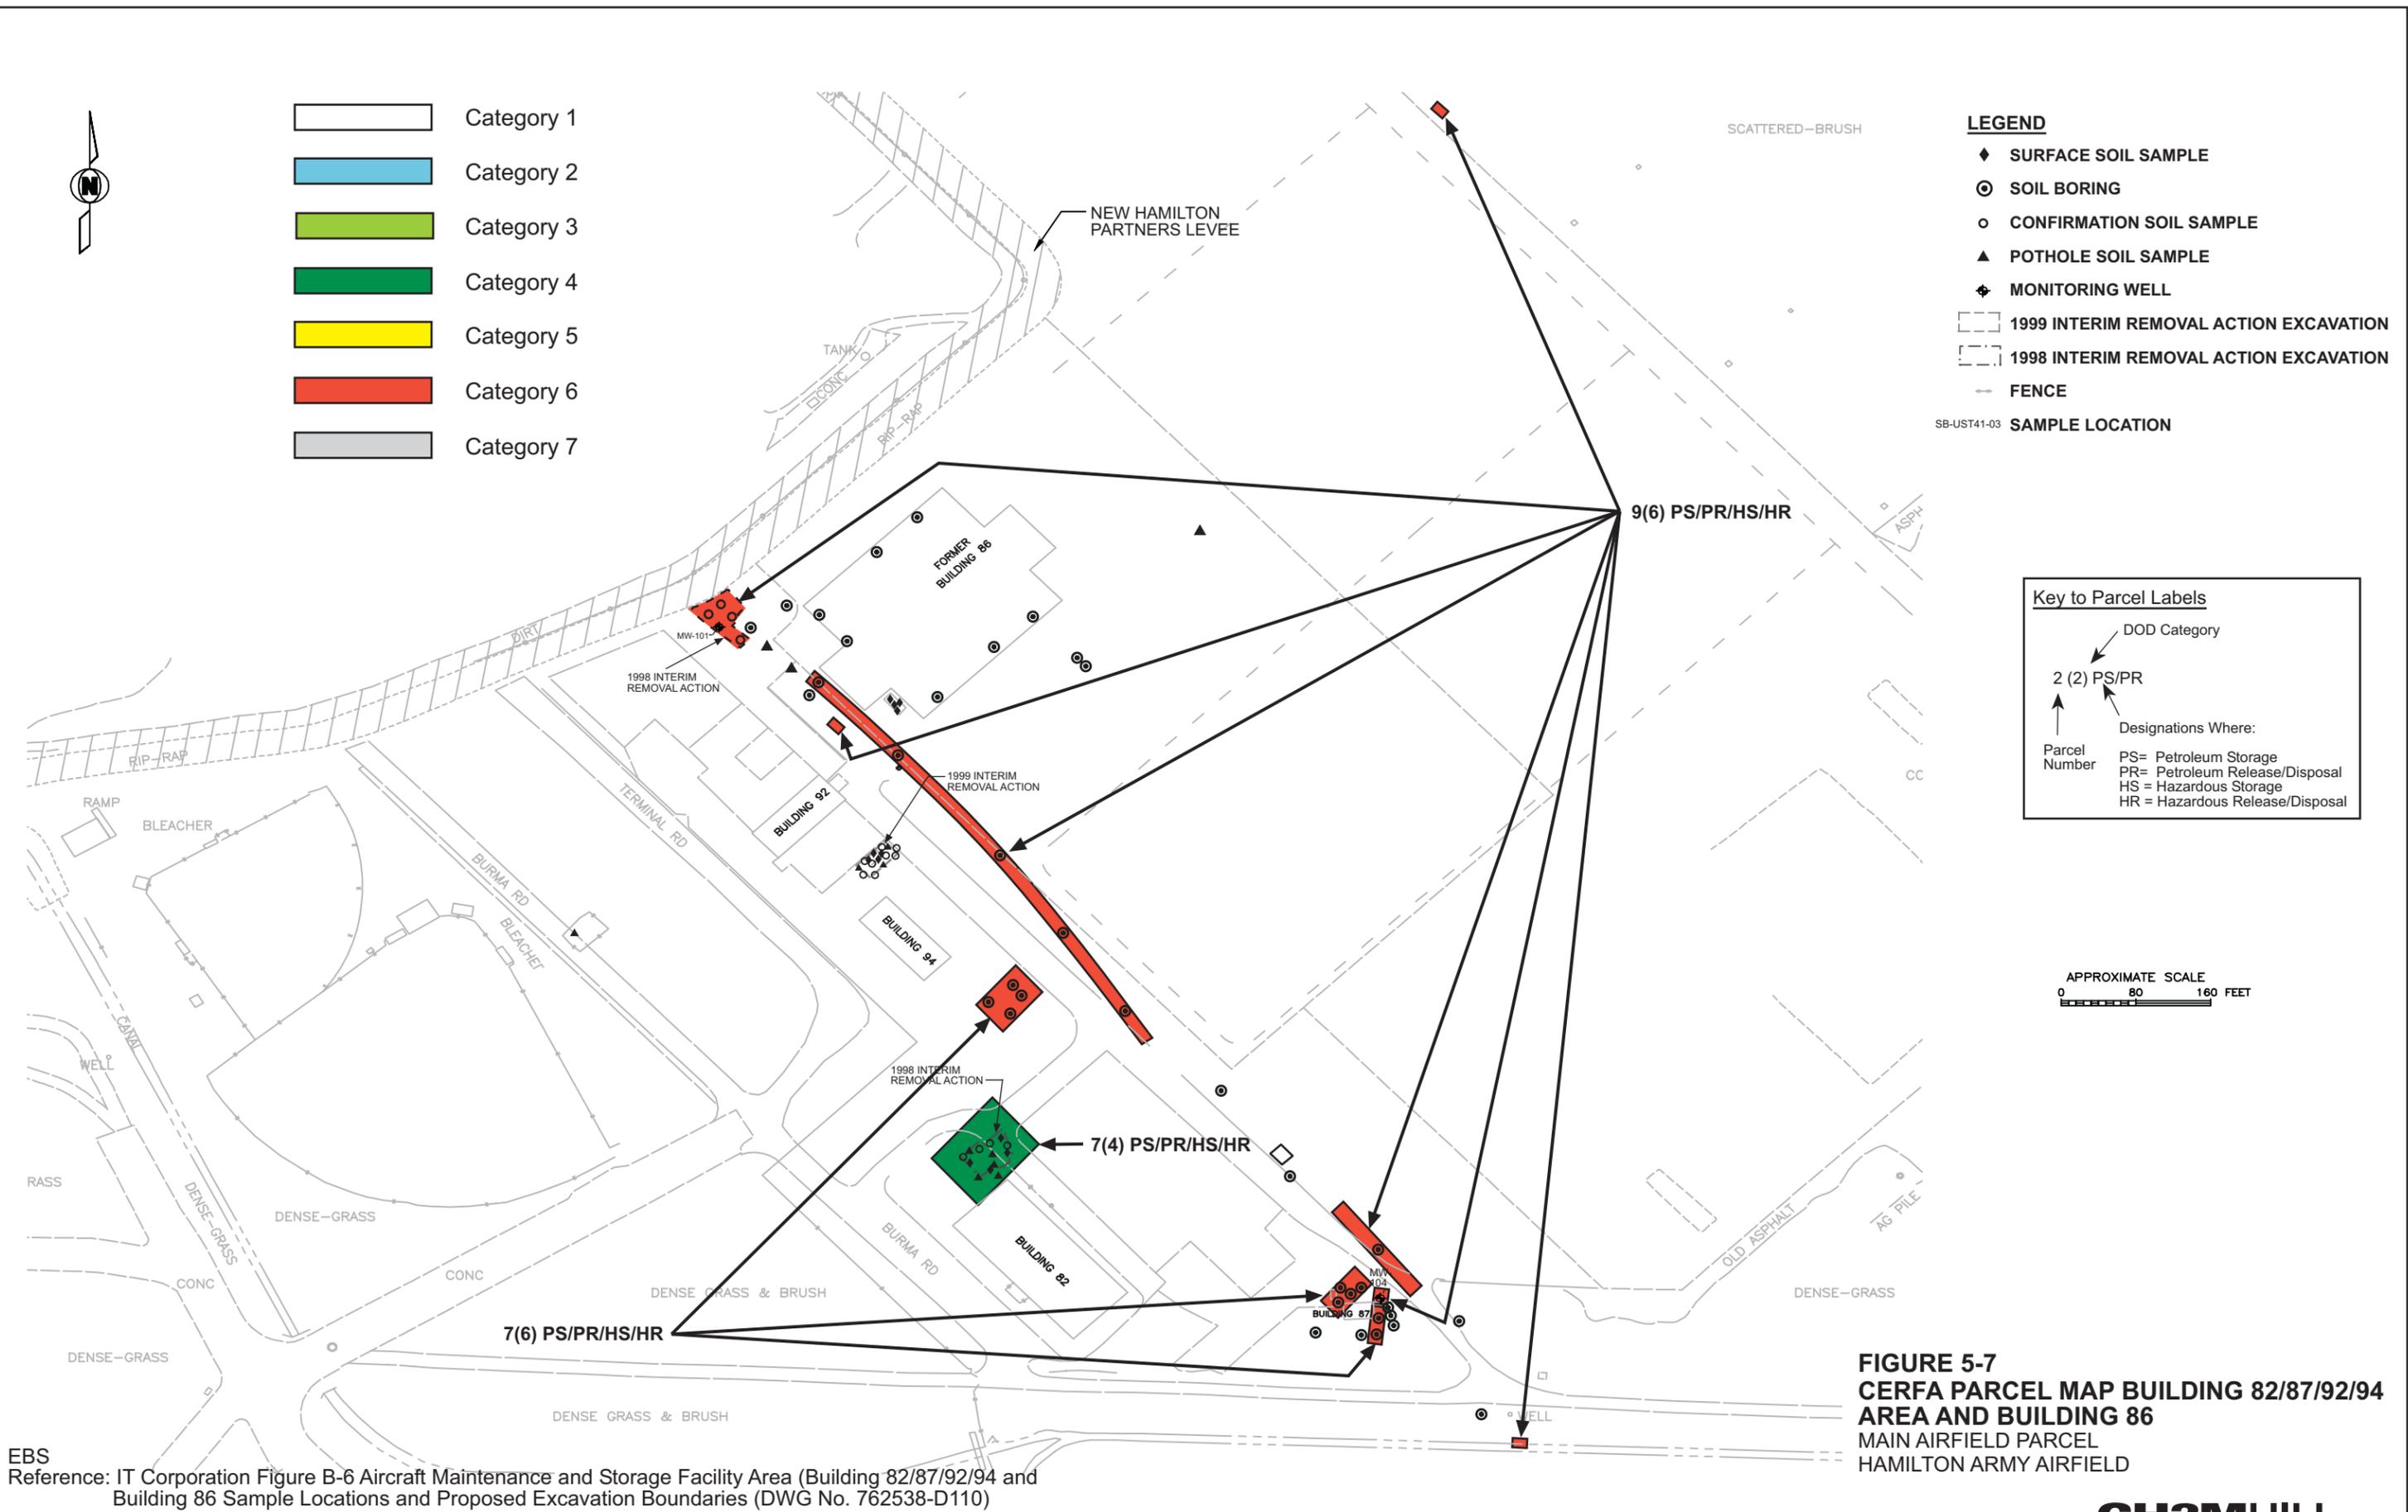
FIGURE 5-7
CERFA PARCEL MAP BUILDING 82/87/92/94
AREA AND BUILDING 86
 MAIN AIRFIELD PARCEL
 HAMILTON ARMY AIRFIELD

EBS
 Reference: IT Corporation Figure B-6 Aircraft Maintenance and Storage Facility Area (Building 82/87/92/94 and Building 86 Sample Locations and Proposed Excavation Boundaries (DWG No. 762538-D110)

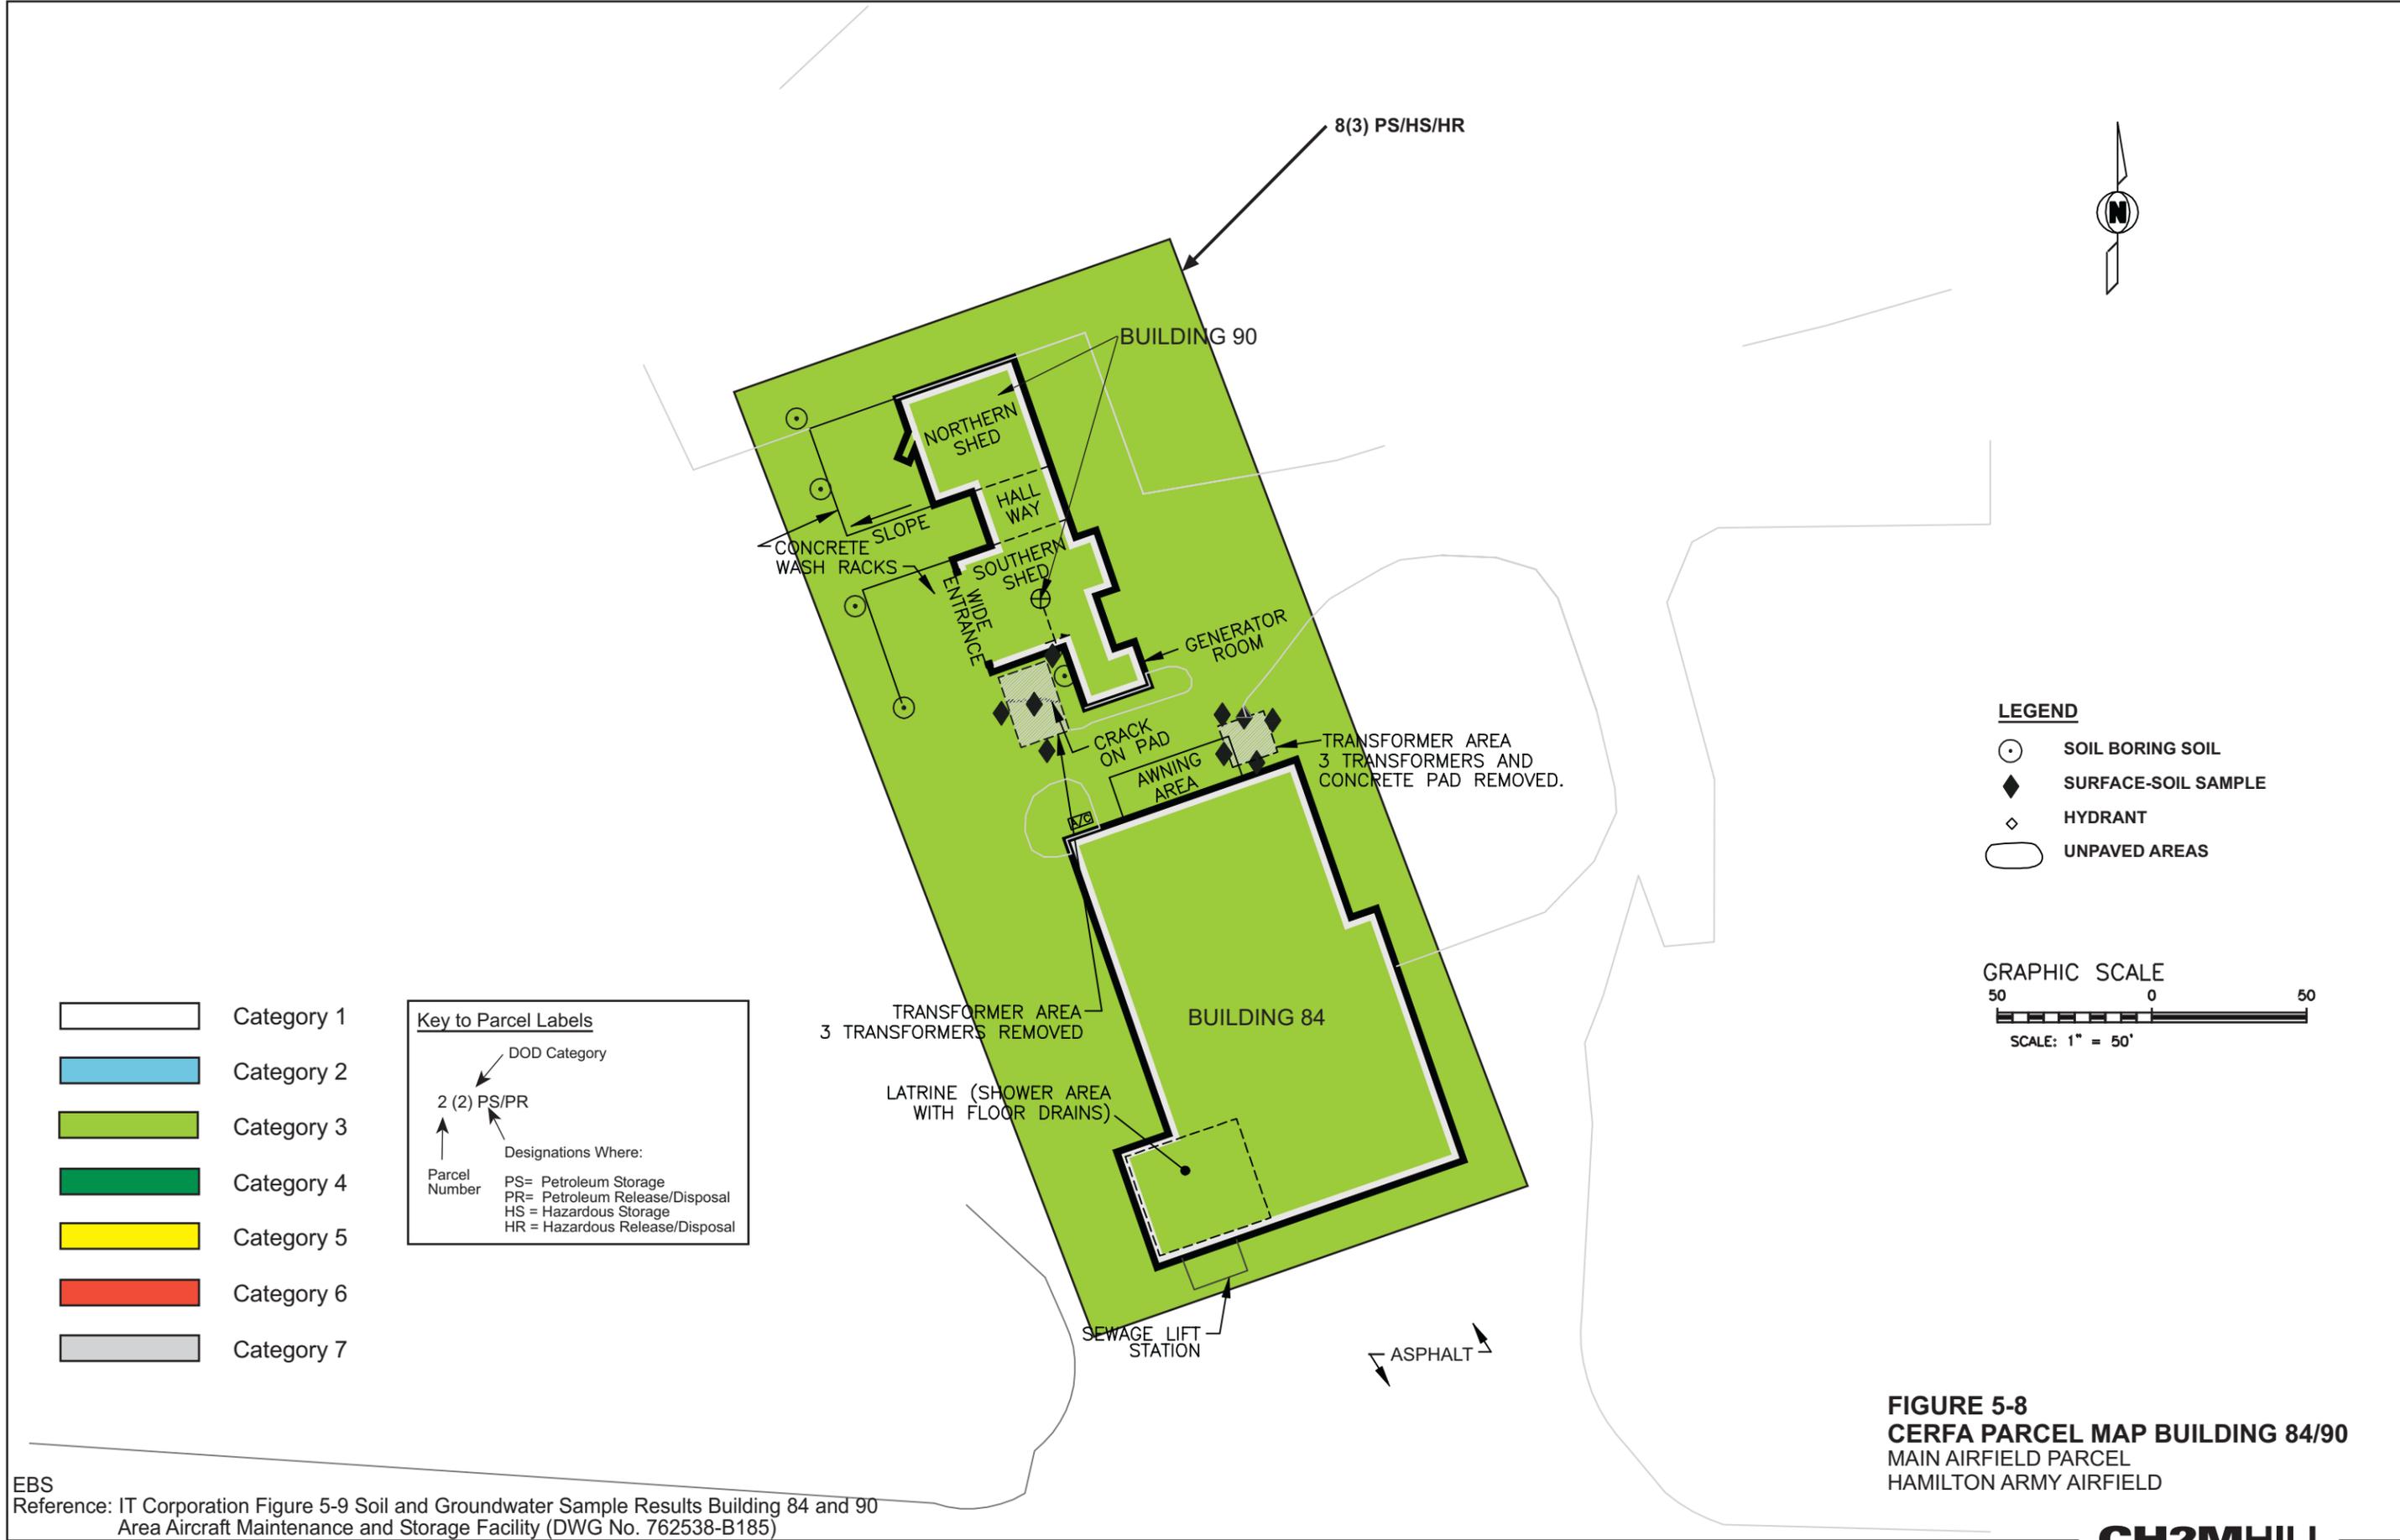
FIGURE 5-8
CERFA PARCEL MAP BUILDING 84/90
 MAIN AIRFIELD PARCEL
 HAMILTON ARMY AIRFIELD

EBS
 Reference: IT Corporation Figure 5-9 Soil and Groundwater Sample Results Building 84 and 90
 Area Aircraft Maintenance and Storage Facility (DWG No. 762538-B185)

BRAC Parcel	Location	Parcel Size (acre)	DoD Category	Basis (Including Source of Evidence and Reference)	EBS Source of Evidence	Remediation or Mitigation
8(3) PS/SHH R	Building 84/90	1.1	3	<p>The Building 84/90 Area is at the southeastern end of the former Aircraft Maintenance and Storage Facility (AMSF) area, northwest of Perimeter Road and south of the taxiways. Building 84 was used for repair of aircraft electronics equipment. A fenced enclosure just northeast of Building 84 formerly contained a concrete slab and three transformers. The transformers were removed in 1995. Three electrical units of unknown use are located on the north exterior wall beneath an awning. Building 90 was used for aircraft maintenance activities. The activities conducted at the building included aircraft equipment repair, oil changing, jet and propeller engine repair and service, aircraft bodywork, painting and washing, and fuel testing. The southern end of the building is a small utility/electrical room and two wash racks adjoin the west side of the building. A small sump is on the southern side of the building. This sump was used as a receiving structure for a floor drain inside the southern shed of Building 90. A fence-enclosed transformer pad adjoined the south side of the building.</p> <p>The transformers were removed in 1991 (IT, 1999). Hazardous substances used and wastes generated during these activities reportedly included stripping and degreasing solvents, batteries, petroleum, oils, lubricants, antifreeze, and paints. No remedial action is needed at this site.</p>	IT, 1999a; IT, 2000a; IT, 2000b; IT, 2001a; IT, 2001b; U.S. Army, 2003	There are no known releases of petroleum substances at this site. No contaminants related to hazardous substances storage, release or disposal at this site are present at concentrations that could pose a risk to future wetland receptors or that would require remedial action. Remediation activities were not performed at Building 84/90. No contaminants are present at levels that could pose a risk to future wetland receptors or that would require remedial action. The ROD/RAP recommends no further action for this site.

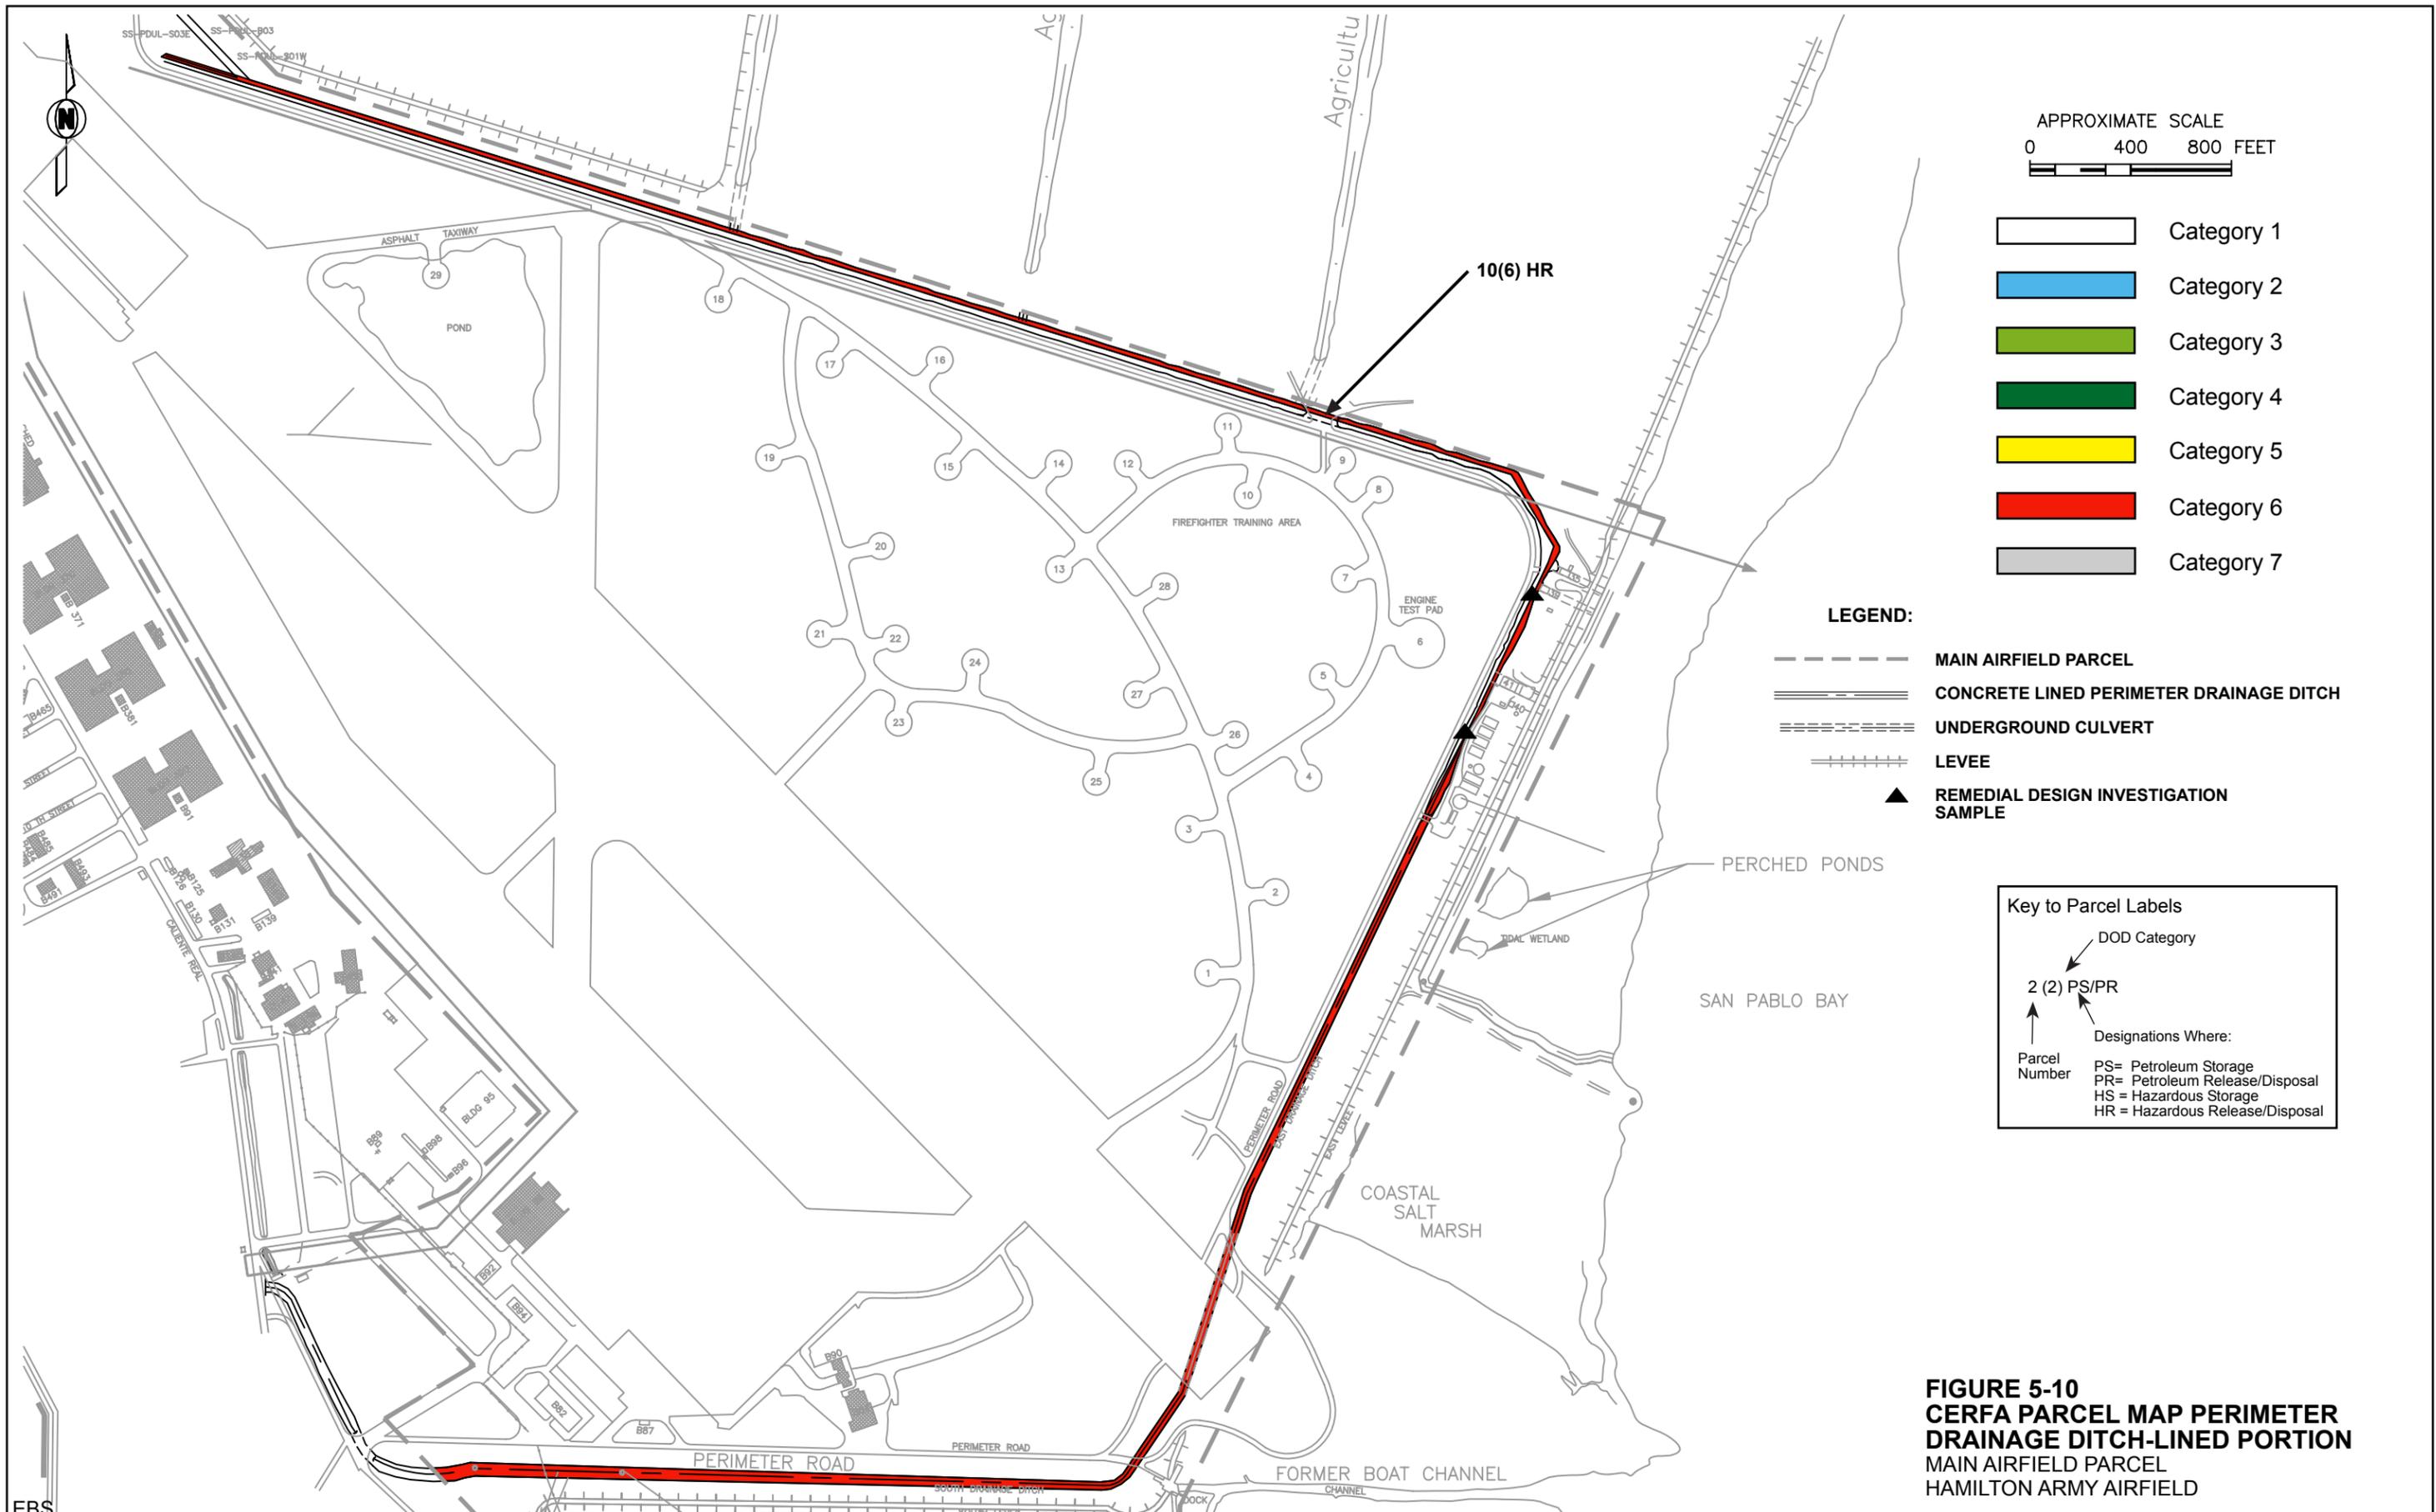
FIGURE 5-10
CERFA PARCEL MAP PERIMETER DRAINAGE DITCH-LINED PORTION
 MAIN AIRFIELD PARCEL
 HAMILTON ARMY AIRFIELD

EBS Reference: IT Corporation (IT) Figure B-8 Perimeter Drainage Ditch--Unlined Portion and Spoils Pile A Sample Locations and Proposed Excavation Boundaries (DWG No. 762538-B690)

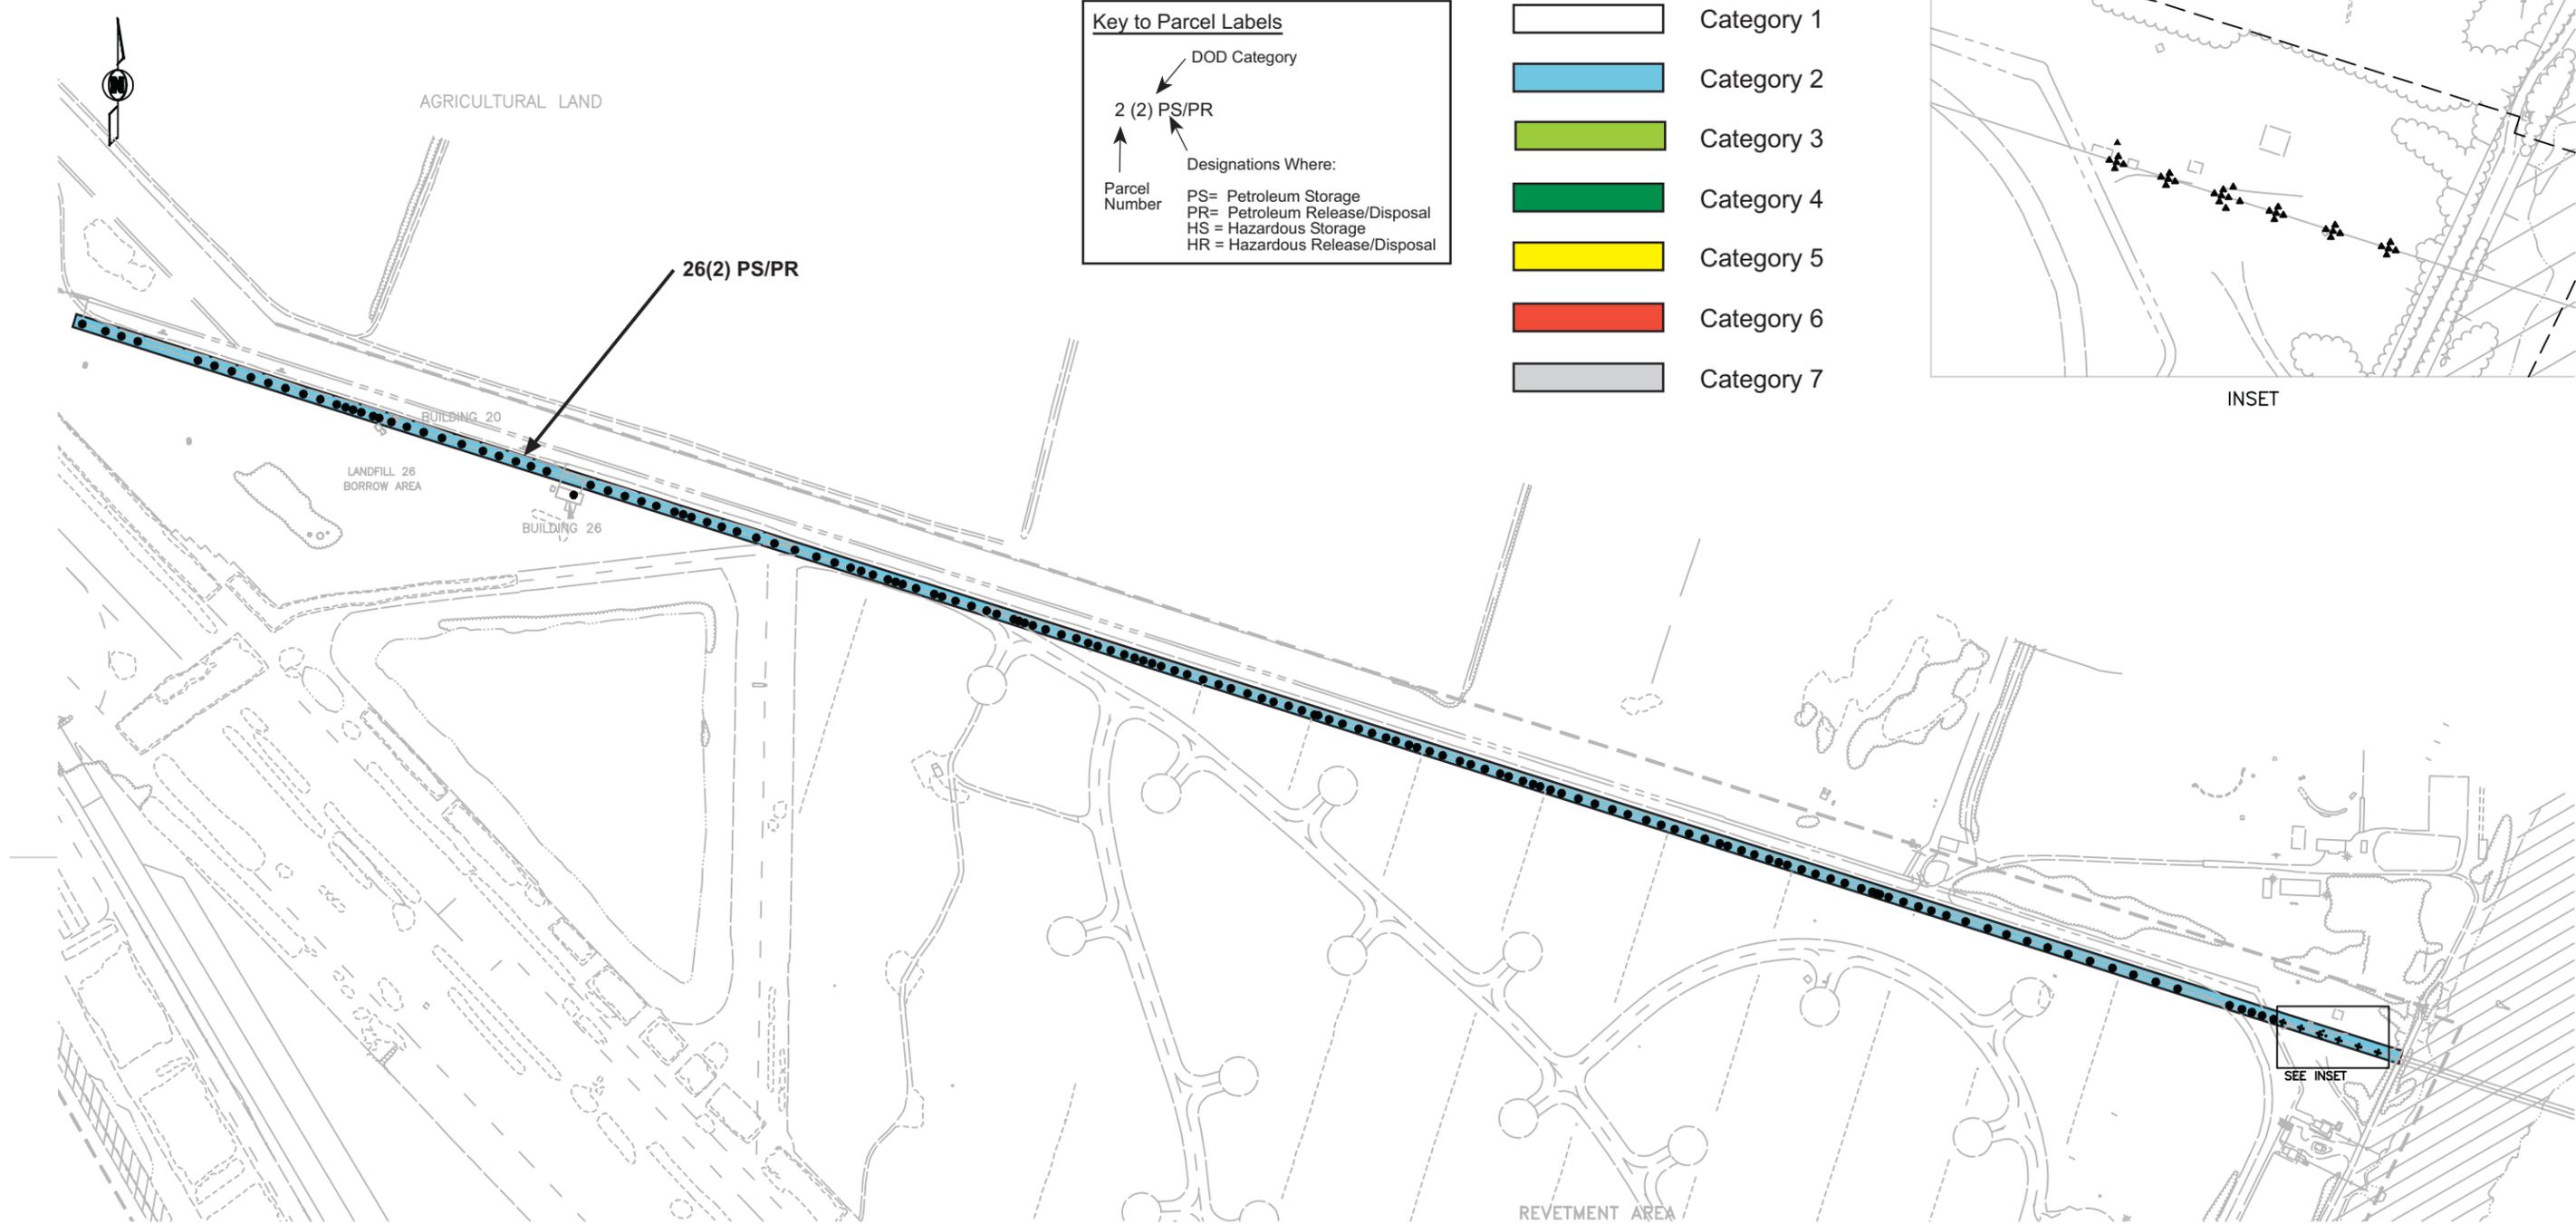
FIGURE 5-15
CERFA PARCEL MAP ON SHORE FUEL
LINE, NORTHERN SEGMENT
 MAIN AIRFIELD PARCEL
 HAMILTON ARMY AIRFIELD

- LEGEND:**
- ▲ POTHOLE SOIL SAMPLE
 - - - MAIN AIRFIELD PARCEL
 - ==== PERIMETER DRAINAGE DITCH
 - SAMPLE LOCATION
 - ==== PERIMETER LEVEES
 - FORMER LOCATION OF FUEL LINE

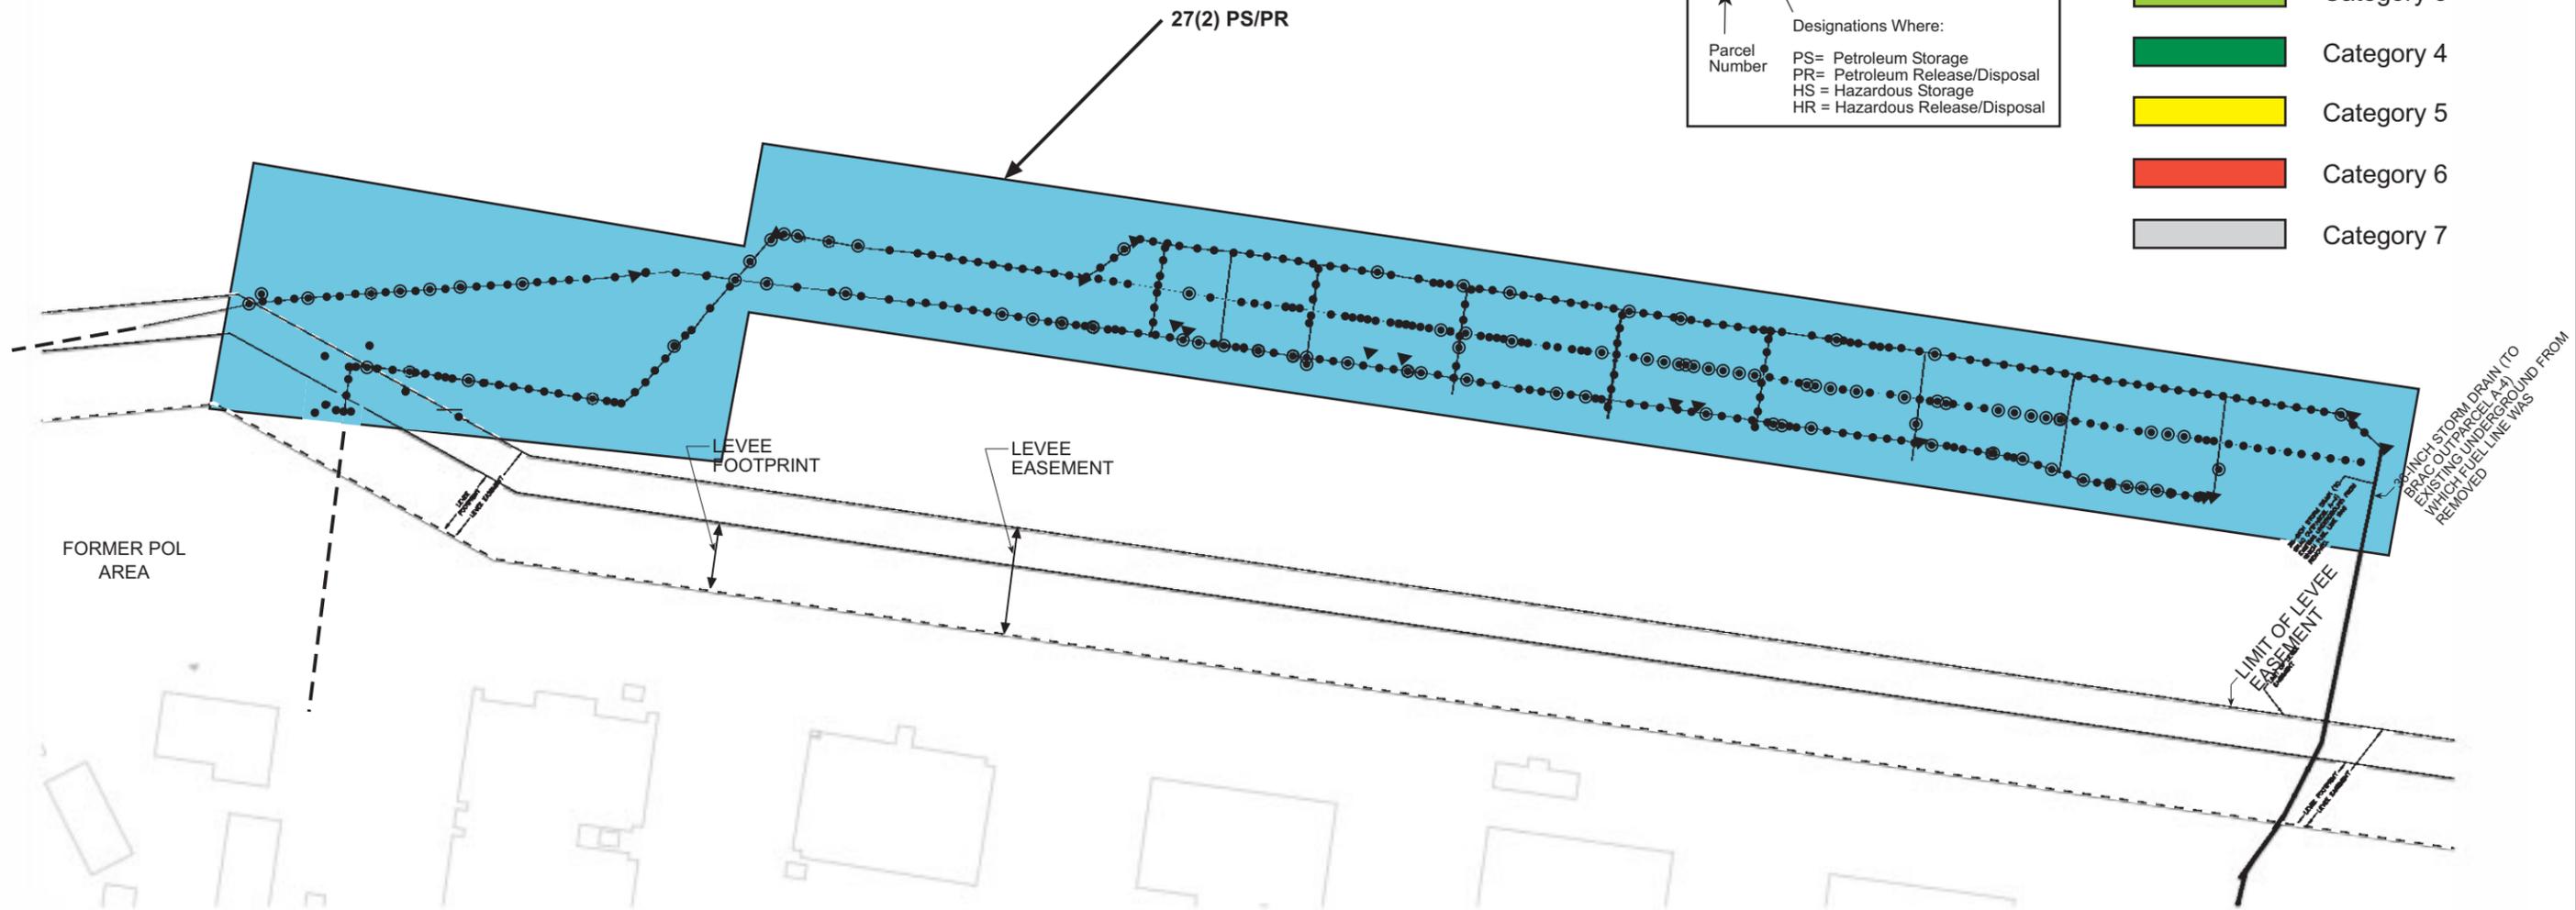
FIGURE 5-16
CERFA PARCEL MAP ONSHORE FUEL LINE HANGAR SEGMENT
 MAIN AIRFIELD PARCEL
 HAMILTON ARMY AIRFIELD

- LEGEND**
- CONFIRMED SAMPLE
 - ⊙ FIELD SCREEN SAMPLE WITH PNA CONFIRMATION SAMPLE
 - ▲ SOIL SAMPLE LOCATIONS
 - BOUNDARY BETWEEN LEVEE FOOTPRINT AND EASEMENT
 - - - LEVEE EASEMENT

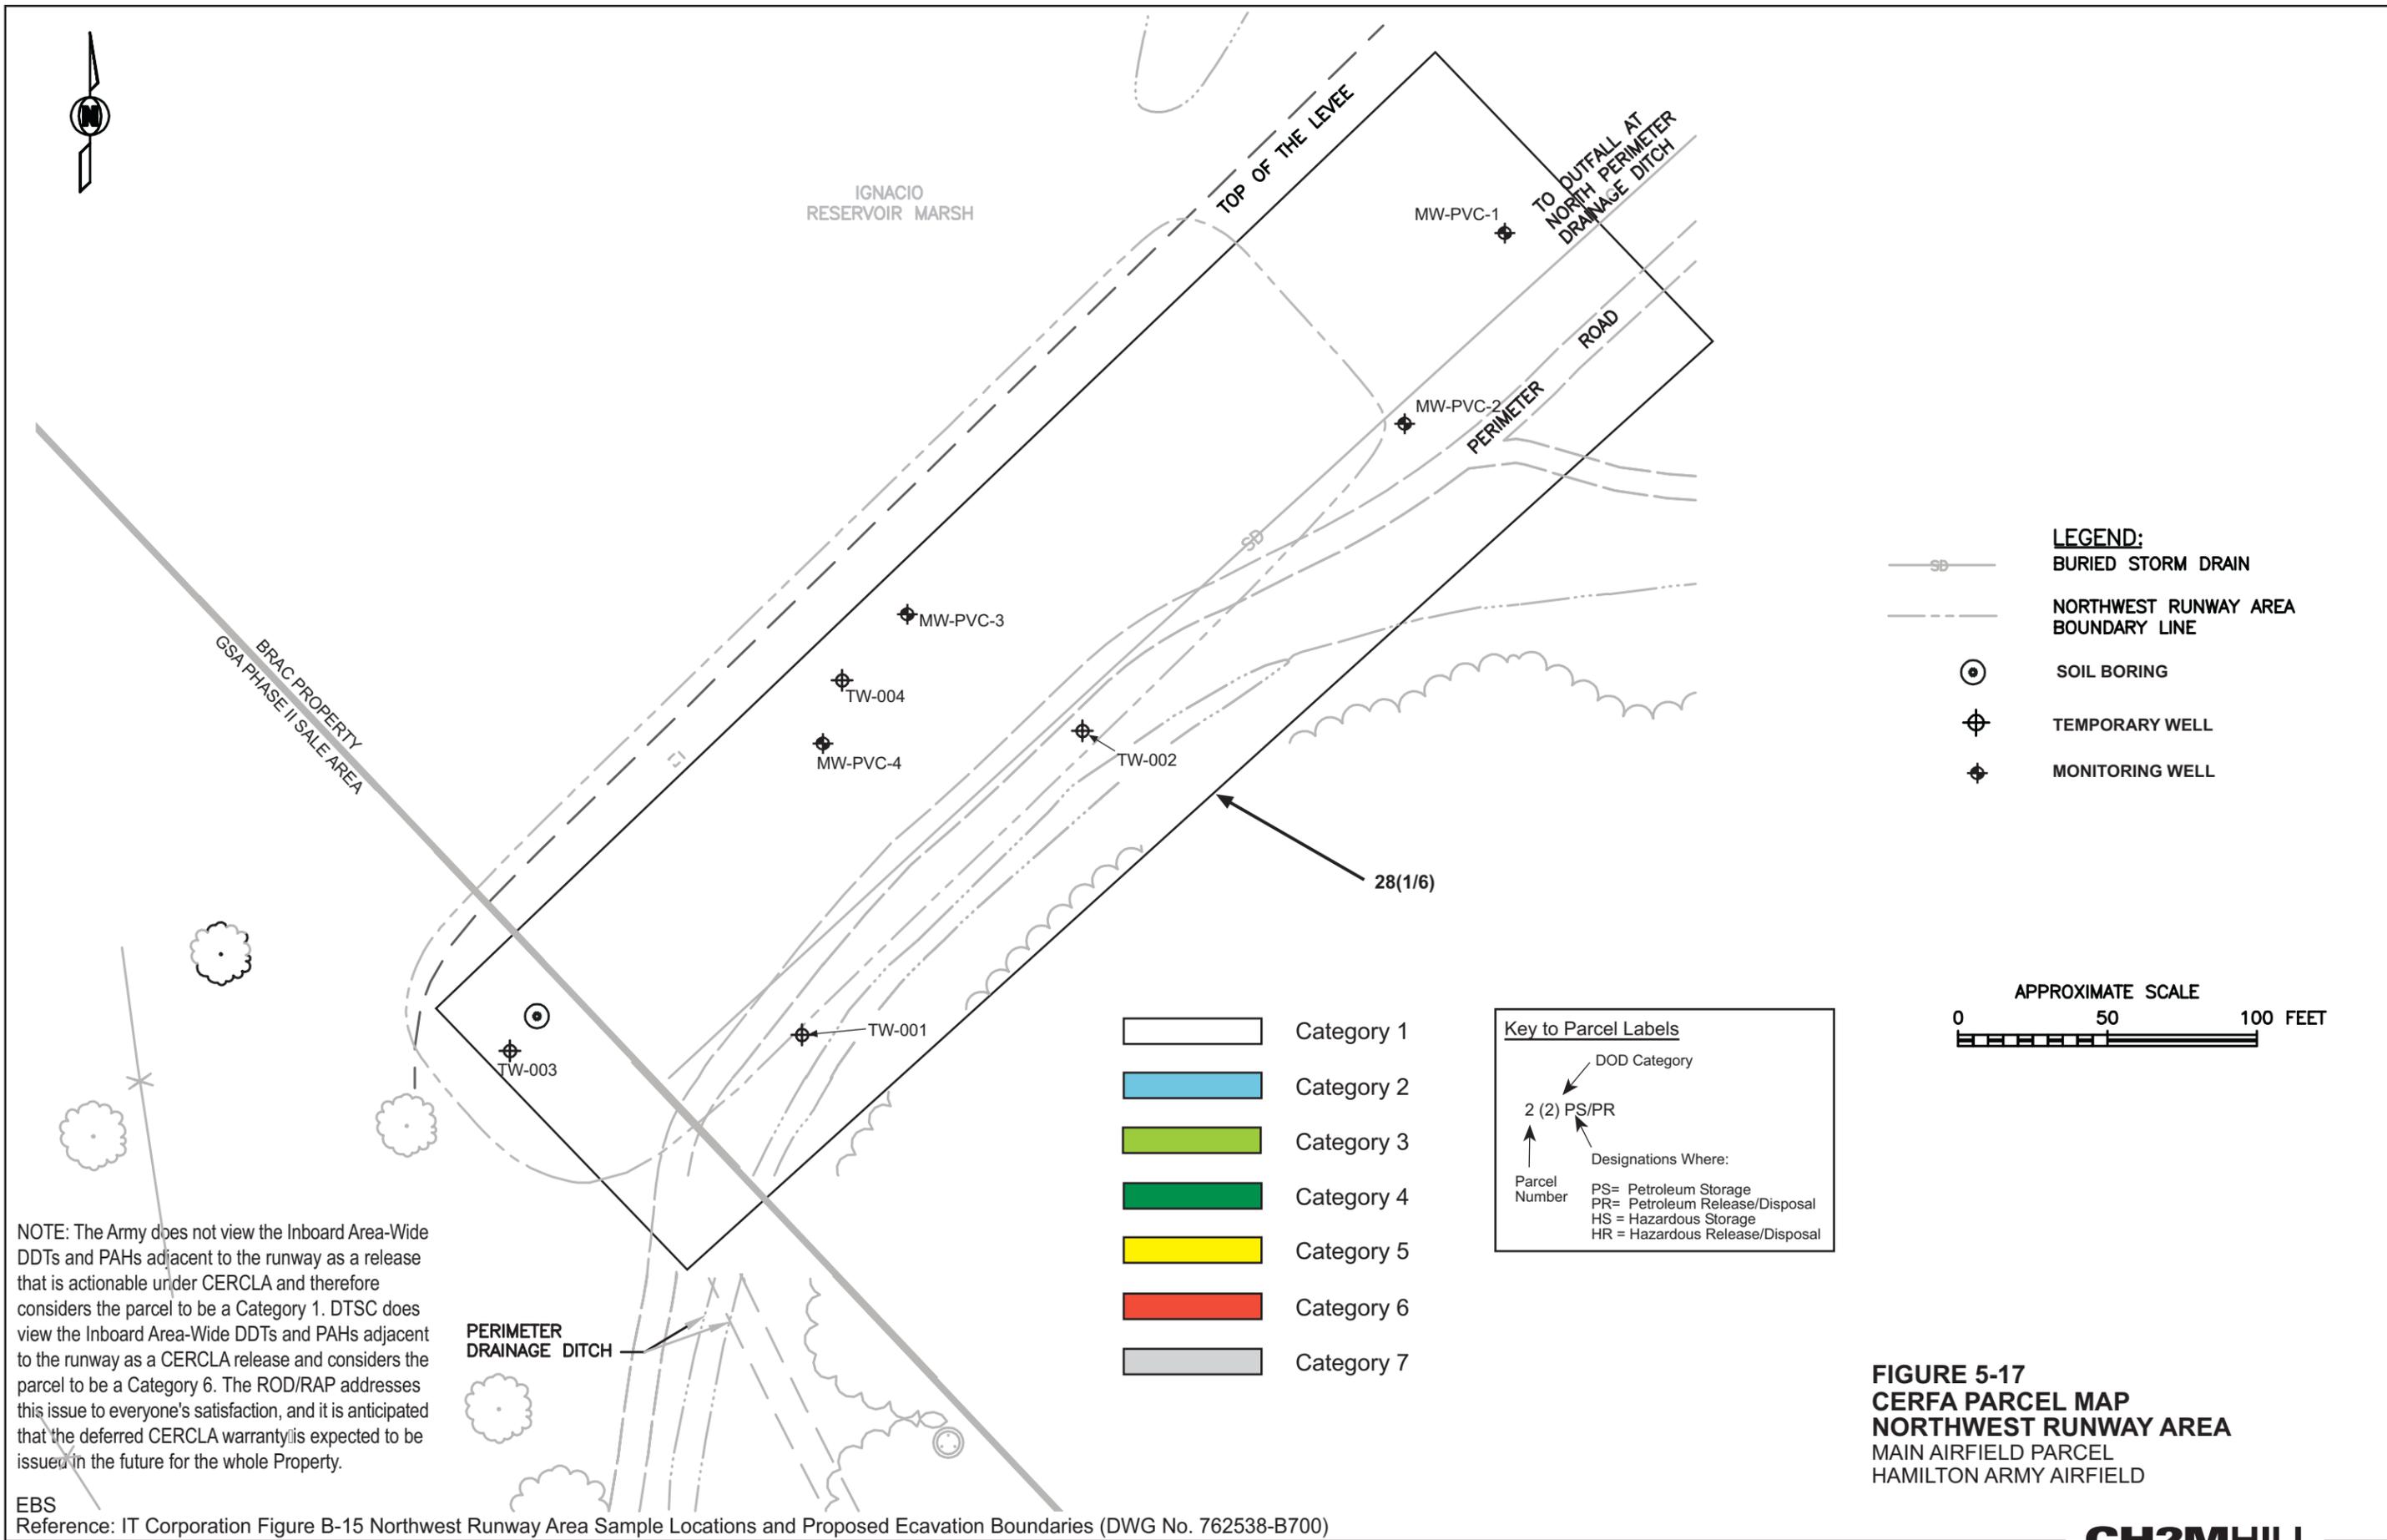
FIGURE 5-17
CERFA PARCEL MAP
NORTHWEST RUNWAY AREA
MAIN AIRFIELD PARCEL
HAMILTON ARMY AIRFIELD

NOTE: The Army does not view the Inboard Area-Wide DDTs and PAHs adjacent to the runway as a release that is actionable under CERCLA and therefore considers the parcel to be a Category 1. DTSC does view the Inboard Area-Wide DDTs and PAHs adjacent to the runway as a CERCLA release and considers the parcel to be a Category 6. The ROD/RAP addresses this issue to everyone's satisfaction, and it is anticipated that the deferred CERCLA warranty is expected to be issued in the future for the whole Property.

EBS
Reference: IT Corporation Figure B-15 Northwest Runway Area Sample Locations and Proposed Ecvation Boundaries (DWG No. 762538-B700)
