Environmental Baseline Survey Main Airfield Parcel Hamilton Army Airfield

Prepared for
U.S. Army Corps of Engineers

June 2003

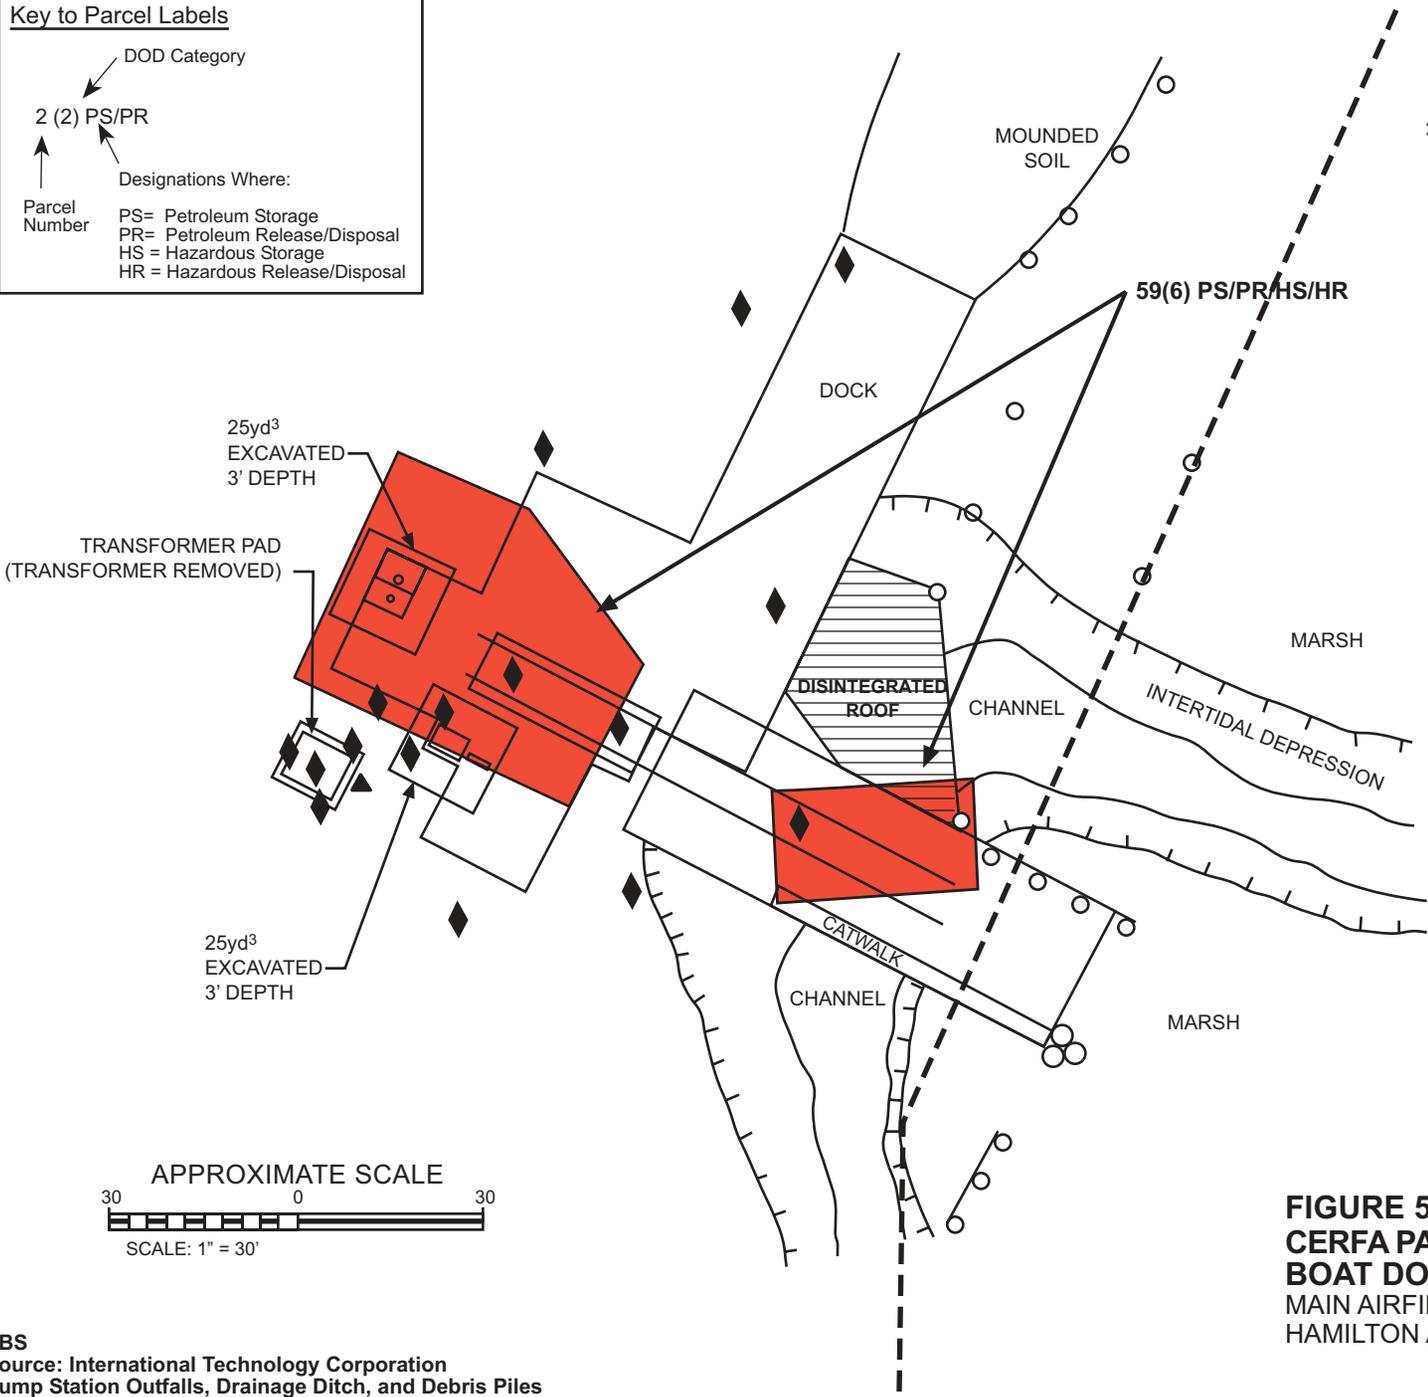
FIGURE 5-23
CERFA PARCEL MAP BOAT DOCK AND
BOAT DOCK CHANNEL
 MAIN AIRFIELD PARCEL
 HAMILTON ARMY AIRFIELD

- MAIN AIRFIELD PARCEL BOUNDARY
- ○ ○ PIERS AND BARRIERS
- × × × FENCE
- ▲ POTHOLE SOIL SAMPLE
- ◆ SURFACE SOIL SAMPLE

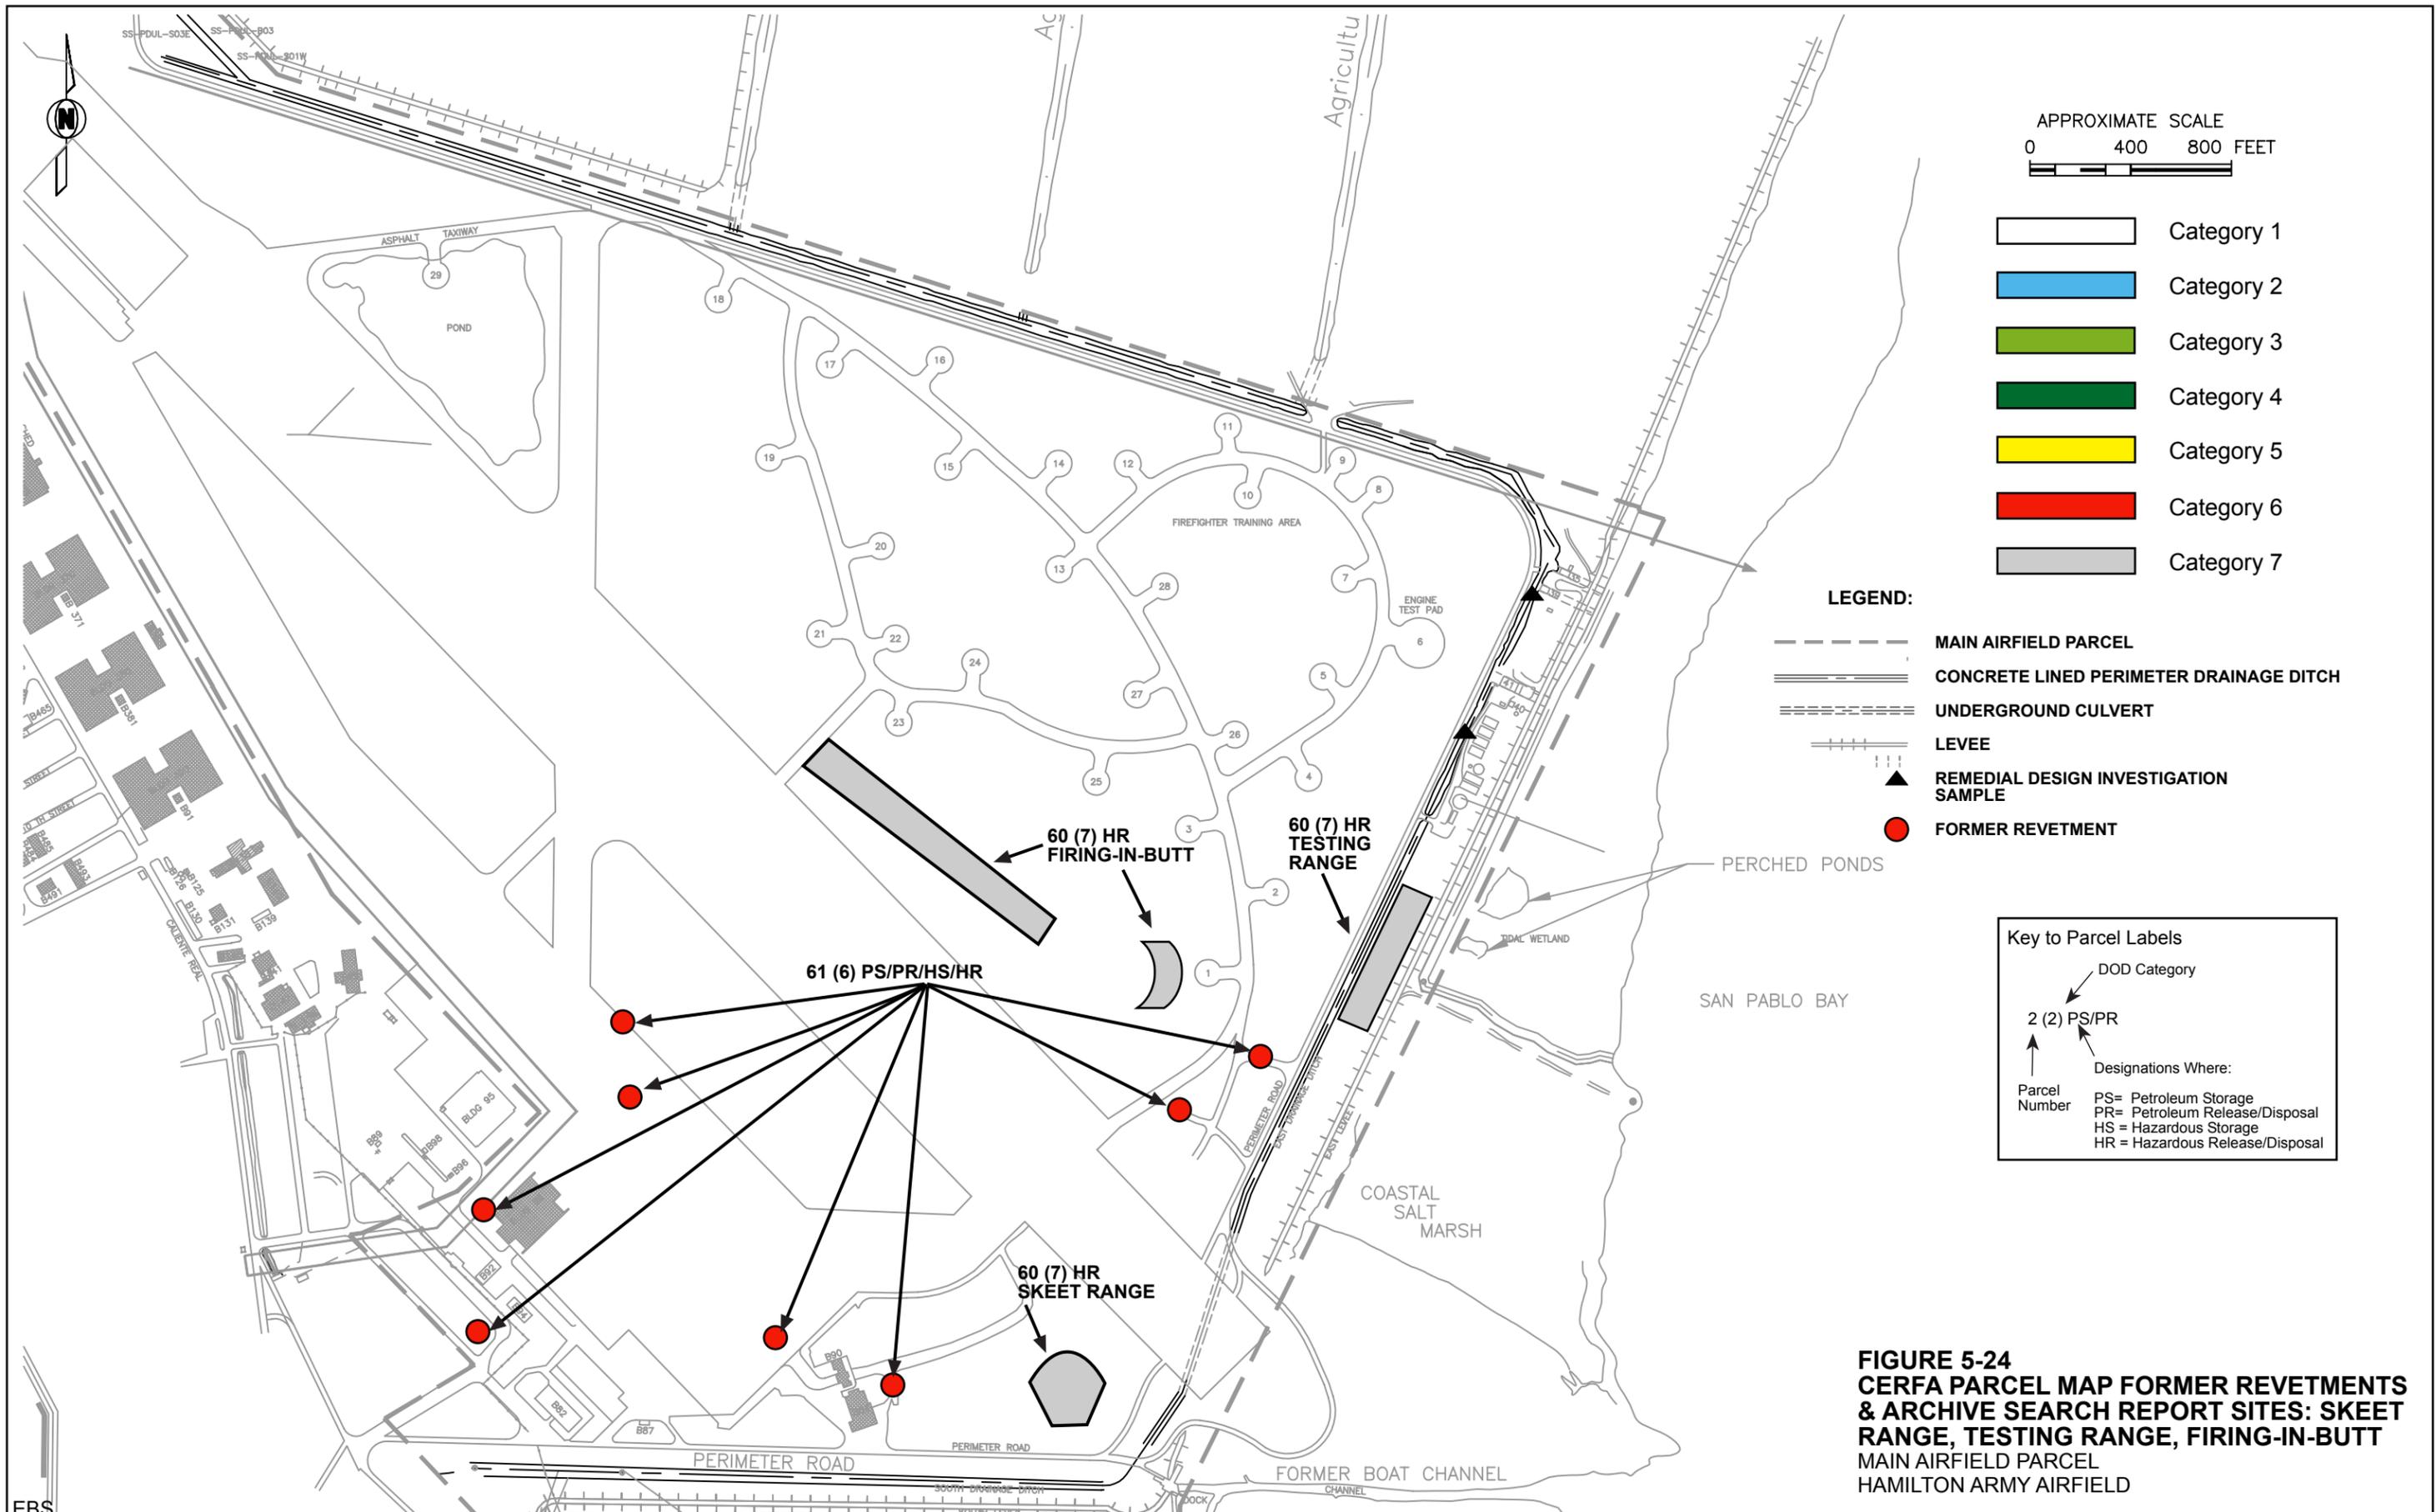
**FIGURE 5-24
 CERFA PARCEL MAP FORMER REVETMENTS
 & ARCHIVE SEARCH REPORT SITES: SKEET
 RANGE, TESTING RANGE, FIRING-IN-BUTT
 MAIN AIRFIELD PARCEL
 HAMILTON ARMY AIRFIELD**

EBS
 Reference: IT Corporation (IT) Figure B-8 Perimeter Drainage Ditch--Unlined Portion and Spoils Pile A Sample Locations and Proposed Excavation Boundaries (DWG No. 762538-B690)
