**2005 - FIELD RECONNAISSANCE REPORT OF BANK EROSION SITES -  
SACRAMENTO RIVER FLOOD CONTROL LEVEES AND TRIBUTARIES**

**Sacramento River Bank Protection Project**

Project No. 32-0530.10, Task 3

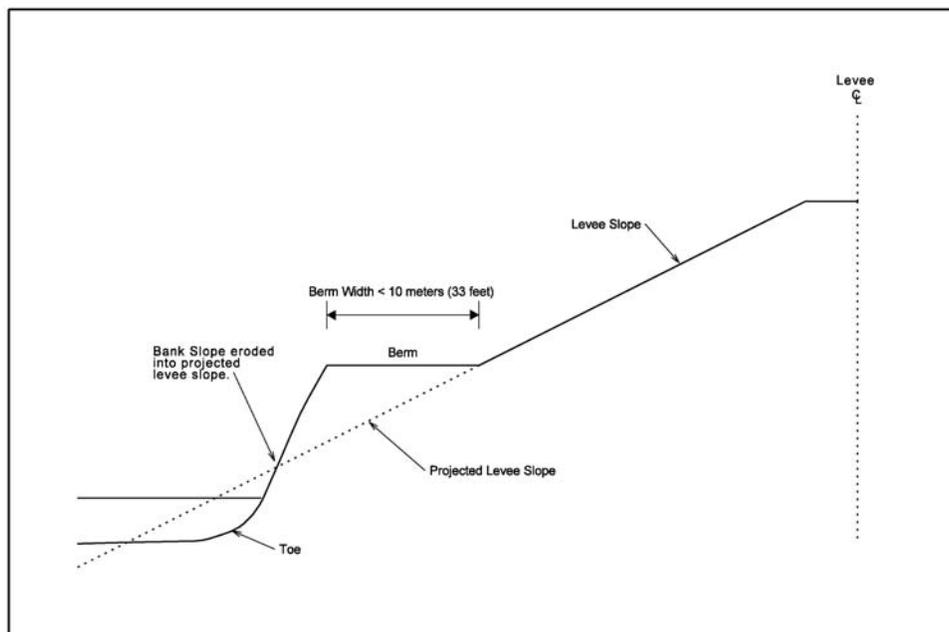
**Figure 2. Schematic of Inventory Erosion site Criteria**

**Figure 2** shows a schematic illustrating these two criteria.
