GENERAL LOCATION MAP
Dike Removal and River Restoration
Four Corners Materials

Map 2: Dike Removal and River Restoration Activities
Four Corners Materials

Map 3: 2002 Aerial
Dike Removal and River Restoration
Four Corners Materials

**Cross-Sections
Dike Removal and River Restoration
Four Corners Materials**

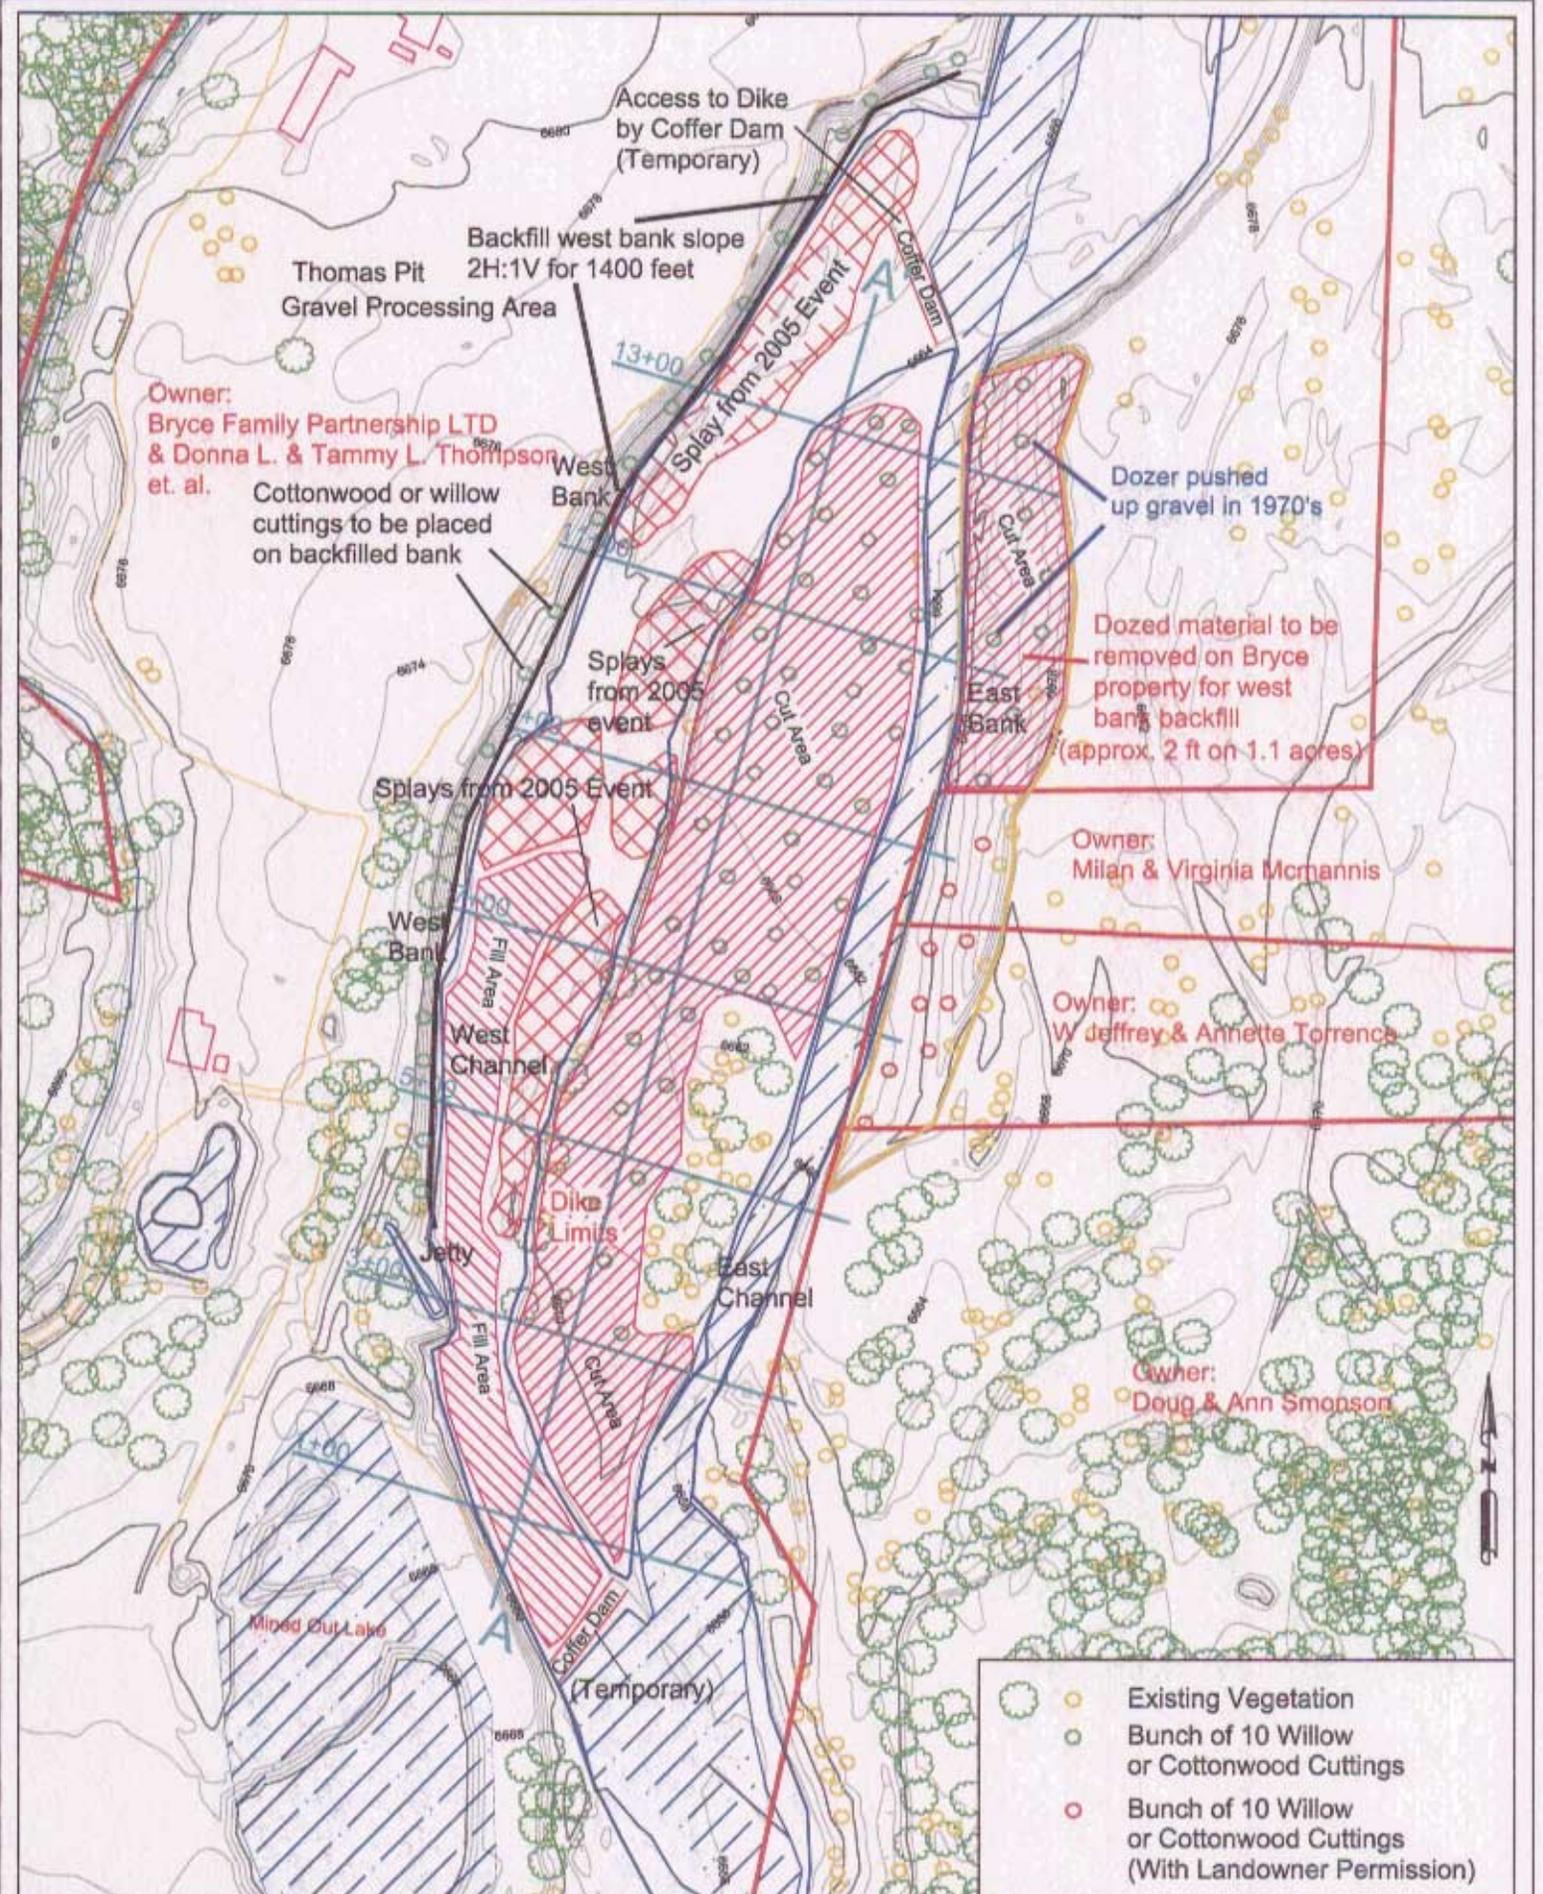
Cottonwood or willow cuttings to be placed on backfilled bank

Backfill west bank slope 2H:1V for 1400 feet

Access to Dike by Cofferd Dam (Temporary)

Dozed material to be removed on Bryce property for west bank backfill (approx. 2 ft on 1.1 acres)

Notes: Topography shown is approx. final topography after dike removal.
 — Approx. 2 Yr High Water

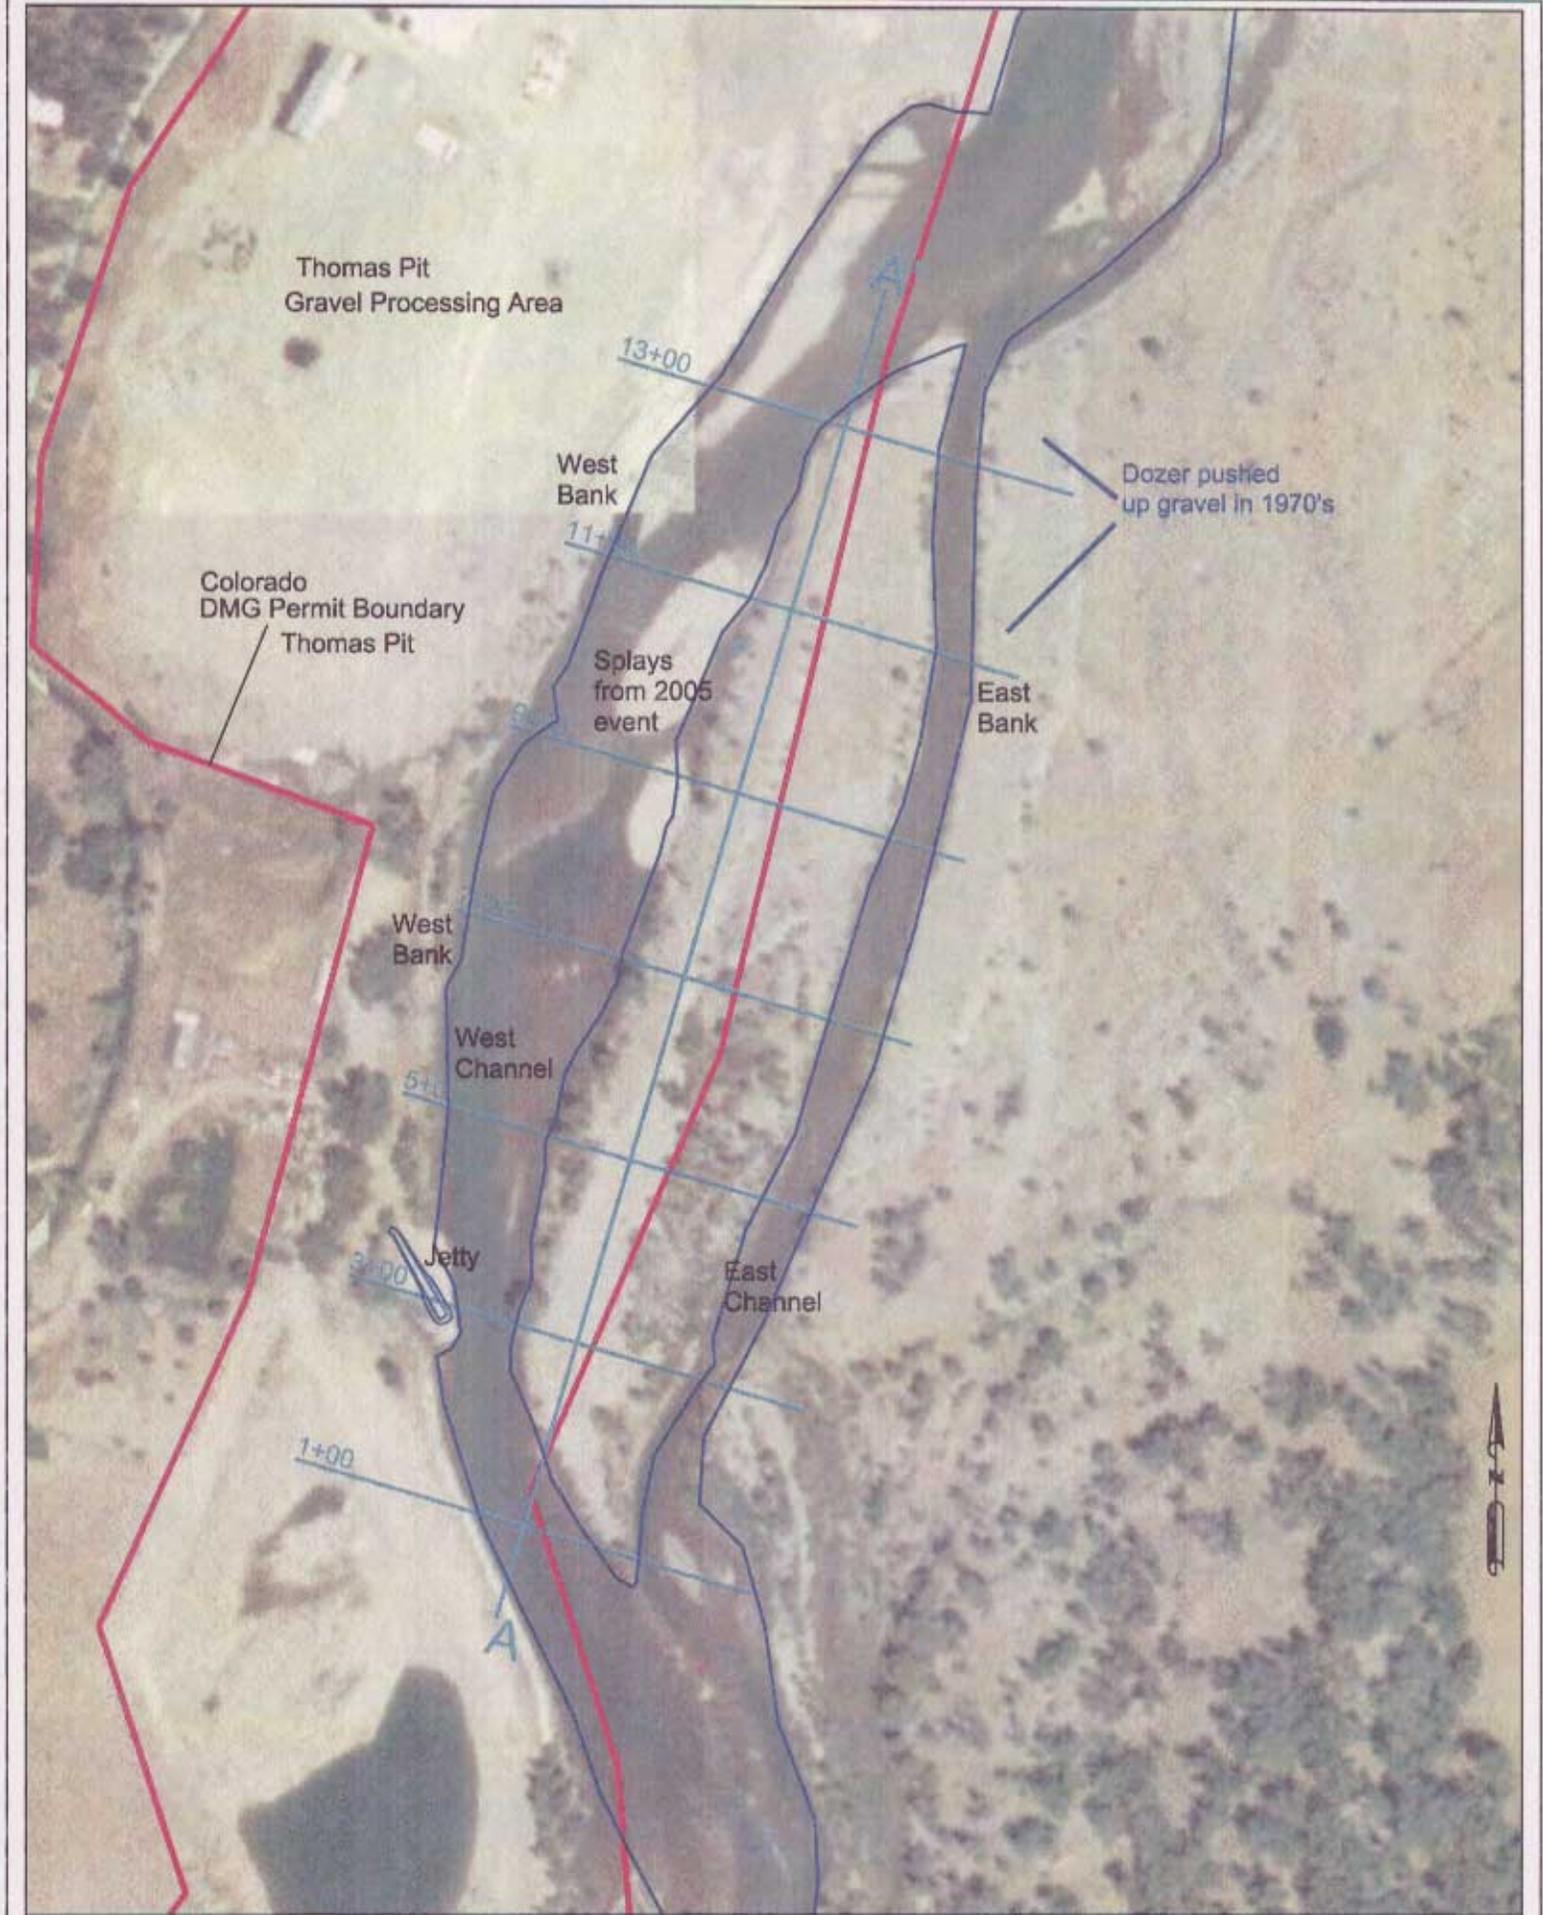
**Map 4: 2005 Aerial
 Dike Removal and River Restoration
 Four Corners Materials**

Notes: Aerial taken in Spring of 2005 as part of USDA agricultural study.

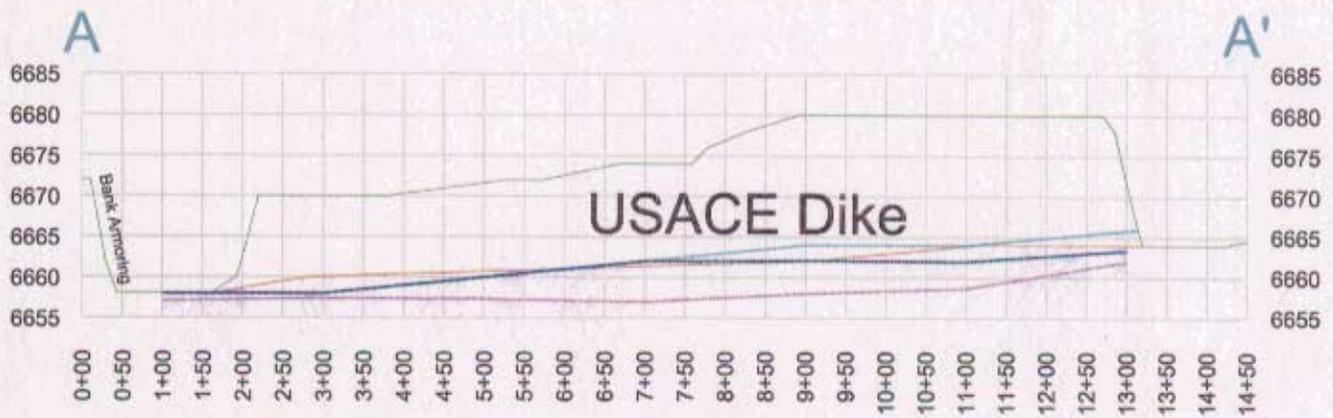
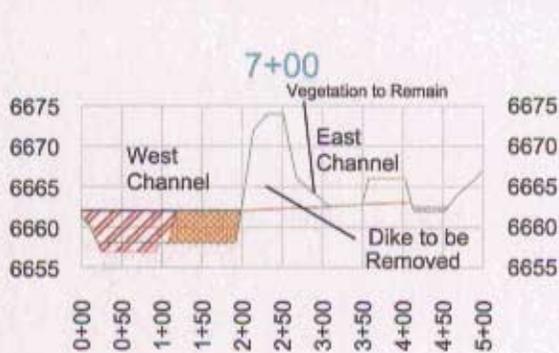
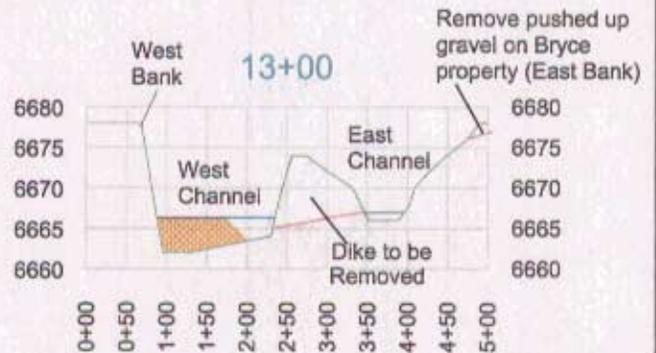
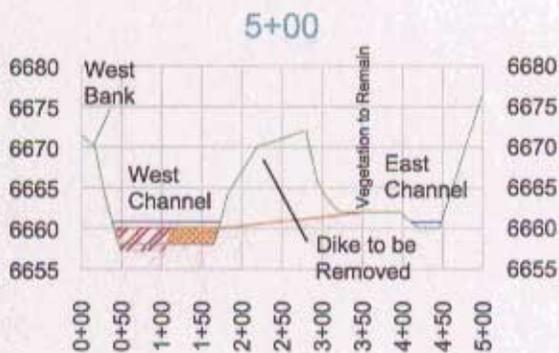
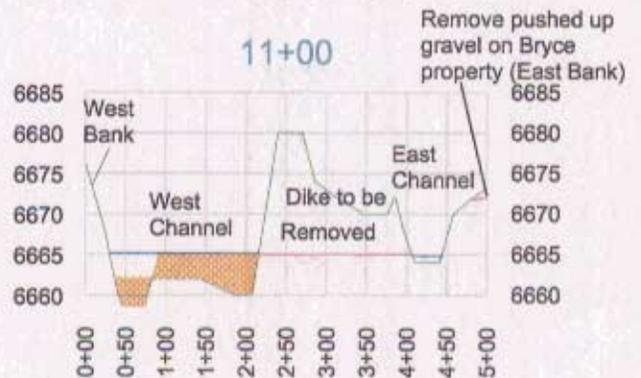
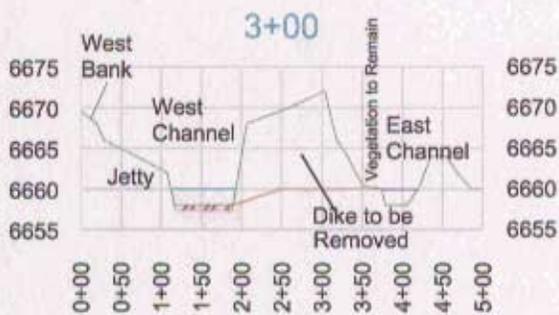
- Existing Surface (2002)
- Post Restoration
- Approximate West Channel Invert (2002)
- Approximate Natural Splay Fill (2005)
- ▨ Placed Fill
- Post Restoration West Channel
- East Channel
- Approx. 2 Yr High Watermark

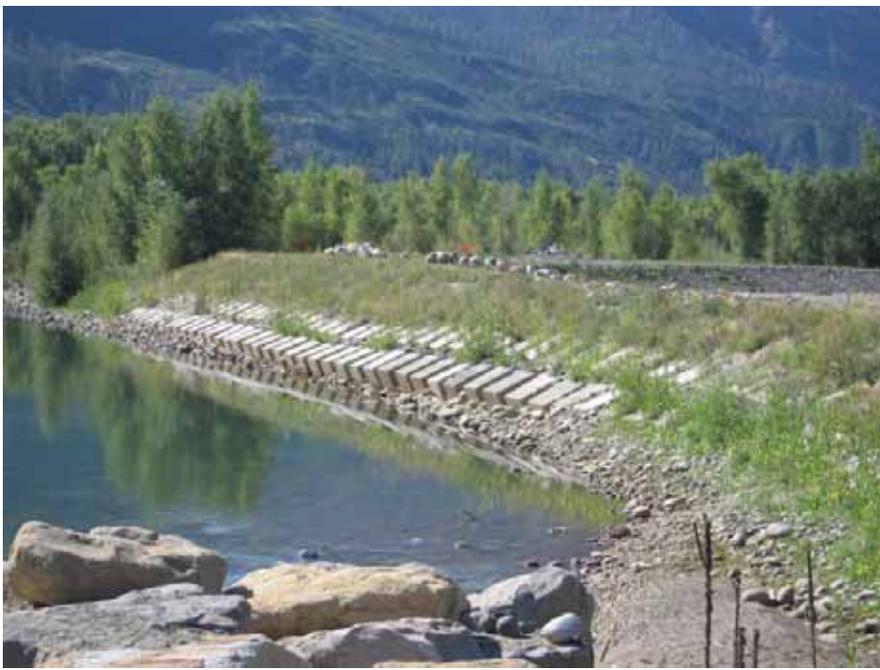
Figure 1: Image taken 9/6/05. Note undercutting of lower tier and inter-block erosion on east bank. Blocks were installed for embankment protection for an adjacent gravel pit lake under Permit 200275200.

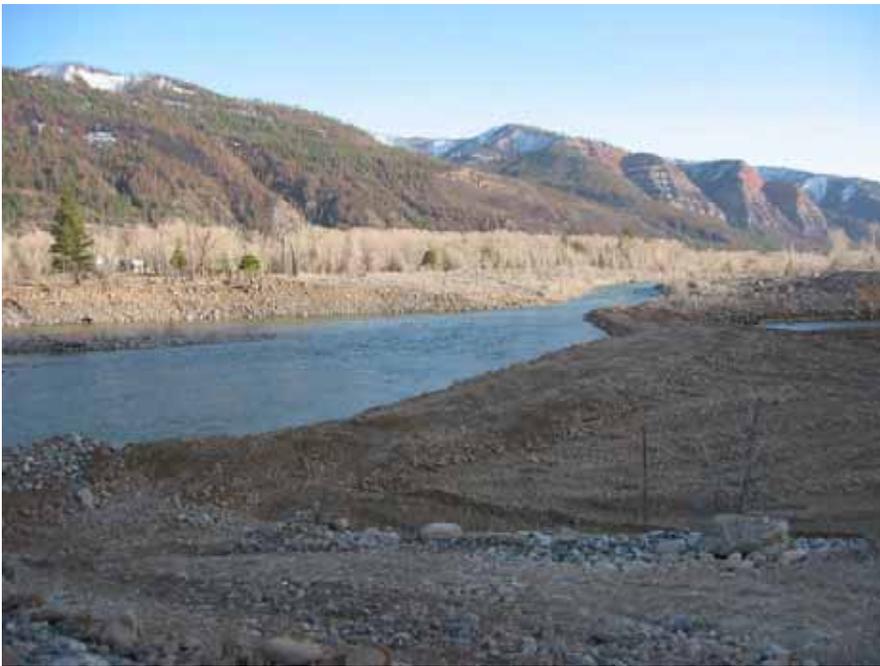
Figure 2: Cofferdam installation during construction of erosion control structures for Permit 200275200 on the same site. Similar dam to be installed for proposed operation. Dam top to be wide enough for one-way equipment traffic (approximately 20 feet).

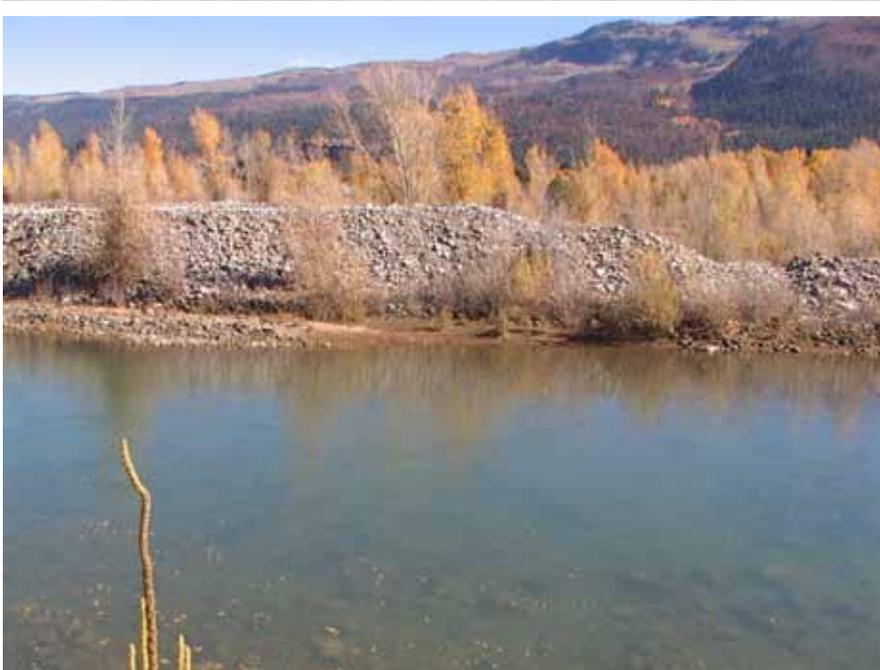
Figure 3: Picture of southern portion of dike from west bank looking east.

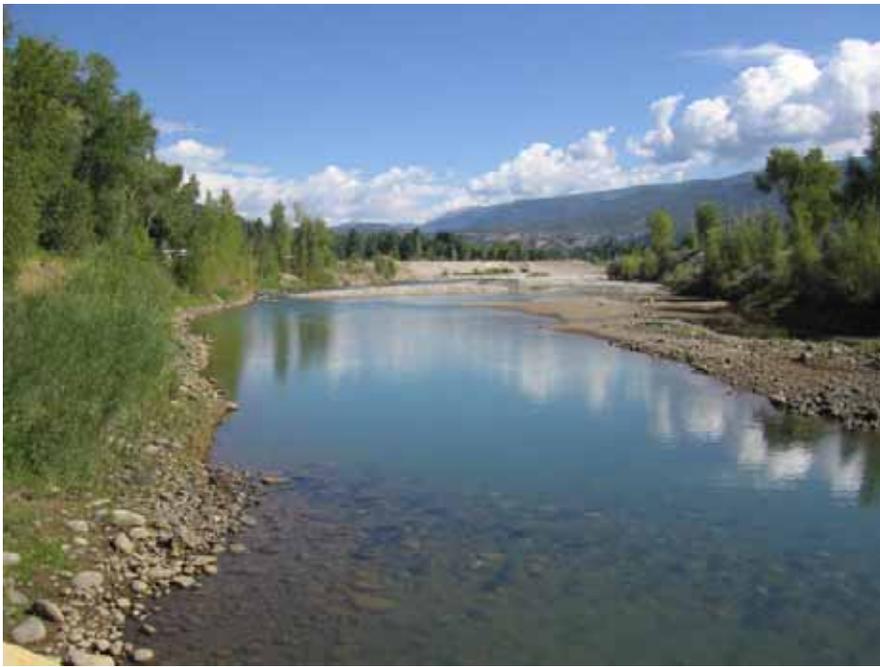
Figure 4: Remnant of dredge hole. Primary fill location.

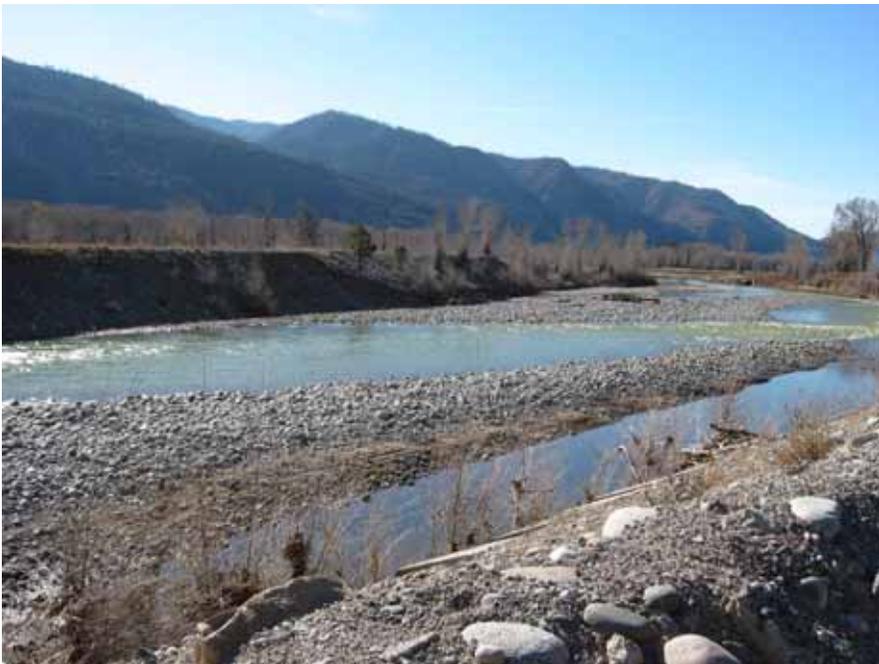
Figure 5 – Looking southeast from west bank with splays in west channel and dike in the shade.

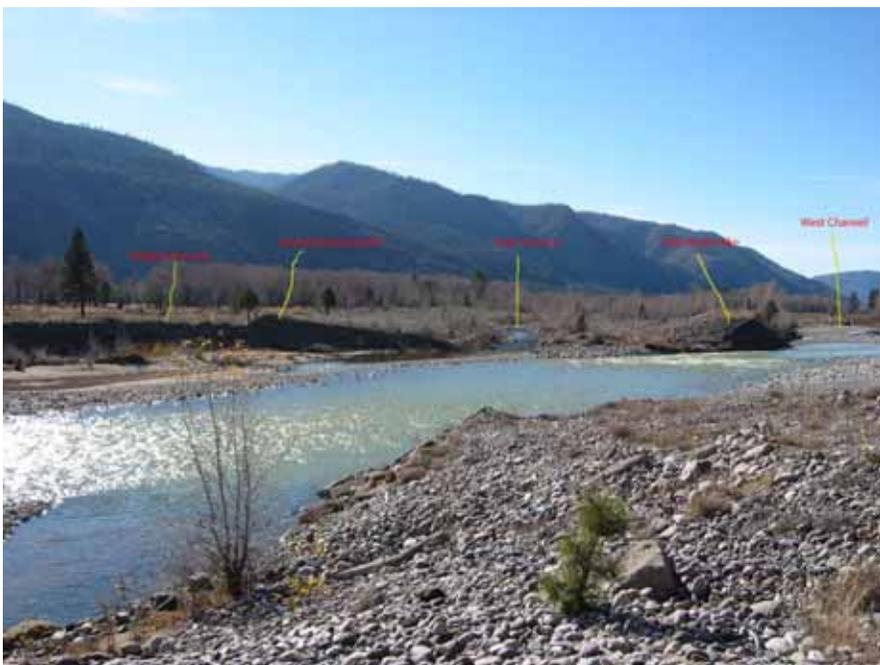
Figure 6 – North of dike looking south at dozer pushed area and both channels.
